## PHOTOGRAPHS

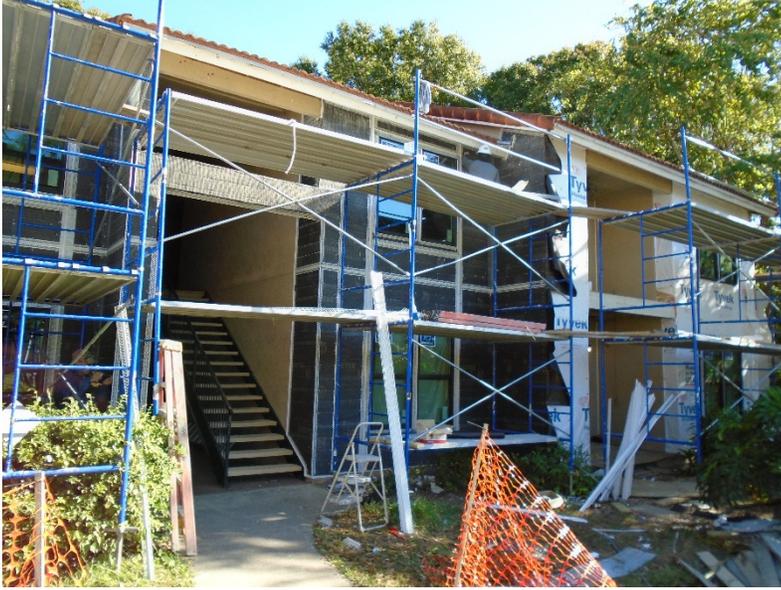
**PHOTOGRAPH #1**

### **BUILDING 10 SECTION G**

Sub-Contractor applying JumboTex WRB,  
lath and stucco accessories.

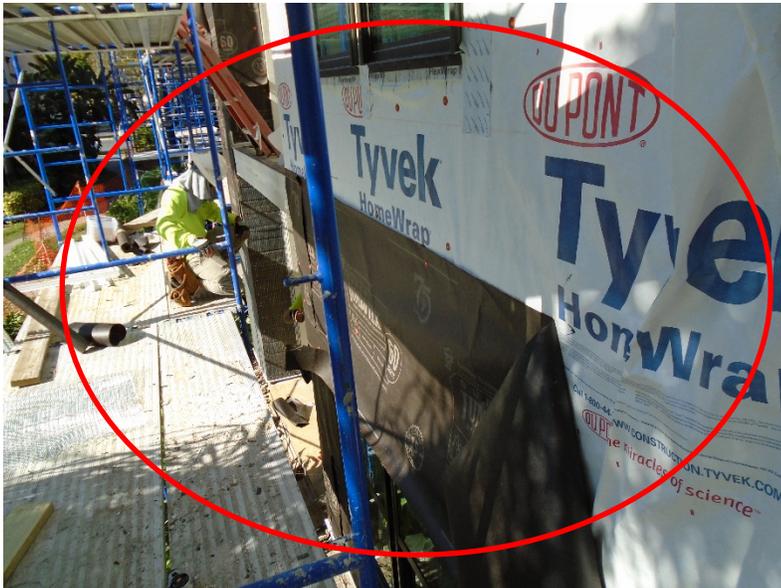
**PHOTOGRAPH #2**

### **BUILDING 10 SECTION G**

Sub-Contractor applying JumboTex WRB,  
lath and stucco accessories.

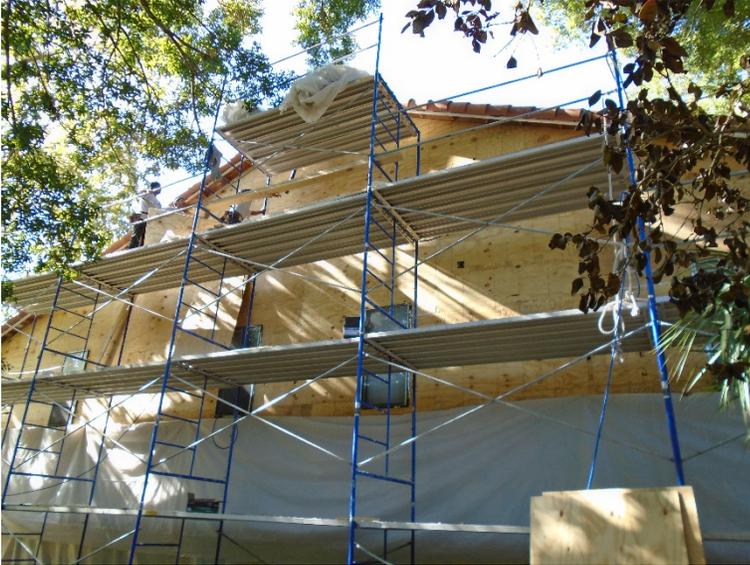
**PHOTOGRAPH #3**

**BUILDING 10  
SECTION H**

Contractor performing application of plywood sheathing.

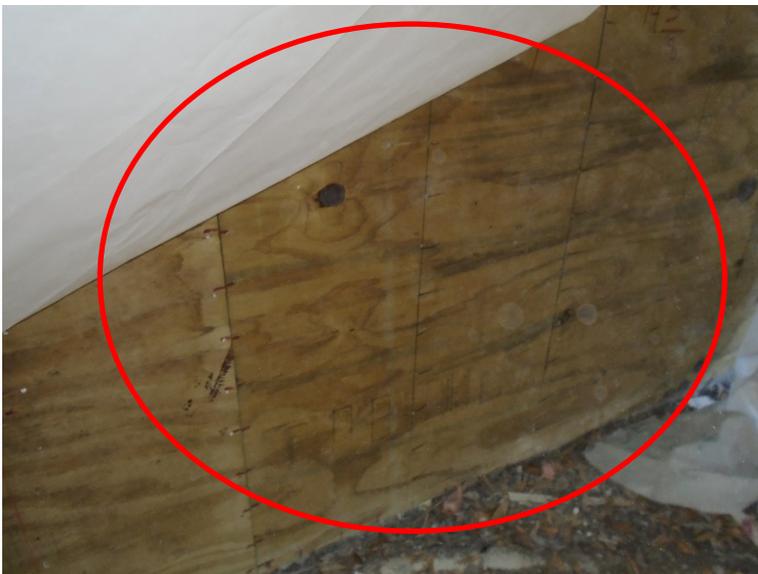
**PHOTOGRAPH #4**

**BUILDING 10  
SECTION H**

Pressure Treated plywood sheathing applied at lower section of wall.

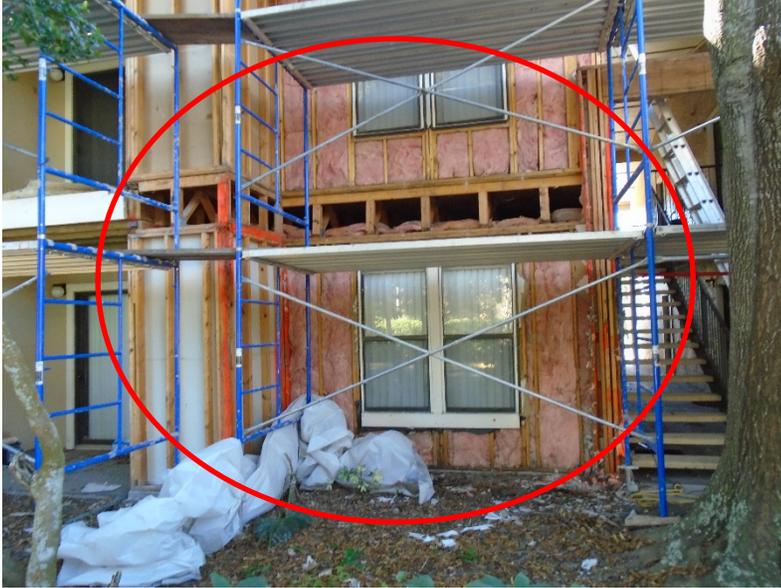
**PHOTOGRAPH #5**

**BUILDING 10  
SECTION A**

Framing damages assessed and marked for Contractor repairs.

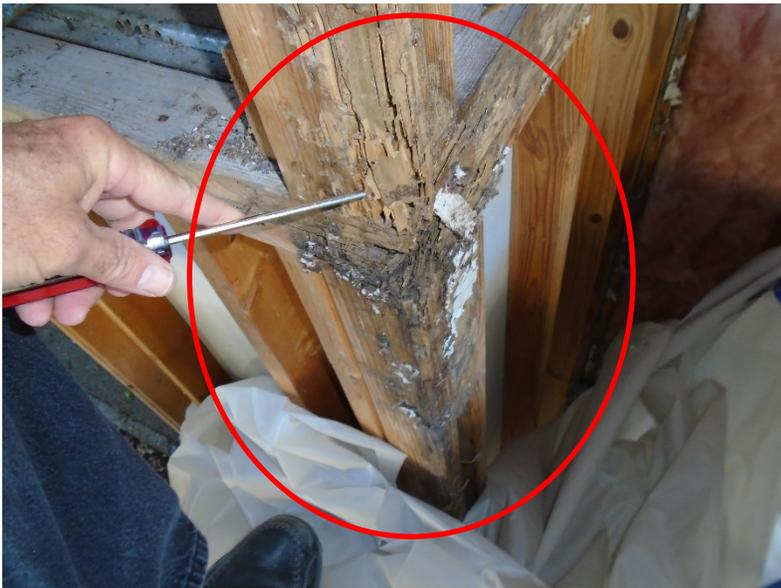
**PHOTOGRAPH #6**

**BUILDING 10  
SECTION A**

Framing damages assessed and marked for Contractor repairs.

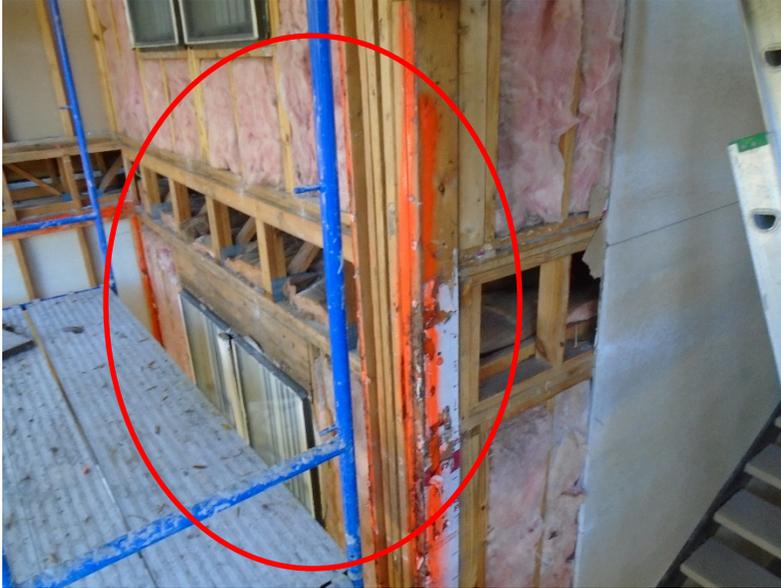
**PHOTOGRAPH #7**

**BUILDING 10  
SECTION A**

Framing damages assessed and marked for Contractor repairs.

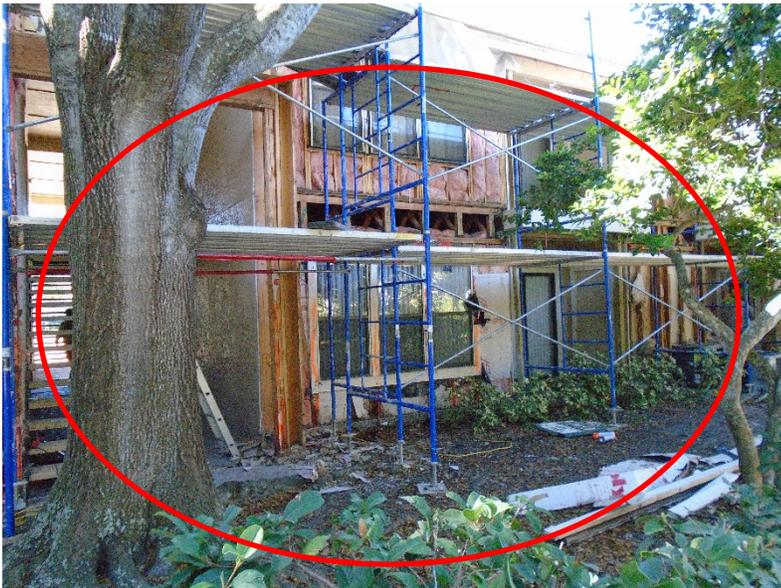
**PHOTOGRAPH #8**

**BUILDING 10  
SECTION B**

Framing damages assessed and marked for Contractor repairs.

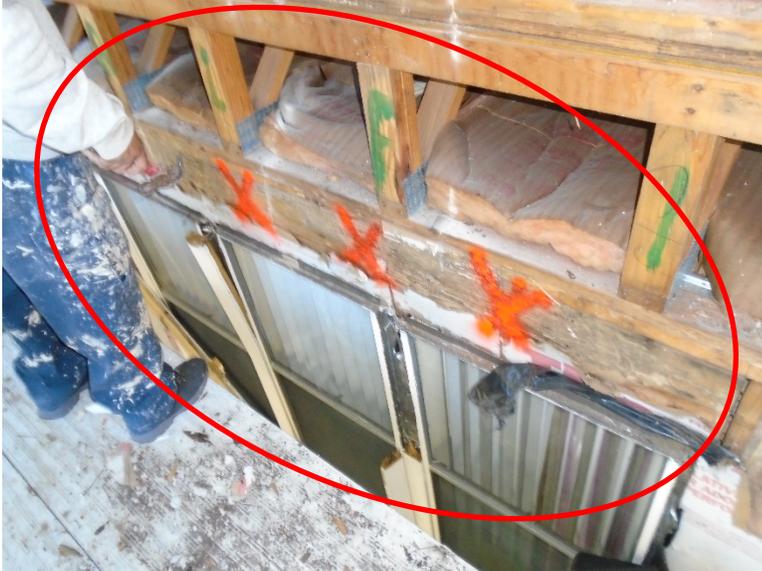
**PHOTOGRAPH #9**

**BUILDING 10  
SECTION B**

Framing damages assessed and marked for Contractor repairs.

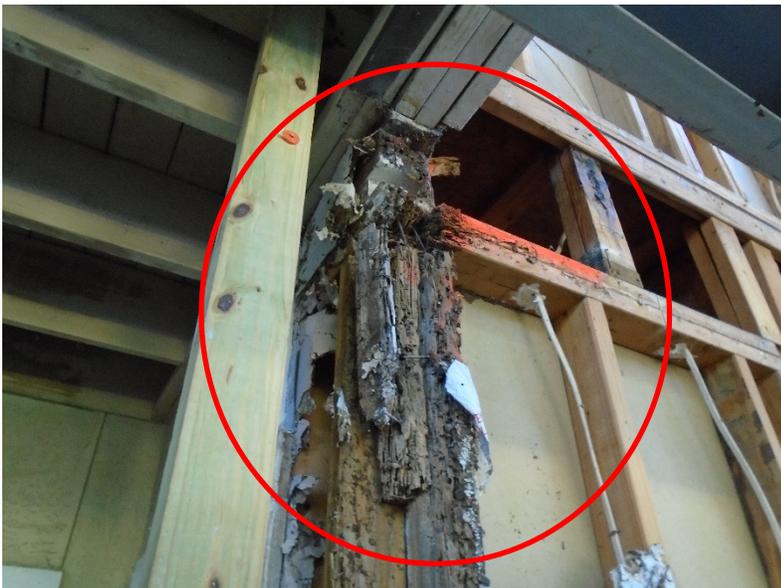
**PHOTOGRAPH #10**

**BUILDING 10  
SECTION B**

Framing damages assessed and marked for Contractor repairs. Additional demo required for further assessment.

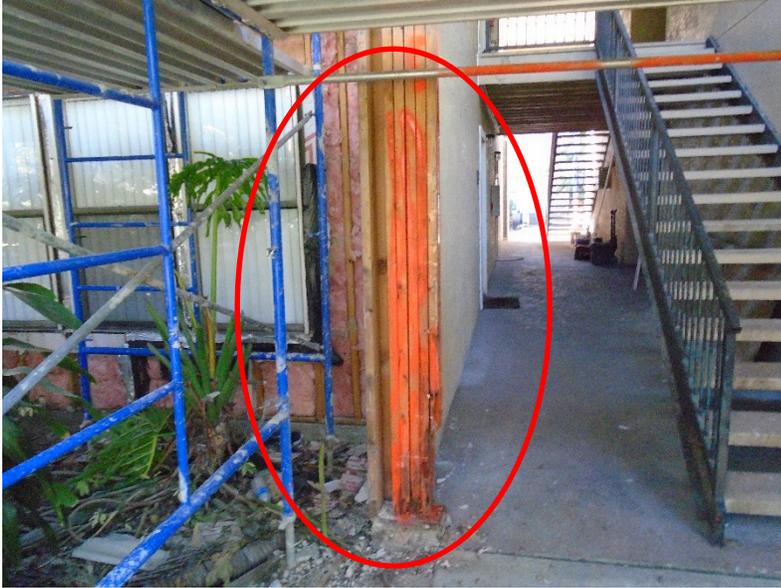
**PHOTOGRAPH #11**

**BUILDING 10  
SECTION C**

Framing damages assessed and marked for Contractor repairs.

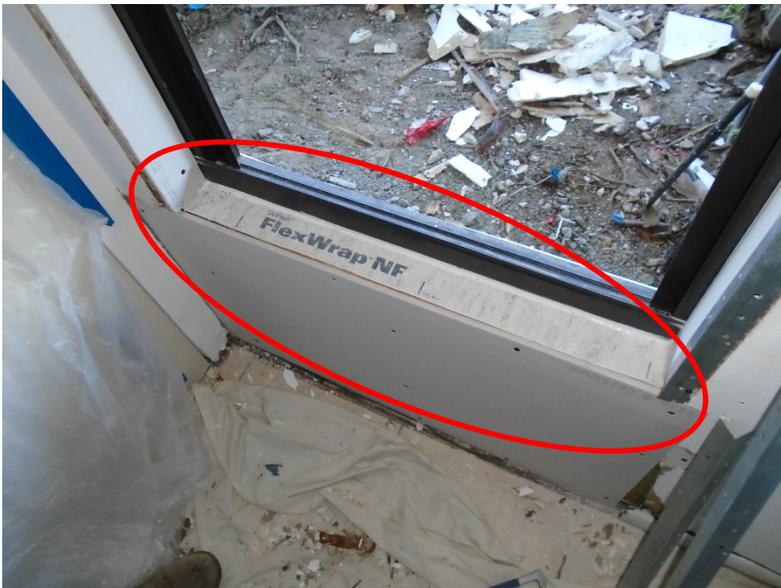
**PHOTOGRAPH #12**

**BUILDING 10  
SECTION D – UNIT #1018**

Contractor has installed new PGT window with DuPont flashings and begun drywall repairs.

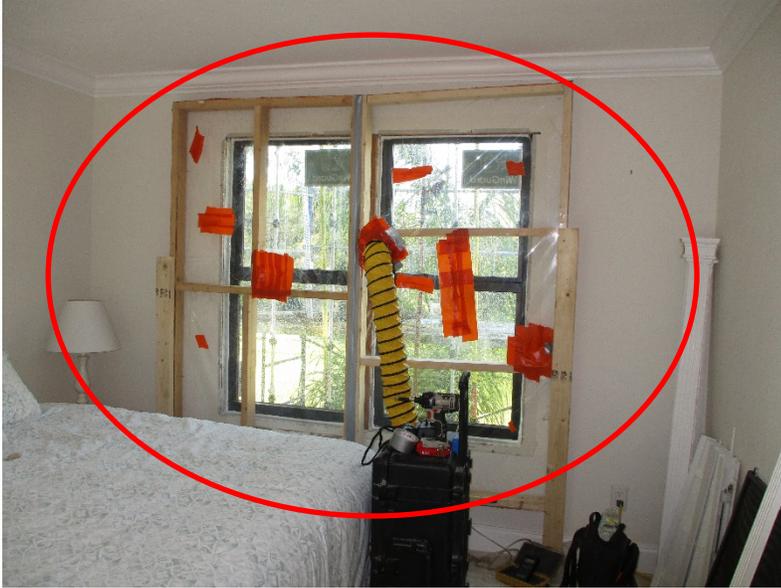
**PHOTOGRAPH #13**

**BUILDING 10  
SECTION G – UNIT #1022**

Double window - Independent testing agency performed AAMA 502 water testing at new windows. No leaks were detected.

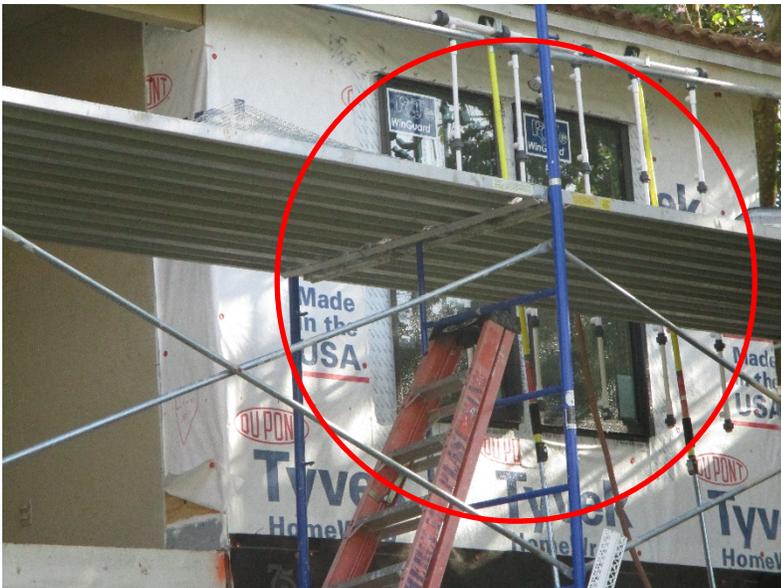
**PHOTOGRAPH #14**

**BUILDING 10  
SECTION G – UNIT #1022**

Double window - Independent testing agency performed AAMA 502 water testing at new windows. No leaks were detected.

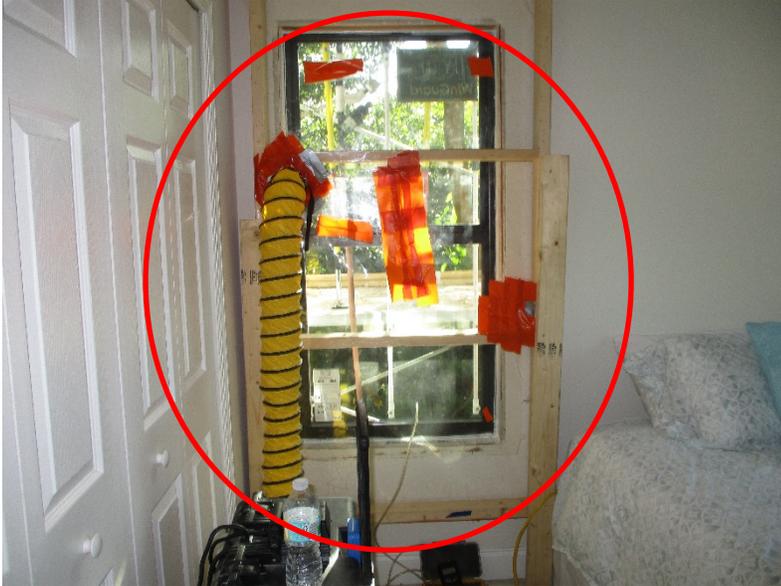
**PHOTOGRAPH #15**

**BUILDING 10  
SECTION H – UNIT #1022**

Single window - Independent testing agency performed AAMA 502 water testing at new windows. No leaks were detected.

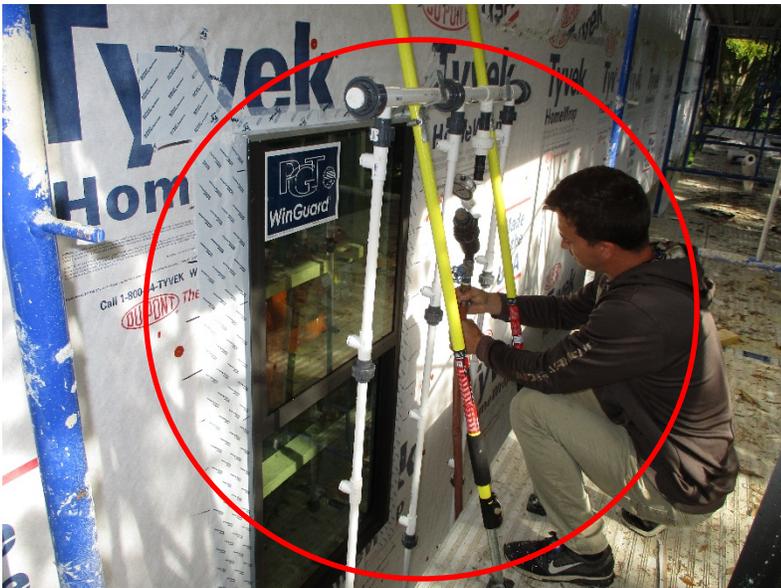
**PHOTOGRAPH #16**

**BUILDING 10  
SECTION H – UNIT #1022**

Single window - Independent testing agency performed AAMA 502 water testing at new windows. No leaks were detected.
