**PHOTOGRAPHS**

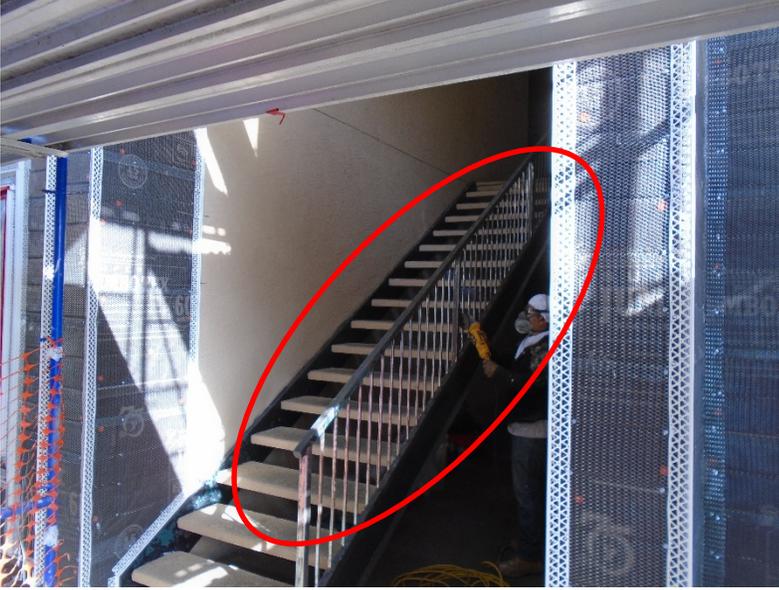
**PHOTOGRAPH #1**

**BUILDING 10  
SECTION E-BREEZWAY**

Contractor removing paint and rust from railings in preparation for priming and finish painting.

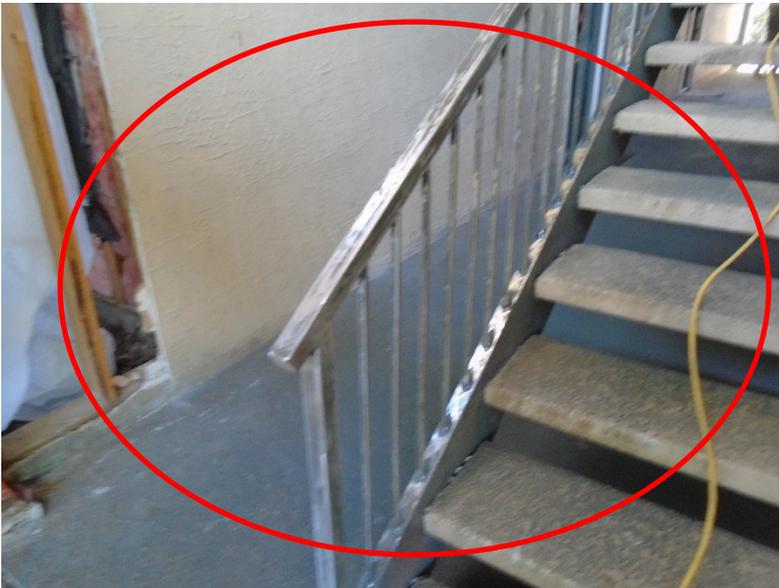
**PHOTOGRAPH #2**

**BUILDING 10  
SECTION E-BREEZWAY**

Contractor removing paint and rust from railings in preparation for priming and finish painting.

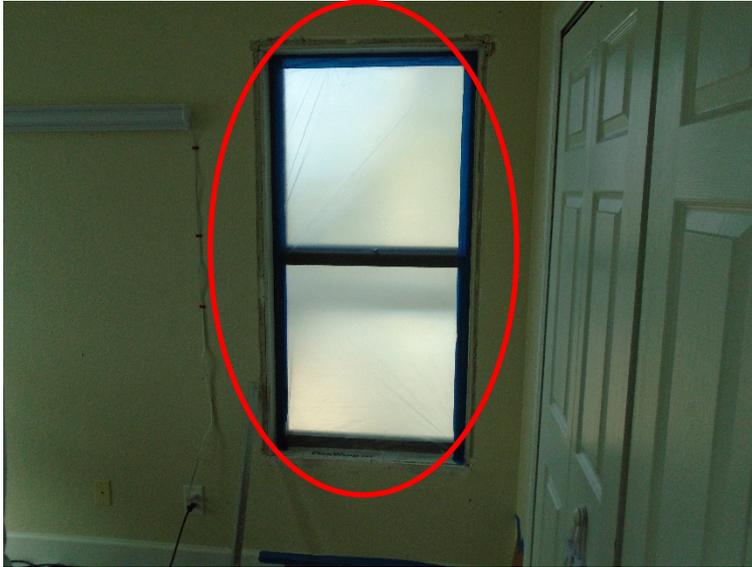
**PHOTOGRAPH #3**

**BUILDING 10  
SECTION E – UNIT #1028**

Contractor refinishing drywall at new window installation.

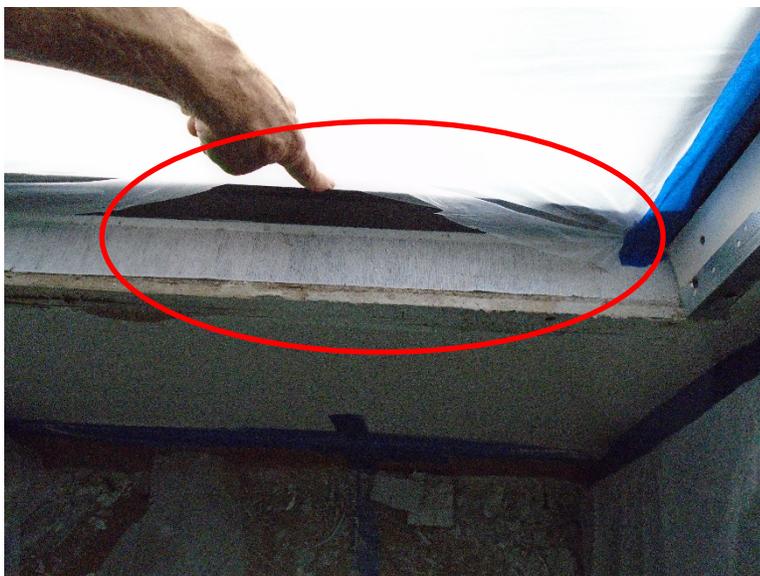
**PHOTOGRAPH #4**

**BUILDING 10  
SECTION E – UNIT #1028**

Window opening flashed with DuPont flashing and interior sealant installed.

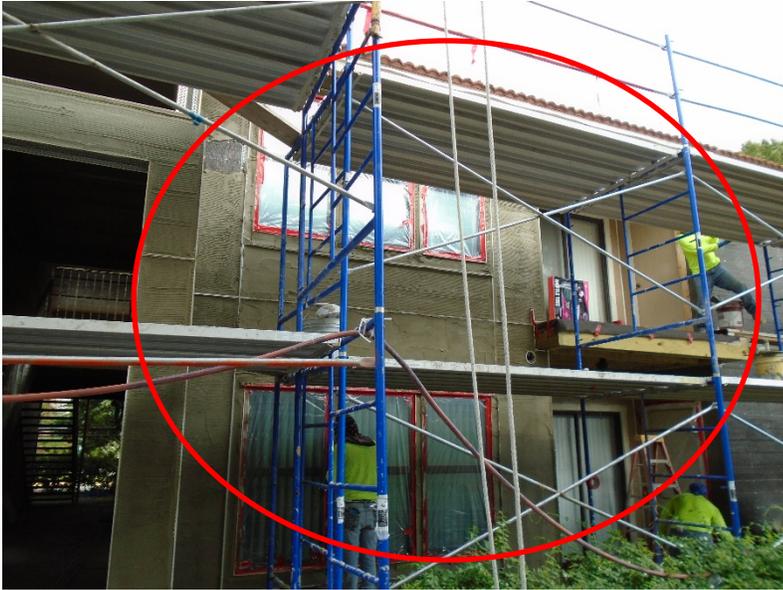
**PHOTOGRAPH #5**

**BUILDING 10  
SECTION F**

Stucco sub-contractor applying scratch coat of stucco.

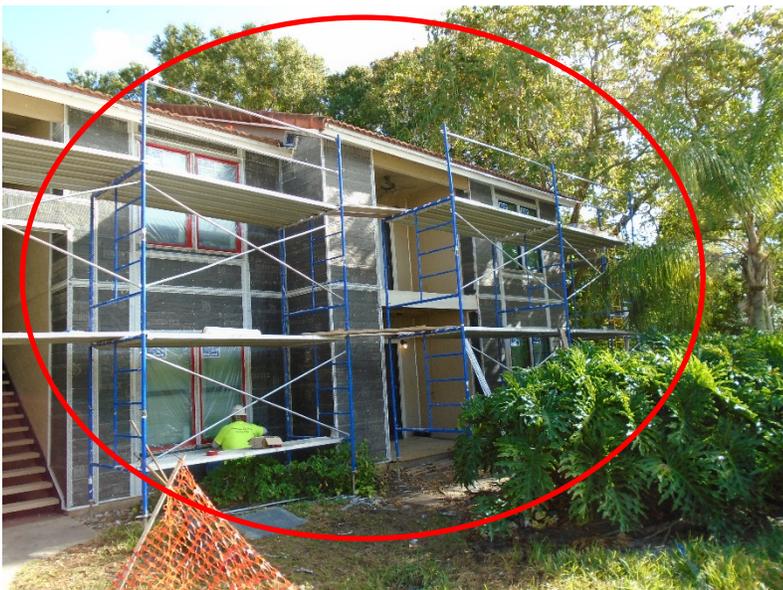
**PHOTOGRAPH #6**

**BUILDING 10  
SECTION G**

Water resistant barrier, stucco accessories and lath in place and ready for stucco application.

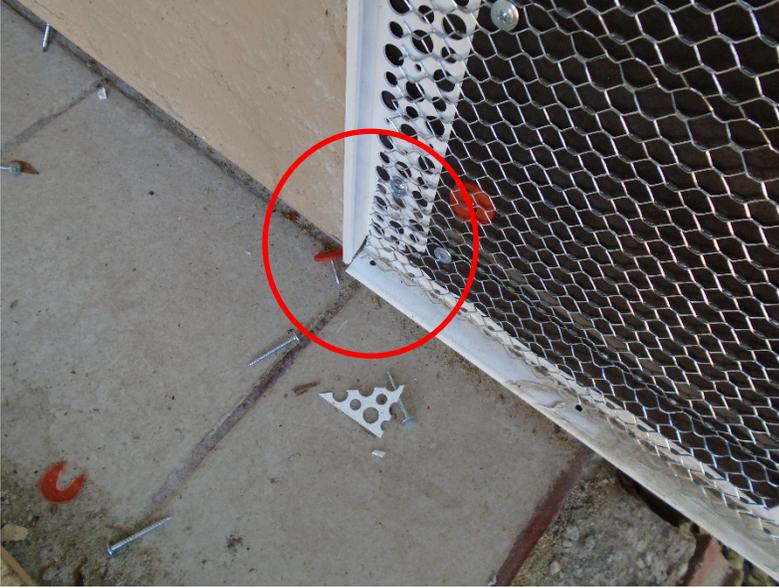
**PHOTOGRAPH #7**

**BUILDING 10  
SECTION G**

Corner of stucco accessories missing required sealant. Contractor notified.

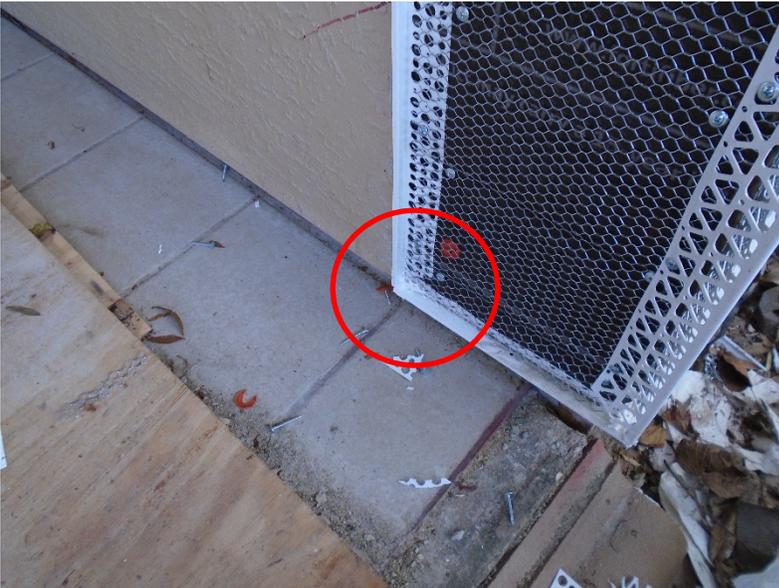
**PHOTOGRAPH #8**

**BUILDING 10  
SECTION G**

Sub-contractor made corrections by applying sealant at accessory transition.

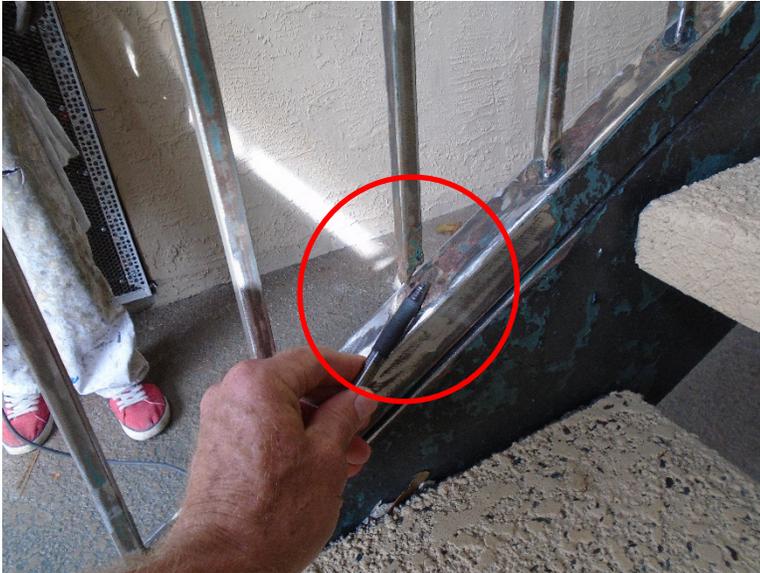
**PHOTOGRAPH #9**

**BUILDING 10  
SECTION G- BREEZWAY**

Steel railing picket has broken loose where deteriorated.

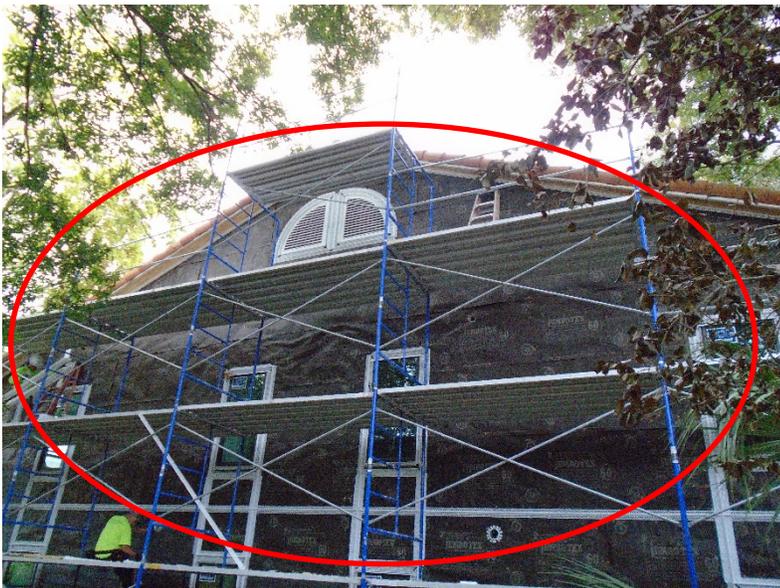
**PHOTOGRAPH #10**

**BUILDING 10  
SECTION H**

Sub-contractor has applied JumboTex 60 and in process of installing stucco accessories.

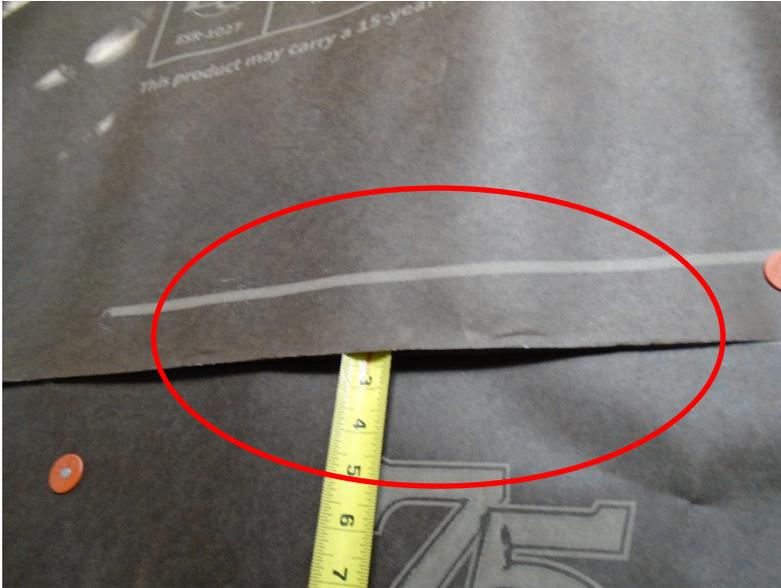
**PHOTOGRAPH #11**

**BUILDING 10  
SECTION H**

JumboTex 60 WRB overlapped as per manufacturers installation instructions.

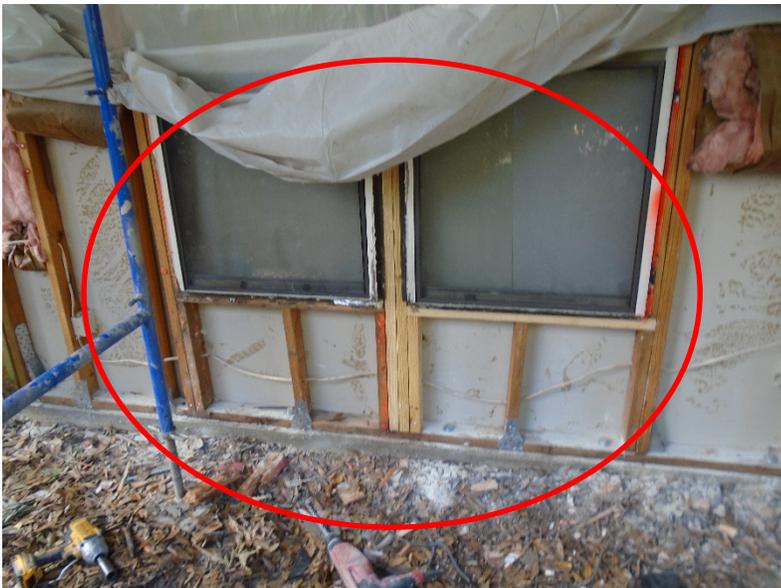
**PHOTOGRAPH #12**

**BUILDING 10  
SECTION A**

Contractor has made repairs at damaged window framing.

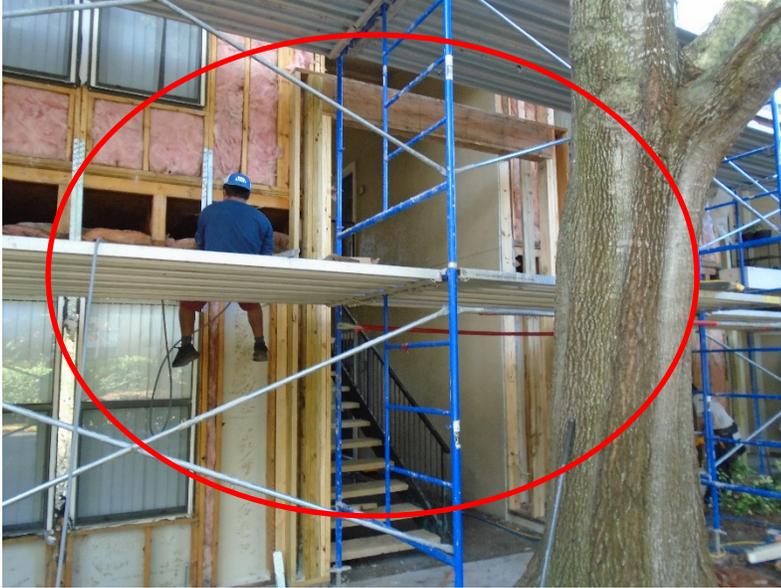
**PHOTOGRAPH #13**

**BUILDING 10  
SECTION A**

Contractor installing Simpson Strong-Tie straps and connectors.

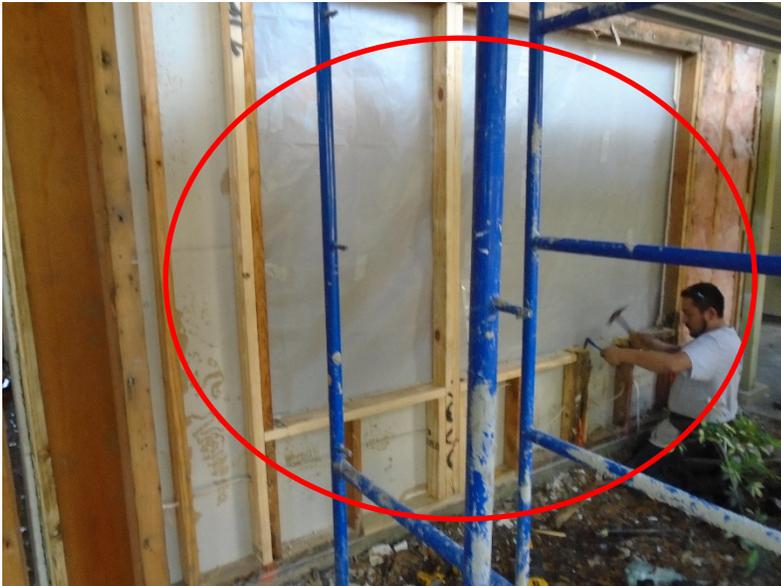
**PHOTOGRAPH #14**

**BUILDING 10  
SECTION B**

Contractor performing framing repairs at triple window.

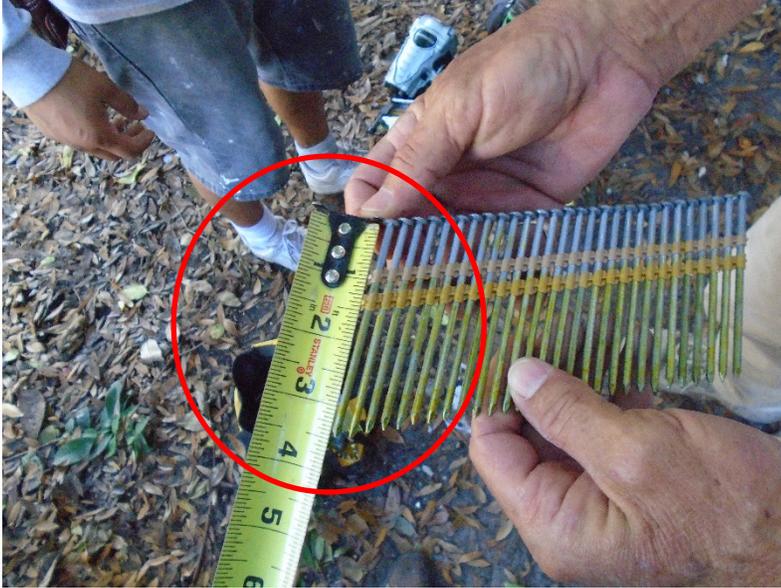
**PHOTOGRAPH #15**

**BUILDING 10  
SECTION B**

Contractor using 16d common nails for framing repairs.

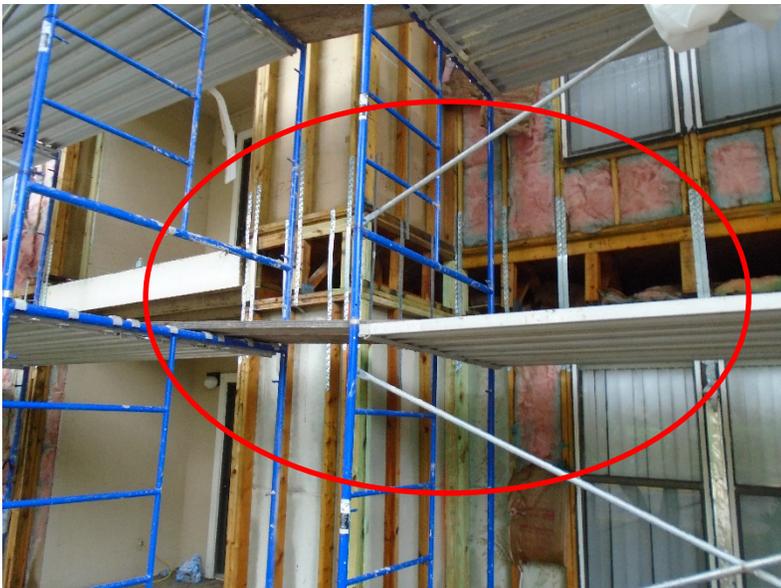
**PHOTOGRAPH #16**

**BUILDING 10  
SECTION B**

Contractor has installed Simpson Strong-Tie straps and connectors.

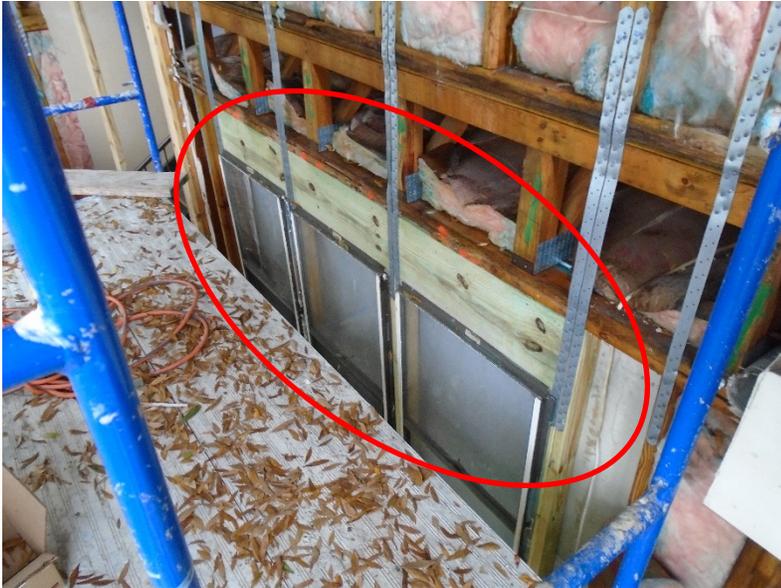
**PHOTOGRAPH #17**

**BUILDING 10  
SECTION B**

Contractor has made window header repairs at triple window.

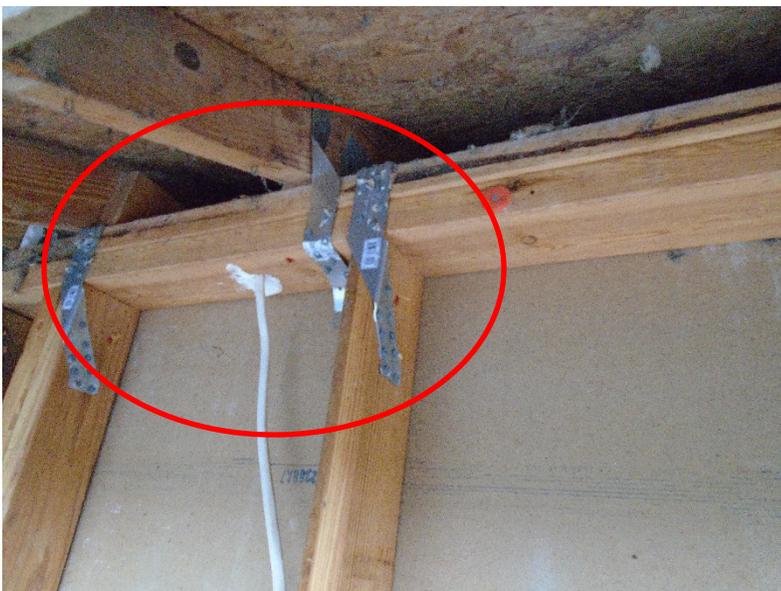
**PHOTOGRAPH #18**

**BUILDING 10  
SECTION B**

Simpson Strong-Tie connectors and screws have been installed at top plate and truss connections.
