PHOTOGRAPHS

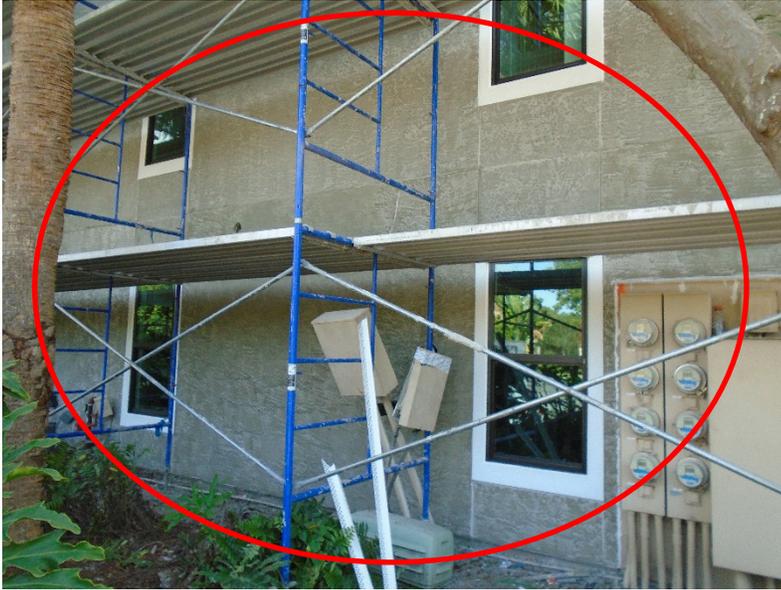
PHOTOGRAPH #1

BUILDING 10 SECTION D

Stucco sub-contractor has completed finish coat of stucco.

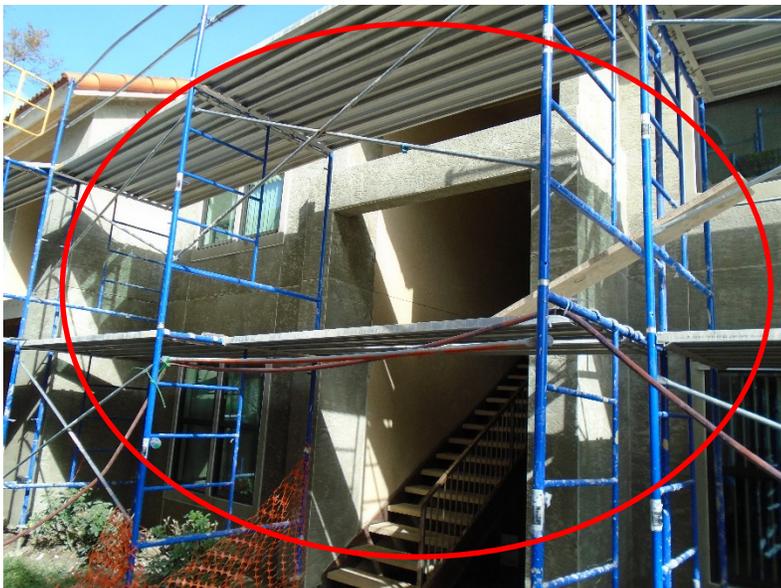
PHOTOGRAPH #2

BUILDING 10 SECTION E

Stucco sub-contractor has completed finish coat of stucco.

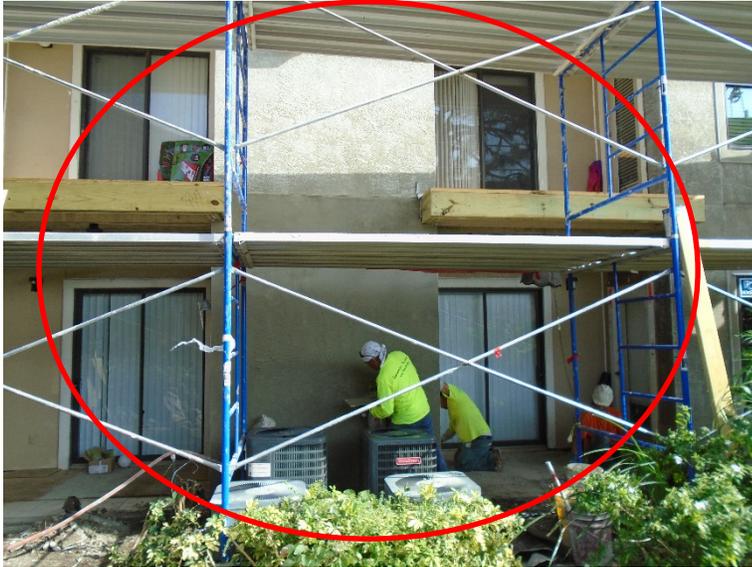
PHOTOGRAPH #3

**BUILDING 10
SECTION F**

Stucco sub-contractor applying brown coat of stucco.

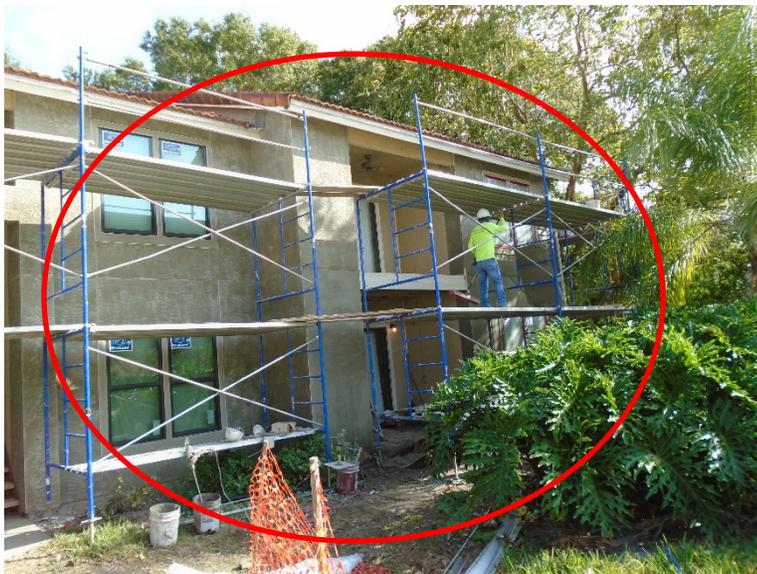
PHOTOGRAPH #4

**BUILDING 10
SECTION G**

Stucco sub-contractor has completed finish coat of stucco.

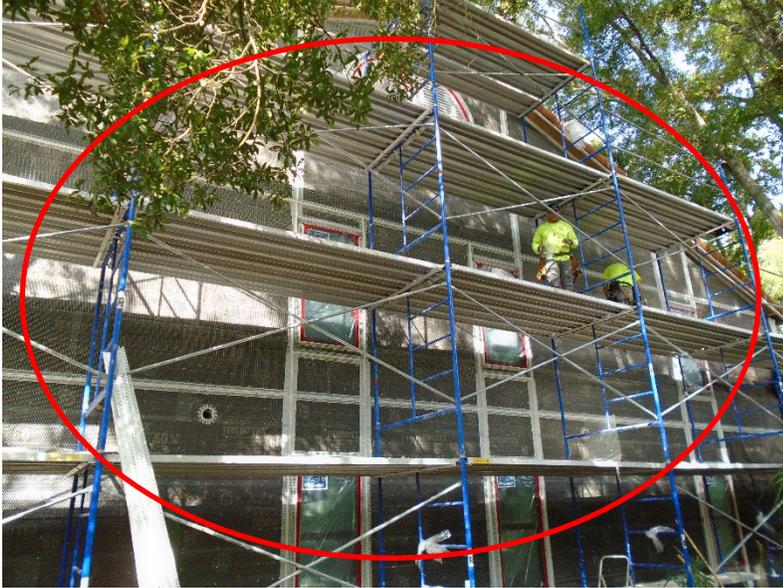
PHOTOGRAPH #5

**BUILDING 10
SECTION H**

Stucco sub-contractor applying stucco accessories and metal lath.

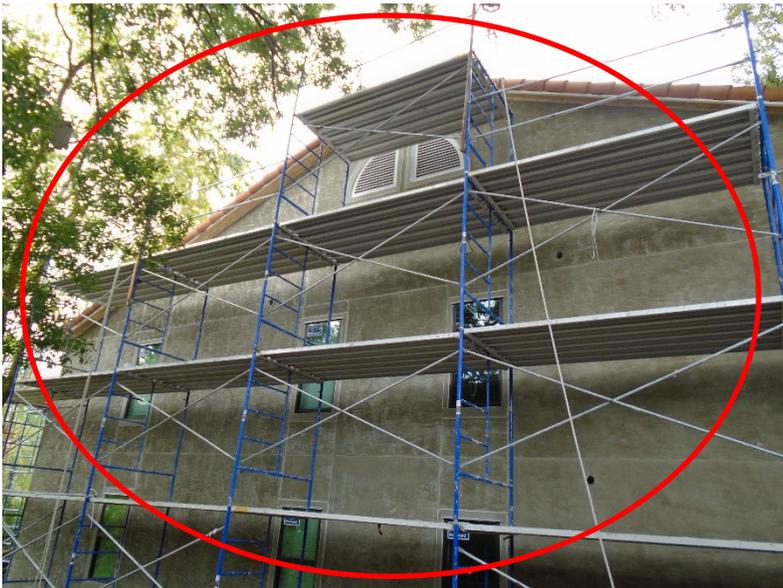
PHOTOGRAPH #6

**BUILDING 10
SECTION H**

Stucco sub-contractor has completed finish coat of stucco.

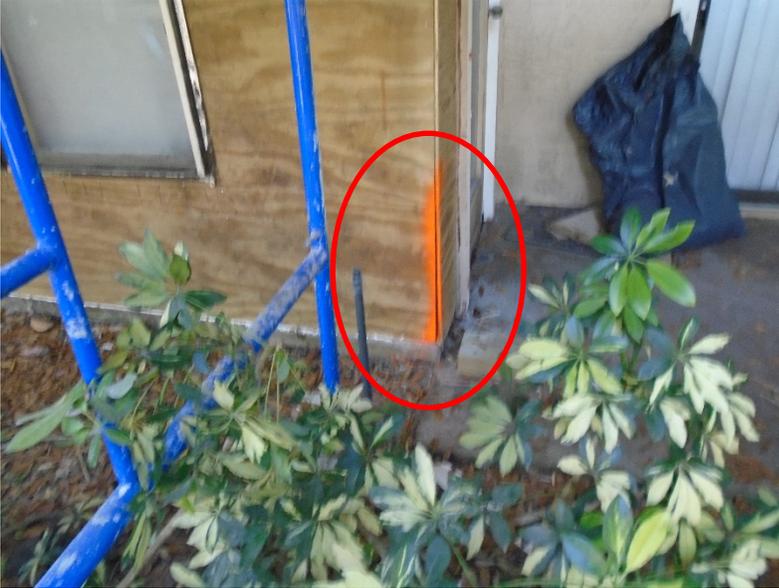
PHOTOGRAPH #7

**BUILDING 10
SECTION A**

Gap at sheathing corner.

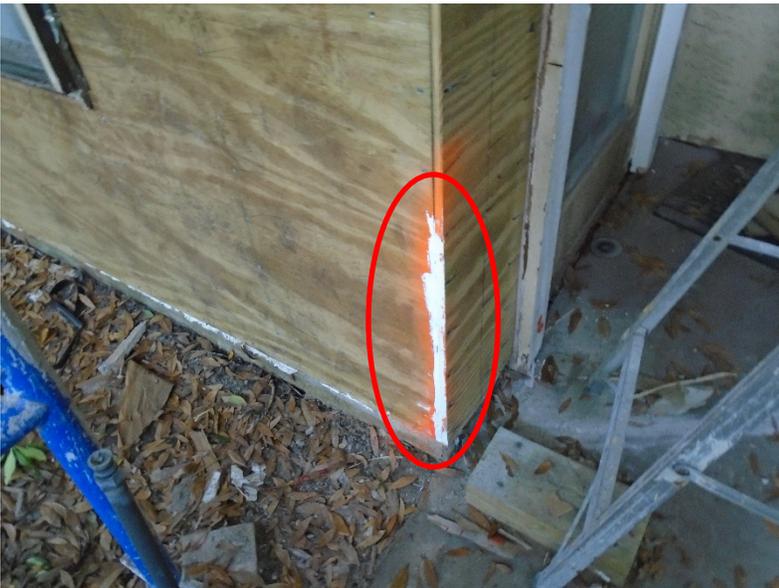
PHOTOGRAPH #8

**BUILDING 10
SECTION A**

Contractor has sealed gap at sheathing corner.

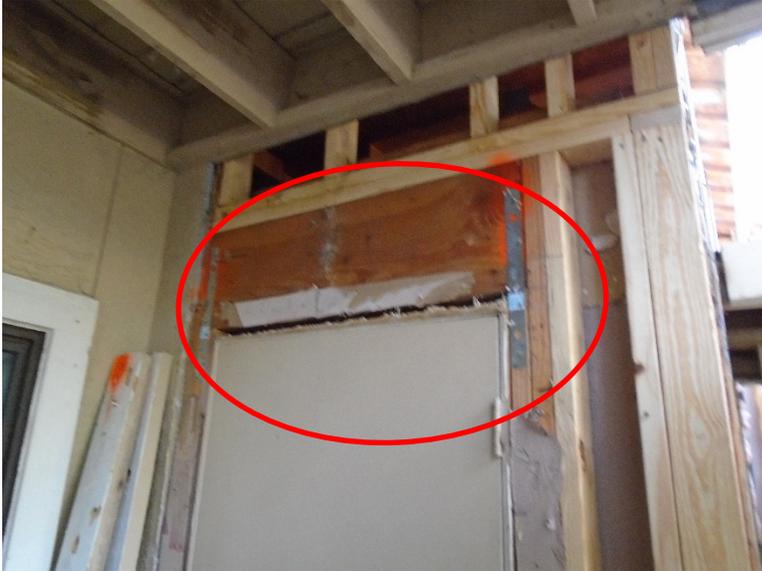
PHOTOGRAPH #9

**BUILDING 10
SECTION B**

Simpson Strong-Tie Strapping installed at header repair.

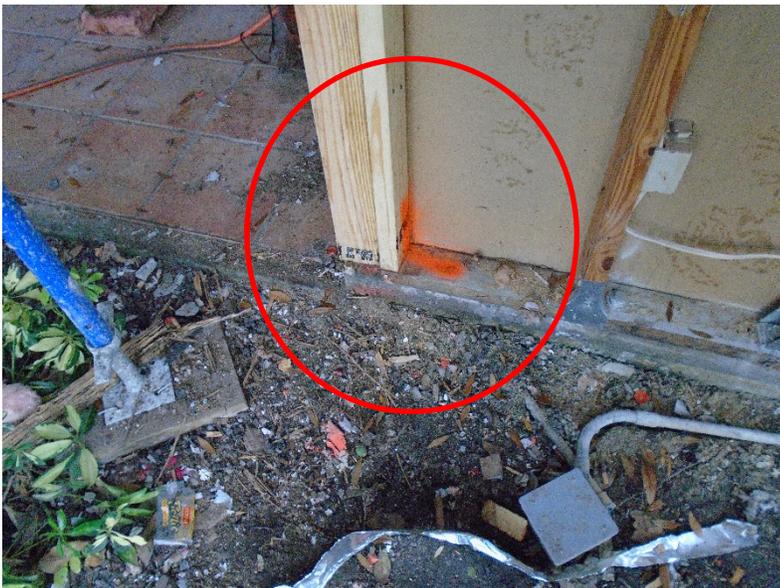
PHOTOGRAPH #10

**BUILDING 10
SECTION C**

Simpson Strong-Tie HTT4 connector and Titen HD anchor required at framing to Bottom plate.

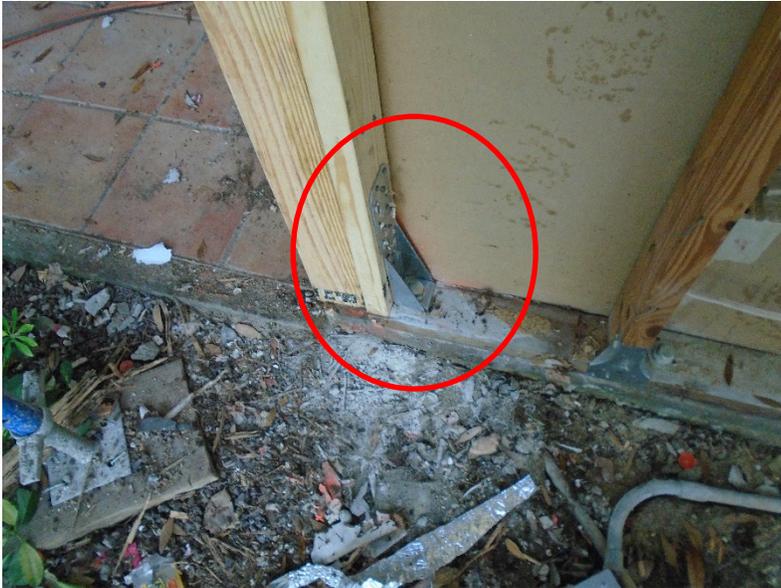
PHOTOGRAPH #11

**BUILDING 10
SECTION C**

Contractor has installed Simpson Strong-Tie HTT4 connector and Titen HD anchor at framing to Bottom plate.

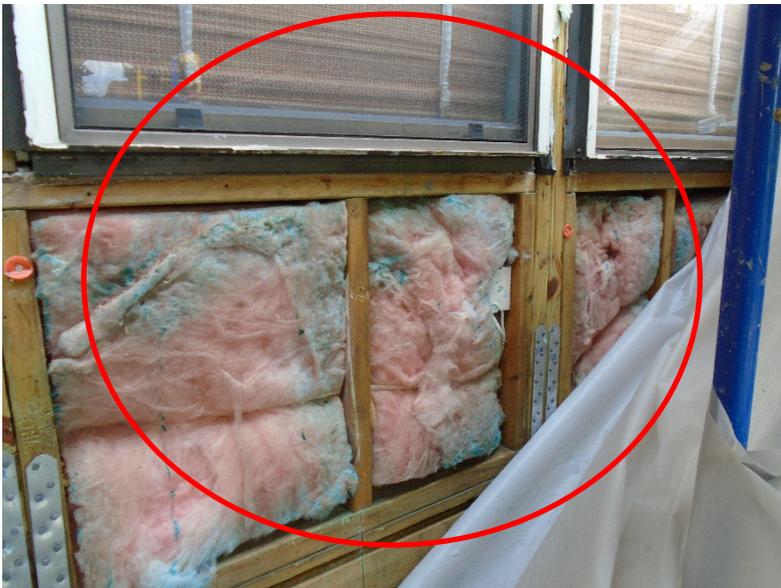
PHOTOGRAPH #12

**BUILDING 10
SECTION C**

Bora Care termite treatment has been applied to framing by termite contractor.

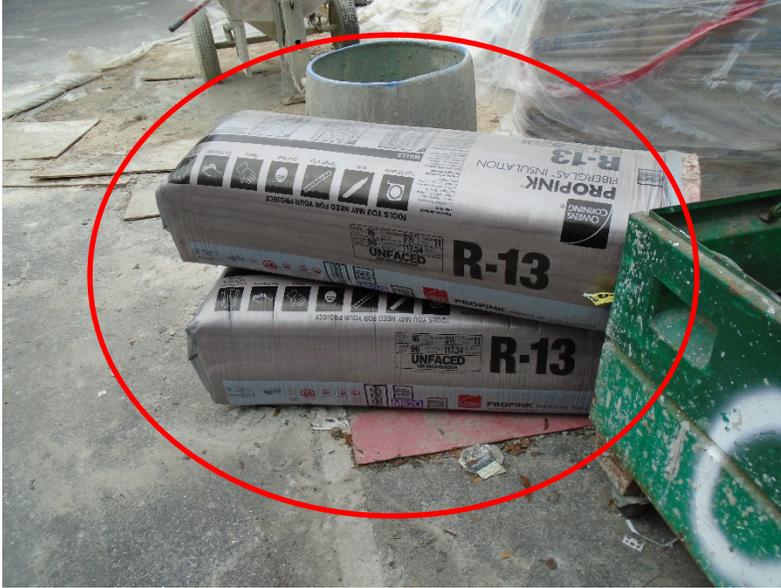
PHOTOGRAPH #13

**BUILDING 10
SECTION C**

Contractor installing R-13 insulation where missing or damaged.
