PHOTOGRAPHS

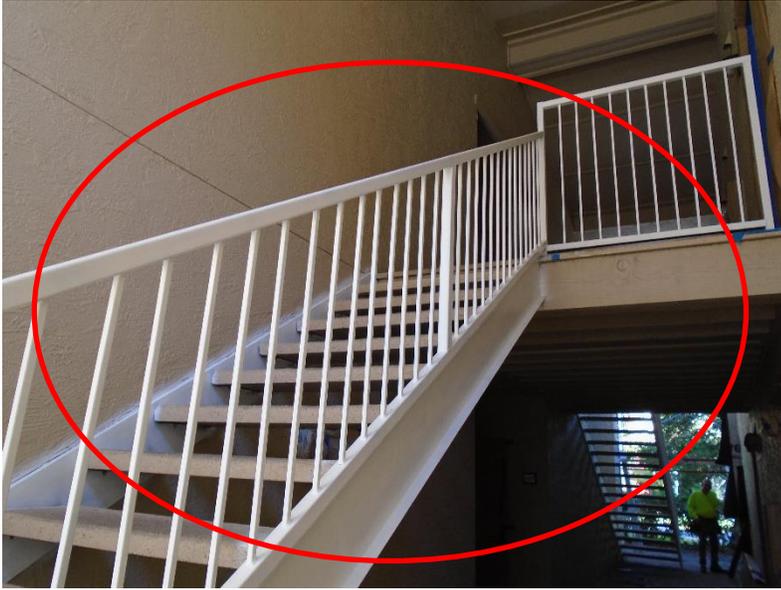
PHOTOGRAPH #1

**BUILDING 10
SECTION E**

Breezeway railings primed with
Encapsulon Epoxy Mastic Primer.

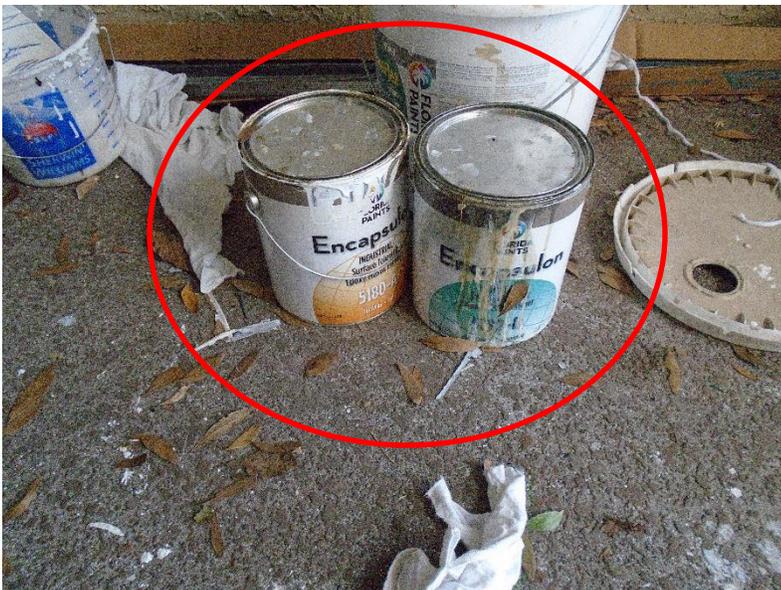
PHOTOGRAPH #2

**BUILDING 10
SECTION E**

Breezeway railings primed with
Encapsulon Epoxy Mastic Primer.

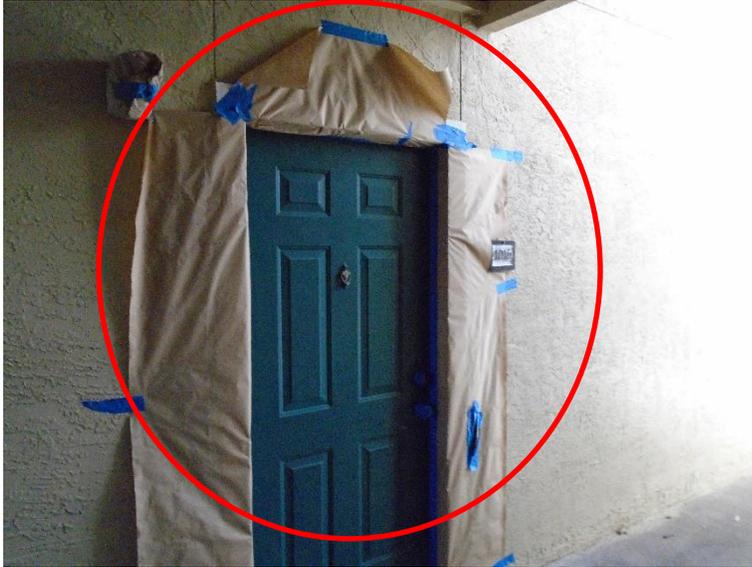
PHOTOGRAPH #3

**BUILDING 10
SECTION E**

Metal front doors prepped and protected for prime and finish paint.

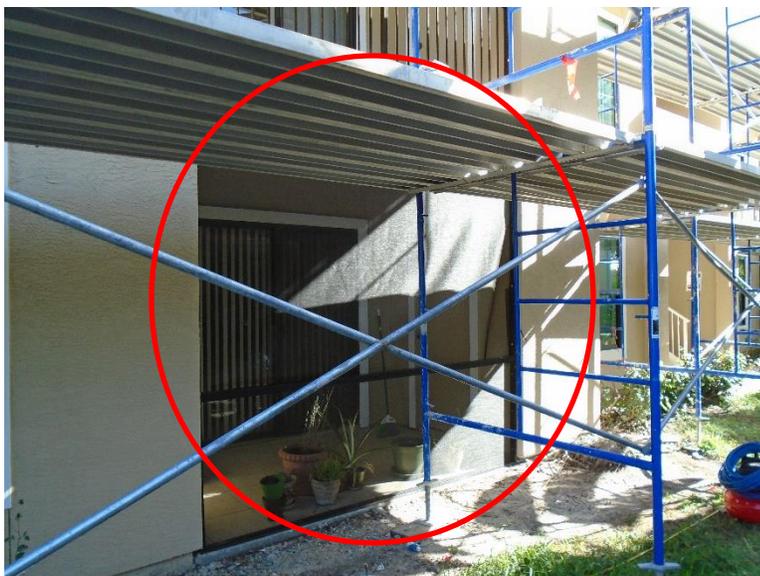
PHOTOGRAPH #4

**BUILDING 10
SECTION E**

Screen enclosures being installed at lower units.

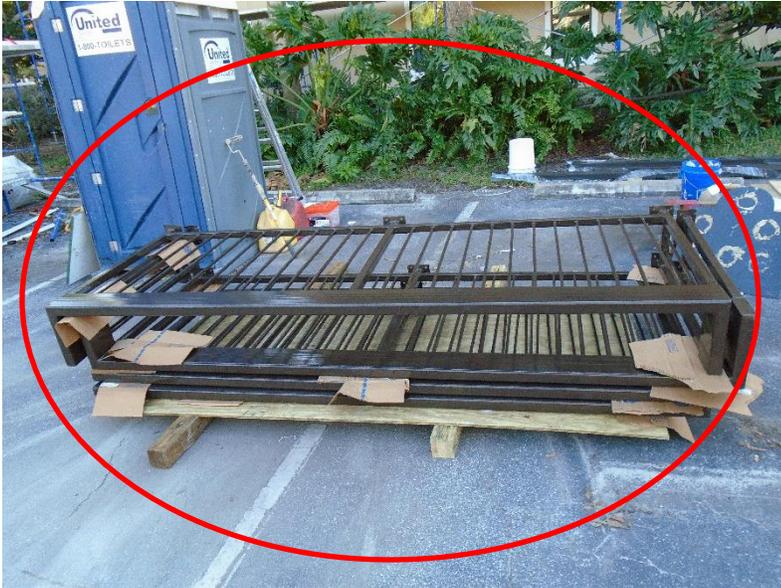
PHOTOGRAPH #5

**BUILDING 10
SECTION F**

Balcony railings finish painted and ready for installation.

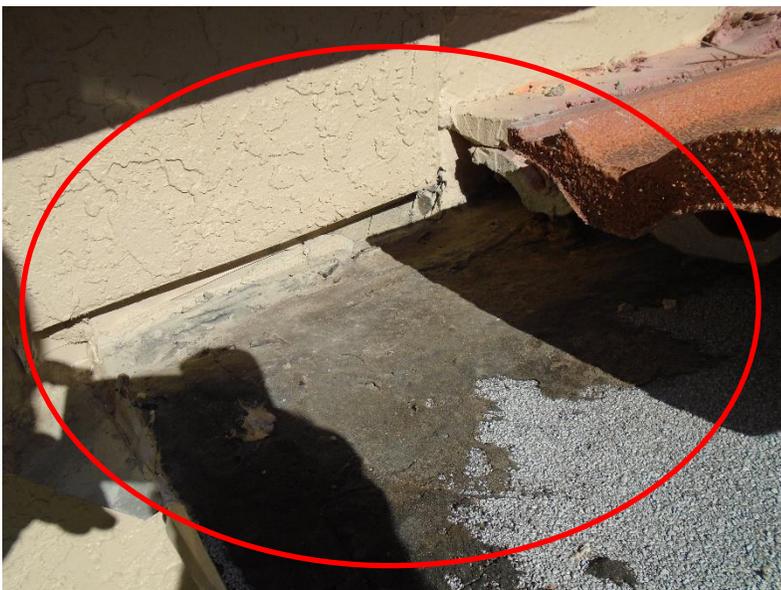
PHOTOGRAPH #6

**BUILDING 10
SECTION F**

Roofing tiles removed at kick out flashing detail will be patched with full bed of roofing mastic before tiles are reinstalled.

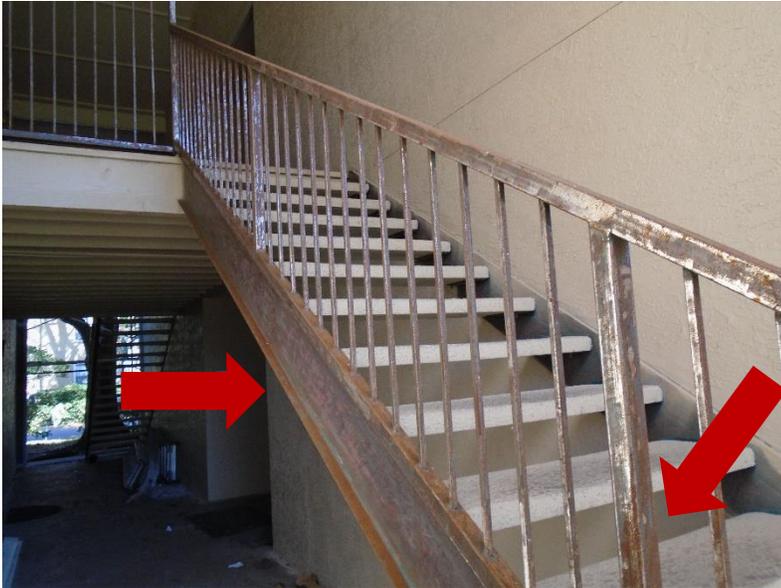
PHOTOGRAPH #7

**BUILDING 10
SECTION G**

Breezeway railing exhibiting surface rust after paint removal. Contractor will remove surface rust prior to primer application.

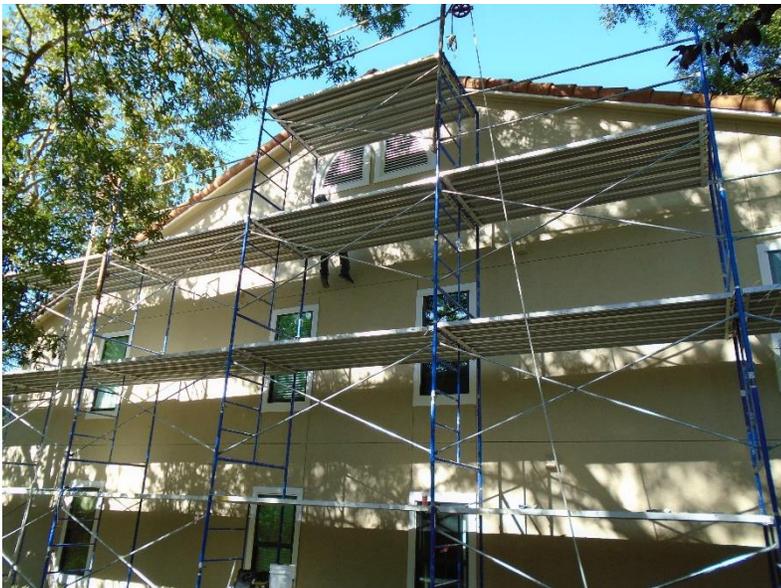
PHOTOGRAPH #8

**BUILDING 10
SECTION H**

New stucco walls and trim being painted with Florida Paints Supercoat 100% acrylic.

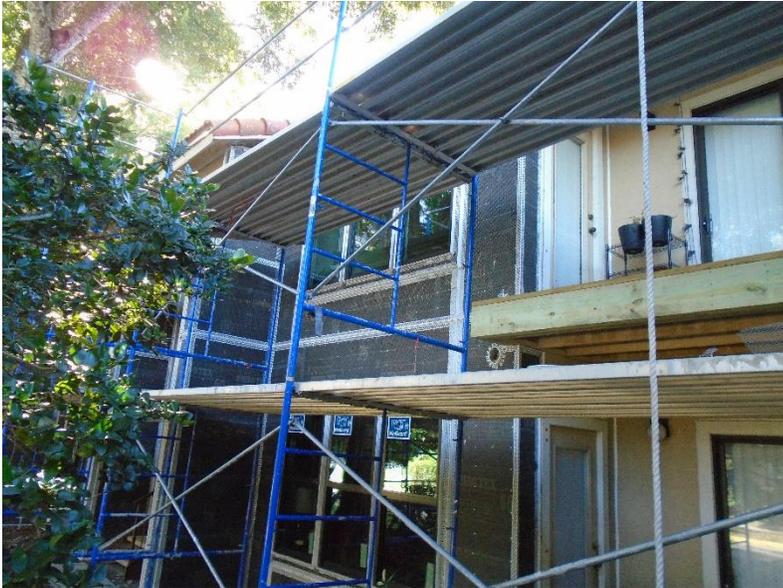
PHOTOGRAPH #9

**BUILDING 10
SECTION B**

Sub-contractor has applied stucco accessories and metal lath in preparation for new stucco applications.

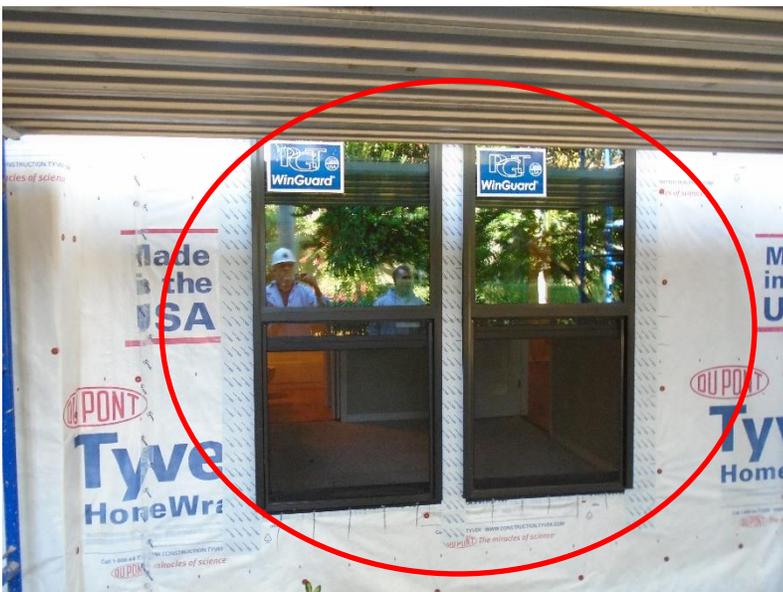
PHOTOGRAPH #10

**BUILDING 10
SECTION C**

New windows installed with DuPont flashings.
