PHOTOGRAPHS

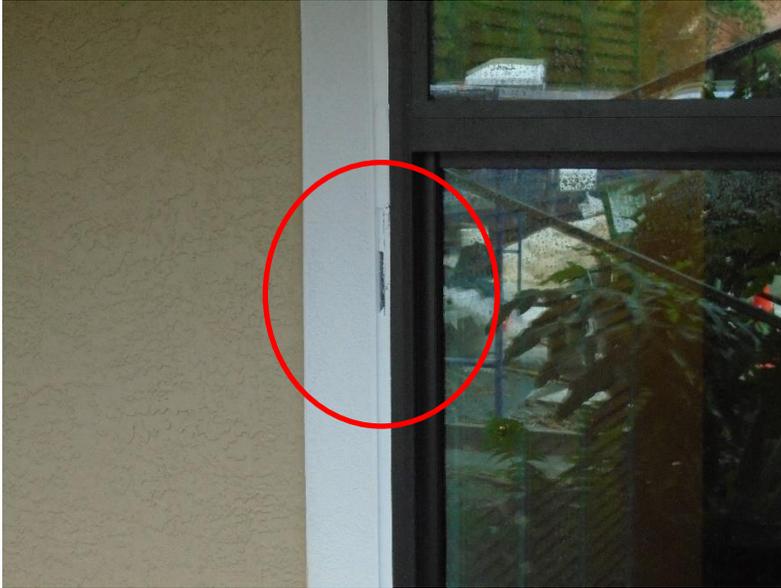
PHOTOGRAPH #1

**BUILDING 10
SECTION D**

Delta performed and passed sealant
adhesion pull test at lower window.

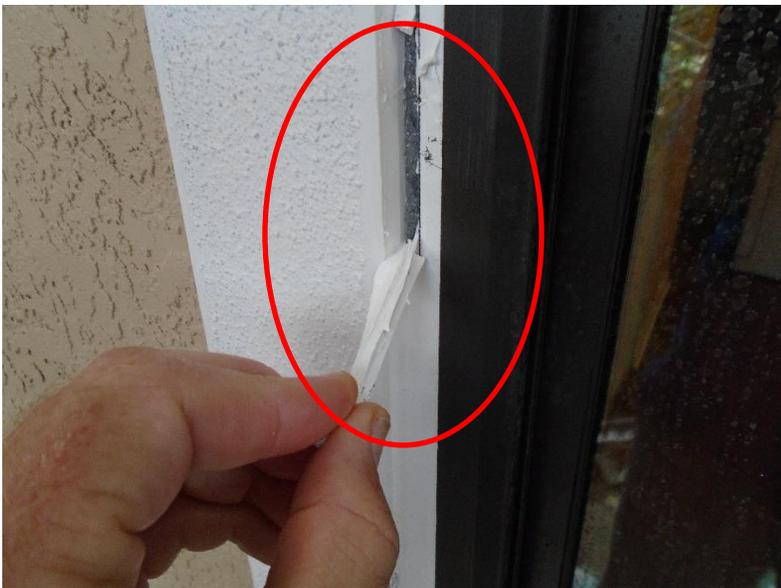
PHOTOGRAPH #2

**BUILDING 10
SECTION D**

Delta performed and passed sealant
adhesion pull test at lower window.

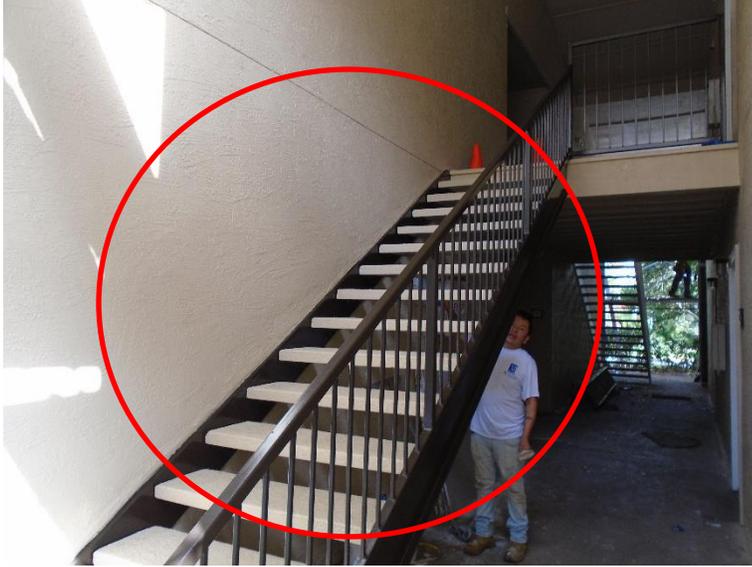
PHOTOGRAPH #3

**BUILDING 10
SECTION E**

Breezeway railings finish painted with Florida Paints #7500WA Acrylic Aliphatic Gloss Enamel.

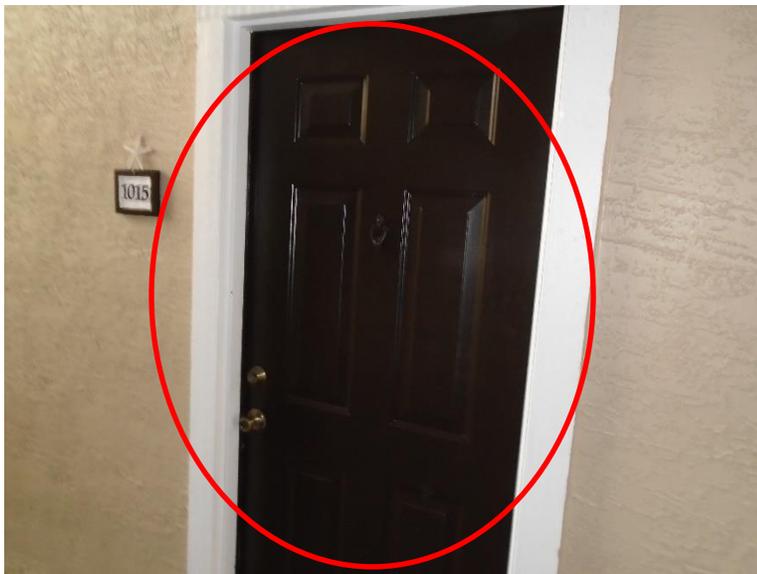
PHOTOGRAPH #4

**BUILDING 10
SECTION E**

Metal front doors finish painted with Florida Paints AllGrip exterior acrylic paint.

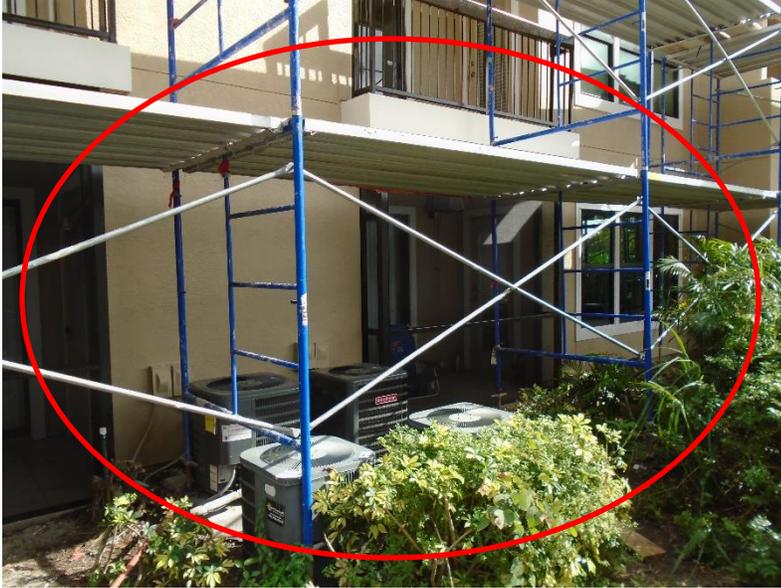
PHOTOGRAPH #5

**BUILDING 10
SECTION F**

Balcony railings and enclosures installed.

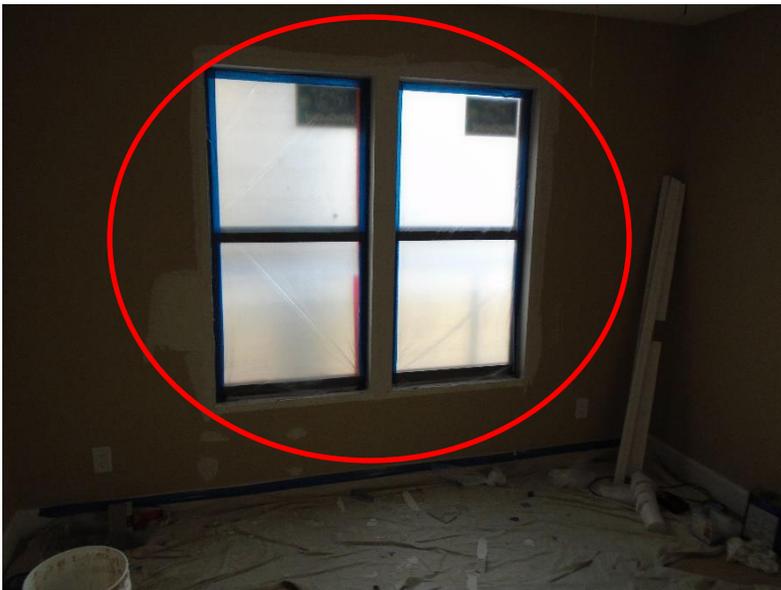
PHOTOGRAPH #6

**BUILDING 10
SECTION G**

Unit #1021- Interior finish work at new windows in progress.

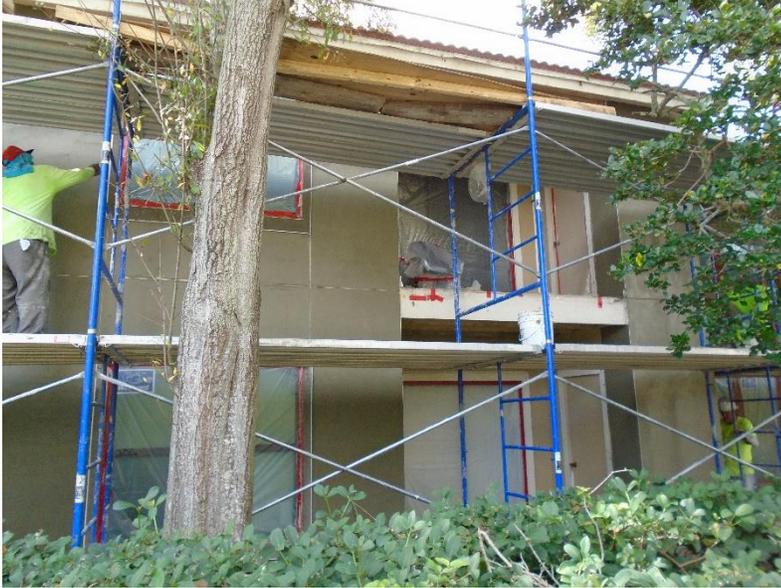
PHOTOGRAPH #7

**BUILDING 10
SECTION A**

Stucco scratch and brown coat applications in progress.

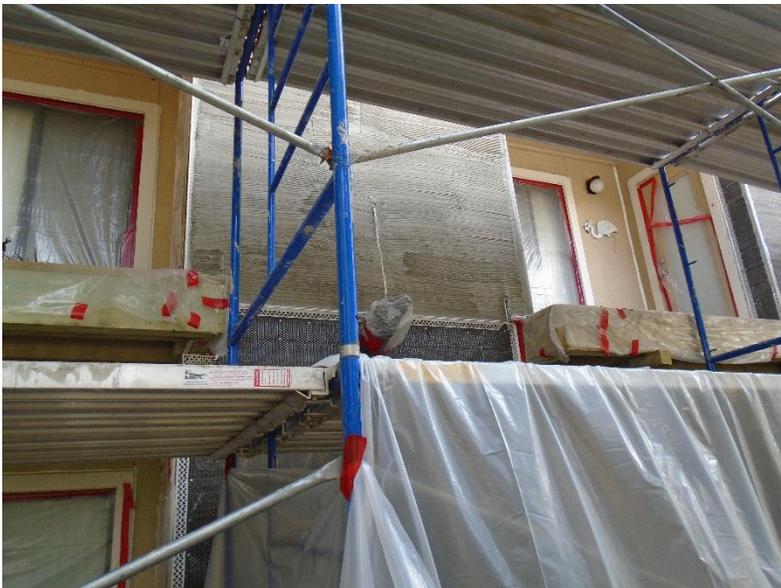
PHOTOGRAPH #8

**BUILDING 10
SECTION B**

Stucco brown coat applied over new metal lath and stucco accessories.

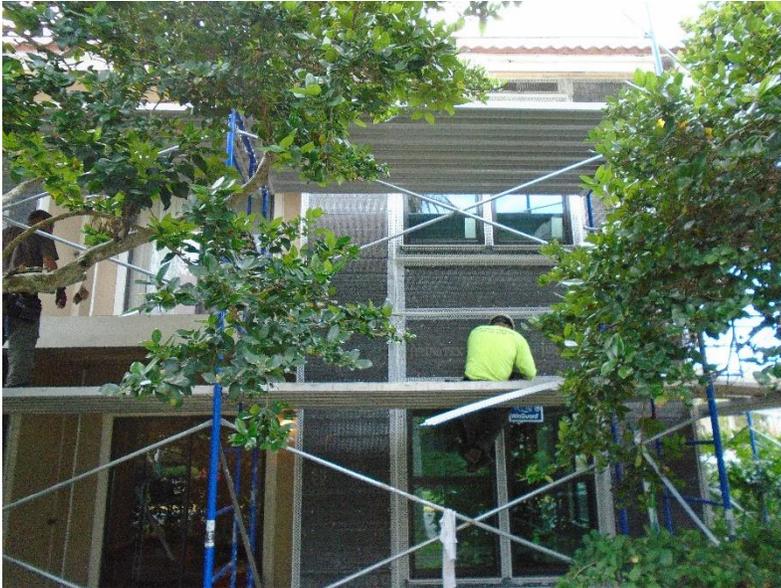
PHOTOGRAPH #9

**BUILDING 10
SECTION C**

Sub-contractor applying stucco accessories and metal lath in preparation for new stucco applications.

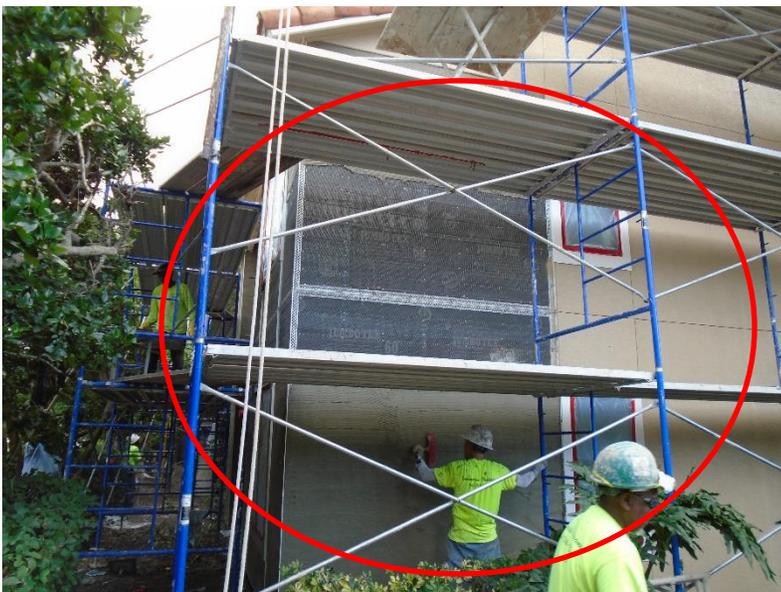
PHOTOGRAPH #10

**BUILDING 10
SECTION D**

Sub-contractor applying stucco scratch coat over new accessories and metal lath.
