PHOTOGRAPHS

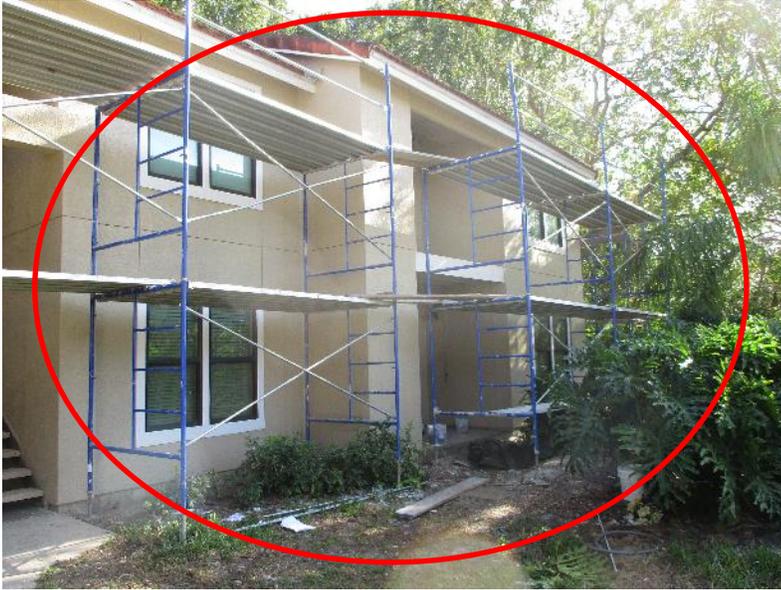
PHOTOGRAPH #1

BUILDING 10 SECTION G

Stucco sub-contractor has completed finish coat & painted stucco.

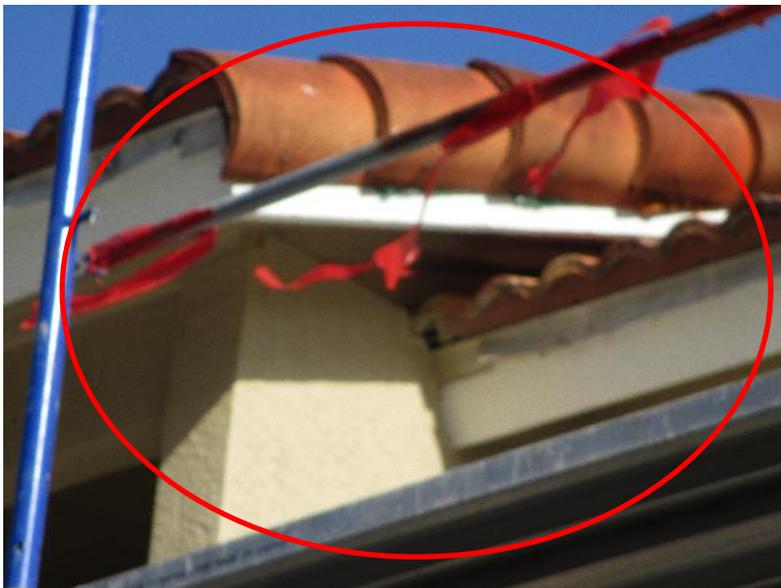
PHOTOGRAPH #2

BUILDING 10 SECTION F

Void in stucco at sidewall.

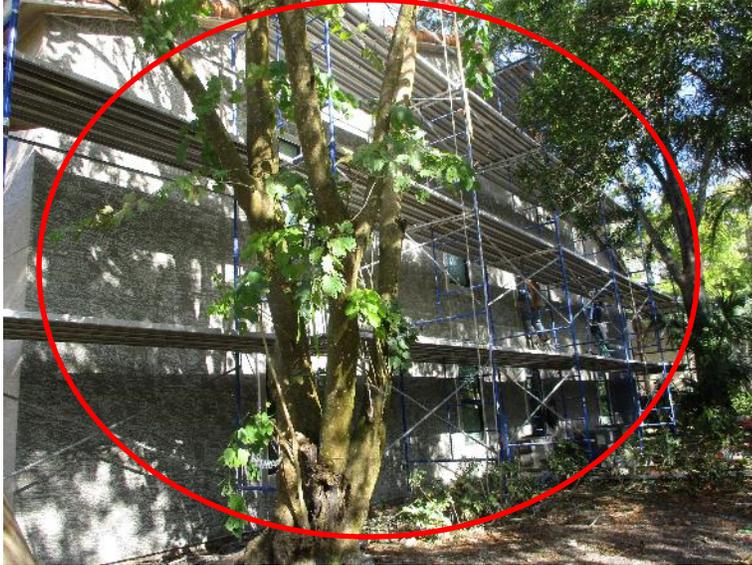
PHOTOGRAPH #3

**BUILDING 10
SECTION H**

Stucco sub-contractor has completed finish coat of stucco.

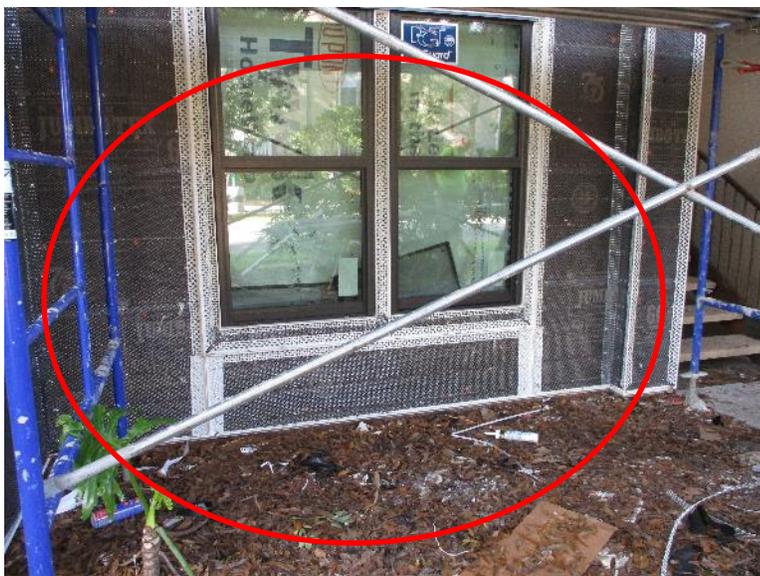
PHOTOGRAPH #4

**BUILDING 10
SECTION C**

Stucco sub-contractor has completed installation of stucco accessories and metal lath.

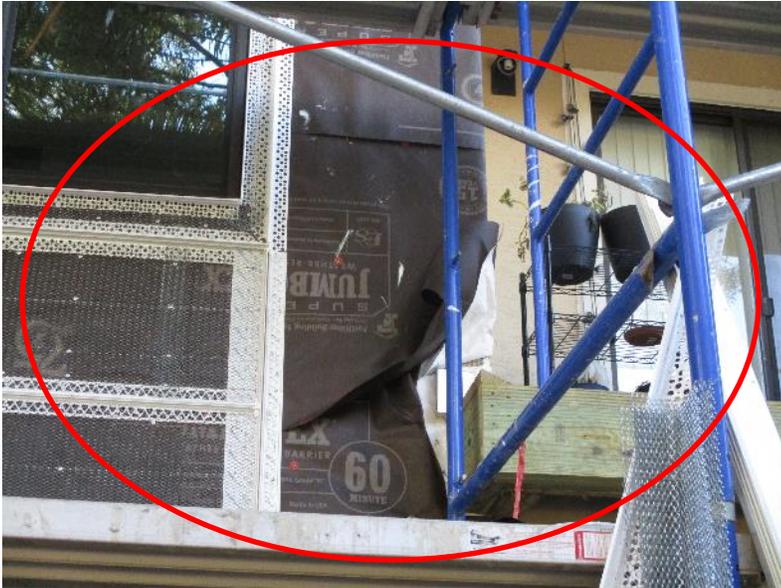
PHOTOGRAPH #5

**BUILDING 10
SECTION B**

Stucco sub-contractor applying stucco accessories and metal lath.

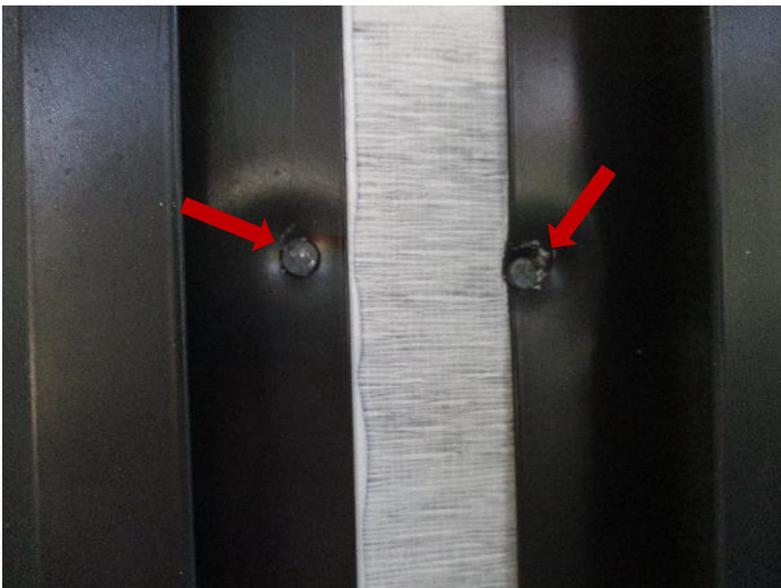
PHOTOGRAPH #6

**BUILDING 10
SECTION A**

Contractor has completed installation of PGT windows. Contractor to install fastener a minimum 1/4" from edge of flange.
