PHOTOGRAPHS

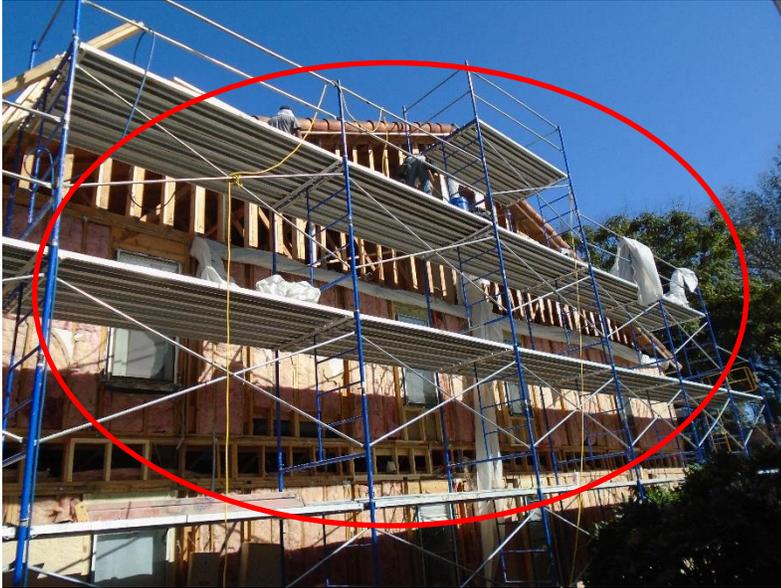
PHOTOGRAPH #1

**BUILDING 5
SECTION D**

Contractor has made wood framing repairs as marked at studs, headers, sub flooring, top and bottom plates.

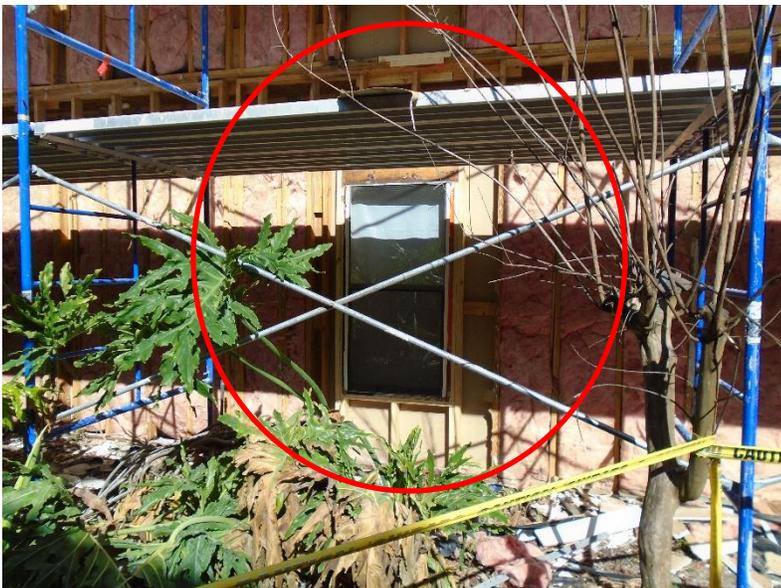
PHOTOGRAPH #2

**BUILDING 5
SECTION D**

Contractor has made wood framing repairs as marked at studs, headers, sub flooring, top and bottom plates.

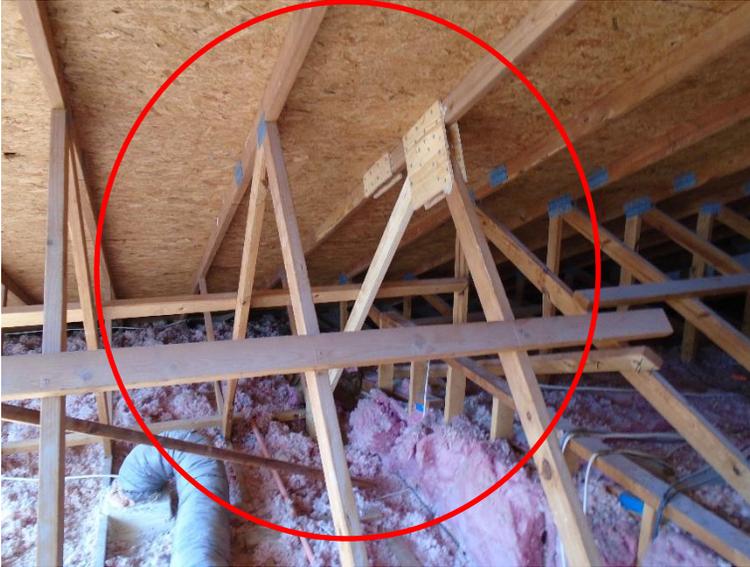
PHOTOGRAPH #3

**BUILDING 5
SECTION D
ATTIC- UNIT #527**

Repairs performed and quantified at gussets and truss framing.

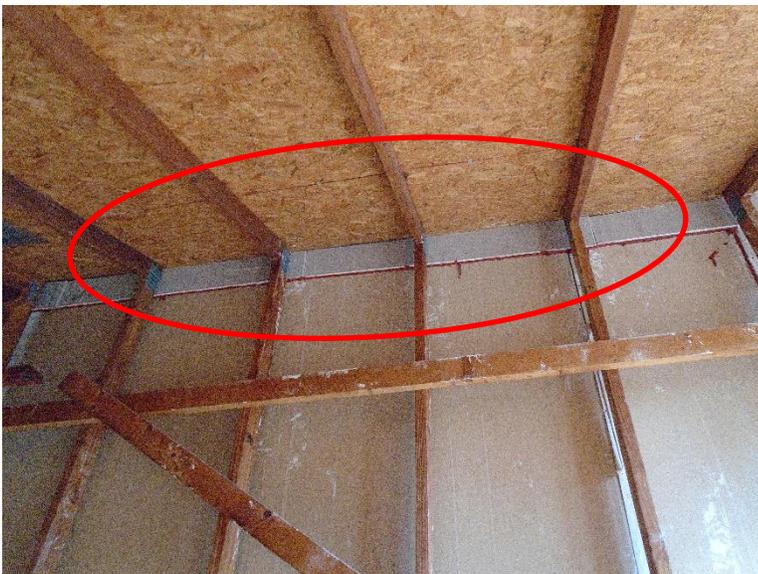
PHOTOGRAPH #4

**BUILDING 5
SECTION D
ATTIC- UNIT #527**

Repairs performed and quantified at firewalls.

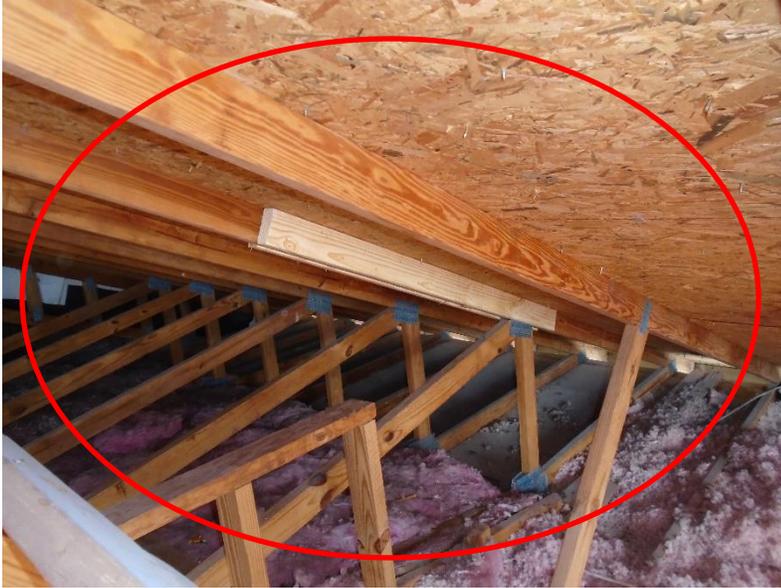
PHOTOGRAPH #5

**BUILDING 5
SECTION D
ATTIC- UNIT #525**

Damaged trusses have been repaired and quantified.

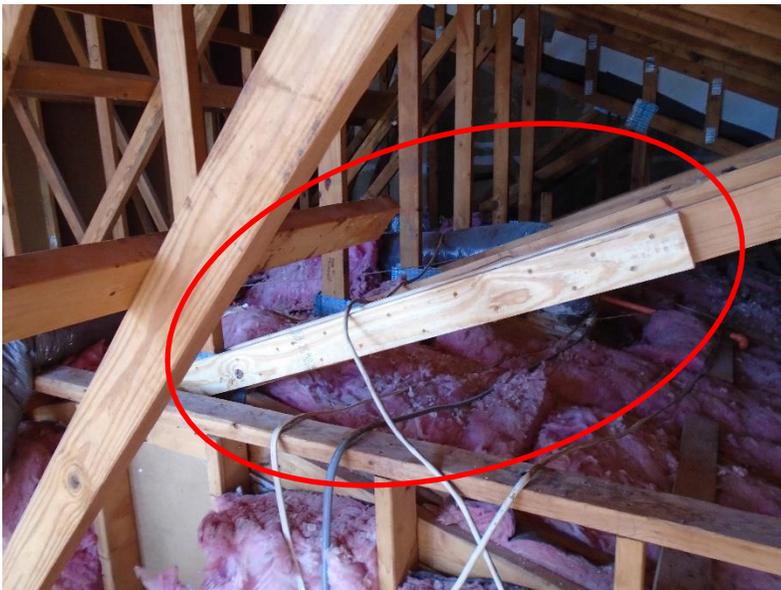
PHOTOGRAPH #6

**BUILDING 5
SECTION D
ATTIC- UNIT #525**

Damaged trusses have been repaired and quantified.

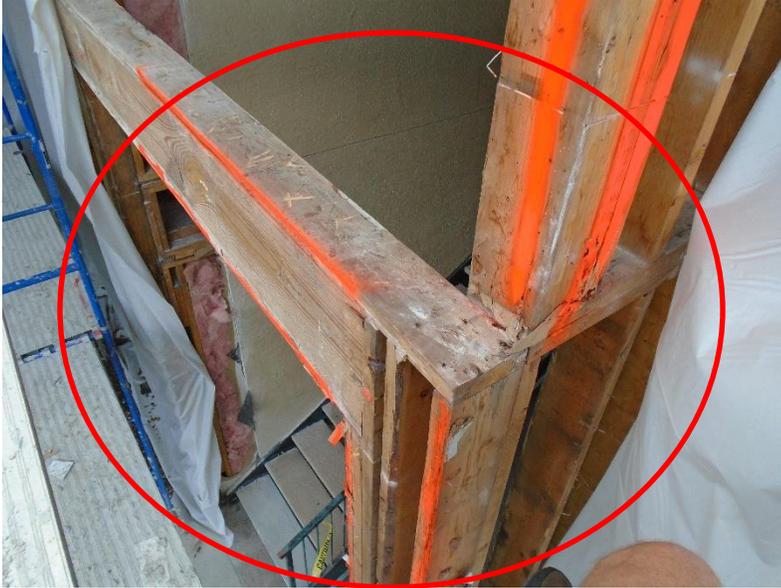
PHOTOGRAPH #7

**BUILDING 5
SECTION E**

Framing damage marked for repairs at Breezeway.

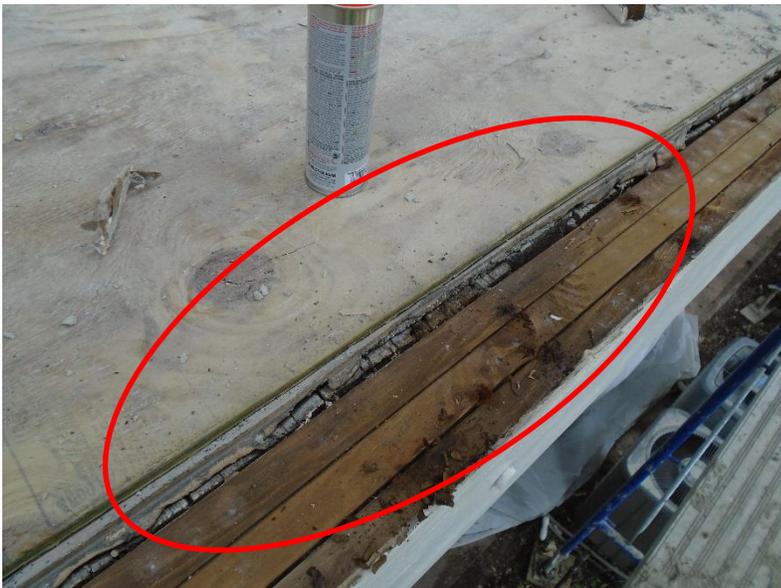
PHOTOGRAPH #8

**BUILDING 5
SECTION F**

Existing damaged balcony deck boards covered with owner's tile decking system.

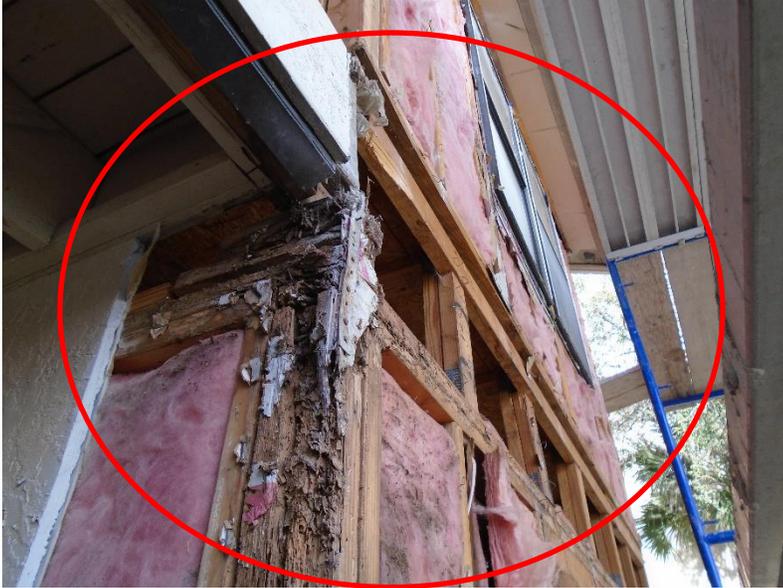
PHOTOGRAPH #9

**BUILDING 5
SECTION F**

Framing damage below balconies.

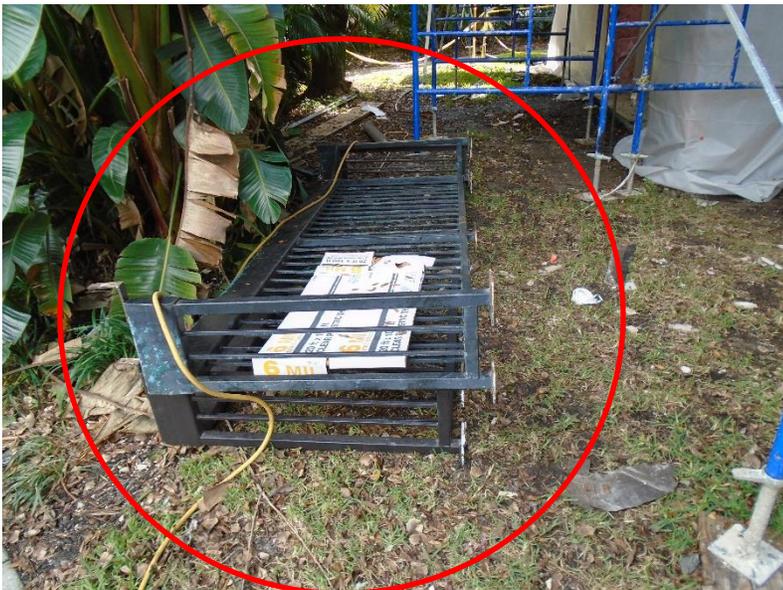
PHOTOGRAPH #10

**BUILDING 5
SECTION F**

Balcony railings removed for repairs and preparation for painting.

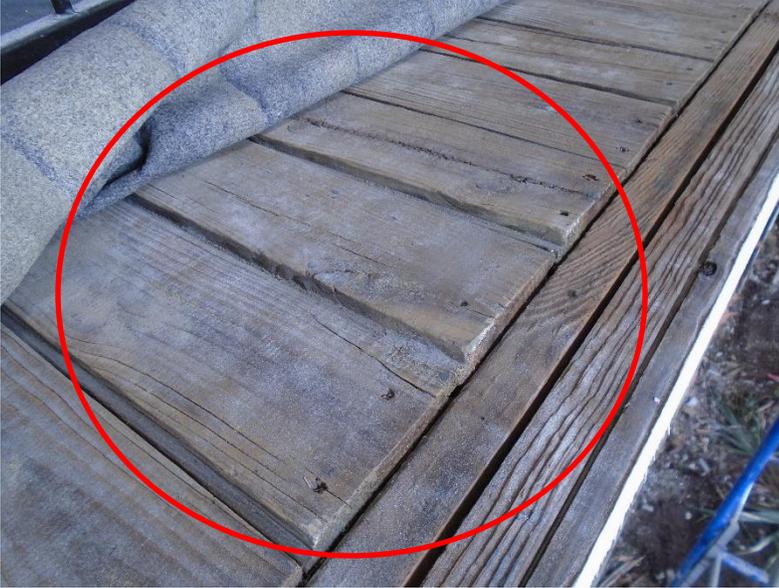
PHOTOGRAPH #11

**BUILDING 5
SECTION F**

Existing damage and poor condition of balcony deck boards to me removed and replaced.
