PHOTOGRAPHS

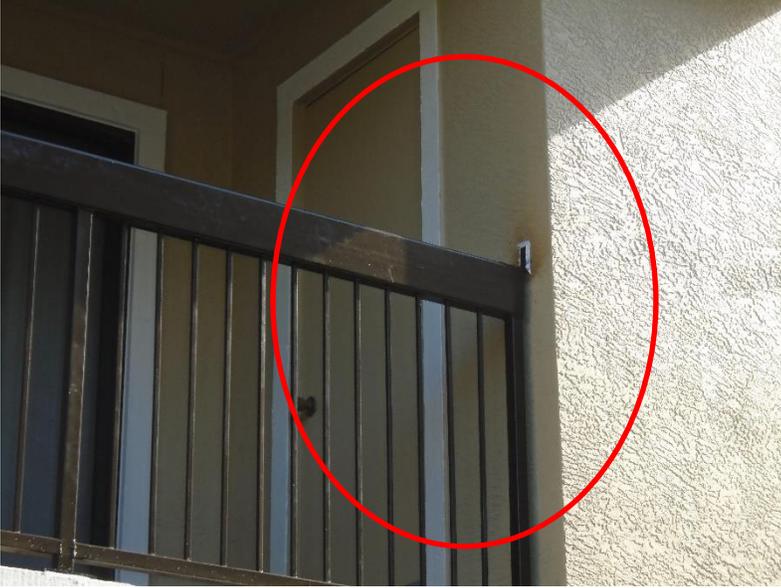
PHOTOGRAPH #1

**BUILDING 10
SECTION F**

Balcony railing brackets welded, fastened and sealed.

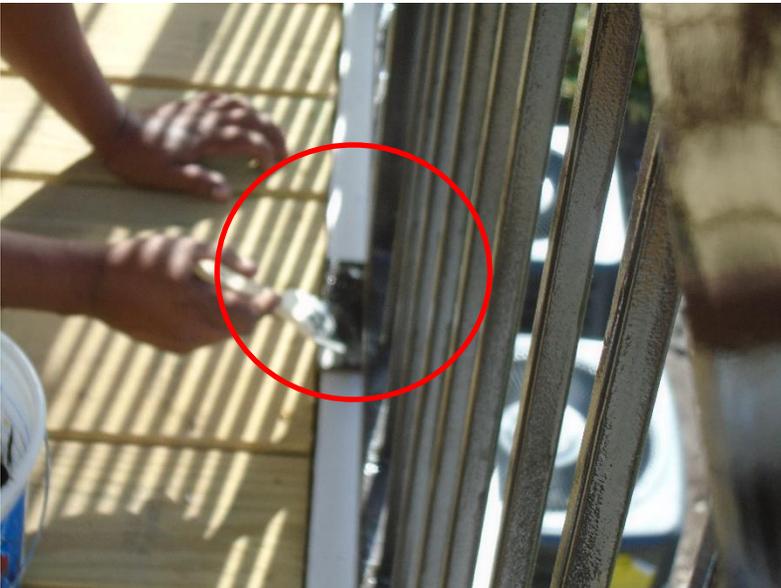
PHOTOGRAPH #2

**BUILDING 10
SECTION F**

Anchor bolts and railing brackets receiving new paint touch ups.

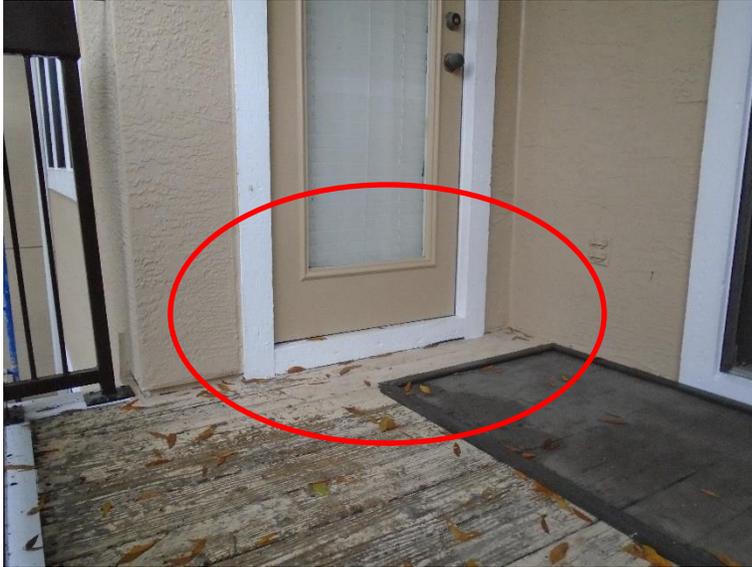
PHOTOGRAPH #3

**BUILDING 10
SECTION B**

Damaged wood trim at wood doors on balconies removed and replaced.

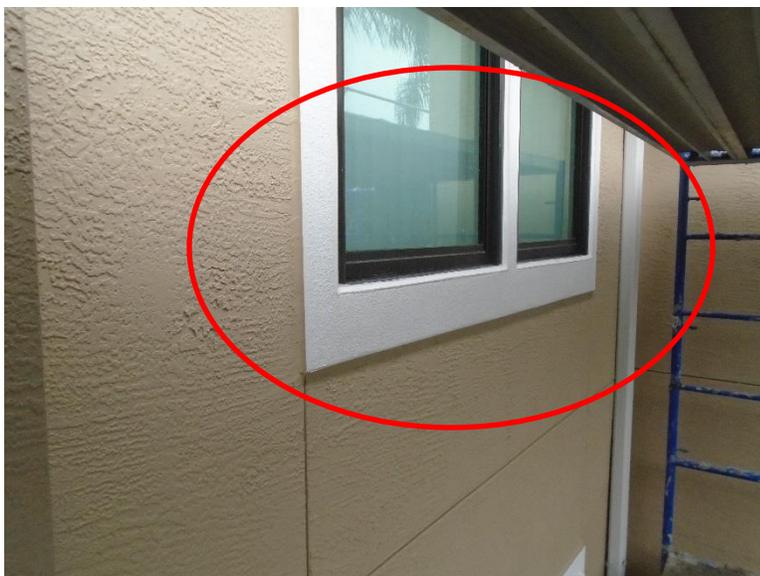
PHOTOGRAPH #4

**BUILDING 10
SECTION B**

Debris stuck in sealants removed or sealant replaced at windows.

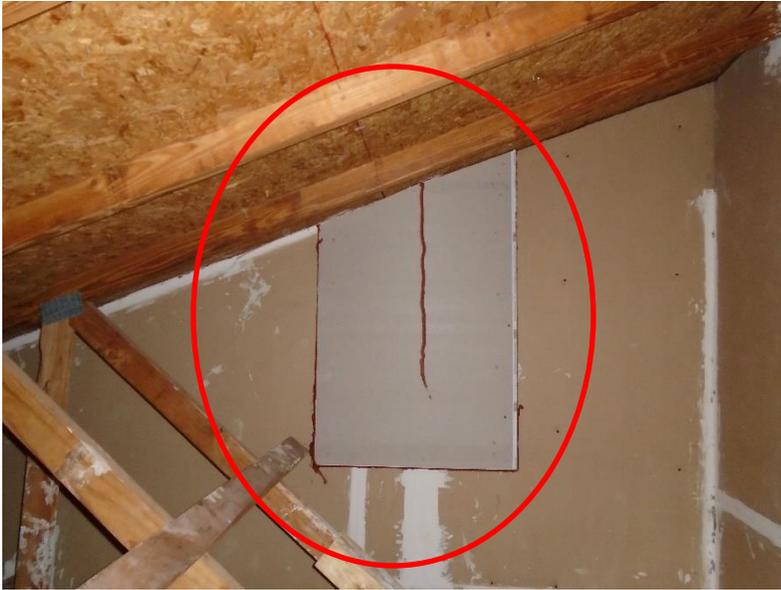
PHOTOGRAPH #5

**BUILDING 10
SECTION G**

Unit #1022- Fire wall repairs not performed as per ESI # 2 and has cracked.

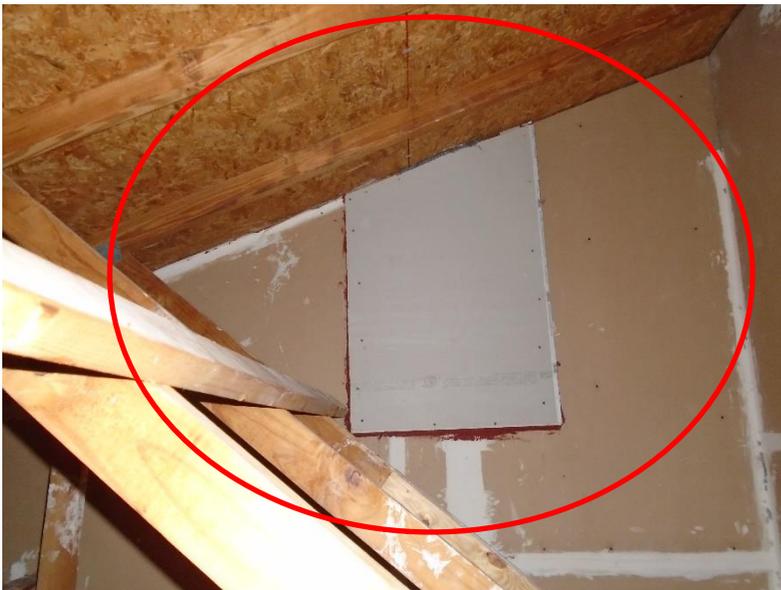
PHOTOGRAPH #6

**BUILDING 10
SECTION G**

Unit #1022- Fire wall repairs removed and replaced as per ESI # 2.

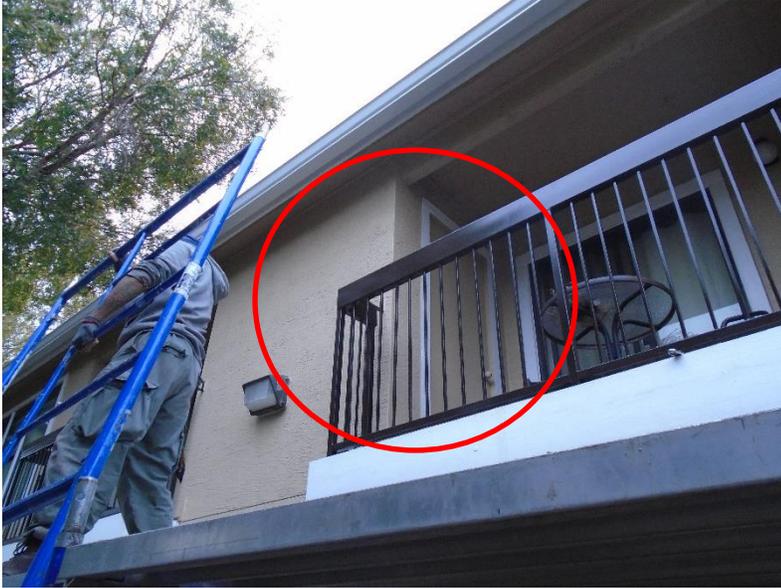
PHOTOGRAPH #7

**BUILDING 10
SECTION B**

Railing brackets installed and painted.
