## PHOTOGRAPHS

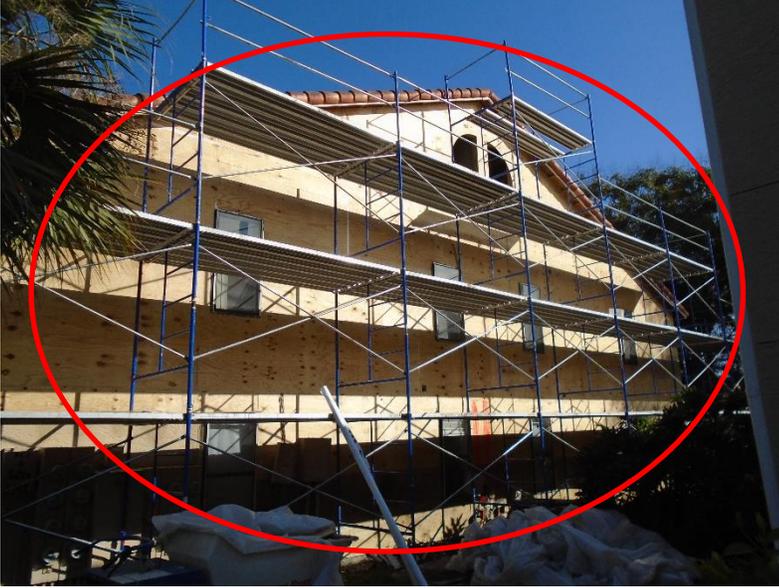
**PHOTOGRAPH #1**

**BUILDING 5  
SECTION D**

Contractor has applied new 15/32" sheathing.

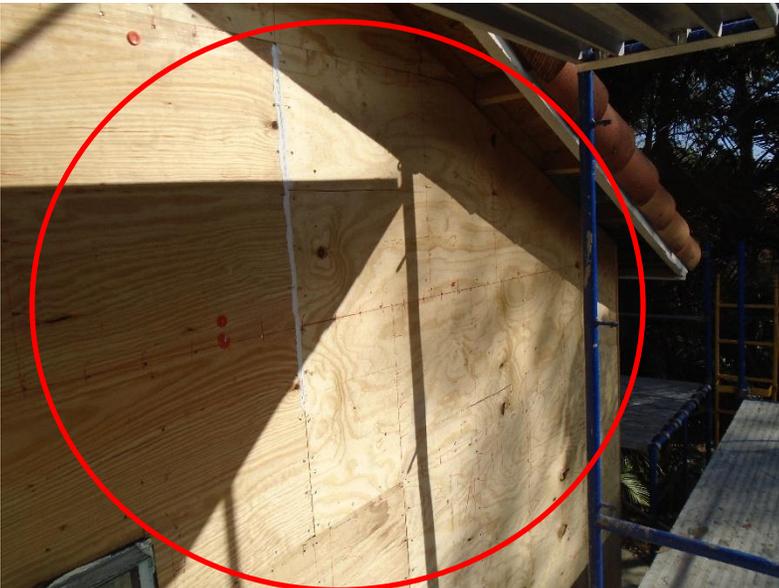
**PHOTOGRAPH #2**

**BUILDING 5  
SECTION D**

Contractor has applied new 15/32" sheathing.

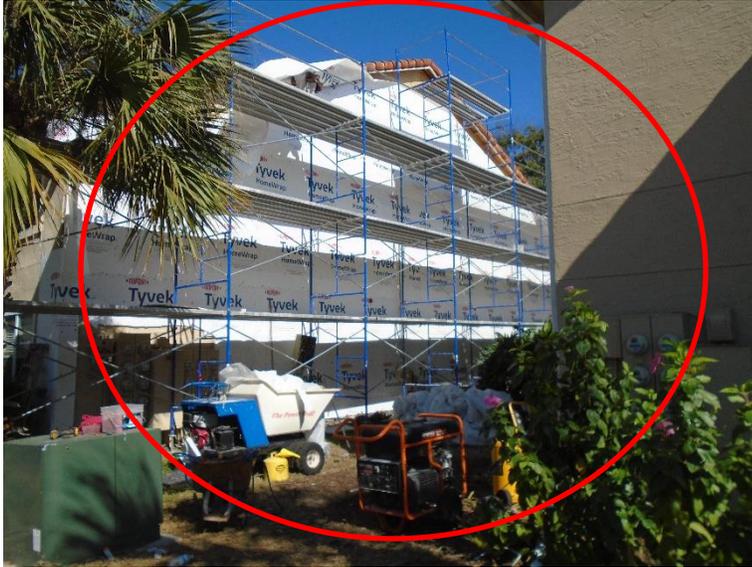
**PHOTOGRAPH #3**

**BUILDING 5  
SECTION D**

Contractor has applied Dupont Tyvek HomeWrap.

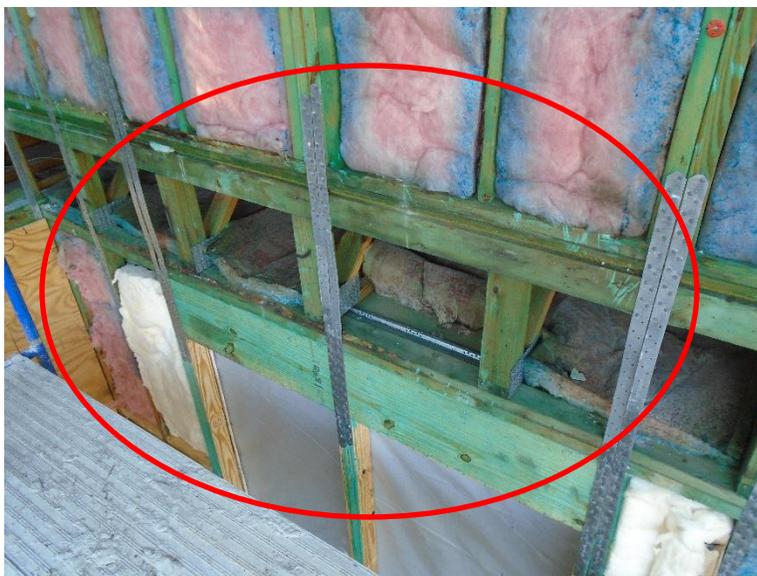
**PHOTOGRAPH #4**

**BUILDING 5  
SECTION E**

Simpson Strong -Tie strapping placed at new window opening repairs. Bora-Care termite treatment applied at framing.

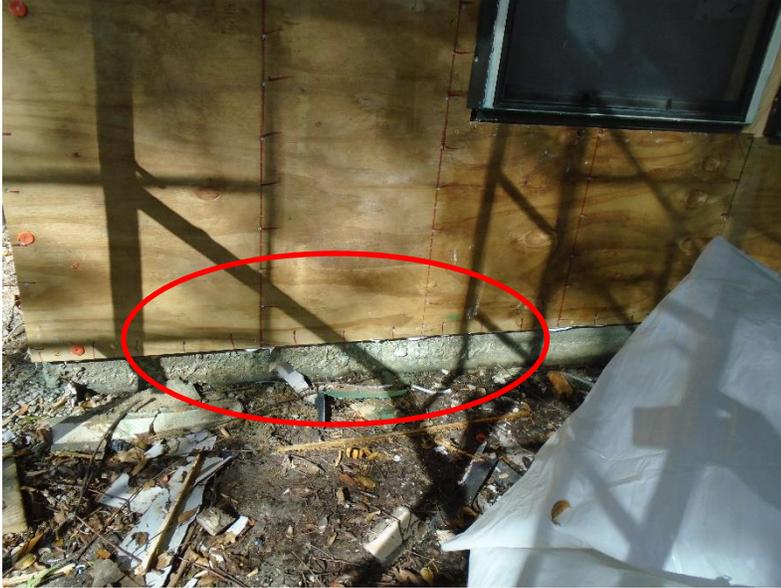
**PHOTOGRAPH #5**

**BUILDING 5  
SECTION E**

New pressure treated plywood sheathing sealed at base plate.

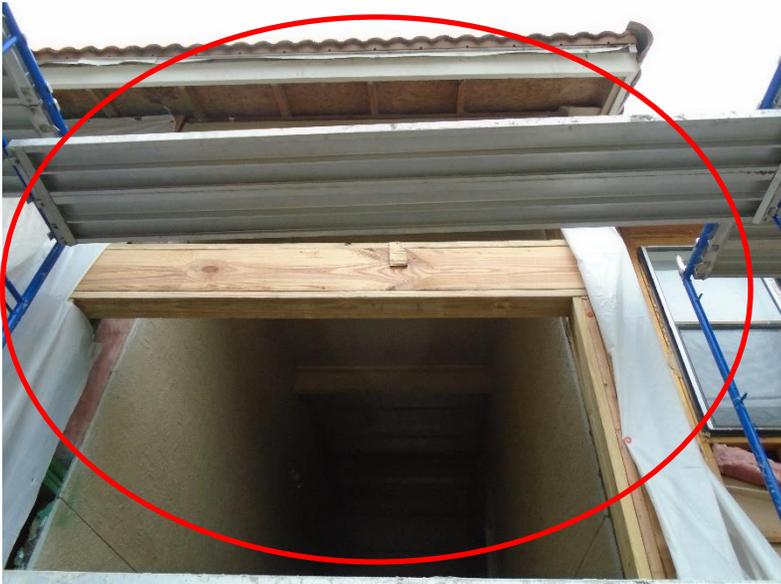
**PHOTOGRAPH #6**

**BUILDING 5  
SECTION E**

Wood framing repairs performed at breezeway.

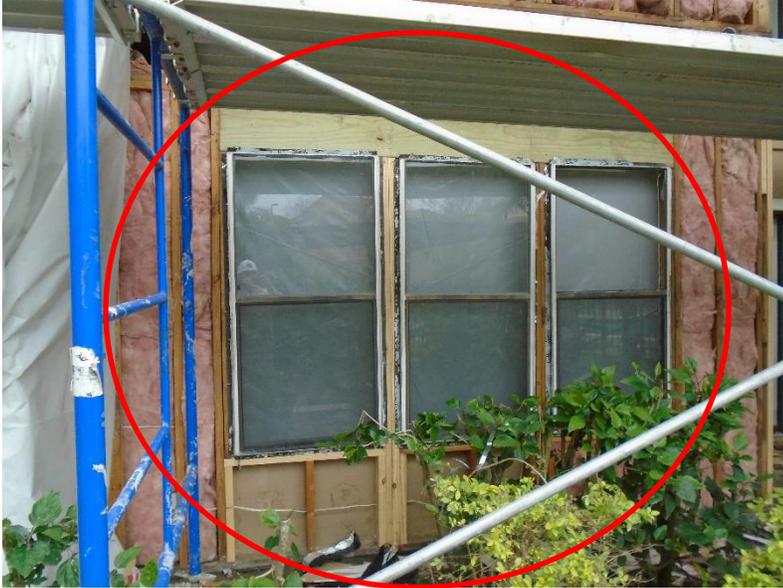
**PHOTOGRAPH #7**

**BUILDING 5  
SECTION F**

Wood framing repairs performed at window header and window framing.

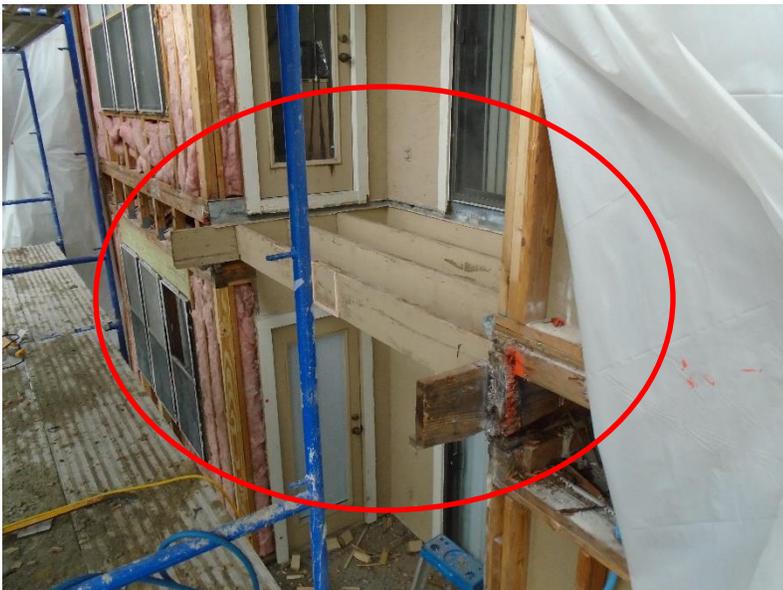
**PHOTOGRAPH #8**

**BUILDING 5  
SECTION F**

**Unit #526-** Contractor working on framing and decking repairs at balcony.

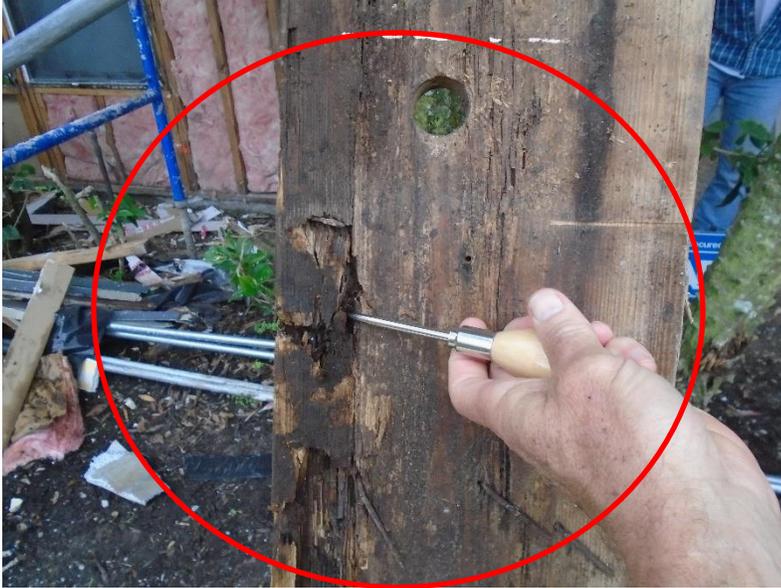
**PHOTOGRAPH #9**

**BUILDING 5  
SECTION F**

**Unit #526-** Wood framing damage at balcony inspected and marked for repairs.

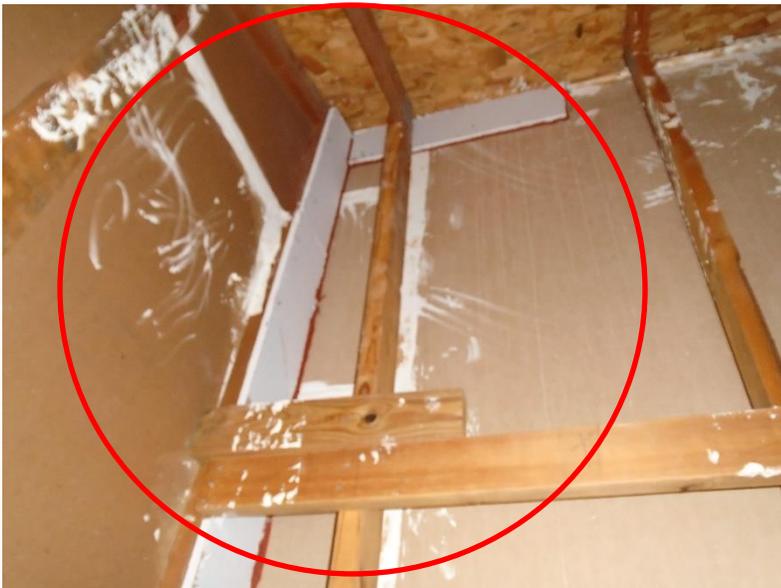
**PHOTOGRAPH #10**

**BUILDING 5  
ATTIC REPAIRS**

**Unit #525-** Framing repairs and fire wall repairs reviewed and verified.

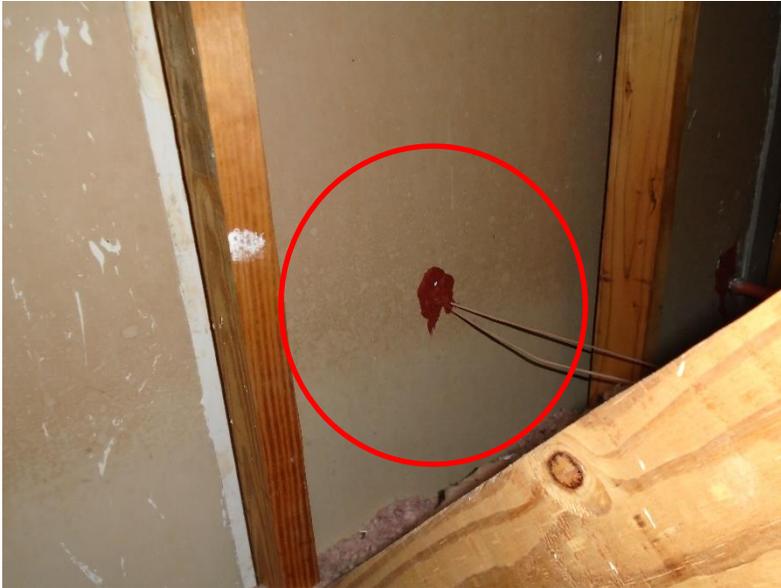
**PHOTOGRAPH #11**

**BUILDING 5  
ATTIC REPAIRS**

**Unit #525-** Framing repairs and fire wall repairs reviewed and verified.

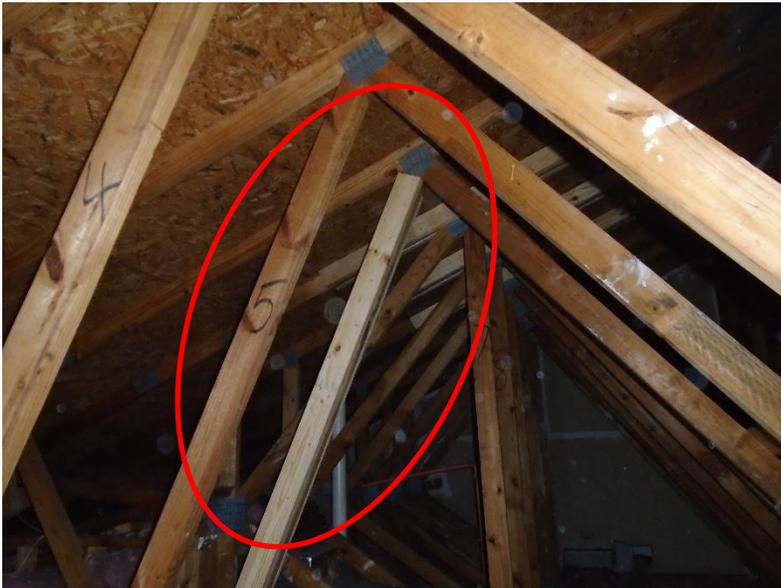
**PHOTOGRAPH #12**

**BUILDING 5  
ATTIC REPAIRS**

**Unit #526-** Framing repairs and fire wall repairs reviewed and verified.

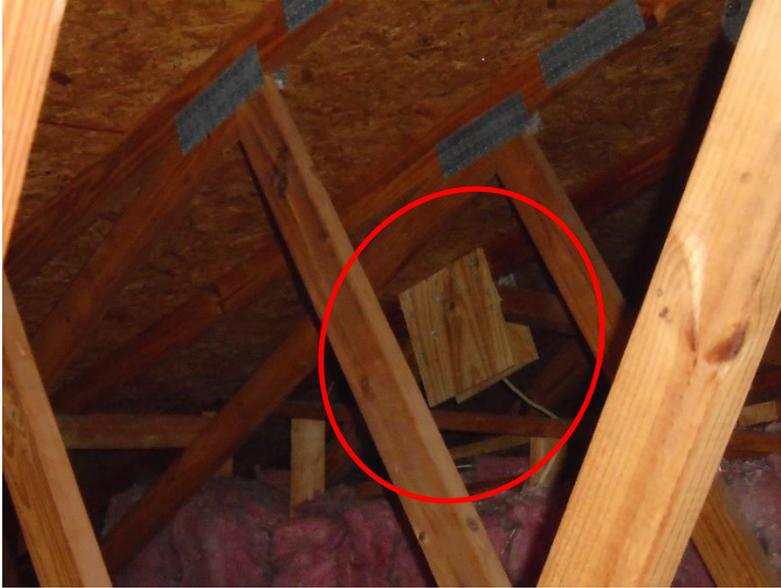
**PHOTOGRAPH #13**

**BUILDING 5  
ATTIC REPAIRS**

**Unit #526-** Framing repairs and fire wall repairs reviewed and verified.

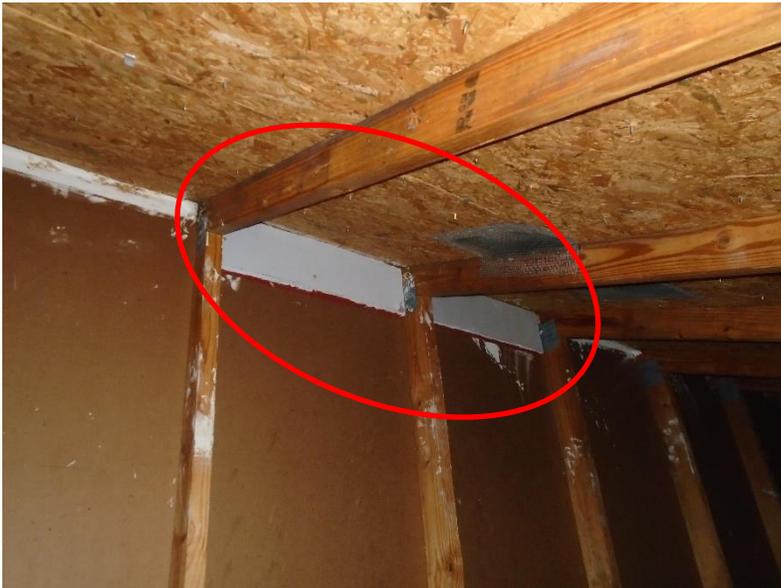
**PHOTOGRAPH #14**

**BUILDING 5  
ATTIC REPAIRS**

**Unit #524-** Framing repairs and fire wall repairs reviewed and verified.

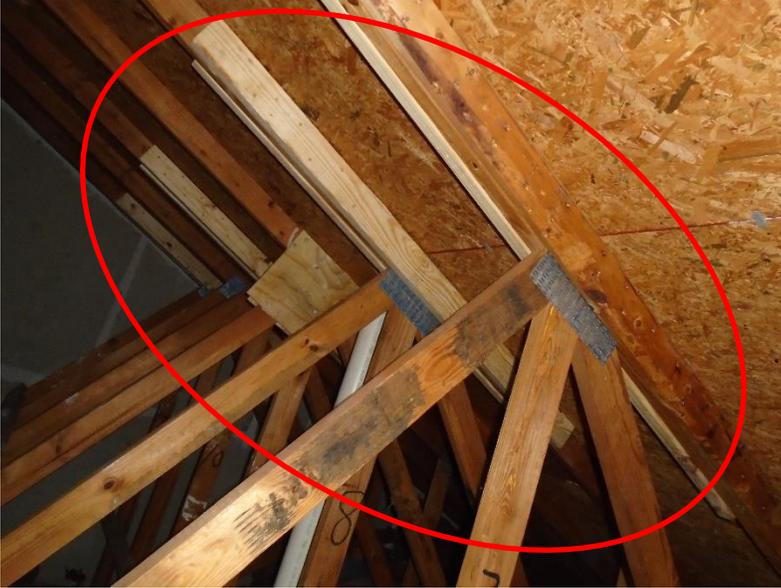
**PHOTOGRAPH #15**

**BUILDING 5  
ATTIC REPAIRS**

**Unit #524-** Framing repairs and fire wall repairs reviewed and verified.

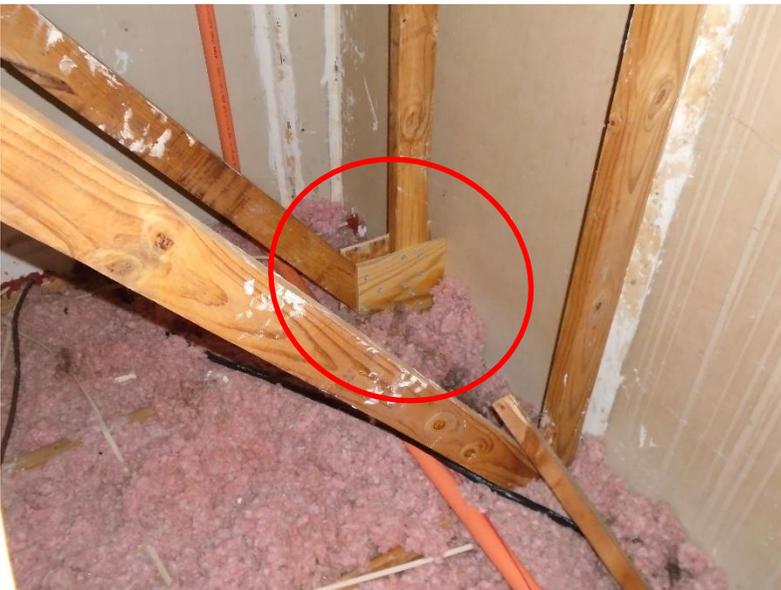
**PHOTOGRAPH #16**

**BUILDING 5  
ATTIC REPAIRS**

**Unit #523-** Framing repairs and fire wall repairs reviewed and verified.

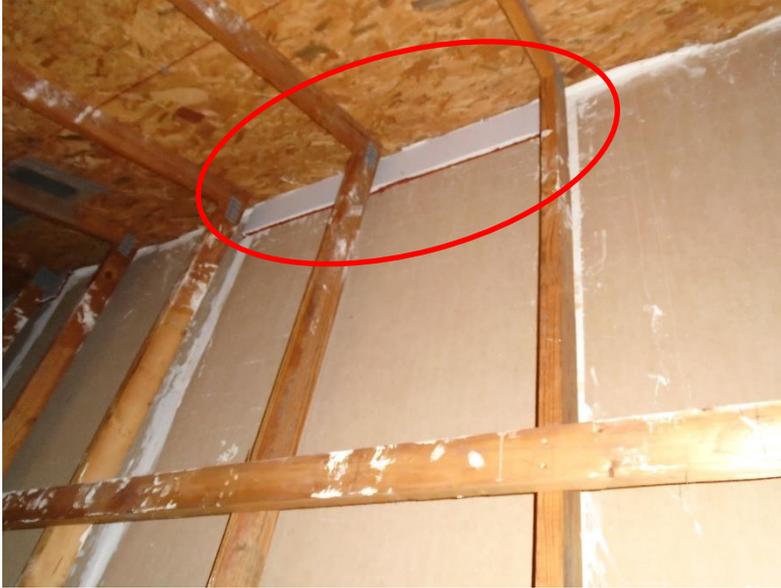
**PHOTOGRAPH #17**

**BUILDING 5  
ATTIC REPAIRS**

**Unit #523-** Framing repairs and fire wall repairs reviewed and verified.
