**PHOTOGRAPHS**

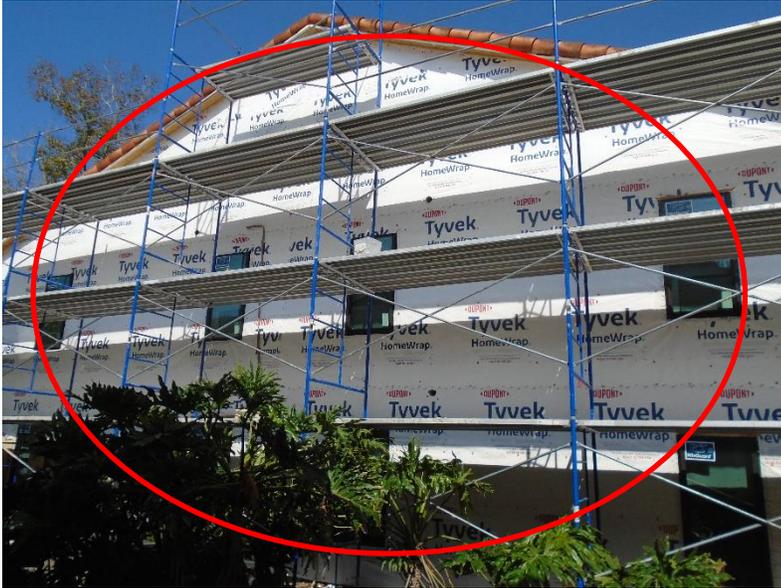
**PHOTOGRAPH #1**

**BUILDING 5  
SECTION D**

Contractor has Installed PGT windows. Upper windows have Window operating control devises (WOCD) installed.

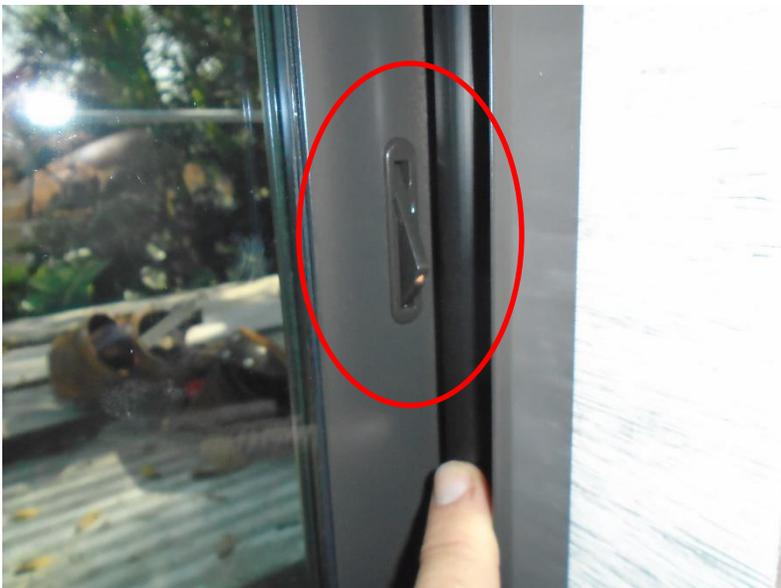
**PHOTOGRAPH #2**

**BUILDING 5  
SECTION D**

Upper windows have Window operating control devises (WOCD) installed.

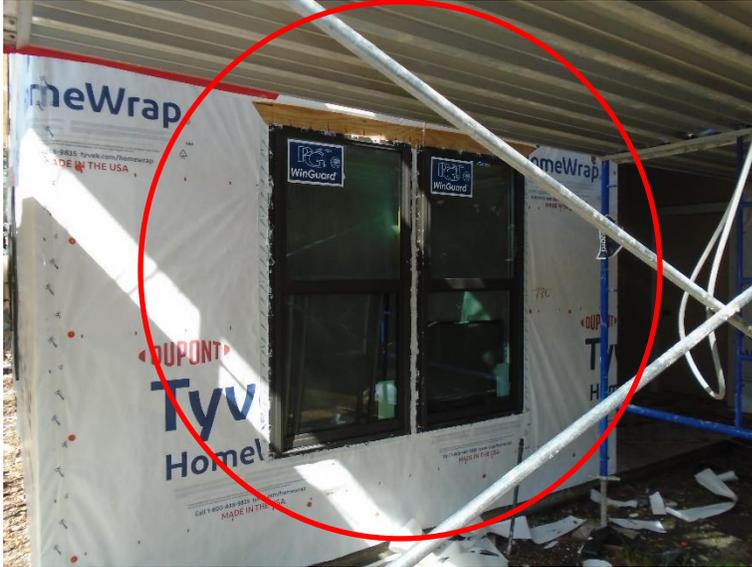
**PHOTOGRAPH #3**

**BUILDING 5  
SECTION E**

Contractor has flashed window opening with DuPont/Tyvek flashing and installed PGT windows.

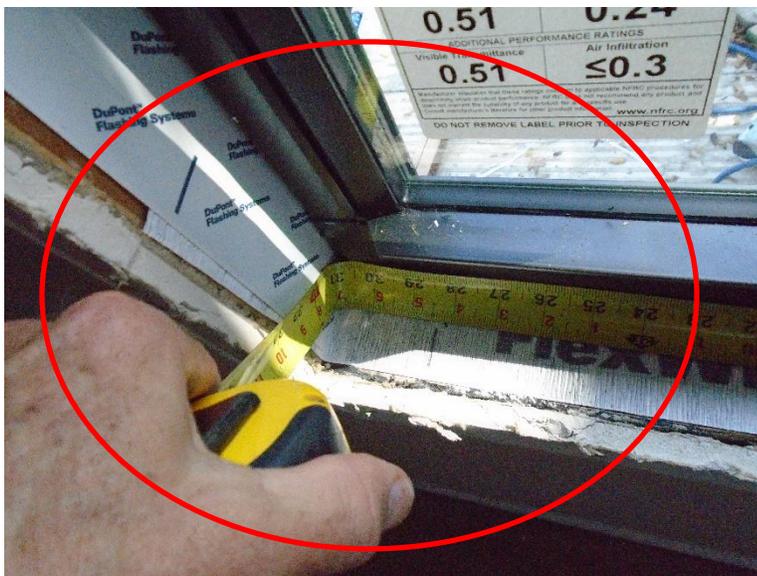
**PHOTOGRAPH #4**

**BUILDING 5  
SECTION E**

New window installations inspected for proper size openings, fasteners and flashings.

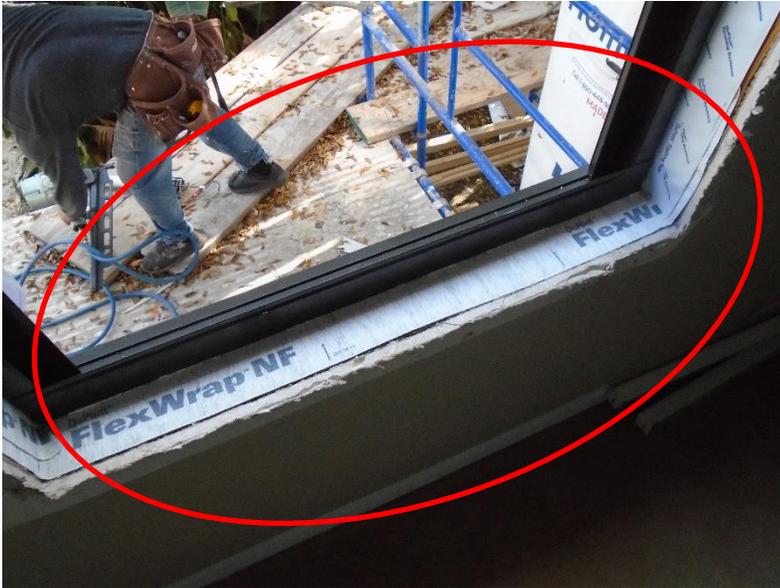
**PHOTOGRAPH #5**

**BUILDING 5  
SECTION E**

New window installations inspected for proper size openings, fasteners and flashings.

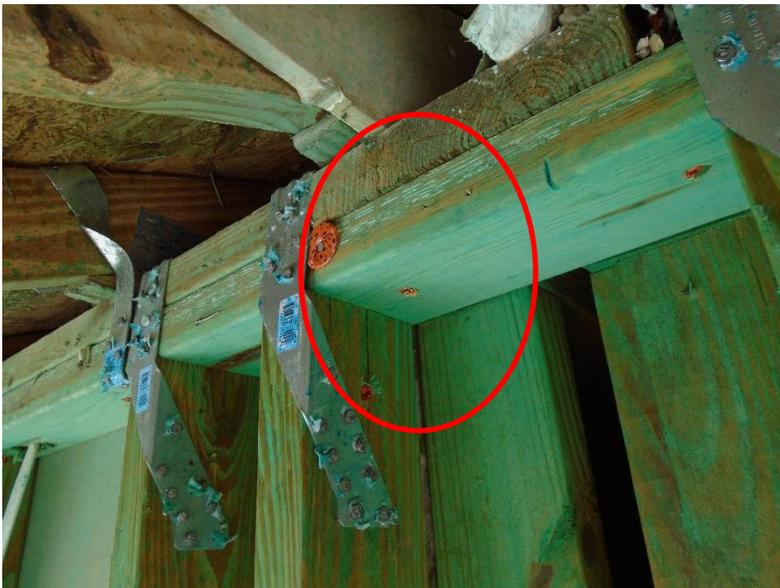
**PHOTOGRAPH #6**

**BUILDING 5  
SECTION F**

Truss to double top plate has been connected with Simpson Strong-Tie screw SDWC 15600 as per drawings.

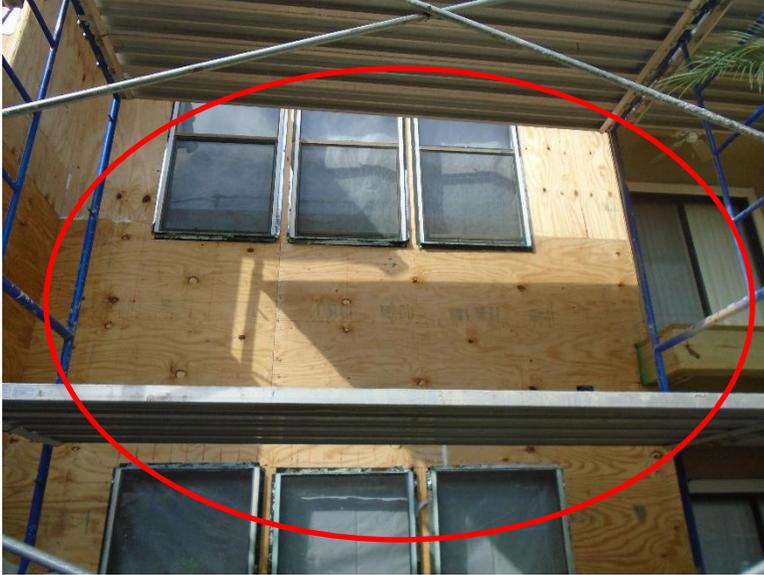
**PHOTOGRAPH #7**

**BUILDING 5  
SECTION F**

New plywood sheathing has been installed and inspected for fastening.

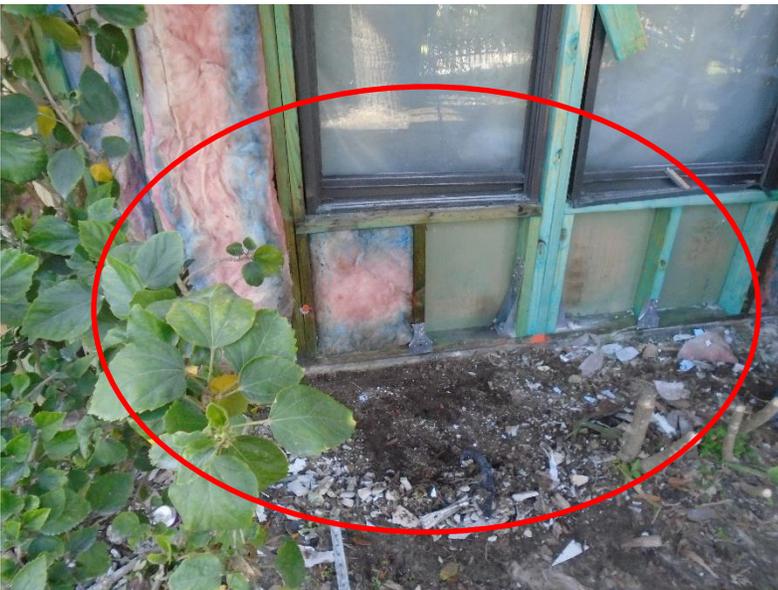
**PHOTOGRAPH #8**

**BUILDING 5  
SECTION G**

Simpson Strong -Tie connectors and Titen HD fasteners installed.

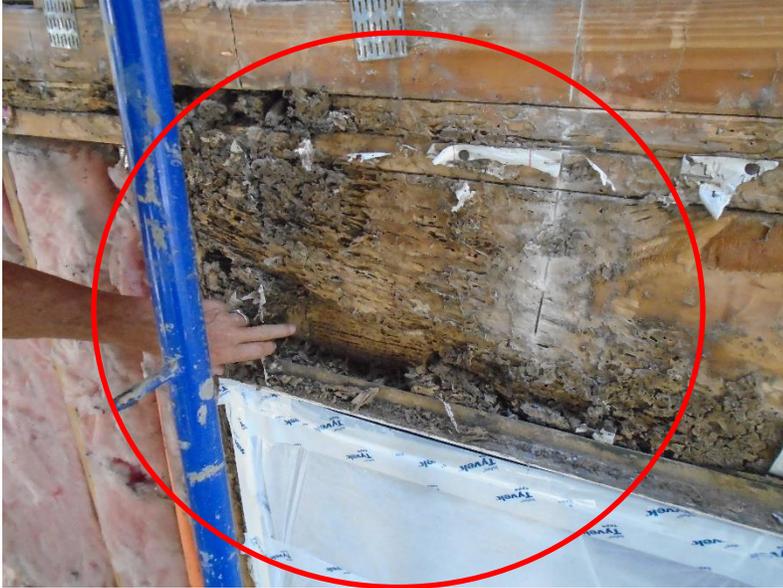
**PHOTOGRAPH #9**

**BUILDING 5  
SECTION H**

Damaged wood framing at headers, subfloors, framing studs, trusses and plates reviewed and marked for repairs.

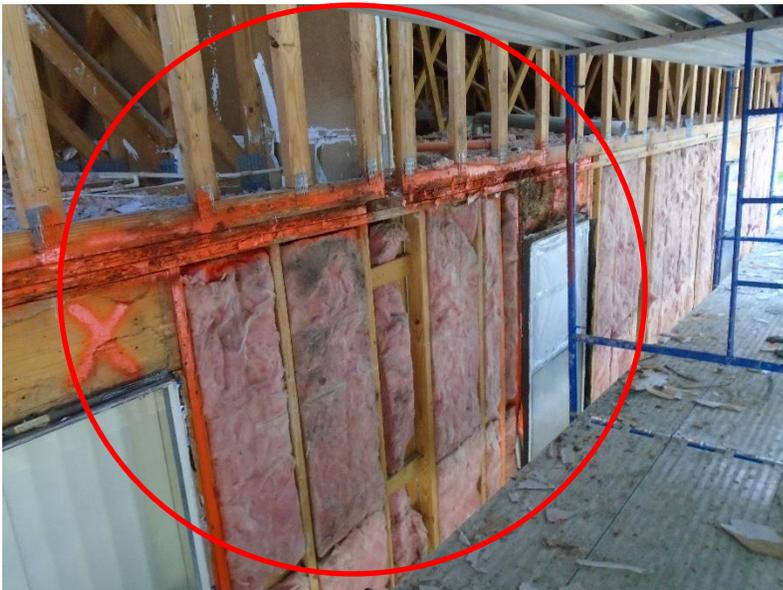
**PHOTOGRAPH #10**

**BUILDING 5  
SECTION H**

Damaged wood framing at headers, subfloors, framing studs, trusses and plates reviewed and marked for repairs.

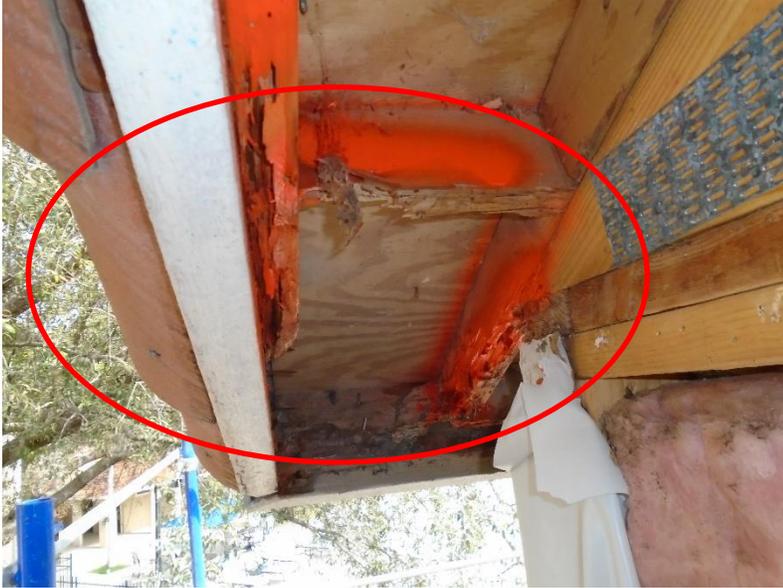
**PHOTOGRAPH #11**

**BUILDING 5  
SECTION H**

Damaged wood framing at headers, subfloors, framing studs, trusses and plates reviewed and marked for repairs.

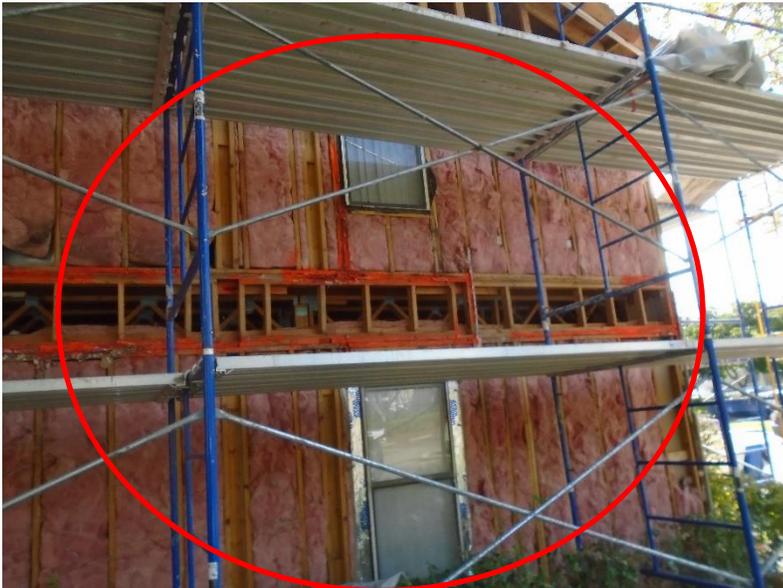
**PHOTOGRAPH #12**

**BUILDING 5  
SECTION H**

Damaged wood framing at headers, subfloors, framing studs, trusses and plates reviewed and marked for repairs.

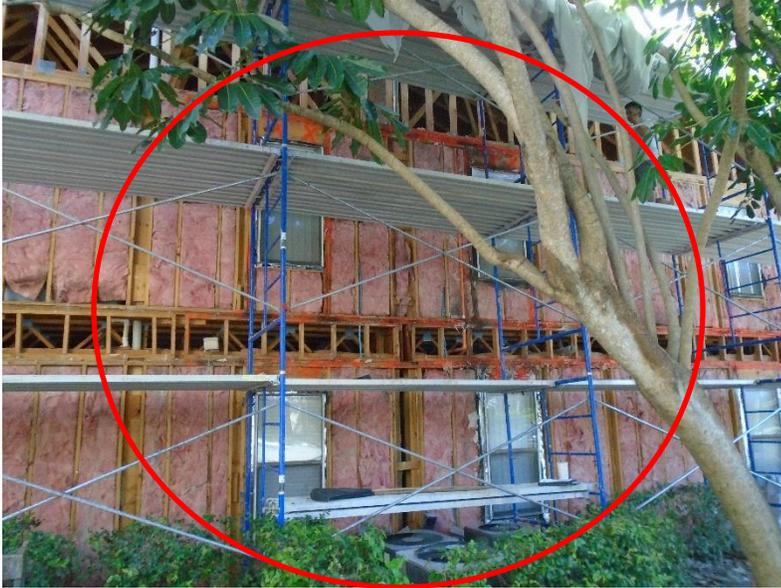
**PHOTOGRAPH #13**

**BUILDING 5  
SECTION H**

Damaged wood framing at headers, subfloors, framing studs, trusses and plates reviewed and marked for repairs.

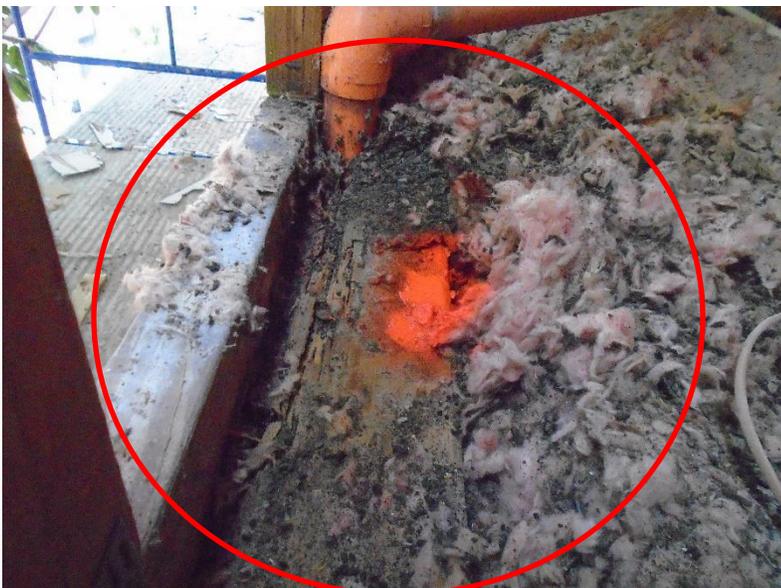
**PHOTOGRAPH #14**

**BUILDING 5  
SECTION H**

Damaged wood framing at headers, subfloors, framing studs, trusses and plates reviewed and marked for repairs.
