## PHOTOGRAPHS

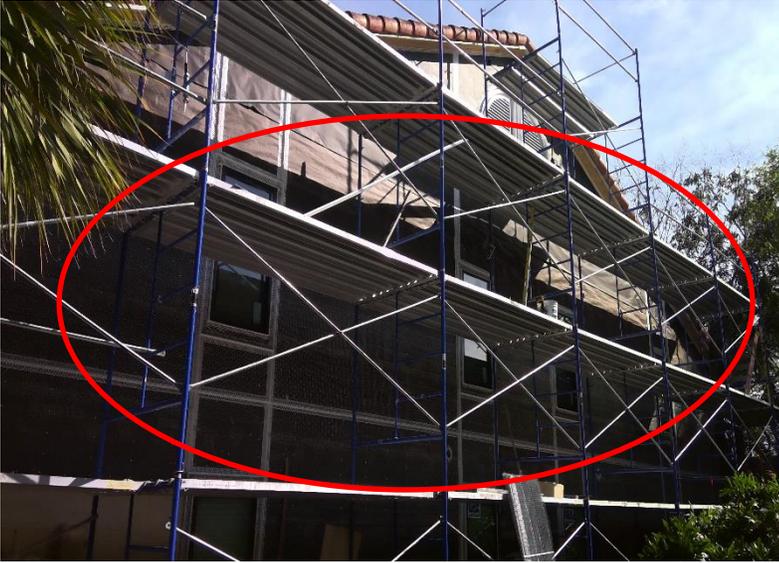
**PHOTOGRAPH #1**

### **BUILDING 5 SECTION D**

Stucco Sub contractor applying lath for stucco application.

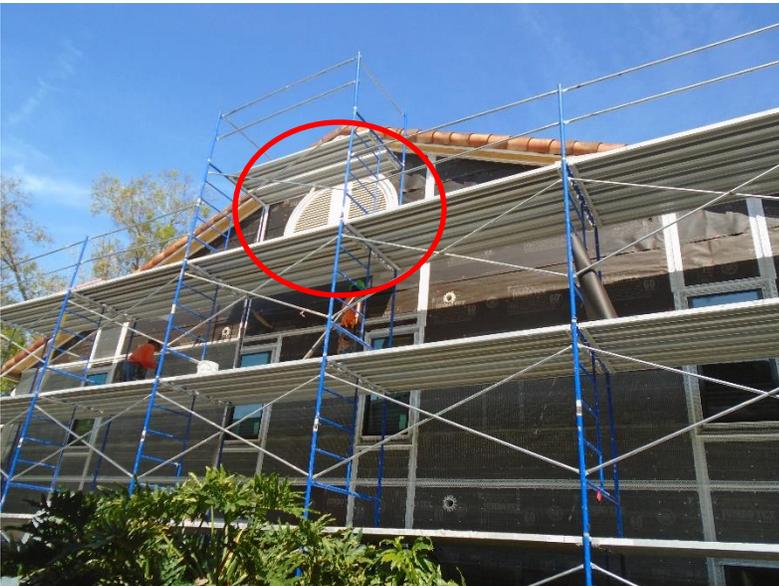
**PHOTOGRAPH #2**

### **BUILDING 5 SECTION D**

Louvered vents installed and flashed into wall system with Dupont flexwrap flashing.

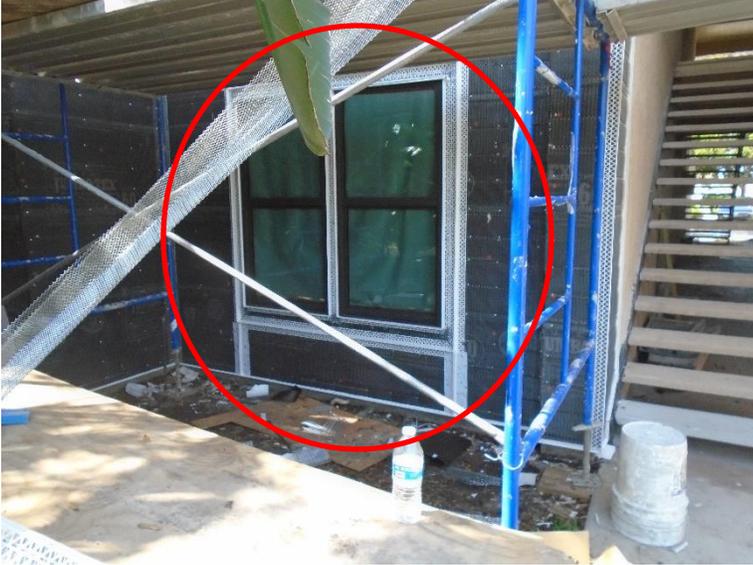
**PHOTOGRAPH #3**

**BUILDING 5  
SECTION E**

New PGT windows installed and stucco accessories with wire lath in place for stucco applications.

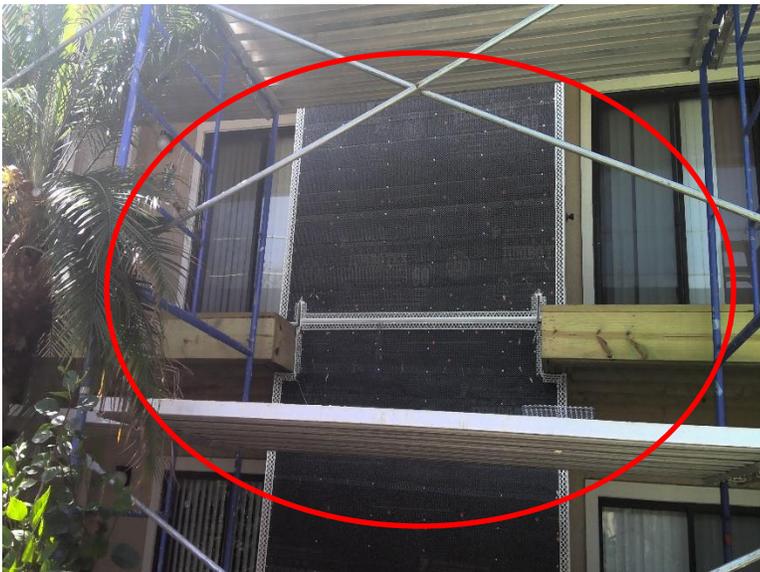
**PHOTOGRAPH #4**

**BUILDING 5  
SECTION F**

New galvanized kick out flashing details installed at balconies with stucco accessories and wire lath in place for stucco applications.

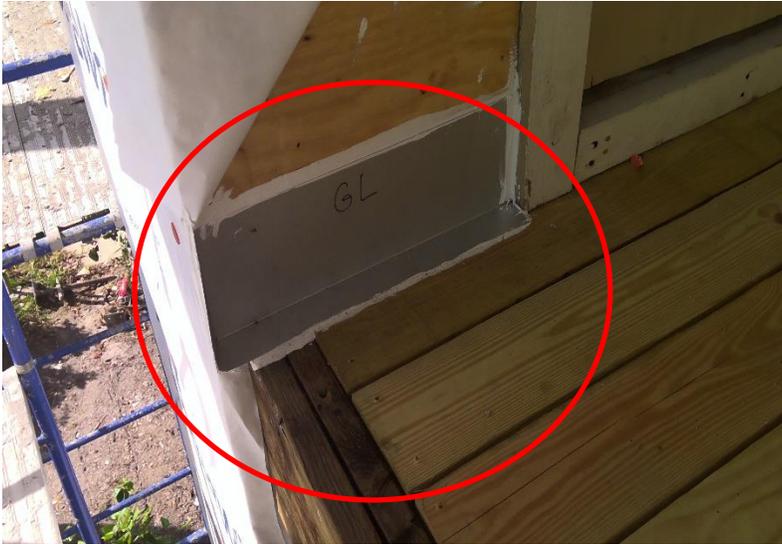
**PHOTOGRAPH #5**

**BUILDING 5  
SECTION F**

Galvanized kick out flashing detail installed over new PT decking boards.

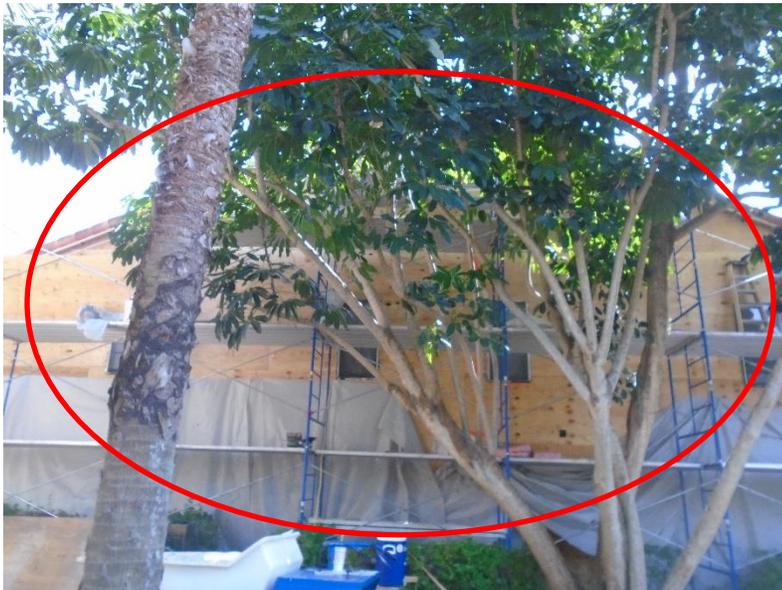
**PHOTOGRAPH #6**

**BUILDING 5  
SECTION H**

Contractor has applied new 15/32" plywood sheathing.

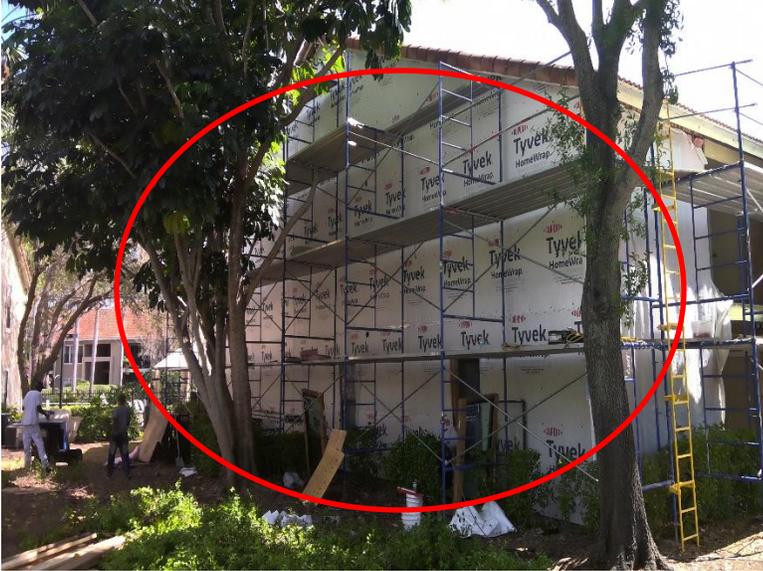
**PHOTOGRAPH #7**

**BUILDING 5  
SECTION H**

Contractor has applied Tyvek HomeWrap WRB for dry in of wall and begun installation of window flashing.

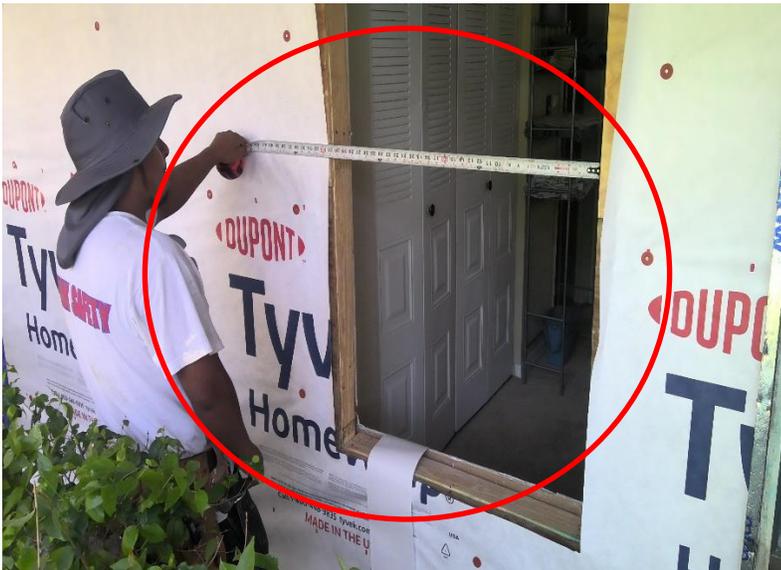
**PHOTOGRAPH #8**

**BUILDING 5  
SECTION H**

Contractor has begun applying Dupont flashing at window openings and installation of PGT windows.

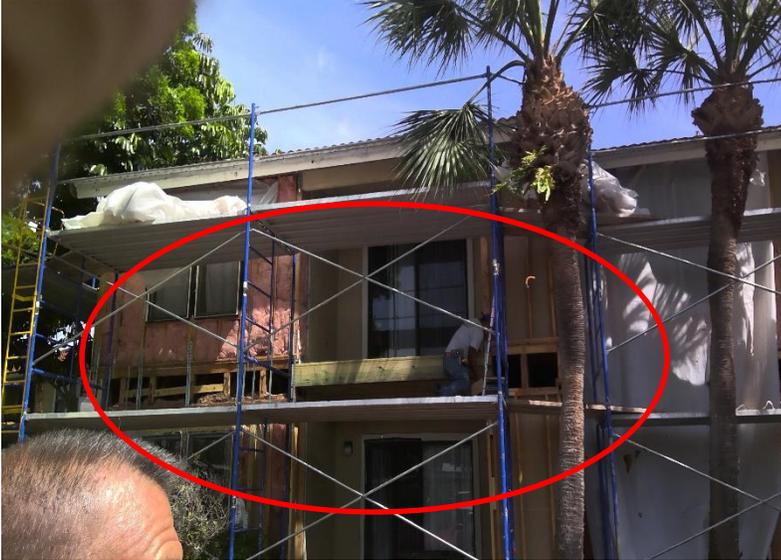
**PHOTOGRAPH #9**

**BUILDING 5  
SECTION A**

Balcony and wall framing repairs in progress where identified and marked by Delta.

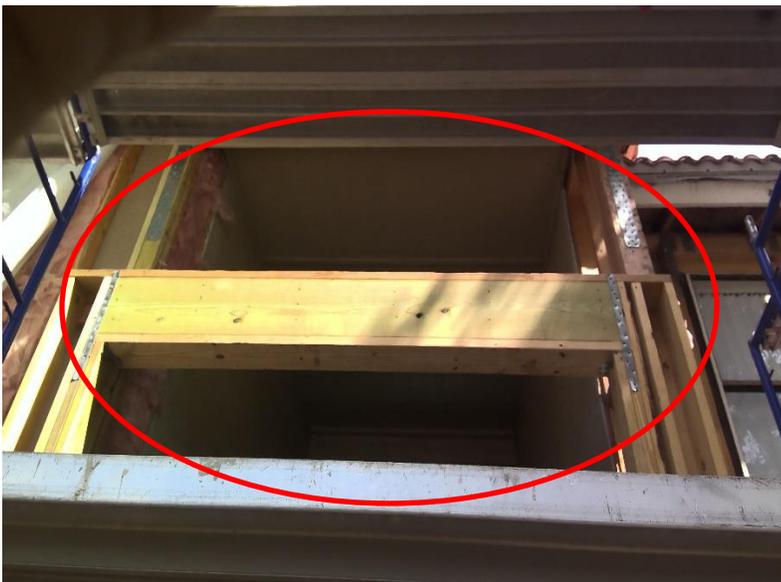
**PHOTOGRAPH #10**

**BUILDING 5  
SECTION A**

Full breezeway framing repairs performed and strapping in place.

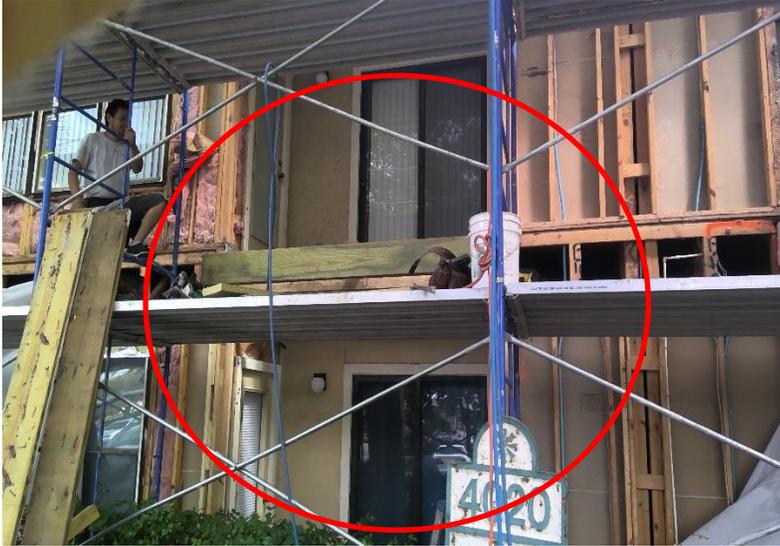
**PHOTOGRAPH #11**

**BUILDING 5  
SECTION B**

Balcony and wall framing repairs in progress where identified and marked by Delta.

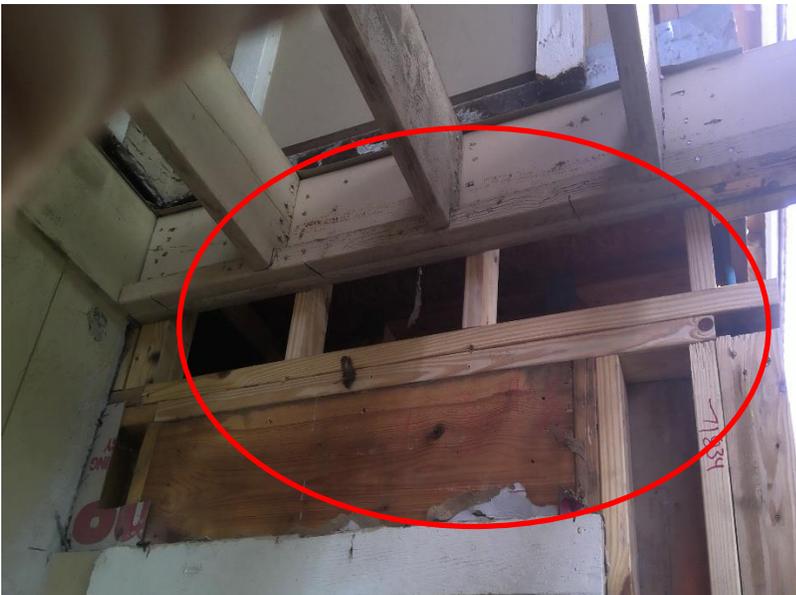
**PHOTOGRAPH #12**

**BUILDING 5  
SECTION B**

Balcony and wall framing repairs in progress where identified and marked by Delta.

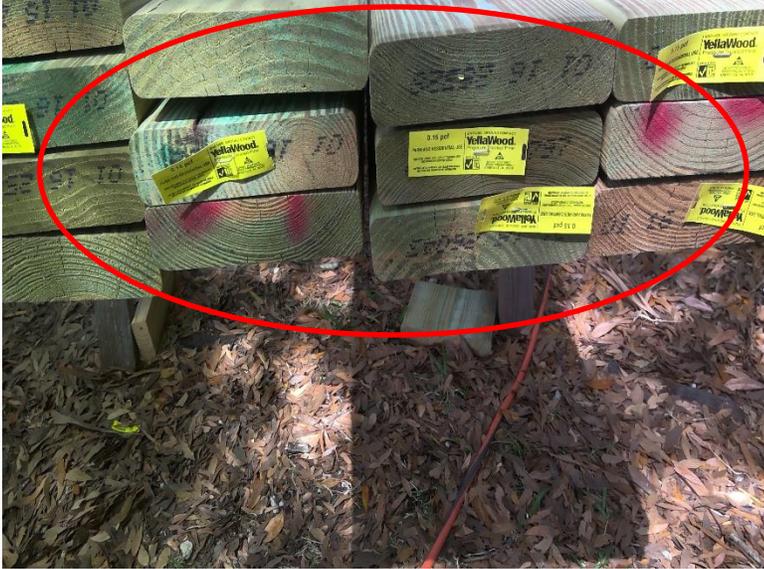
**PHOTOGRAPH #13**

**BUILDING 5  
SECTION B**

New pressure treated lumber for decking flooring replacement.
