PHOTOGRAPHS

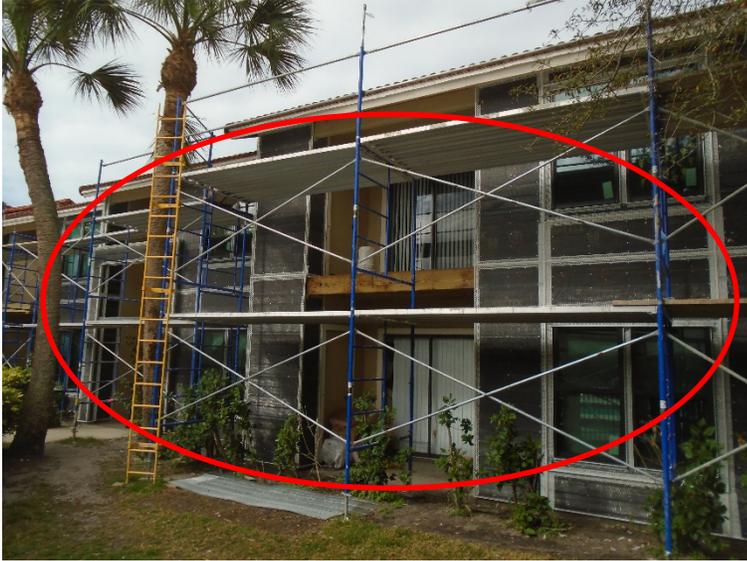
PHOTOGRAPH #1

BUILDING 5 SECTION G

Stucco Sub contractor has completed applying lath for stucco application.

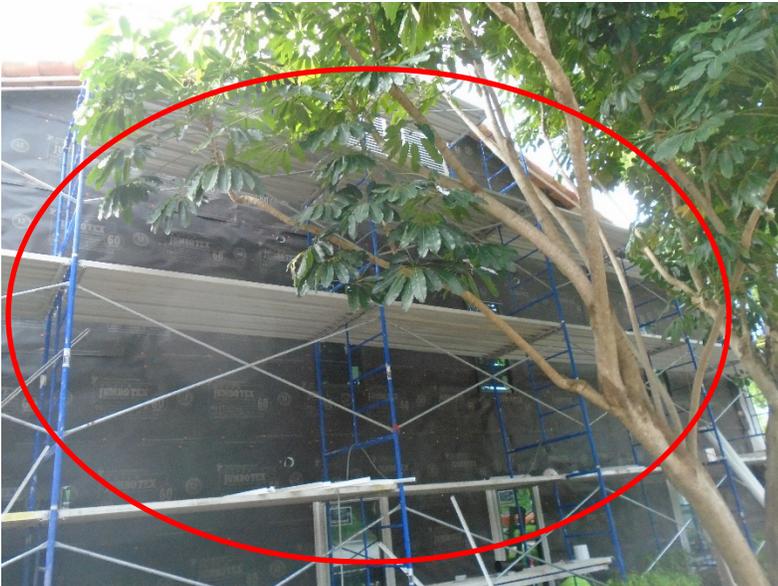
PHOTOGRAPH #2

BUILDING 5 SECTION H

Stucco Sub-contractor applying JumboTex 60 water resistant barrier.

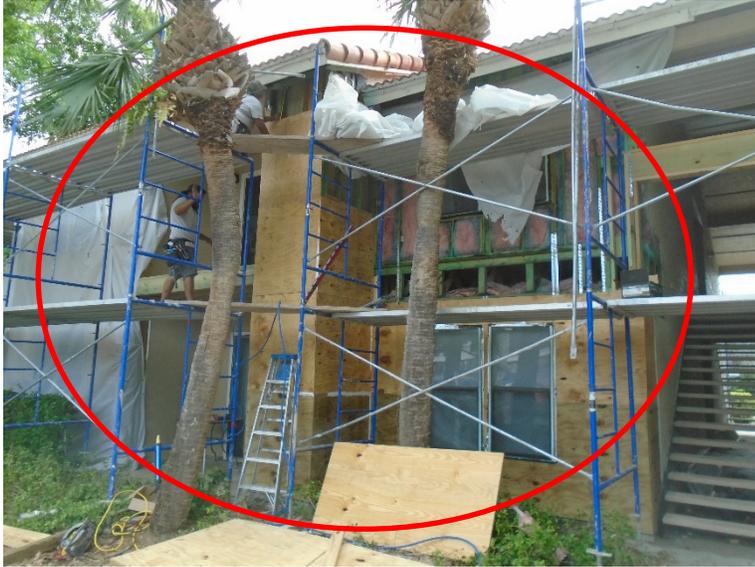
PHOTOGRAPH #3

**BUILDING 5
SECTION A**

Bora Care termite treatment applied on framing and 15/32" plywood sheathing being installed.

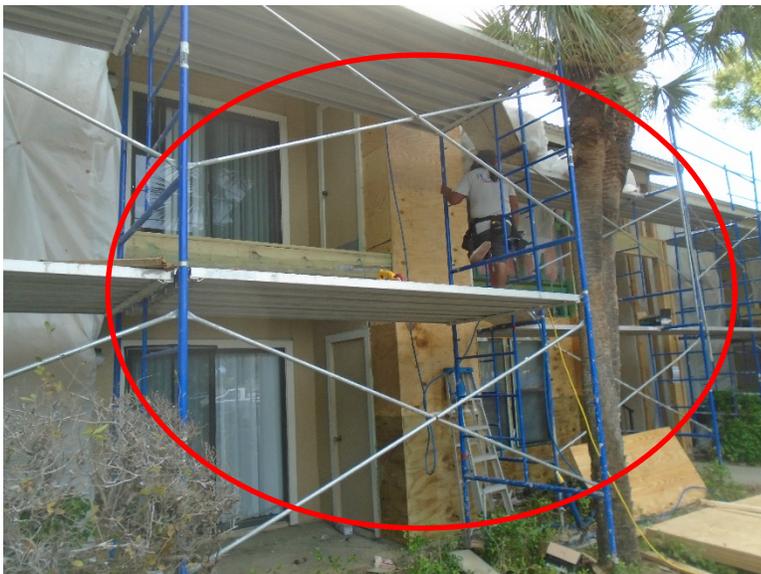
PHOTOGRAPH #4

**BUILDING 5
SECTION A**

New PT sheathing used at bottom row of plywood sheets being applied.

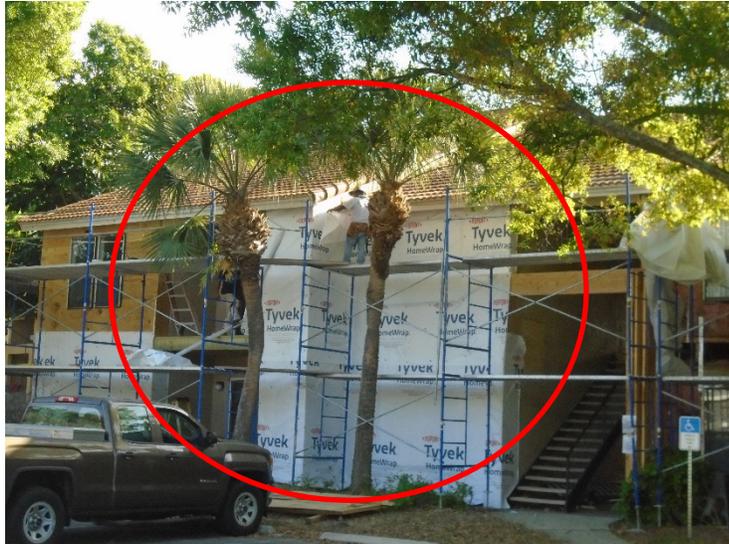
PHOTOGRAPH #5

**BUILDING 5
SECTION A**

Tyvek HomeWrap WRB installed over sheathing.

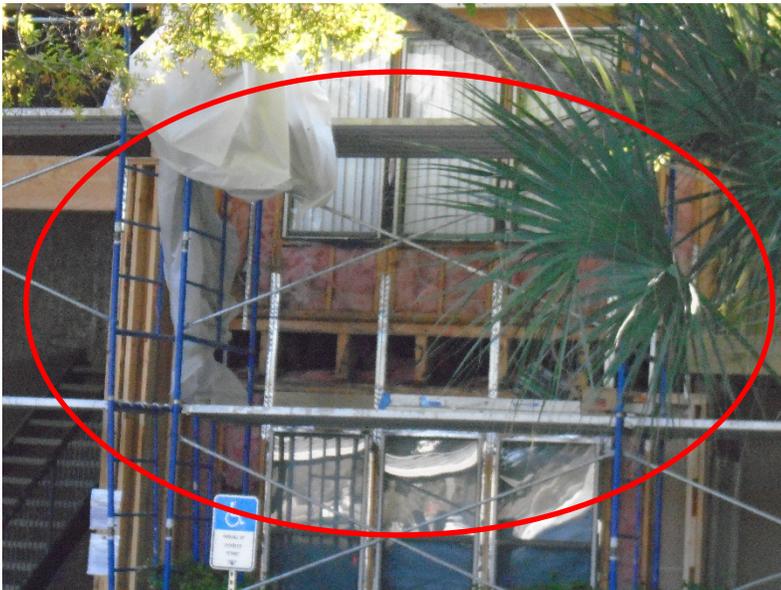
PHOTOGRAPH #6

**BUILDING 5
SECTION B**

Contractor has provided new Simpson Strong-Tie strapping and connectors at wall framing.

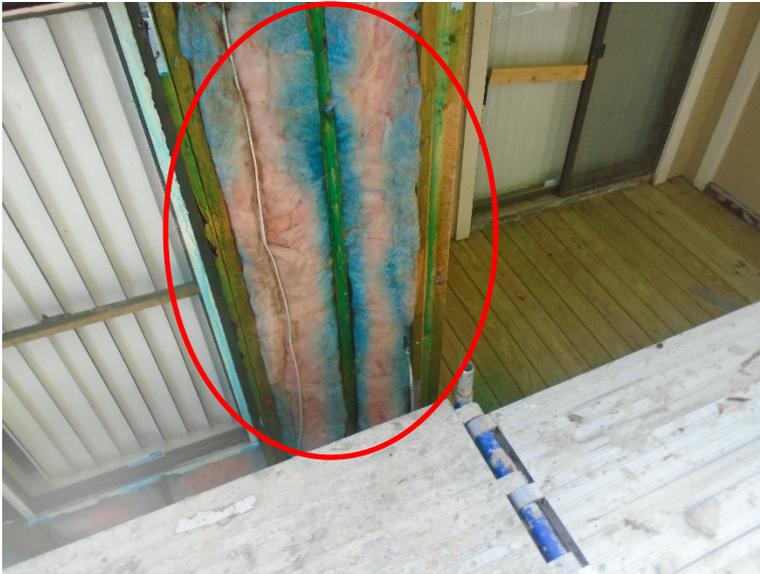
PHOTOGRAPH #7

**BUILDING 5
SECTION B**

Termite contractor has sprayed framing with Bora Care termite treatment.

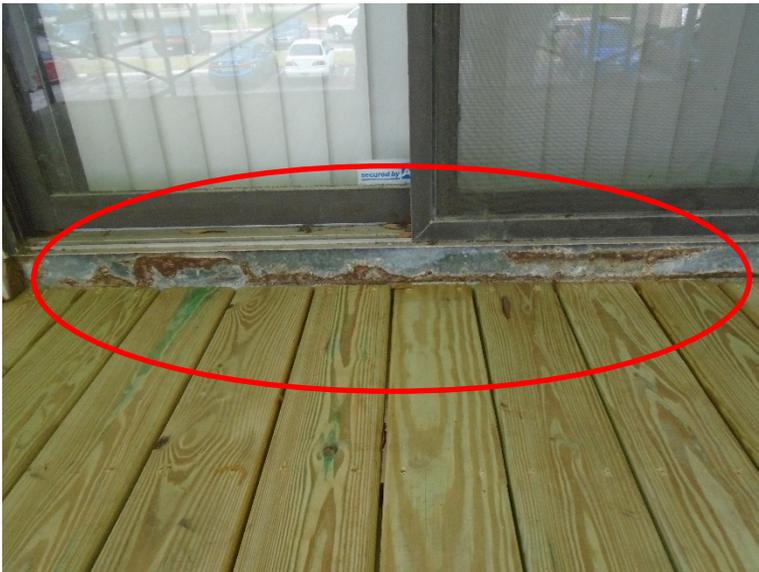
PHOTOGRAPH #8

**BUILDING 5
SECTION B**

Contractor has replaced damaged decking with new 2" X 6" PT lumber. Rusted existing metal flashings exposed by decking repair will require replacement or coating to address rust.

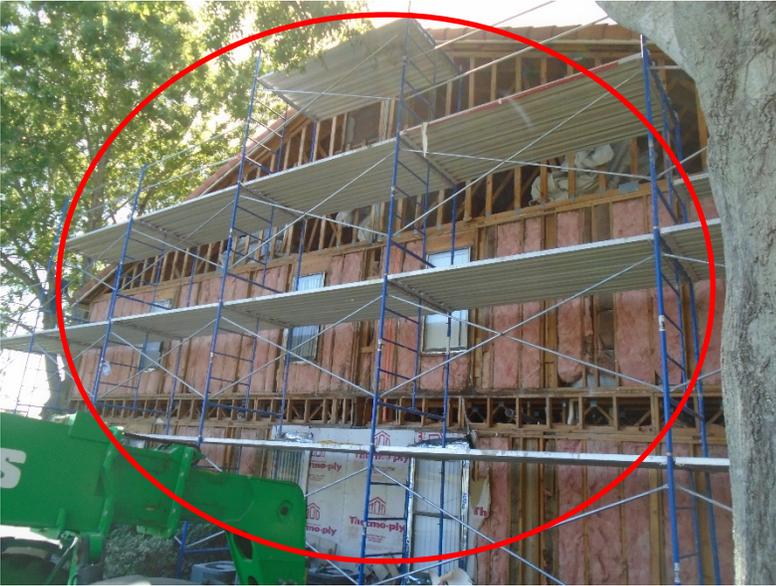
PHOTOGRAPH #9

**BUILDING 23
SECTION H**

Removal of stucco and sheathing has exposed wood framing for damage review.

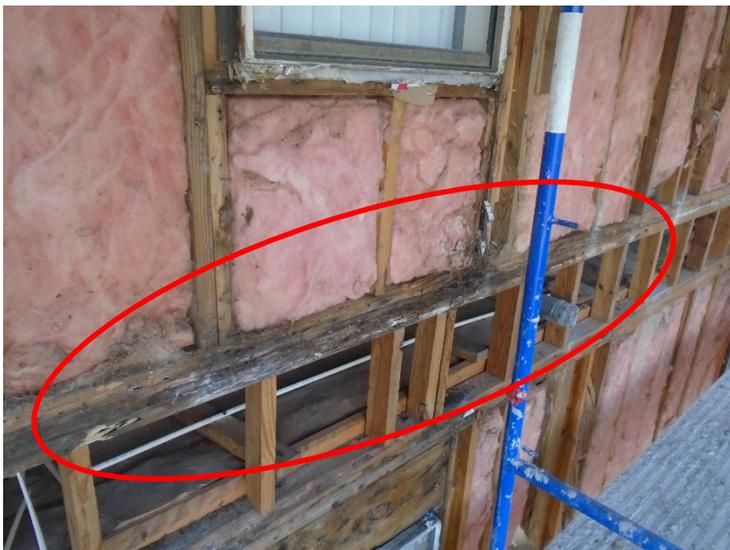
PHOTOGRAPH #10

**BUILDING 23
SECTION H**

Removal of stucco and sheathing has exposed wood framing for damage review.

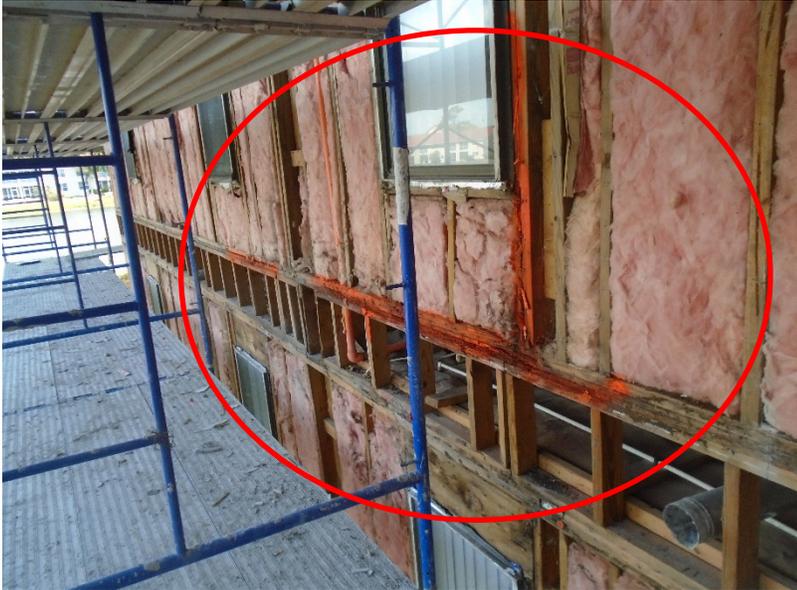
PHOTOGRAPH #11

**BUILDING 5
SECTION H**

Damaged wood marked for repairs at window framing, 2nd floor bottom plates and subflooring edges.

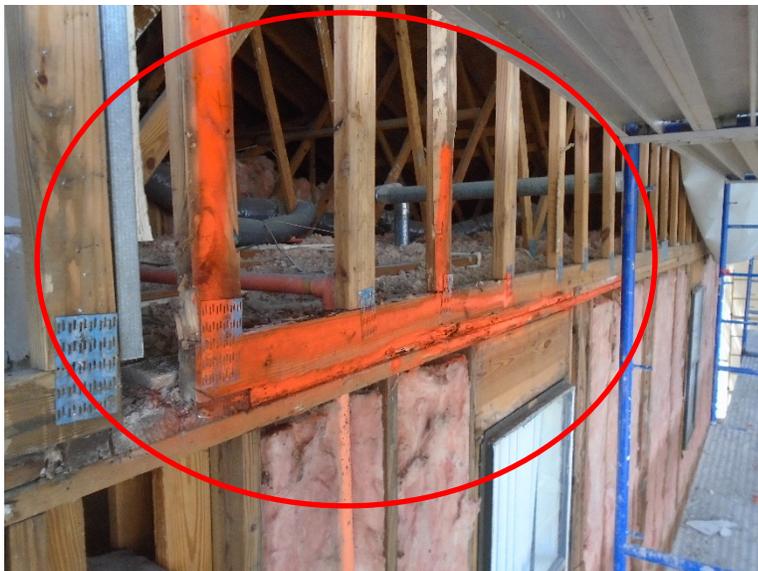
PHOTOGRAPH #12

**BUILDING 23
SECTION H**

Damaged framing marked for repairs at 2nd floor top plates and gable end roof trusses.

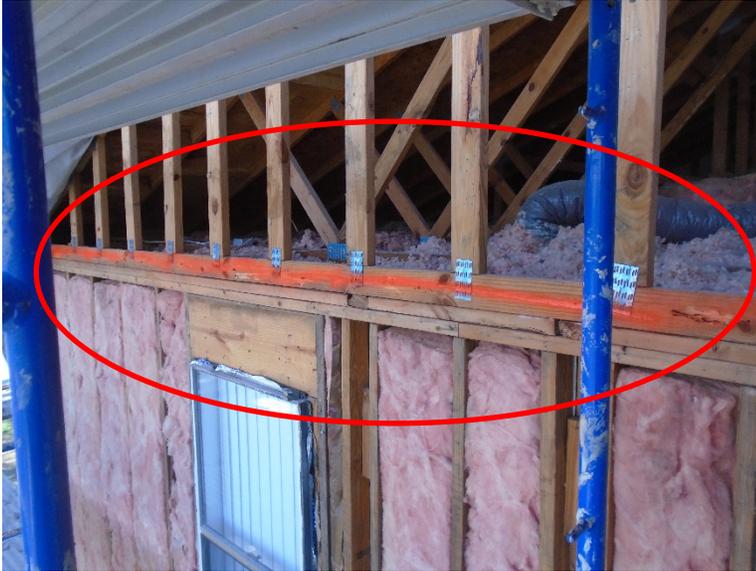
PHOTOGRAPH #13

**BUILDING 23
SECTION H**

Damaged framing marked for repairs at 2nd floor top plates and gable end roof trusses.

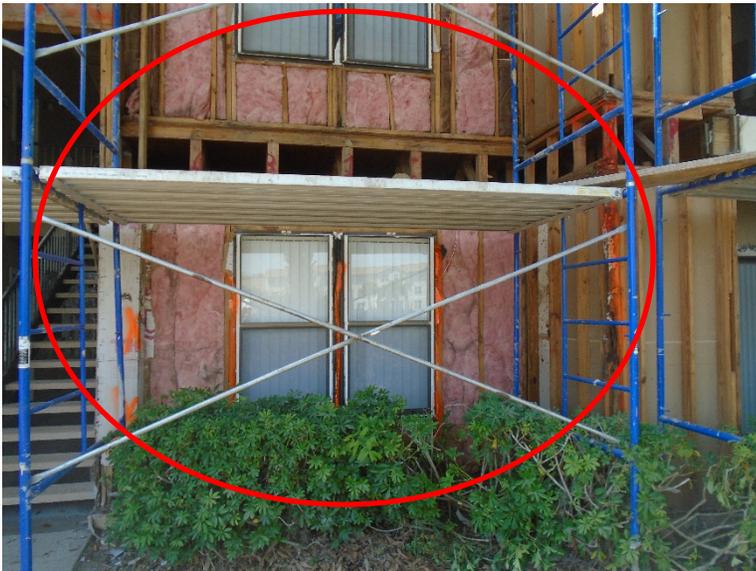
PHOTOGRAPH #14

**BUILDING 23
SECTION G**

Damage at wall framing, window framing and breezeway framing marked for repairs.
