PHOTOGRAPHS

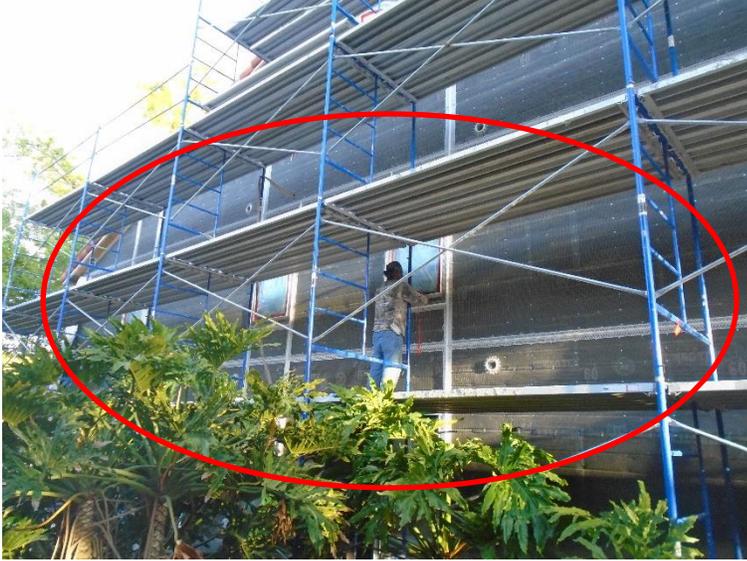
PHOTOGRAPH #1

BUILDING 5 SECTION D

Stucco Sub-contractor protecting new windows in preparation for new stucco.

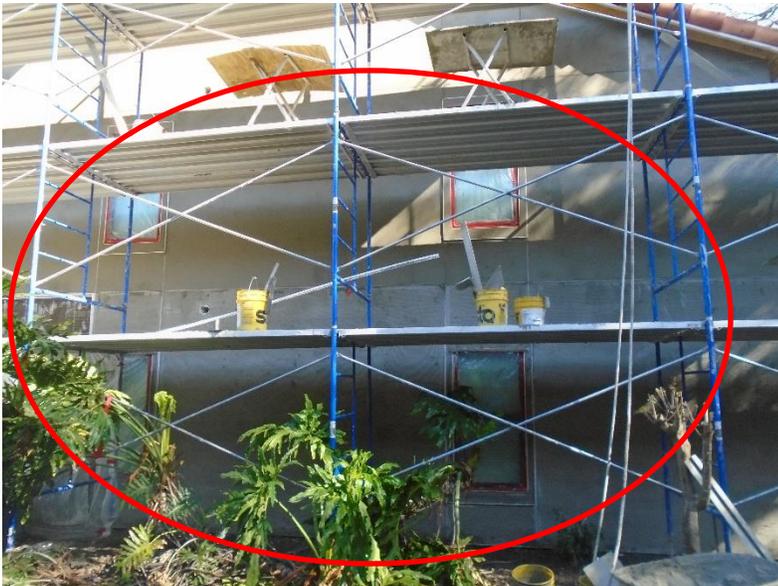
PHOTOGRAPH #2

BUILDING 5 SECTION D

Stucco Sub-contractor applying scratch coats and sand coats of stucco.

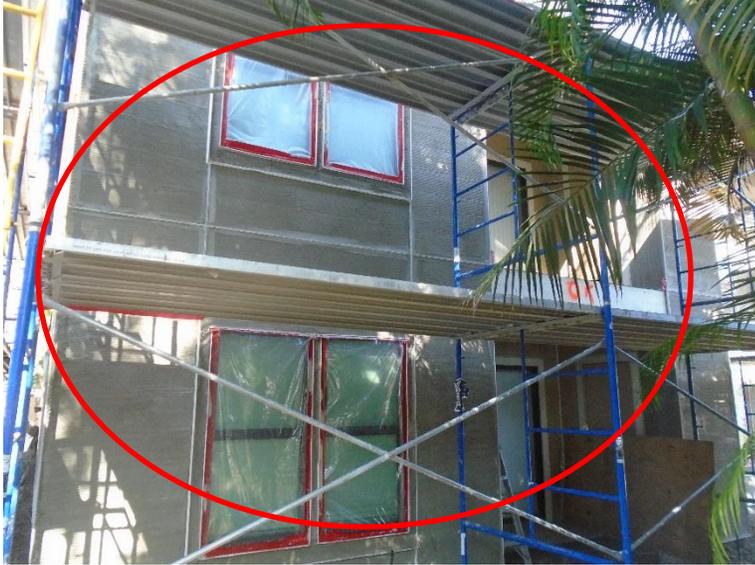
PHOTOGRAPH #3

**BUILDING 5
SECTION E**

Stucco Sub-contractor applying scratch coat of stucco.

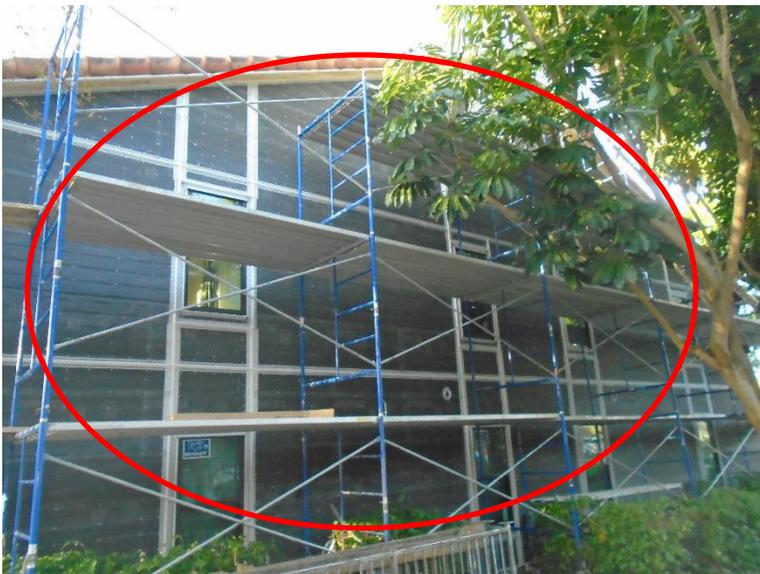
PHOTOGRAPH #4

**BUILDING 5
SECTION H**

Stucco sub-contractor has applied JumboTex WRB, new stucco accessories and metal lath.

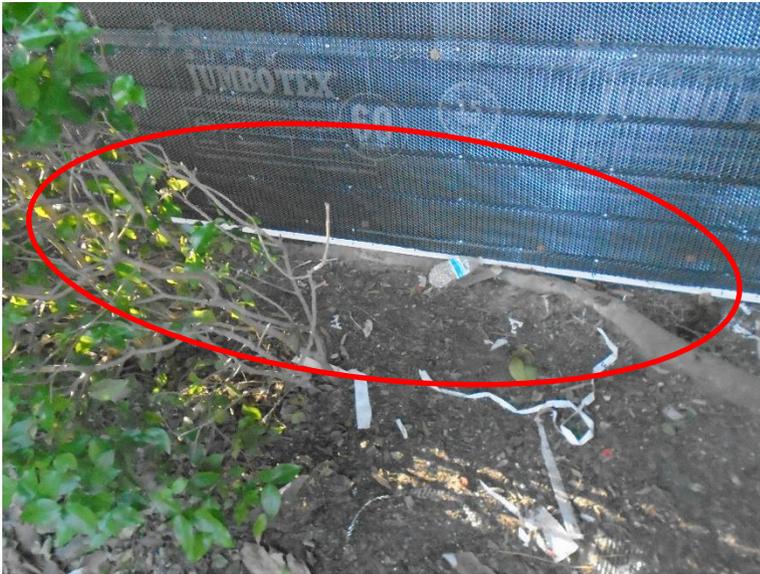
PHOTOGRAPH #5

**BUILDING 5
SECTION H**

Grade and roots are up to bottom of weep screed. Grading is required to be 6" below stucco weep screed termination.

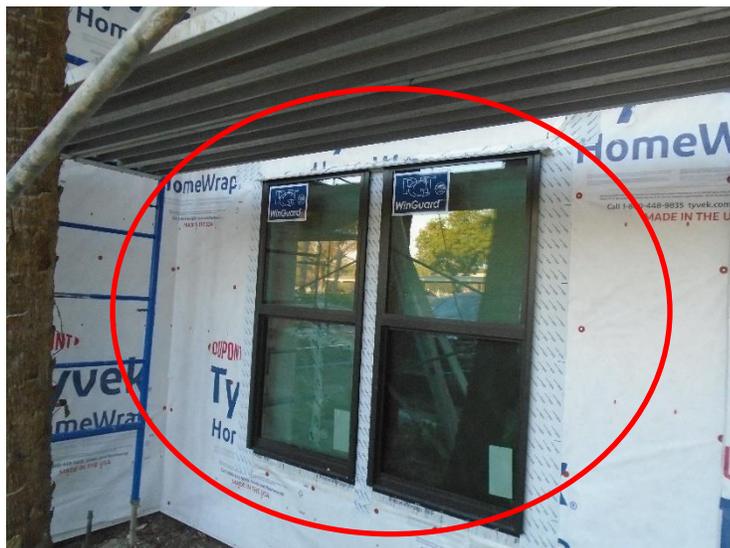
PHOTOGRAPH #6

**BUILDING 5
SECTION A**

New PGT windows have been installed and inspected.

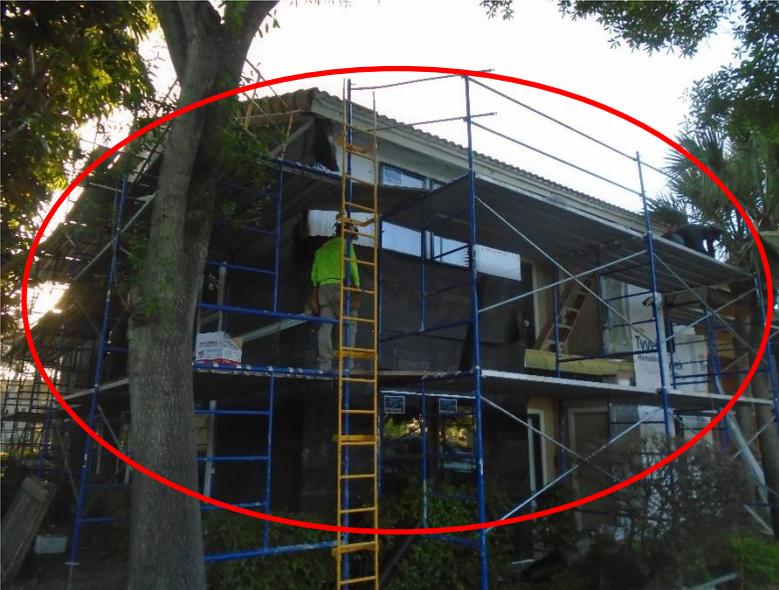
PHOTOGRAPH #7

**BUILDING 5
SECTION A**

Stucco sub-contractor applying
JumboTex WRB.

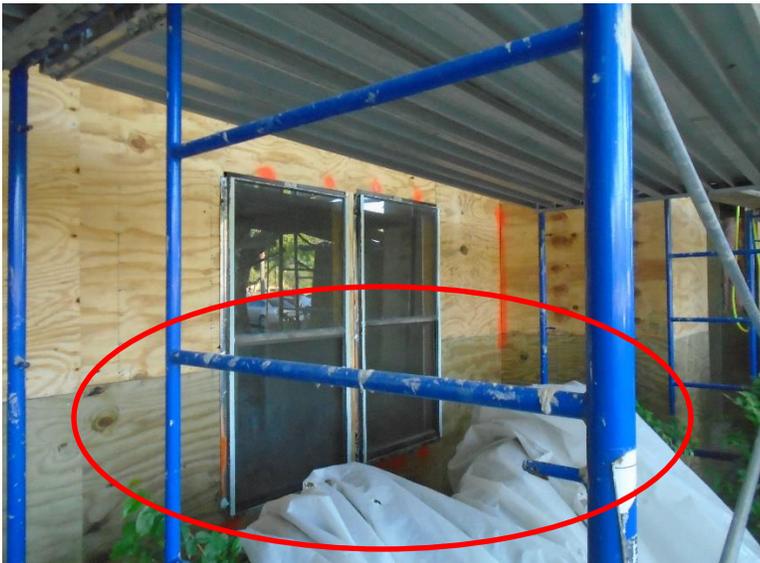
PHOTOGRAPH #8

**BUILDING 5
SECTION B**

Contractor has provided new PT
sheathing for bottom row of sheathing.

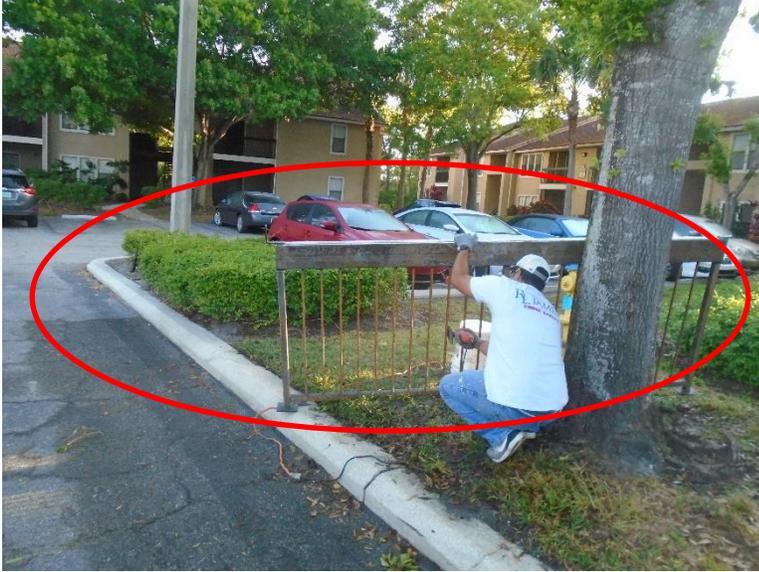
PHOTOGRAPH #9

**BUILDING 5
SECTION B**

Contractor has removed balcony railings and in process of removing rust for painting applications.

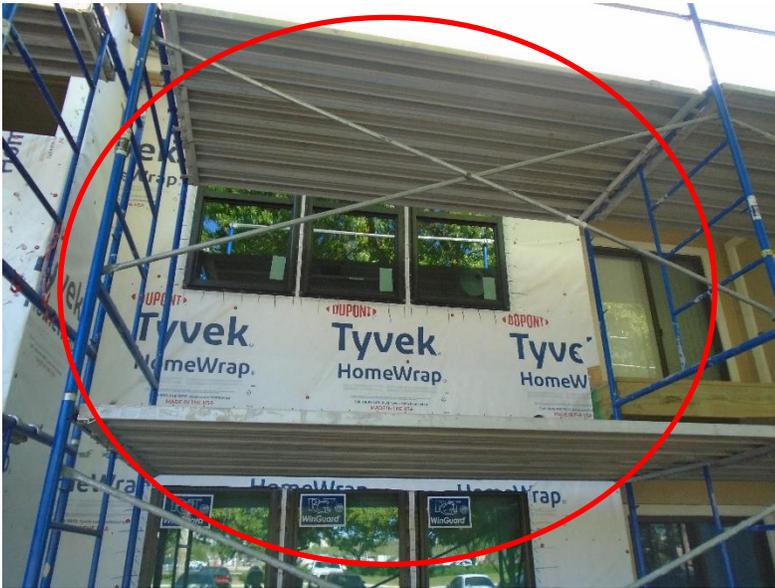
PHOTOGRAPH #10

**BUILDING 23
SECTION B**

Tyvek HomeWrap and DuPont flashings applied at new window openings prior to installation of new PGT windows.

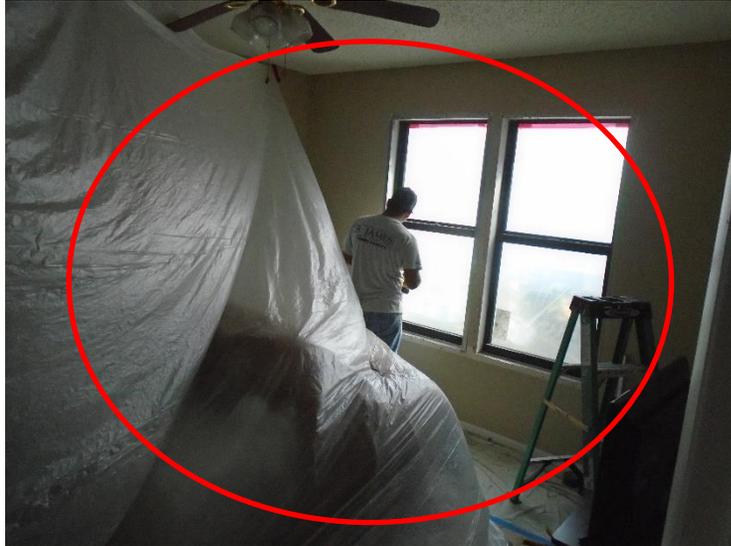
PHOTOGRAPH #11

**BUILDING 23
SECTION B**

Interior window drywall repairs in progress.

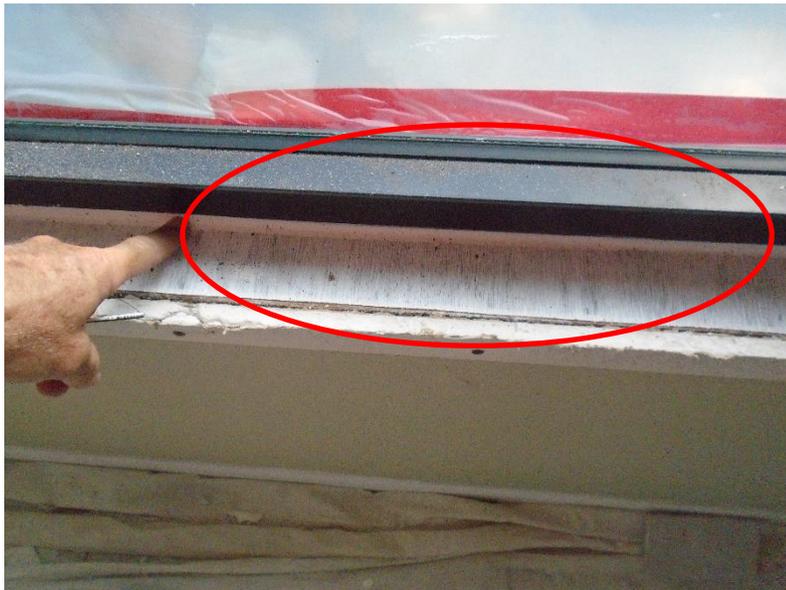
PHOTOGRAPH #12

**BUILDING 5
SECTION B**

Contractor has sealed interior window to Dupont flashing as per manufacturers instruction with approved sealant.

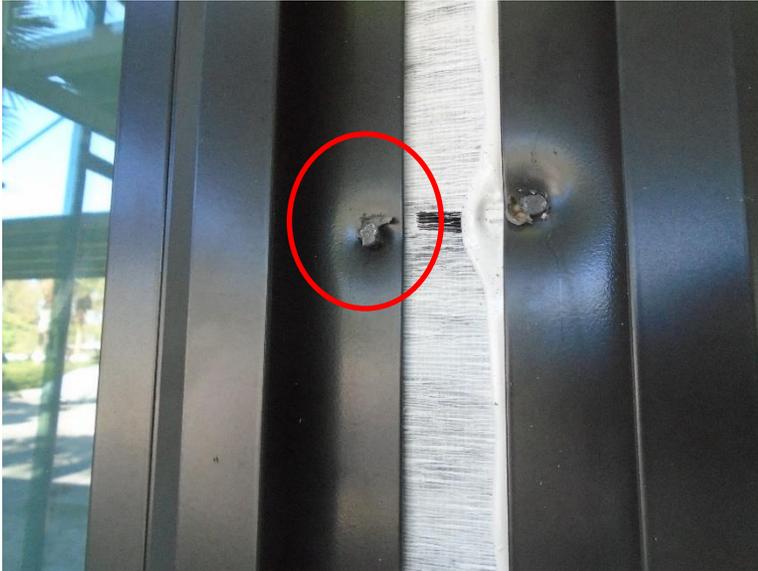
PHOTOGRAPH #13

**BUILDING 05
SECTION B**

Wind flange nail not fully engaged.

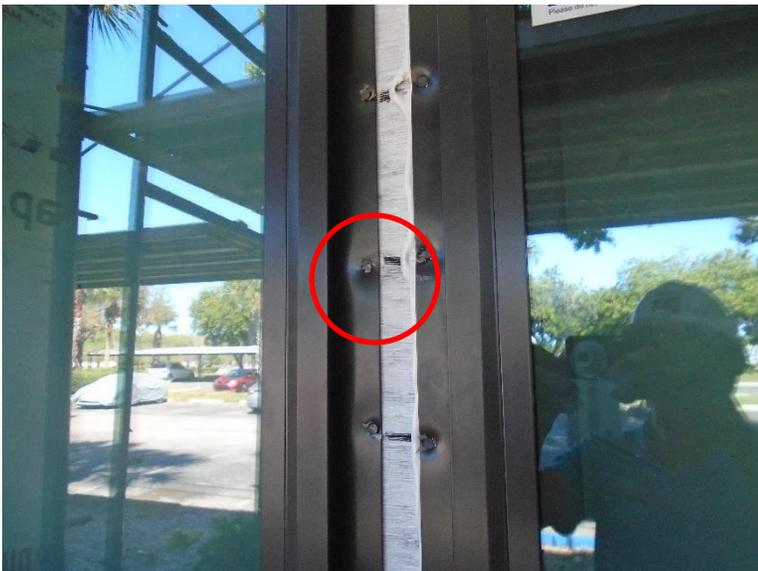
PHOTOGRAPH #14

**BUILDING 05
SECTION B**

Wind flange nail not fully engaged
corrected by contractor upon notification.

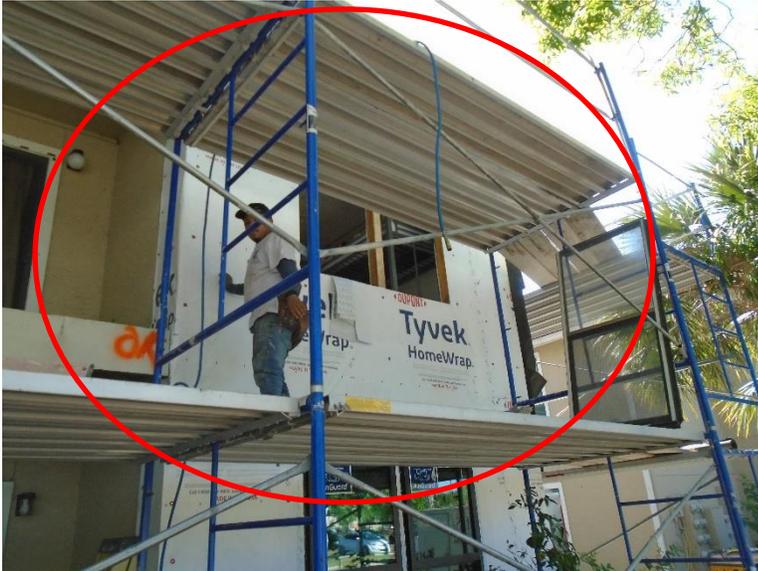
PHOTOGRAPH #15

**BUILDING 05
SECTION C**

Contractor in process of installing window flashings.

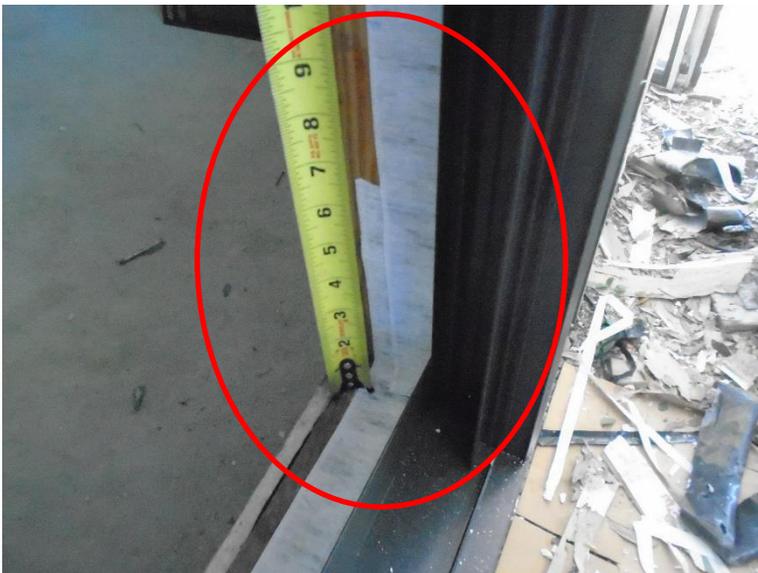
PHOTOGRAPH #16

**BUILDING 05
SECTION C**

Window flashings in compliance with manufacturers application instruction.

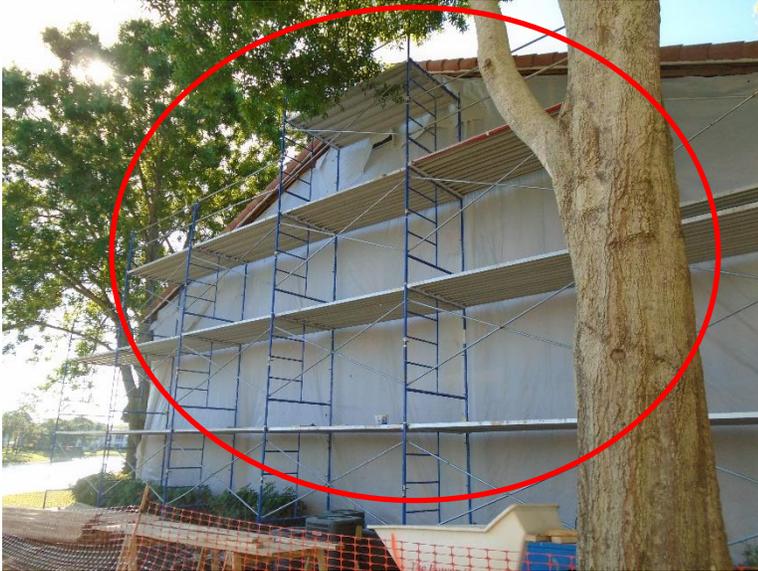
PHOTOGRAPH #17

**BUILDING 23
SECTION H**

Contractor protecting wall with plastic sheathing where stucco has been removed.

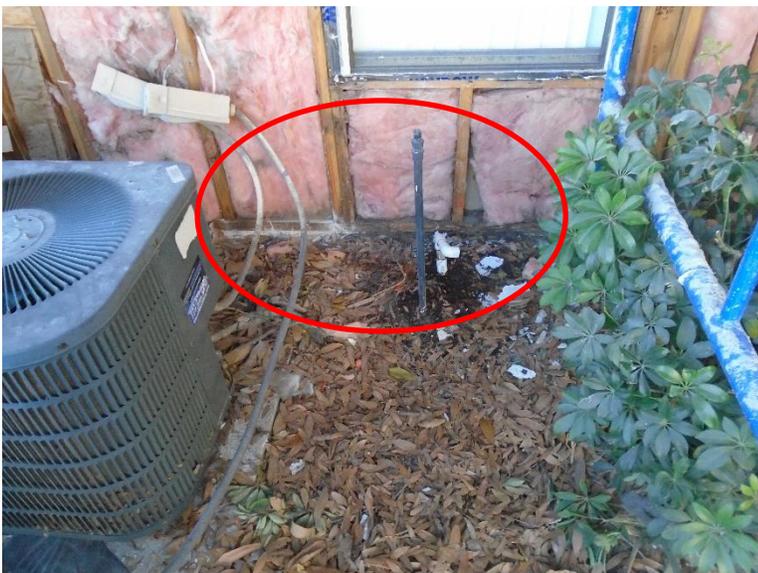
PHOTOGRAPH #18

**BUILDING 23
SECTION H**

Grade is up to bottom of existing base plate. Grading is required to be 6" below stucco weep screed termination.

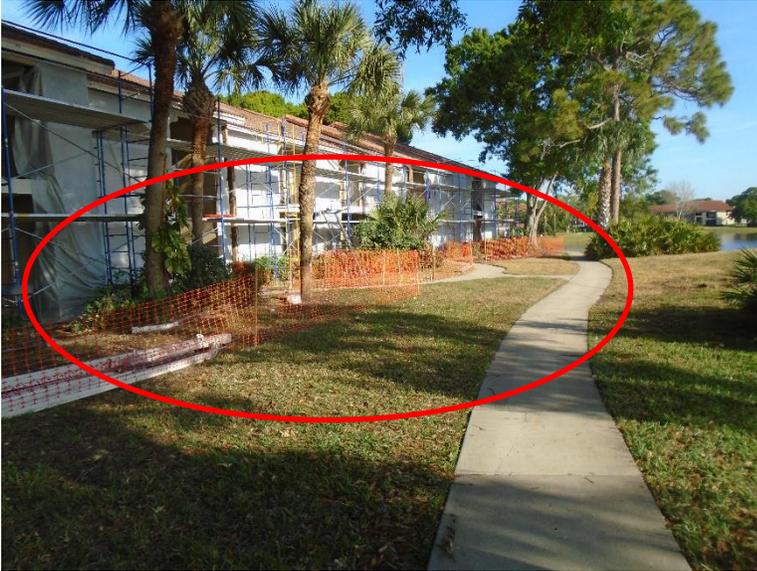
PHOTOGRAPH #19

**BUILDING 23
SECTION G**

Construction fencing has been provided as required at all work areas and pedestrian entrances in professional manner.

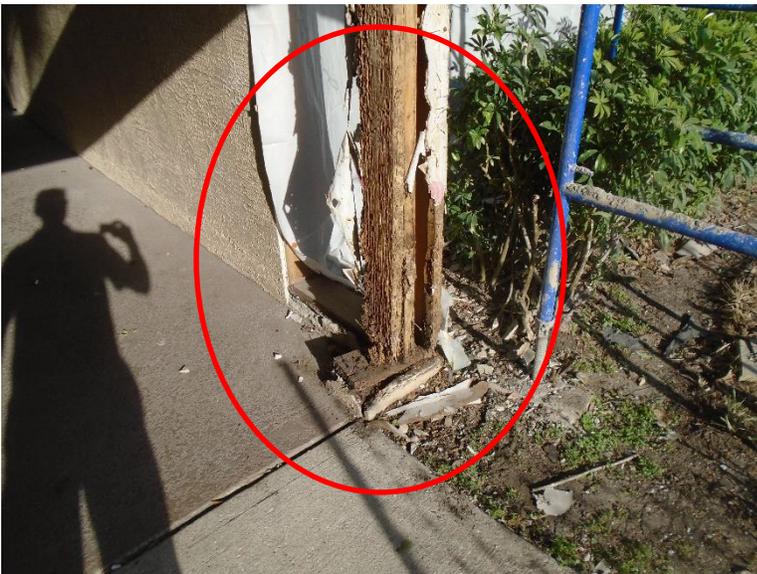
PHOTOGRAPH #20

**BUILDING 23
SECTION G**

Deteriorated wood framing conditions at breezeway entrance.

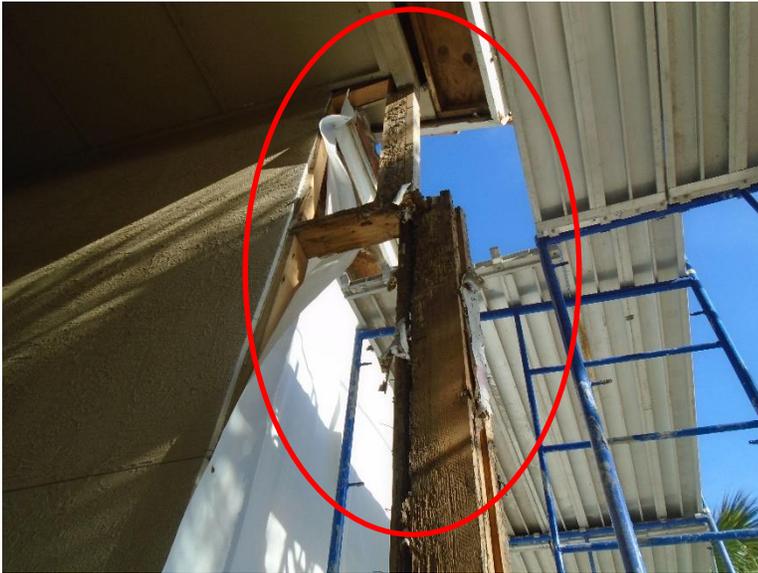
PHOTOGRAPH #21

**BUILDING 23
SECTION G**

Deteriorated wood framing conditions at breezeway entrance.

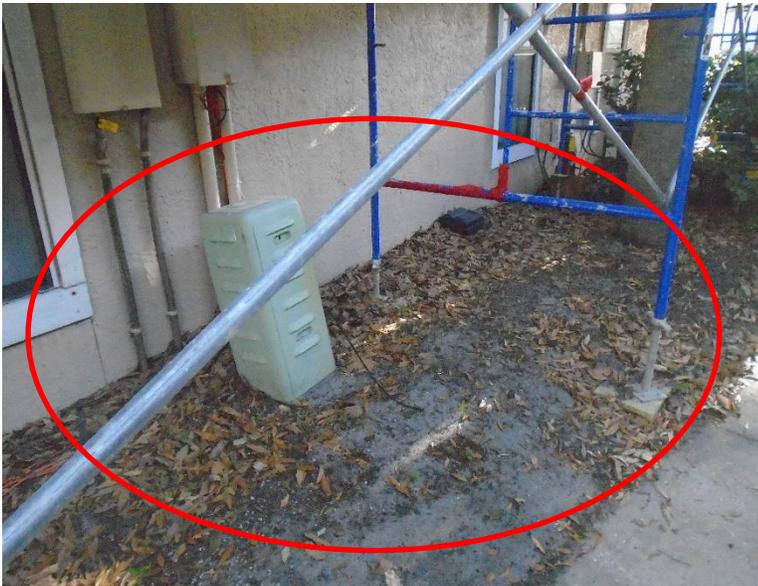
PHOTOGRAPH #22

**BUILDING 23
SECTION C**

Grade is up to bottom of existing stucco. Grading is required to be 6" below stucco weep screed termination.

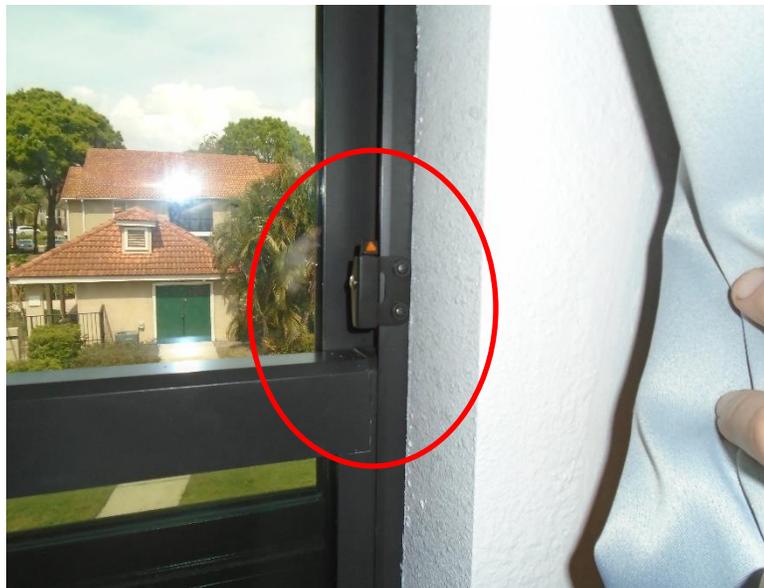
PHOTOGRAPH #23

**BUILDING 27
SECOND FLOOR WINDOWS
UNIT 2728**

Window Operation Control Device installed in accordance with FBC 2017 complying with ASTM F2090.

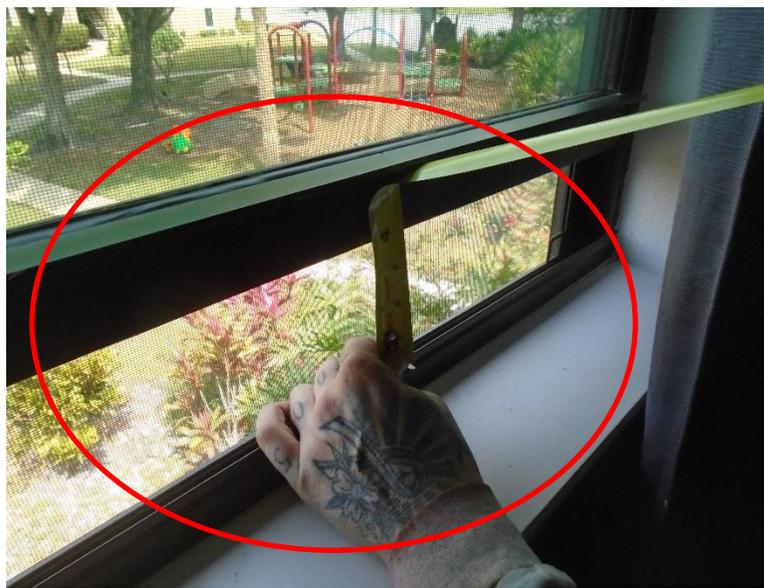
PHOTOGRAPH #24

**BUILDING 27
SECOND FLOOR WINDOWS
UNIT 2728**

Window Operation Control Device installed in accordance with FBC 2017 complying with ASTM F2090.

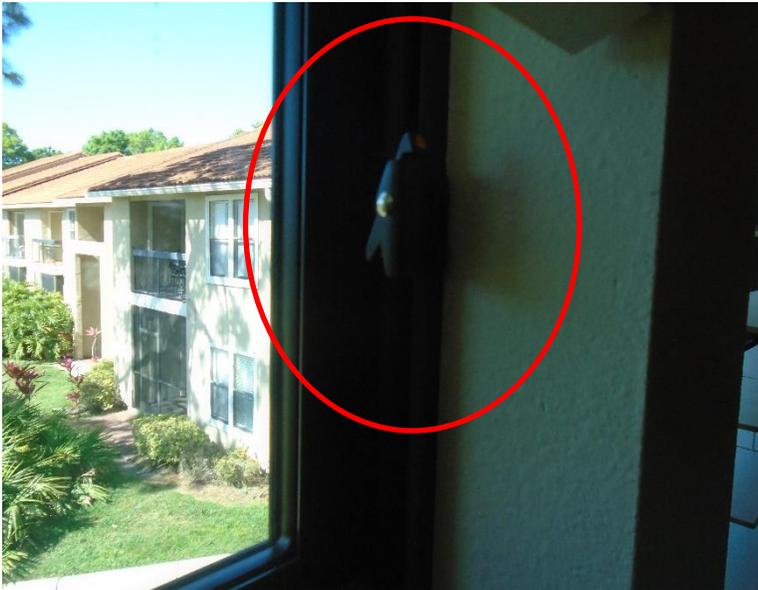
PHOTOGRAPH #25

**BUILDING 10
SECOND FLOOR WINDOWS
UNIT 1024**

Window Operation Control Device
installed in accordance with FBC 2017
complying with ASTM F2090.
