PHOTOGRAPHS

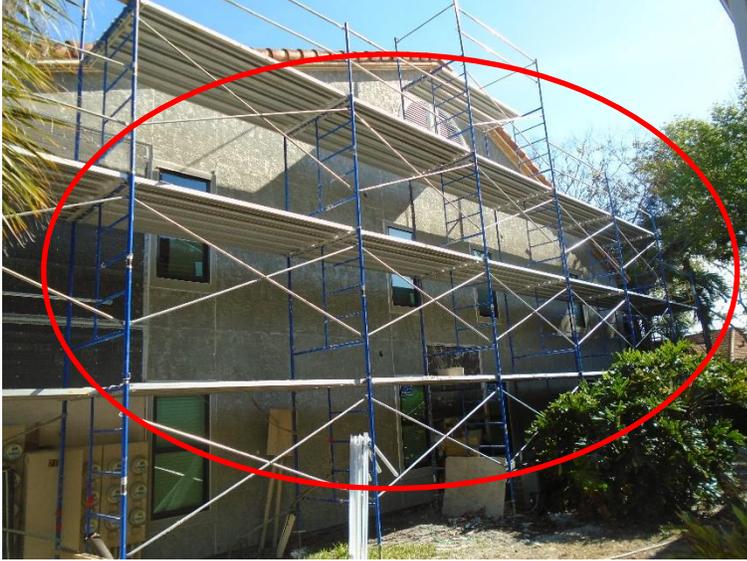
PHOTOGRAPH #1

BUILDING 5 SECTION D

Stucco Sub-contractor has applied scratch, brown and finish coats of stucco.

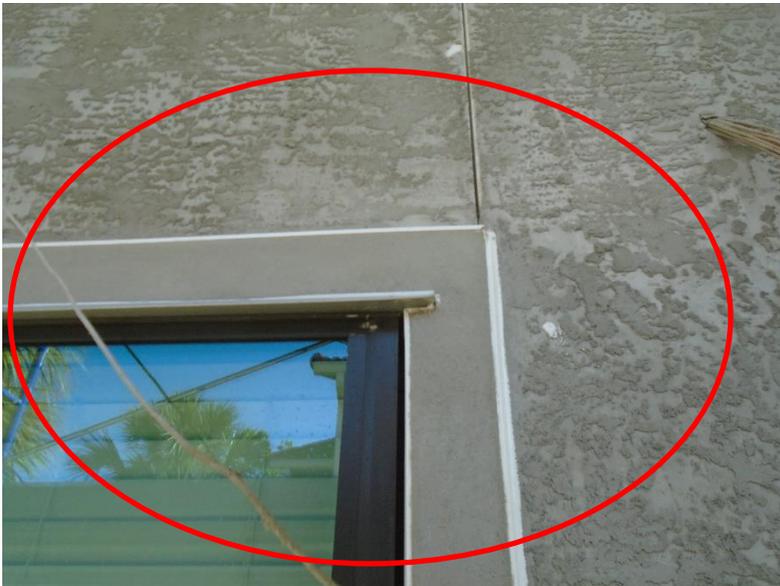
PHOTOGRAPH #2

BUILDING 5 SECTION D

Stucco Sub-contractor has applied scratch, brown and finish coats of stucco.

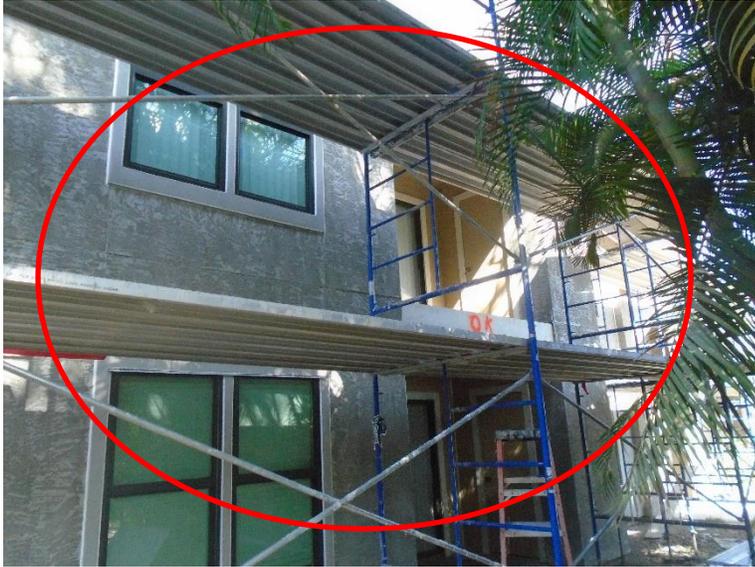
PHOTOGRAPH #3

**BUILDING 5
SECTION E**

Stucco Sub-contractor has applied scratch, brown and finish coats of stucco.

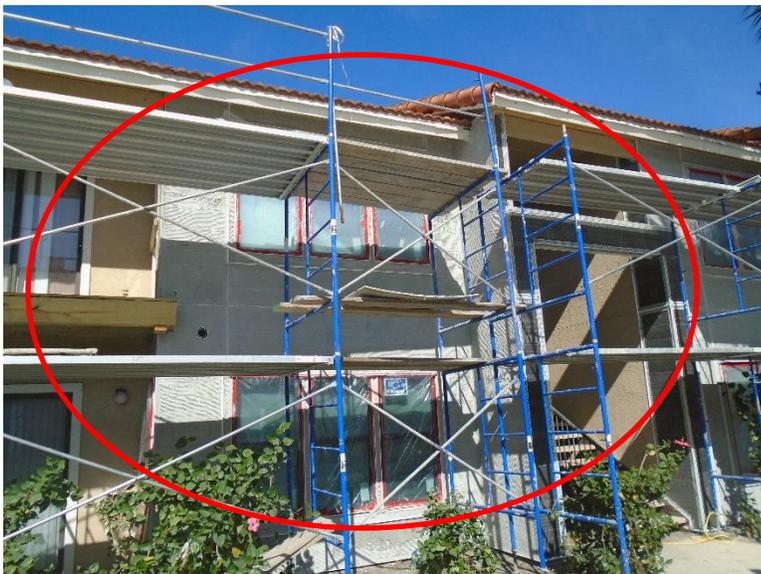
PHOTOGRAPH #4

**BUILDING 5
SECTION F**

Stucco sub-contractor in process of applying scratch and brown coats.

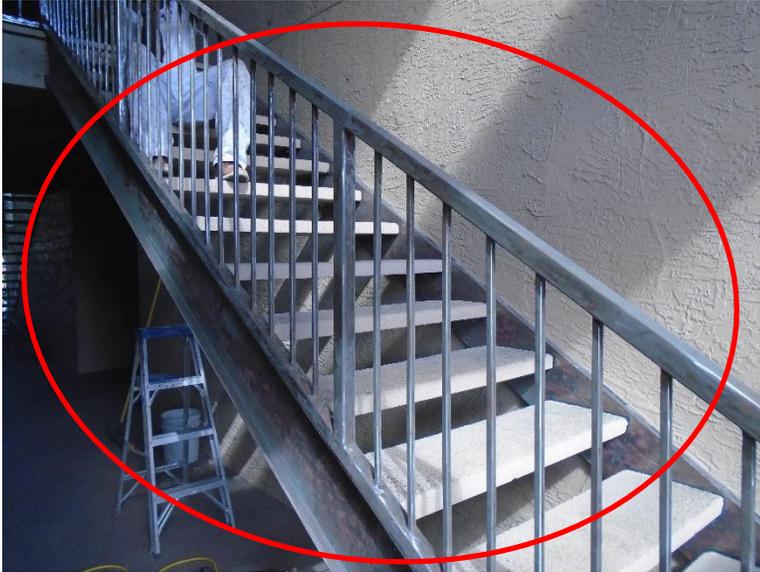
PHOTOGRAPH #5

**BUILDING 5
SECTION G**

Breezeway railings in process of peeling paint and rust removal.

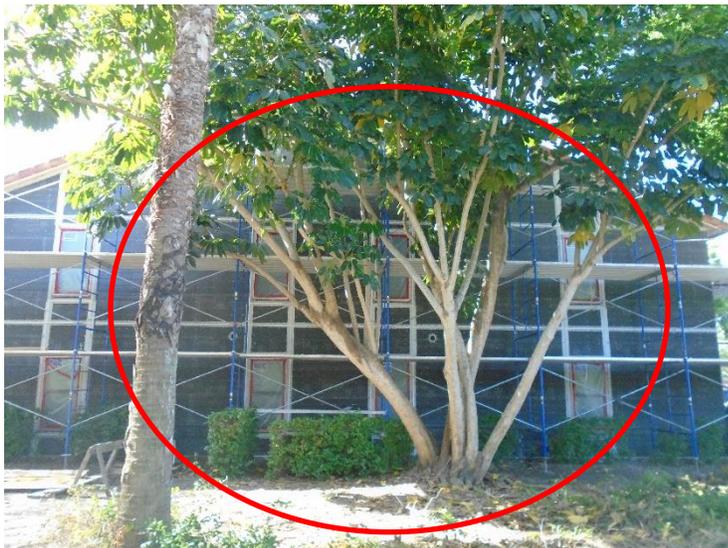
PHOTOGRAPH #6

**BUILDING 5
SECTION H**

Stucco Sub- Contractor has applied JumboTex WRB, stucco accessories and metal lathing.

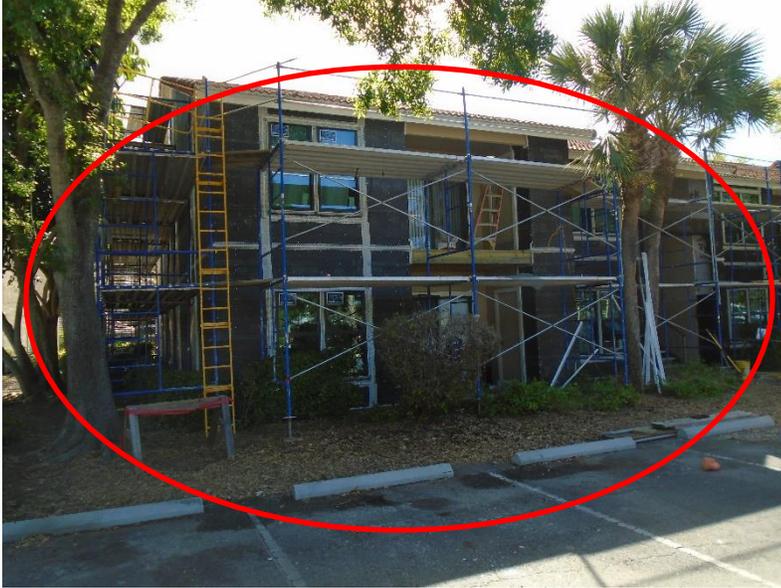
PHOTOGRAPH #7

**BUILDING 5
SECTION A**

Stucco Sub- Contractor in process of applying JumboTex WRB, stucco accessories and metal lathing.

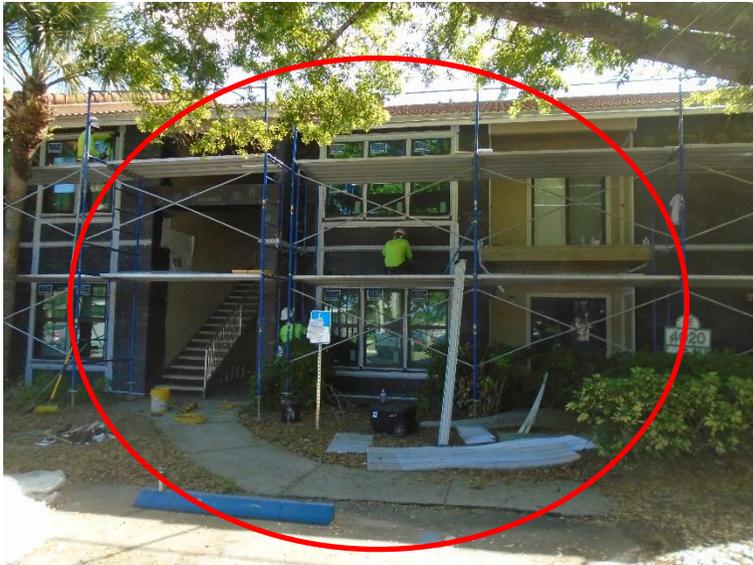
PHOTOGRAPH #8

**BUILDING 5
SECTION B**

Stucco Sub- Contractor in process of applying JumboTex WRB, stucco accessories and metal lathing.

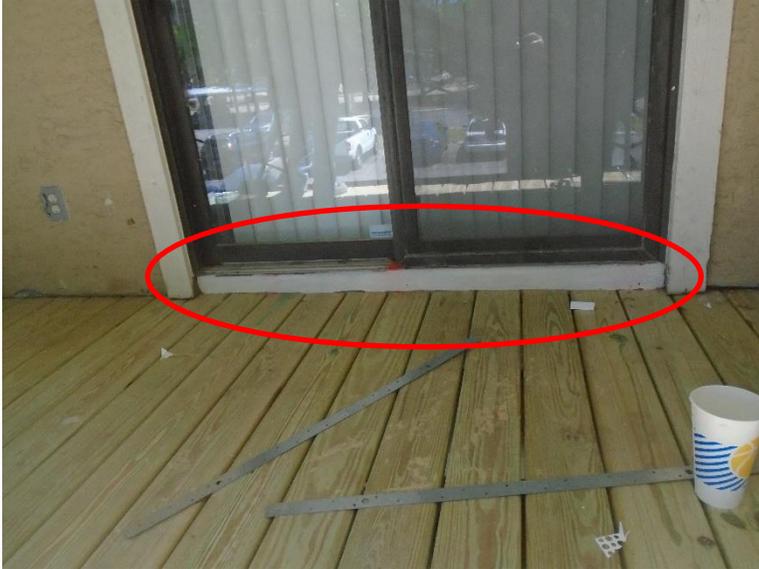
PHOTOGRAPH #9

**BUILDING 5
SECTION B**

Contractor has removed rust from metal flashing and coated for protection.

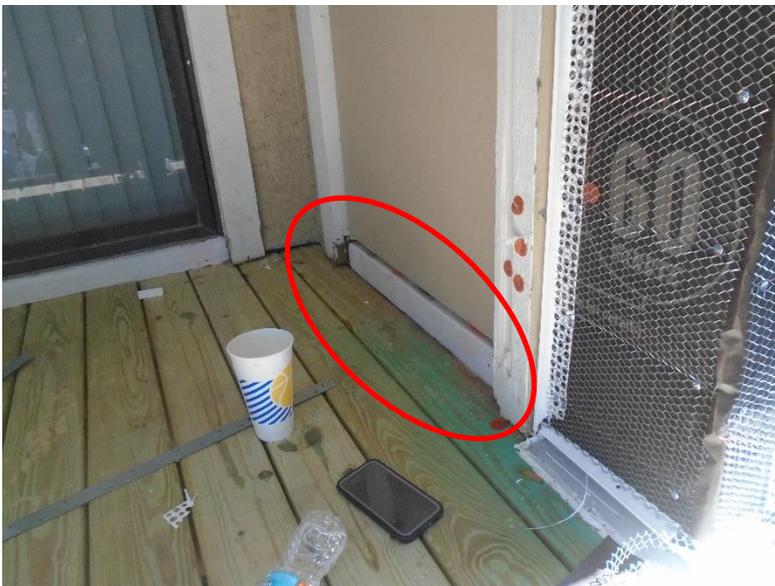
PHOTOGRAPH #10

**BUILDING 5
SECTION B**

Contractor has removed rust from metal flashing and coated for protection.

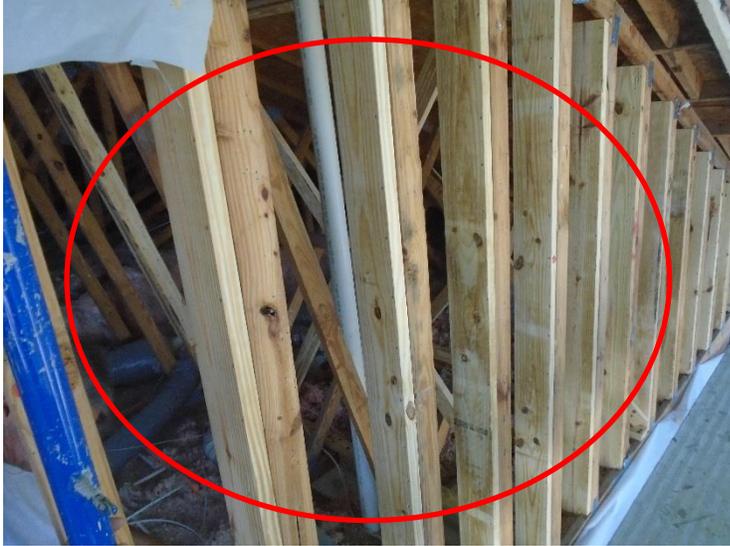
PHOTOGRAPH #11

**BUILDING 23
SECTION H**

Contractor has performed gable end wall bracing and repairs.

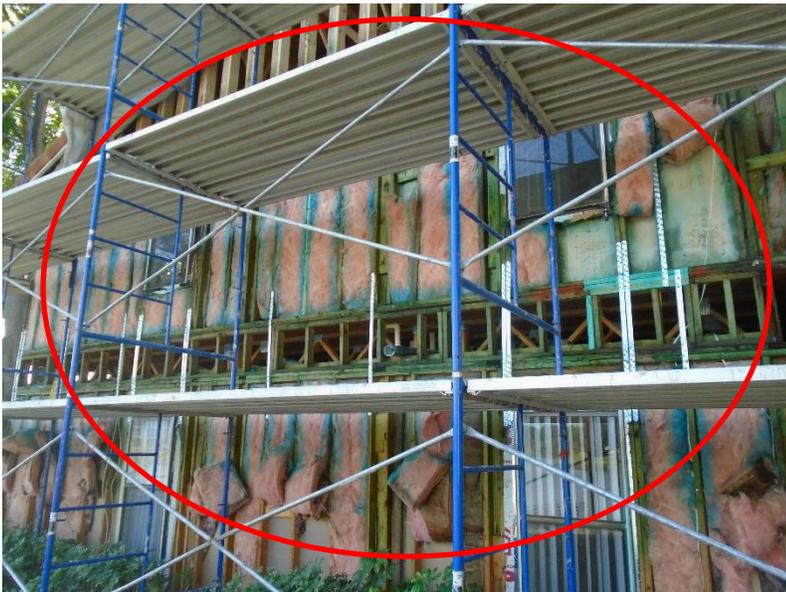
PHOTOGRAPH #12

**BUILDING 23
SECTION H**

Contractor has provided Simpson Strong-tie strapping and termite contractor has applied Bora Care termite treatment.

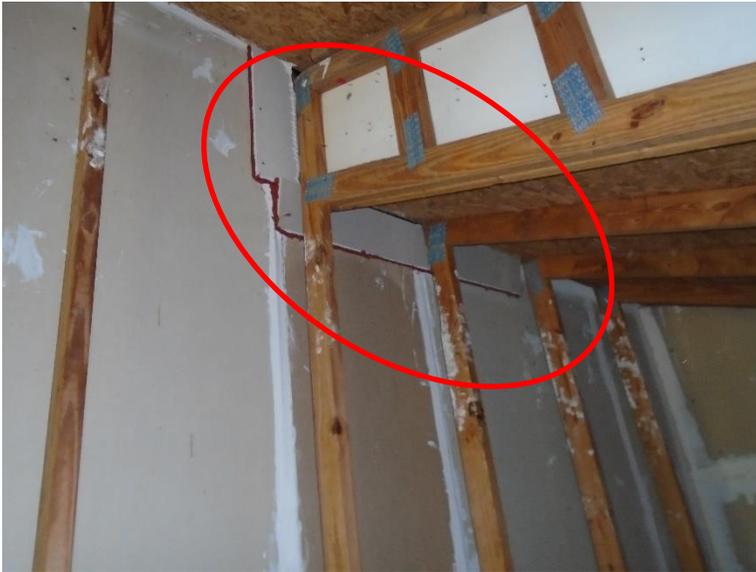
PHOTOGRAPH #13

**BUILDING 23
SECTION H
ATTIC UNIT #2321**

Framing scabs, gussets and fire wall repairs have been performed and quantified.

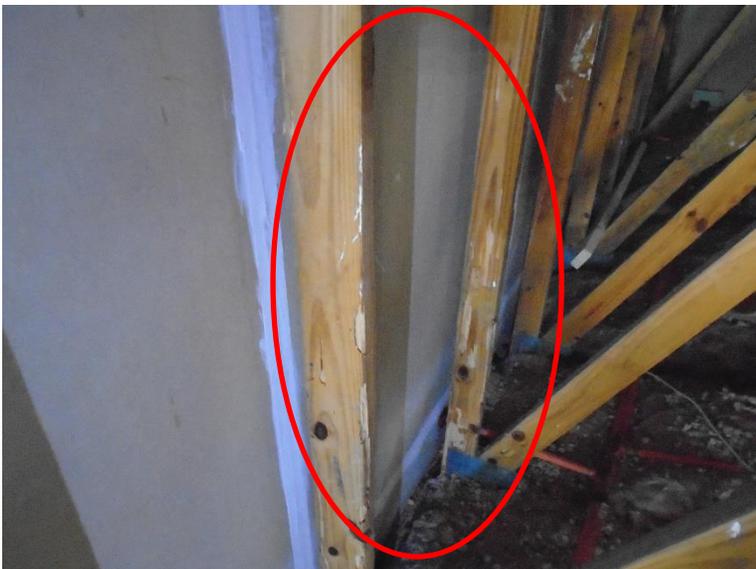
PHOTOGRAPH #14

**BUILDING 23
SECTION H
ATTIC UNIT #2321**

Additional truss framing repaired where extensive termite damage was observed.

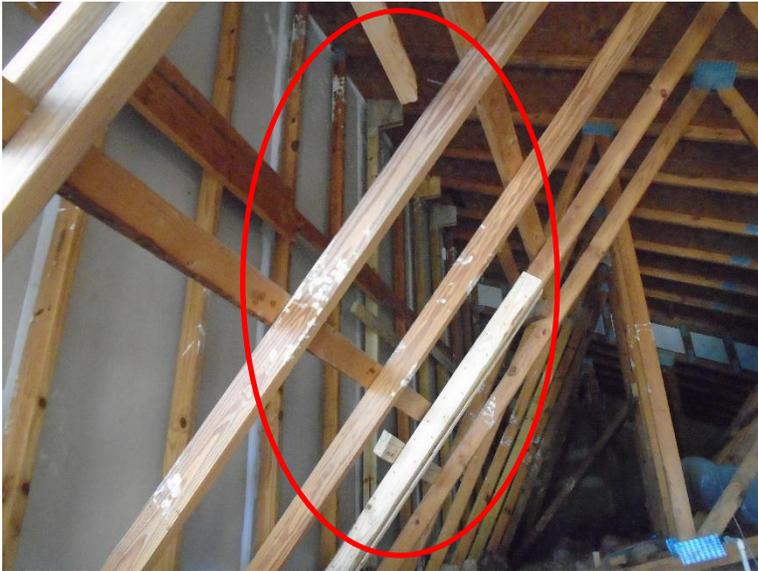
PHOTOGRAPH #15

**BUILDING 23
SECTION H
ATTIC UNIT #2321**

Additional truss framing repaired where extensive termite damage was observed.

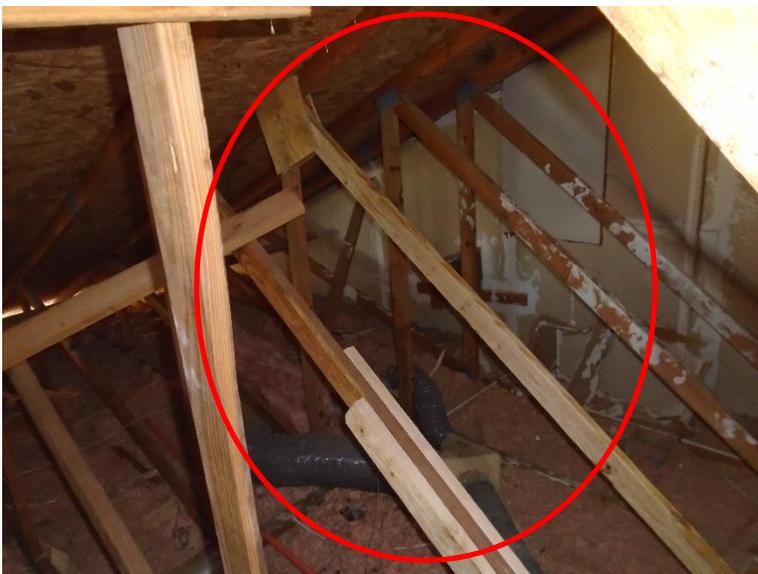
PHOTOGRAPH #16

**BUILDING 23
SECTION H
ATTIC UNIT #2322**

Framing scabs, gussets and fire wall repairs have been performed and quantified.

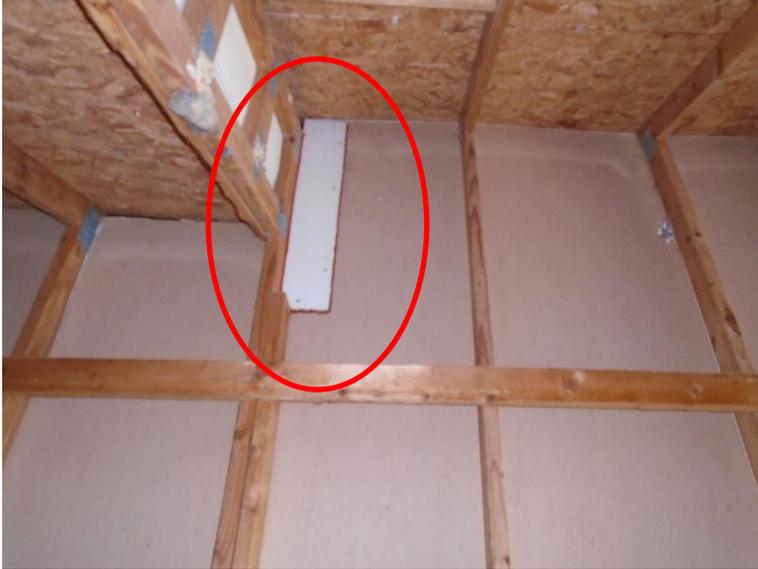
PHOTOGRAPH #17

**BUILDING 23
SECTION H
ATTIC UNIT #2322**

Framing scabs, gussets and fire wall repairs have been performed and quantified.

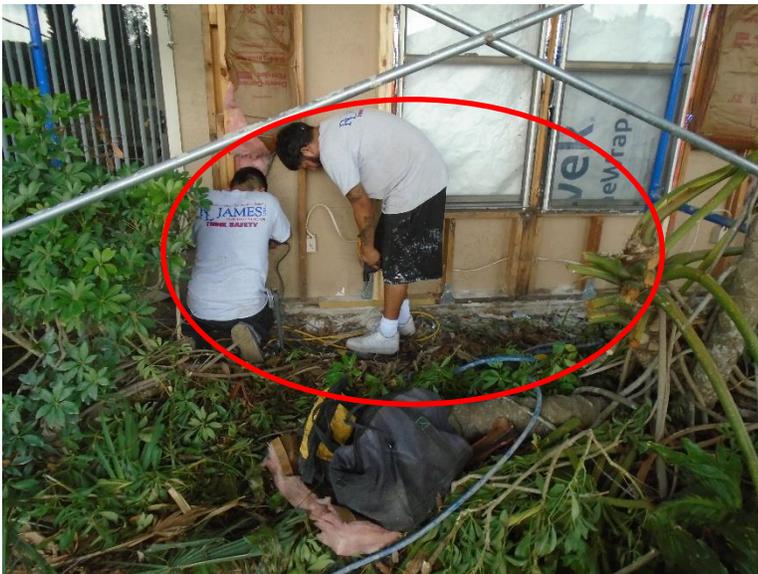
PHOTOGRAPH #18

**BUILDING 23
SECTION G**

Contractor in process of installing Simpson Strong-Tie Titan bolts and framing connectors at base plate.

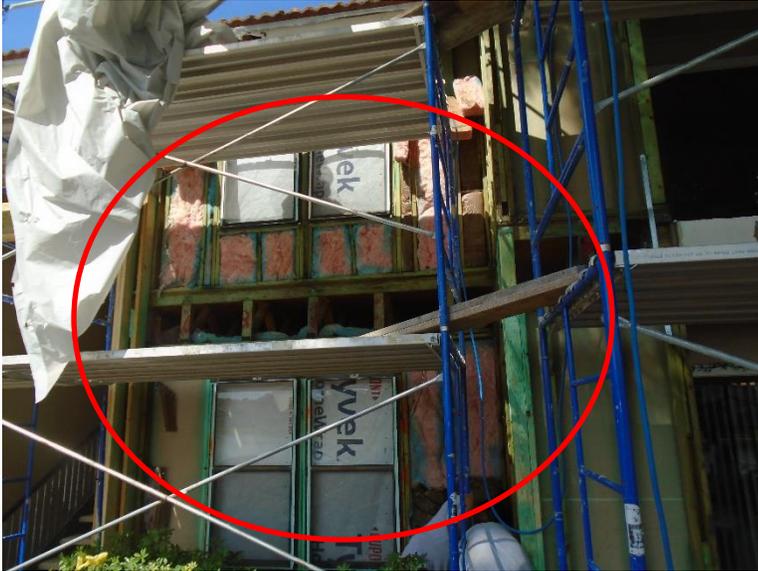
PHOTOGRAPH #19

**BUILDING 23
SECTION G**

Termite Contactor has applied BoraCare termite treatment.

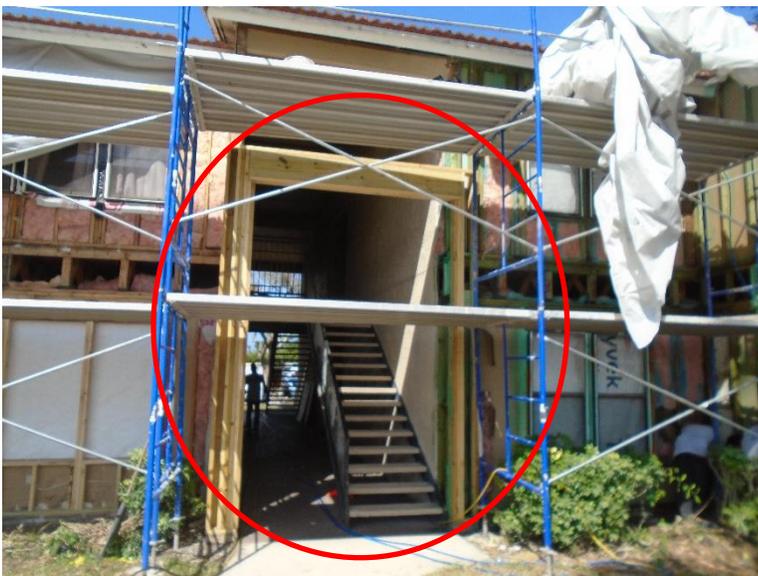
PHOTOGRAPH #20

**BUILDING 23
SECTION G**

Full breezeway framing repairs have been performed.

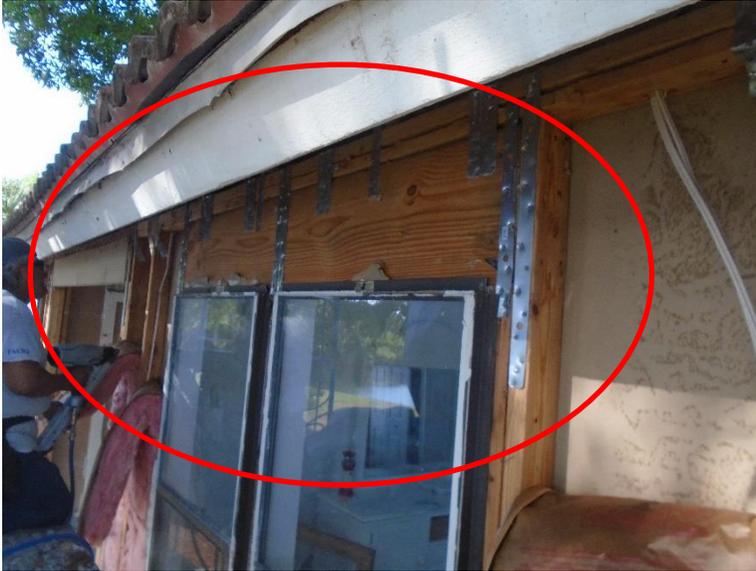
PHOTOGRAPH #21

**BUILDING 23
SECTION G**

Simpson Strong-Tie strapping and connectors have been installed at headers, top plate and truss connections.

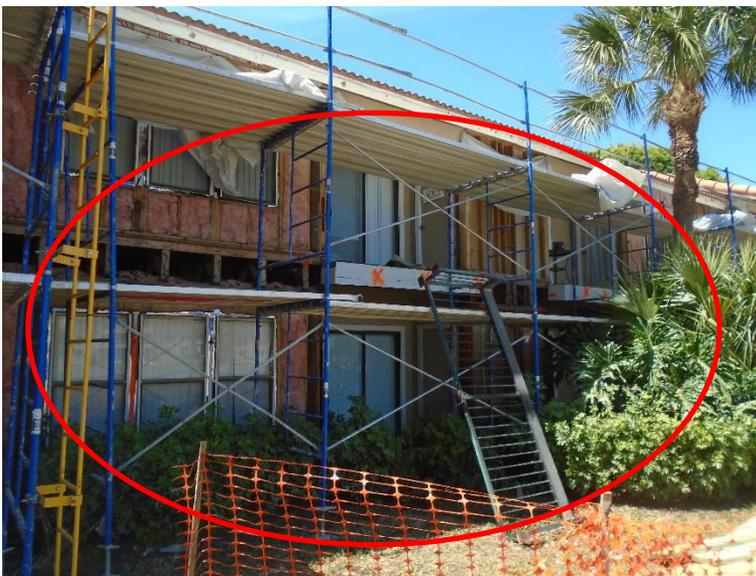
PHOTOGRAPH #22

**BUILDING 23
SECTION F**

Framing and balcony decking damage have been inspected and marked for repairs.

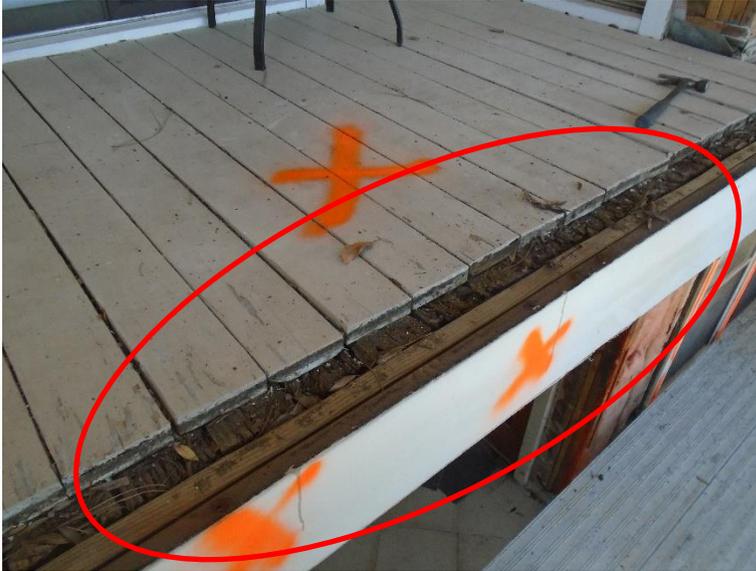
PHOTOGRAPH #23

**BUILDING 23
SECTION F**

Framing and balcony decking damage have been inspected and marked for repairs.

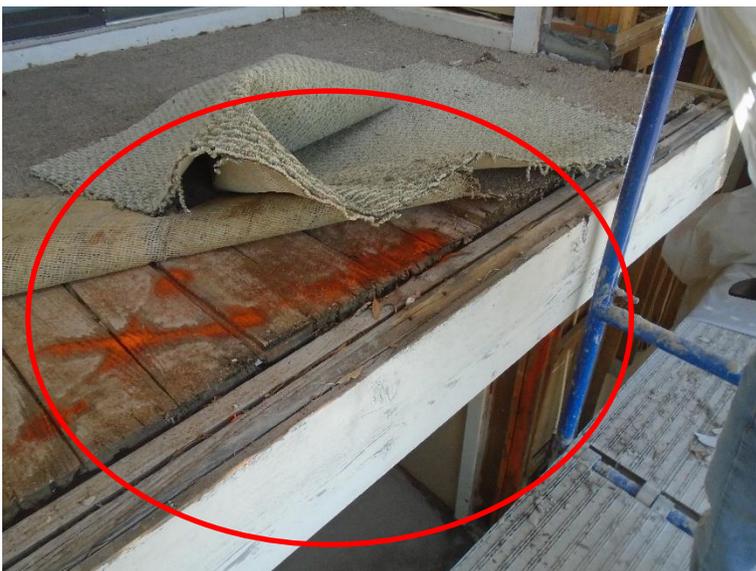
PHOTOGRAPH #24

**BUILDING 23
SECTION F**

Framing and balcony decking damage have been inspected and marked for repairs.

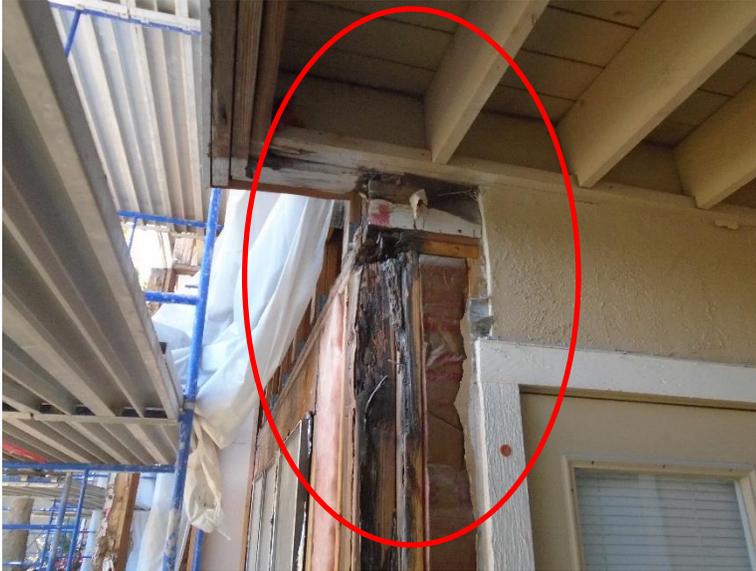
PHOTOGRAPH #25

**BUILDING 23
SECTION F**

Damaged framing at balconies and walls have been identified and marked for repairs.

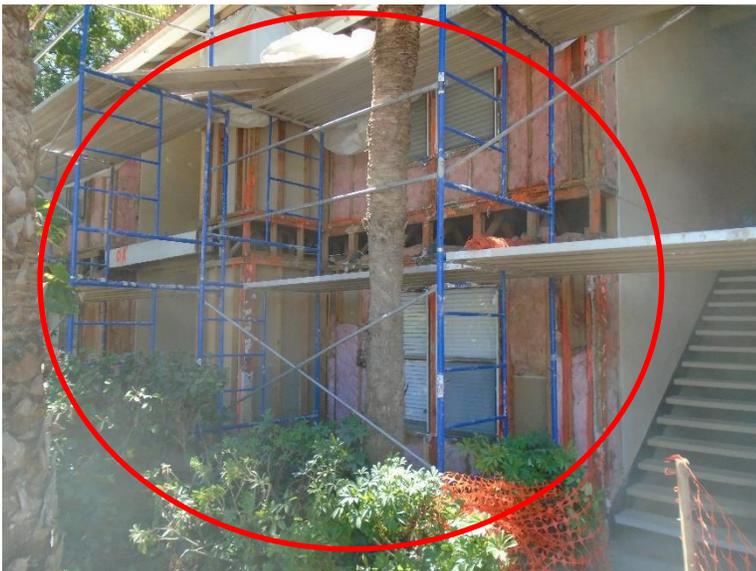
PHOTOGRAPH #26

**BUILDING 23
SECTION E**

Damaged framing at balconies and walls have been identified and marked for repairs.

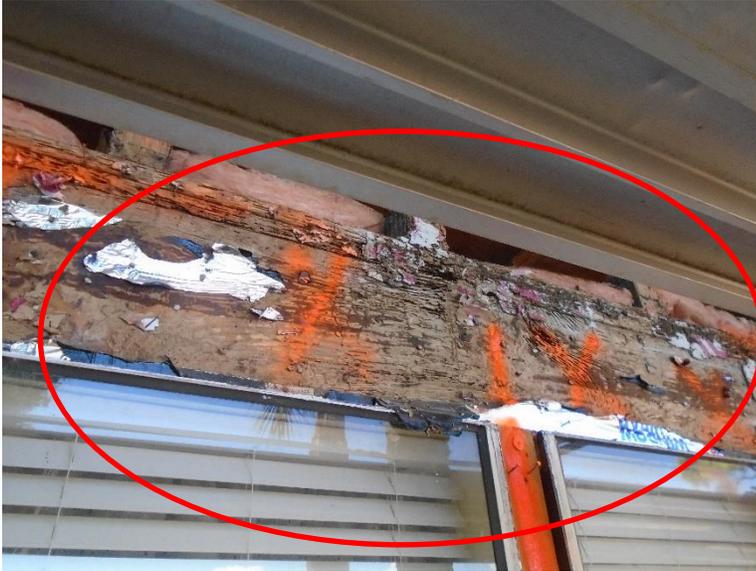
PHOTOGRAPH #27

**BUILDING 23
SECTION E**

Damaged framing at window headers and subfloor framing have been identified and marked for repairs.

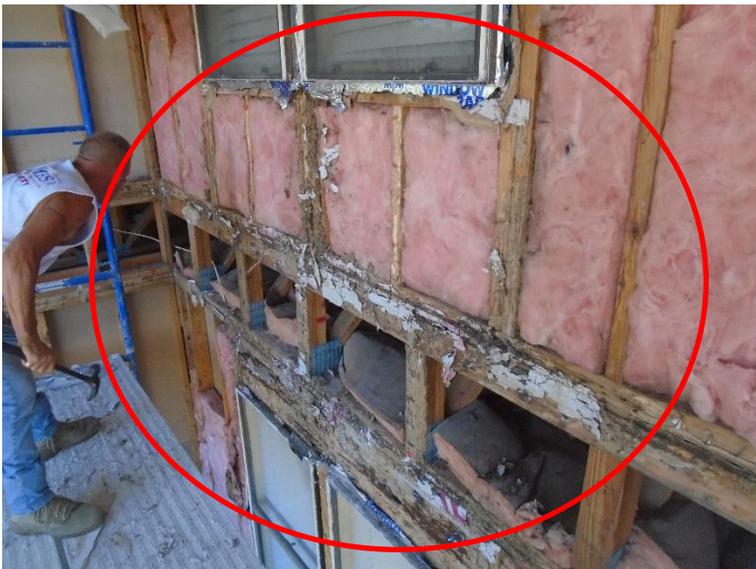
PHOTOGRAPH #28

**BUILDING 23
SECTION E**

Damaged framing at window headers and subfloor framing have been identified and marked for repairs.
