PHOTOGRAPHS

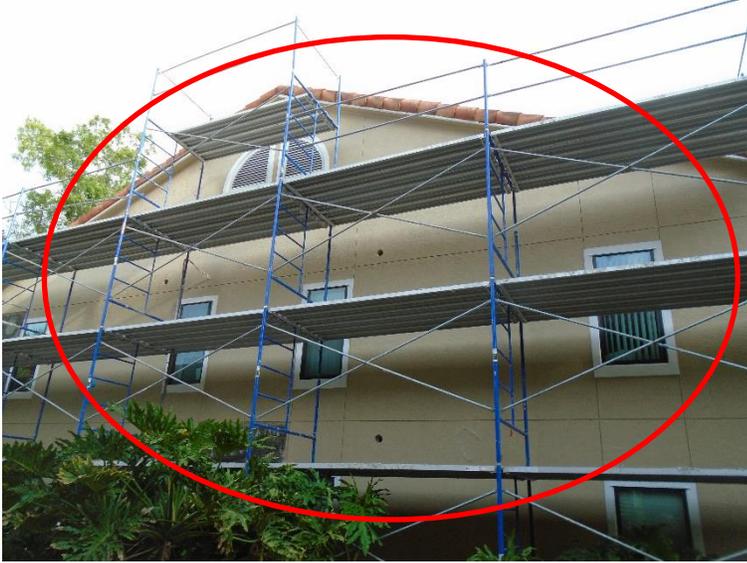
PHOTOGRAPH #1

BUILDING 5 SECTION D

Florida Paints primer and finish Acrylic paint has been applied to new stucco.

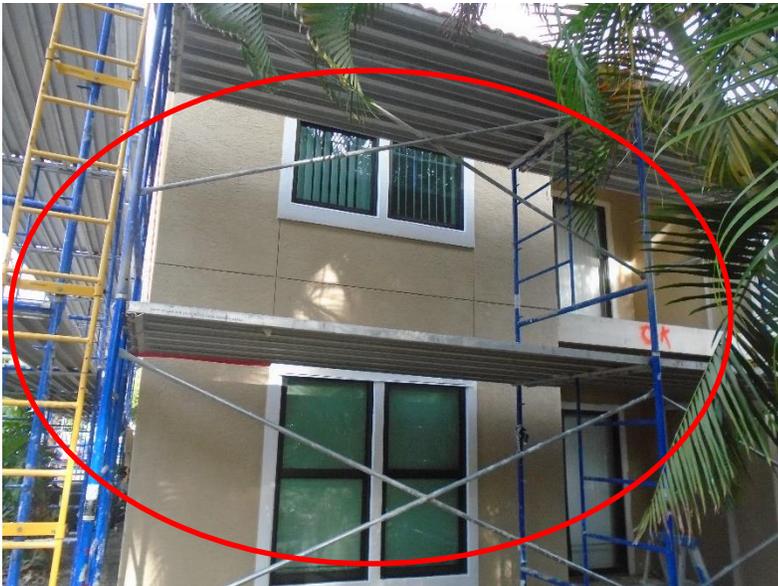
PHOTOGRAPH #2

BUILDING 5 SECTION E

Florida Paints primer and finish Acrylic paint has been applied to new stucco.

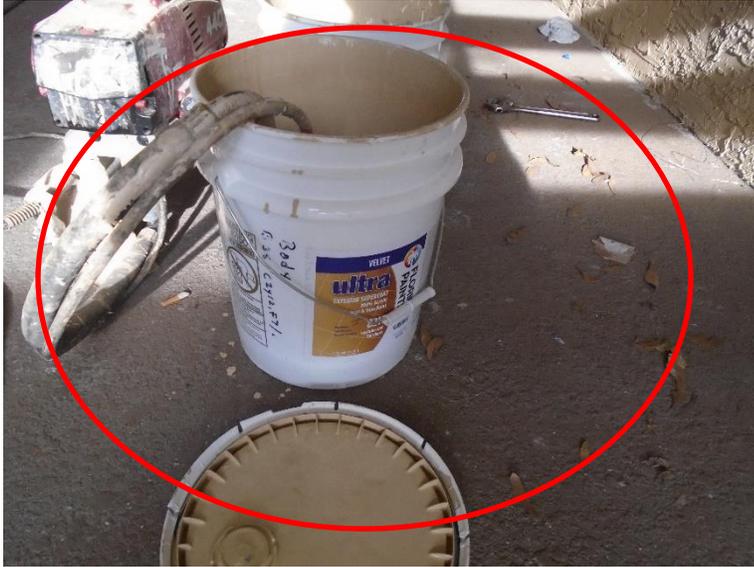
PHOTOGRAPH #3

**BUILDING 5
SECTION E**

Florida Paints primer and finish Acrylic paint has been applied to new stucco.

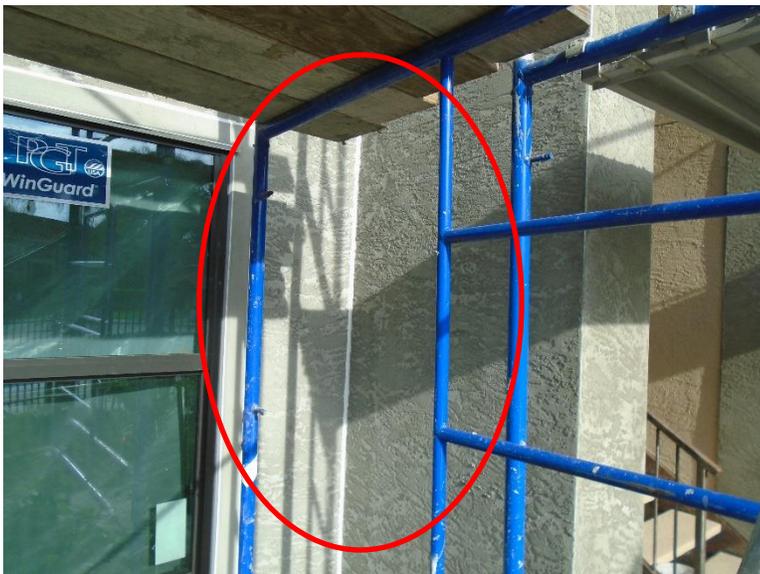
PHOTOGRAPH #4

**BUILDING 5
SECTION F**

New BASF sealant are being applied at all inside corner transitions prior to painting.

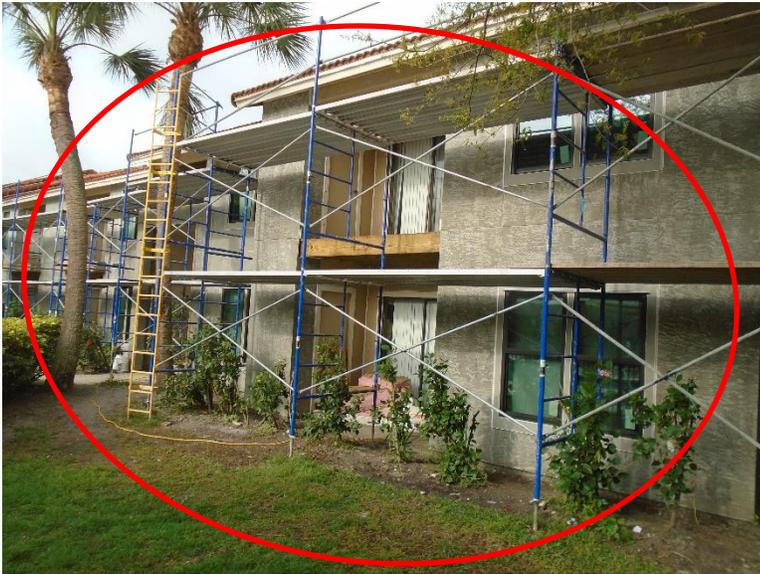
PHOTOGRAPH #5

**BUILDING 5
SECTION G**

Stucco Sub-contractor has applied new finish coats of stucco.

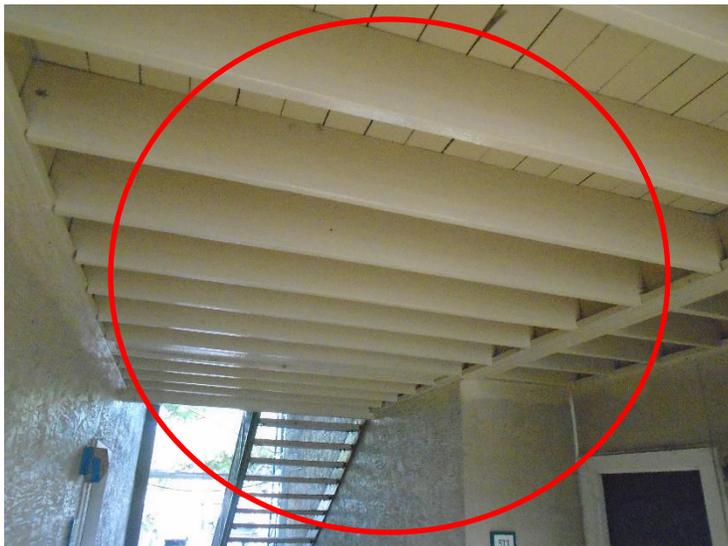
PHOTOGRAPH #6

**BUILDING 5
SECTION G - BREEZEWAY**

Florida Paints primer and finish Acrylic paint has been applied to previously painted wood and stucco.

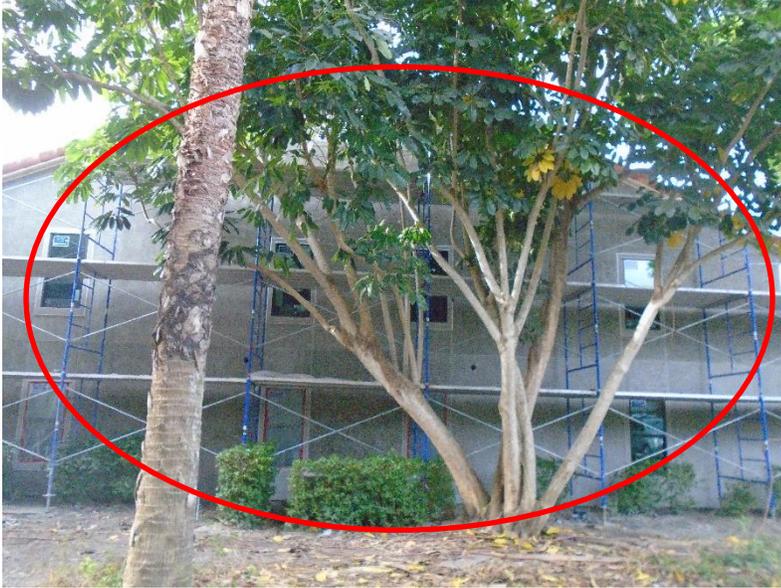
PHOTOGRAPH #7

**BUILDING 5
SECTION H**

Stucco sub-contractor has applied new three coat system of scratch, brown and finish stucco.

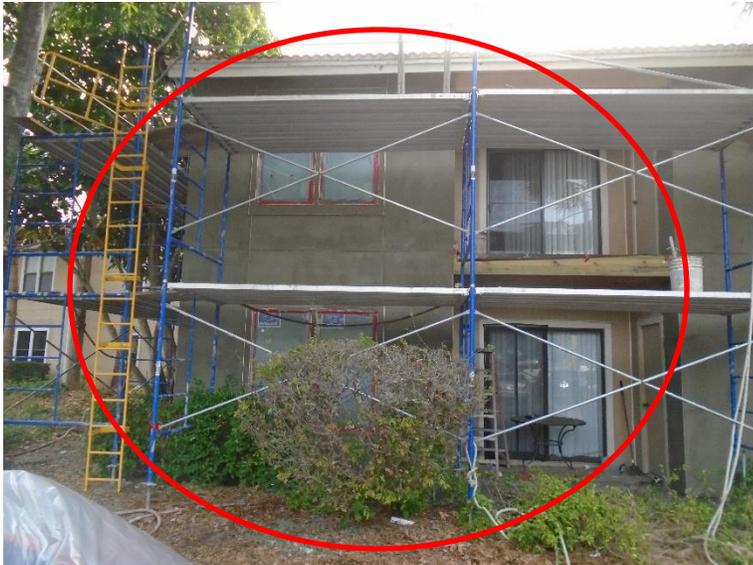
PHOTOGRAPH #8

**BUILDING 5
SECTION A**

Stucco sub-contractor has applied new scratch and brown coats of stucco.

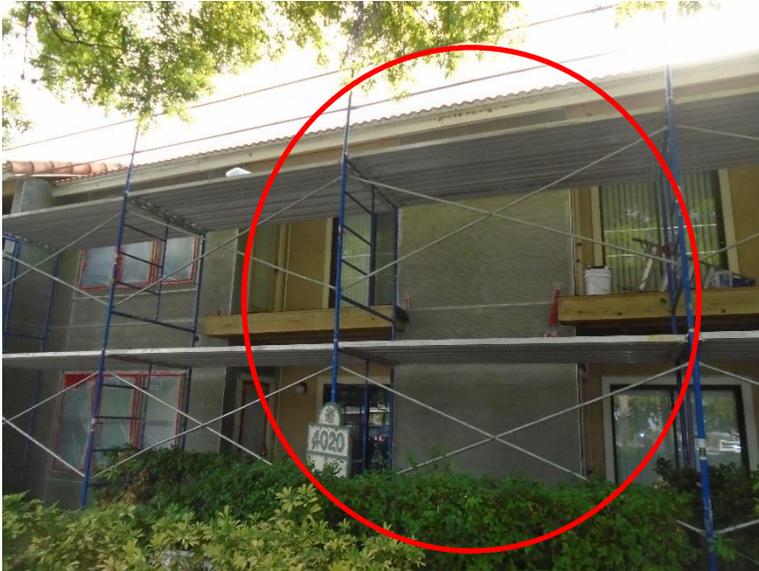
PHOTOGRAPH #9

**BUILDING 5
SECTION B**

Stucco sub-contractor has applied new scratch coat of stucco.

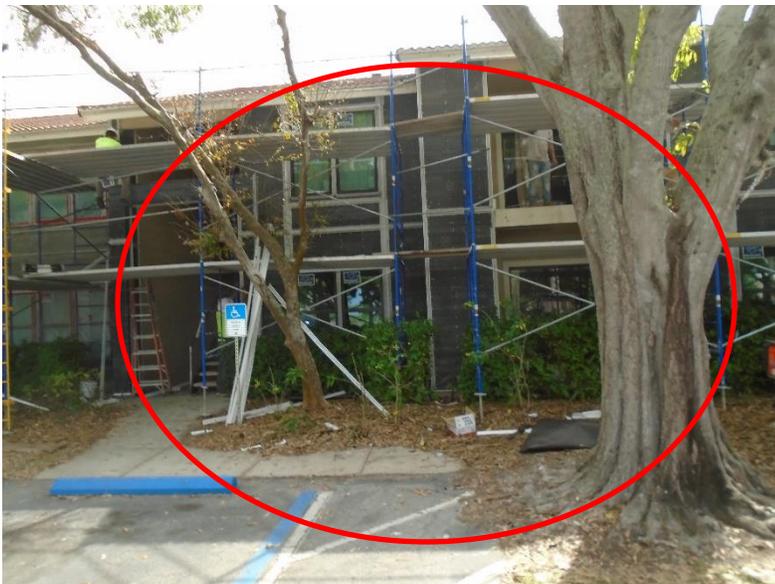
PHOTOGRAPH #10

**BUILDING 5
SECTION C**

Stucco sub-contractor in process of applying JumboTex WRB, stucco accessories and metal lath in preparation for new stucco.

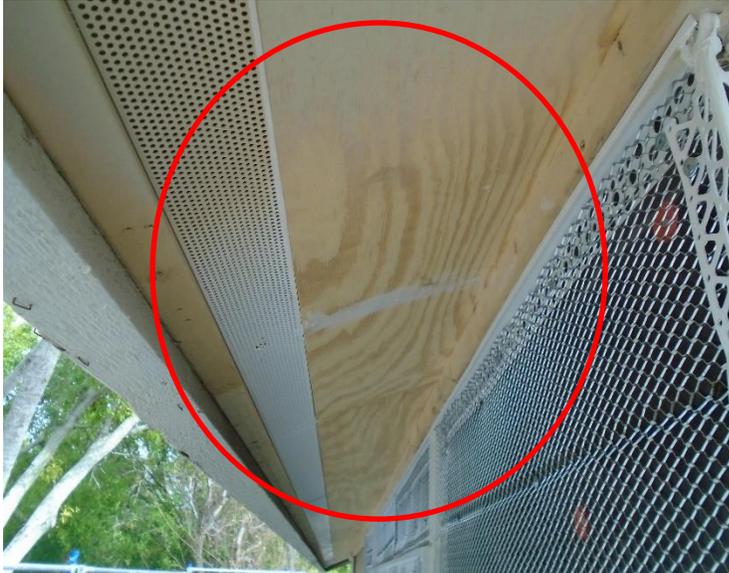
PHOTOGRAPH #11

**BUILDING 5
SECTION C**

New wood soffit and soffit screening has been installed.

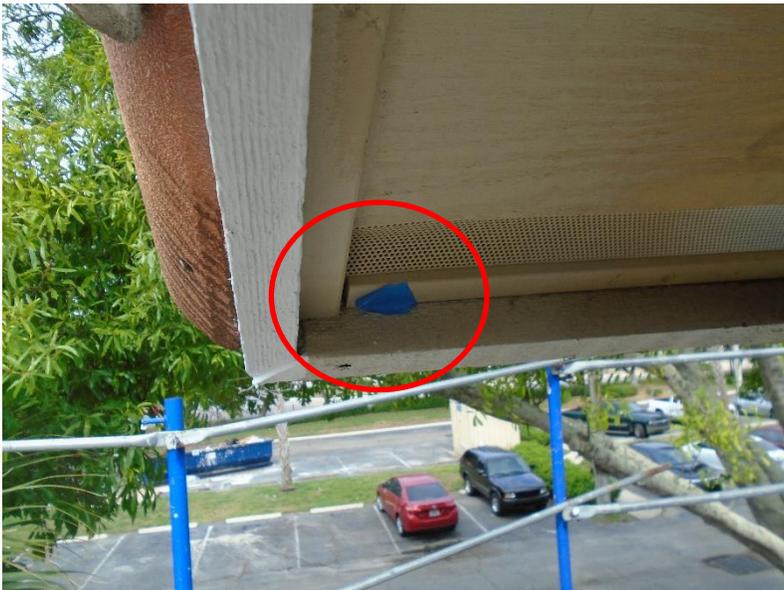
PHOTOGRAPH #12

**BUILDING 5
SECTION C**

Gap in soffit trim will be filled at transition with new sealant prior to finish painting.

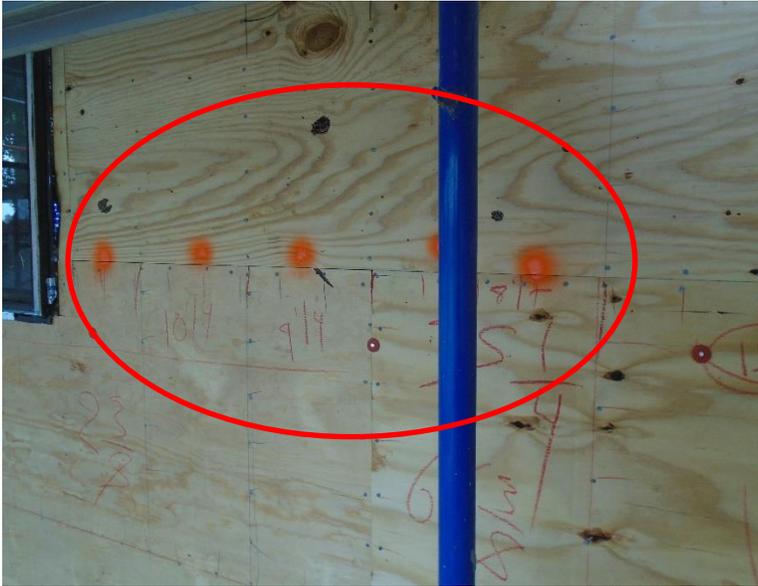
PHOTOGRAPH #13

**BUILDING 23
SECTION H**

Delta marked missing fasteners at perimeter sheathing. Corrections made by Contractor.

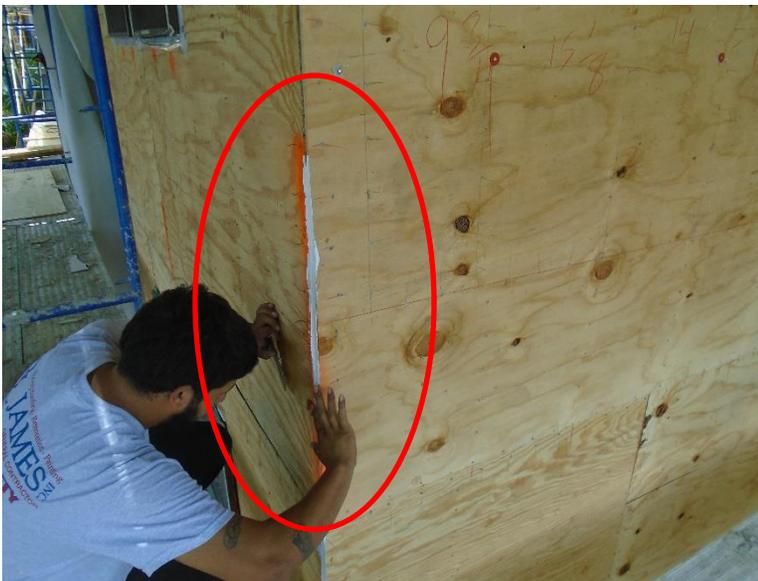
PHOTOGRAPH #14

**BUILDING 23
SECTION H**

Delta marked gaps at sheathing. Corrections made by contractor.

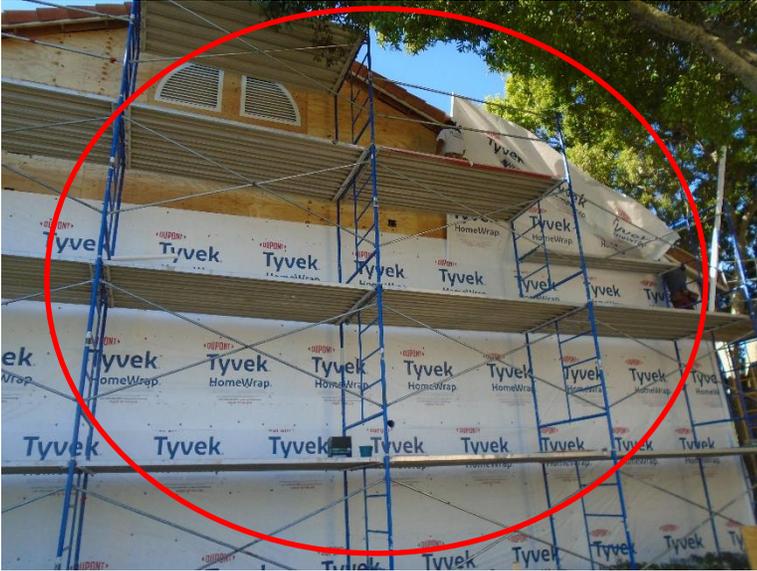
PHOTOGRAPH #15

**BUILDING 23
SECTION H**

Contractor in process of applying new Tyvek HomeWrap WRB over new plywood sheathing.

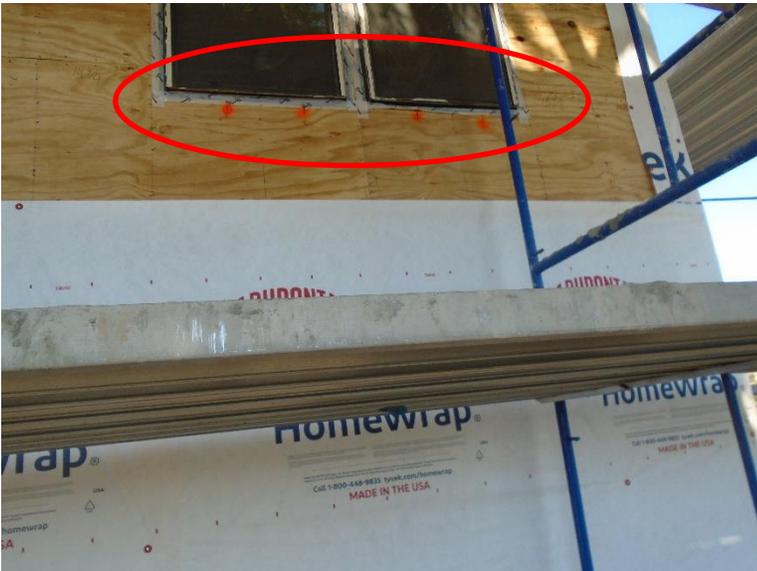
PHOTOGRAPH #16

**BUILDING 23
SECTION G**

Delta marked missing fasteners at perimeter sheathing. Corrections made by Contractor.

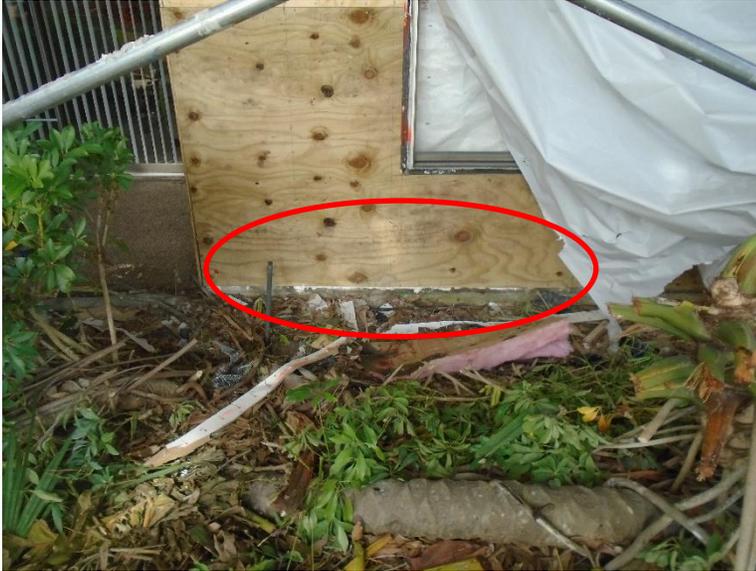
PHOTOGRAPH #17

**BUILDING 23
SECTION G**

Delta marked missing fasteners at perimeter sheathing. Corrections made by Contractor.

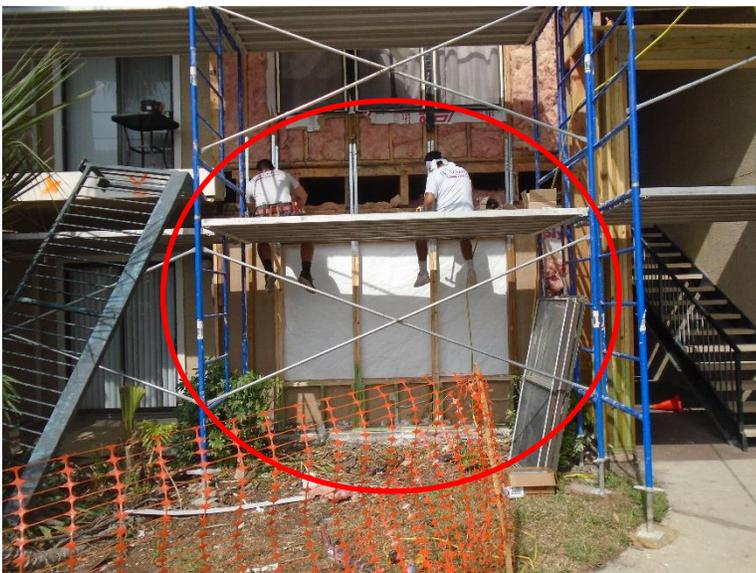
PHOTOGRAPH #18

**BUILDING 23
SECTION F**

Contractor in process of installing Simpson Strong-Tie framing connectors and strapping at wall framing.

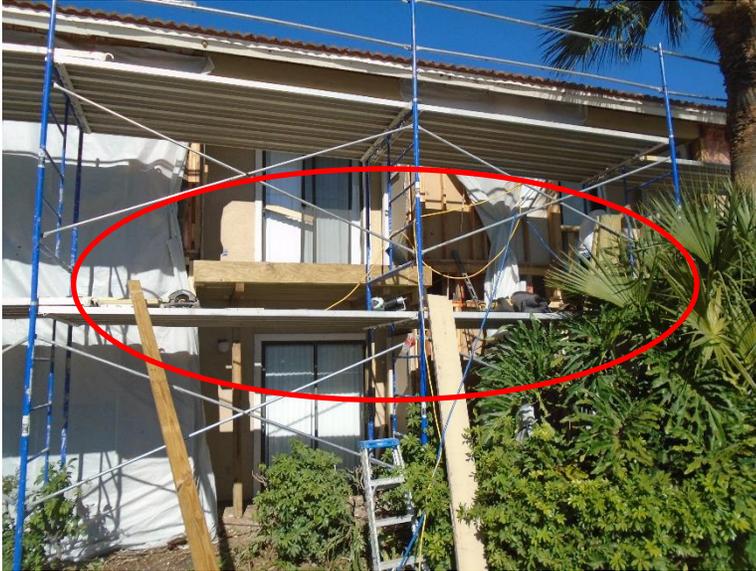
PHOTOGRAPH #19

**BUILDING 23
SECTION F**

Contractor performing full balcony and deck board replacement repairs at both balcony decks.

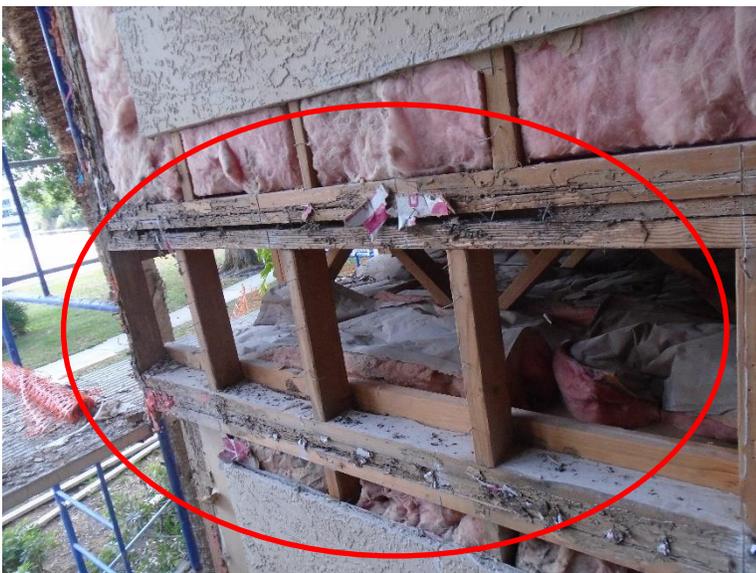
PHOTOGRAPH #20

**BUILDING 23
SECTION E- BREEZEWAY**

Extensive termite damage to wood framing at breezeway return walls and subflooring.

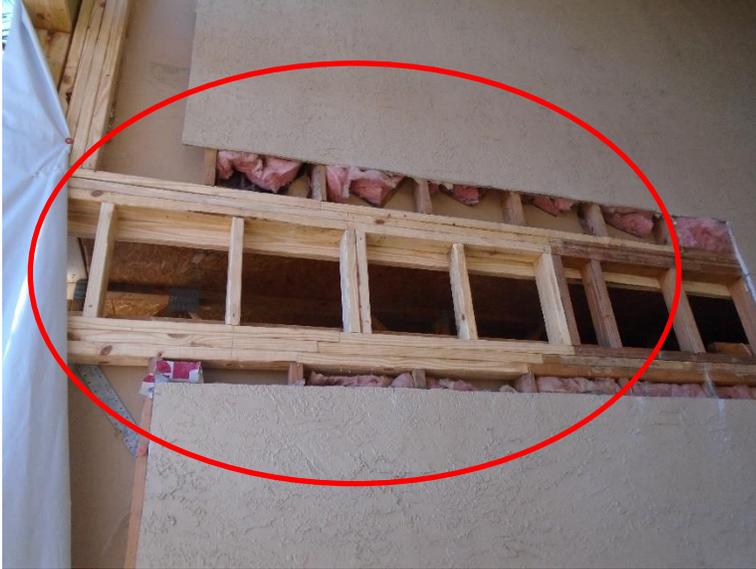
PHOTOGRAPH #21

**BUILDING 23
SECTION E -BREEZEWAY**

Contractor has made repairs to breezeway framing damage and subflooring.

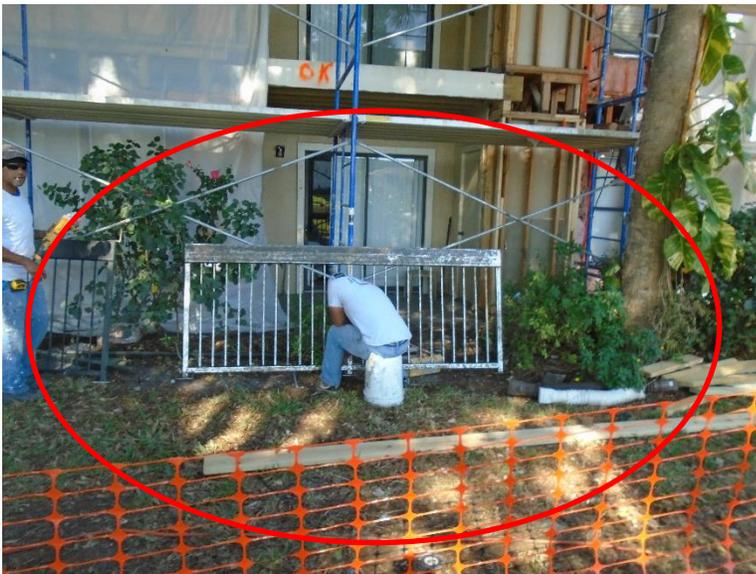
PHOTOGRAPH #22

**BUILDING 23
SECTION E**

Contractor in process of balcony railing preparation for painting.
