## PHOTOGRAPHS

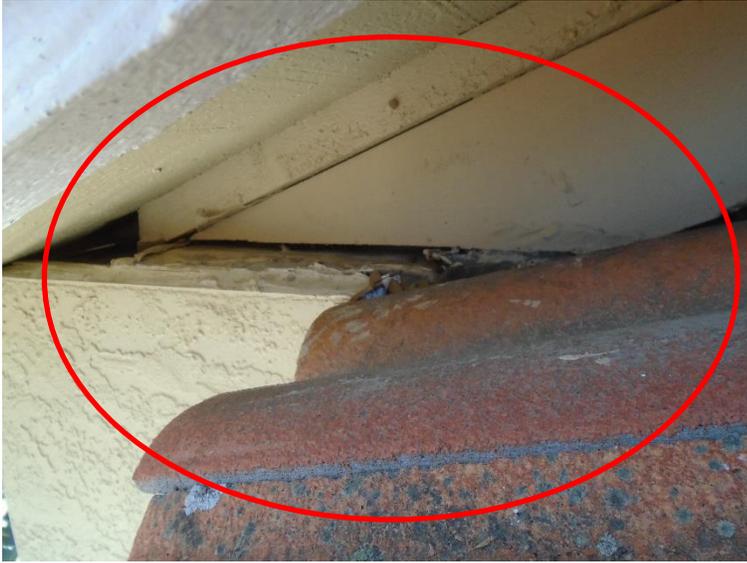
PHOTOGRAPH #1

### **BUILDING 5 SECTION F**

Transition from existing roof trim and soffit at head of new stucco stop is open and requires sealant.

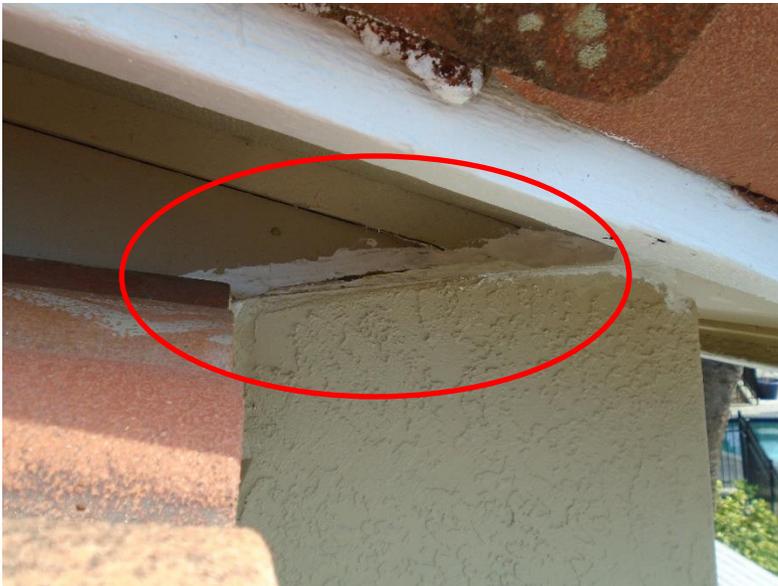
PHOTOGRAPH #2

### **BUILDING 5 SECTION F**

Contractor has sealed transition from existing roof trim and soffit at head of new stucco stop as directed by Delta.

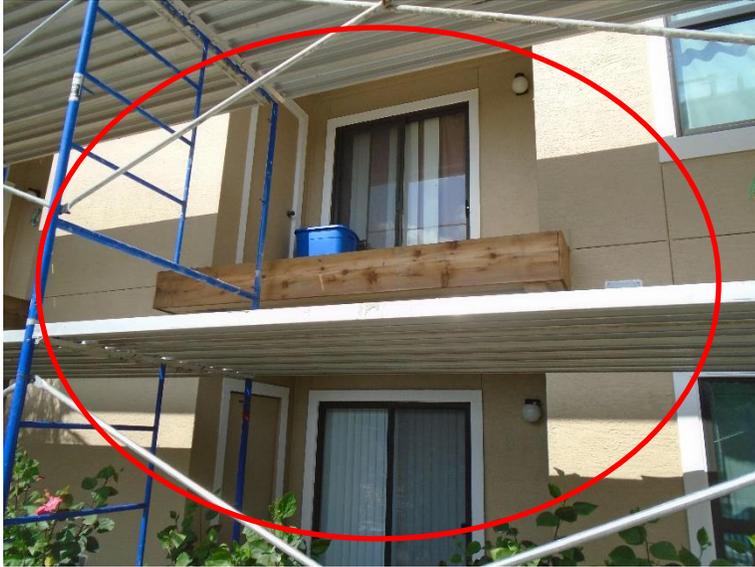
**PHOTOGRAPH #3**

**BUILDING 5  
SECTION F**

New stucco walls have been finished painted and new cedar trim applied to balcony facing.

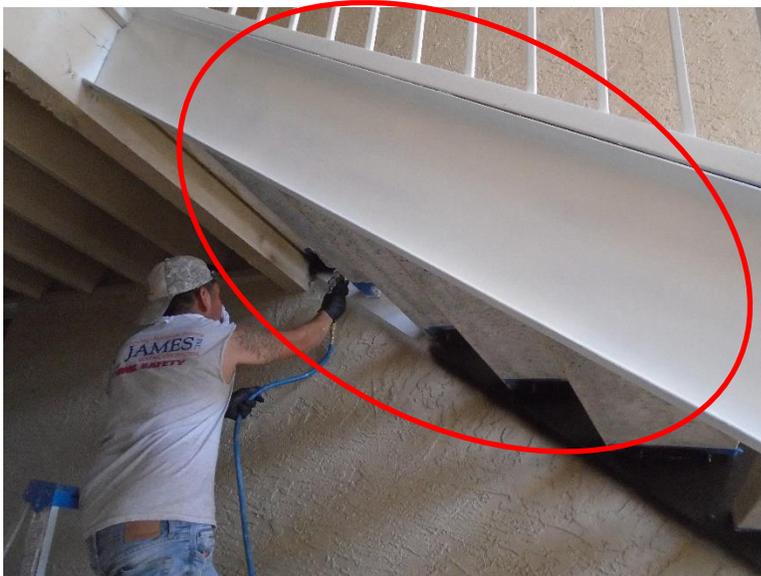
**PHOTOGRAPH #4**

**BUILDING 5  
SECTION G**

Contractor is applying Florida Paints Urethane Gloss Enamel finish paint over primer at stairways.

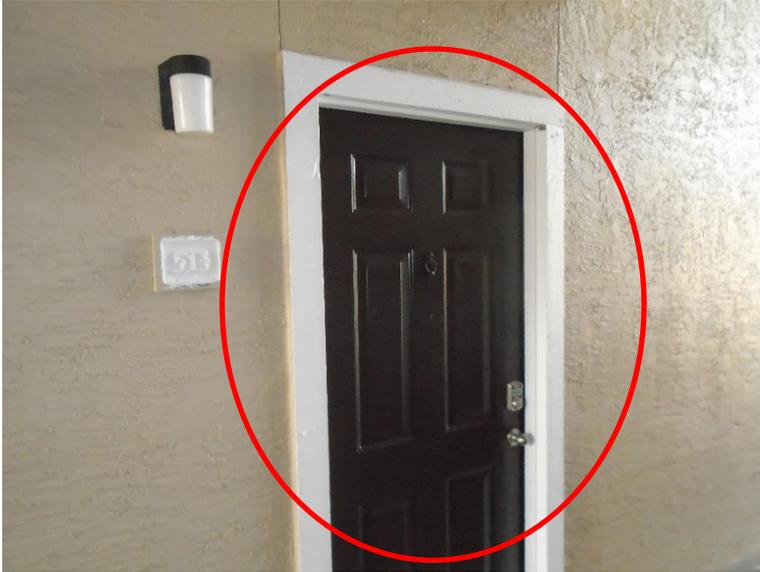
**PHOTOGRAPH #5**

**BUILDING 5  
SECTION G**

Contractor has applied Florida paints AllGrip Exterior Acrylic on entrance doors.

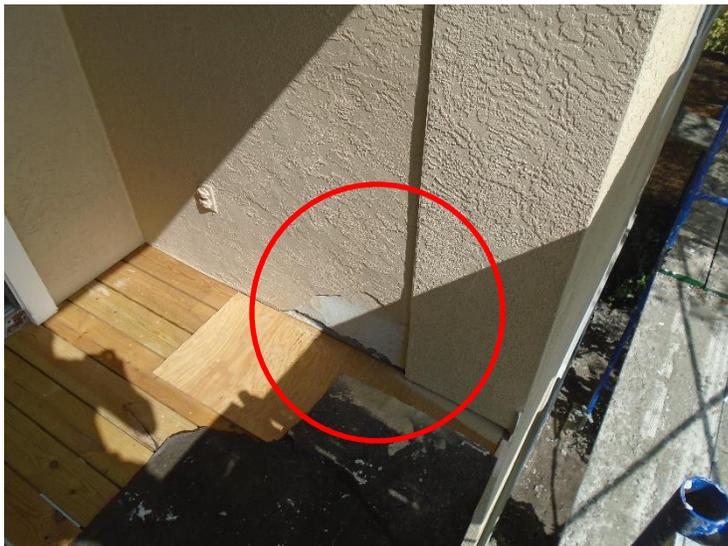
**PHOTOGRAPH #6**

**BUILDING 5  
SECTION G**

Stucco remaining at balcony wall has delaminated and will require patching with new stucco and painting.

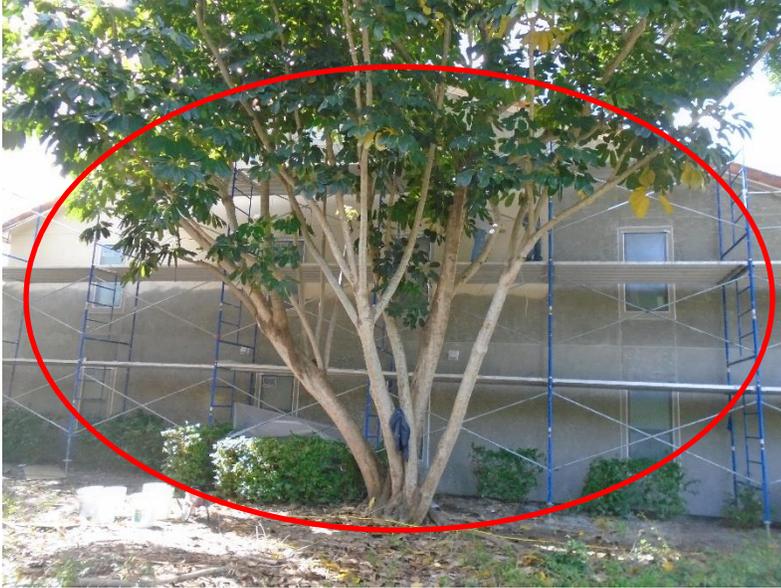
**PHOTOGRAPH #7**

**BUILDING 5  
SECTION H**

Contractor in process of applying paint prime coat to new stucco.

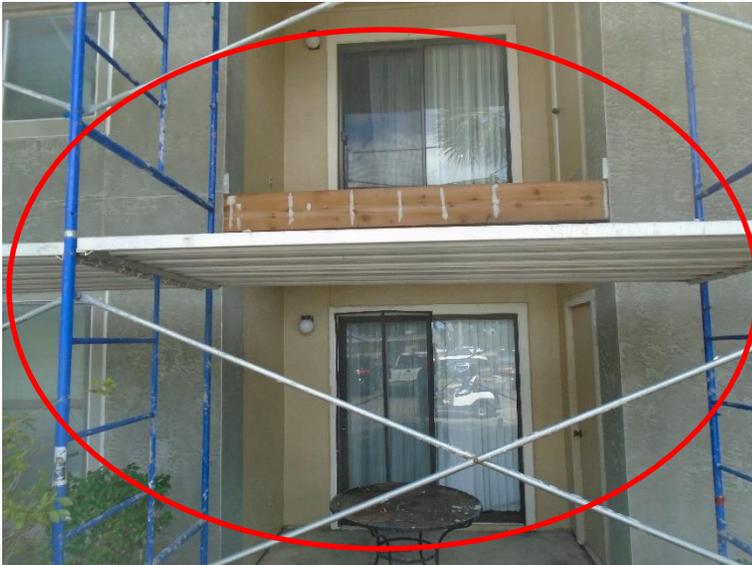
**PHOTOGRAPH #8**

**BUILDING 5  
SECTION A**

Final finish coat of stucco applied at walls and cedar trim installed at balcony facing.

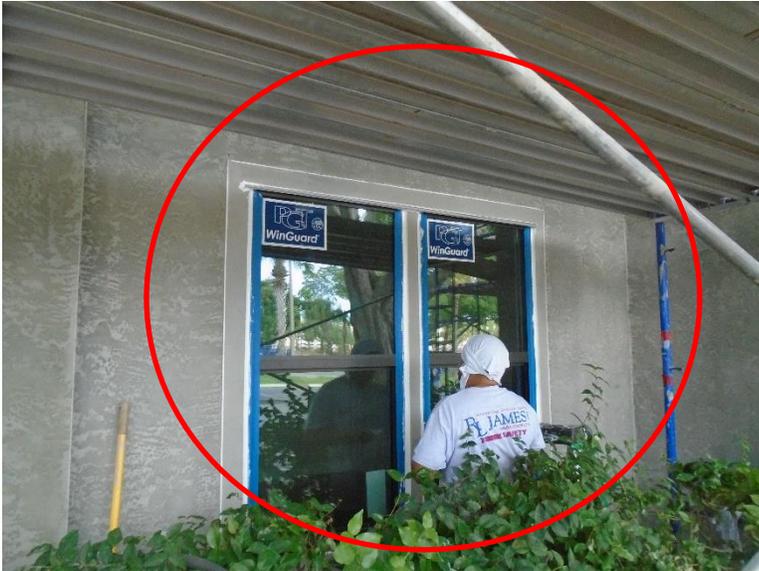
**PHOTOGRAPH #9**

**BUILDING 5  
SECTION B**

Contractor installing new BASF sealants at window perimeters.

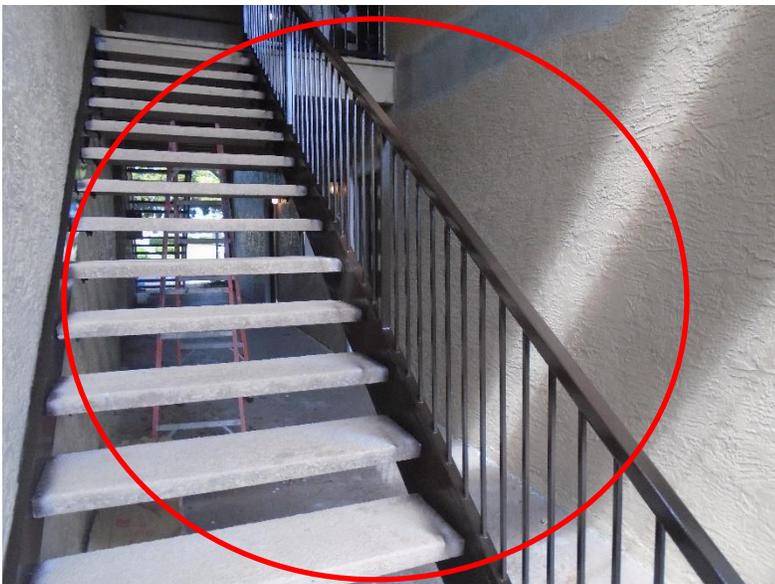
**PHOTOGRAPH #10**

**BUILDING 5  
SECTION C**

Breezeway railings have been finish coated with Florida Paints Acrylic Gloss Aliphatic Enamel.

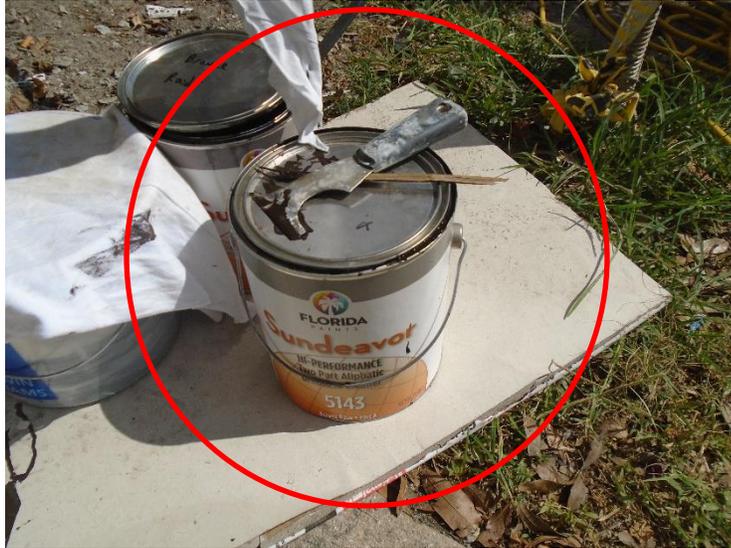
**PHOTOGRAPH #11**

**BUILDING 5  
SECTION C**

Breezeway railings have been finish coated with Florida Paints Acrylic Gloss Aliphatic Enamel.

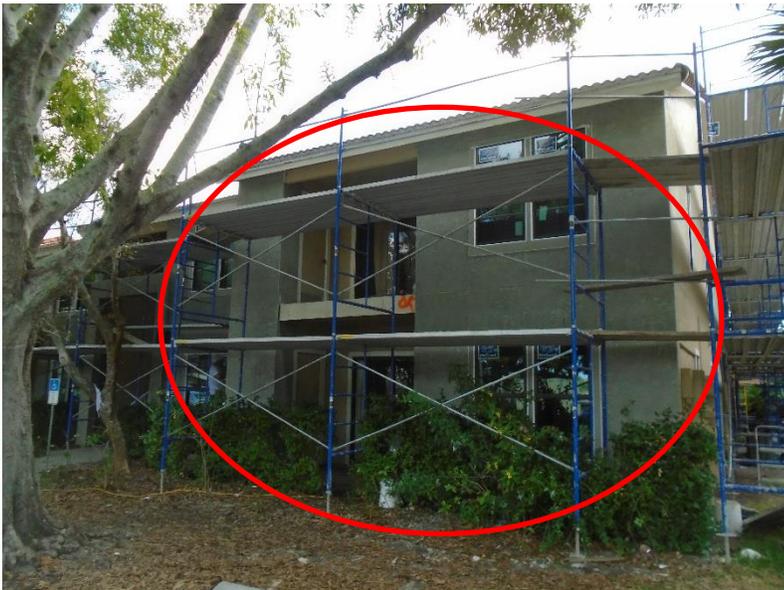
**PHOTOGRAPH #12**

**BUILDING 5  
SECTION C**

Stucco Sub-contractor has completed three coat system of stucco.

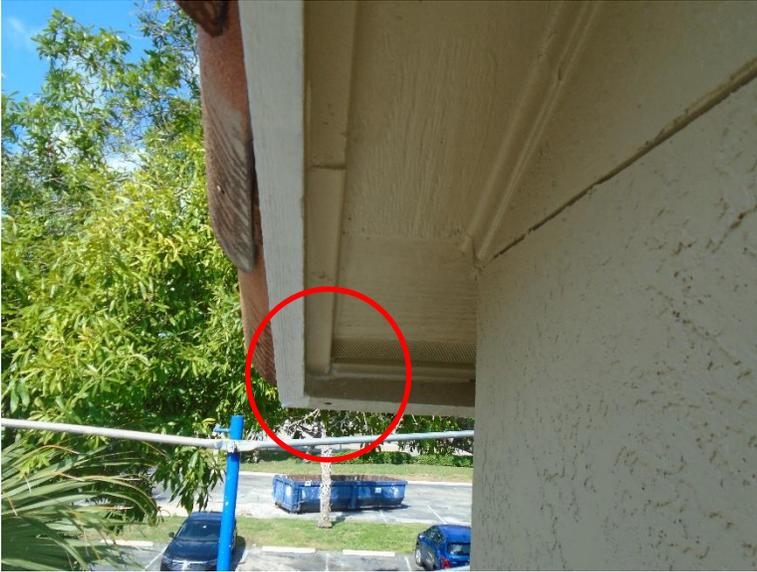
**PHOTOGRAPH #13**

**BUILDING 5  
SECTION C**

Gap in soffit has been filled and finish painted.

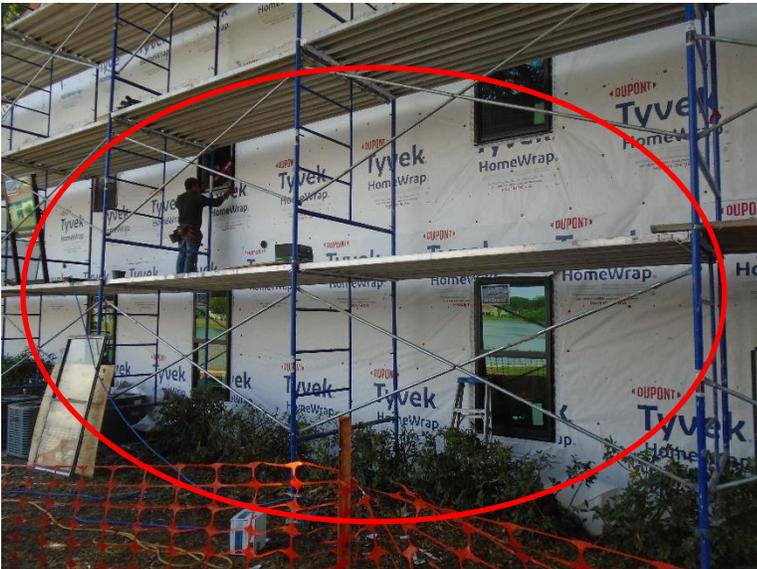
**PHOTOGRAPH #14**

**BUILDING 23  
SECTION H**

PGT windows being installed at 2<sup>nd</sup> floor with manufacturer supplied window operation control devises for compliance with Florida Building codes.

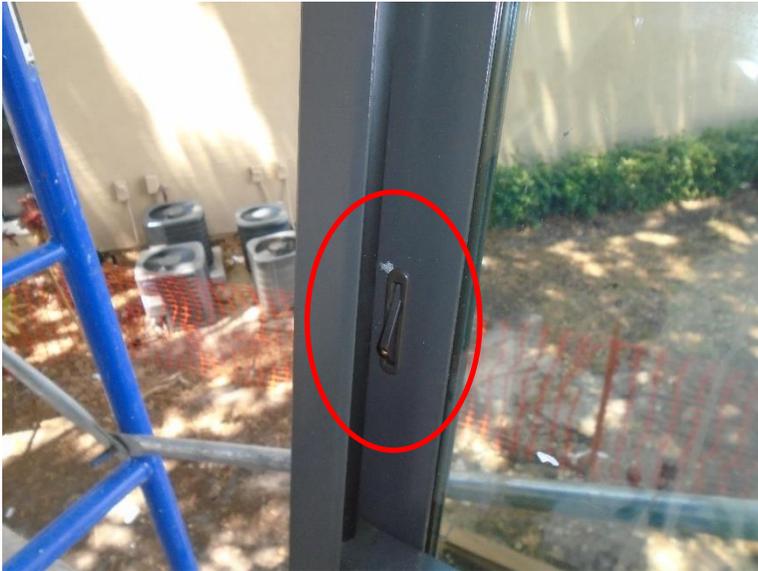
**PHOTOGRAPH #15**

**BUILDING 23  
SECTION H**

PGT windows being installed at 2<sup>nd</sup> floor with manufacturer supplied window operation control devises for compliance with Florida Building codes.

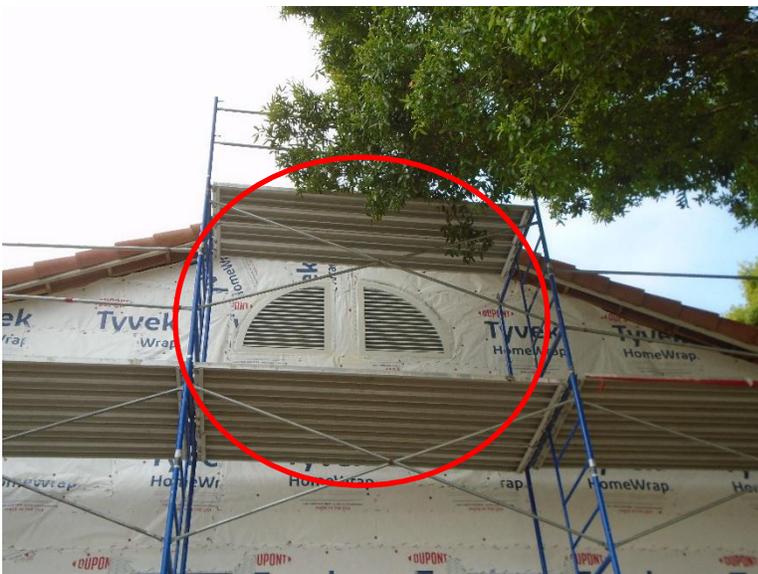
**PHOTOGRAPH #16**

**BUILDING 23  
SECTION H**

GreenHeck attic louvers installed with DuPont flashings as per manufacturer's instructions.

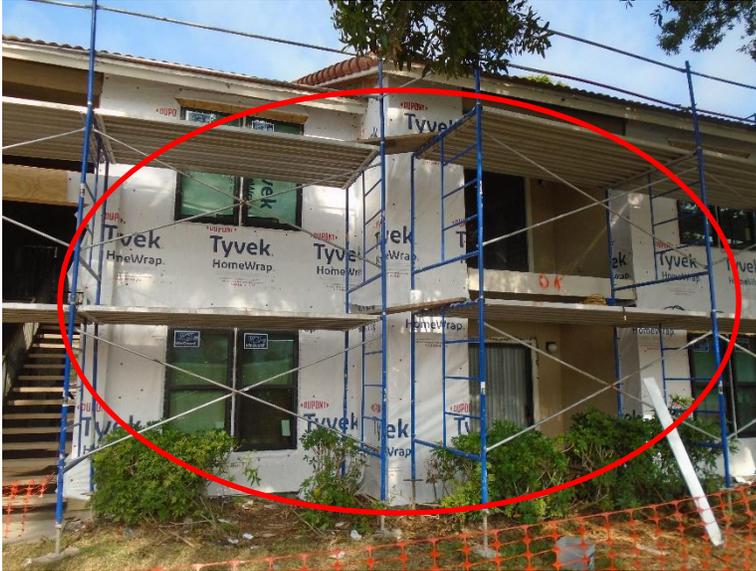
**PHOTOGRAPH #17**

**BUILDING 23  
SECTION G**

Tyvek HomeWrap, Dupont flashings and PGT windows installed.

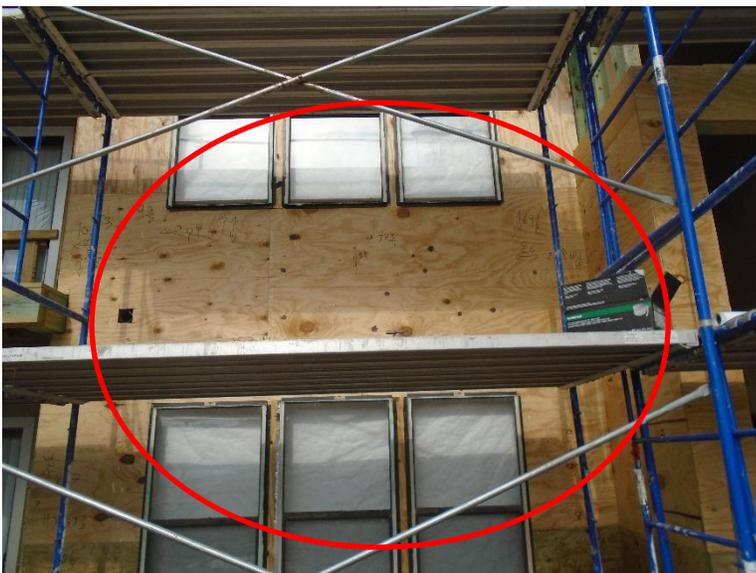
**PHOTOGRAPH #18**

**BUILDING 23  
SECTION F**

Contractor has attached new plywood sheathing to framing as per project manual and drawings.

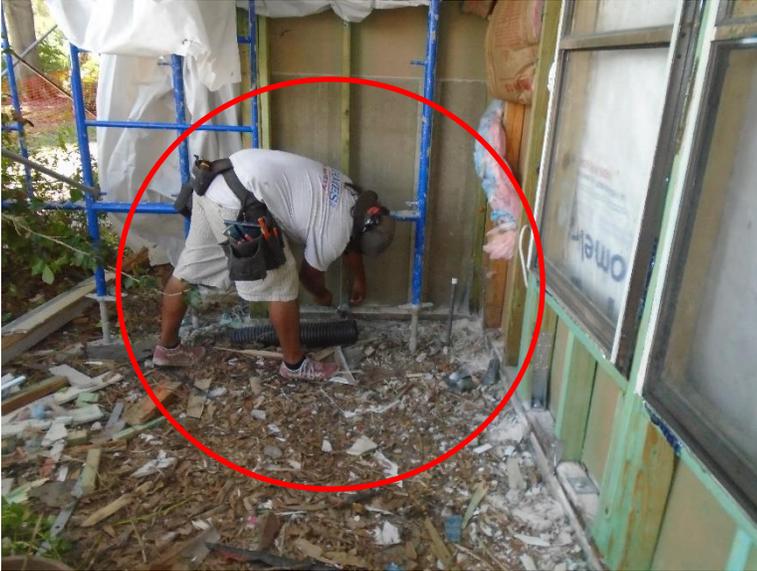
**PHOTOGRAPH #19**

**BUILDING 23  
SECTION F**

Contractor installing missing Simpson Strong-Tie connectors identified by Delta.

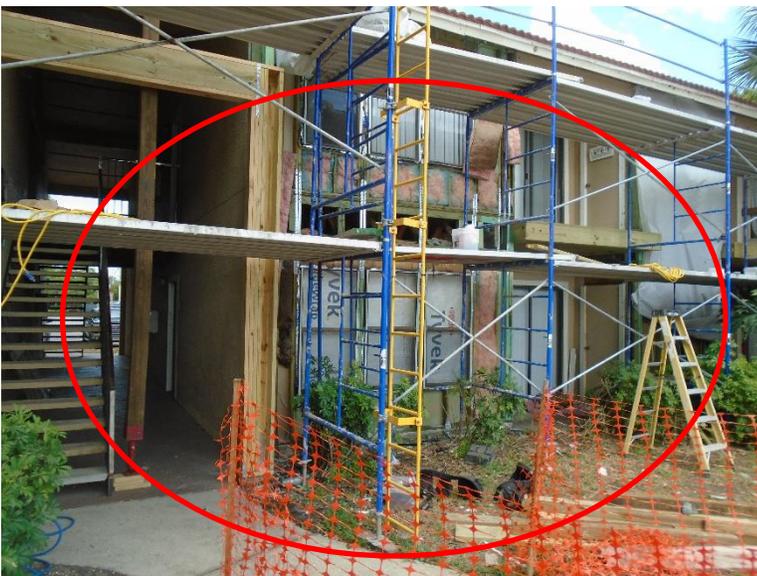
**PHOTOGRAPH #20**

**BUILDING 23  
SECTION F**

Framing repairs, strapping, connectors, and termite treatment in place for inspection.

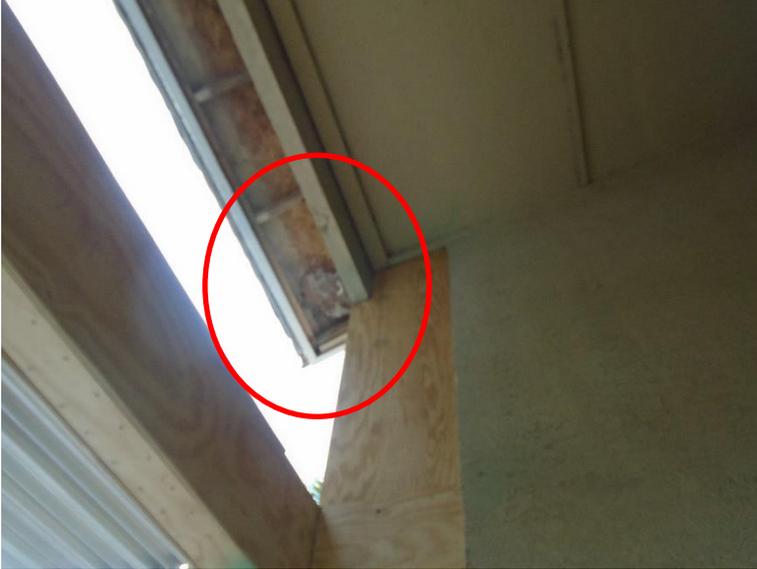
**PHOTOGRAPH #21**

**BUILDING 23  
SECTION E -BREEZEWAY**

Previous roof sheathing damage observed before new soffit is installed. Roof repairs not part of current scope and to be repaired by owners.

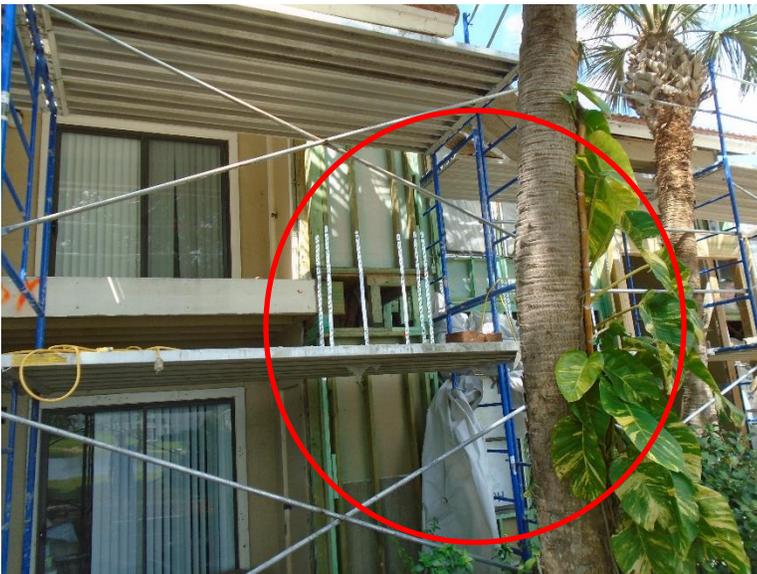
**PHOTOGRAPH #22**

**BUILDING 23  
SECTION E**

Framing repairs, strapping, connectors, and termite treatment in place for inspection.

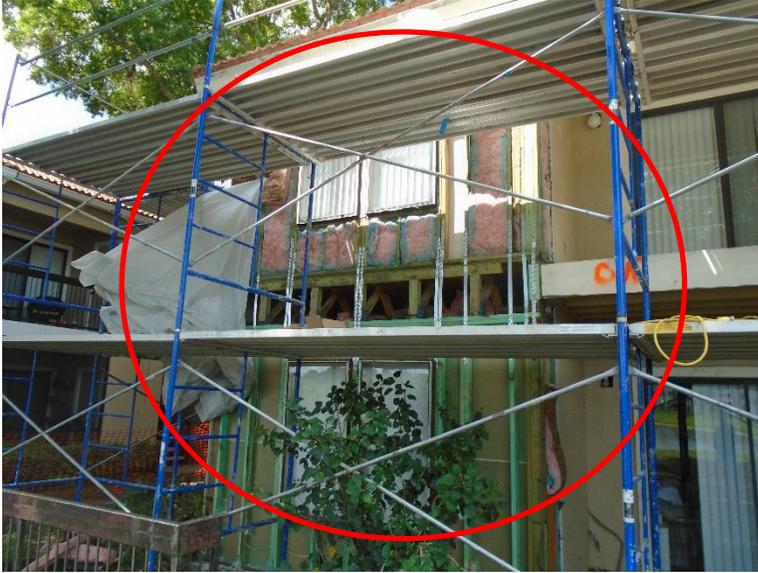
**PHOTOGRAPH #23**

**BUILDING 23  
SECTION E**

Framing repairs, strapping, connectors, and termite treatment in place for inspection.
