PHOTOGRAPHS

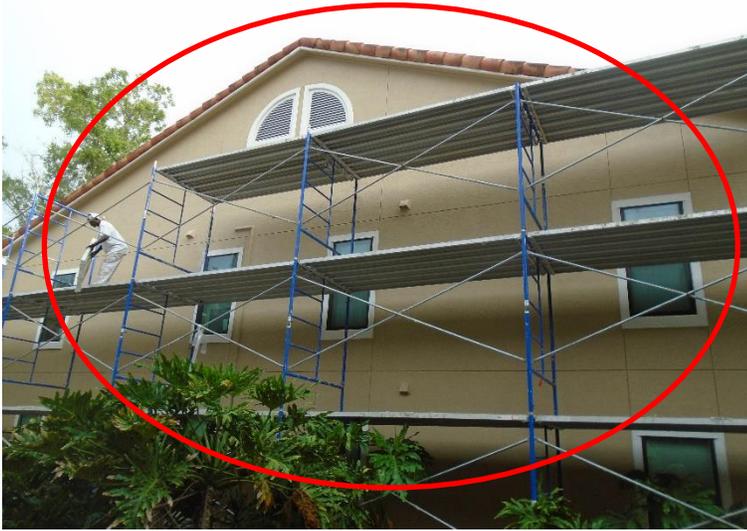
PHOTOGRAPH #1

BUILDING 5 SECTION D

Contractor removing access scaffolding where were repair work is completed.

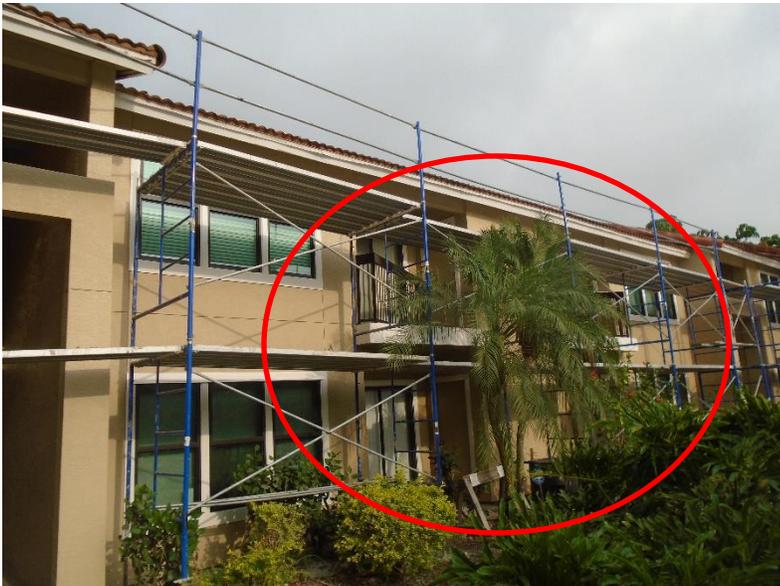
PHOTOGRAPH #2

BUILDING 5 SECTION F

Contractor has placed repainted railings on balconies for installation.

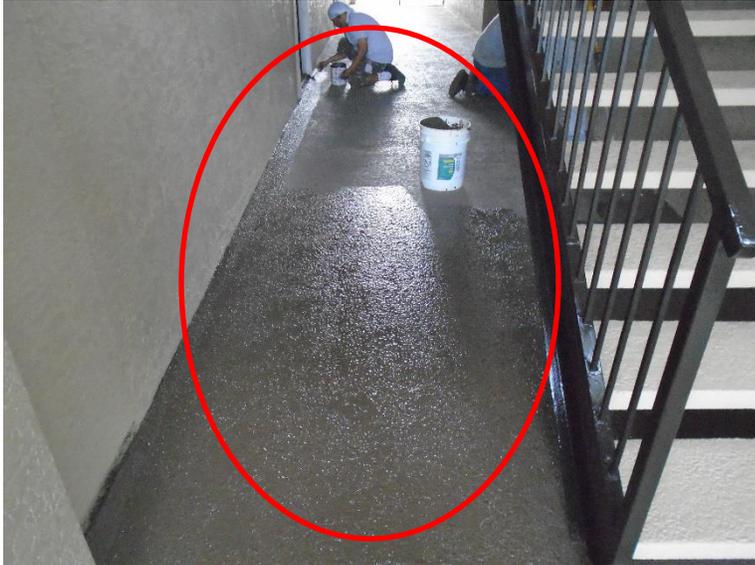
PHOTOGRAPH #3

**BUILDING 5
SECTION G**

Contractor applying second coat of Florida Paints TropiCrete concrete sealer.

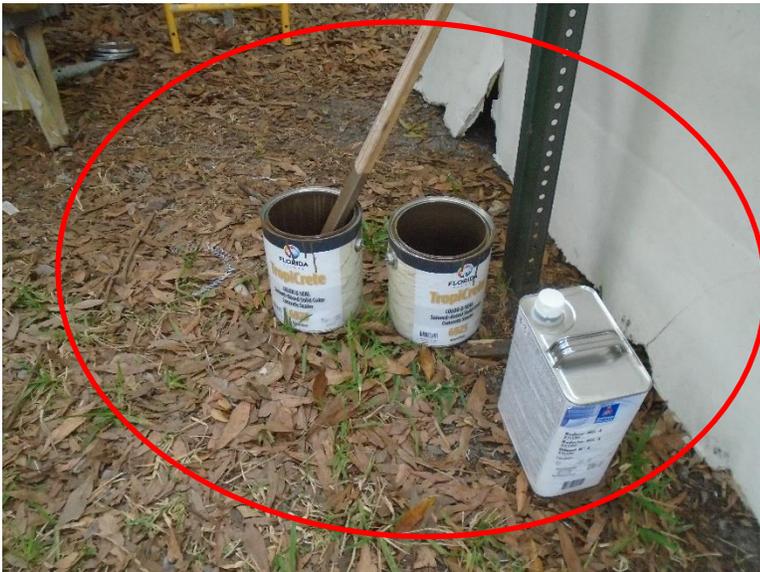
PHOTOGRAPH #4

**BUILDING 5
SECTION G**

Contractor applying second coat of Florida Paints TropiCrete concrete sealer.

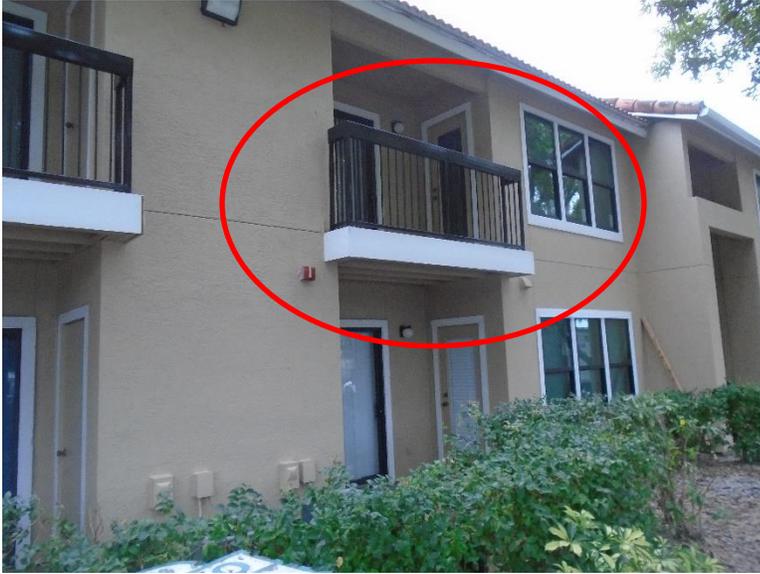
PHOTOGRAPH #5

**BUILDING 5
SECTION B**

Contractor has reattached railings to decks with 4" galvanized lag bolts.

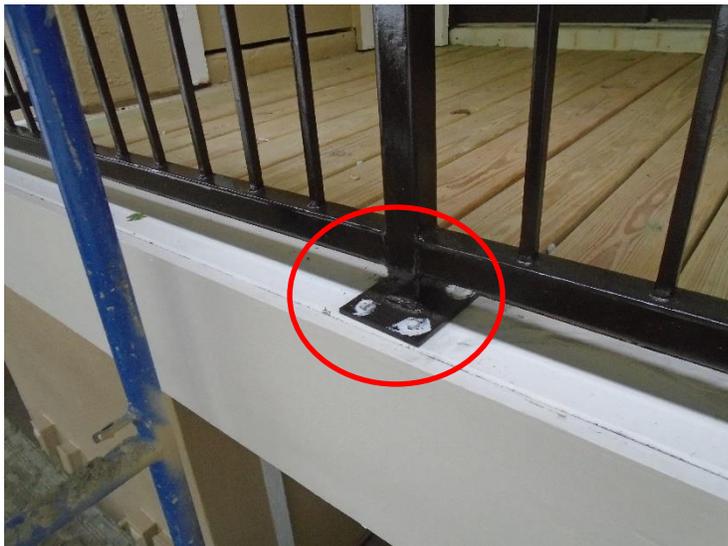
PHOTOGRAPH #6

**BUILDING 5
SECTION B**

Contractor has reattached railings to decks with 4" galvanized lag bolts.

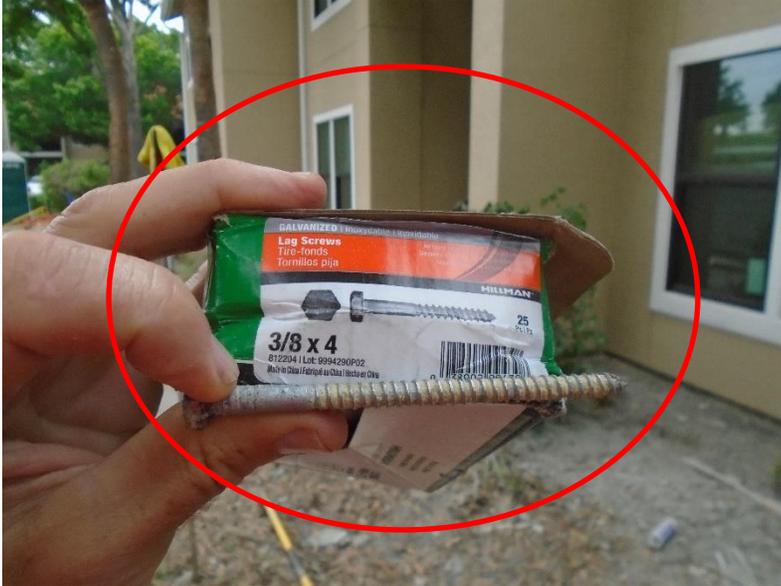
PHOTOGRAPH #7

**BUILDING 5
SECTION B**

Contractor has reattached railings to decks with 4" galvanized lag bolts.

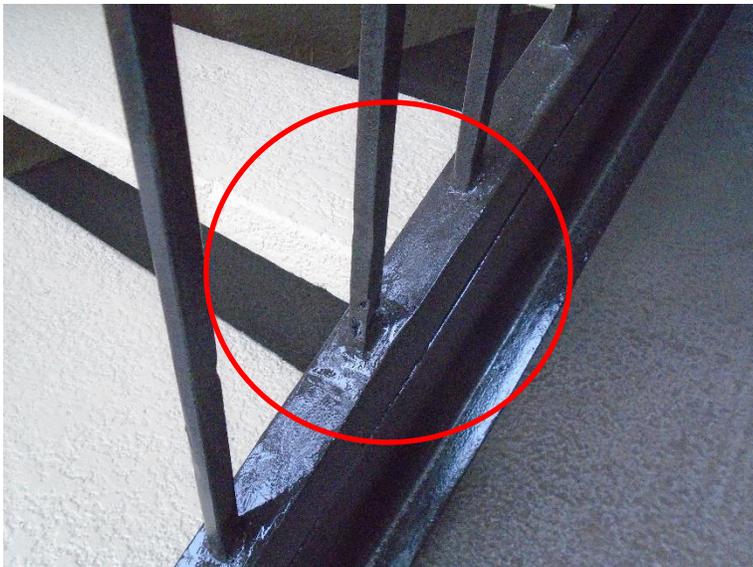
PHOTOGRAPH #8

**BUILDING 5
SECTION C**

Damaged Breezeway railing pickets have not yet been repaired.

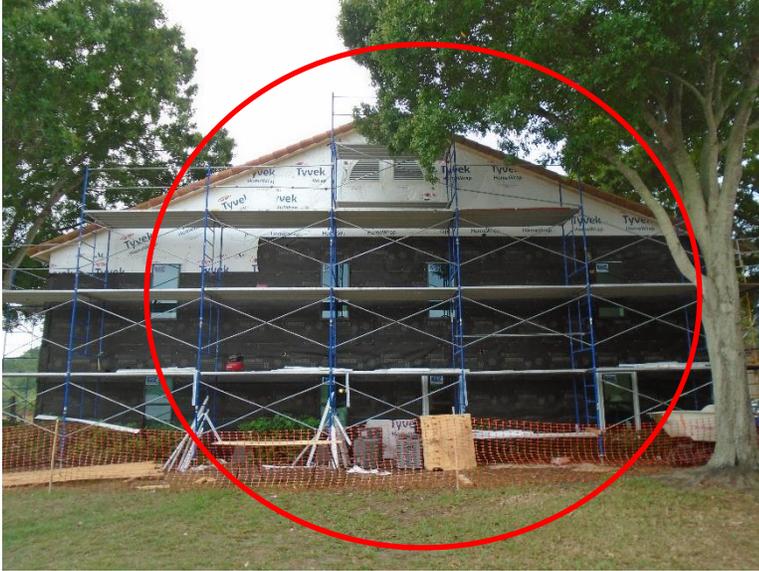
PHOTOGRAPH #9

**BUILDING 23
SECTION H**

Stucco contractor has begun to apply JumboTex WRB and stucco accessories.

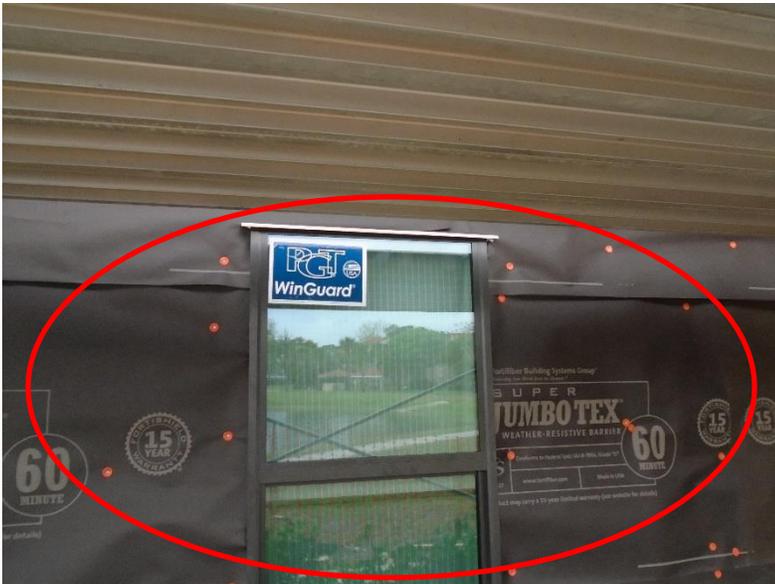
PHOTOGRAPH #10

**BUILDING 23
SECTION H**

Stucco contractor has begun to apply JumboTex WRB and stucco accessories.

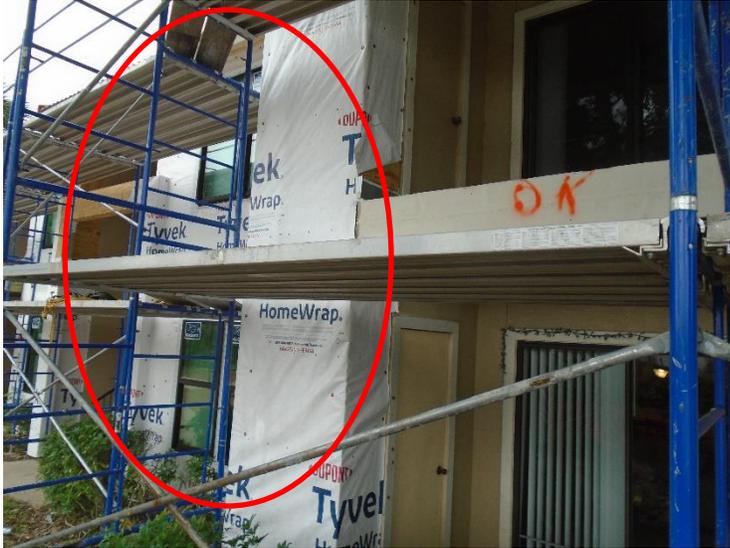
PHOTOGRAPH #11

**BUILDING 5
SECTION G**

New PGT Windows installed with Dupont Flashing system.

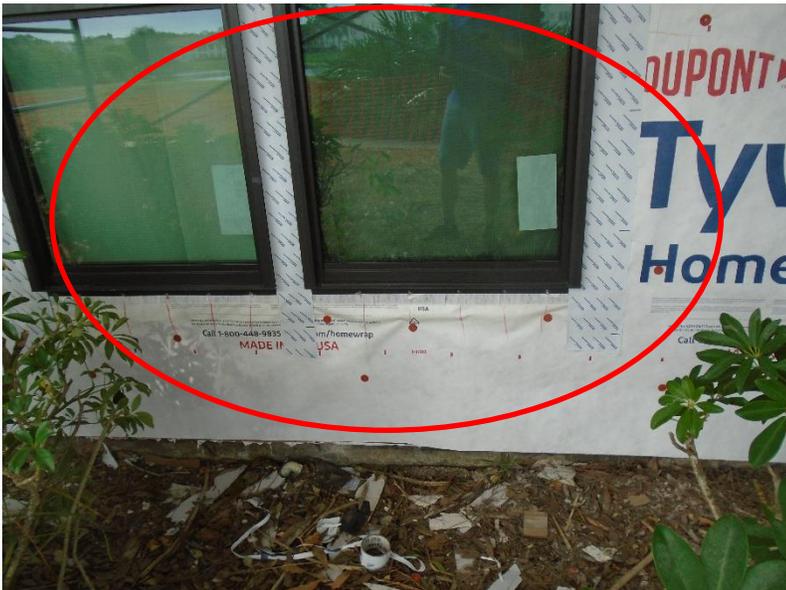
PHOTOGRAPH #12

**BUILDING 5
SECTION G**

New PGT Windows installed with Dupont Flashing system.

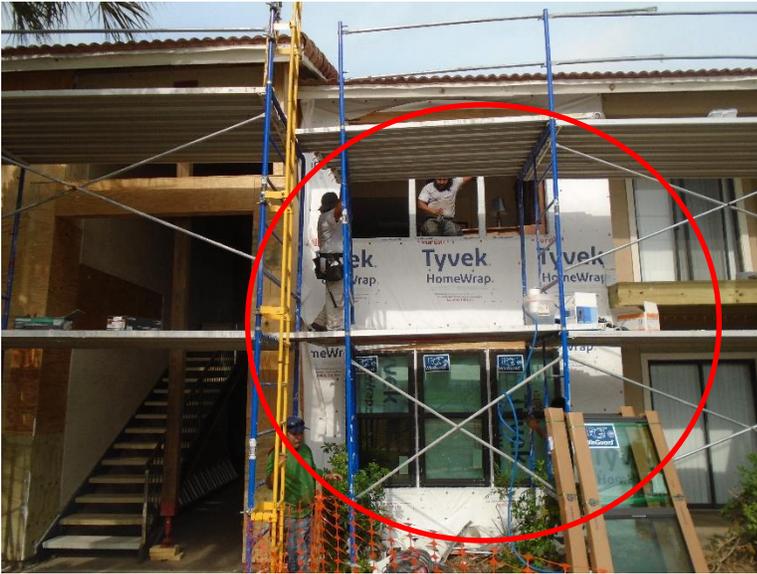
PHOTOGRAPH #13

**BUILDING 5
SECTION F**

Contractor installing new PGT 770A windows with Dupont flashing system.

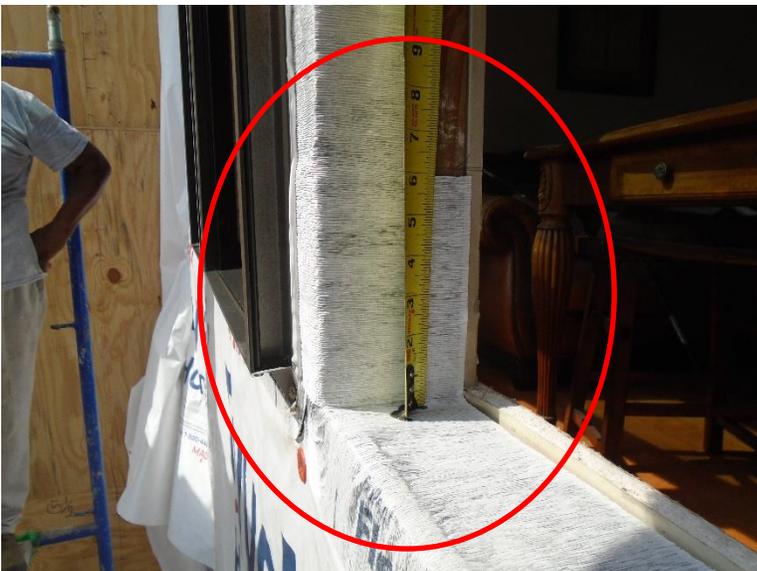
PHOTOGRAPH #14

**BUILDING 5
SECTION F**

Dupont flashing at frame opening checked for overlaps at jambs and sills.

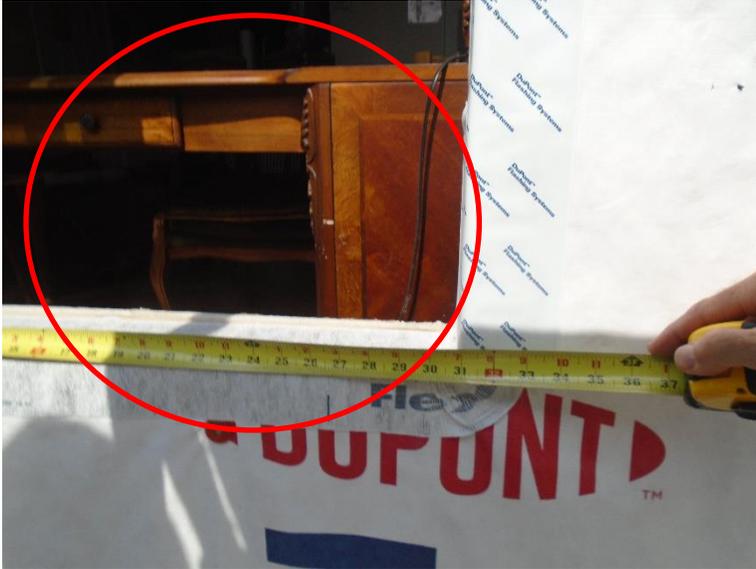
PHOTOGRAPH #15

**BUILDING 5
SECTION F**

Frame opening sizes checked to meet fastening requirements as per window manufacturer NOAs.

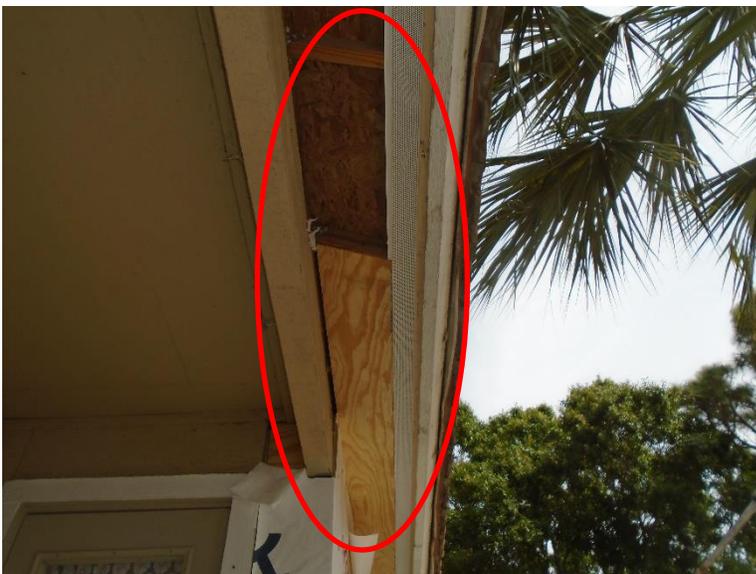
PHOTOGRAPH #16

**BUILDING 23
SECTION F**

New soffit installation in progress.

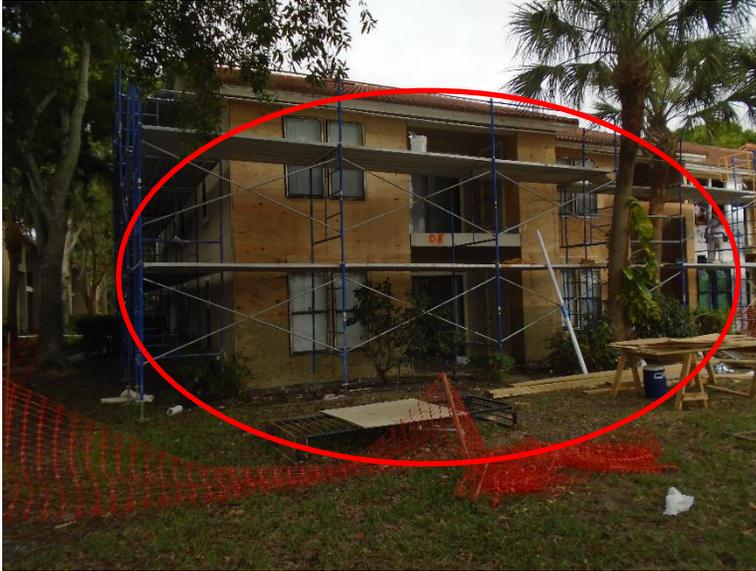
PHOTOGRAPH #17

**BUILDING 23
SECTION E**

New plywood sheathing applied and inspected.

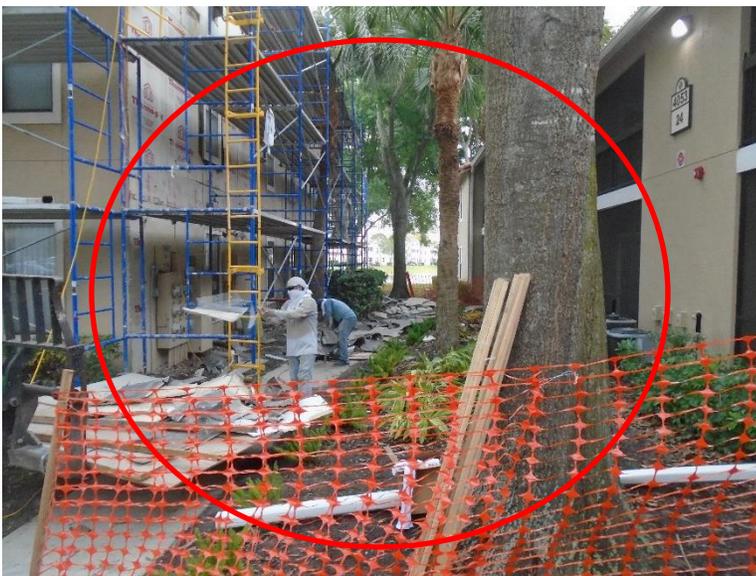
PHOTOGRAPH #18

**BUILDING 23
SECTION D**

Contractor has begun removal of stucco and sheathing. Construction fencing in place for pedestrian safety.

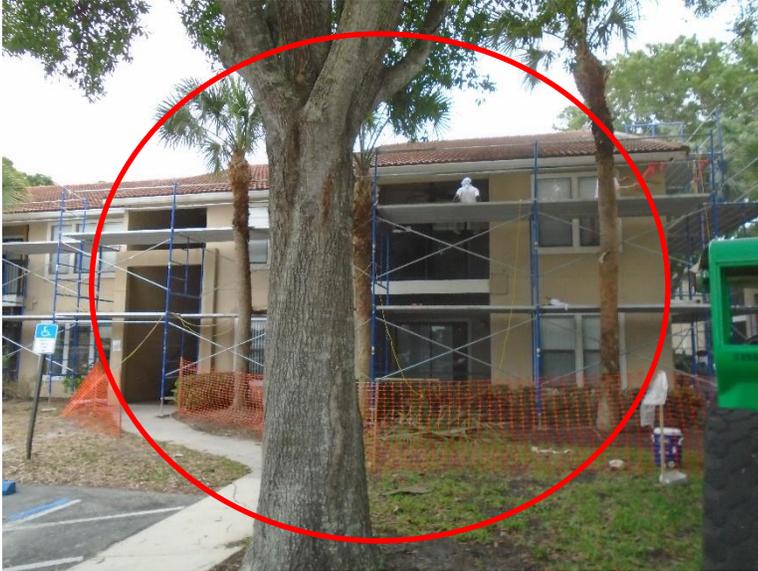
PHOTOGRAPH #19

**BUILDING 23
SECTION C**

Contractor has placed construction fencing, erected access scaffolding and begun demolition.
