PHOTOGRAPHS

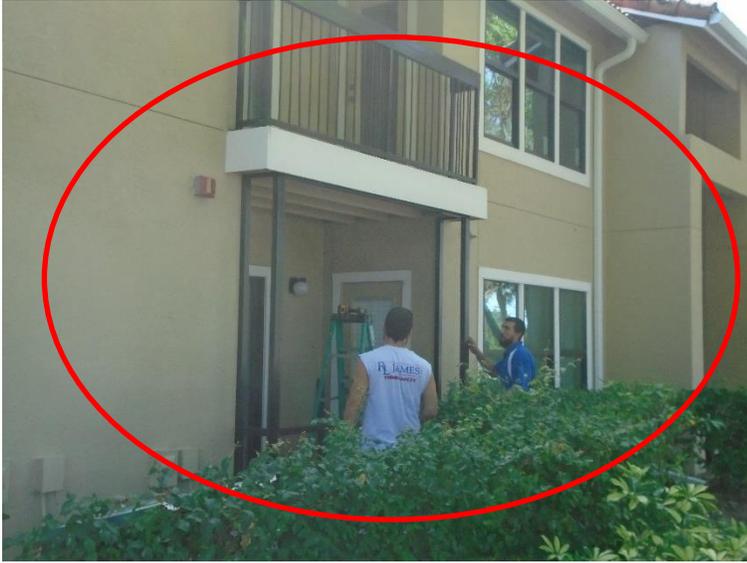
PHOTOGRAPH #1

**BUILDING 5
SECTION B**

Contractor Installing new screen enclosures where removed for repairs.

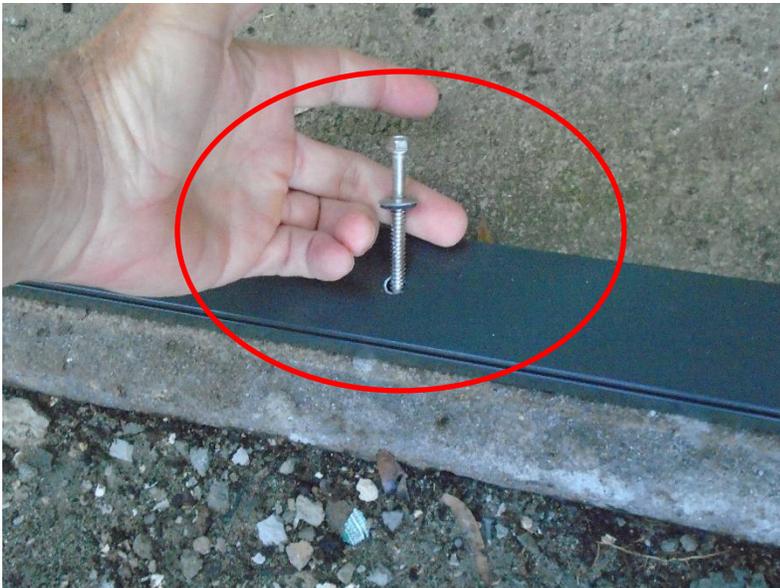
PHOTOGRAPH #2

**BUILDING 5
SECTION B**

Stainless steel fasteners used for screen enclosures.

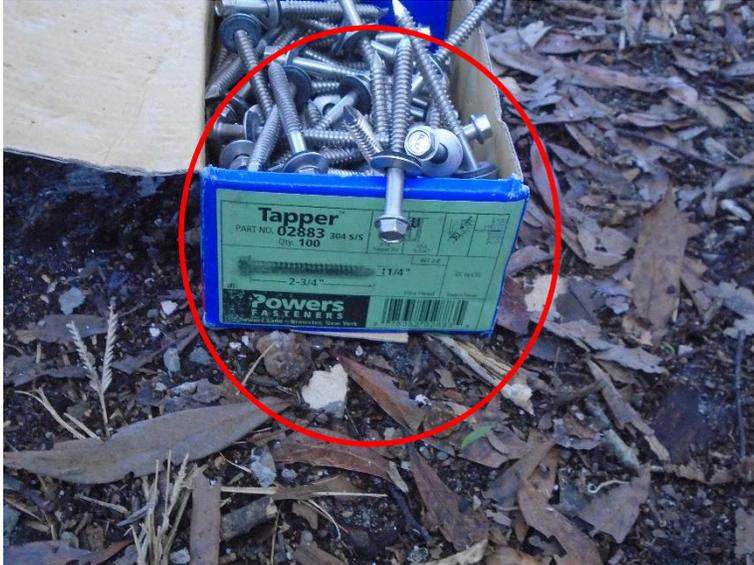
PHOTOGRAPH #3

**BUILDING 5
SECTION B**

Stainless steel fasteners used for screen enclosures.

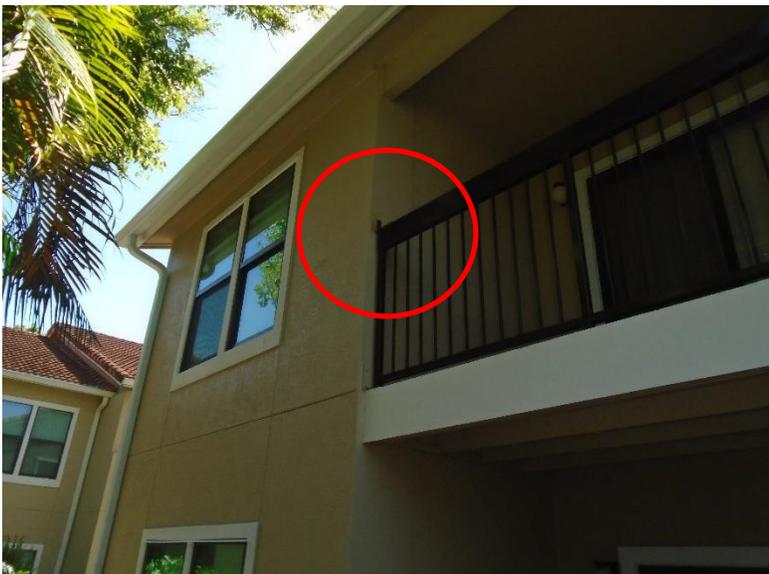
PHOTOGRAPH #4

**BUILDING 5
SECTION E**

Balcony railing attachments flanges have been welded to railings and being attached with lag screws.

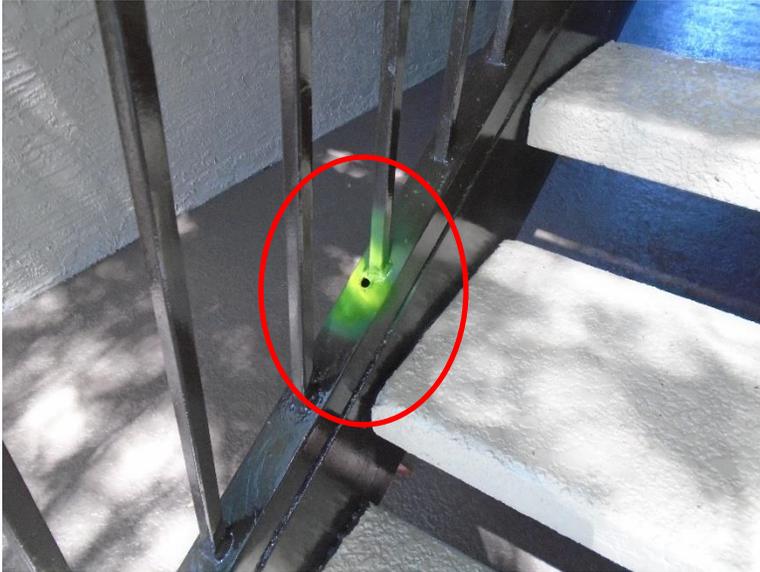
PHOTOGRAPH #5

**BUILDING 5
SECTION E**

Breezeway railing pickets marked for welding repairs.

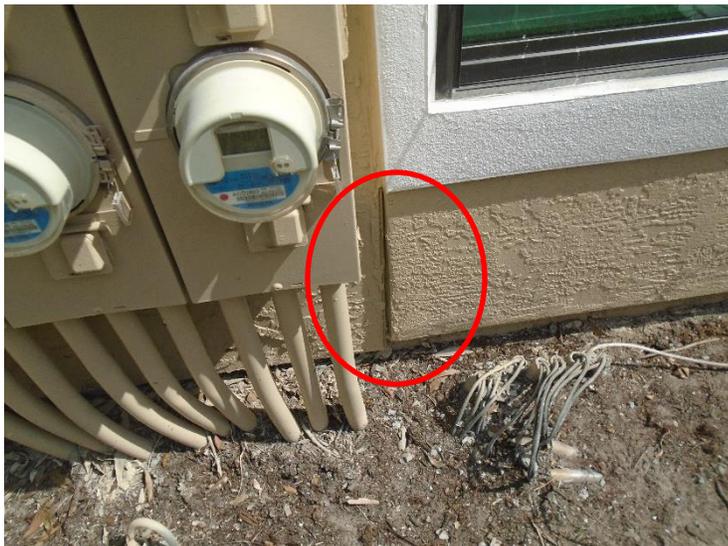
PHOTOGRAPH #6

**BUILDING 5
SECTION D
EXTERIOR PUNCH LIST**

Sealant missing at transition to be sealed and touched up.

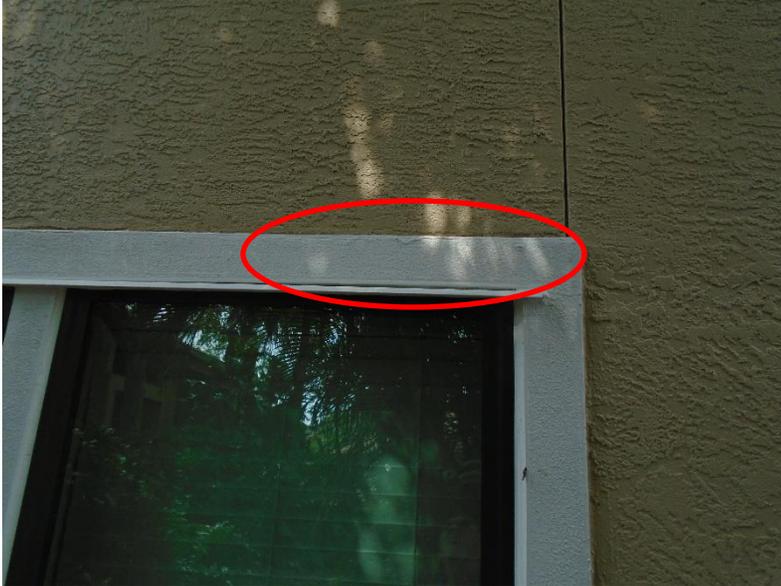
PHOTOGRAPH #7

**BUILDING 5
SECTION D
EXTERIOR PUNCH LIST**

Drips at white window bands to be removed and repainted.

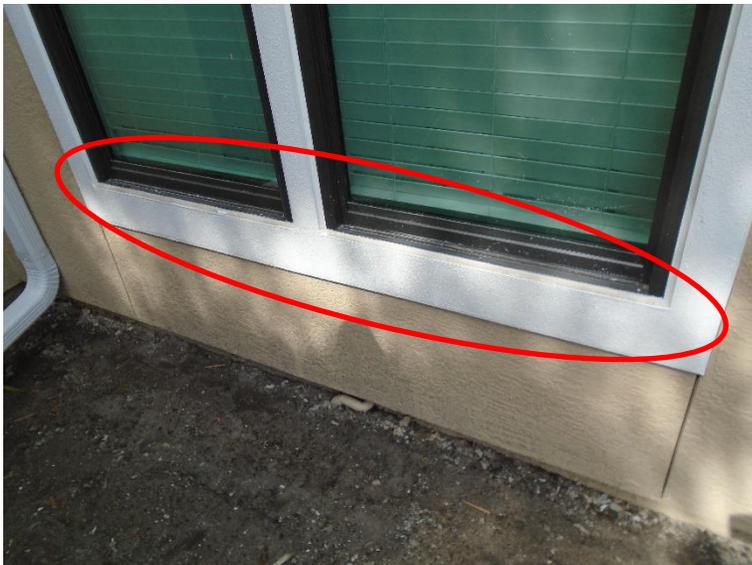
PHOTOGRAPH #8

**BUILDING 5
SECTION E
EXTERIOR PUNCH LIST**

Soiled sealant at bottom of windows to be painted white.

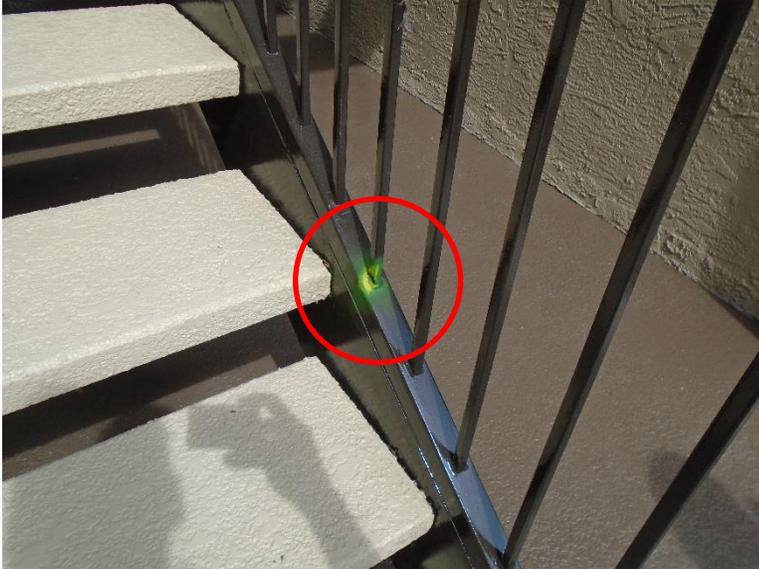
PHOTOGRAPH #9

**BUILDING 5
SECTION E
EXTERIOR PUNCH LIST**

Breezeway railing picket to be repaired and repainted.

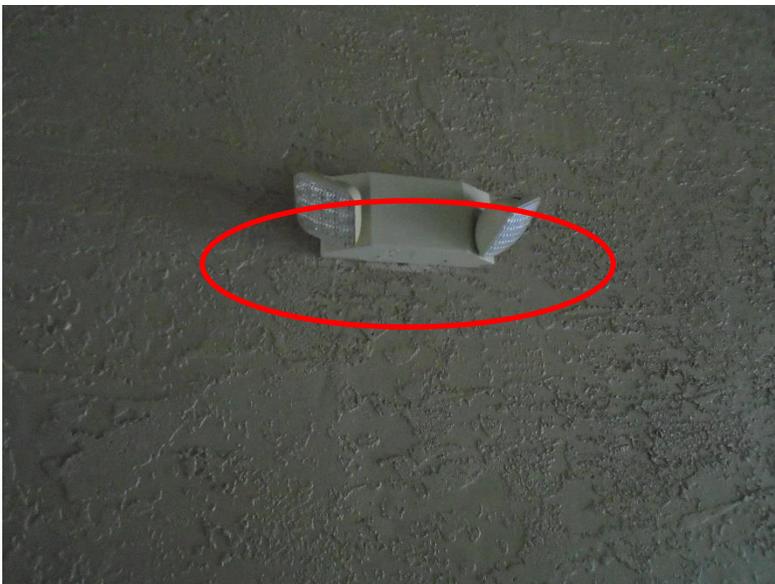
PHOTOGRAPH #10

**BUILDING 5
SECTION E
EXTERIOR PUNCH LIST**

Paint missing below emergency lights to be touched up.

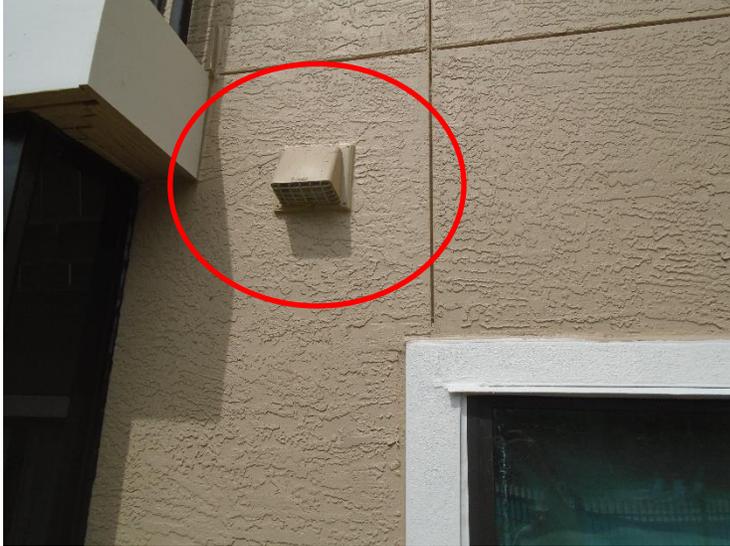
PHOTOGRAPH #11

**BUILDING 5
SECTION F
EXTERIOR PUNCH LIST**

Paint on dryer vent has alligatored and will require repainting.

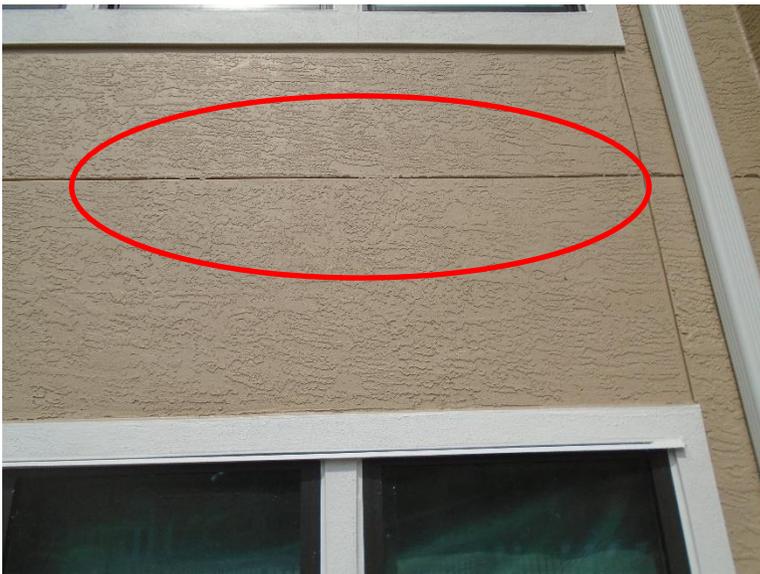
PHOTOGRAPH #12

**BUILDING 5
SECTION G
EXTERIOR PUNCH LIST**

Stucco covering stucco joint to be removed and touched up.

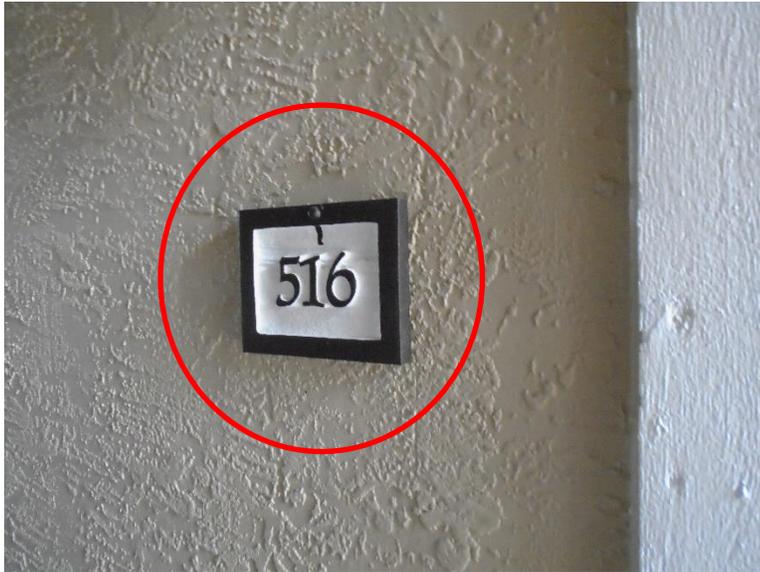
PHOTOGRAPH #13

**BUILDING 5
SECTION G
EXTERIOR PUNCH LIST**

Bronze paint drip on unit numbers to be touched up.

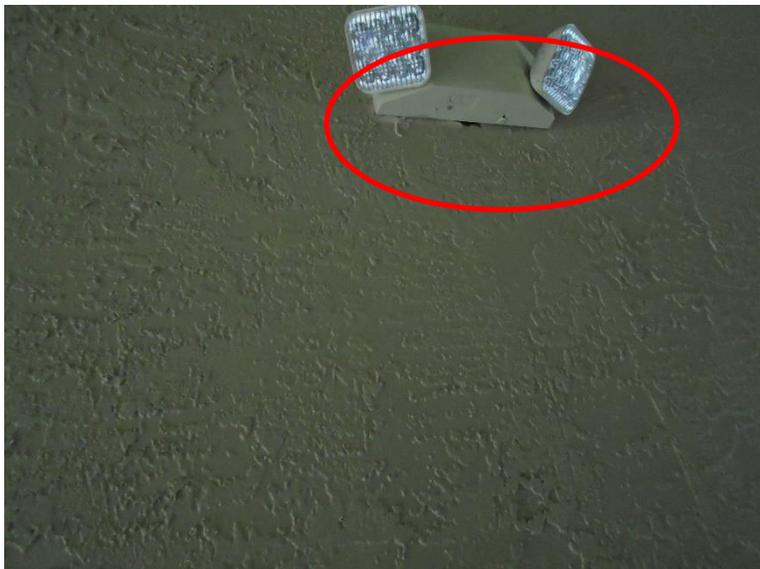
PHOTOGRAPH #14

**BUILDING 5
SECTION G
EXTERIOR PUNCH LIST**

Paint missing below emergency lights to be touched up.

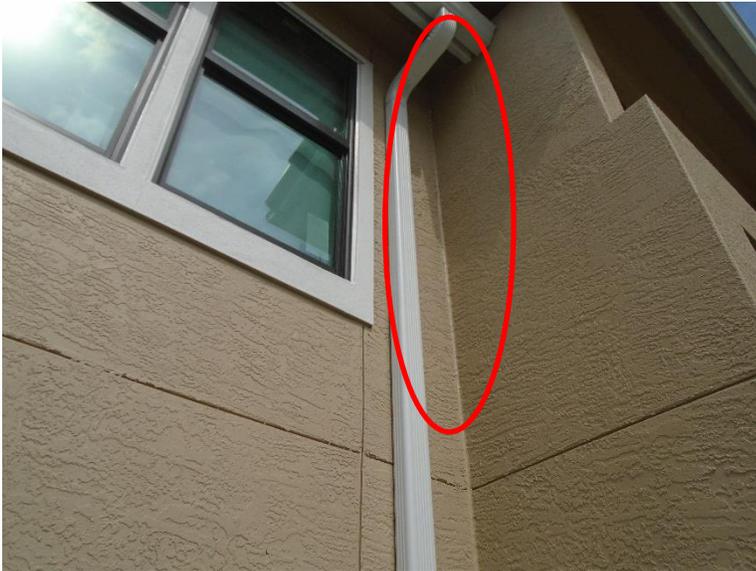
PHOTOGRAPH #15

**BUILDING 5
SECTION G
EXTERIOR PUNCH LIST**

Paint missing in corner to be touched up.

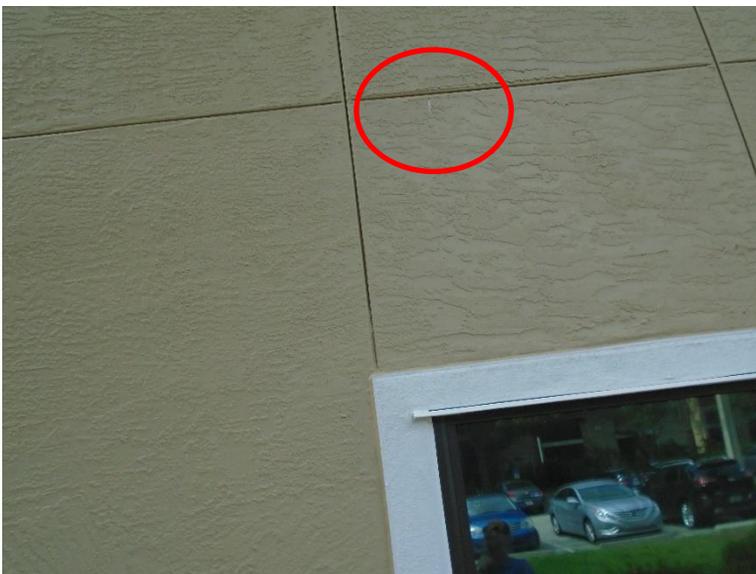
PHOTOGRAPH #16

**BUILDING 5
SECTION H
EXTERIOR PUNCH LIST**

Paint drip to be touched up.

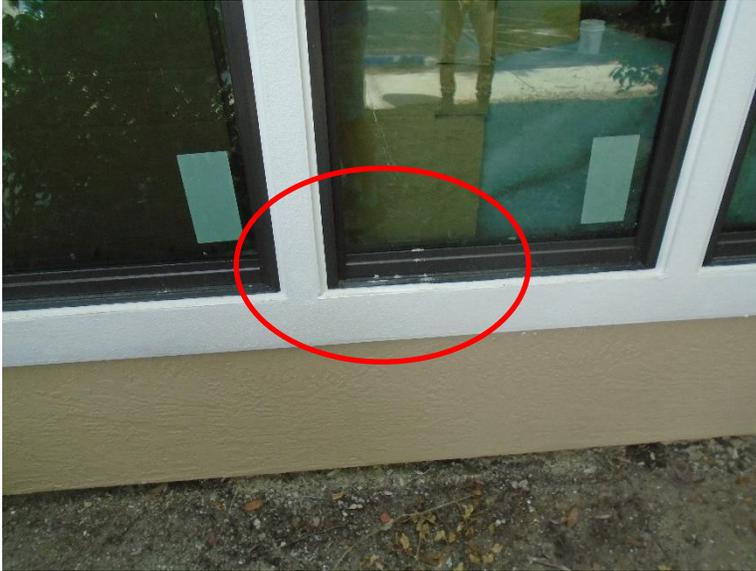
PHOTOGRAPH #17

**BUILDING 5
SECTION B
EXTERIOR PUNCH LIST**

Stucco on window frame to be removed.

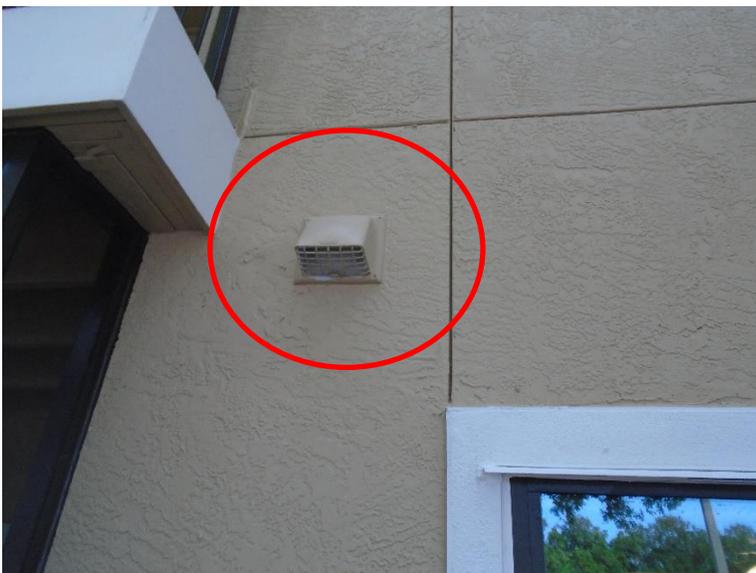
PHOTOGRAPH #18

**BUILDING 5
SECTION B
EXTERIOR PUNCH LIST**

Missing paint at dryer vent to be touched up.

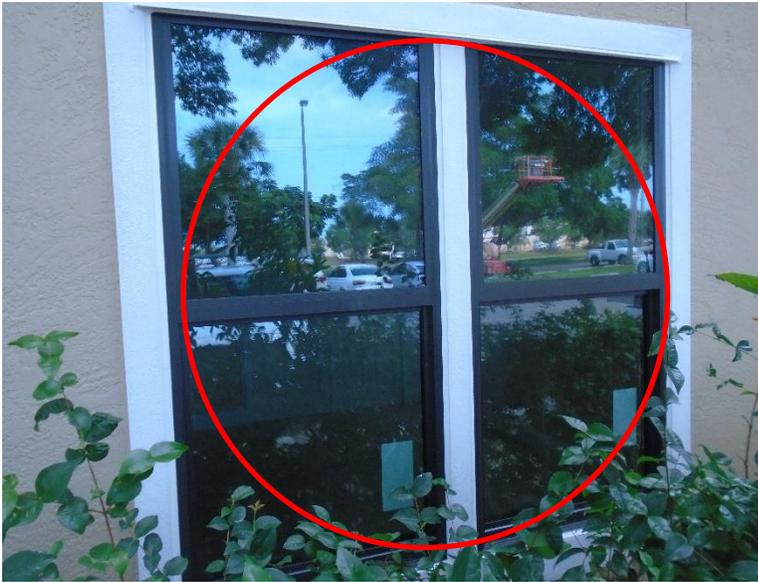
PHOTOGRAPH #19

**BUILDING 5
SECTION C
EXTERIOR PUNCH LIST**

Paint and sealant on window glass to be cleaned.

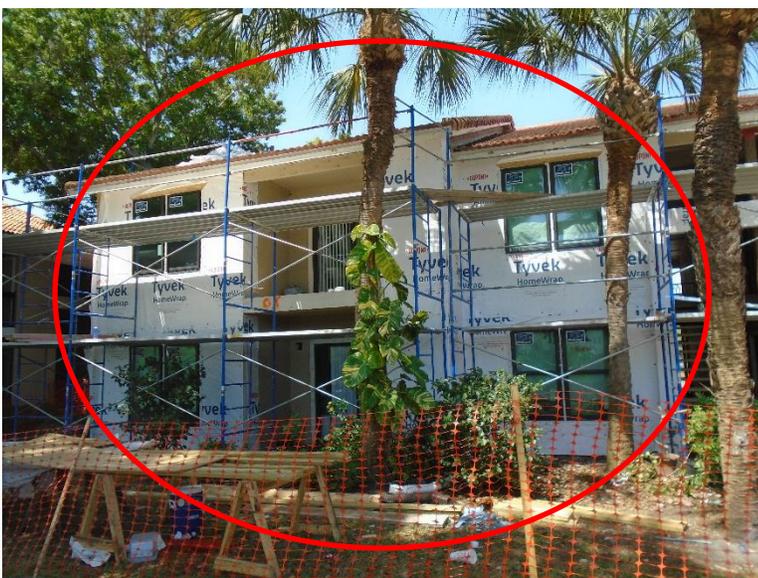
PHOTOGRAPH #20

**BUILDING 23
SECTION E**

New PGT windows installed with Tyvek/Dupont flashing.

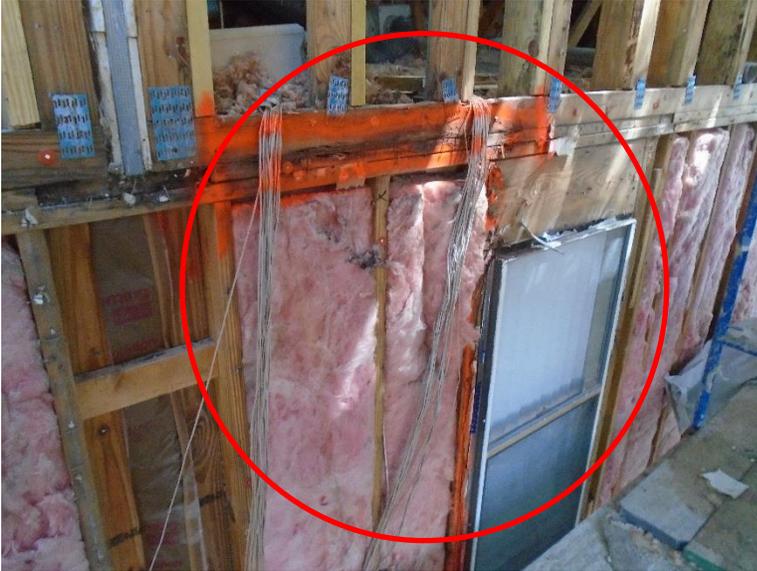
PHOTOGRAPH #21

**BUILDING 23
SECTION D**

Additional damage identified and marked for repairs.

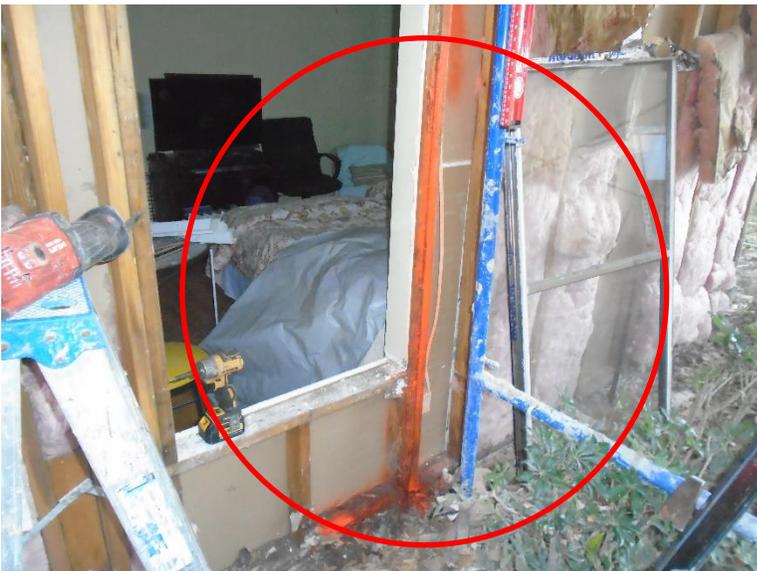
PHOTOGRAPH #22

**BUILDING 23
SECTION D**

Additional damage identified and marked for repairs.

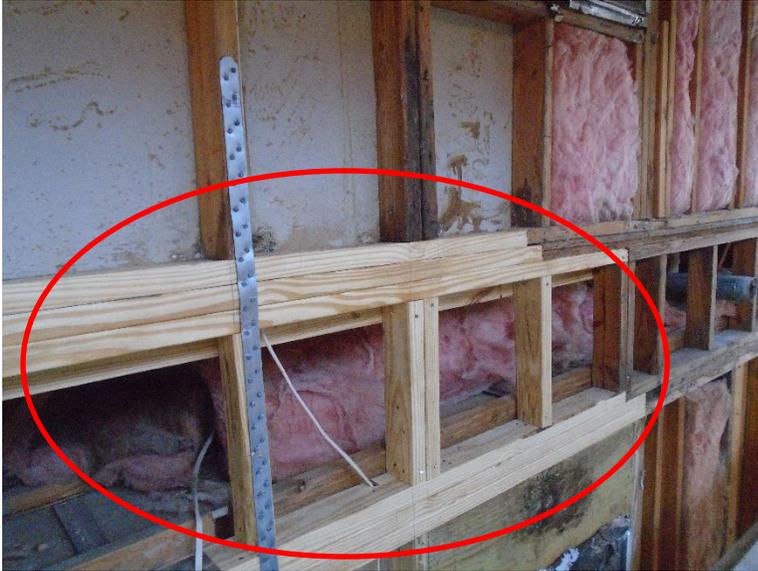
PHOTOGRAPH #23

**BUILDING 23
SECTION D**

Subfloor repairs at gable end repairs have been performed.

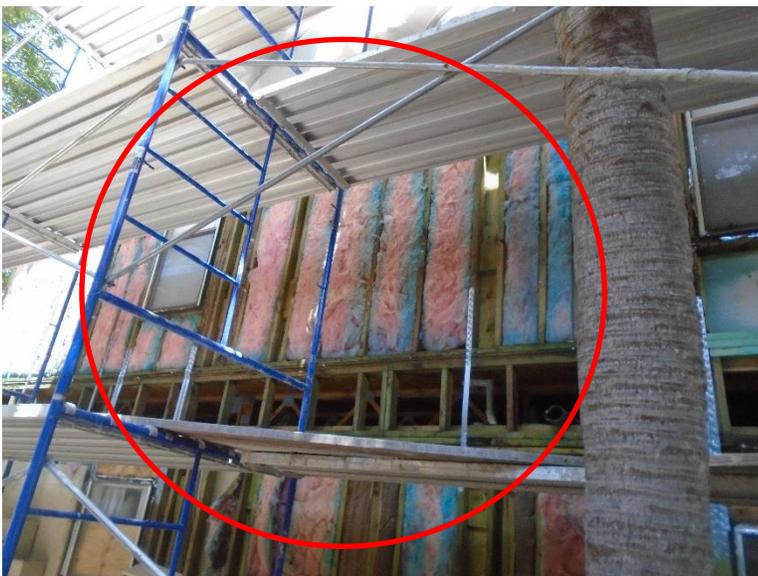
PHOTOGRAPH #24

**BUILDING 23
SECTION D**

BoraCare Termite treatment has been applied at all framing.

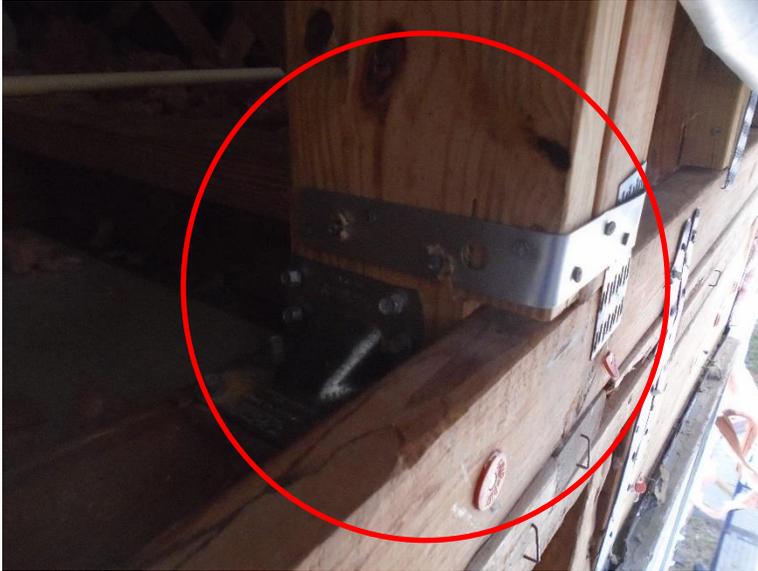
PHOTOGRAPH #25

**BUILDING 23
SECTION D**

Simpson Strong-Tie straps, connectors and clips have been installed and inspected.

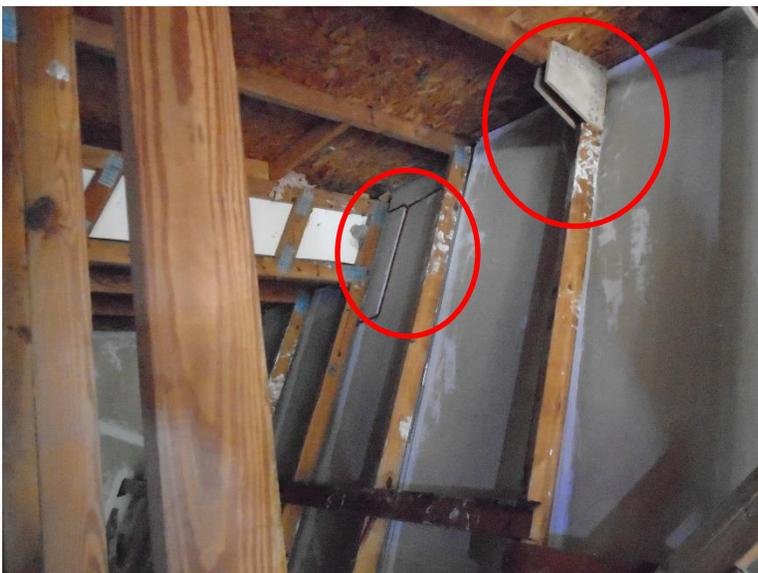
PHOTOGRAPH #26

**BUILDING 23
SECTION D
ATTIC UNIT # 2327**

Repairs made at framing trusses and firewalls.

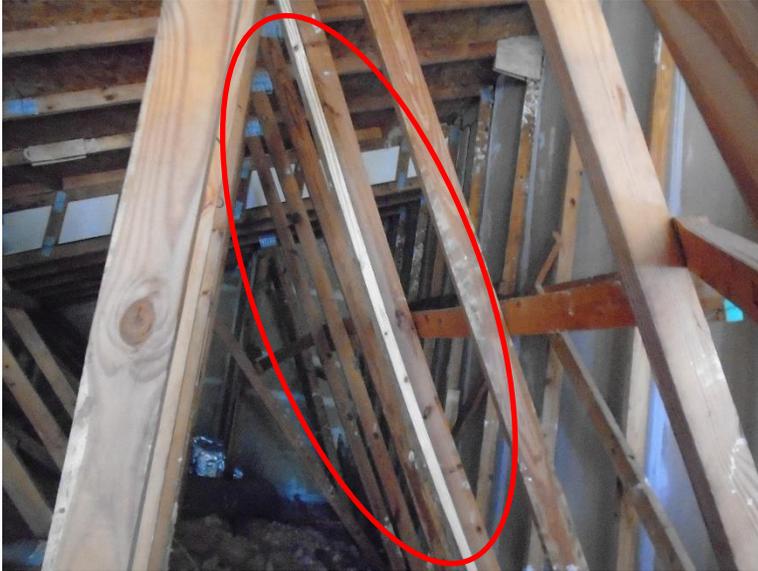
PHOTOGRAPH #27

**BUILDING 23
SECTION D
ATTIC UNIT # 2327**

Repairs made at framing trusses and firewalls.

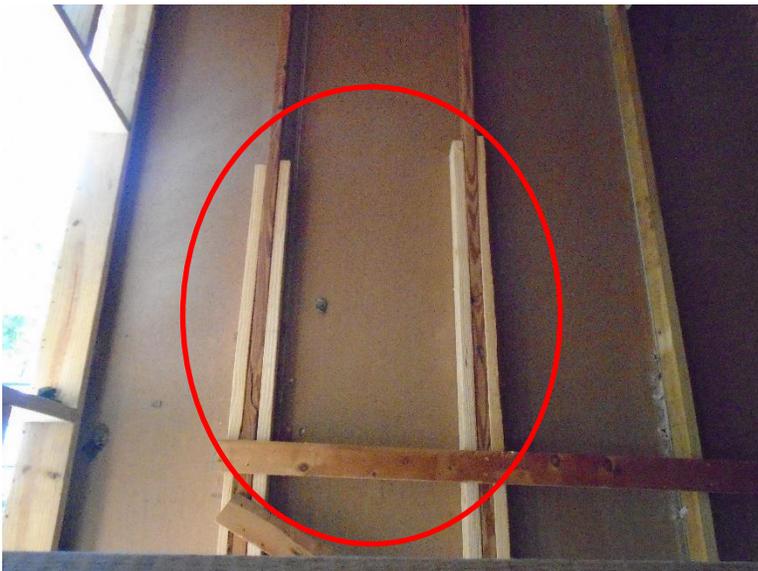
PHOTOGRAPH #28

**BUILDING 23
SECTION D
ATTIC UNIT # 2328**

Repairs made at framing trusses and firewalls.

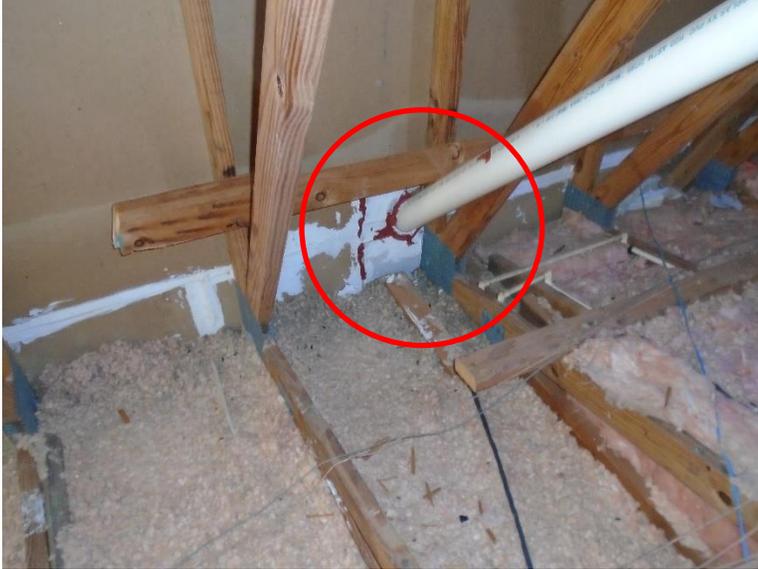
PHOTOGRAPH #29

**BUILDING 23
SECTION D
ATTIC UNIT # 2328**

Repairs made at framing trusses and firewalls.

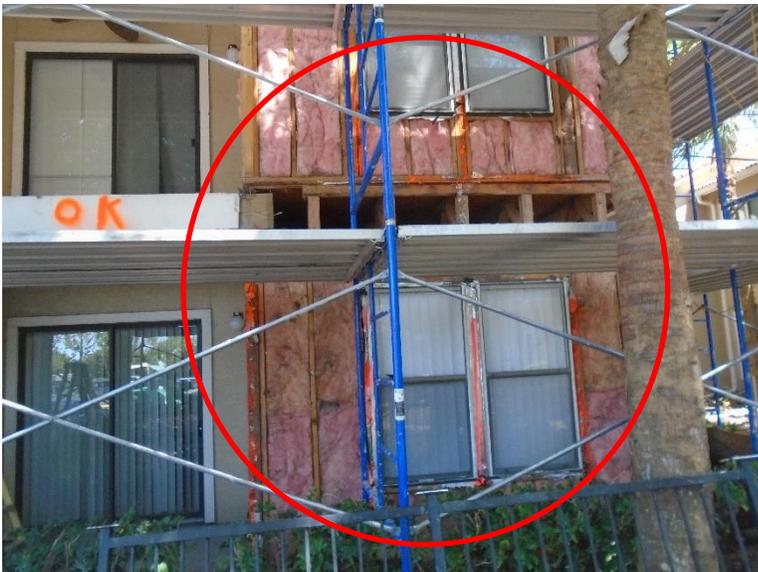
PHOTOGRAPH #30

**BUILDING 23
SECTION C**

Framing damage identified and marked by Delta for repairs.

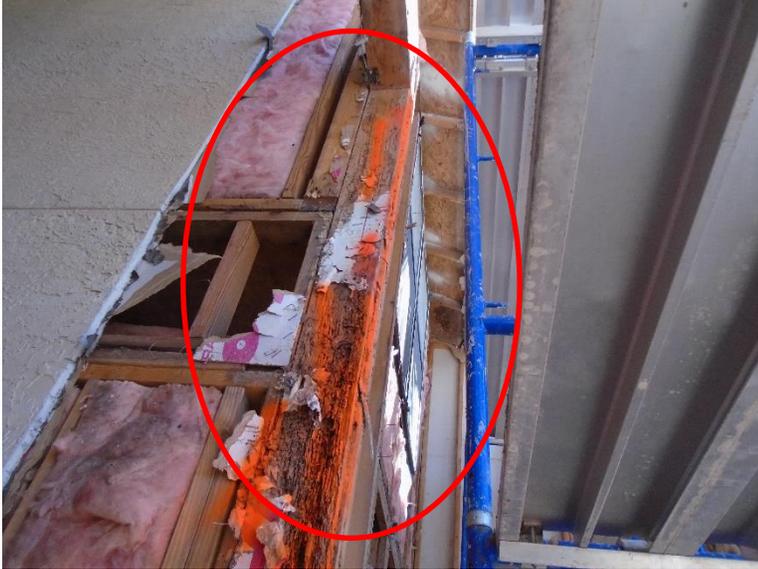
PHOTOGRAPH #31

**BUILDING 23
SECTION C**

Framing damage identified and marked by Delta for repairs.

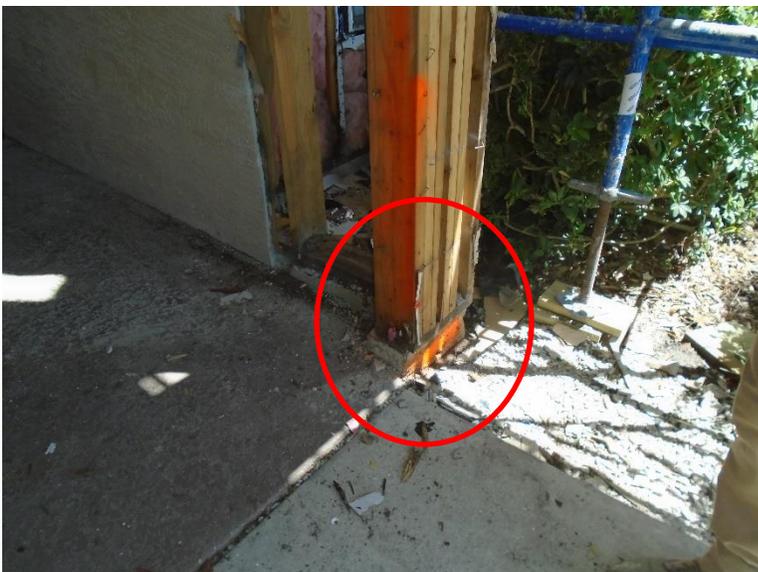
PHOTOGRAPH #32

**BUILDING 23
SECTION C**

Breezeway column support pedestal marked for repair.

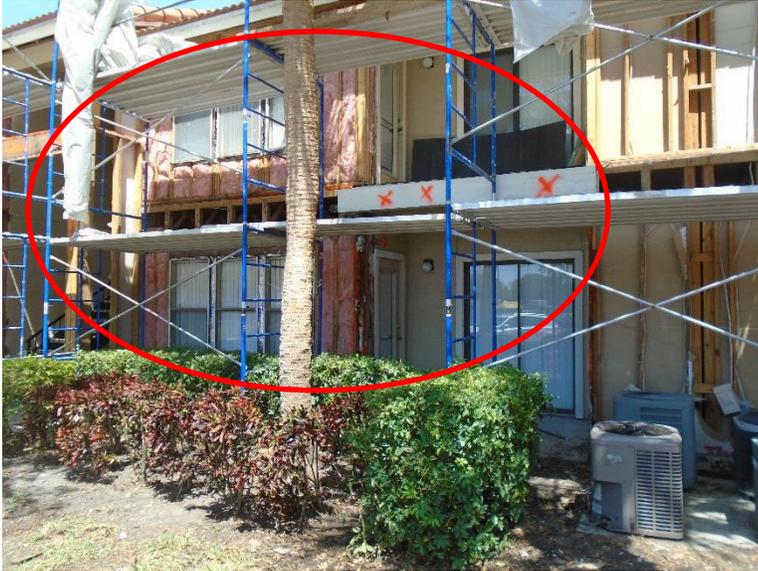
PHOTOGRAPH #33

**BUILDING 23
SECTION B**

Framing and balcony deck damage identified and marked by Delta for repairs.

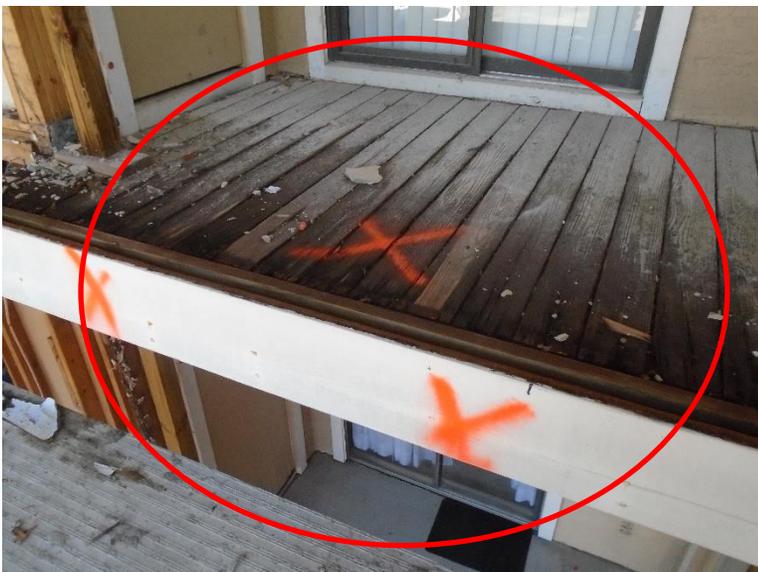
PHOTOGRAPH #34

**BUILDING 23
SECTION B**

Framing and balcony deck damage identified and marked by Delta for repairs.

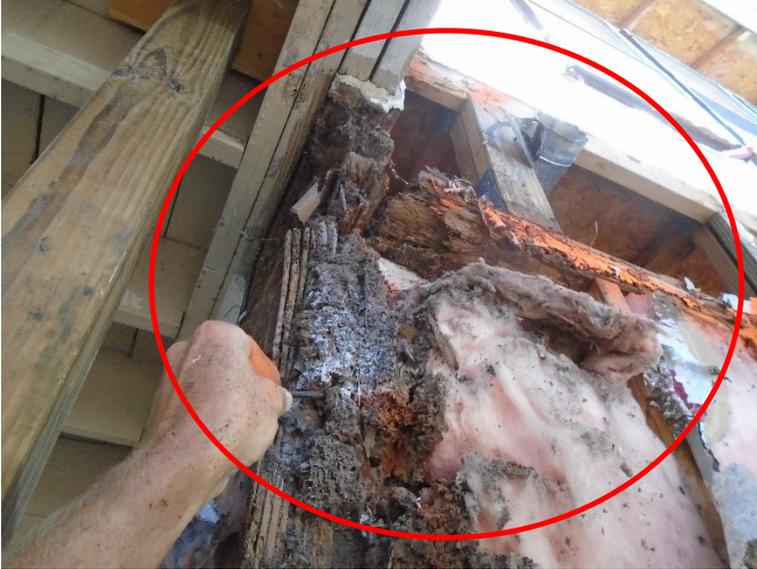
PHOTOGRAPH #35

**BUILDING 23
SECTION B**

Framing and balcony deck damage identified and marked by Delta for repairs.

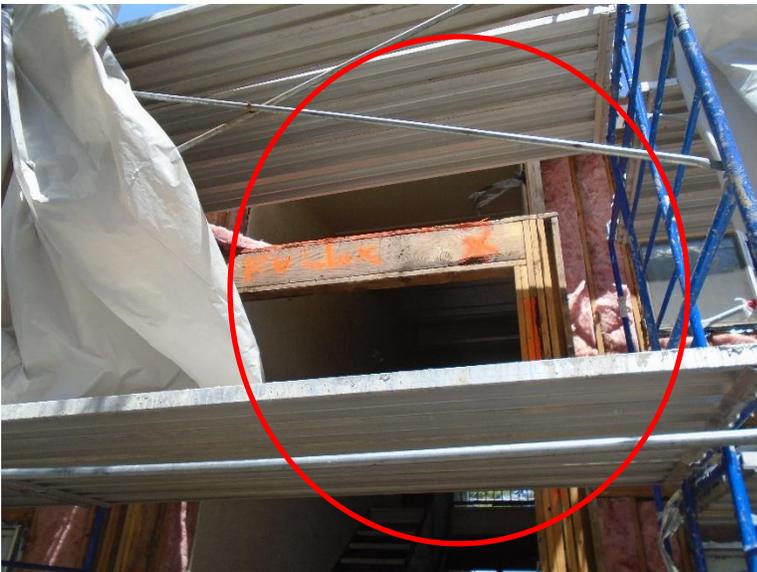
PHOTOGRAPH #36

**BUILDING 23
SECTION A**

Framing damage identified and marked by Delta for repairs.
