## PHOTOGRAPHS

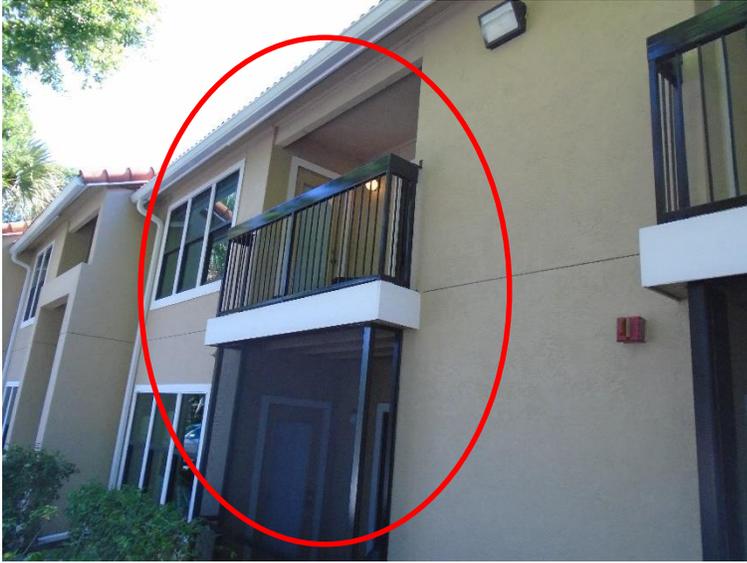
**PHOTOGRAPH #1**

### **BUILDING 5 SECTION B**

New screen enclosures installed, and balcony railing attachments completed.

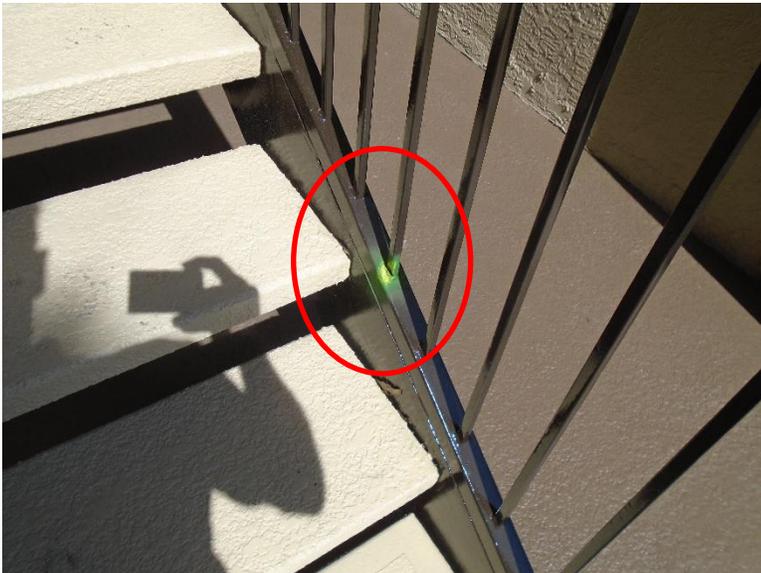
**PHOTOGRAPH #2**

### **BUILDING 5 SECTION B EXTERIOR PUNCH LIST**

Breezeway railings pickets to be repaired and touched up.

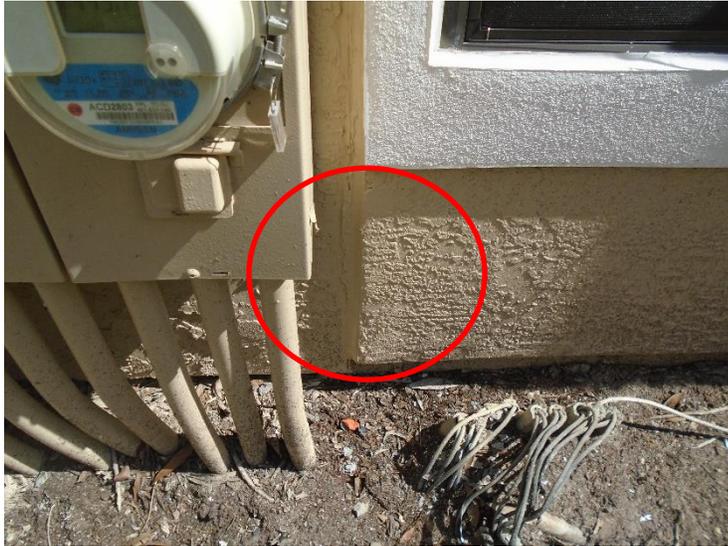
**PHOTOGRAPH #3**

**BUILDING 5  
SECTION D  
EXTERIOR PUNCH LIST**

Sealant has been installed at transition and touched up.

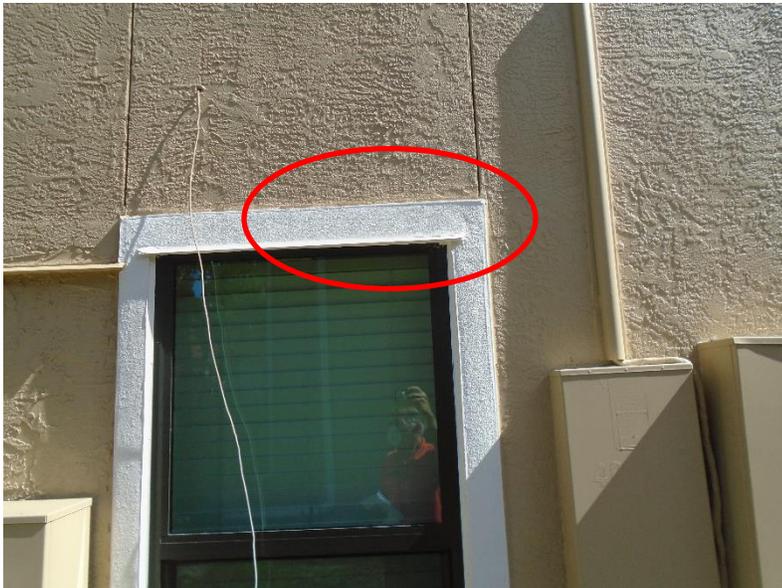
**PHOTOGRAPH #4**

**BUILDING 5  
SECTION D  
EXTERIOR PUNCH LIST**

Drips at white window bands removed and repainted.

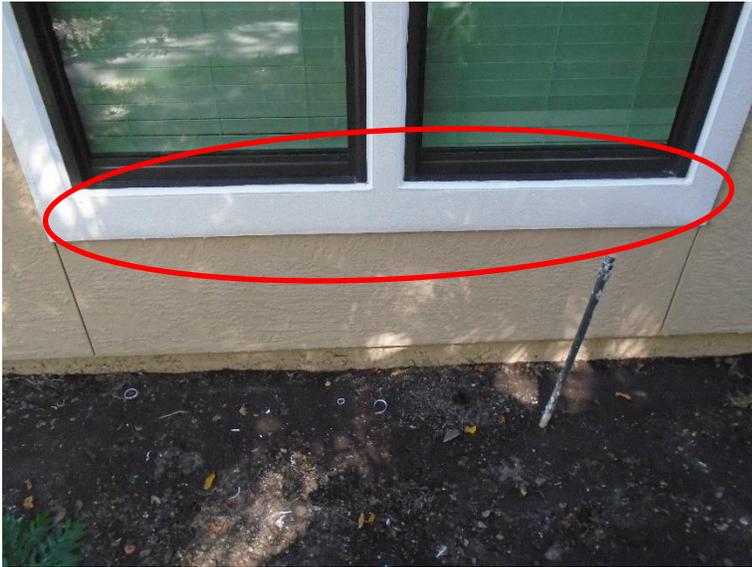
**PHOTOGRAPH #5**

**BUILDING 5  
SECTION E  
EXTERIOR PUNCH LIST**

Soiled sealant at bottom of windows painted white.

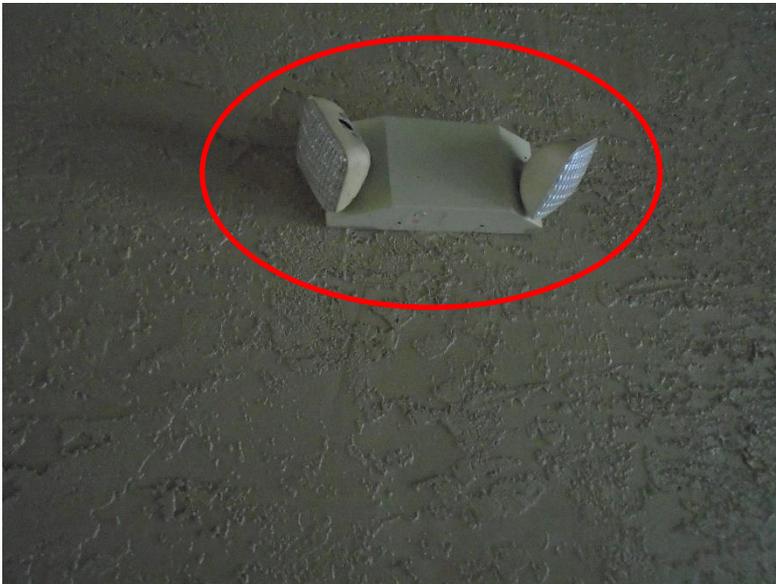
**PHOTOGRAPH #6**

**BUILDING 5  
SECTION E  
EXTERIOR PUNCH LIST**

Paint missing below emergency lights touched up.

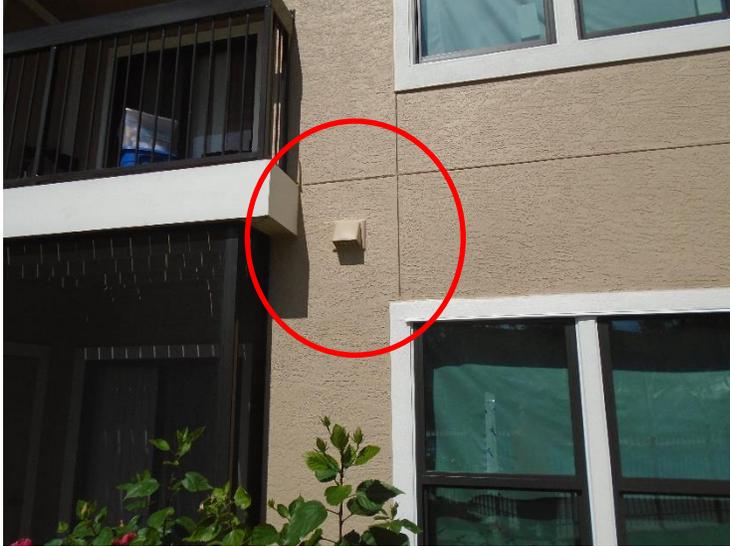
**PHOTOGRAPH #7**

**BUILDING 5  
SECTION F  
EXTERIOR PUNCH LIST**

Dryer vent has been repainted.

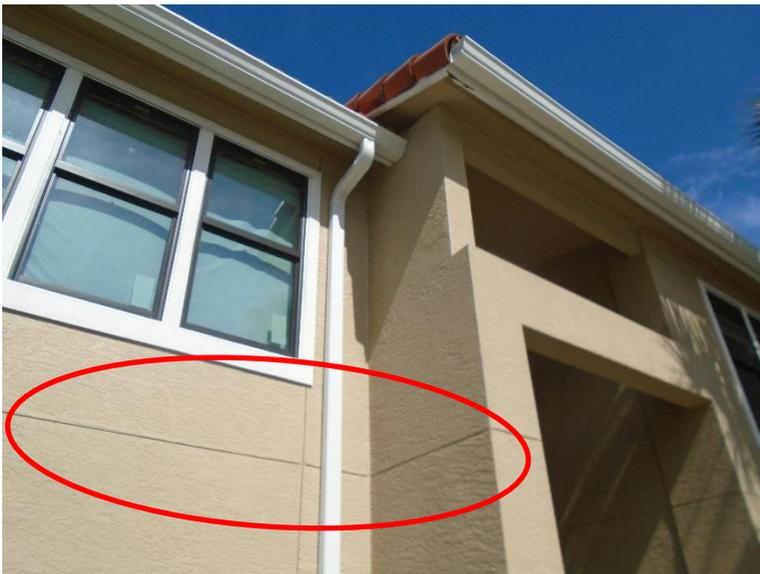
**PHOTOGRAPH #8**

**BUILDING 5  
SECTION G  
EXTERIOR PUNCH LIST**

Stucco covering stucco joint has been removed and touched up.

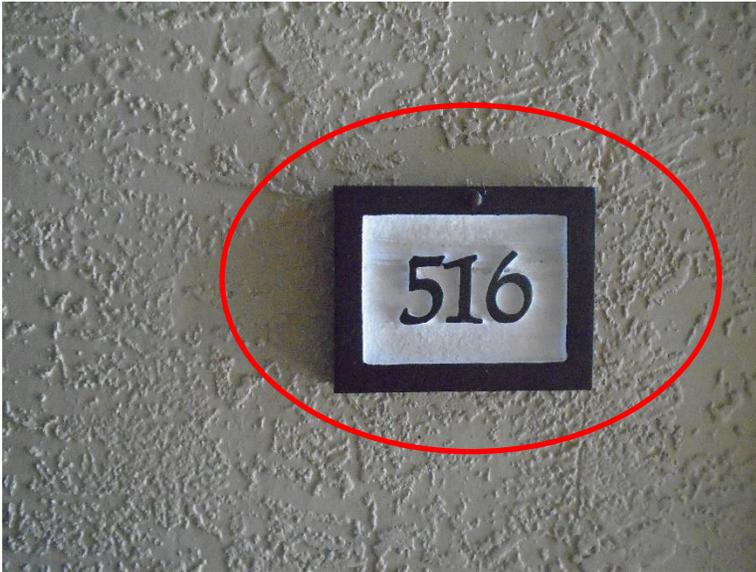
**PHOTOGRAPH #9**

**BUILDING 5  
SECTION G  
EXTERIOR PUNCH LIST**

Bronze paint drip on unit numbers have been touched up.

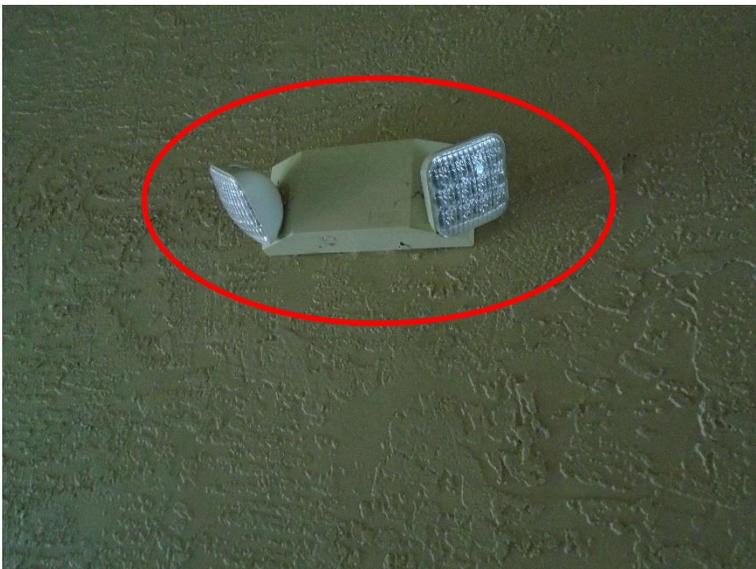
**PHOTOGRAPH #10**

**BUILDING 5  
SECTION G  
EXTERIOR PUNCH LIST**

Paint missing below emergency lights touched up.

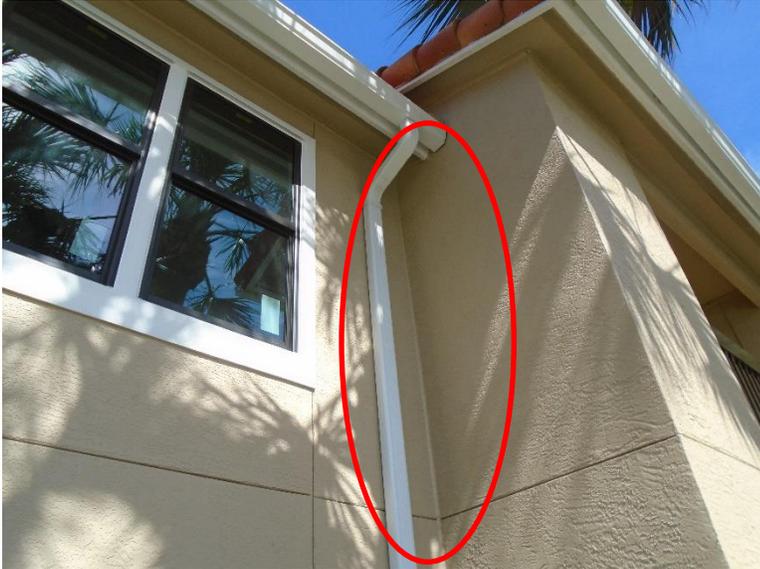
**PHOTOGRAPH #11**

**BUILDING 5  
SECTION G  
EXTERIOR PUNCH LIST**

Paint missing in corner has been touched up.

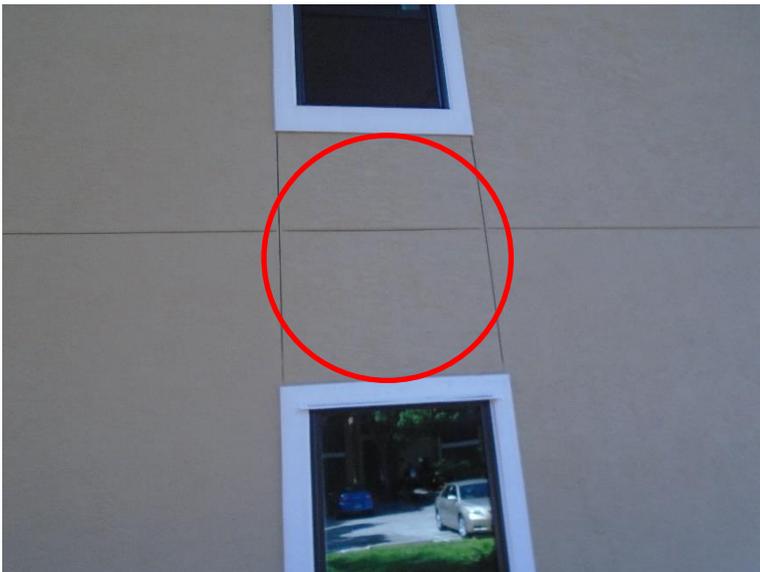
**PHOTOGRAPH #12**

**BUILDING 5  
SECTION H  
EXTERIOR PUNCH LIST**

Paint drip has been touched up.

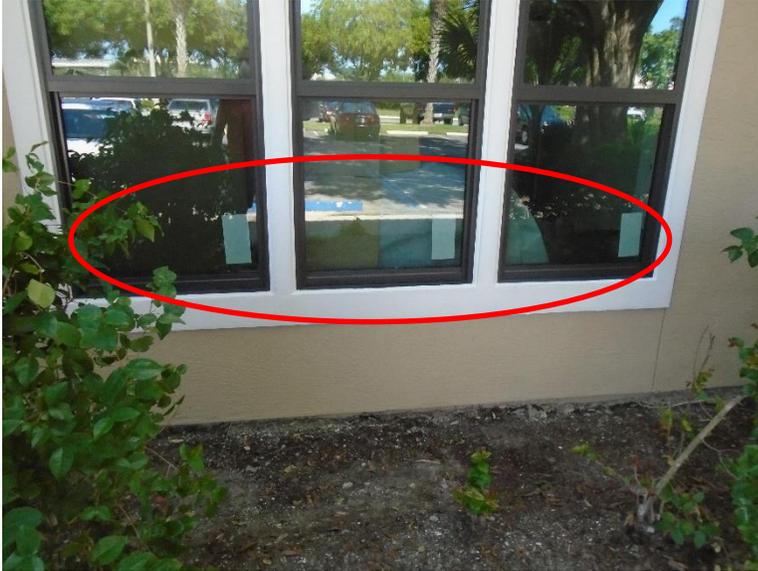
**PHOTOGRAPH #13**

**BUILDING 5  
SECTION B  
EXTERIOR PUNCH LIST**

Stucco on window frame removed.

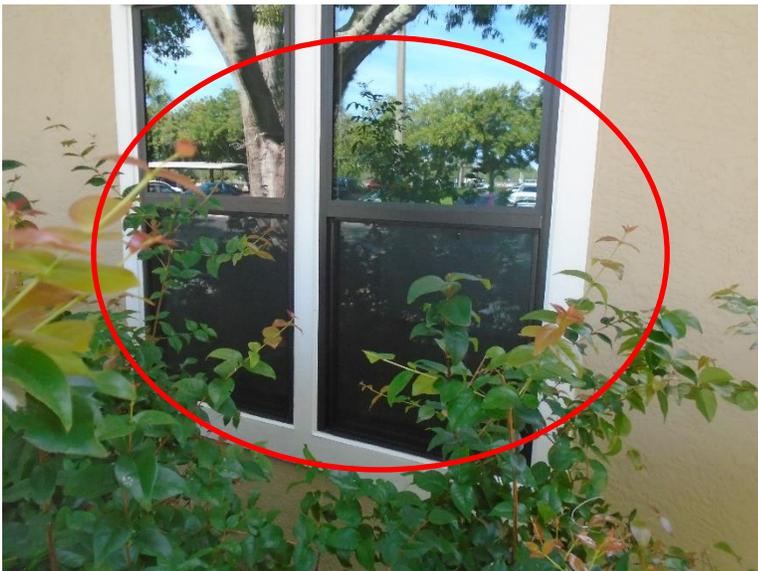
**PHOTOGRAPH #14**

**BUILDING 5  
SECTION C  
EXTERIOR PUNCH LIST**

Paint and sealant on window glass cleaned.

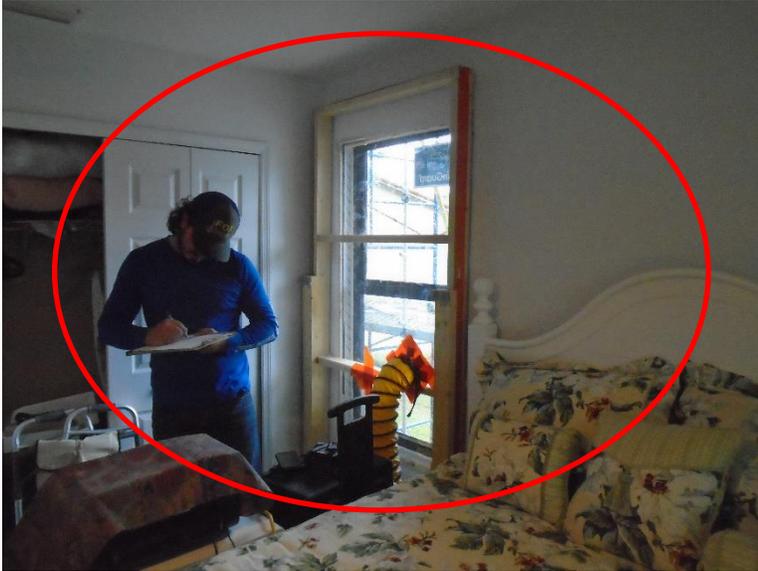
**PHOTOGRAPH #15**

**BUILDING 23  
SECTION H  
Unit #2322 – Water testing**

Independent Testing Agency performed AAMA 502 water testing at single window with no leaks.

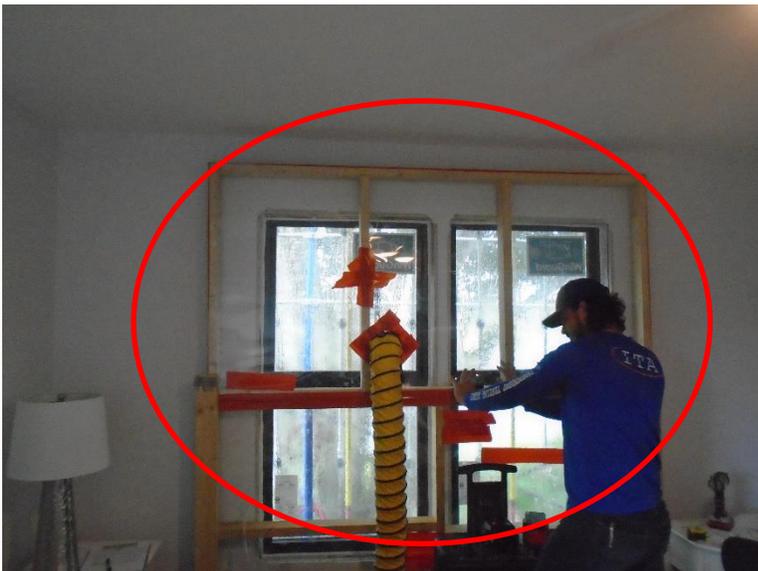
**PHOTOGRAPH #16**

**BUILDING 23  
SECTION G  
Unit #2322 – Water testing**

Independent Testing Agency performed AAMA 502 water testing at double window with no leaks.

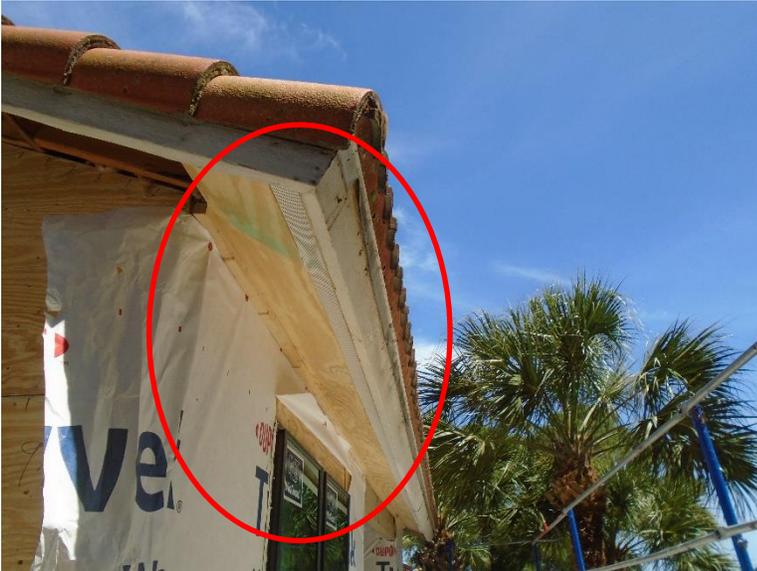
**PHOTOGRAPH #17**

**BUILDING 23  
SECTION E**

New soffit and soffit screen has been installed.

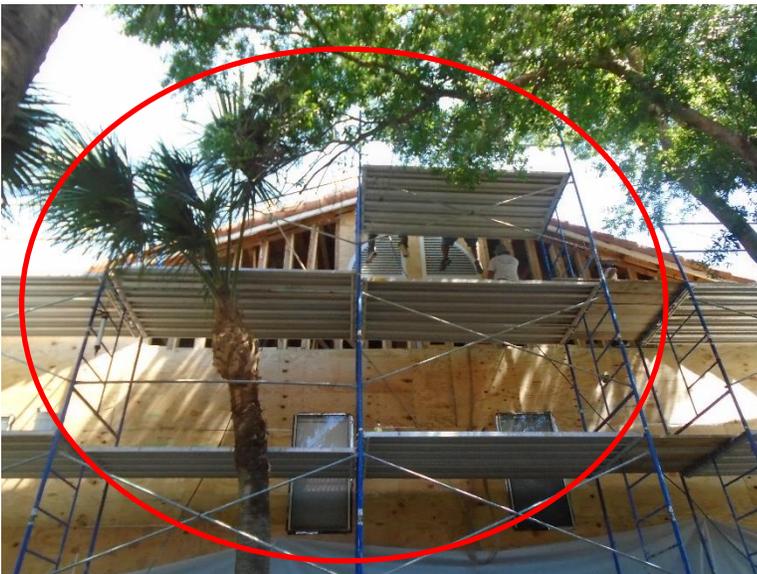
**PHOTOGRAPH #18**

**BUILDING 23  
SECTION D**

Contractor applying new plywood sheathing at gable end.

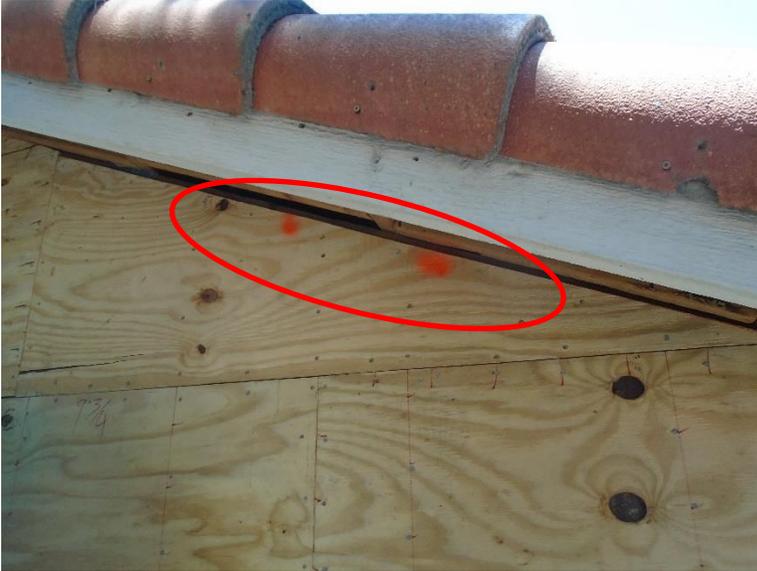
**PHOTOGRAPH #19**

**BUILDING 23  
SECTION D**

Delta marked missing fasteners at new sheathing.

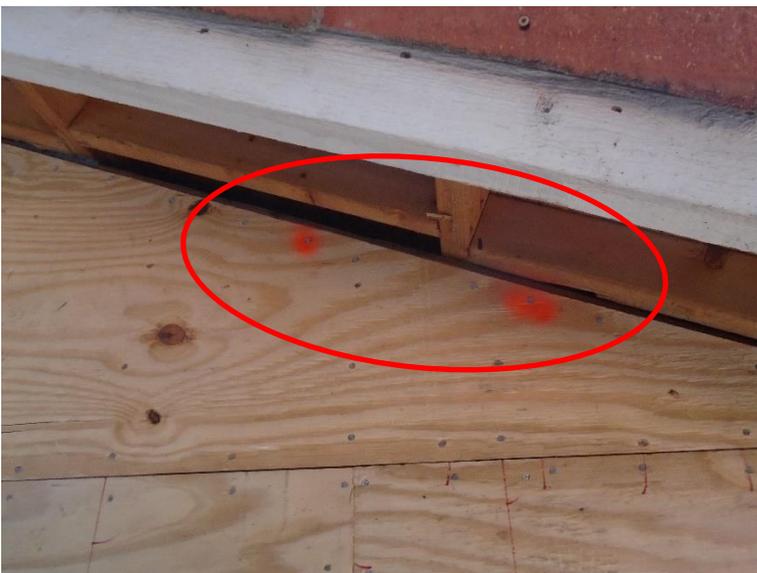
**PHOTOGRAPH #20**

**BUILDING 23  
SECTION D**

Contractor has corrected missing fasteners at plywood sheathing.

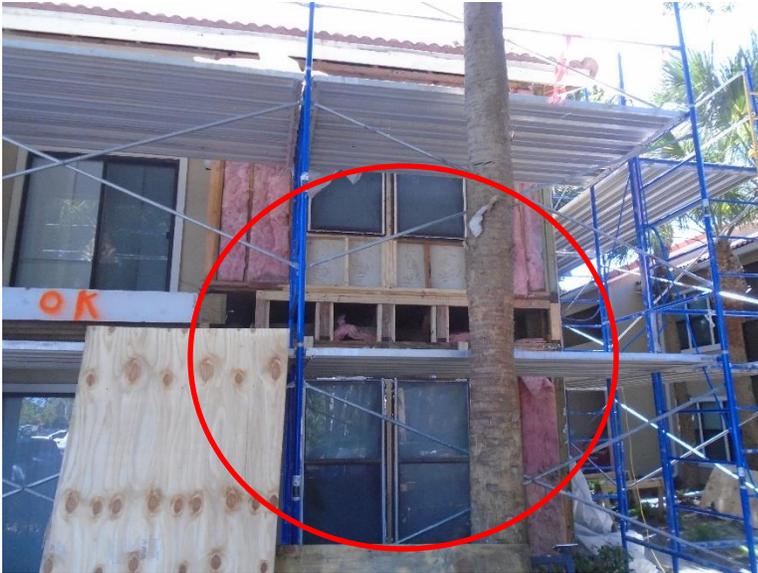
**PHOTOGRAPH #21**

**BUILDING 23  
SECTION C**

Repairs made at framing studs, plates and subflooring.

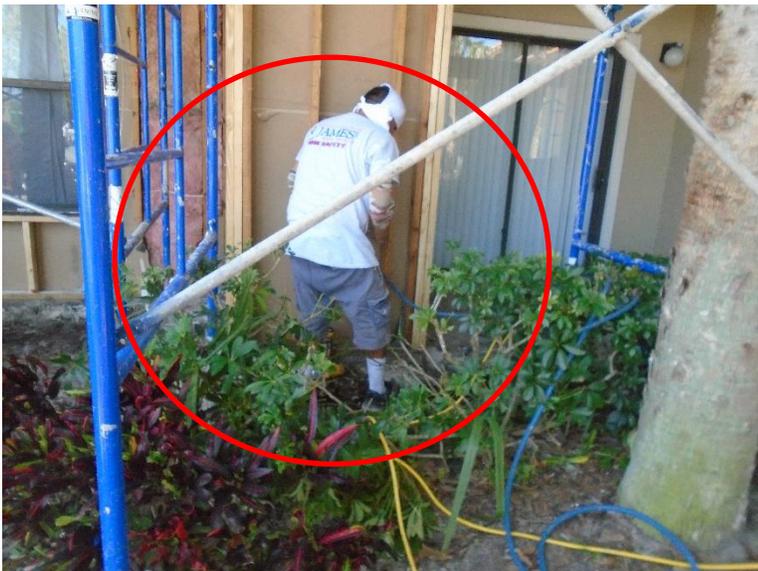
**PHOTOGRAPH #22**

**BUILDING 23  
SECTION C**

Contractor installing Titan anchors at base plate.

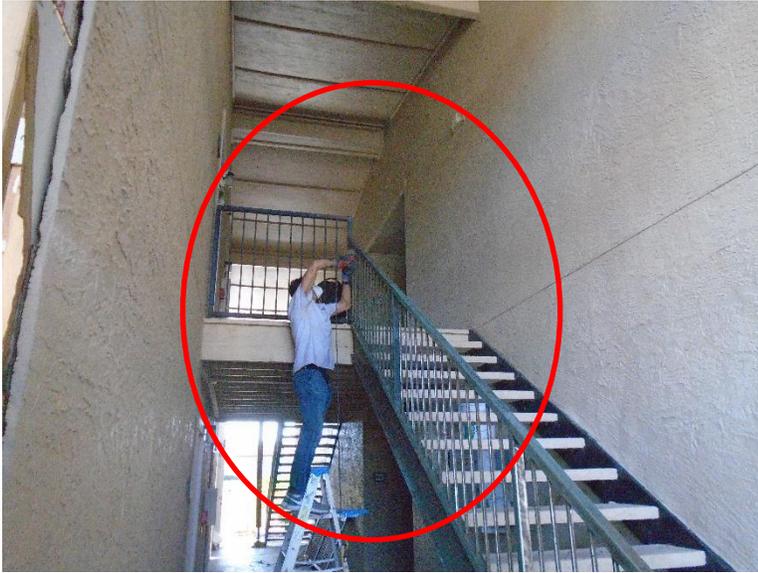
**PHOTOGRAPH #23**

**BUILDING 23  
SECTION C**

Breezeway railings being prepared for priming and painting.

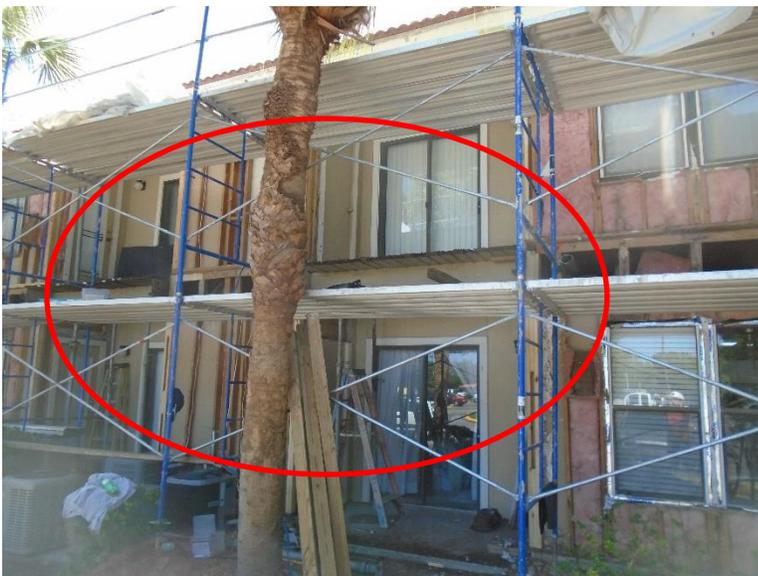
**PHOTOGRAPH #24**

**BUILDING 23  
SECTION B**

Repairs in progress at damaged balcony framing and decks.

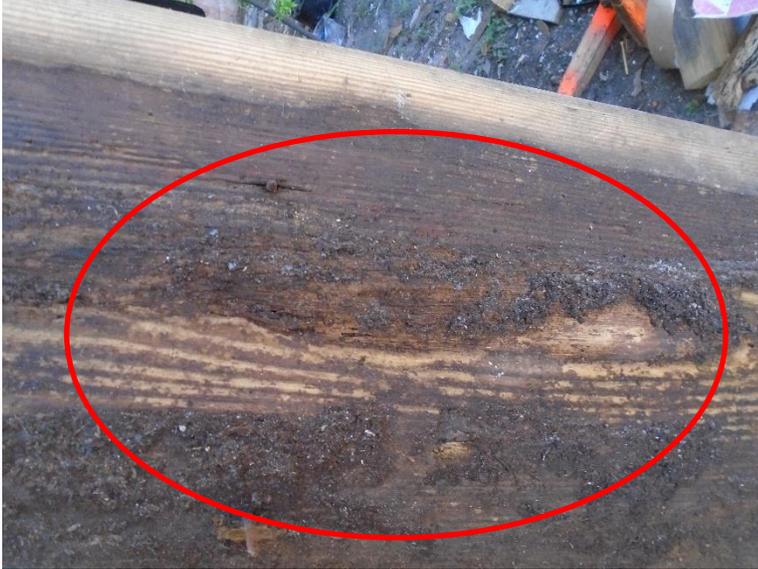
**PHOTOGRAPH #25**

**BUILDING 23  
SECTION B**

Live termites active at damaged balcony edge rim joist.

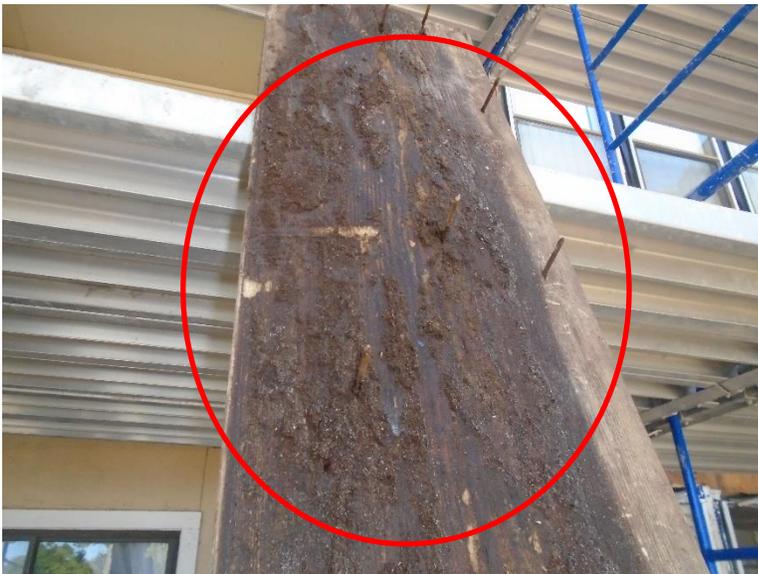
**PHOTOGRAPH #26**

**BUILDING 23  
SECTION B**

Live termites active at damaged balcony edge rim joist.

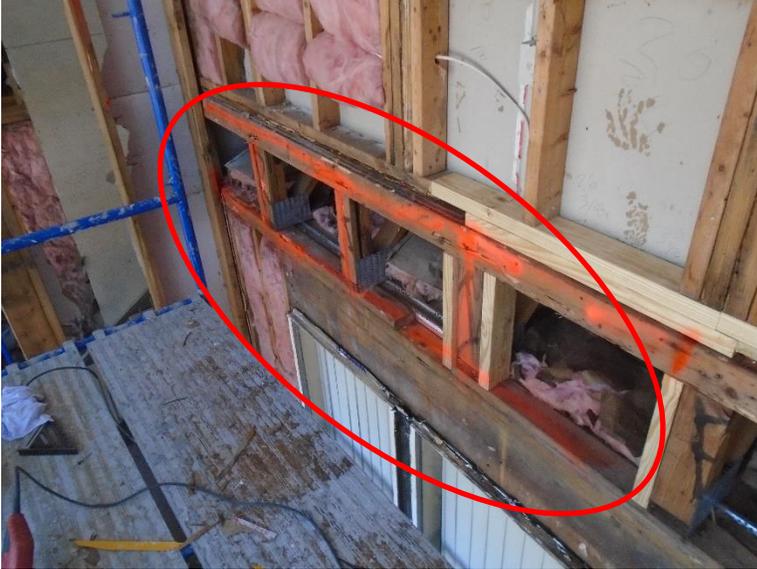
**PHOTOGRAPH #27**

**BUILDING 23  
SECTION B**

Additional damage discovered and marked for repairs by Delta.

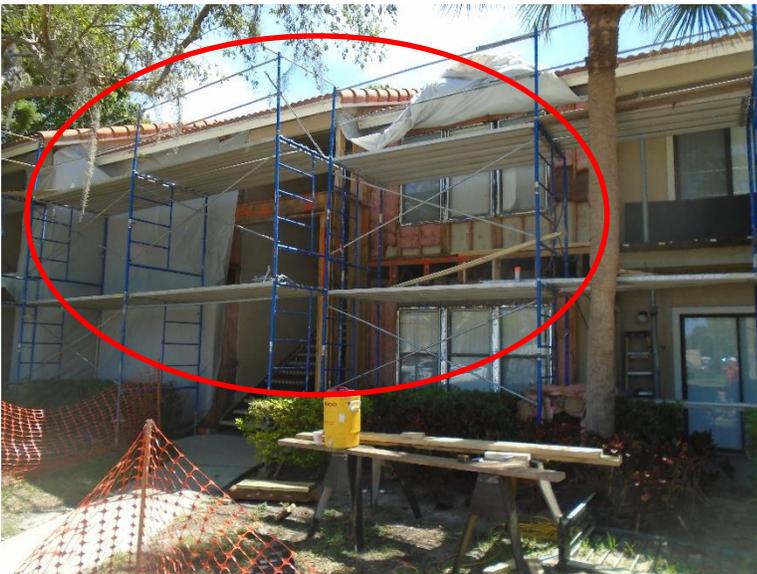
**PHOTOGRAPH #28**

**BUILDING 23  
SECTION B**

Additional damage discovered and marked for repairs by Delta.

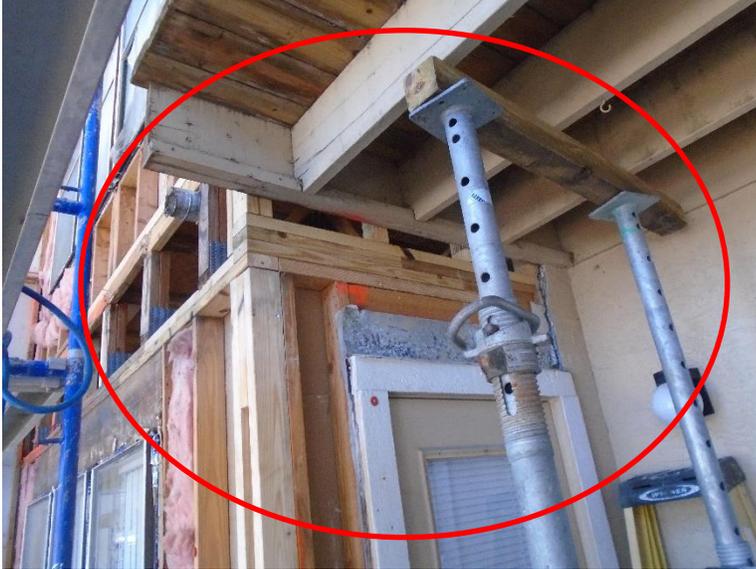
**PHOTOGRAPH #29**

**BUILDING 23  
SECTION B**

Framing and balcony deck repairs in progress.

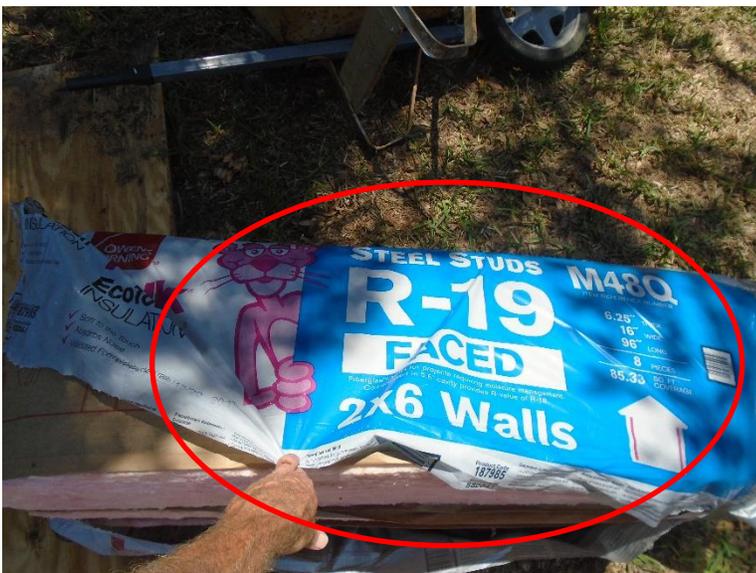
**PHOTOGRAPH #30**

**BUILDING 23  
SECTION B**

R-19 insulation on site for replacement of damaged or missing insulation.

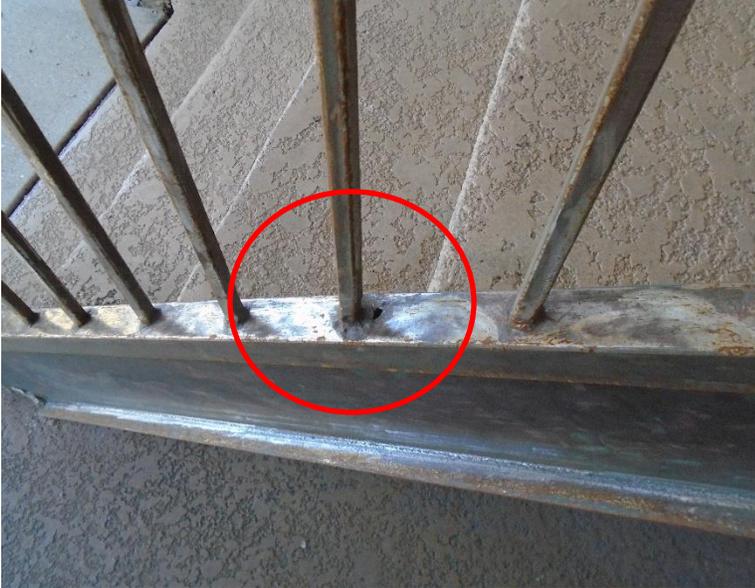
**PHOTOGRAPH #31**

**BUILDING 23  
SECTION A**

Breezeway railing damage will require welding repairs.
