PHOTOGRAPHS

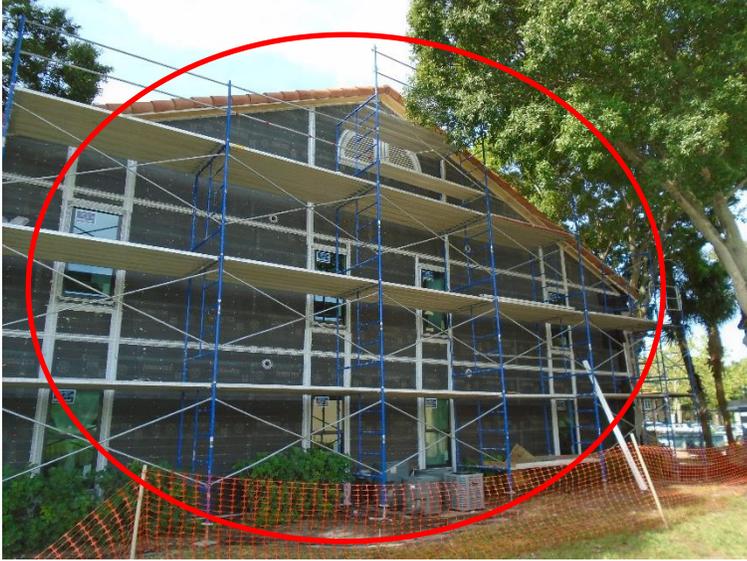
PHOTOGRAPH #1

BUILDING 23 SECTION H

Sub-contractor has applied stucco accessories and metal lathing in accordance with drawings and specifications.

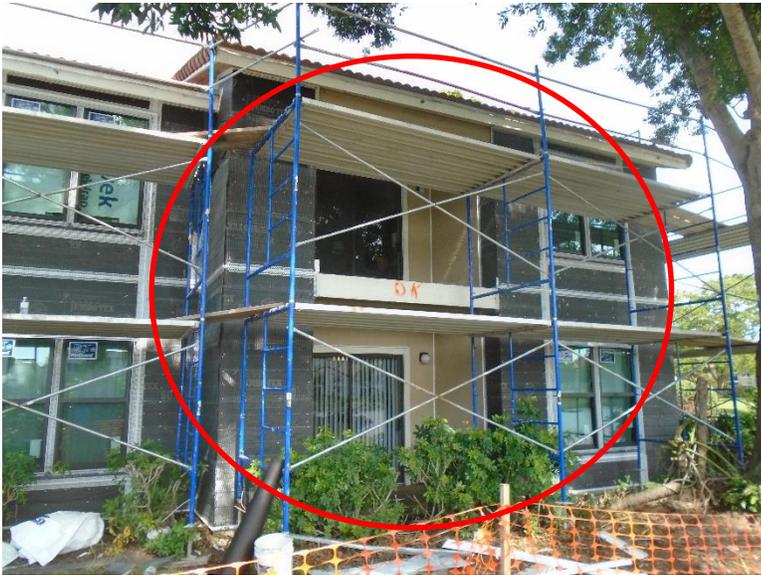
PHOTOGRAPH #2

BUILDING 23 SECTION G

Sub-contractor in process of installing stucco accessories and metal lathing.

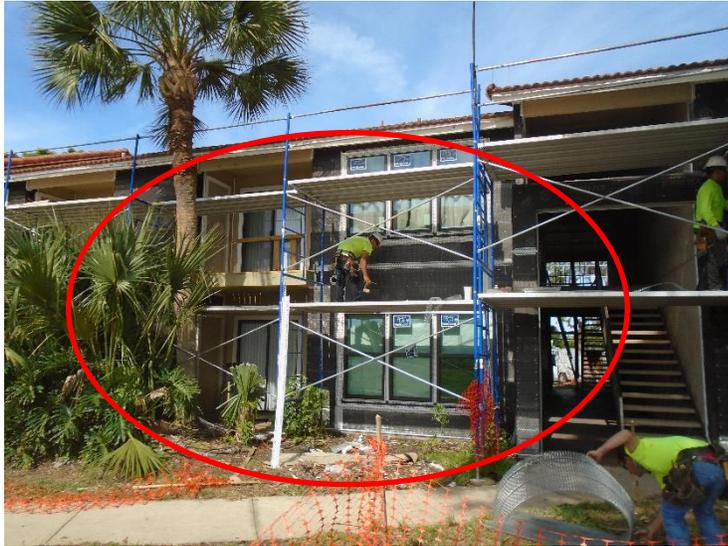
PHOTOGRAPH #3

**BUILDING 23
SECTION F**

Sub-contractor in process of installing stucco accessories and metal lathing.

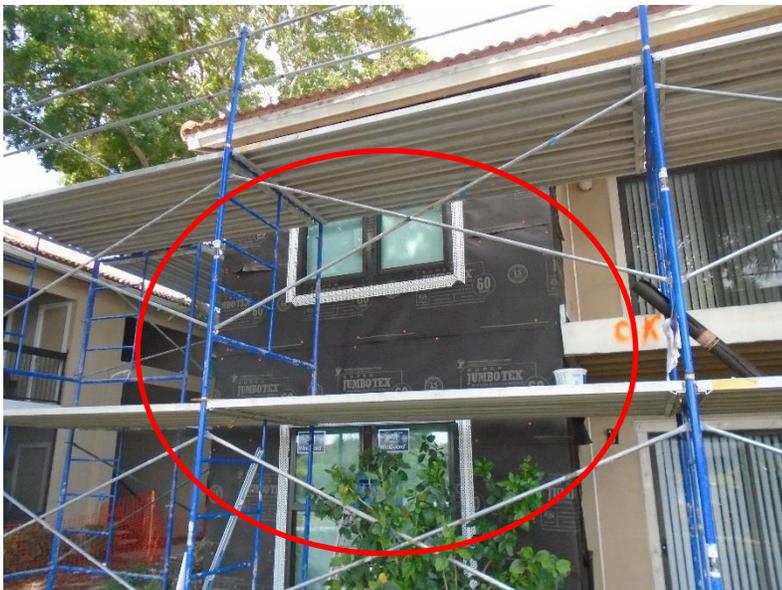
PHOTOGRAPH #4

**BUILDING 23
SECTION E**

Sub-contractor has applied JumboTex water resistant barrier and begun to apply stucco accessories.

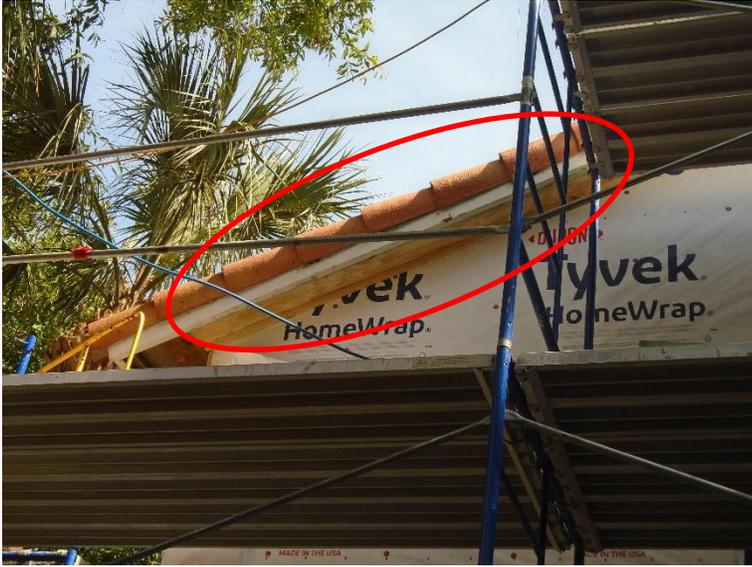
PHOTOGRAPH #5

**BUILDING 23
SECTION D**

New wood soffit and soffit vent has been installed.

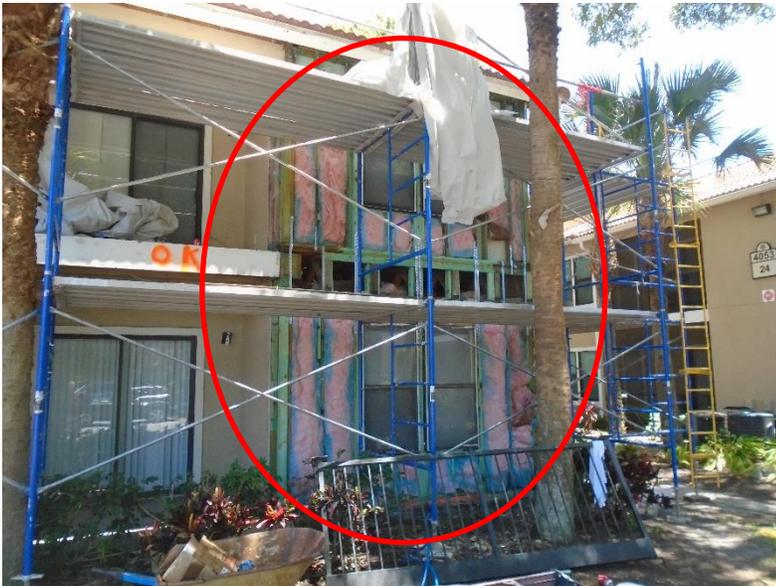
PHOTOGRAPH #6

**BUILDING 23
SECTION C**

New insulation has been installed where required and termite treatment has been applied to framing members.

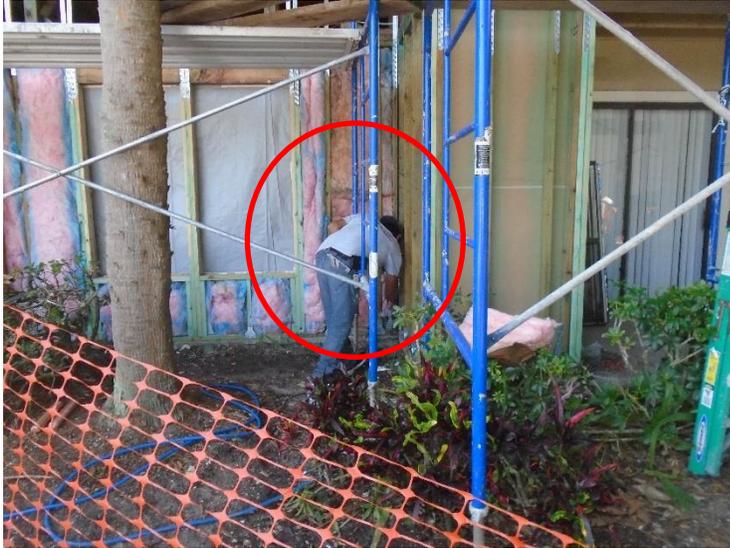
PHOTOGRAPH #7

**BUILDING 23
SECTION C**

Simpson Strong-Tie Titan HD anchors being installed at base plate.

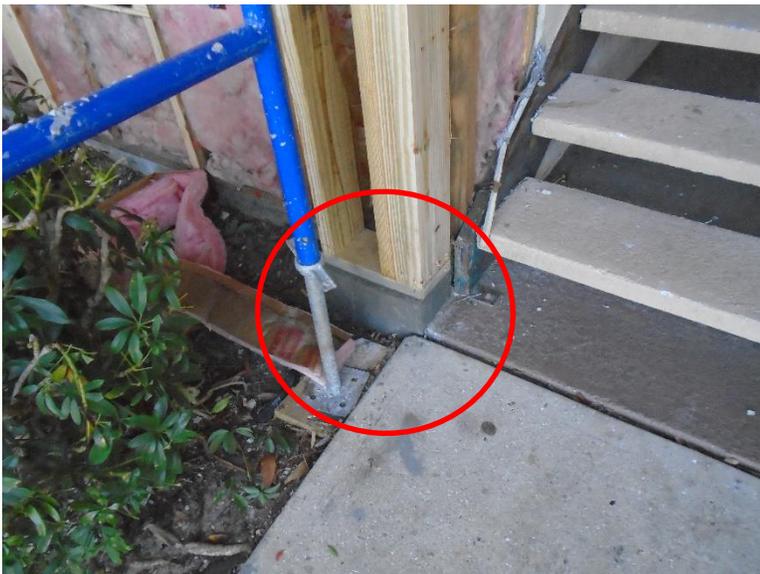
PHOTOGRAPH #8

**BUILDING 23
SECTION C**

Concrete pedestals at breezeway columns have been extended for edge support.

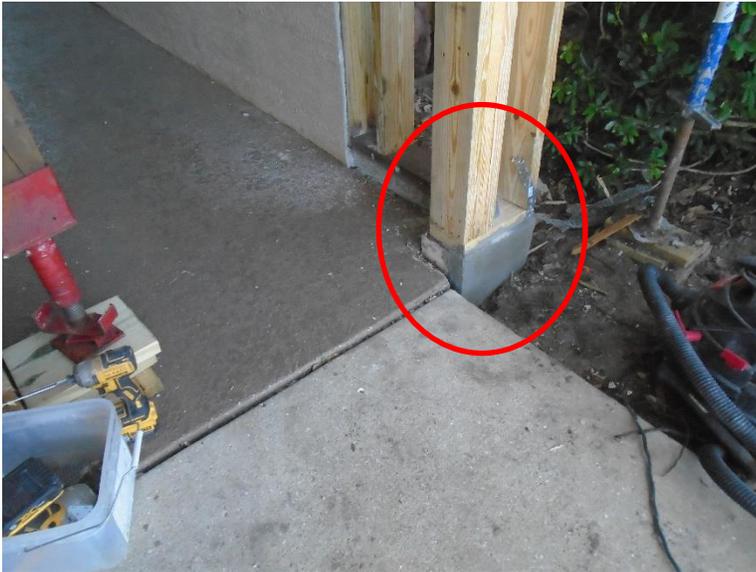
PHOTOGRAPH #9

**BUILDING 23
SECTION C**

Concrete pedestals at breezeway columns have been extended for edge support

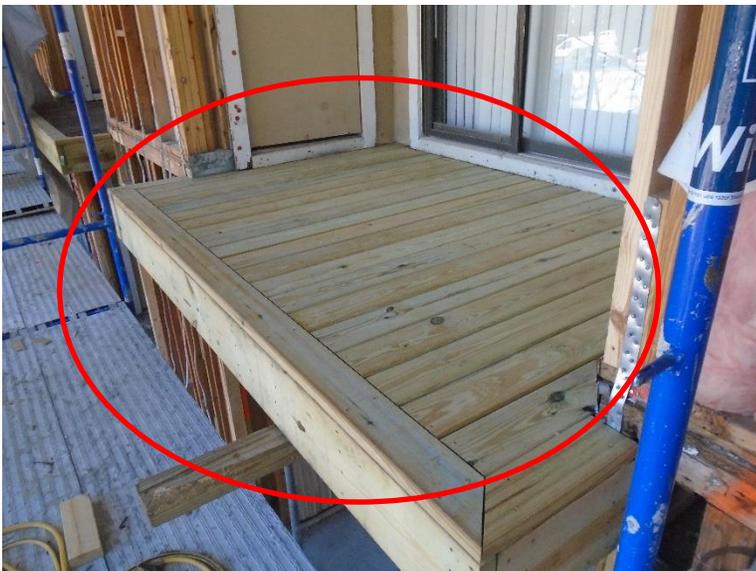
PHOTOGRAPH #10

**BUILDING 23
SECTION B**

Balcony repairs have included full replacement of decking boards at this location.

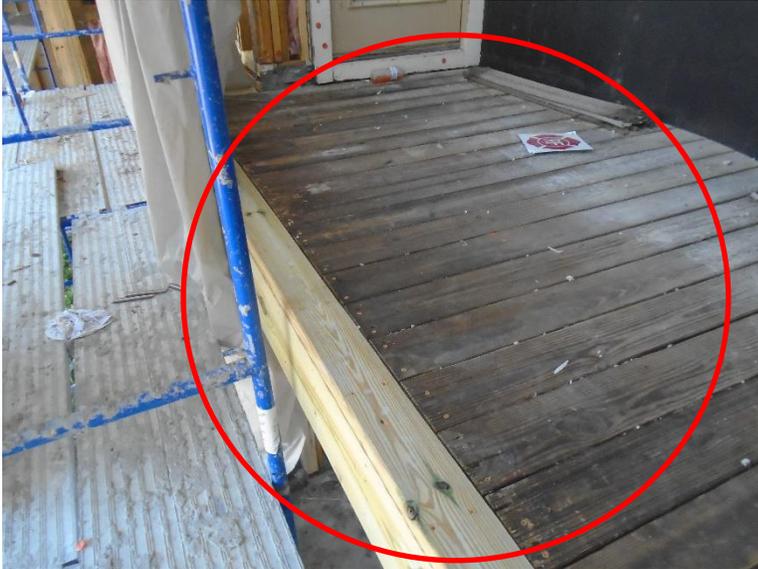
PHOTOGRAPH #11

**BUILDING 23
SECTION B**

Repairs at this balcony did not require full deck board replacement.

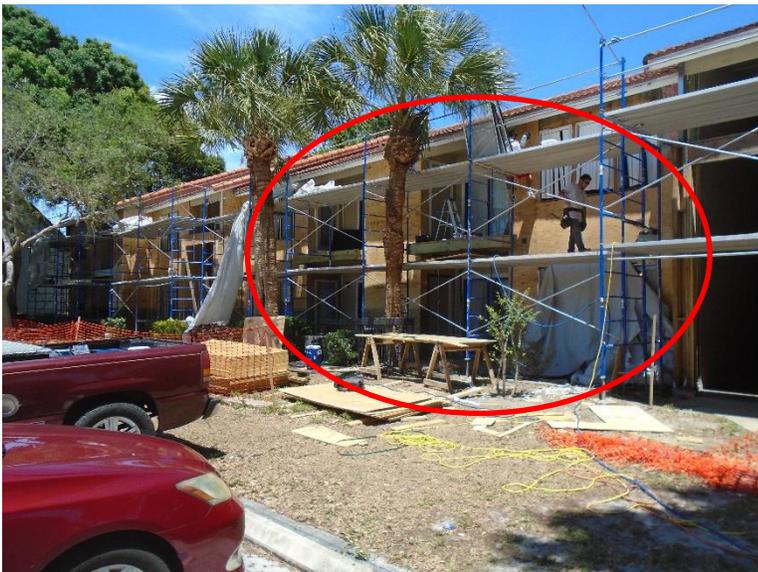
PHOTOGRAPH #12

**BUILDING 23
SECTION B**

Contractor in process of installing new 15/32" plywood sheathing.

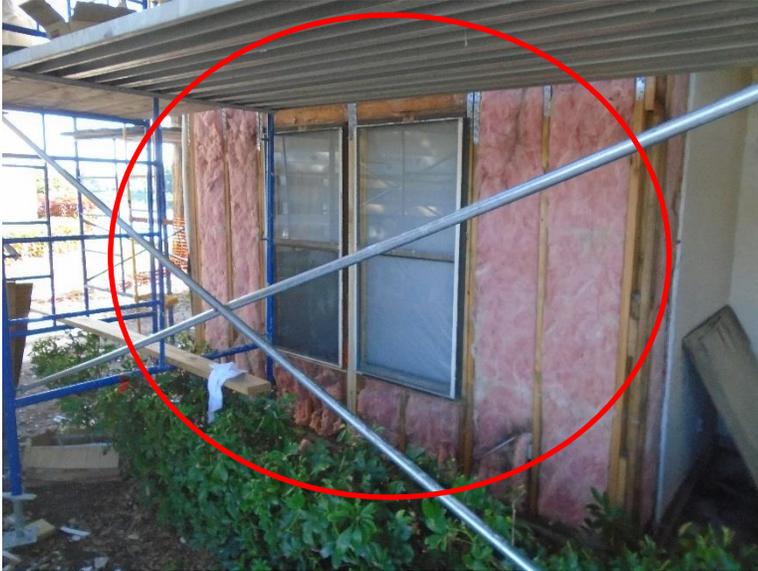
PHOTOGRAPH #13

**BUILDING 23
SECTION A**

New insulation has been installed where required.

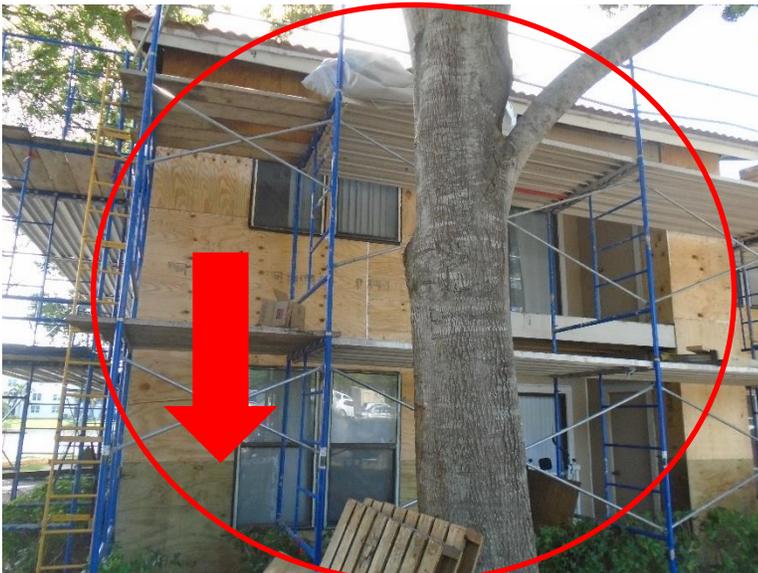
PHOTOGRAPH #14

**BUILDING 23
SECTION A**

New plywood sheathing has been provided with PT plywood used at lower first row of sheathing.

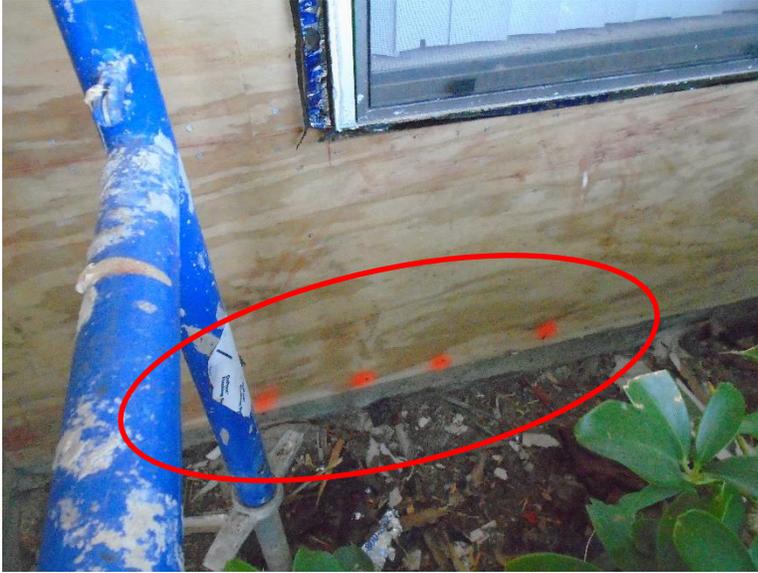
PHOTOGRAPH #15

**BUILDING 23
SECTION A**

Contractor has made fastening corrections at plywood where marked by Delta.

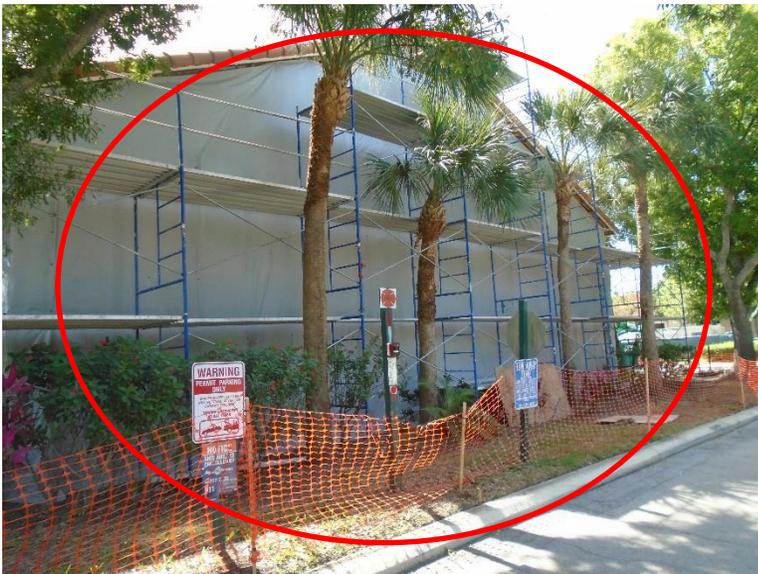
PHOTOGRAPH #16

**BUILDING 21
SECTION H**

Contractor has provided plastic sheathing protection where existing stucco and sheathing has been removed at gable end wall.

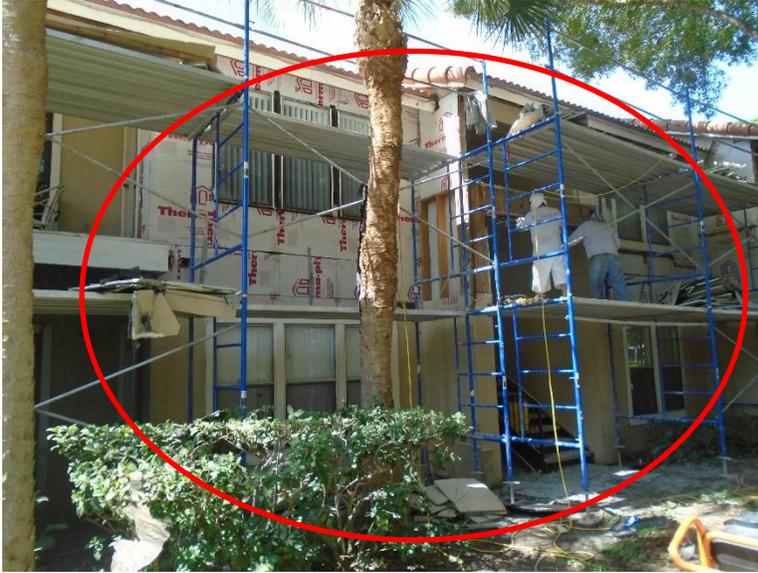
PHOTOGRAPH #17

**BUILDING 21
SECTION G**

Contractor in process of removal of existing stucco wall, wood trim and sheathing.
