PHOTOGRAPHS

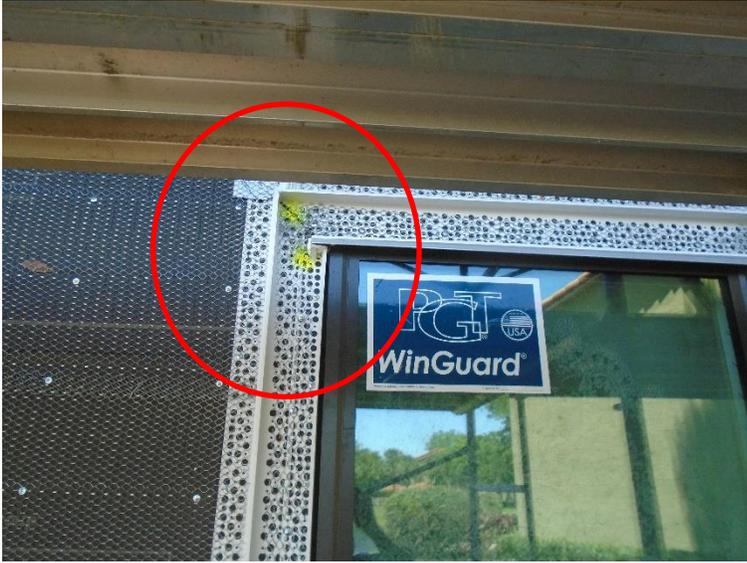
PHOTOGRAPH #1

BUILDING 23 SECTION H

Sub-contractor has made corrections marked by Delta where sealant is required.

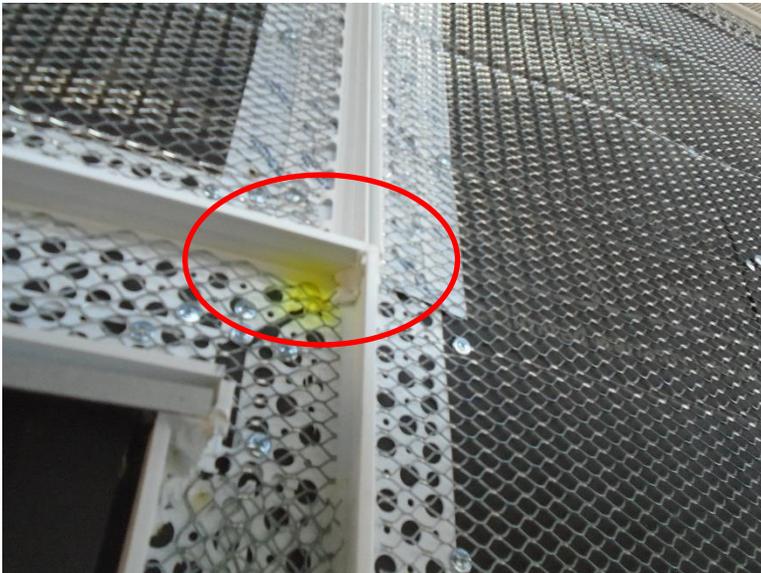
PHOTOGRAPH #2

BUILDING 23 SECTION G

Sub-contractor has made corrections marked by Delta where sealant is required.

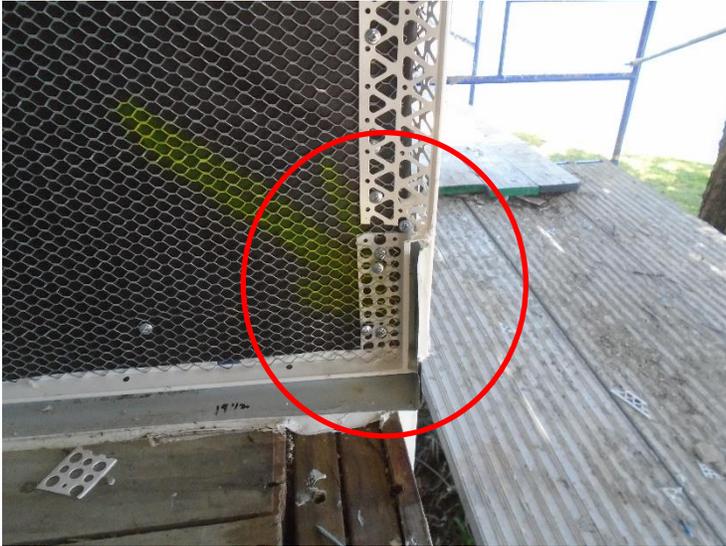
PHOTOGRAPH #3

**BUILDING 23
SECTION G**

Sub-contractor has made corrections at new stucco accessories to kick out balcony flashing as marked by Delta.

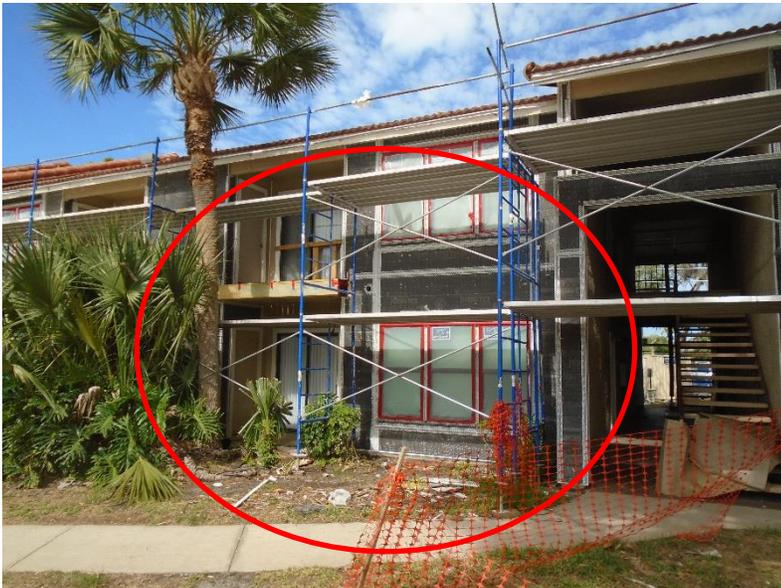
PHOTOGRAPH #4

**BUILDING 23
SECTION F**

Sub-contractor has applied plastic protection at windows and balcony surfaces in preparation for stucco application.

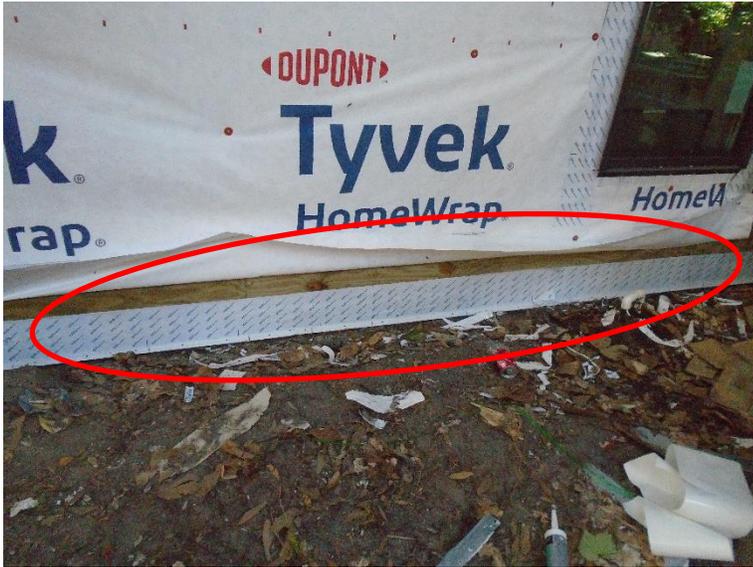
PHOTOGRAPH #5

**BUILDING 23
SECTION D**

New stucco stop weep screed has been flashed with Dupont straight flash to the new plywood sheathing.

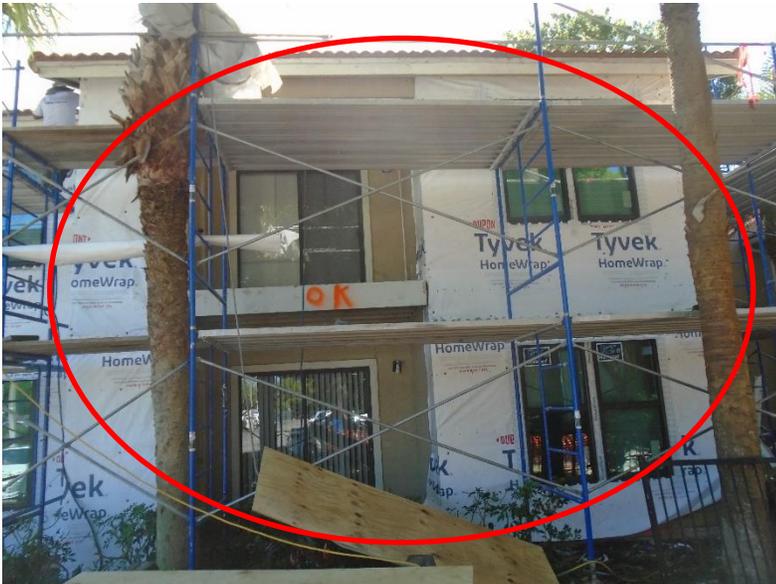
PHOTOGRAPH #6

**BUILDING 23
SECTION C**

Tyvek HomeWrap, Dupont flashings and new PGT windows have been installed.

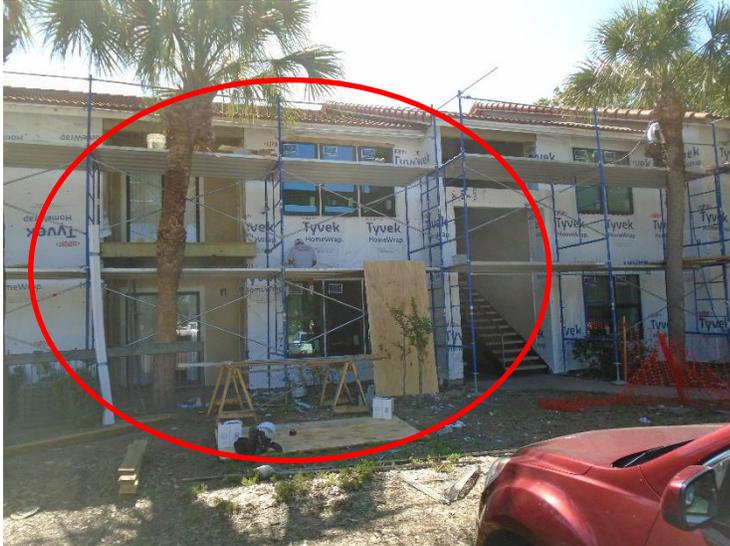
PHOTOGRAPH #7

**BUILDING 23
SECTION B**

Tyvek HomeWrap, Dupont flashings and new PGT windows have been installed.

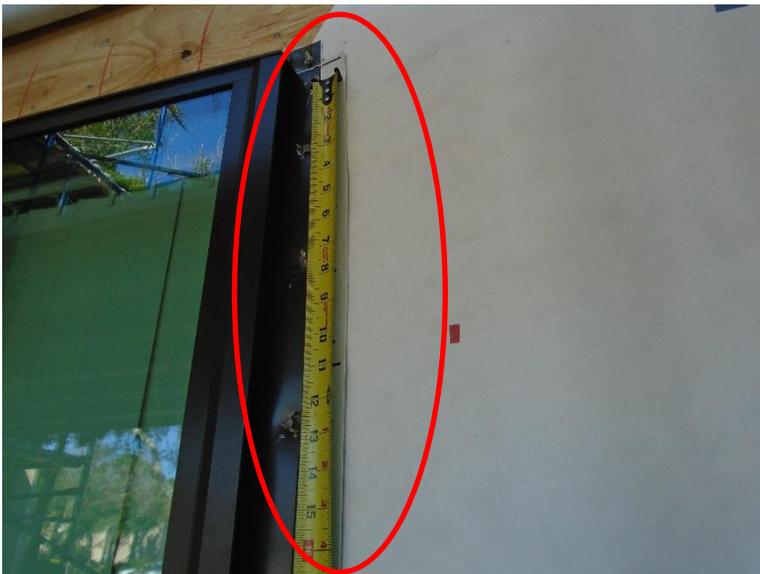
PHOTOGRAPH #8

**BUILDING 23
SECTION A**

New PGT window fin fastening confirmed at proper distance per manufacturers NOAs.

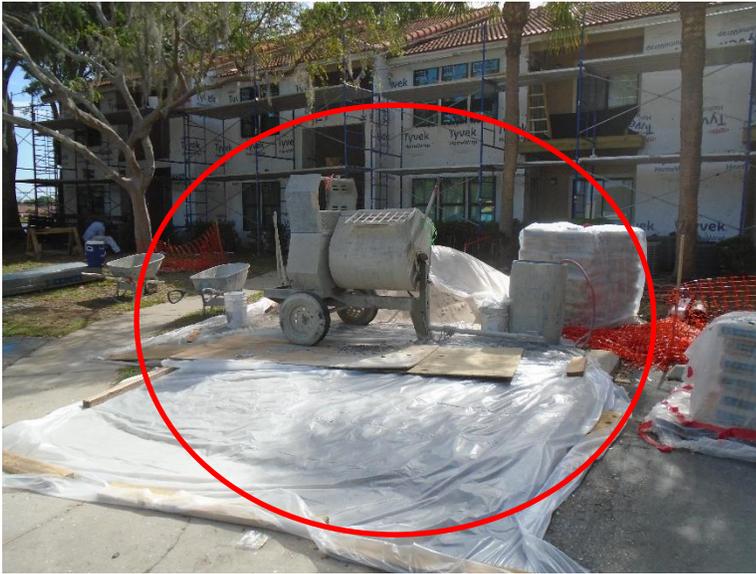
PHOTOGRAPH #9

**BUILDING 23
SECTION A**

Stucco contractor has set up for mixing stucco.

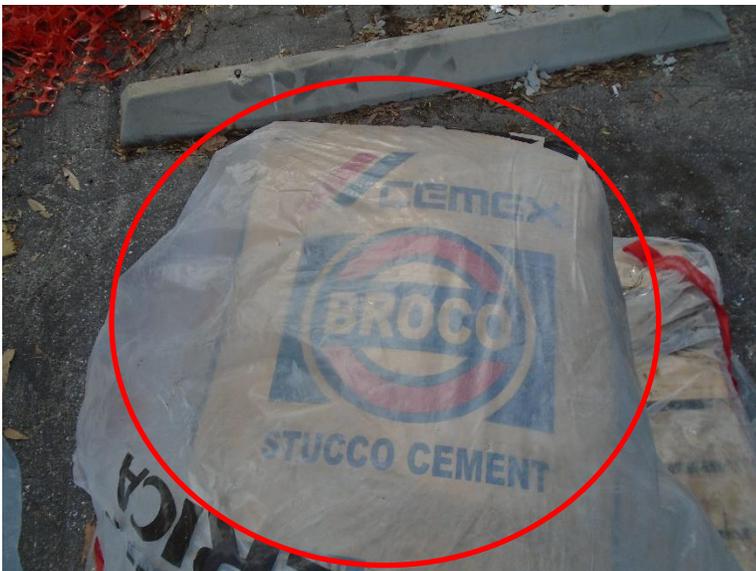
PHOTOGRAPH #10

**BUILDING 23
SECTION A**

BROCO Stucco bag mix approved for application.

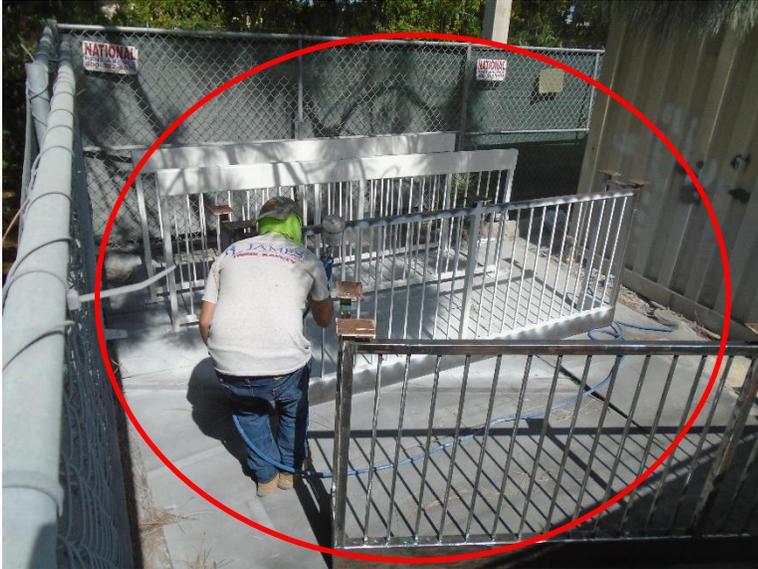
PHOTOGRAPH #11

**BUILDING 23
STORAGE AREA**

Contractor spray priming balcony railings with Florida Paints Encapsulant epoxy mastic primer.

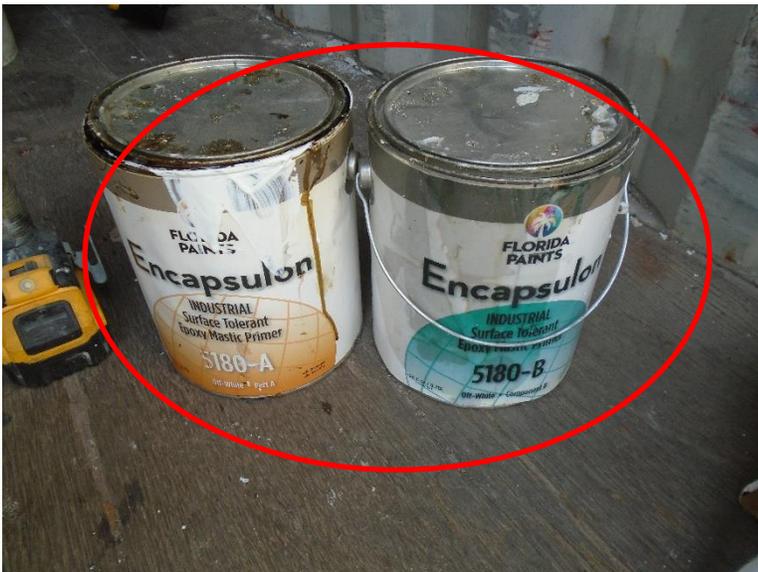
PHOTOGRAPH #12

**BUILDING 23
STORAGE AREA**

Contractor spray priming balcony railings with Florida Paints Encapsulant epoxy mastic primer.

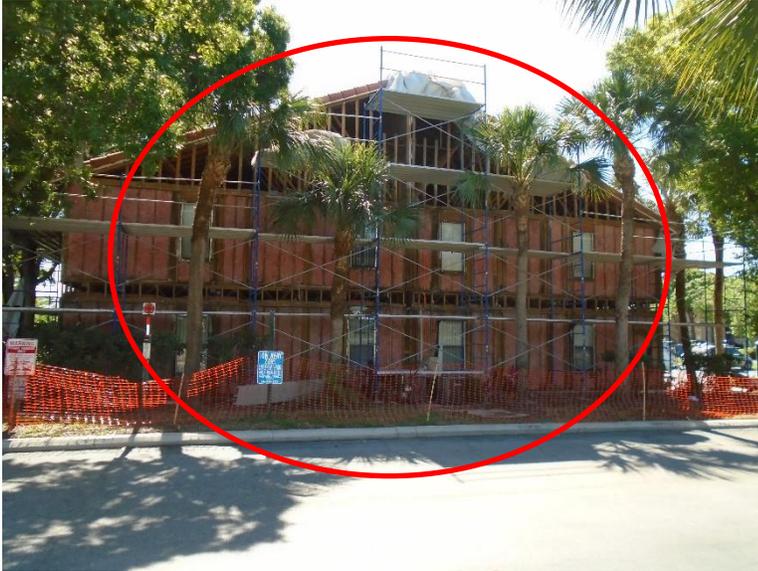
PHOTOGRAPH #13

**BUILDING 21
SECTION H**

Delta has inspected and marked damaged framing for repairs.

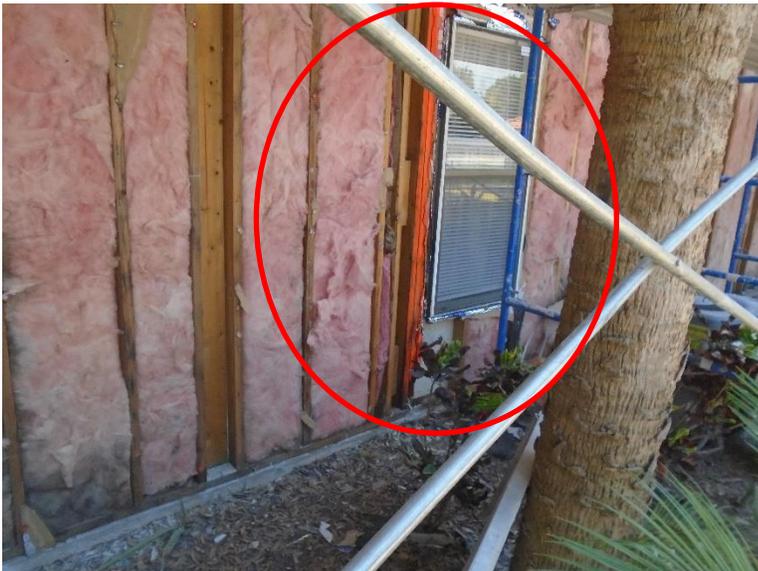
PHOTOGRAPH #14

**BUILDING 21
SECTION H**

Delta has inspected and marked damaged framing for repairs.

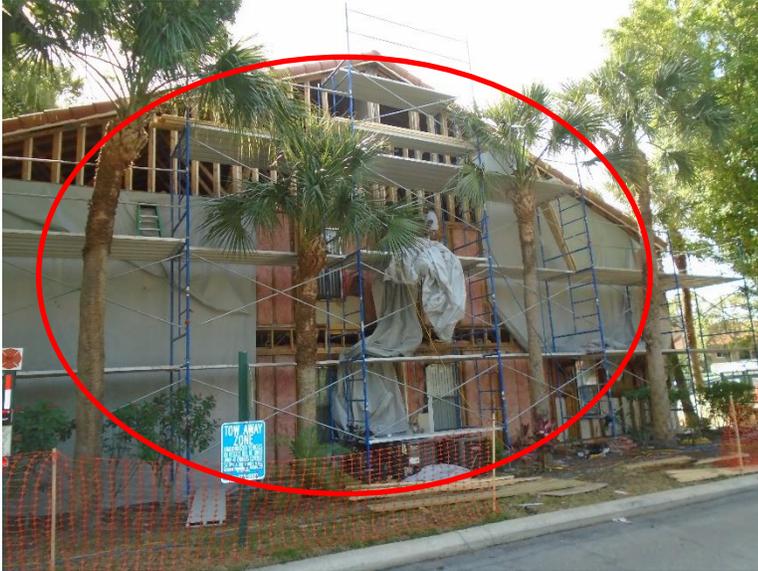
PHOTOGRAPH #15

**BUILDING 21
SECTION H**

Contractor performing damage repairs marked at framing and gable end reinforcement repairs.

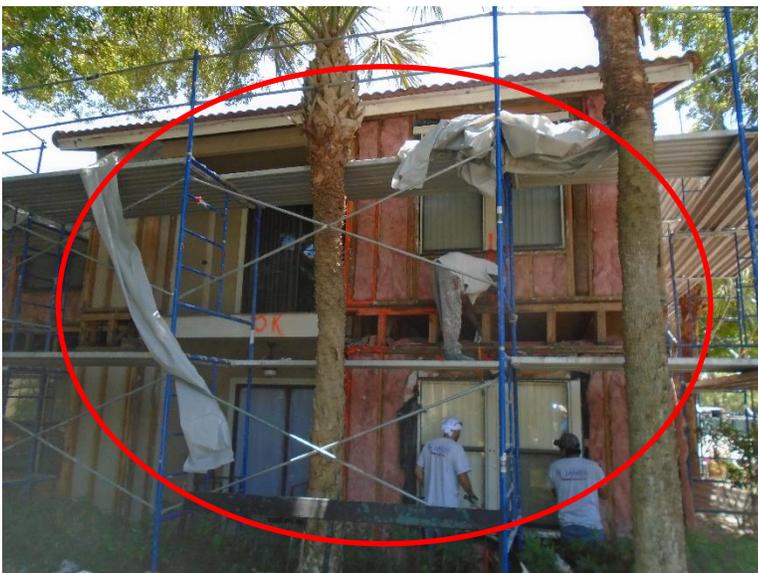
PHOTOGRAPH #16

**BUILDING 21
SECTION G**

Delta has inspected and marked damaged framing for repairs.

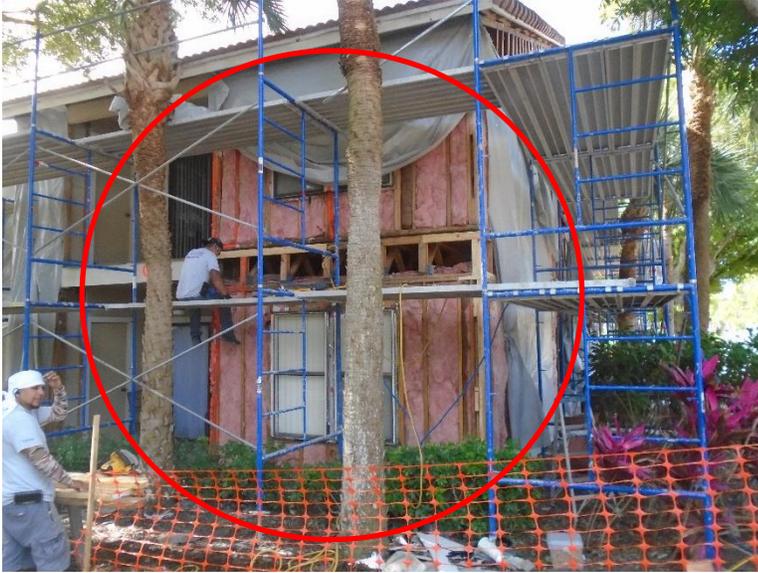
PHOTOGRAPH #17

**BUILDING 21
SECTION G**

Contractor performing damaged framing repairs.

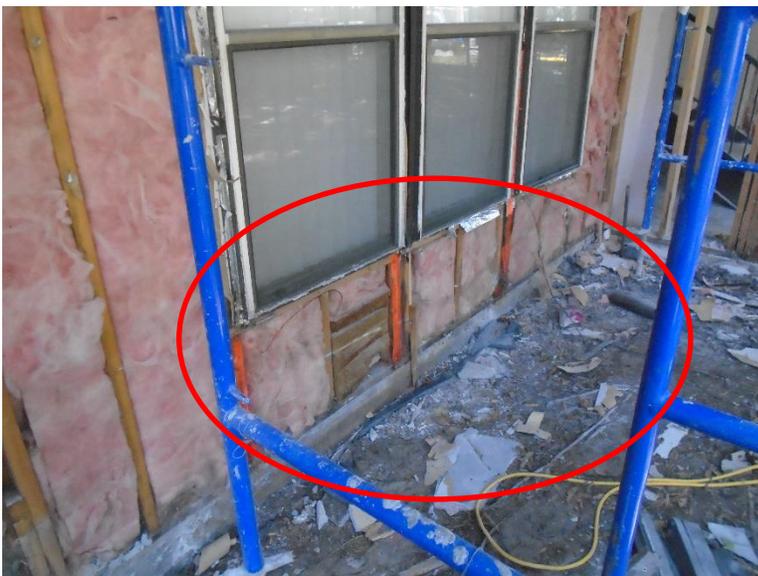
PHOTOGRAPH #18

**BUILDING 21
SECTION F**

Delta has inspected and marked damaged framing for repairs

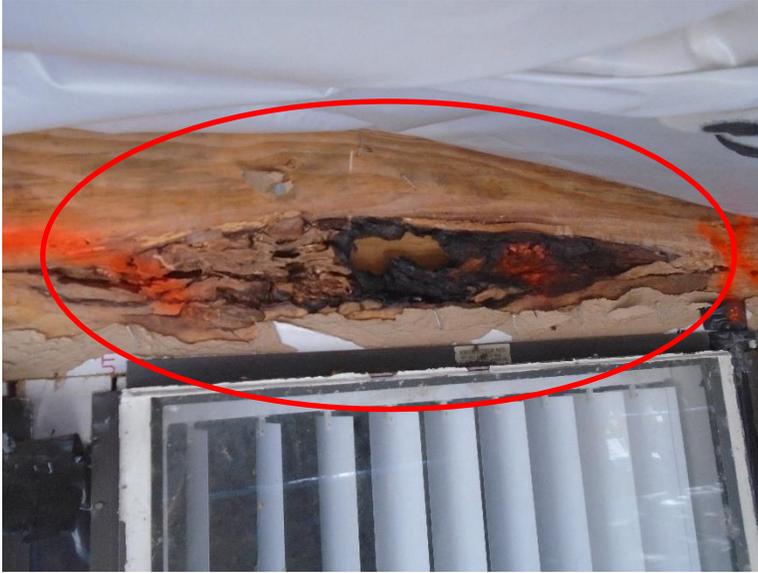
PHOTOGRAPH #19

**BUILDING 21
SECTION F**

Delta has inspected and marked damaged window headers for repairs.

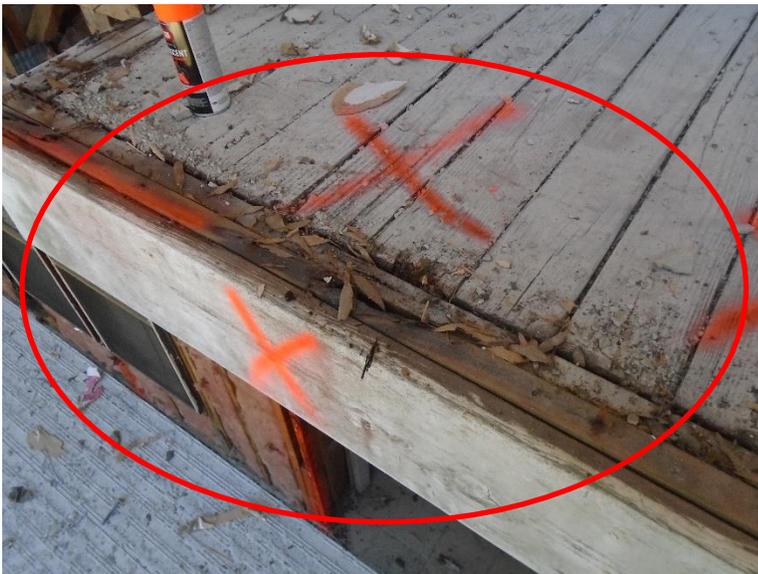
PHOTOGRAPH #20

**BUILDING 21
SECTION F**

Delta has inspected and marked damaged deck framing and decking for repairs and replacement.

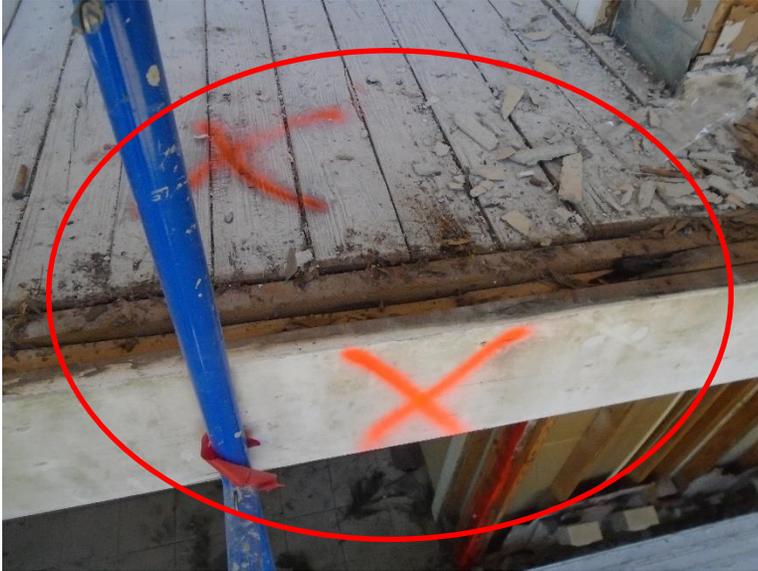
PHOTOGRAPH #21

**BUILDING 21
SECTION F**

Delta has inspected and marked damaged deck framing and decking for repairs and replacement.

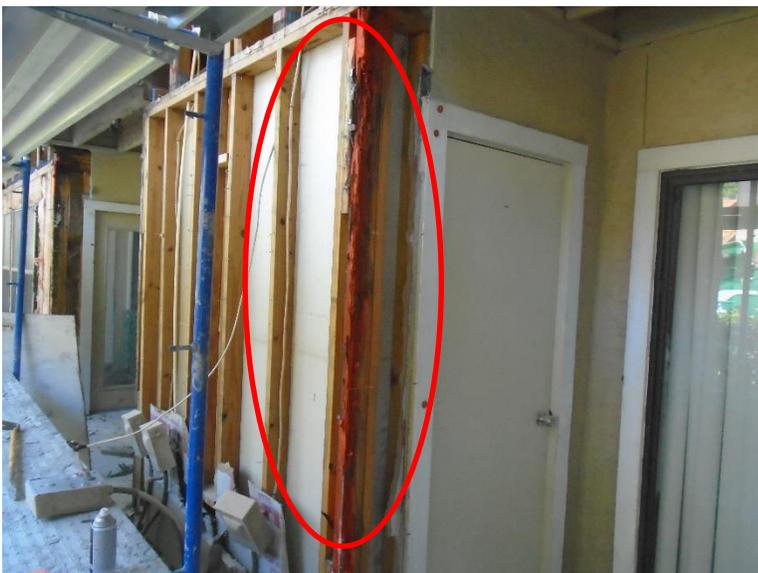
PHOTOGRAPH #22

**BUILDING 21
SECTION F**

Delta has inspected and marked damaged framing for repairs.

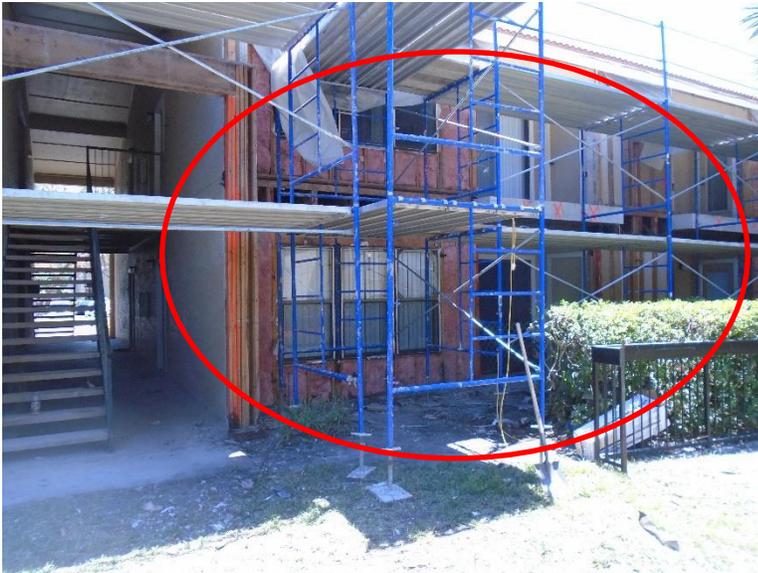
PHOTOGRAPH #23

**BUILDING 21
SECTION F**

Delta has inspected and marked damaged framing for repairs.

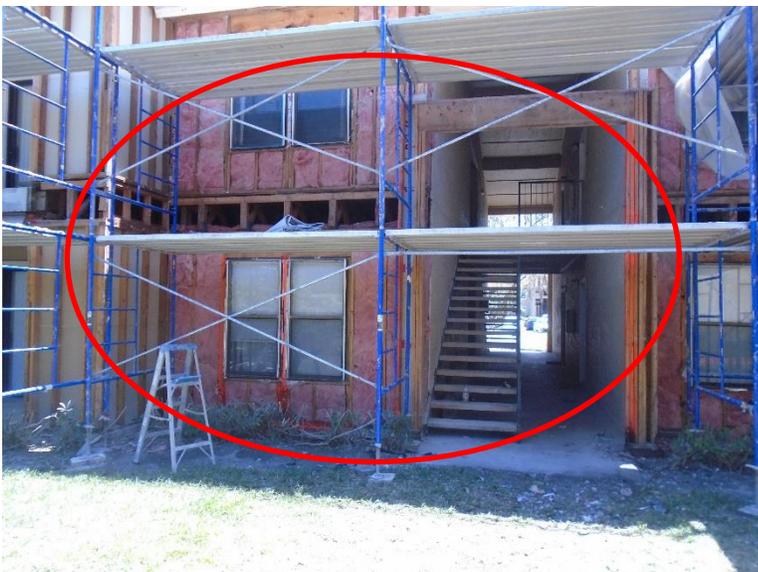
PHOTOGRAPH #24

**BUILDING 21
SECTION E**

Delta has inspected and marked damaged framing for repairs.

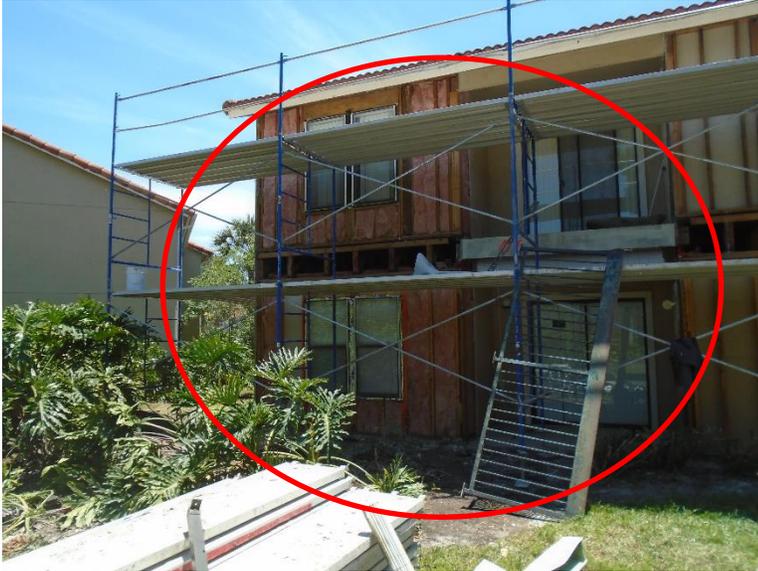
PHOTOGRAPH #25

**BUILDING 21
SECTION E**

Delta has inspected and marked damaged framing for repairs.
