**PHOTOGRAPHS**

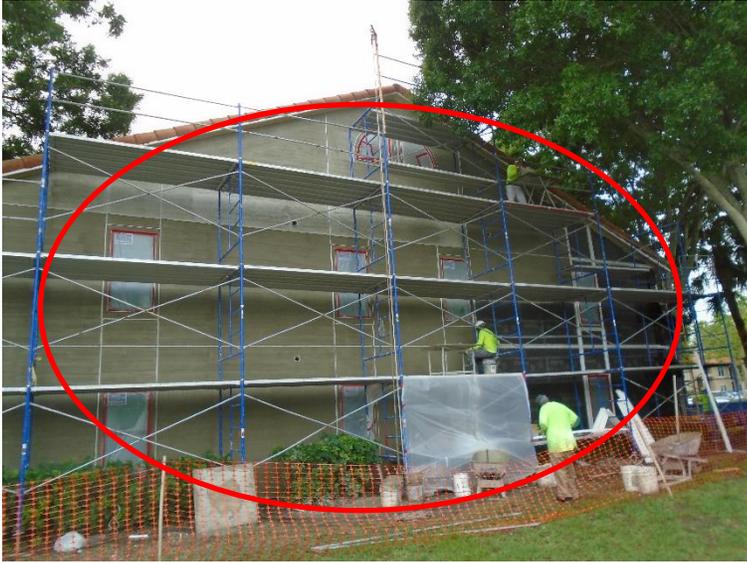
**PHOTOGRAPH #1**

**BUILDING 23  
SECTION H**

Stucco Sub-contractor applying scratch coat of stucco.

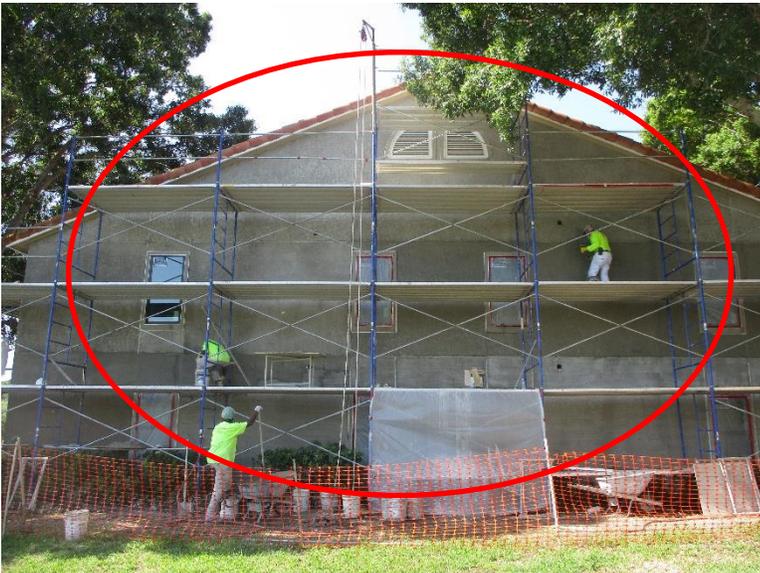
**PHOTOGRAPH #2**

**BUILDING 23  
SECTION H**

Stucco Sub-contractor applying brown coat of stucco.

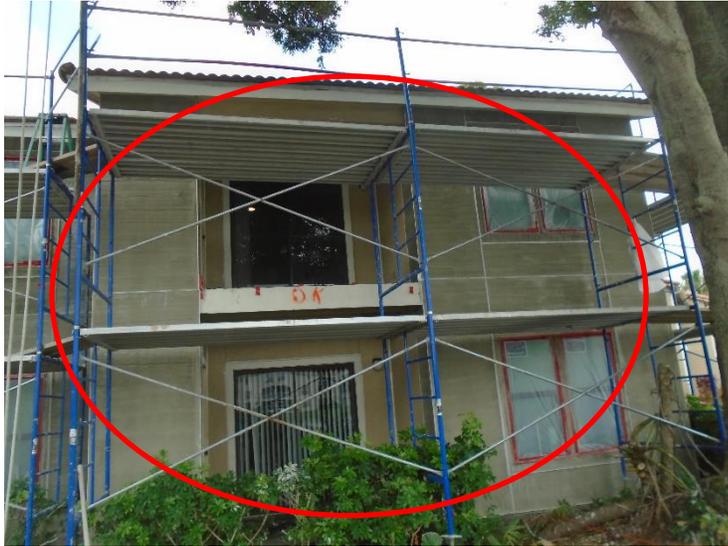
**PHOTOGRAPH #3**

**BUILDING 23  
SECTION G**

Stucco Sub-contractor has applied  
scratch coat of stucco.

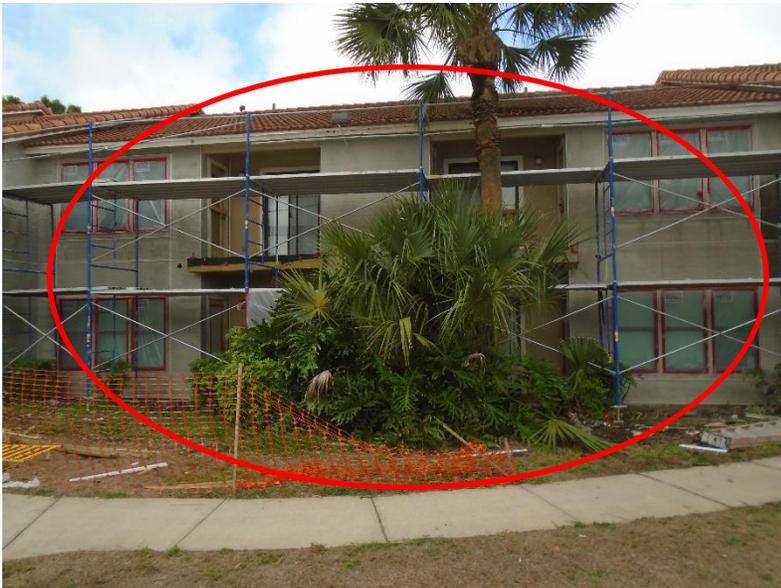
**PHOTOGRAPH #4**

**BUILDING 23  
SECTION F**

Stucco Sub-contractor has applied  
scratch coat of stucco.

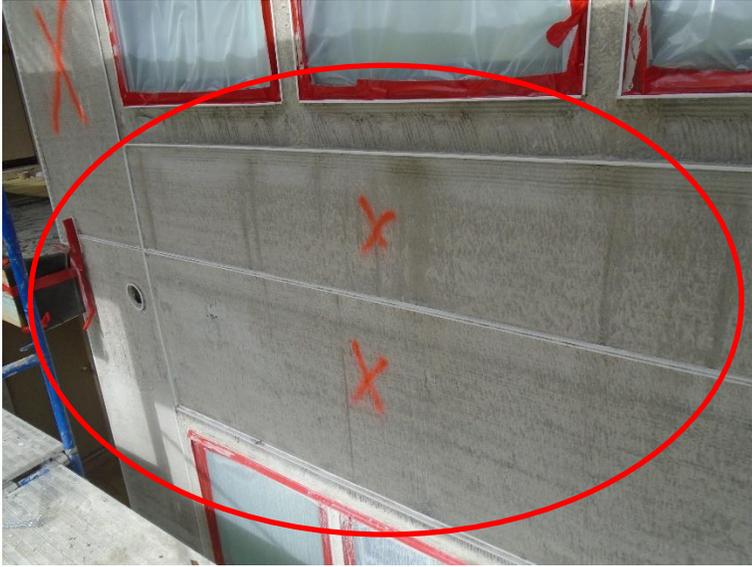
**PHOTOGRAPH #5**

**BUILDING 23  
SECTION F**

Scratch coat of stucco washed out in this section and will require corrections.

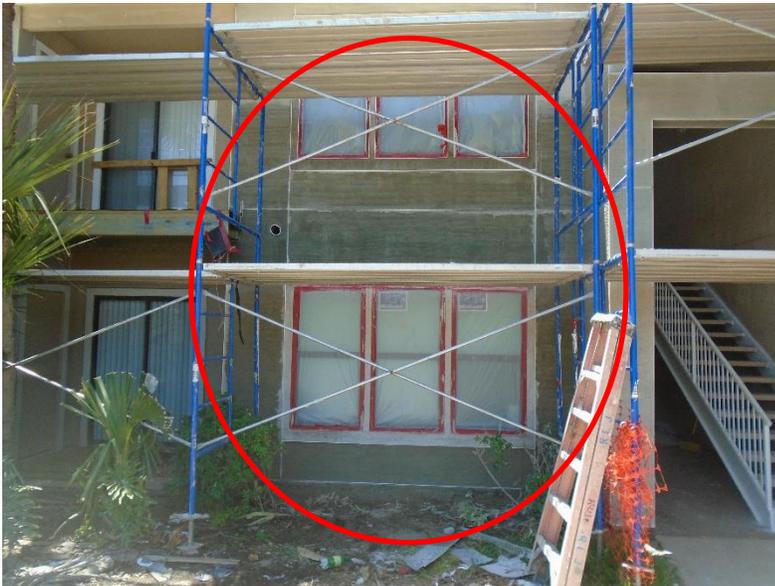
**PHOTOGRAPH #6**

**BUILDING 23  
SECTION F**

Stucco Sub – contractor has corrected section of washed out scratch coat as directed.

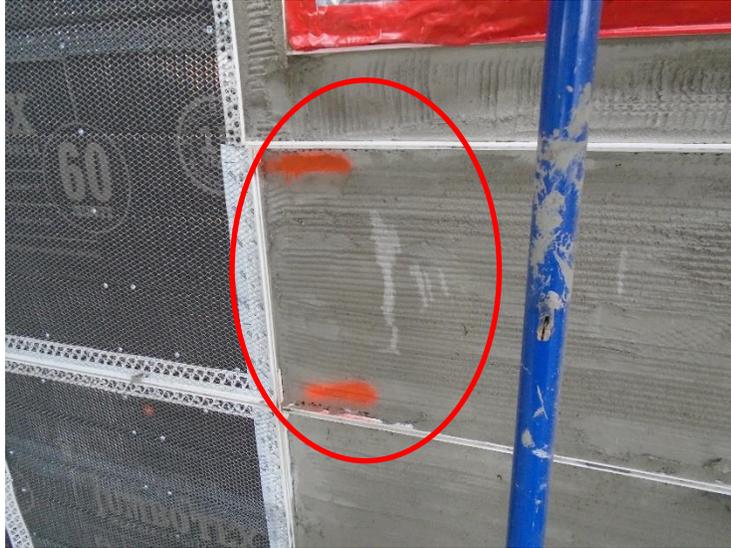
**PHOTOGRAPH #7**

**BUILDING 23  
SECTION E**

Voids at the accessories and lath will require corrections as marked by Delta.

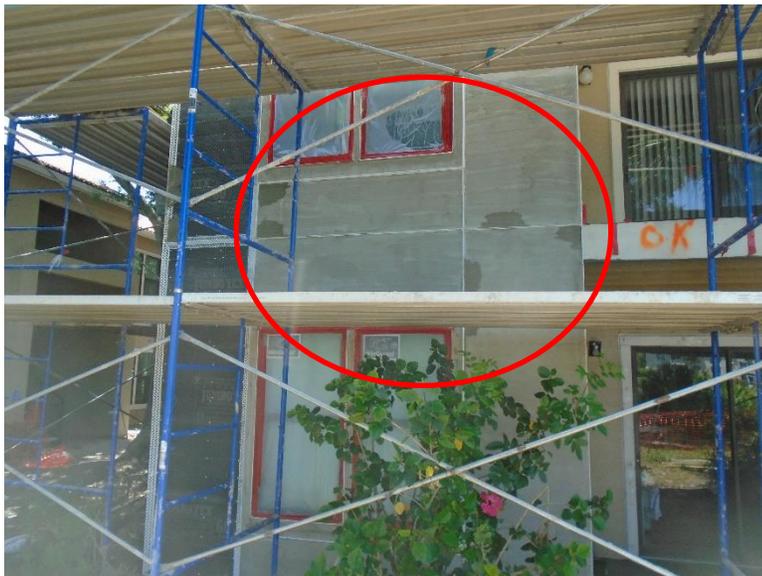
**PHOTOGRAPH #8**

**BUILDING 23  
SECTION E**

Stucco Sub – contractor has corrected areas of voids as directed by Delta.

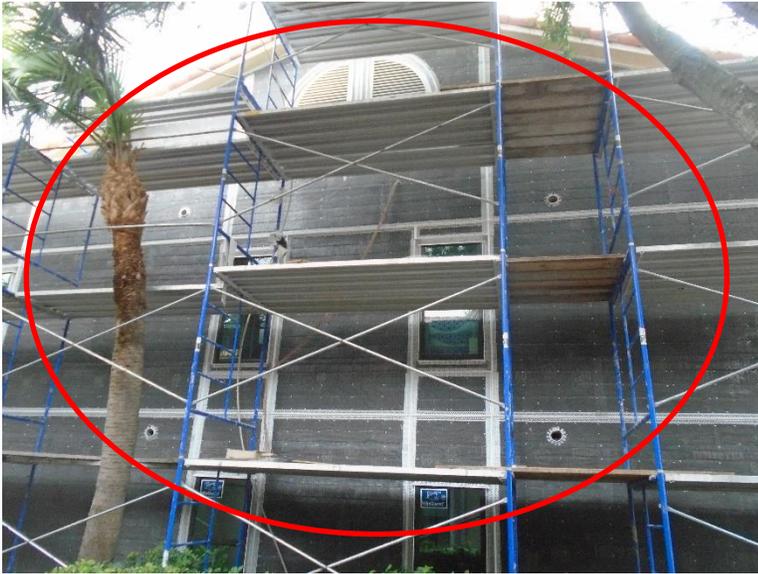
**PHOTOGRAPH #9**

**BUILDING 23  
SECTION D**

Stucco contractor applied stucco accessories and metal lathing in preparation for stucco applications.

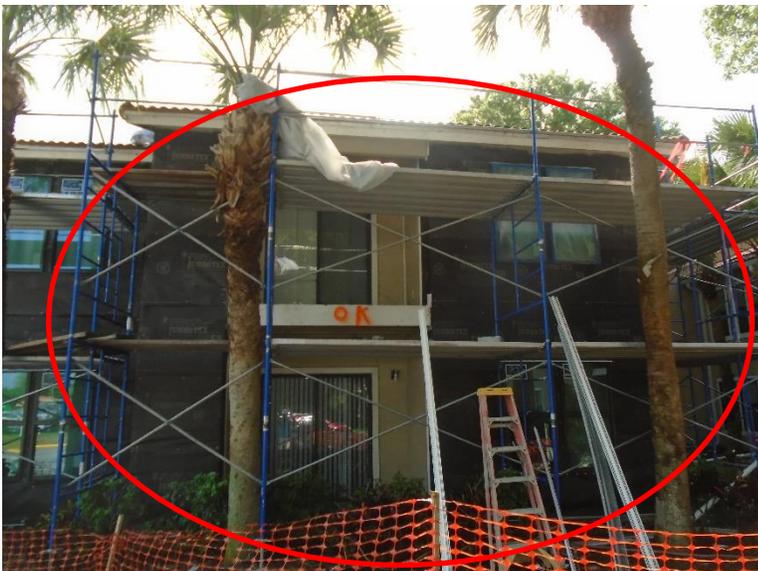
**PHOTOGRAPH #10**

**BUILDING 23  
SECTION C**

JumboTex Water Resistant Barrier in place and stucco accessory applications in progress.

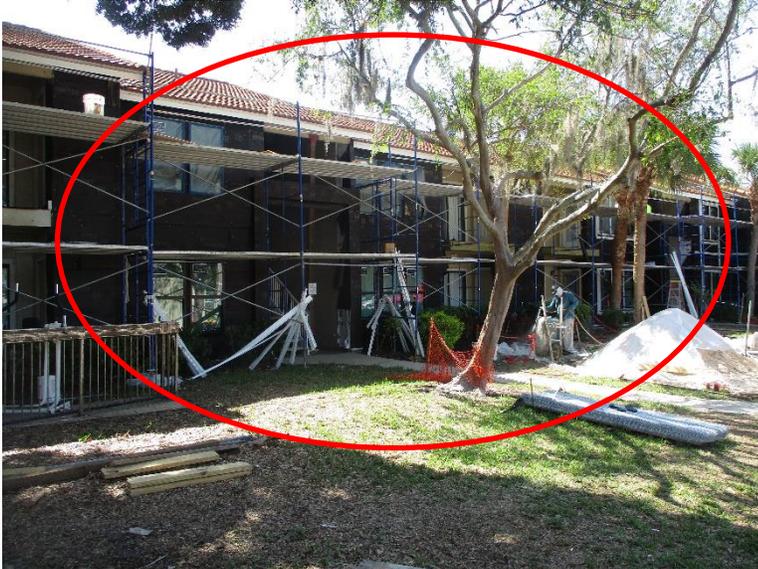
**PHOTOGRAPH #11**

**BUILDING 23  
SECTION B**

JumboTex Water Resistant Barrier in place and stucco accessory applications in progress.

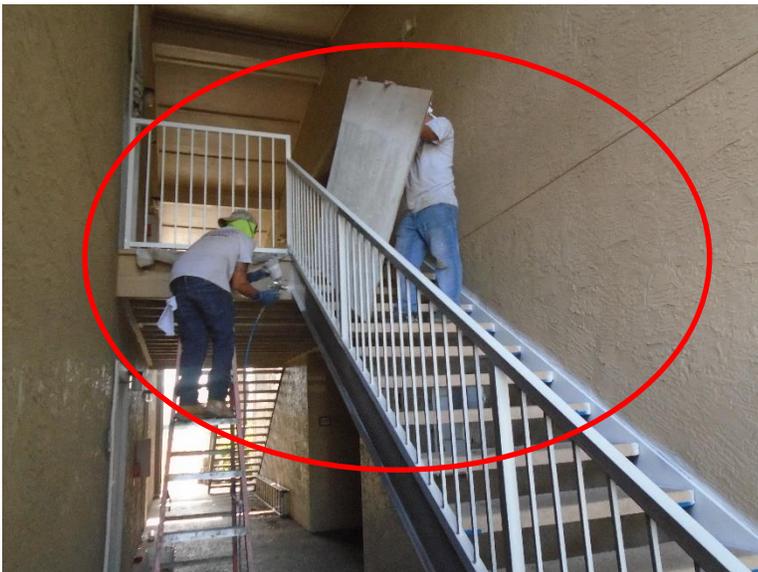
**PHOTOGRAPH #12**

**BUILDING 23  
SECTION B**

Contractor spray priming stairway railings with Florida Paints Encapsulant epoxy mastic primer.

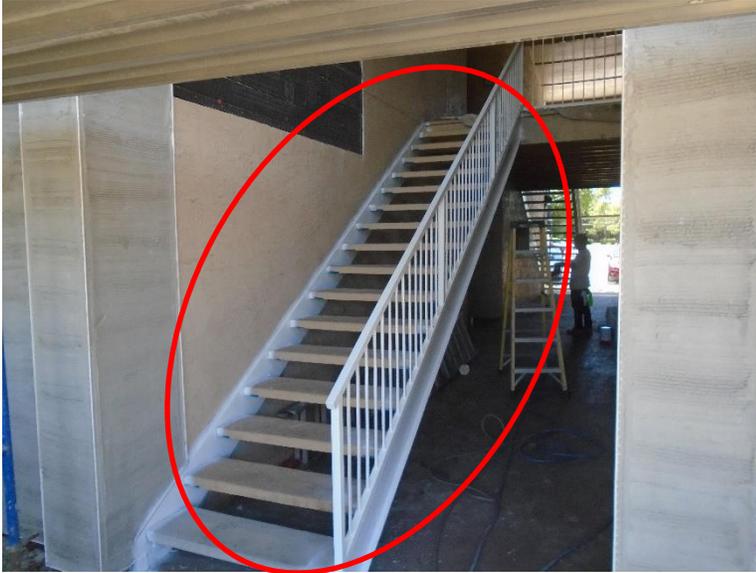
**PHOTOGRAPH #13**

**BUILDING 23  
SECTION B**

Contractor spray priming stairway railings with Florida Paints Encapsulant epoxy mastic primer.

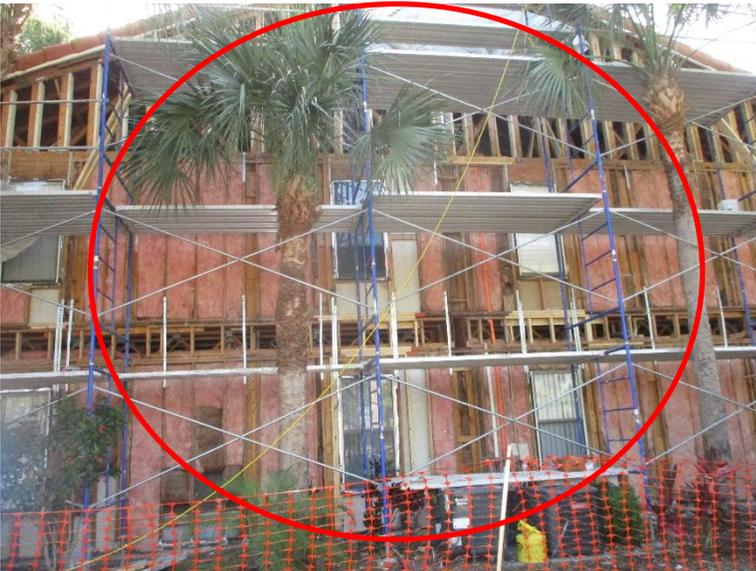
**PHOTOGRAPH #14**

**BUILDING 21  
SECTION H**

Contractor has performed framing repairs, gable end reinforcement, strapping and Simpson Strong -Tie connectors.

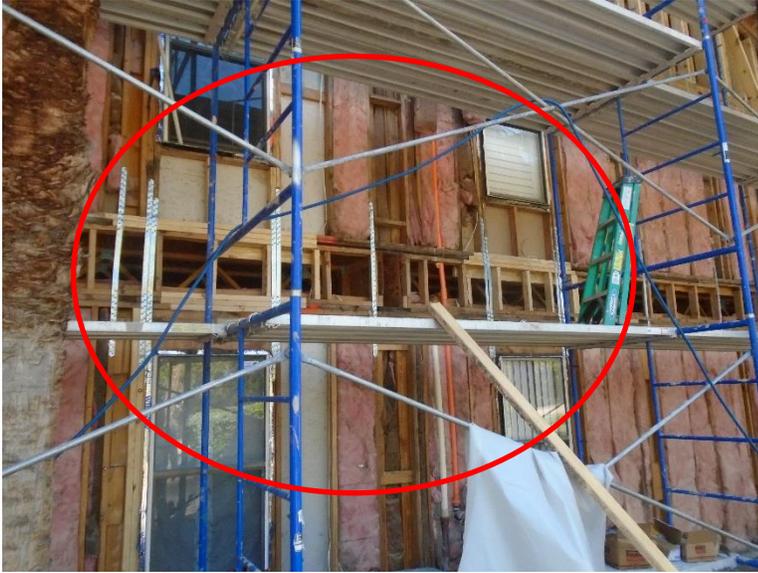
**PHOTOGRAPH #15**

**BUILDING 21  
SECTION H**

Contractor has performed framing repairs, gable end reinforcement, strapping and Simpson Strong -Tie connectors.

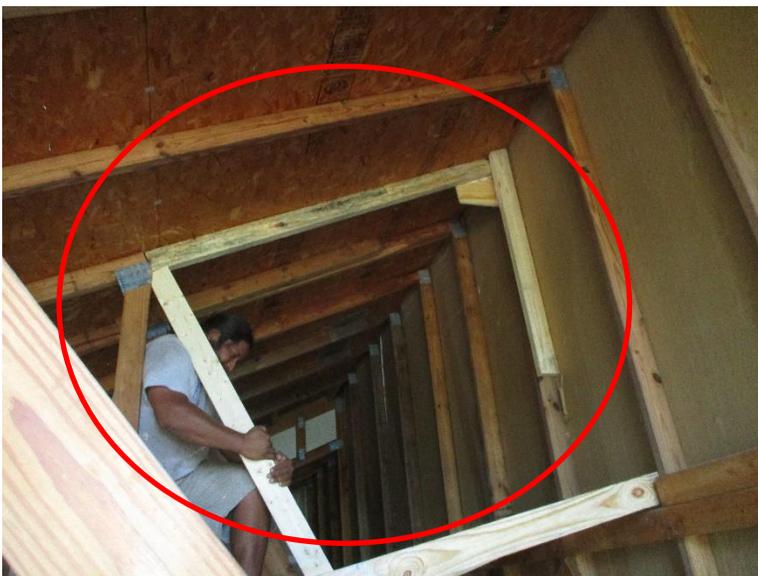
**PHOTOGRAPH #16**

**BUILDING 21  
SECTION H**

Attic framing repairs in progress.

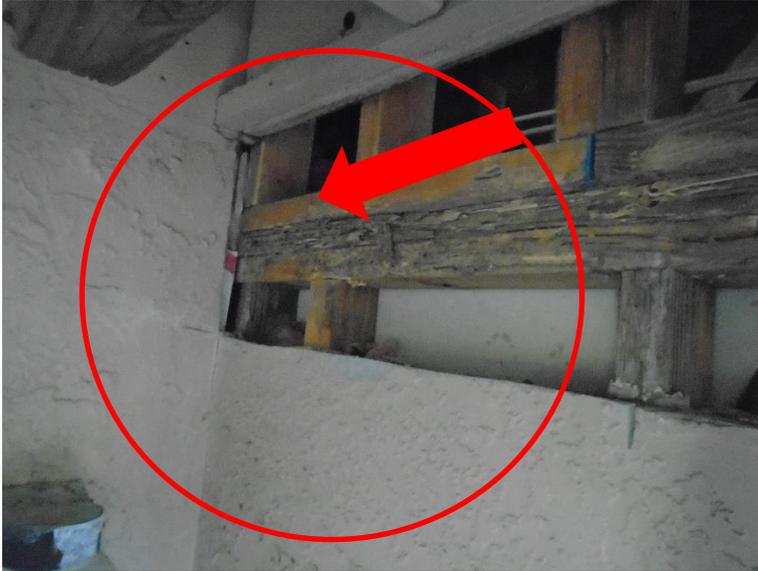
**PHOTOGRAPH #17**

**BUILDING 21  
SECTION G**

Termite damage at top plate at **Unit #2112** is extensive and may extend into owners Unit.

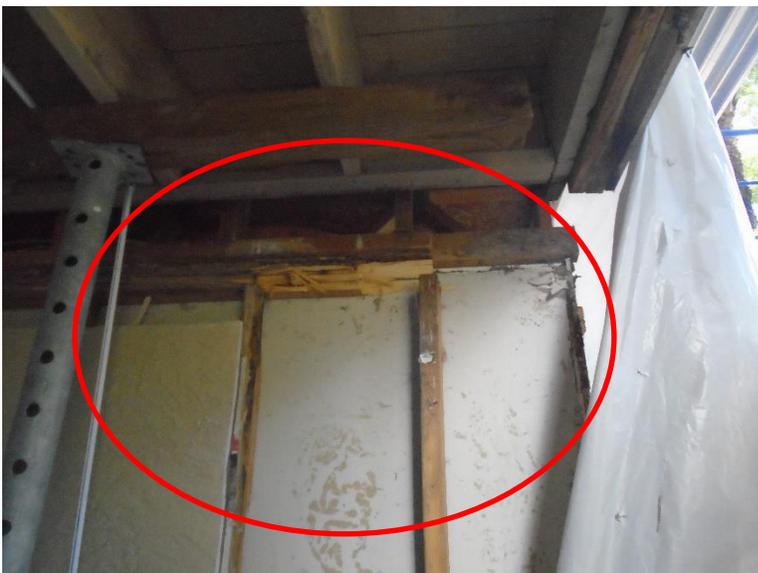
**PHOTOGRAPH #18**

**BUILDING 21  
SECTION G**

Termite damage at top plate at **Unit #2112** is extensive and may extend into owners Unit.

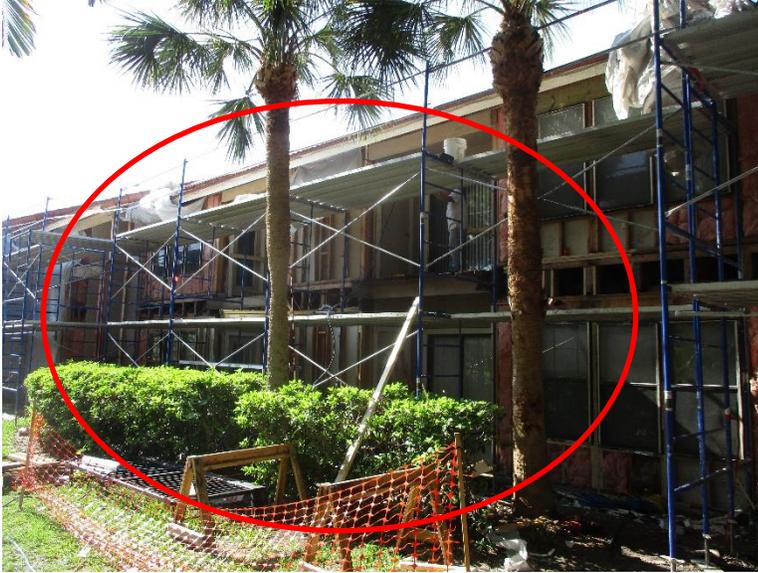
**PHOTOGRAPH #19**

**BUILDING 21  
SECTION F**

Contractor has begun framing and balcony damage repairs.

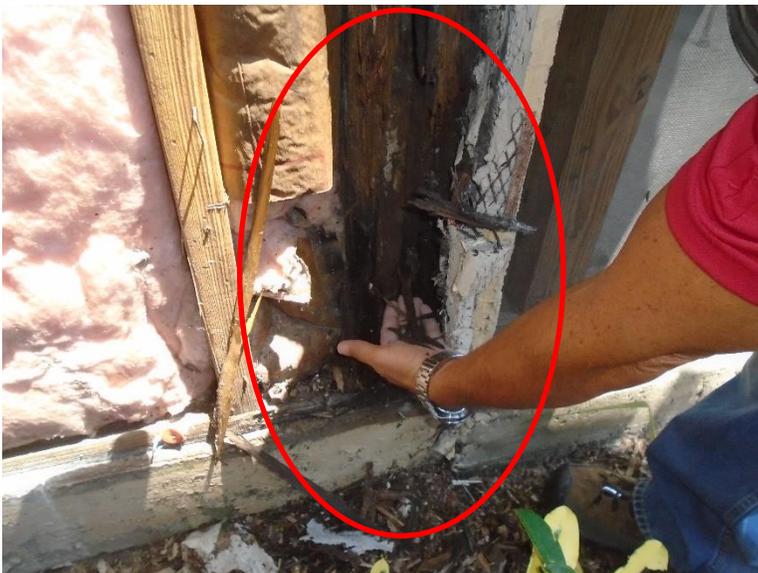
**PHOTOGRAPH #20**

**BUILDING 21  
SECTION A**

Framing damage and collapse observed and documented.
