## PHOTOGRAPHS

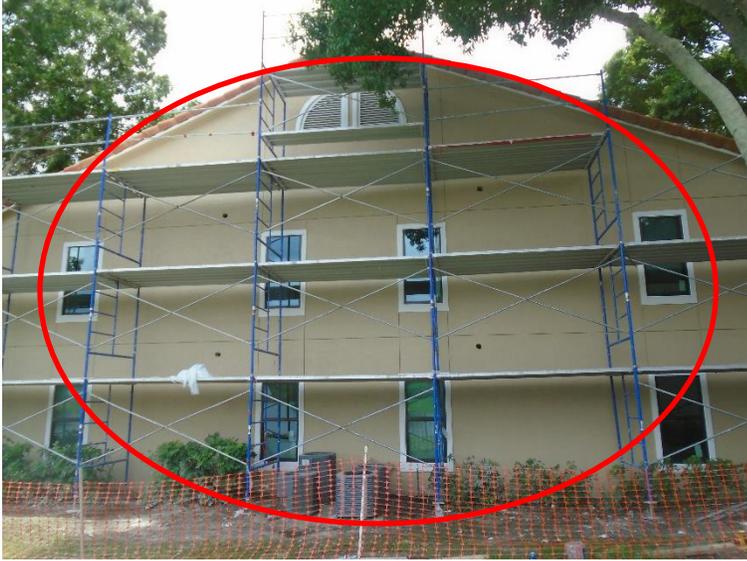
**PHOTOGRAPH #1**

### **BUILDING 23 SECTION H**

Contractor has applied Florida Paints Ultra exterior supercoat finish paint.

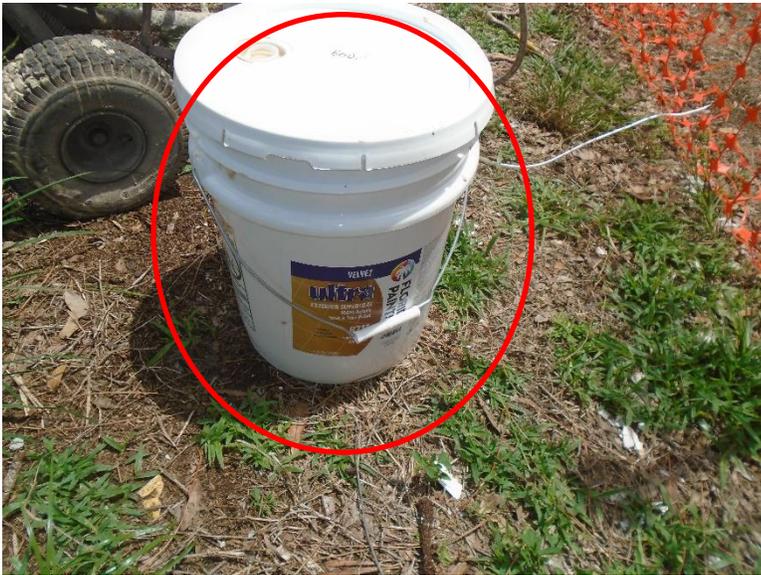
**PHOTOGRAPH #2**

### **BUILDING 23 SECTION H**

Contractor has applied Florida Paints Ultra exterior supercoat finish paint.

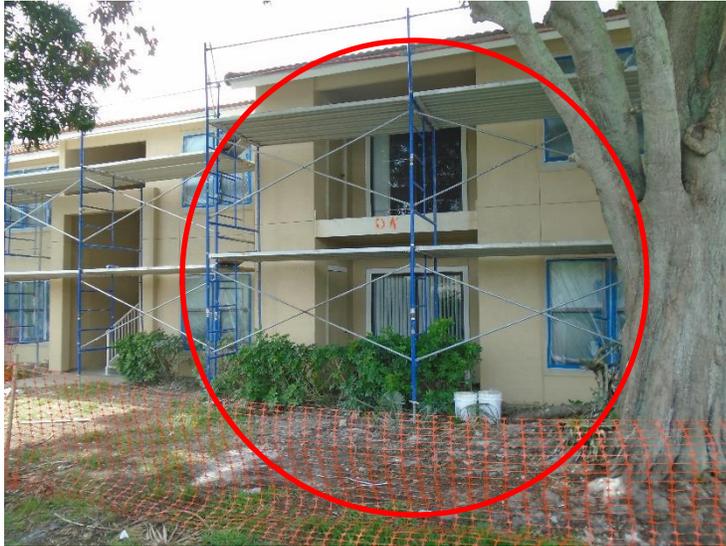
**PHOTOGRAPH #3**

**BUILDING 23  
SECTION G**

Stucco primed with Florida Paints SunFlex masonry primer.

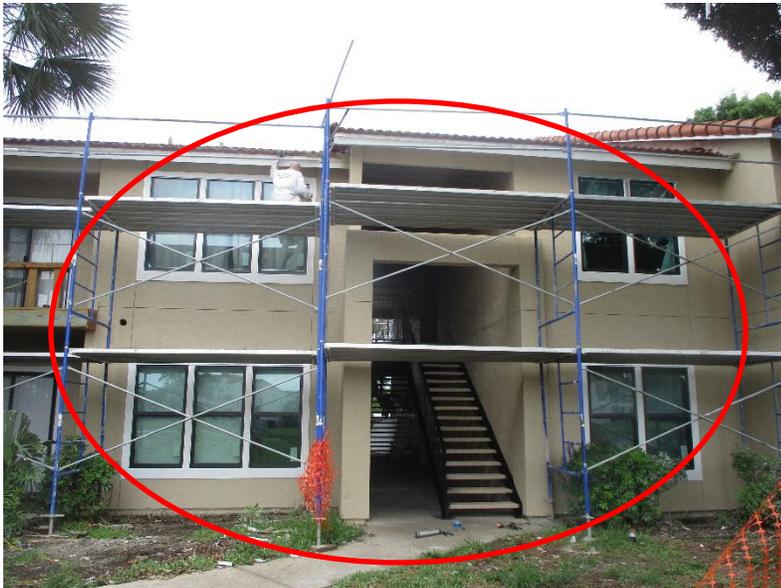
**PHOTOGRAPH #4**

**BUILDING 23  
SECTION F**

Stucco primed with Florida Paints SunFlex masonry primer and finished with Ultra exterior supercoat finish paint.

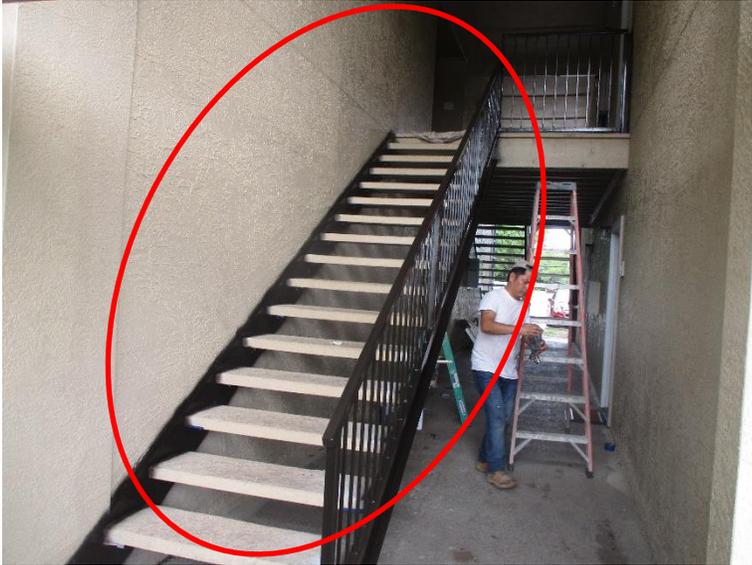
**PHOTOGRAPH #5**

**BUILDING 23  
SECTION F**

Contractor has applied enamel finish coat at stairs and railings.

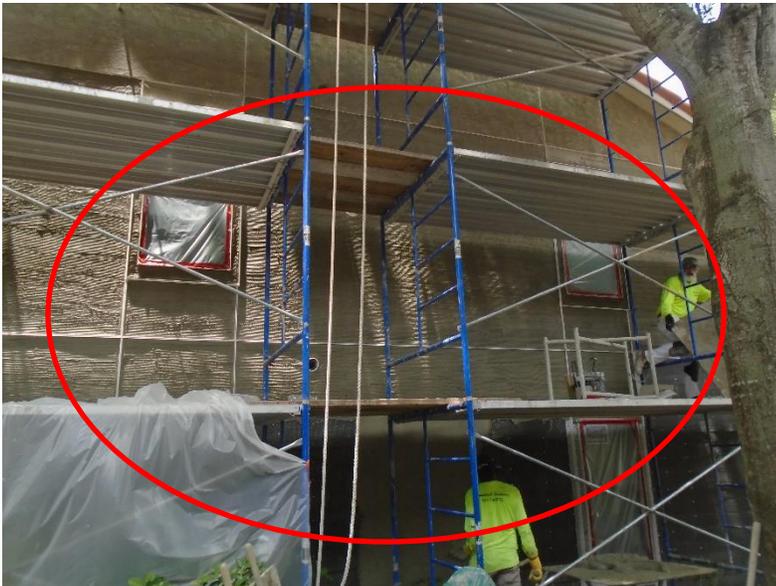
**PHOTOGRAPH #6**

**BUILDING 23  
SECTION D**

Stucco Sub – contractor applying scratch coats and brown coats.

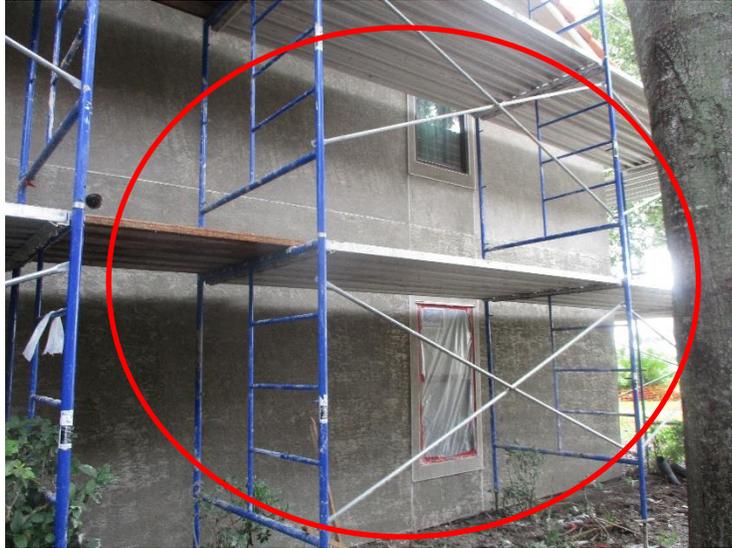
**PHOTOGRAPH #7**

**BUILDING 23  
SECTION D**

Stucco Sub – contractor has applied finish coats of stucco.

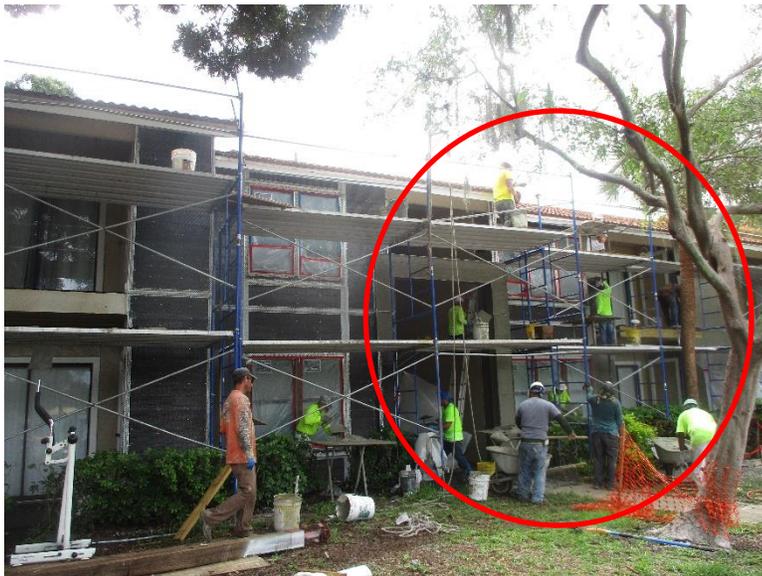
**PHOTOGRAPH #8**

**BUILDING 23  
SECTION C**

Stucco Sub – contractor has begun to apply scratch coat of stucco.

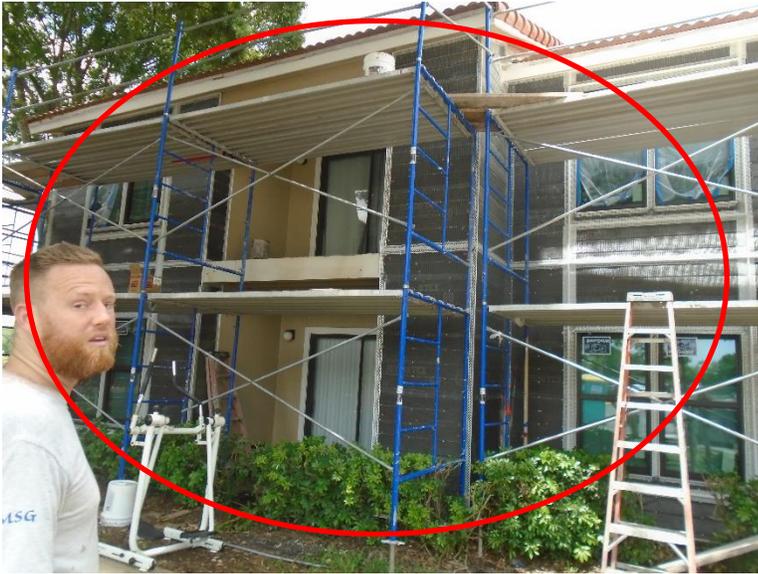
**PHOTOGRAPH #9**

**BUILDING 23  
SECTION A**

Stucco Sub – contractor has applied JumboTex, stucco accessories and metal lath.

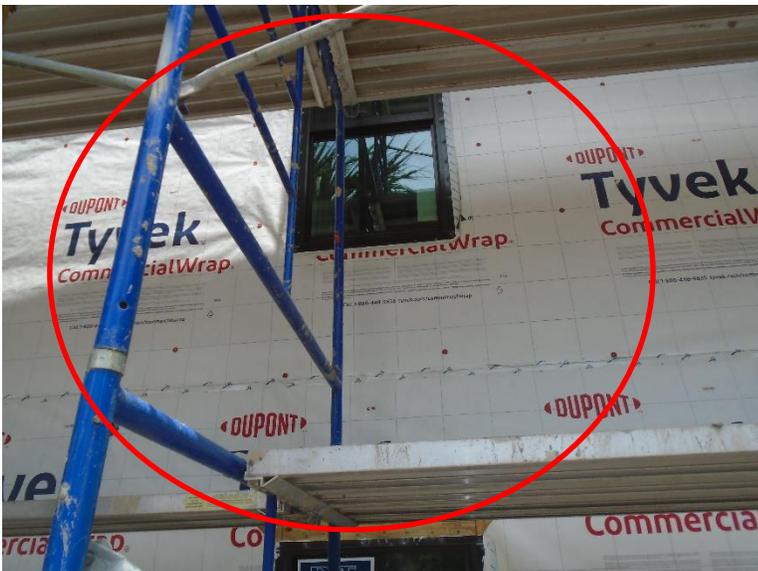
**PHOTOGRAPH #10**

**BUILDING 21  
SECTION H**

New PGT windows have been installed with Dupont / Tyvek flashings.

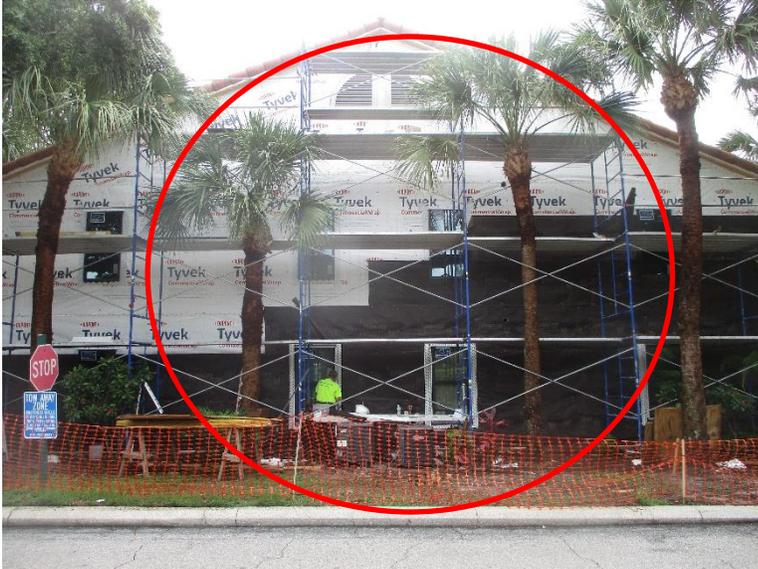
**PHOTOGRAPH #11**

**BUILDING 21  
SECTION H**

Stucco Sub-contractor has begun to install JumboTex water resistant barrier.

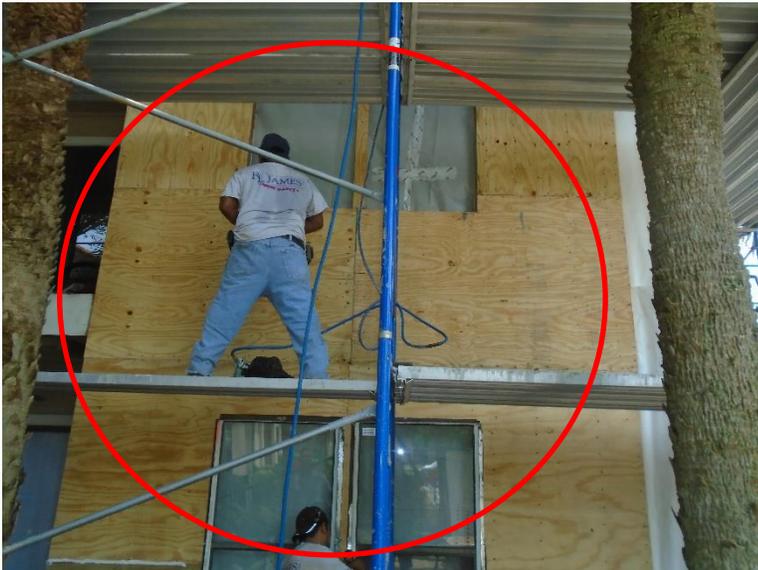
**PHOTOGRAPH #12**

**BUILDING 21  
SECTION G**

New plywood sheathing installation in progress.

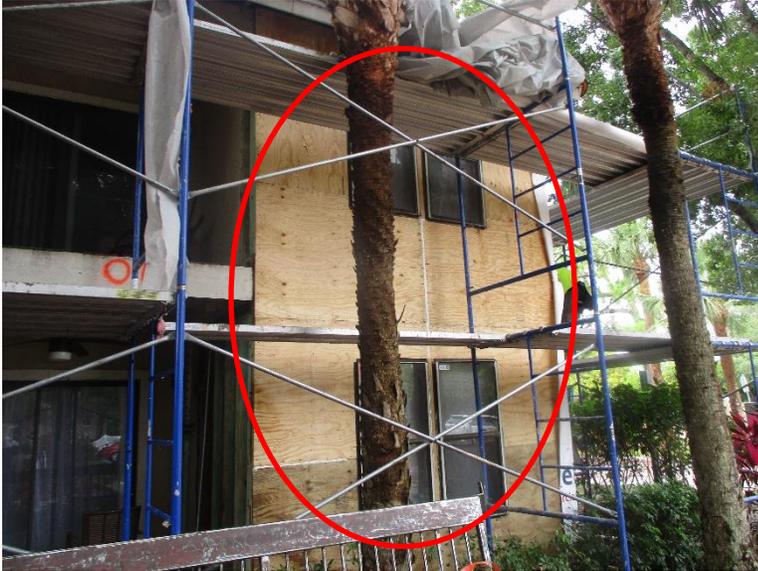
**PHOTOGRAPH #13**

**BUILDING 21  
SECTION G**

Contractor has installed plywood sheathing and Delta has inspected fastening.

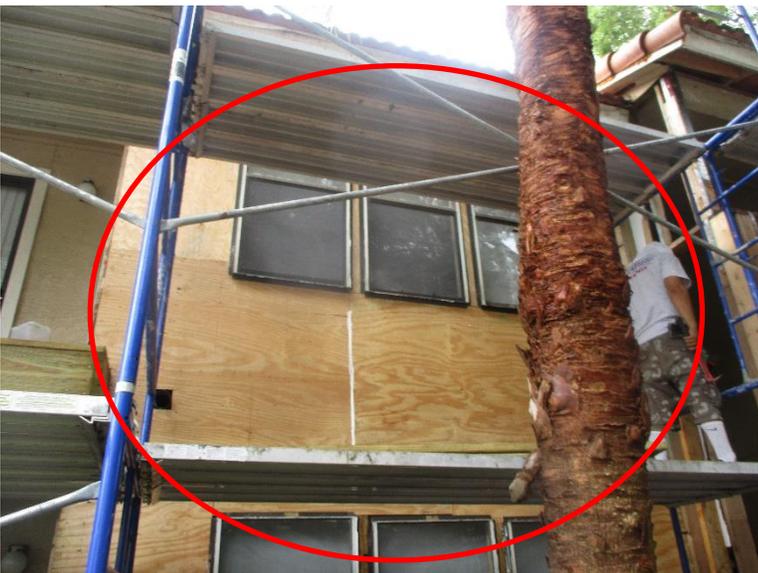
**PHOTOGRAPH #14**

**BUILDING 21  
SECTION F**

Contractor has installed plywood sheathing and Delta has inspected fastening.

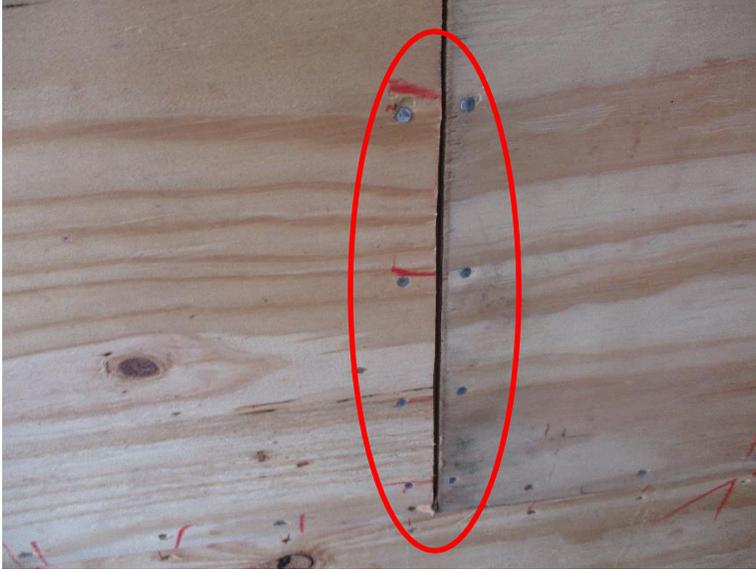
**PHOTOGRAPH #15**

**BUILDING 21  
SECTION F**

Missed fasteners and excessive gaps marked for correction by Delta have been addressed by contractor.

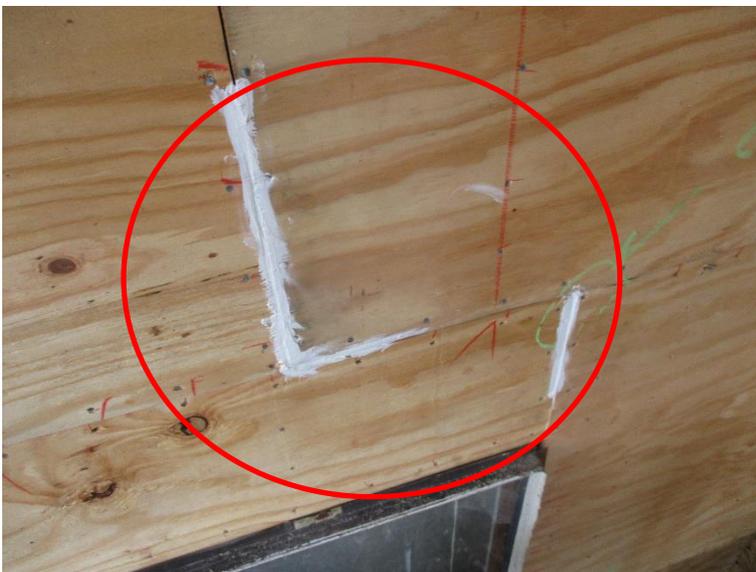
**PHOTOGRAPH #16**

**BUILDING 21  
SECTION F**

Missed fasteners and excessive gaps marked for correction by Delta have been addressed by contractor.

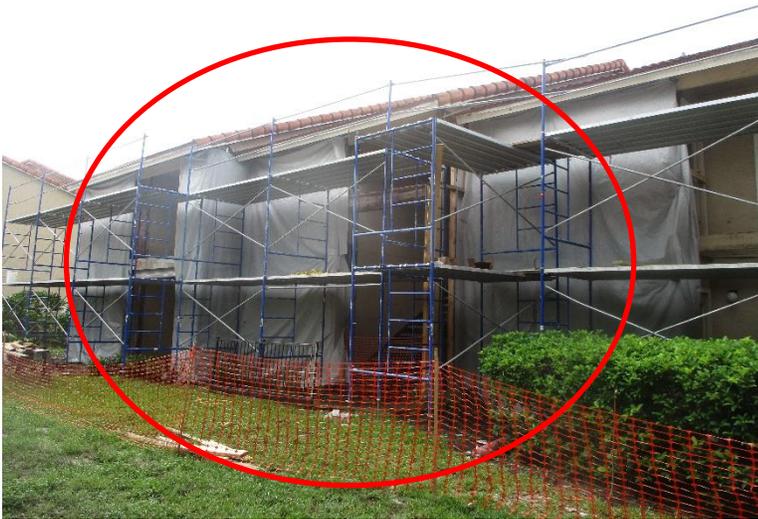
**PHOTOGRAPH #17**

**BUILDING 21  
SECTION E**

Contractor protecting incomplete repairs and with heavy plastic sheathing.
