PHOTOGRAPHS

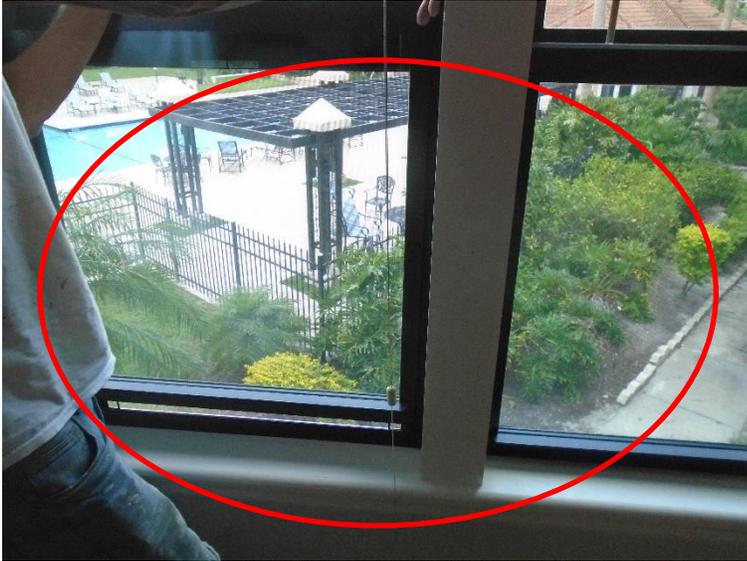
PHOTOGRAPH #1

**BUILDING 5- UNIT 526
PUNCH LIST**

Living room- middle operable window is loose from frame.

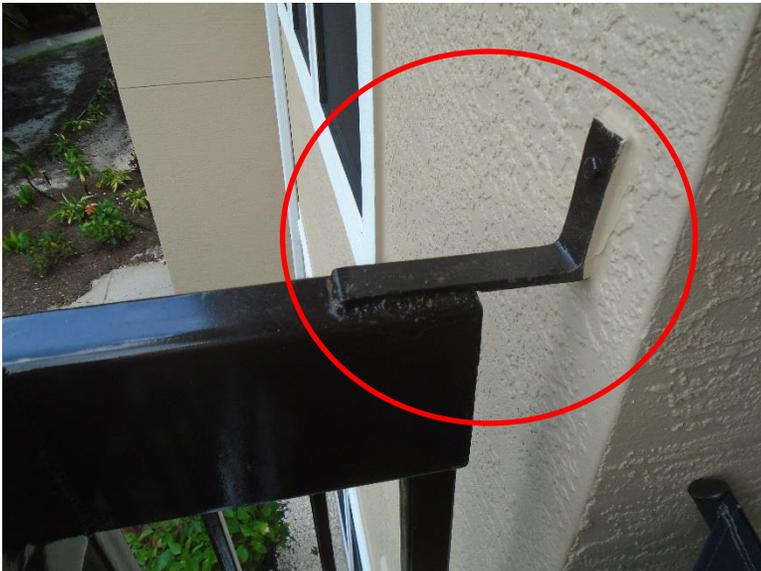
PHOTOGRAPH #2

**BUILDING 5- UNIT 526
PUNCH LIST**

Balcony railing attachments have begun to show surface rust.

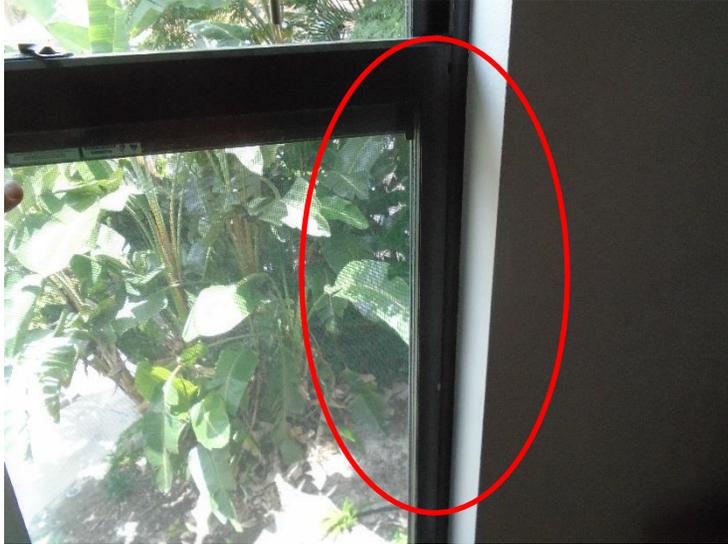
PHOTOGRAPH #3

**BUILDING 5- UNIT 528
PUNCH LIST**

Bedroom- Right operable window is loose from frame.

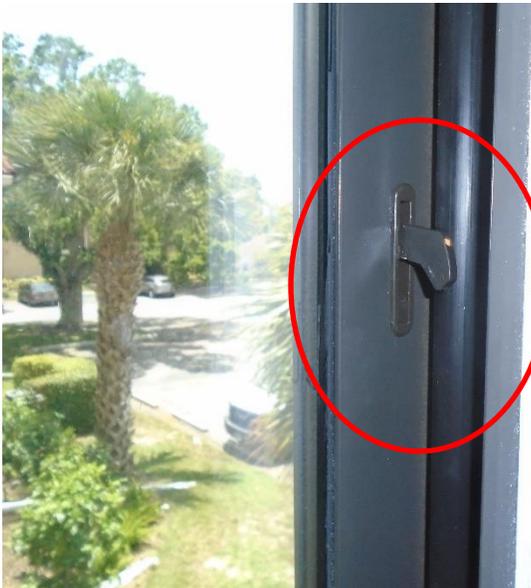
PHOTOGRAPH #4

**BUILDING 5- UNIT 527
PUNCH LIST**

Guest bedroom - WOCD safety device is broken.

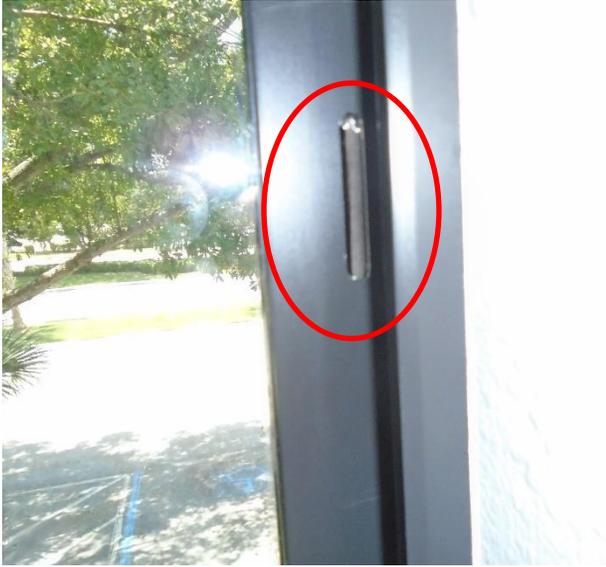
PHOTOGRAPH #5

**BUILDING 5- UNIT 523
PUNCH LIST**

Guest bedroom - WOCD safety device is missing.

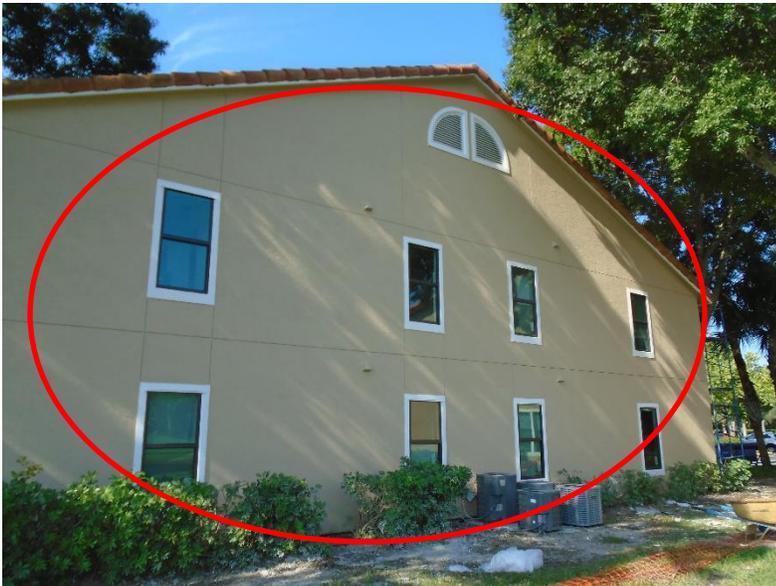
PHOTOGRAPH #6

**BUILDING 23
SECTION H**

Painting has been completed and scaffolding has been removed.

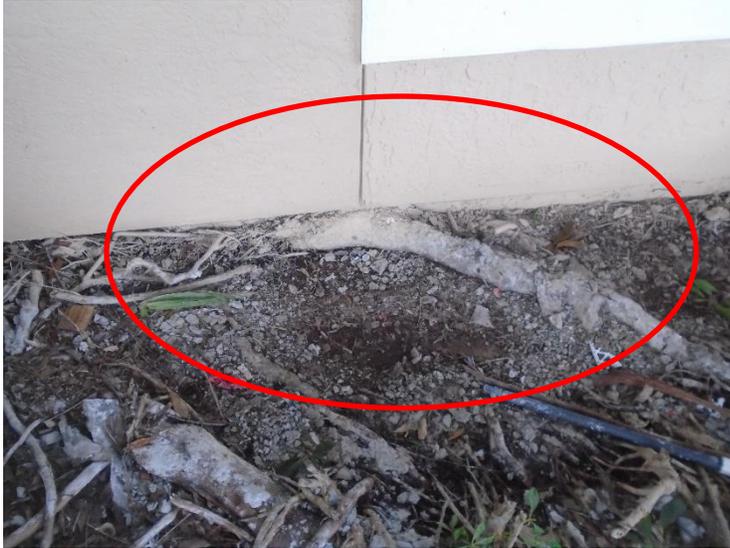
PHOTOGRAPH #7

**BUILDING 23
SECTION G**

Problematic tree roots at base of walls.

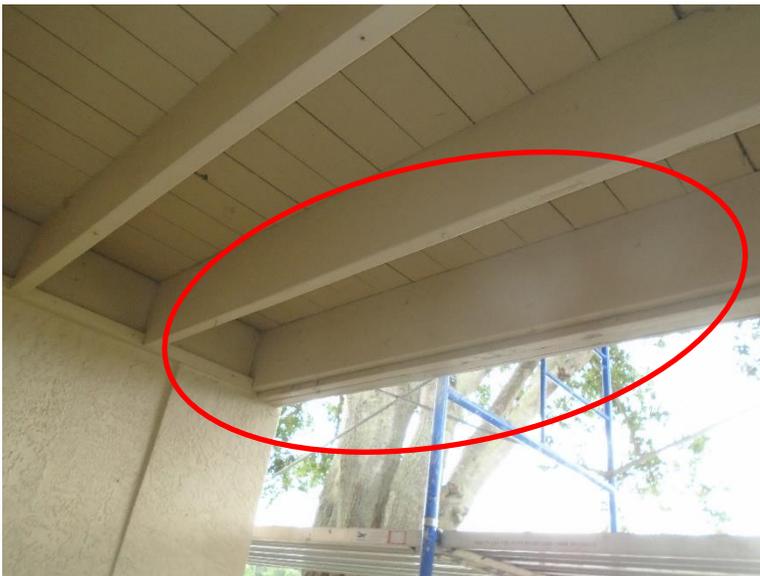
PHOTOGRAPH #8

**BUILDING 23
SECTION G**

Simpson Strong - Tie screws and clips had not been installed at rim joist. Delta notified contractor.

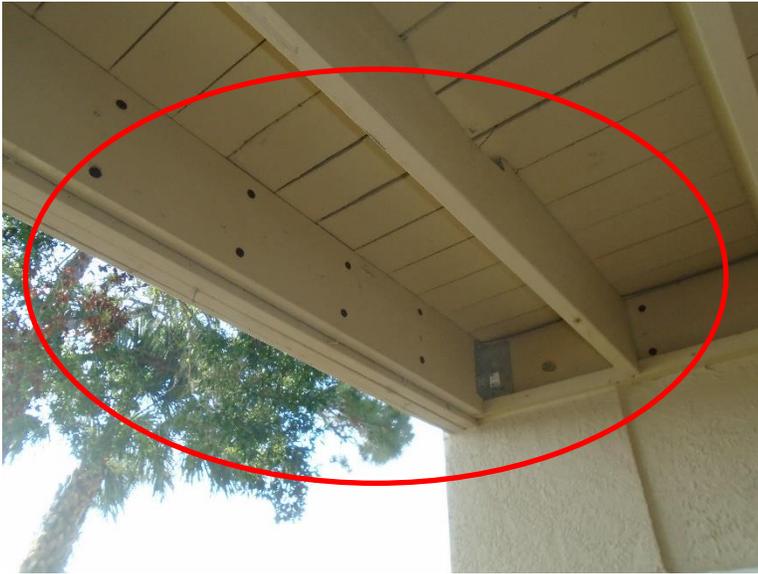
PHOTOGRAPH #9

**BUILDING 23
SECTION G**

Contractor has installed Simpson Strong – Tie screws and clips.

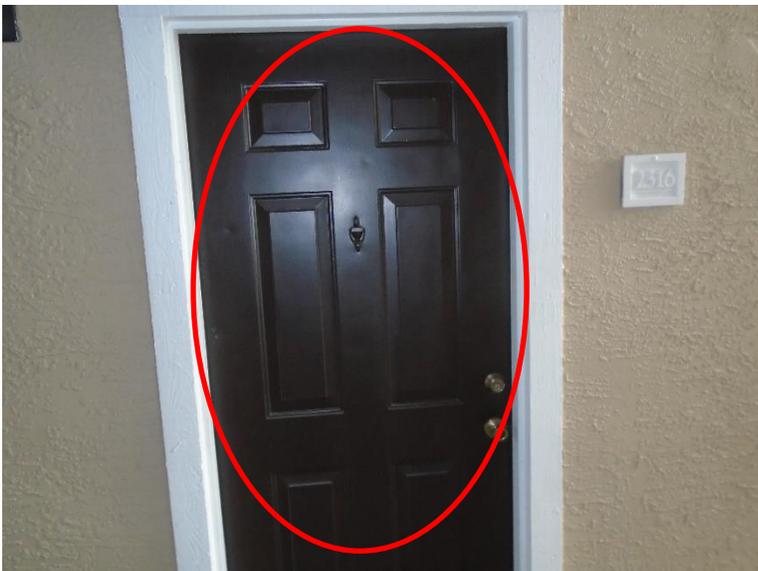
PHOTOGRAPH #10

**BUILDING 23
SECTION G**

Florida Paint finish enamel has been applied to front doors.

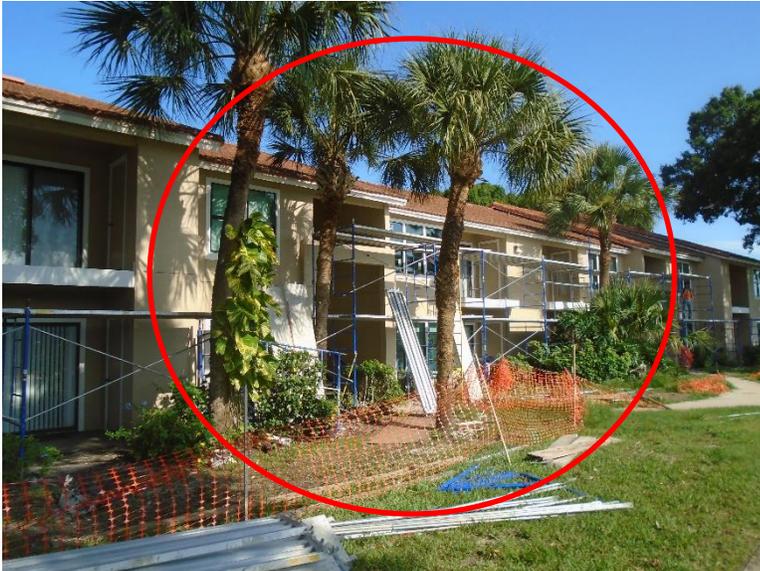
PHOTOGRAPH #11

**BUILDING 23
SECTION F**

Contractor has completed painting of walls and in process of removing scaffolding.

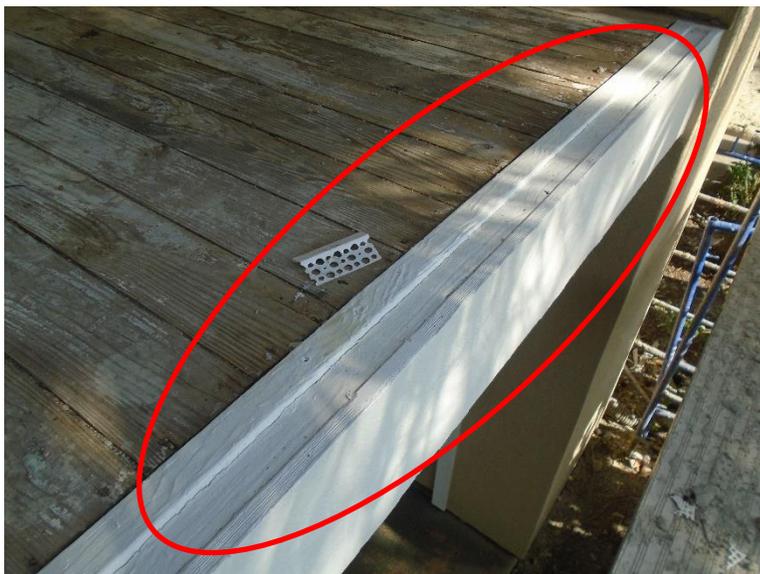
PHOTOGRAPH #12

**BUILDING 23
SECTION E**

Caulking details at top of rim joist and cedar face trim have not been provided with urethane sealants.

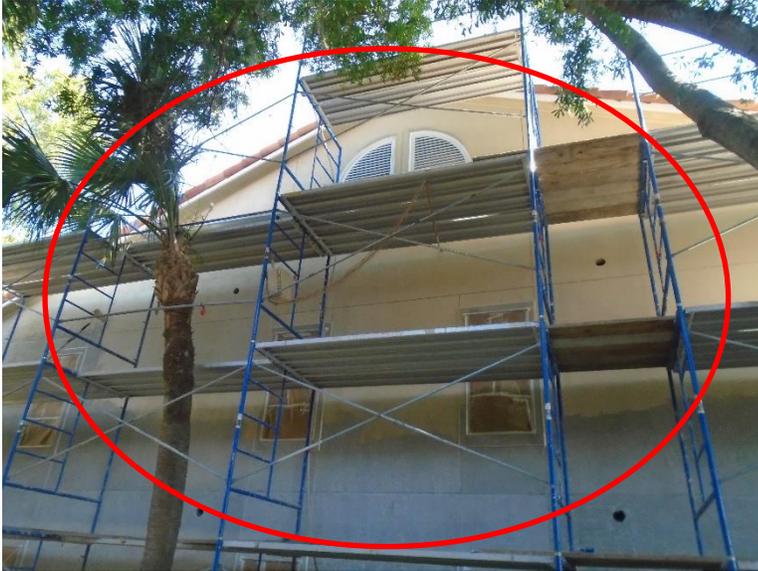
PHOTOGRAPH #13

**BUILDING 23
SECTION D**

Contractor in process of priming new stucco with Florida Paints acrylic primer.

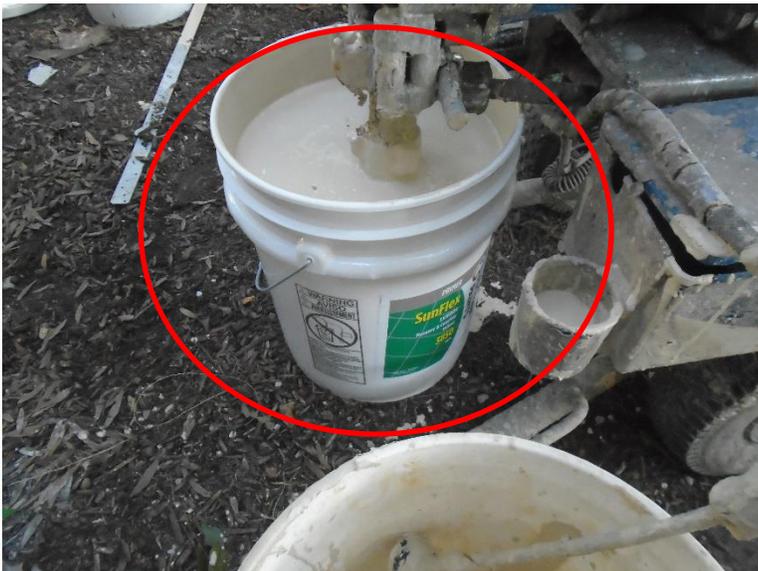
PHOTOGRAPH #14

**BUILDING 23
SECTION D**

Contractor in process of priming new stucco with Florida Paints acrylic primer.

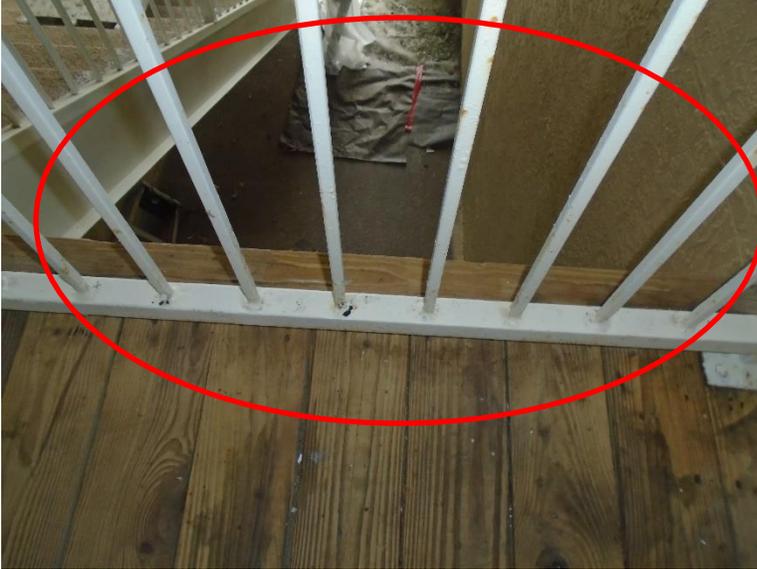
PHOTOGRAPH #15

**BUILDING 23
SECTION C**

Steel railings showing surface rust after application of primer will require additional preparation and re priming before finish coat of paint.

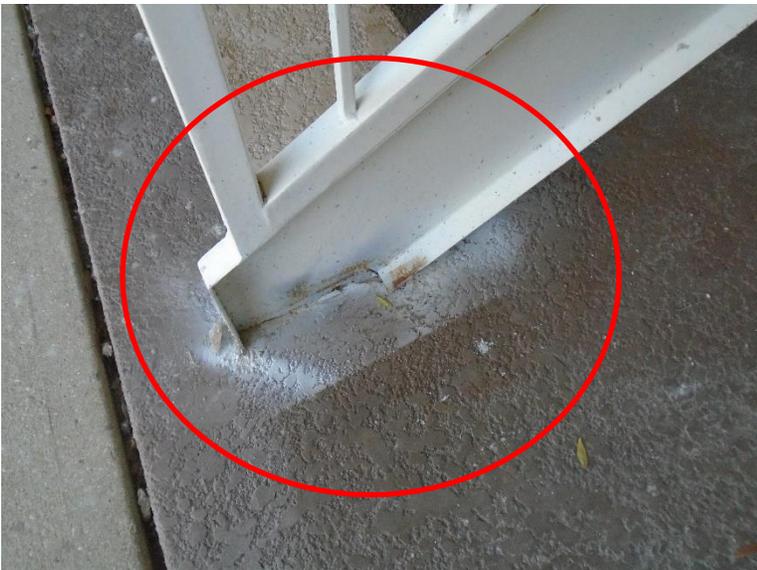
PHOTOGRAPH #16

**BUILDING 23
SECTION C**

Steel railings showing surface rust after application of primer will require additional preparation and re priming before finish coat of paint.

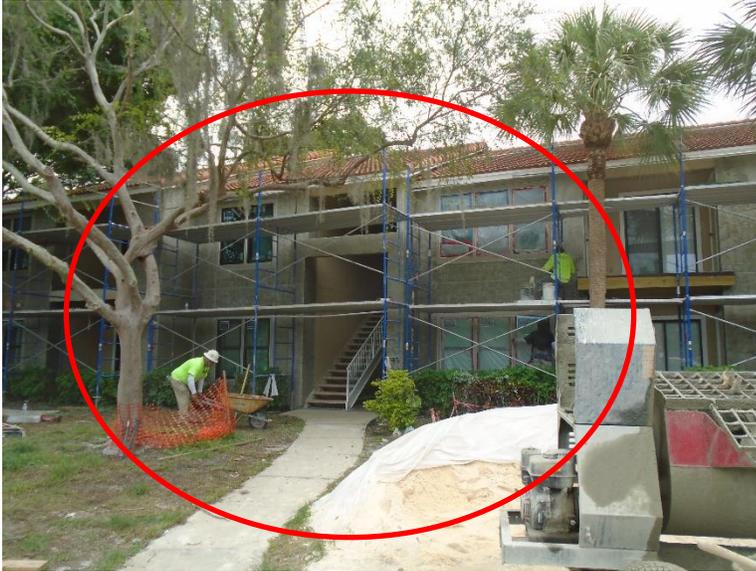
PHOTOGRAPH #17

**BUILDING 23
SECTION A**

Stucco sub-contractor applying texture coat of stucco.

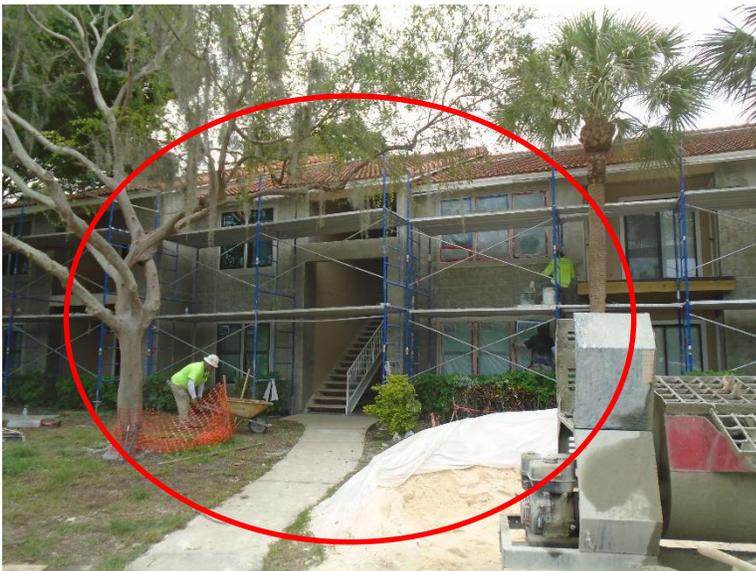
PHOTOGRAPH #17

**BUILDING 23
SECTION A**

Stucco sub-contractor applying texture coat of stucco.

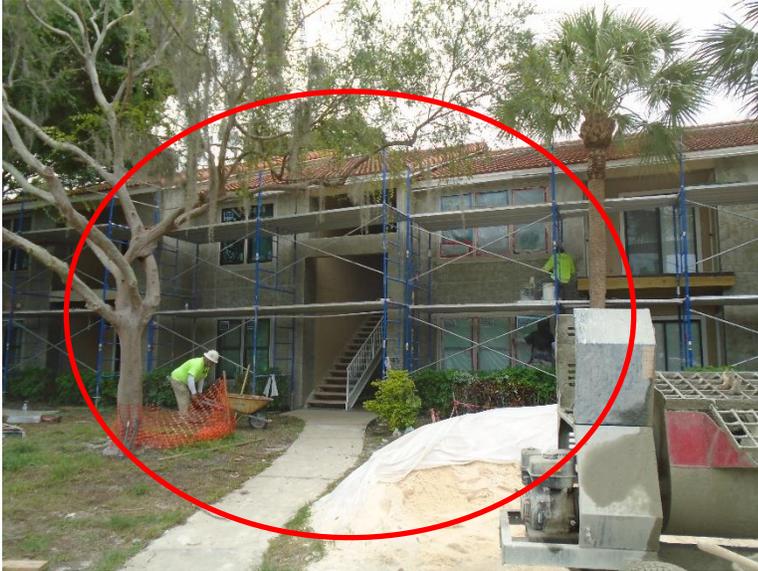
PHOTOGRAPH #17

**BUILDING 23
SECTION A**

Stucco sub-contractor applying texture coat of stucco.

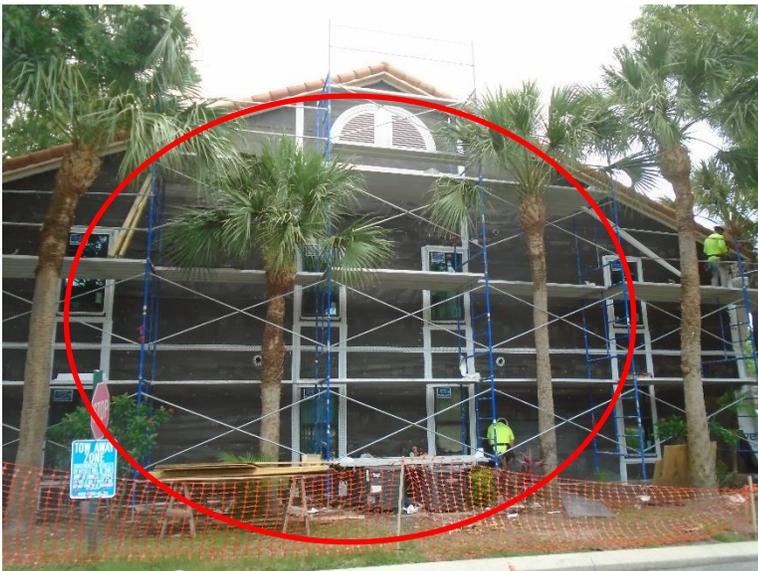
PHOTOGRAPH #18

**BUILDING 21
SECTION H**

Sub- Contractor installing stucco accessories in preparation for lath and stucco.

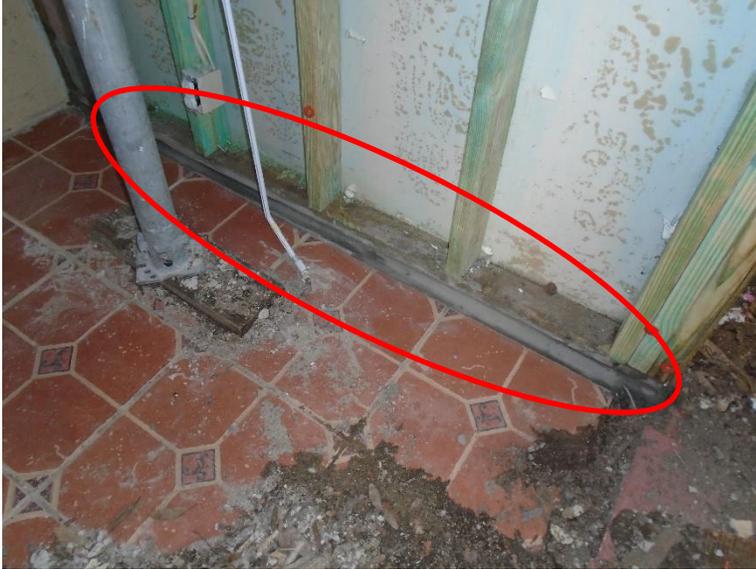
PHOTOGRAPH #19

**BUILDING 21
SECTION G
UNIT 2121**

Contractor has supported bottom plate by forming and pouring BASF MasterEmaco N 425 under bottom plate.

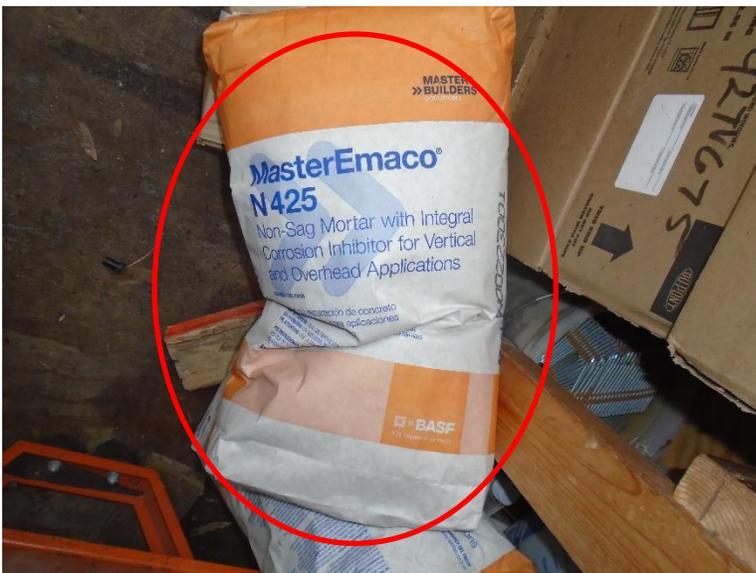
PHOTOGRAPH #20

**BUILDING 21
SECTION G
UNIT 2121**

Contractor has supported bottom plate by forming and pouring BASF MasterEmaco N 425 under bottom plate.

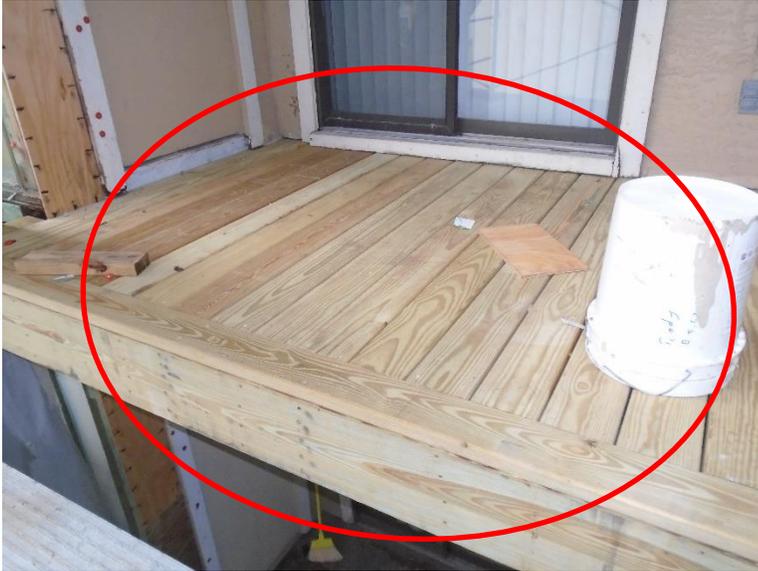
PHOTOGRAPH #21

**BUILDING 21
SECTION F**

Deck framing repairs and new decking boards on balconies.

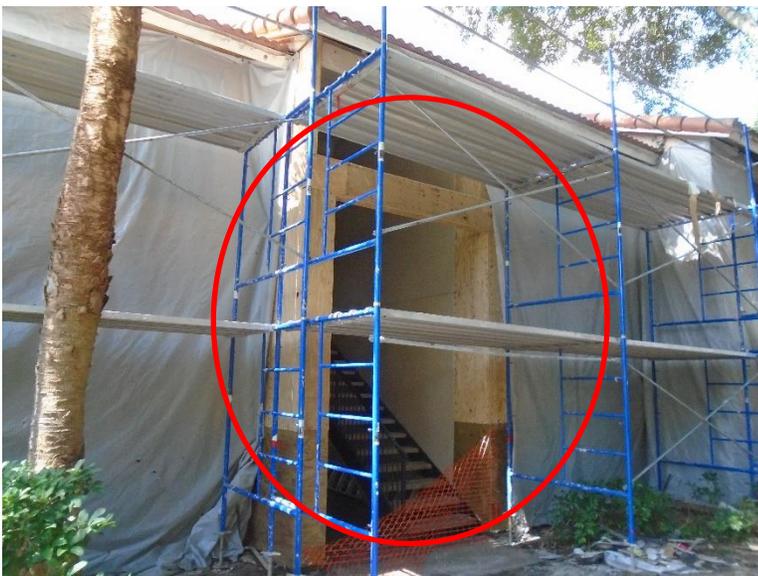
PHOTOGRAPH #22

**BUILDING 21
SECTION F**

Breezeway framing repairs complete and new sheathing installed.

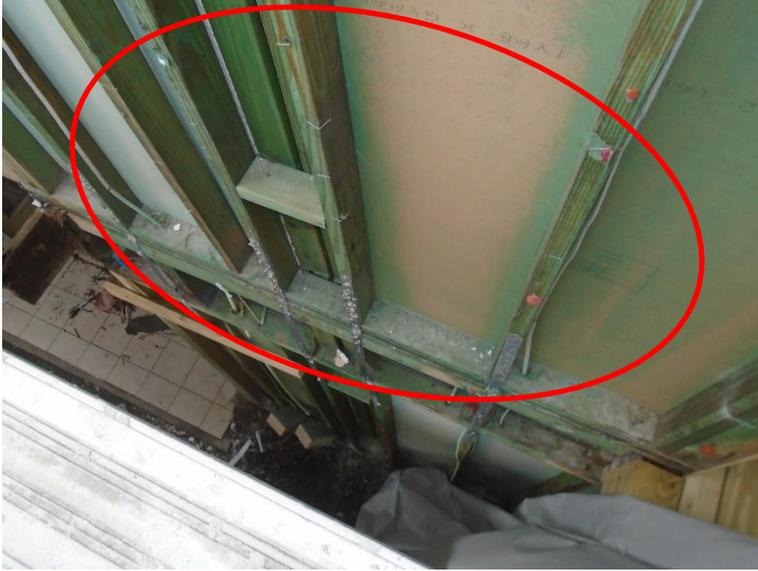
PHOTOGRAPH #23

**BUILDING 21
SECTION F**

BoraCare termite treatment applied to framing.

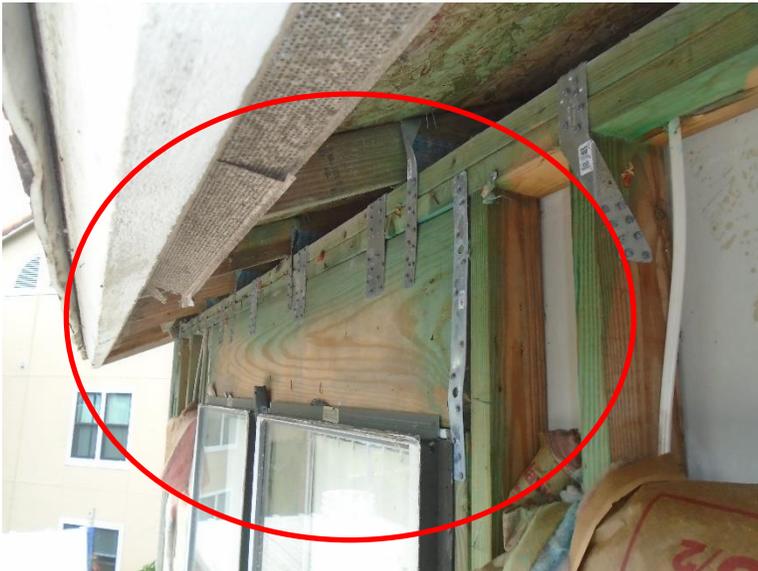
PHOTOGRAPH #24

**BUILDING 21
SECTION E**

Simpson Strong – Tie straps, screws, and connectors in place at framing, window headers and roof trusses.
