PHOTOGRAPHS

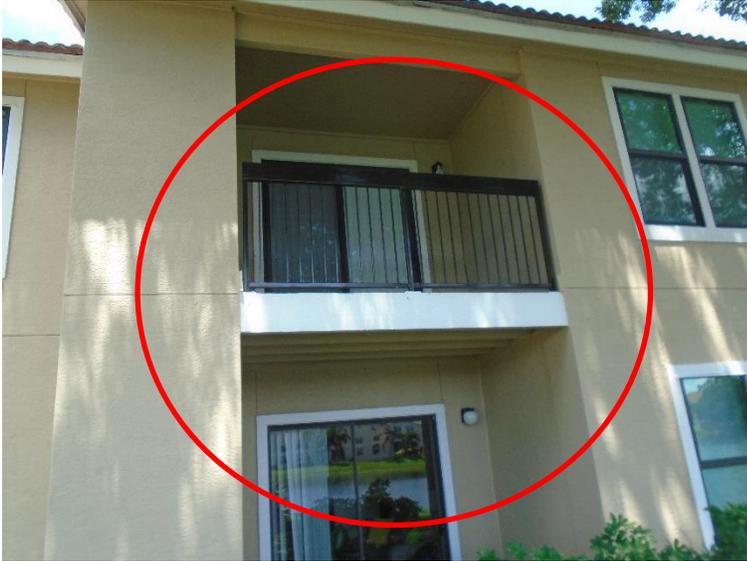
PHOTOGRAPH #1

**BUILDING 23
SECTION G**

Contractor has completed trim painting and re installed repainted balcony railing.

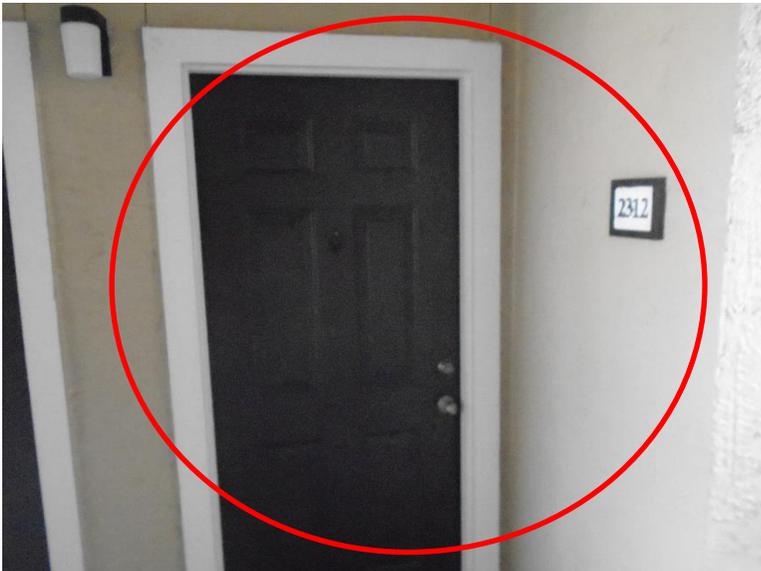
PHOTOGRAPH #2

**BUILDING 23
SECTION G**

Contractor has painted front doors, trim and unit signs.

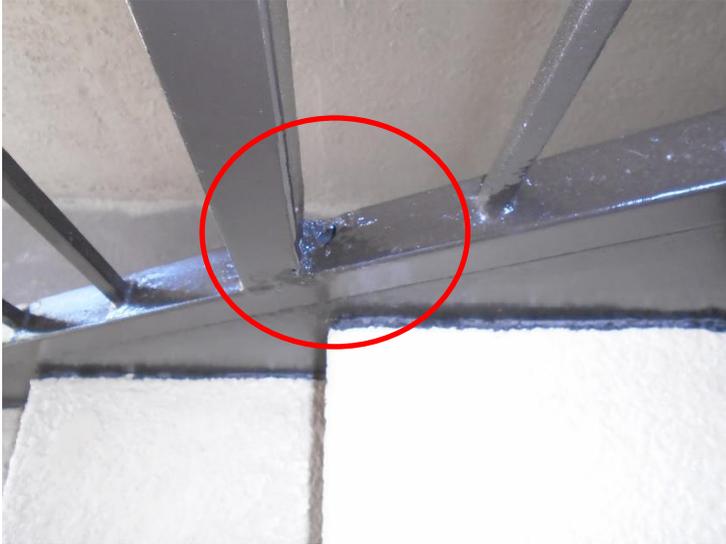
PHOTOGRAPH #3

**BUILDING 23
SECTION G**

Stairway railing repairs have not been completed prior to finish painting.

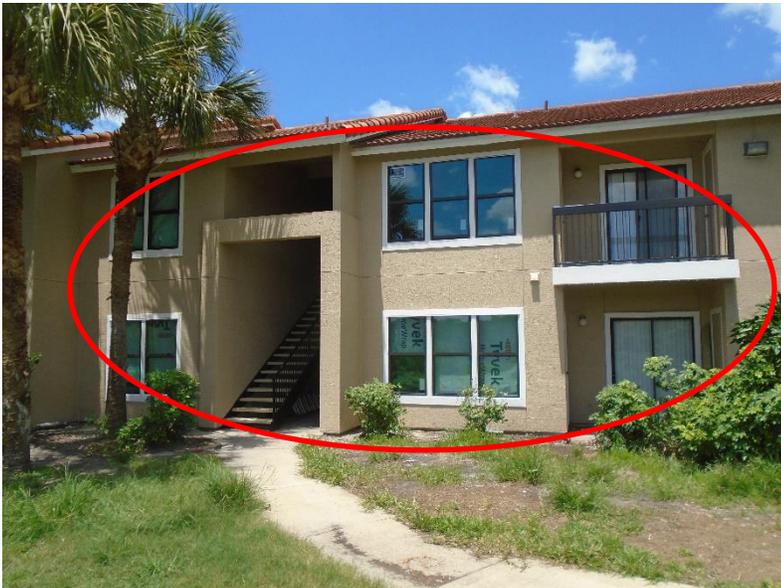
PHOTOGRAPH #4

**BUILDING 23
SECTION F**

Contractor has completed trim painting and re installed repainted balcony railing.

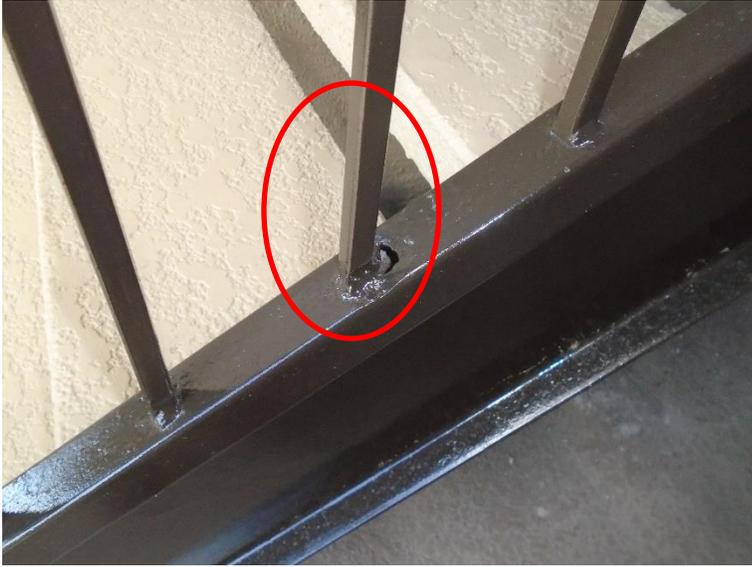
PHOTOGRAPH #5

**BUILDING 23
SECTION E**

Stairway railing repairs have not been completed prior to finish painting

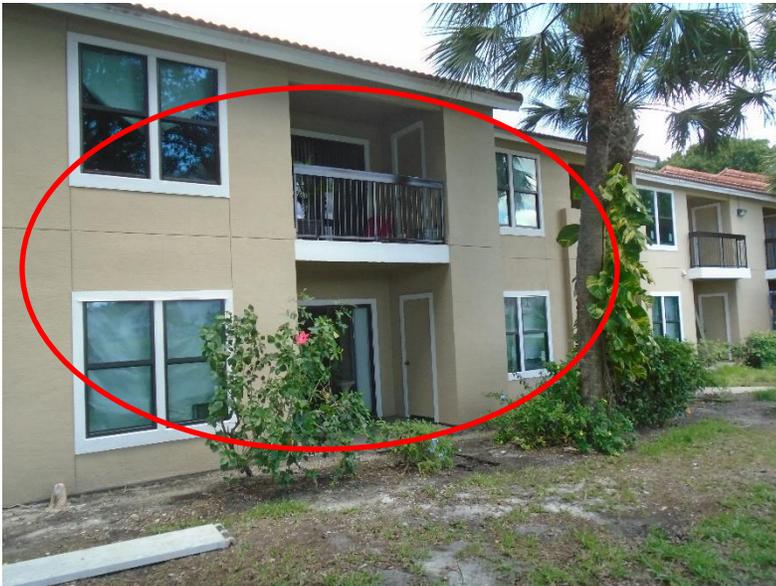
PHOTOGRAPH #6

**BUILDING 23
SECTION E**

Contractor has completed trim painting and re installed repainted balcony railing.

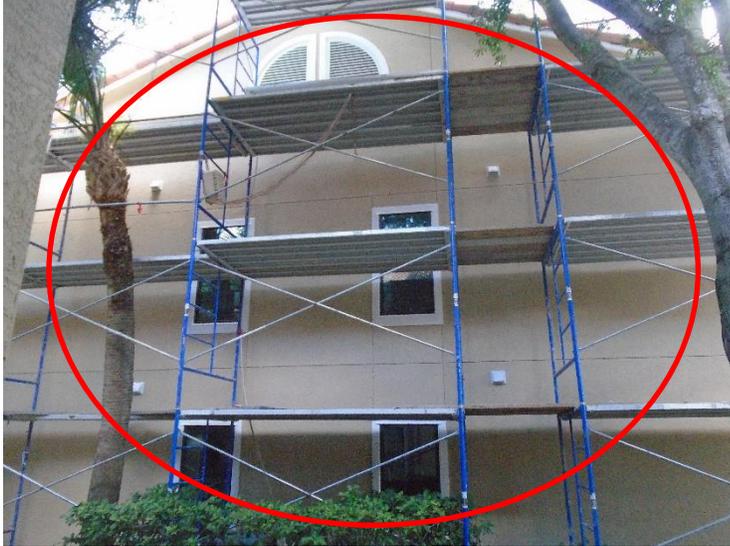
PHOTOGRAPH #7

**BUILDING 23
SECTION D**

Trim painting completed and dryer vents installed.

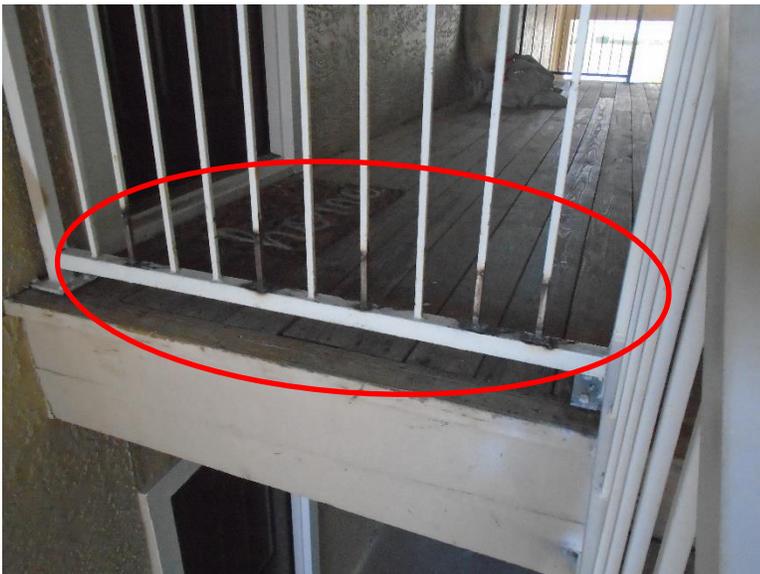
PHOTOGRAPH #8

**BUILDING 23
SECTION C**

Pickets and bottom rail welding repairs have begun at stairway railings.

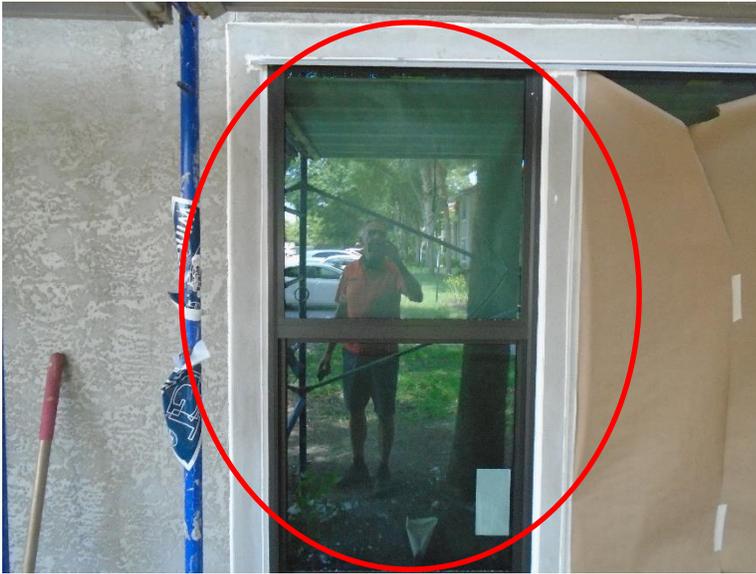
PHOTOGRAPH #9

**BUILDING 23
SECTION C**

Contractor has installed new BASF 150 sealants at window perimeters and transition joints.

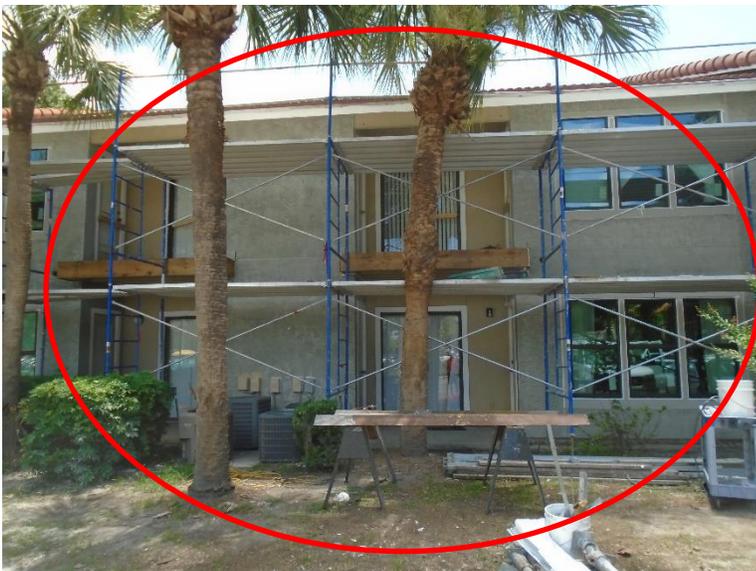
PHOTOGRAPH #10

**BUILDING 23
SECTION B**

Stucco completed and cedar trim installed at balcony facing.

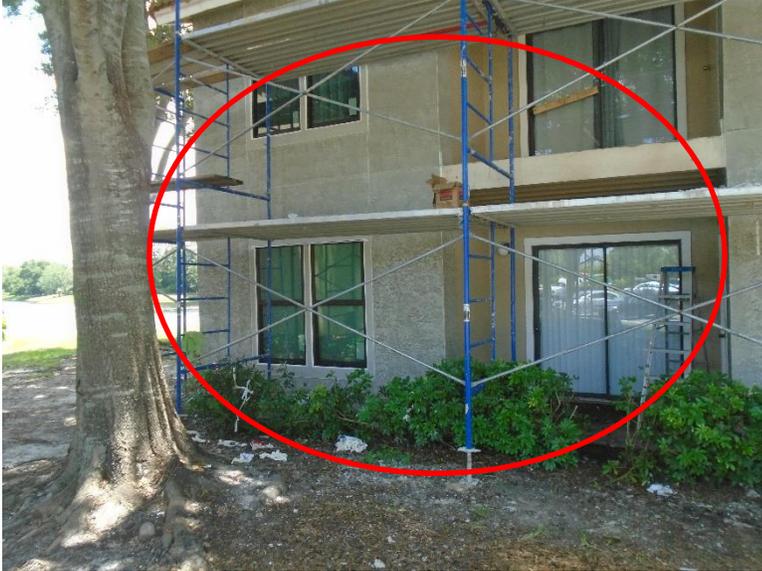
PHOTOGRAPH #11

**BUILDING 23
SECTION A**

Stucco finish completed and new sealants installed at window perimeters and transition joints.

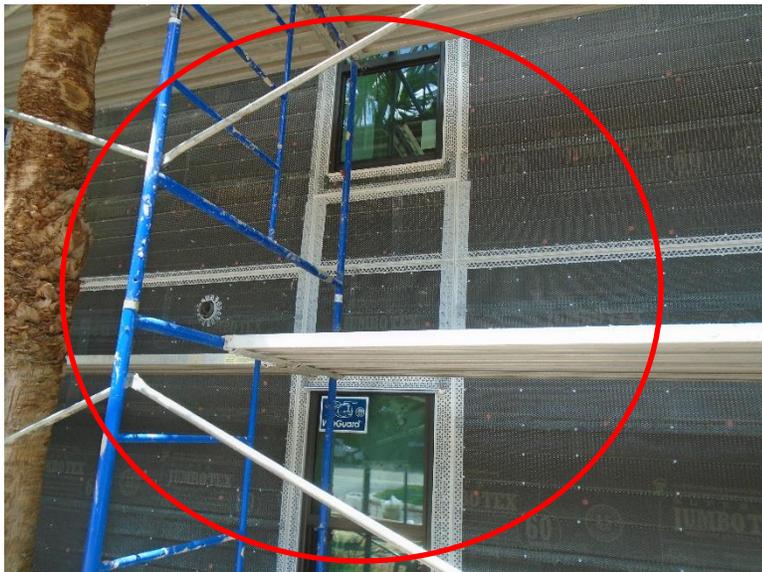
PHOTOGRAPH #12

**BUILDING 21
SECTION H**

Stucco accessories and metal lath installed in compliance with ASTM C1063.

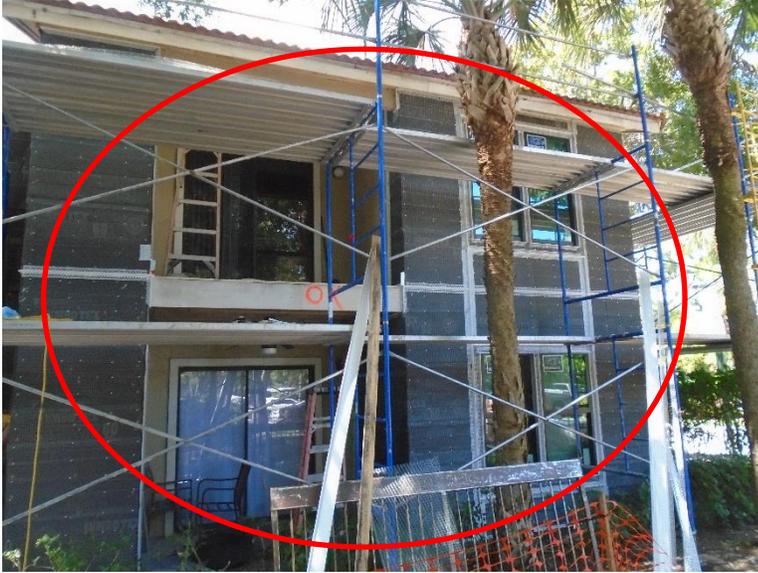
PHOTOGRAPH #13

**BUILDING 21
SECTION G**

Sub-contractor in process installing stucco accessories and metal lath.

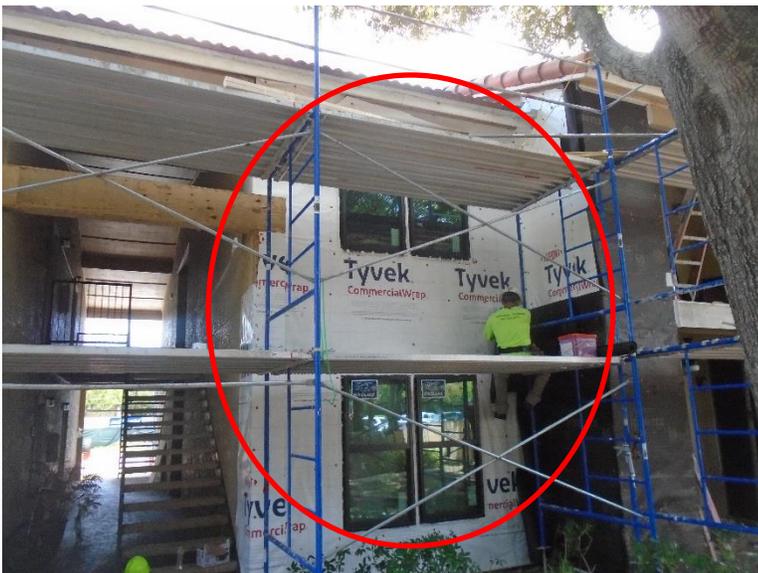
PHOTOGRAPH #14

**BUILDING 21
SECTION G**

Contractor has applied Tyvek WRB and Dupont flashings prior to installation of new PGT windows.

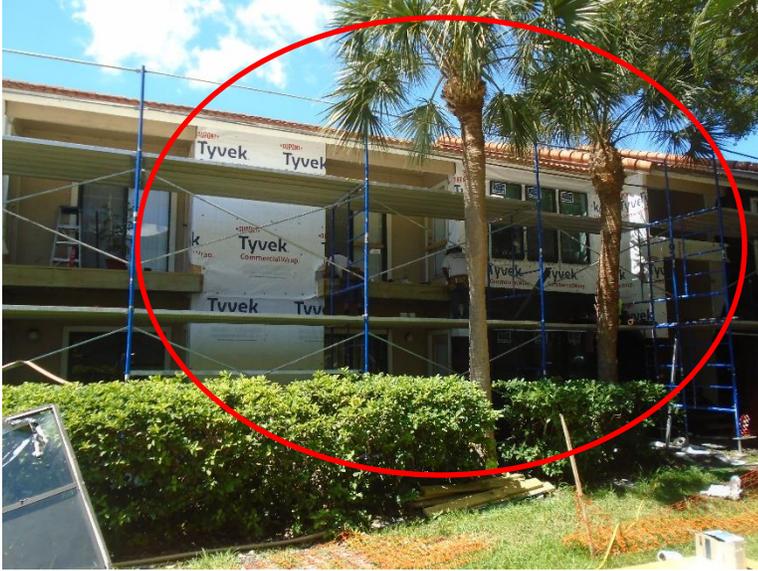
PHOTOGRAPH #15

**BUILDING 21
SECTION F**

Contractor has applied Tyvek WRB and Dupont flashings prior to installation of new PGT windows.

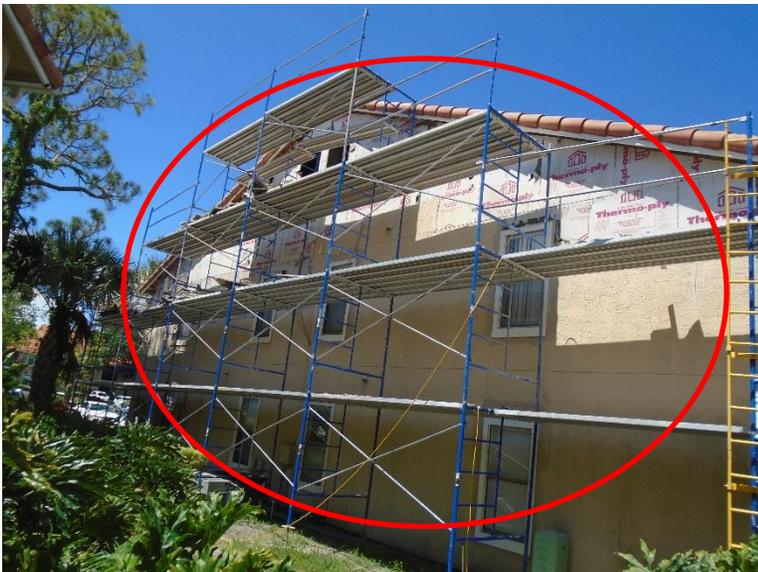
PHOTOGRAPH #16

**BUILDING 21
SECTION D**

Contractor has begun stucco removal, exposing existing Thermo Ply product.

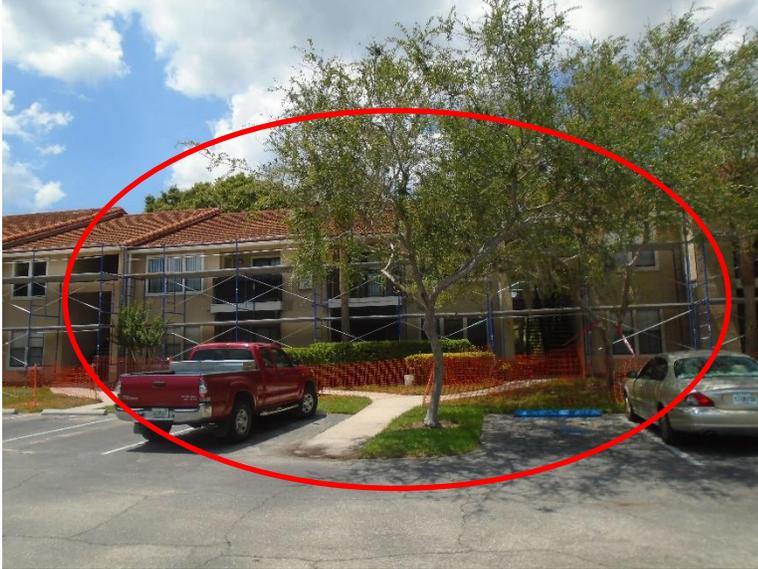
PHOTOGRAPH #17

**BUILDING 21
SECTION B**

Contractor has erected scaffolding for access to repairs and installed temporary construction fencing.
