PHOTOGRAPHS

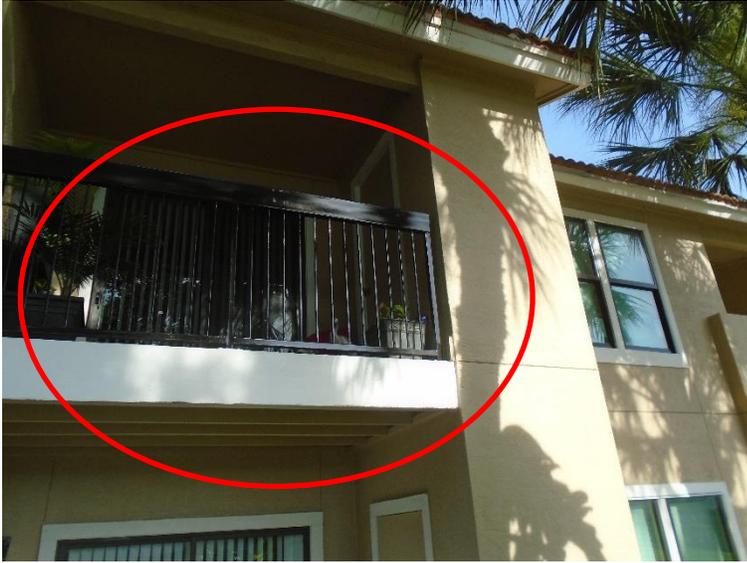
PHOTOGRAPH #1

**BUILDING 23
SECTION G**

Balcony railings painted and reinstalled.
Top railing attachments have not been
installed.

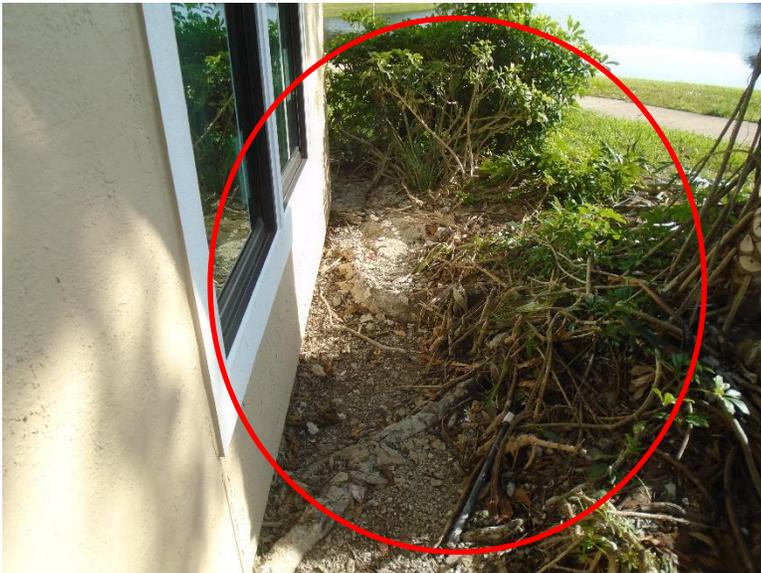
PHOTOGRAPH #2

**BUILDING 23
SECTION G**

Construction and stucco debris remain
for final clean up.

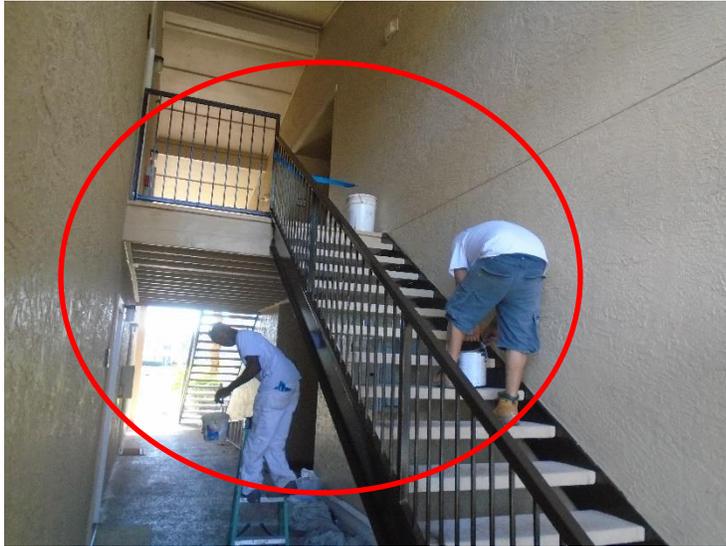
PHOTOGRAPH #3

**BUILDING 23
SECTION G**

Contractor applying Florida paints TropiCrete concrete sealer at steps and flooring.

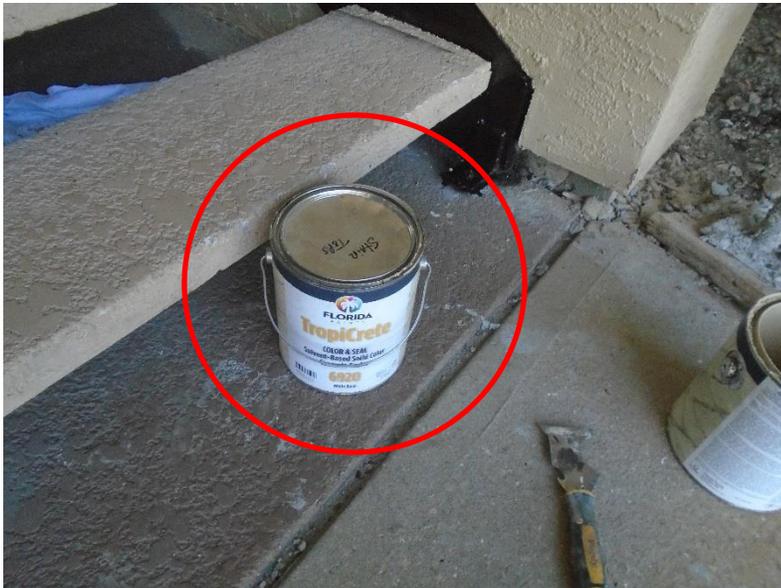
PHOTOGRAPH #4

**BUILDING 23
SECTION G**

Contractor applying Florida paints TropiCrete concrete sealer at steps and flooring.

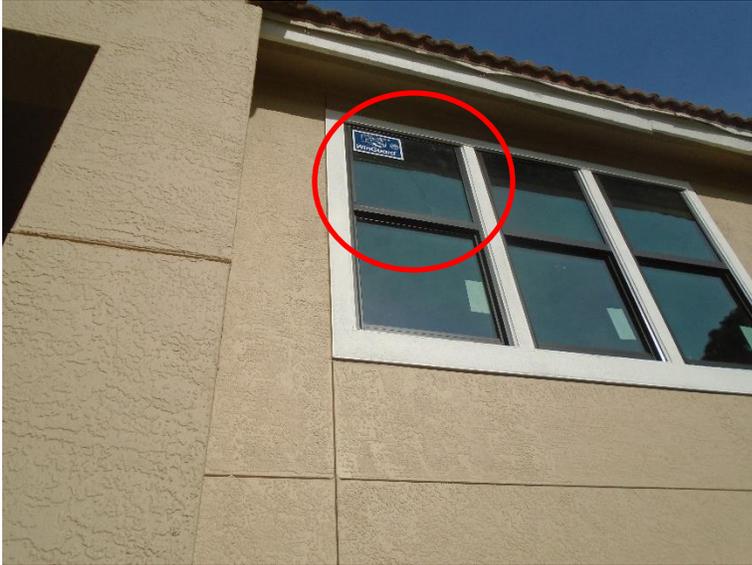
PHOTOGRAPH #5

**BUILDING 23
SECTION F**

New PGT window is cracked and will require replacement.

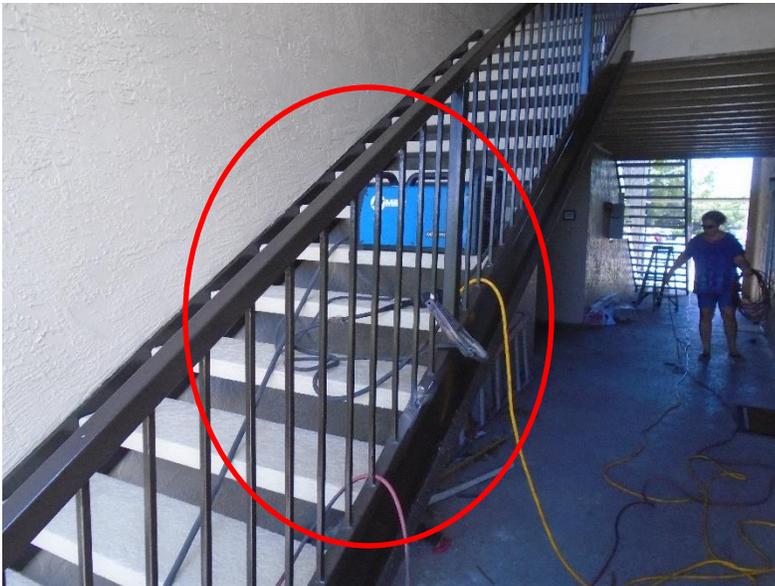
PHOTOGRAPH #6

**BUILDING 23
SECTION E**

Welding sub-contractor repairing damaged steel railing system.

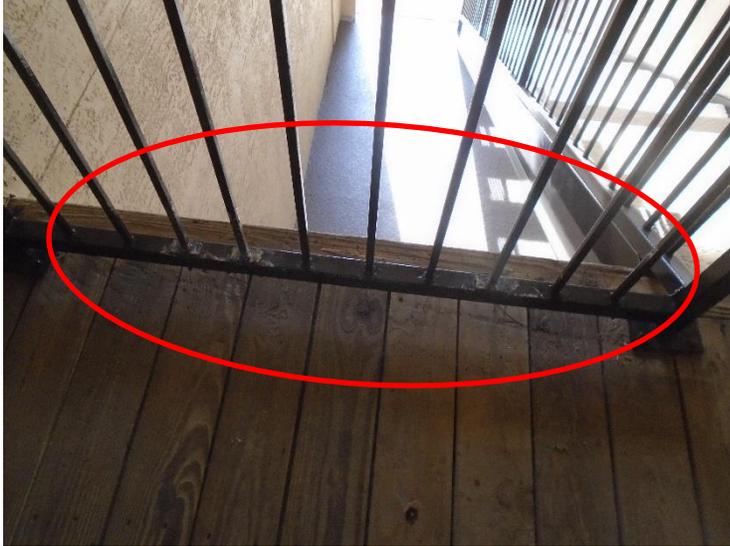
PHOTOGRAPH #7

**BUILDING 23
SECTION E**

Welding sub-contractor repairing
damaged steel railing system.

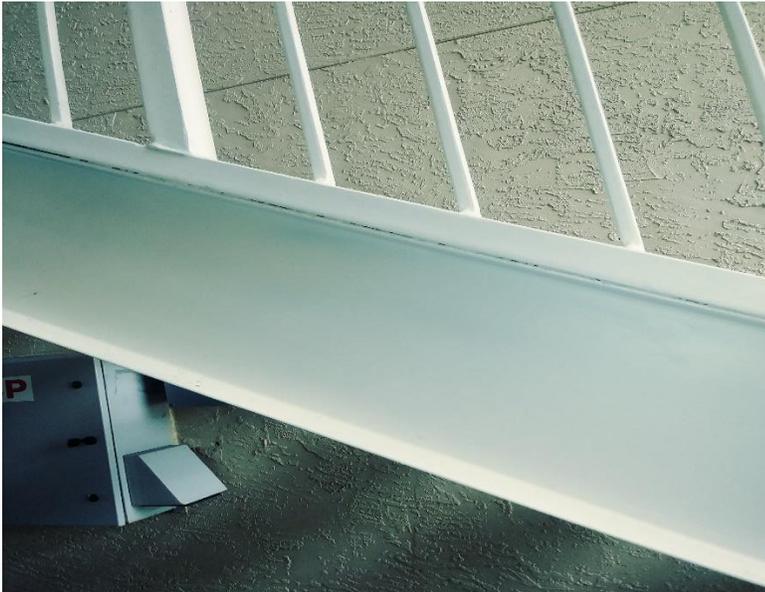
PHOTOGRAPH #8

**BUILDING 23
SECTION C**

Contractor has re primed stairway railings
prior to application of finish coat as
directed.

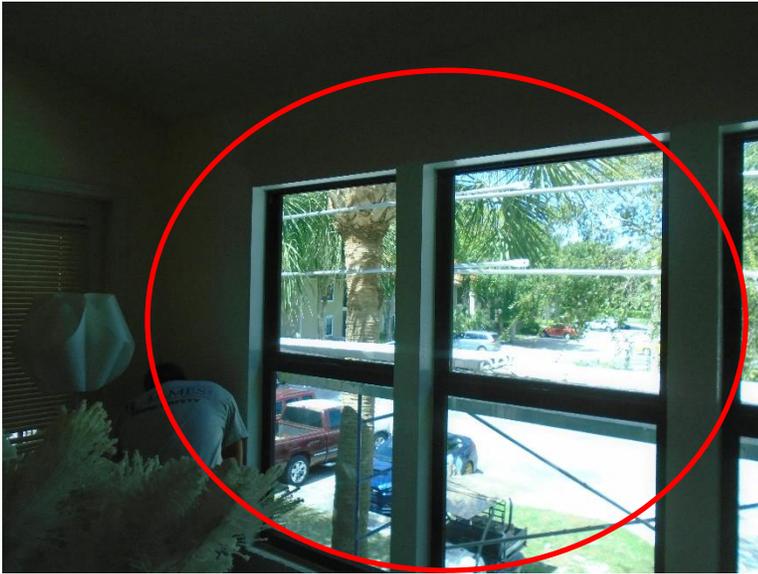
PHOTOGRAPH #9

**BUILDING 23
SECTION B – UNIT 2323**

Contractor finishing interior drywall and windowsill repairs.

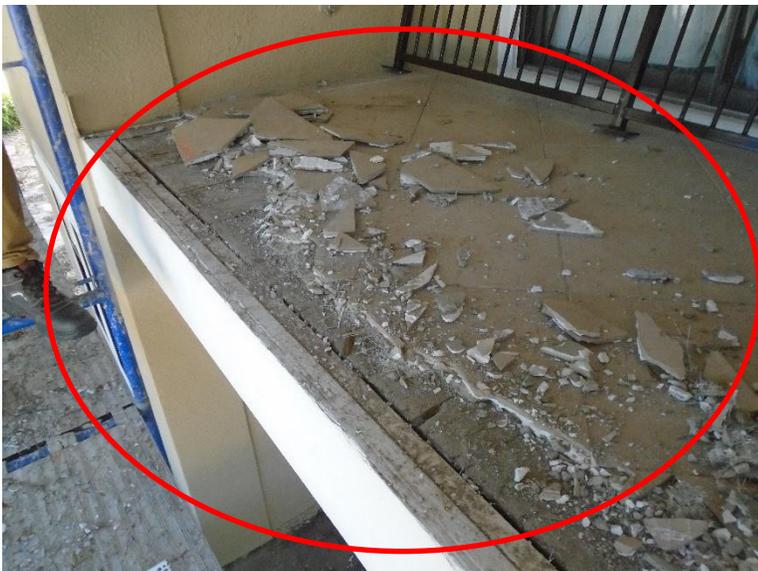
PHOTOGRAPH #10

**BUILDING 23
SECTION A- UNIT 2321**

Homeowners have begun to remove tile from balcony decking.

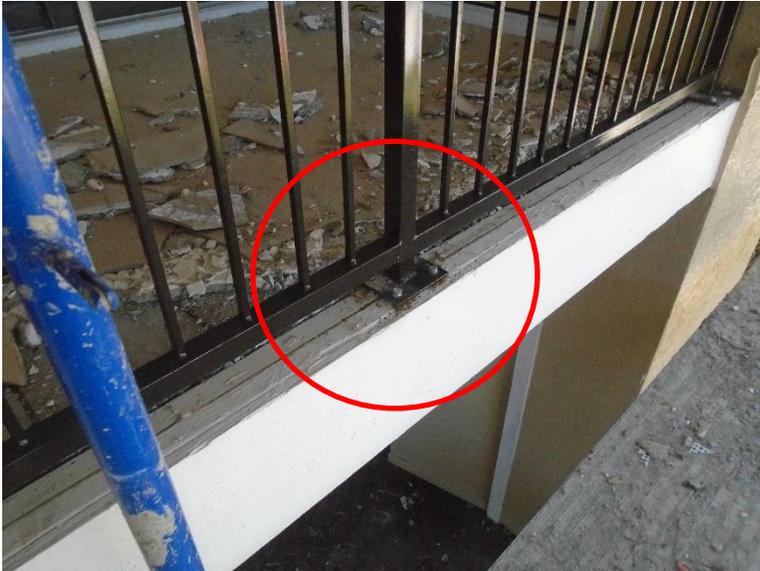
PHOTOGRAPH #11

**BUILDING 23
SECTION A- UNIT 2321**

Contractor has reinstalled repainted steel railing at balcony with 4" lag bolts.

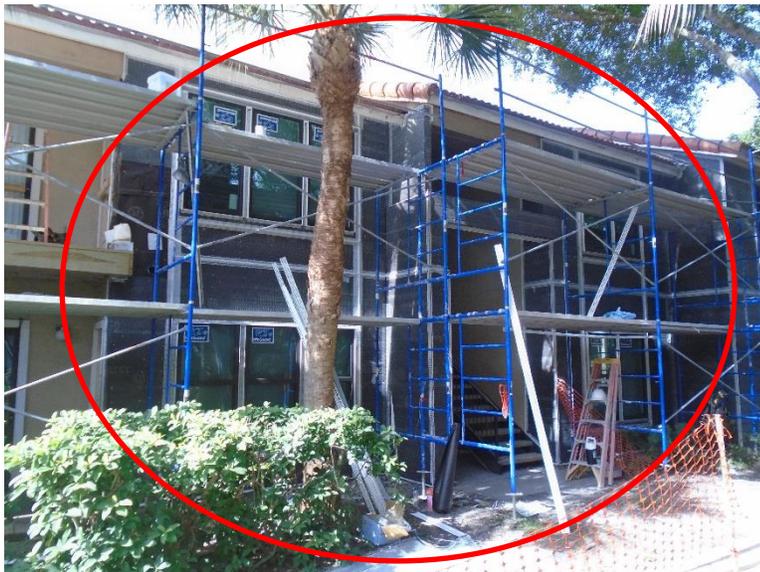
PHOTOGRAPH #12

**BUILDING 21
SECTION F**

Sub-contractor applying vinyl accessories and metal lath in preparation for new stucco.

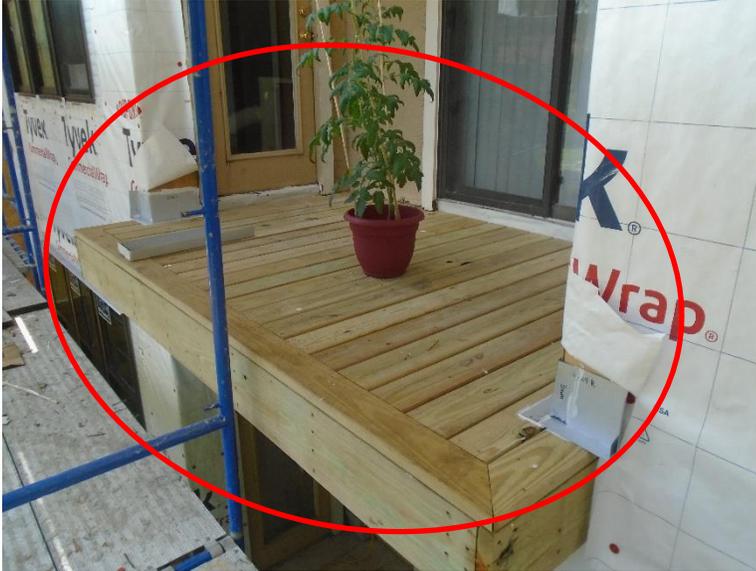
PHOTOGRAPH #13

**BUILDING 21
SECTION F**

Contractor has rebuilt balcony with new framing and new deck boards.

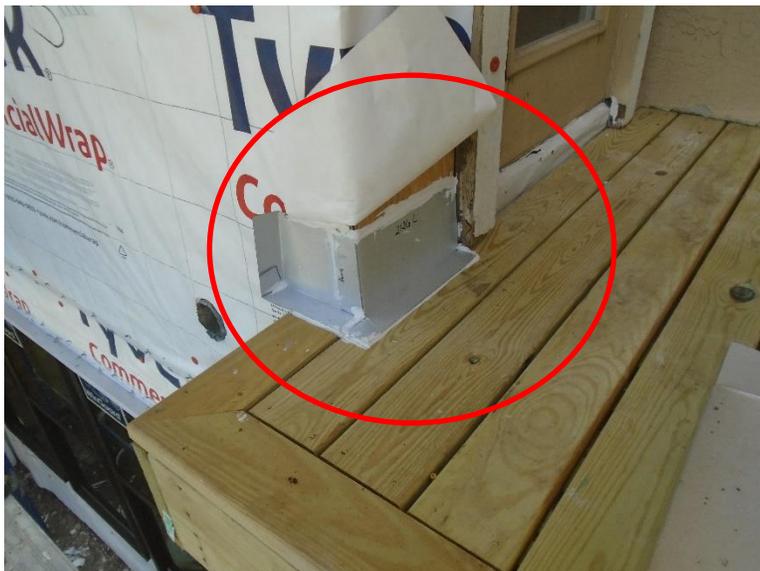
PHOTOGRAPH #14

**BUILDING 21
SECTION F**

Galvanized flashing and kick out installed and sealed at balcony decks.

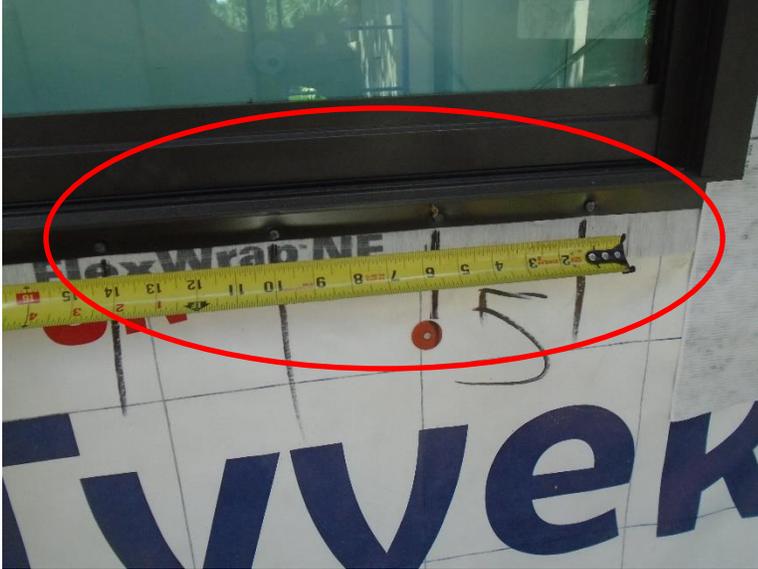
PHOTOGRAPH #15

**BUILDING 21
SECTION F**

Window fasteners and Dupont/Tyvek flashings inspected for compliance at new window installations.

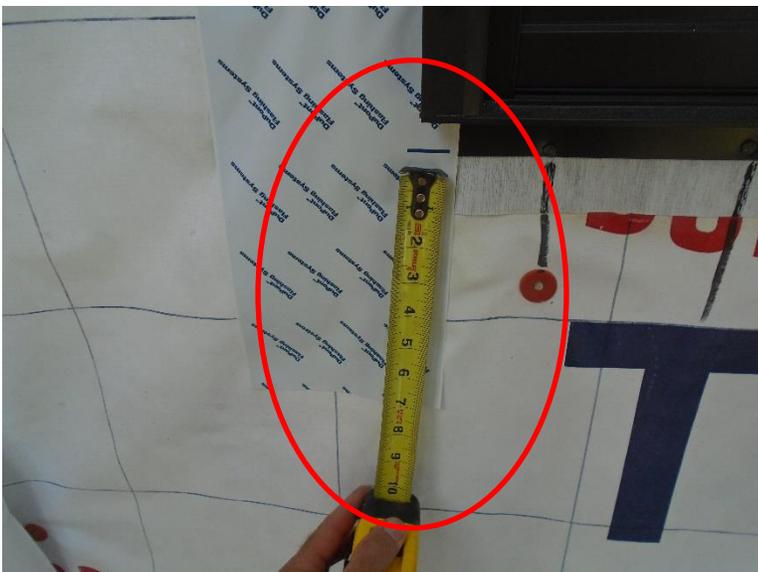
PHOTOGRAPH #16

**BUILDING 21
SECTION F**

Window fasteners and Dupont/Tyvek flashings inspected for compliance at new window installations.

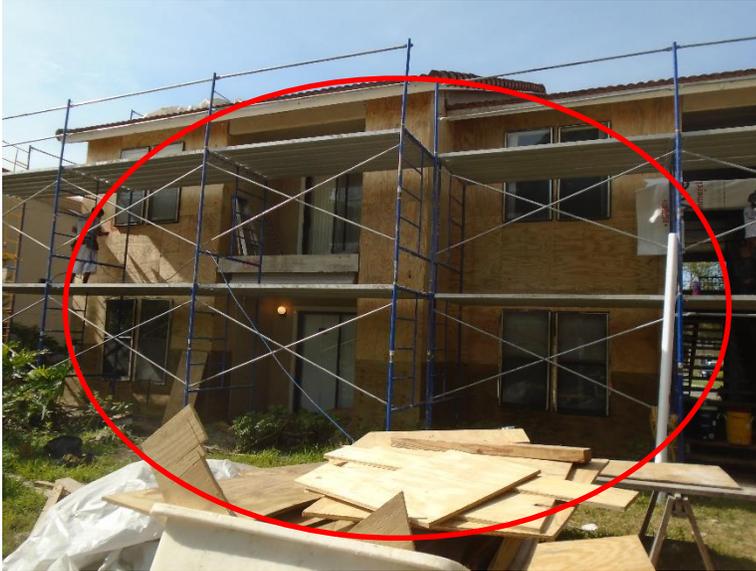
PHOTOGRAPH #17

**BUILDING 21
SECTION E**

Sheathing inspection revealed lack of 1/8" required spacing gaps between sheathing at several locations. Contractor made corrections as directed.

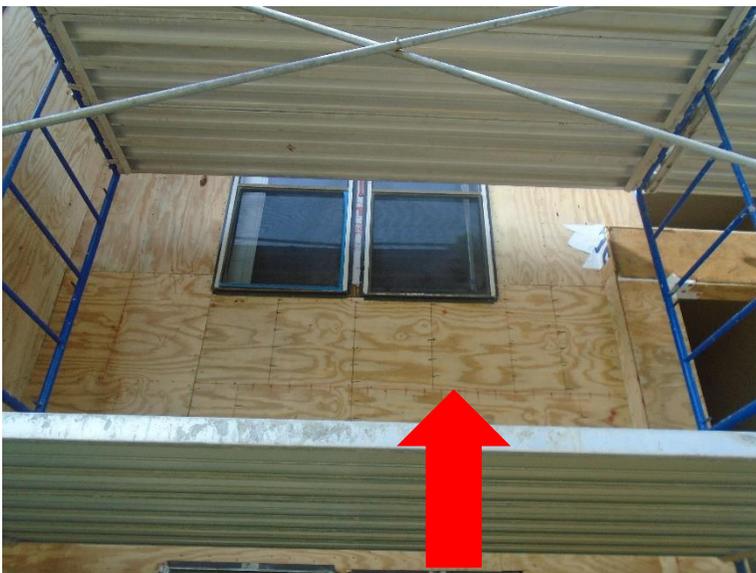
PHOTOGRAPH #18

**BUILDING 21
SECTION E**

Sheathing inspection revealed lack of 1/8" required spacing gaps between sheathing at several locations. Contractor made corrections as directed.

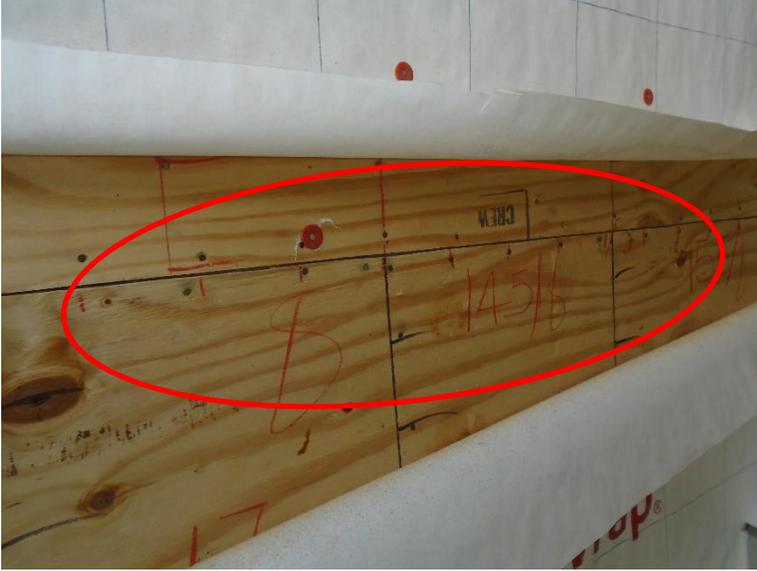
PHOTOGRAPH #19

**BUILDING 21
SECTION E**

Gaps opened to meet 1/8" required spacing at sheathing to sheathing. Nails between boards used for testing and spacing.

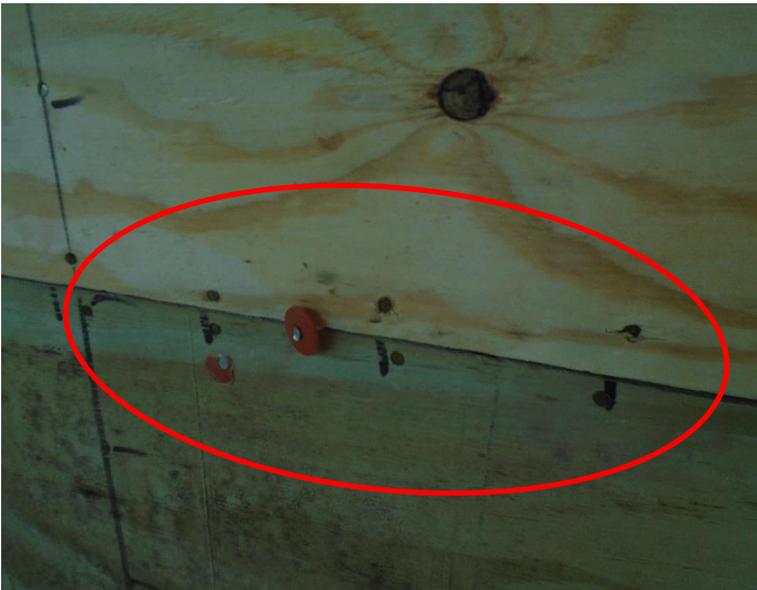
PHOTOGRAPH #20

**BUILDING 21
SECTION E**

Gaps opened to meet 1/8" required spacing at sheathing to sheathing. Nails between boards used for testing and spacing.

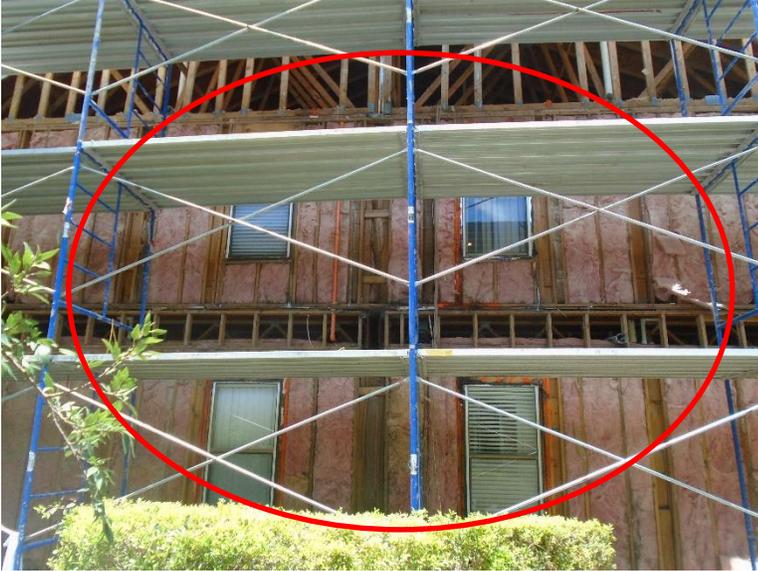
PHOTOGRAPH #21

**BUILDING 21
SECTION D**

Damaged headers, top plate and window framing inspected and marked for repairs.

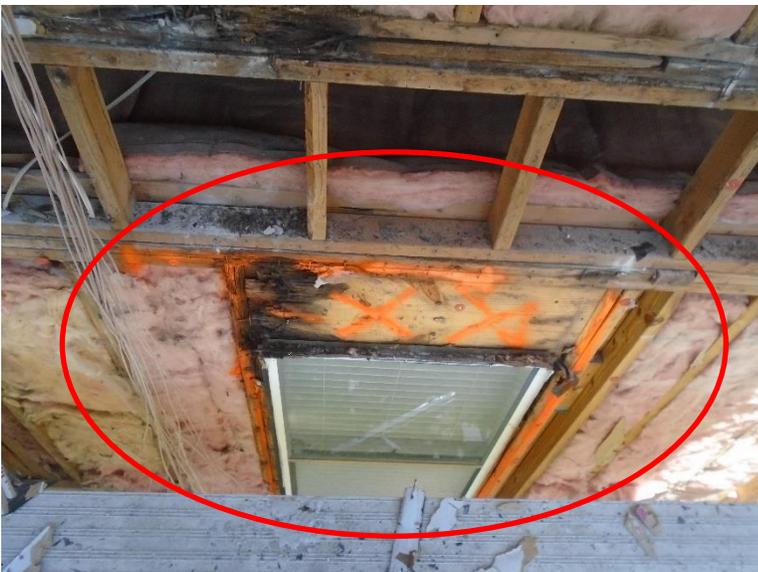
PHOTOGRAPH #22

**BUILDING 21
SECTION D**

Damaged headers, top plate and window framing inspected and marked for repairs.

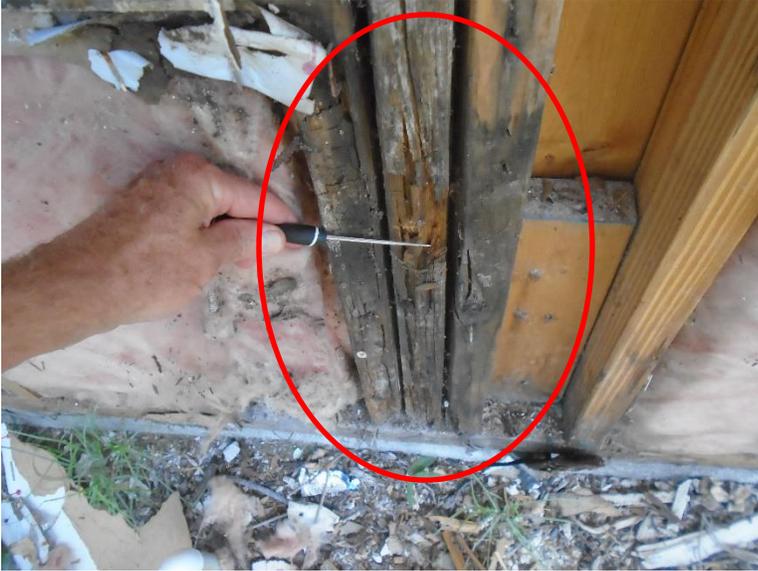
PHOTOGRAPH #23

**BUILDING 21
SECTION D**

Damaged wall framing inspected and marked for repairs.

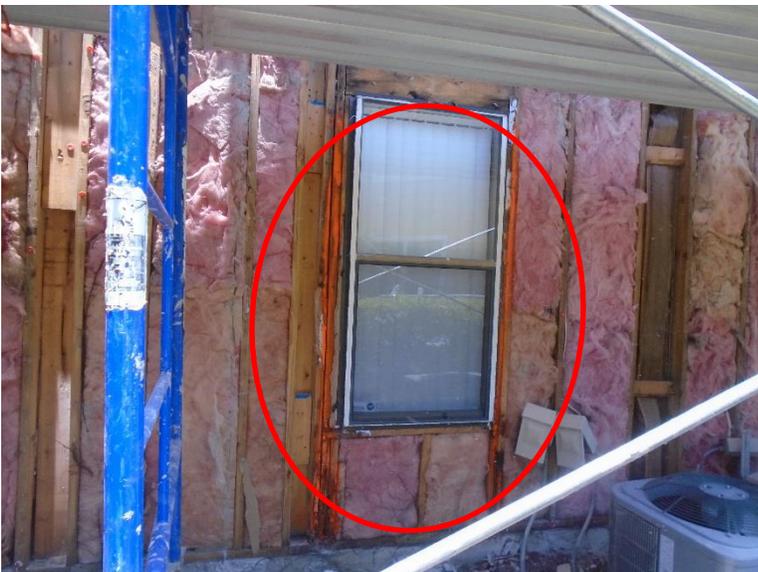
PHOTOGRAPH #24

**BUILDING 21
SECTION D**

Damaged wall framing inspected and marked for repairs.

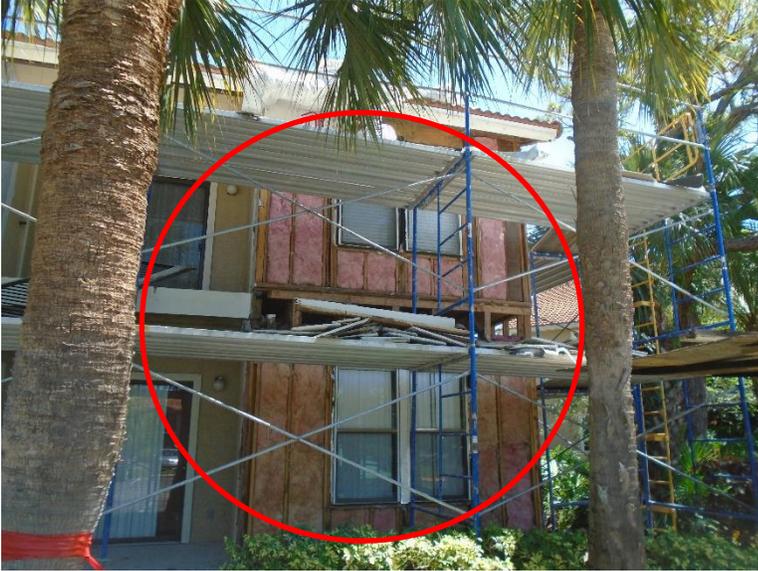
PHOTOGRAPH #25

**BUILDING 21
SECTION C**

Damaged wall framing inspected and marked for repairs.

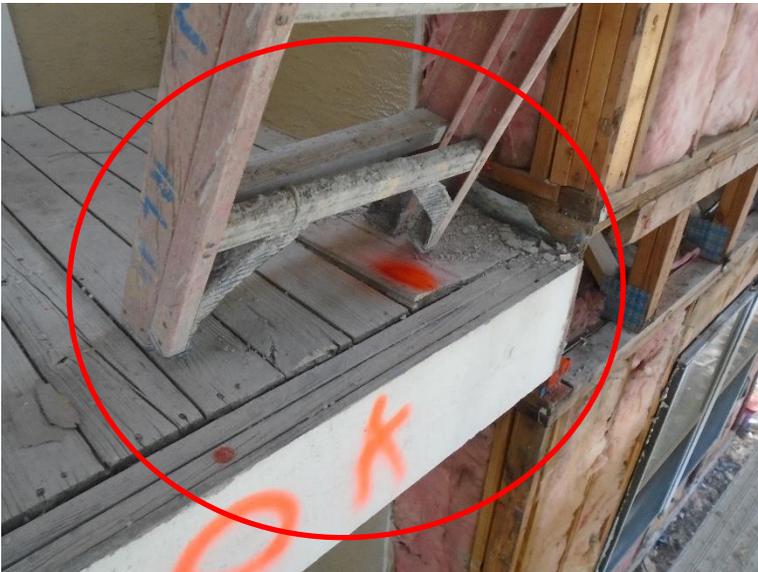
PHOTOGRAPH #26

**BUILDING 21
SECTION C**

Damaged balcony framing and deck board have been marked for repairs.

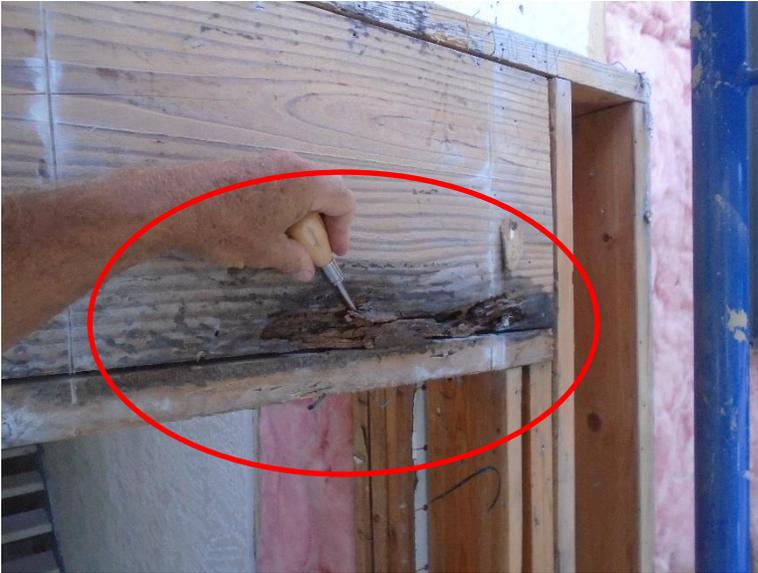
PHOTOGRAPH #27

**BUILDING 21
SECTION D**

Framing damage at breezeway has been identified and marked for repairs.

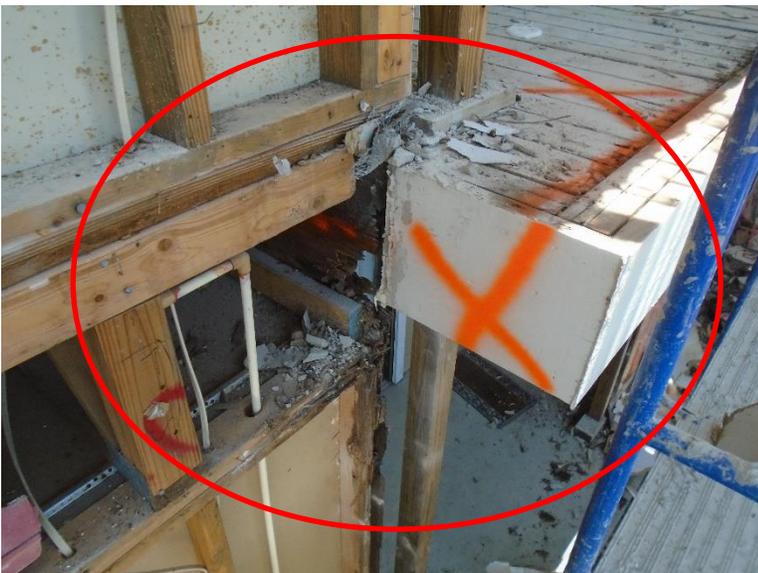
PHOTOGRAPH #28

**BUILDING 21
SECTION B**

Damaged balcony framing and deck board have been marked for repairs.

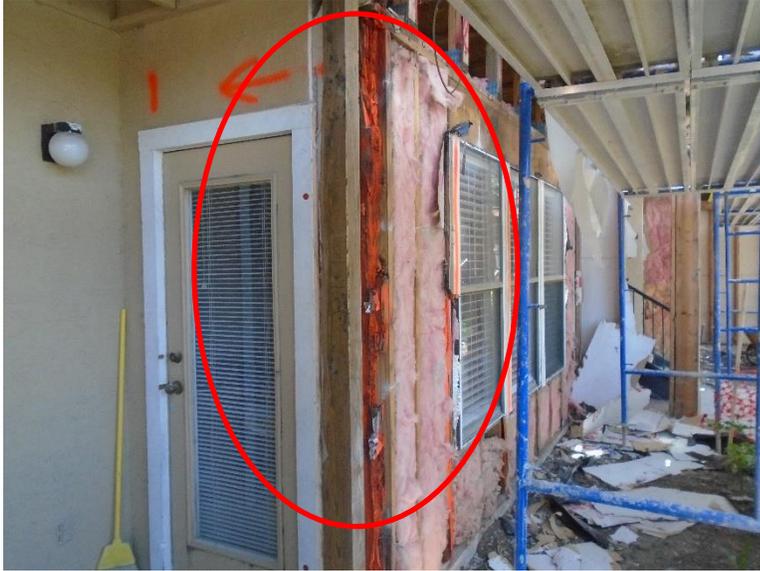
PHOTOGRAPH #29

**BUILDING 21
SECTION B**

Framing damage at balconies has been identified and marked for repairs.

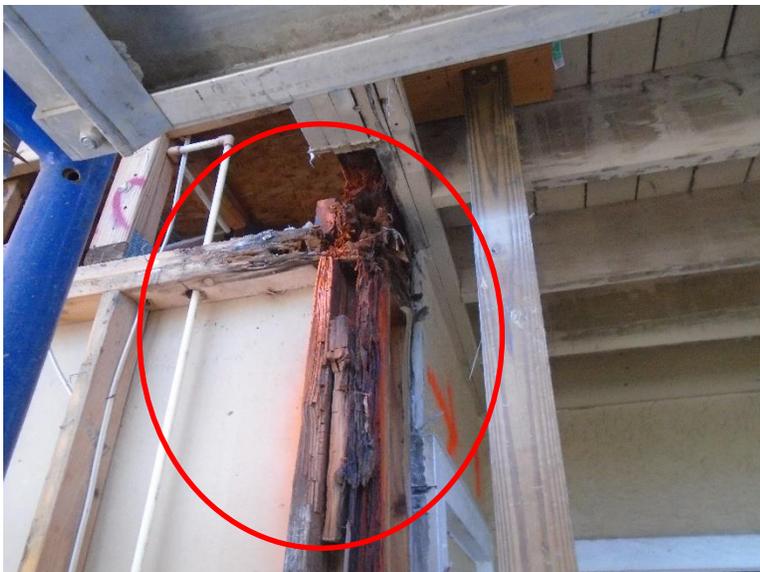
PHOTOGRAPH #30

**BUILDING 21
SECTION B**

Framing damage at balconies has been identified and marked for repairs.
