PHOTOGRAPHS

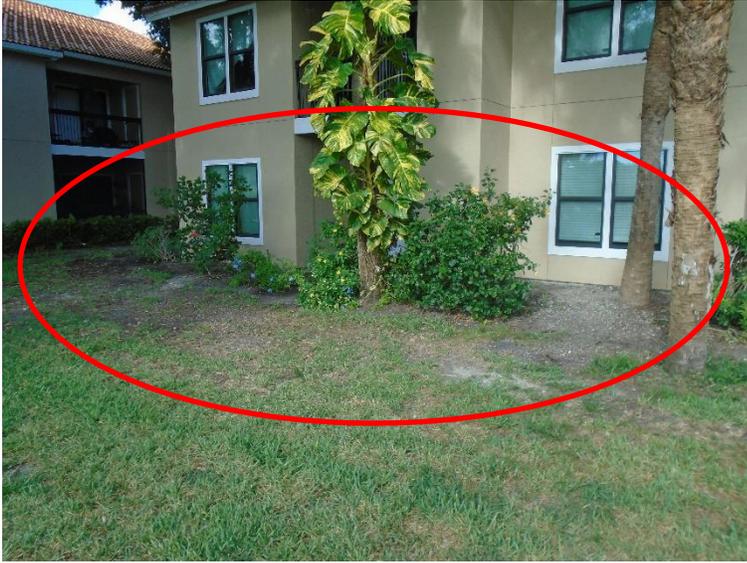
PHOTOGRAPH #1

**BUILDING 23
SECTION E**

Contractor has cleaned construction debris and raked grounds.

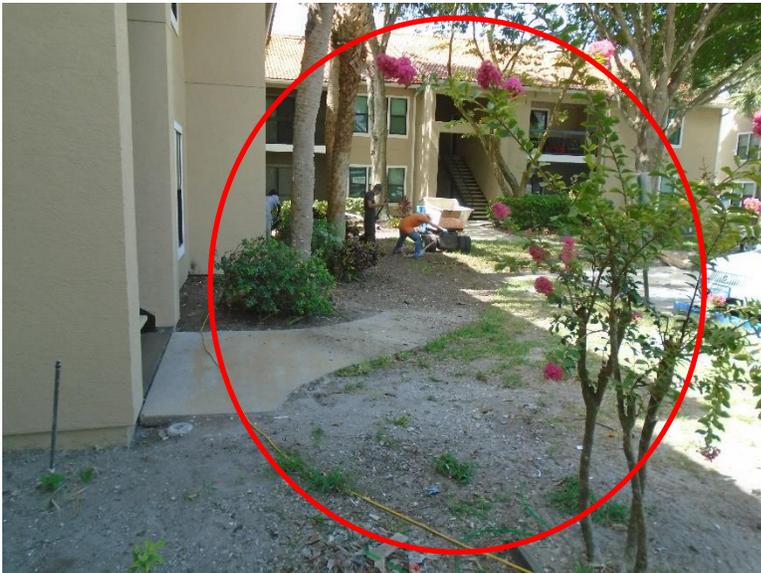
PHOTOGRAPH #2

**BUILDING 23
SECTION C**

Contractor in process of removing construction debris and raking grounds.

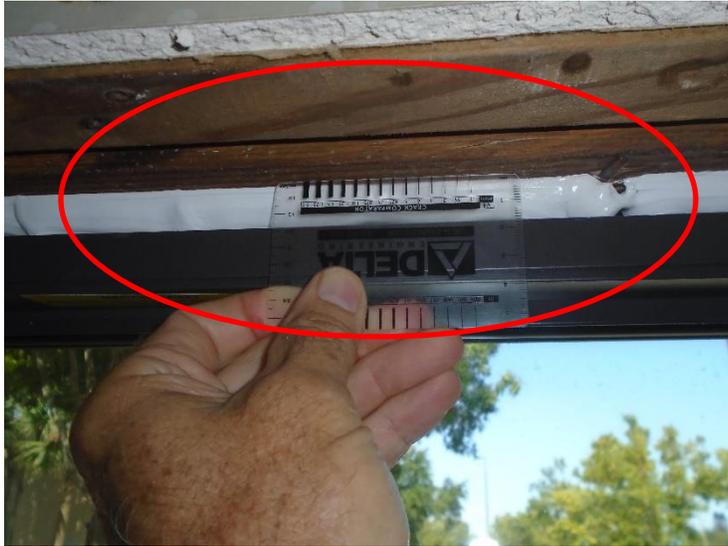
PHOTOGRAPH #3

**BUILDING 23
UNIT # 2317**

Gap at head of both windows in guest bedroom exceed allowable spacing for compliance with manufacturer's NOA for integral fin anchorage.

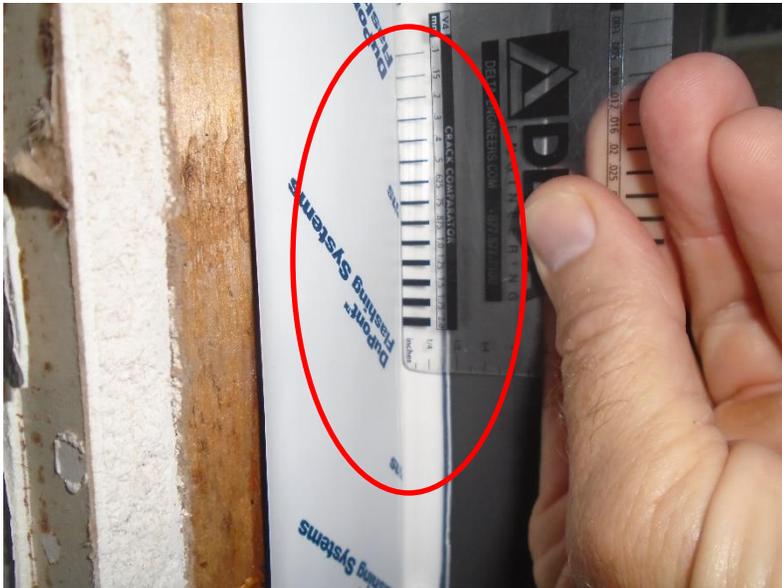
PHOTOGRAPH #4

**BUILDING 23
UNIT #2317**

Gap at jambs of windows spacing is at maximum spacing tolerance for manufacturer's NOAs for integral fin anchorage.

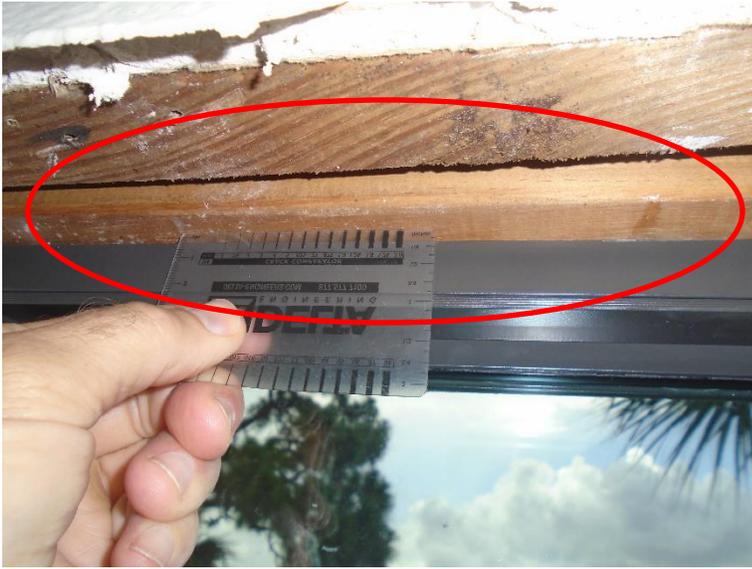
PHOTOGRAPH #5

**BUILDING 23
UNIT #2318**

Gap at head of window within allowable spacing for compliance with manufacturer's NOA for integral fin anchorage.

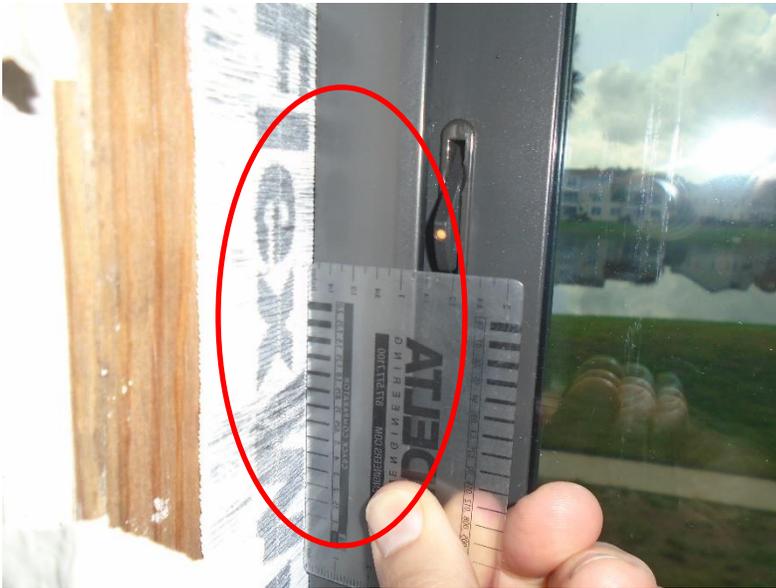
PHOTOGRAPH #6

**BUILDING 23
UNIT #2318**

Gap at jamb of window within allowable spacing for compliance with manufacturer's NOA for integral fin anchorage.

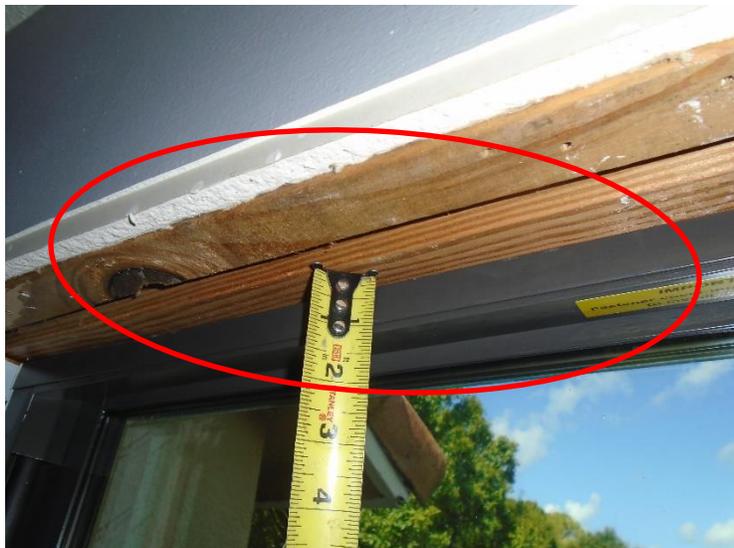
PHOTOGRAPH #7

**BUILDING 23
UNIT #2325**

Gap at head of window within allowable spacing for compliance with manufacturer's NOA for integral fin anchorage.

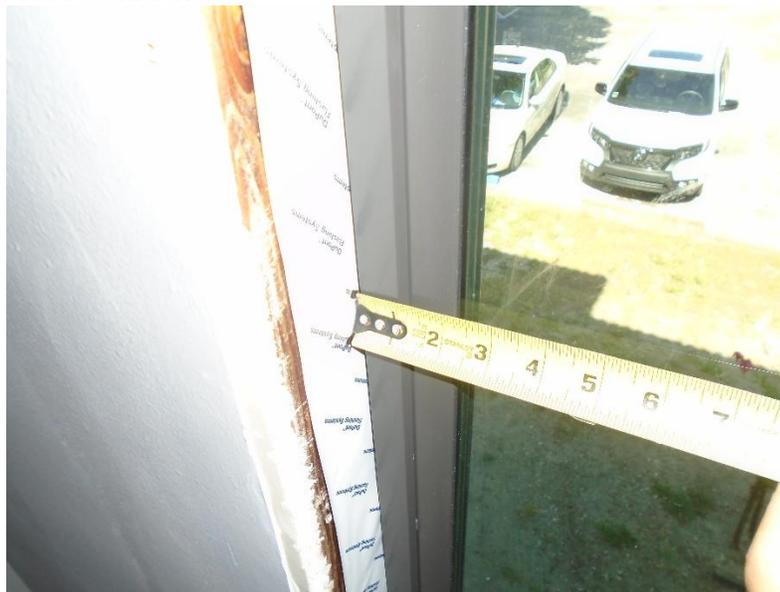
PHOTOGRAPH #8

**BUILDING 23
UNIT #2325**

Gap at jamb of window within allowable spacing for compliance with manufacturer's NOA for integral fin anchorage.

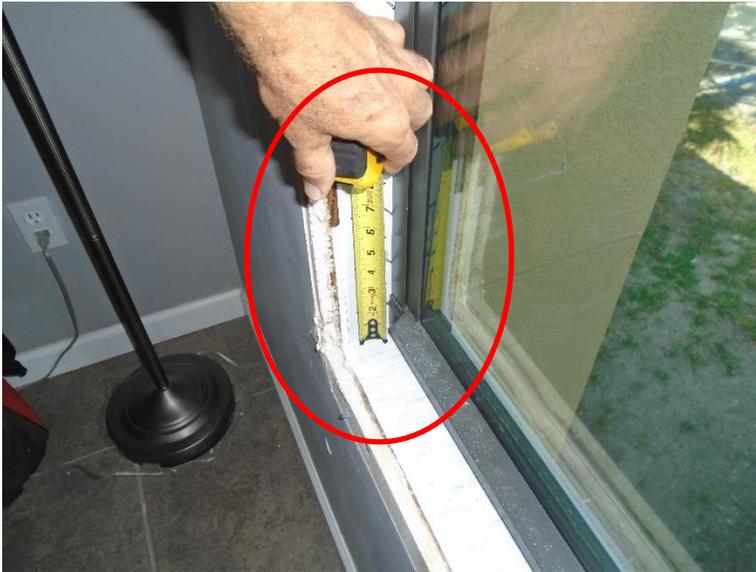
PHOTOGRAPH #9

**BUILDING 23
UNIT #2325**

Dupont flashing overlaps as per manufacturer's requirements at jambs to sill transition.

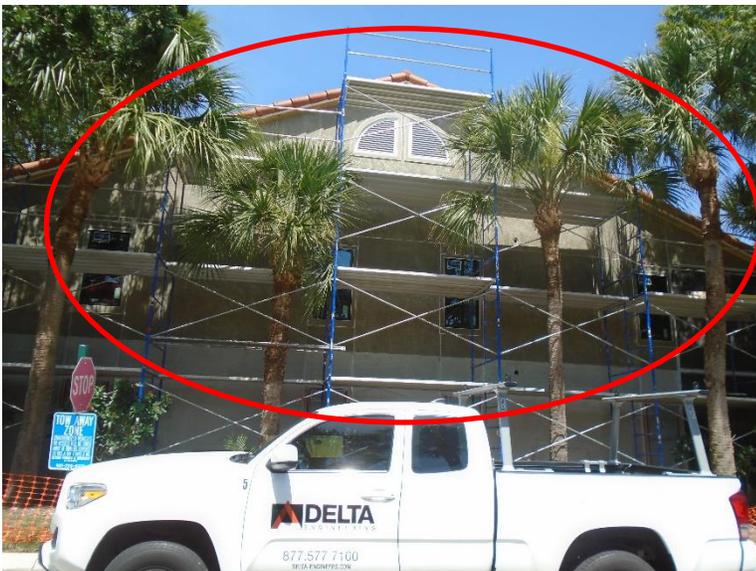
PHOTOGRAPH #10

**BUILDING 21
SECTION H**

Stucco sub-contractor has applied brown coat of stucco and begun finish coat of stucco.

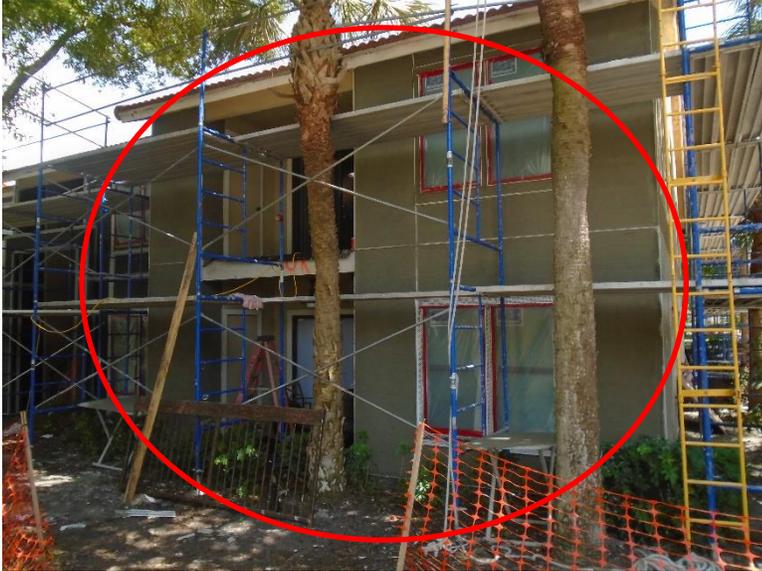
PHOTOGRAPH #11

**BUILDING 21
SECTION G**

Stucco sub-contractor has applied scratch coat of stucco.

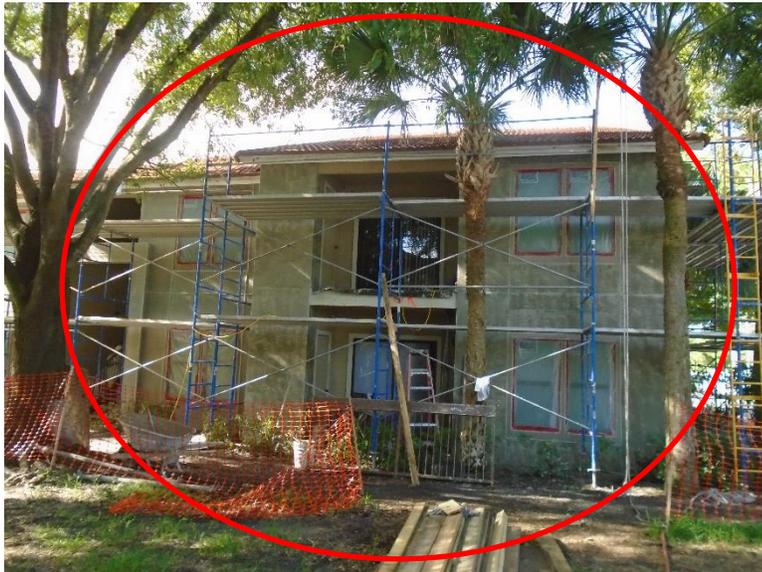
PHOTOGRAPH #12

**BUILDING 21
SECTION G**

Sub-contractor has applied brown coat of stucco and begun finish coat of stucco.

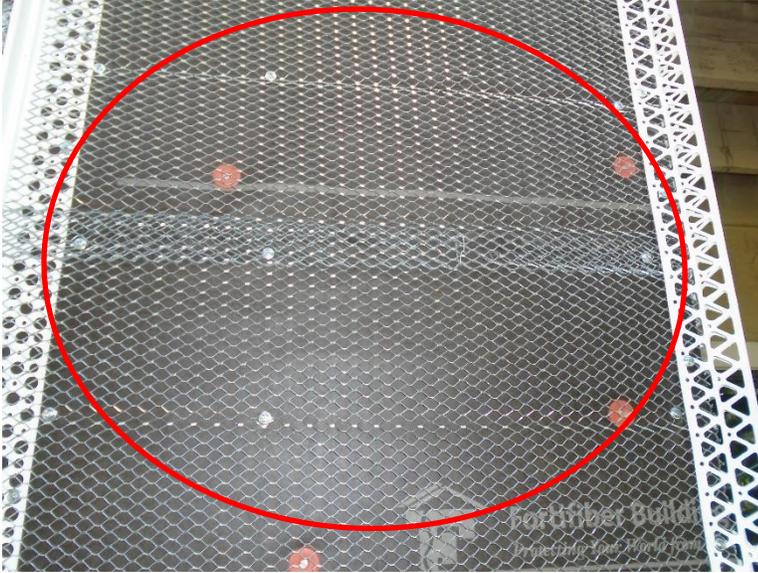
PHOTOGRAPH #13

**BUILDING 21
SECTION F**

Metal lathing and stucco accessories have been installed and inspected for fastening and overlapping requirements.

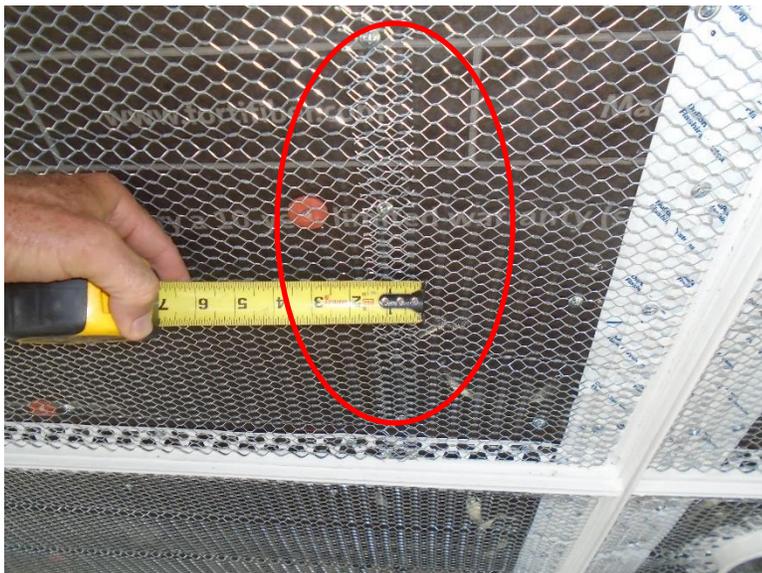
PHOTOGRAPH #14

**BUILDING 21
SECTION F**

Metal lathing and stucco accessories have been installed and inspected for fastening and overlapping requirements.

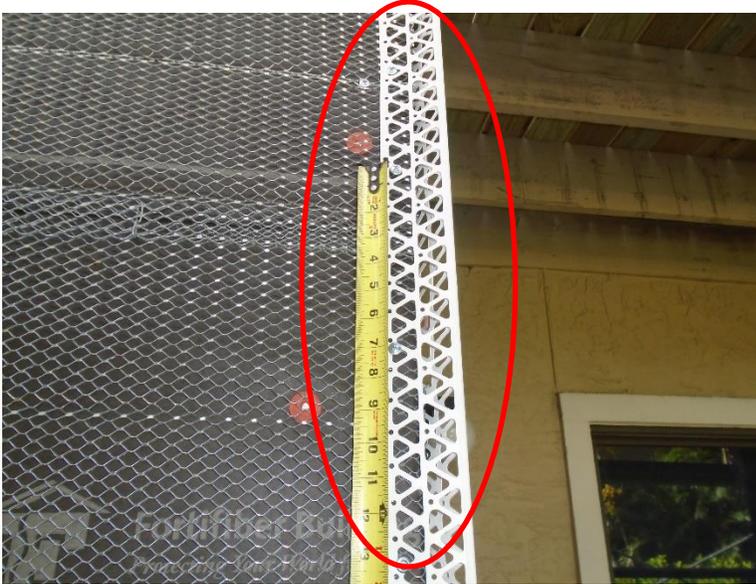
PHOTOGRAPH #15

**BUILDING 21
SECTION F**

Metal lathing and stucco accessories have been installed and inspected for fastening and overlapping requirements.

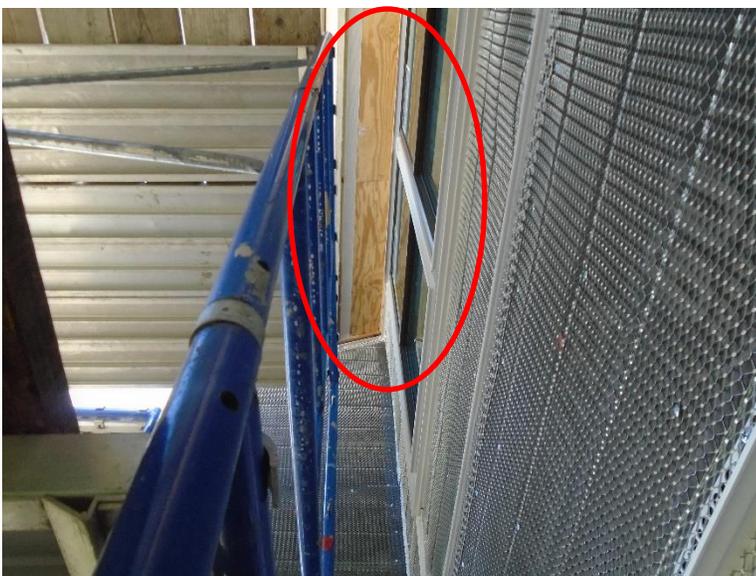
PHOTOGRAPH #16

**BUILDING 21
SECTION F**

New vented soffit has been installed and inspected.

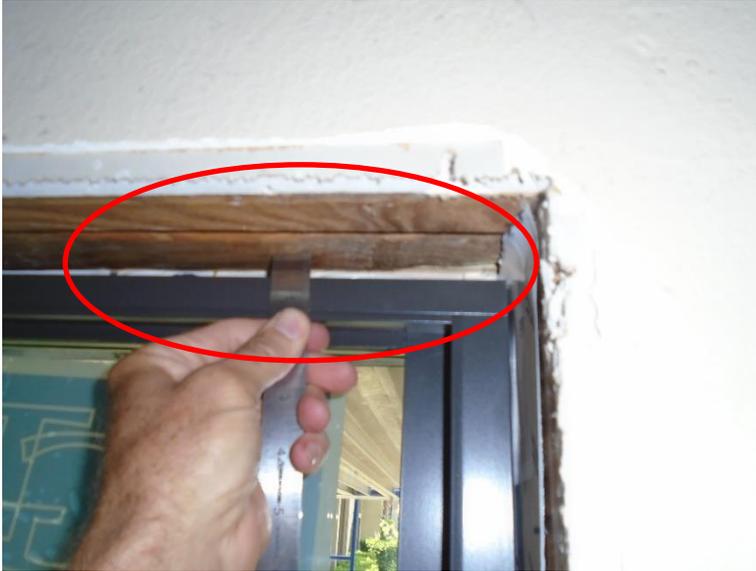
PHOTOGRAPH #17

**BUILDING 21
UNIT #2116**

Gap at head of one window in living room exceeds allowable spacing for compliance with manufacturer's NOA for integral fin anchorage.

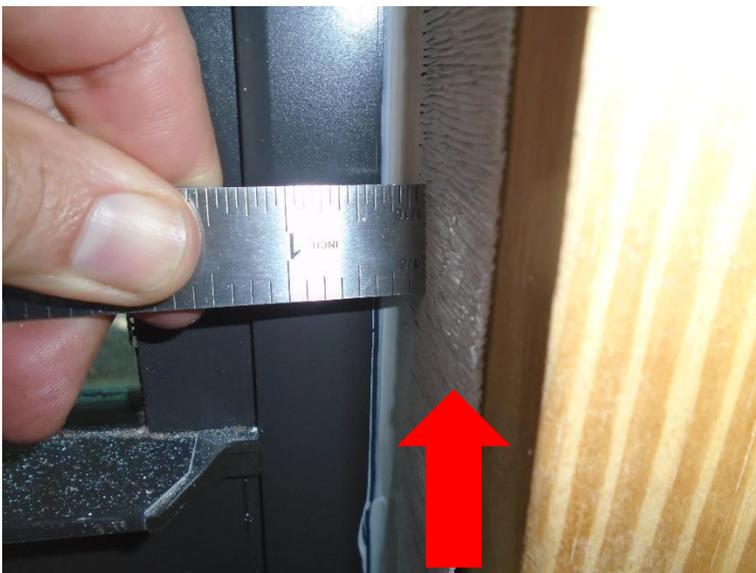
PHOTOGRAPH #18

**BUILDING 21
UNIT #2116**

Gap at jambs of windows within allowable spacing for compliance with manufacturer's NOA for integral fin anchorage.

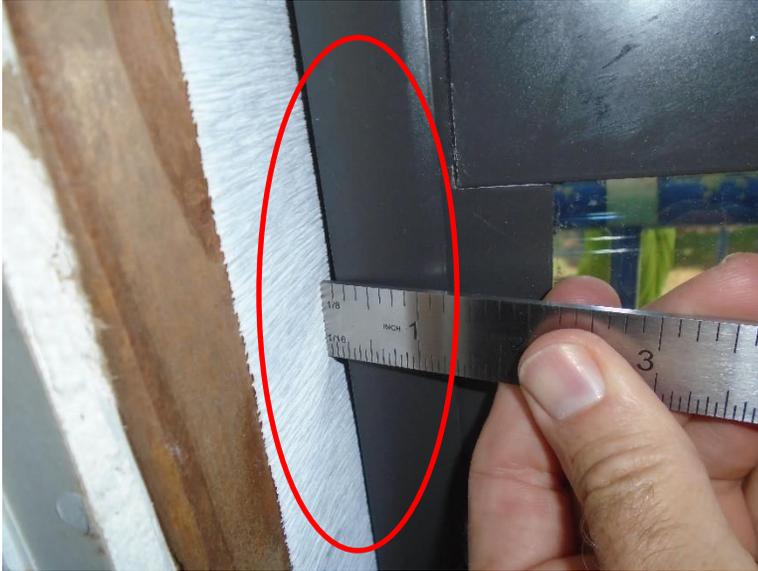
PHOTOGRAPH #19

**BUILDING 21
UNIT # 2128**

Gap at windows within allowable spacing for compliance with manufacturer's NOA for integral fin anchorage.

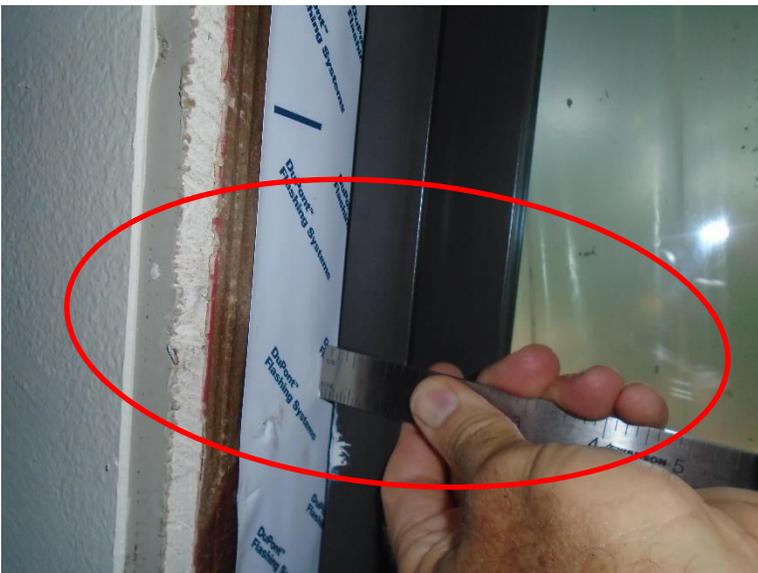
PHOTOGRAPH #20

**BUILDING 21
UNIT # 2111**

Gap at windows within allowable spacing for compliance with manufacturer's NOA for integral fin anchorage.

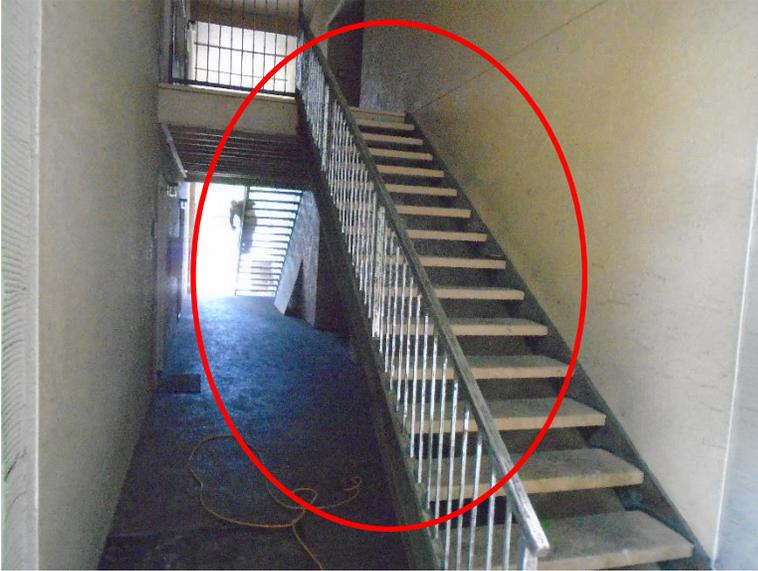
PHOTOGRAPH #21

**BUILDING 21
SECTION E**

Contractor removing old paints and rust at breezeway railings with electric grinders.

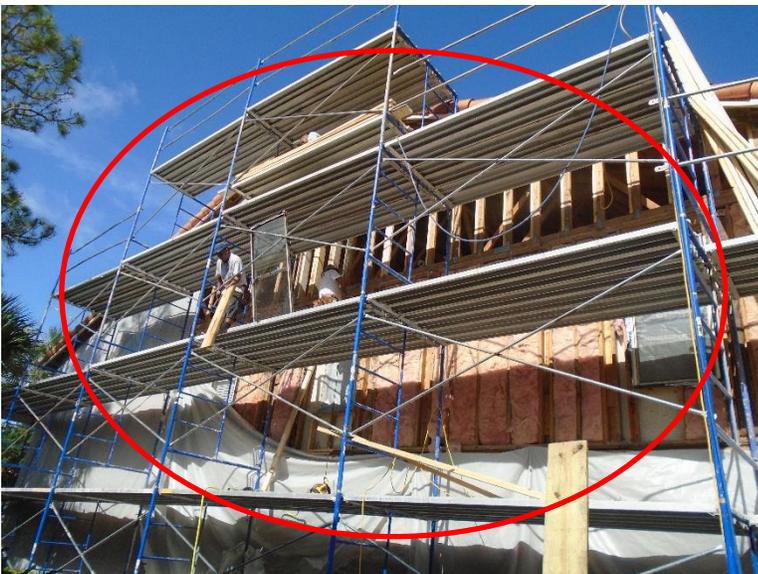
PHOTOGRAPH #22

**BUILDING 21
SECTION D**

Contractor performing framing and gable end repairs.

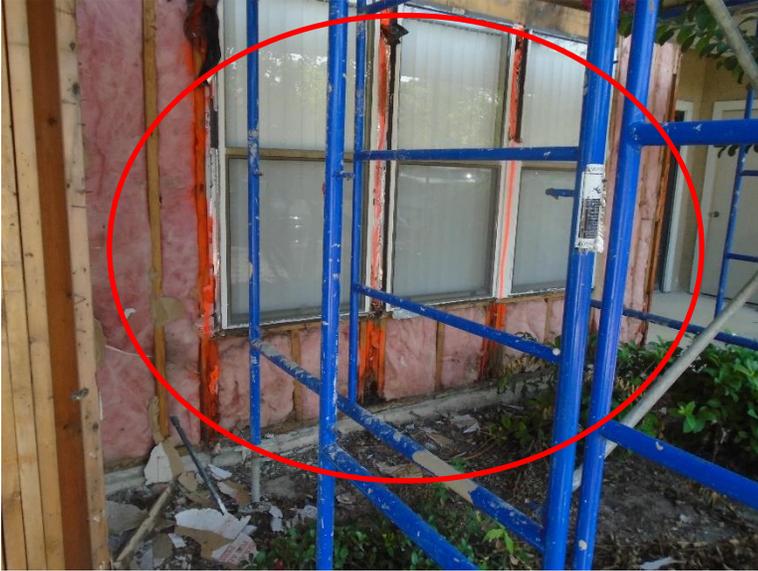
PHOTOGRAPH #23

**BUILDING 21
SECTION B**

Damaged wall framing inspected and marked for repairs.

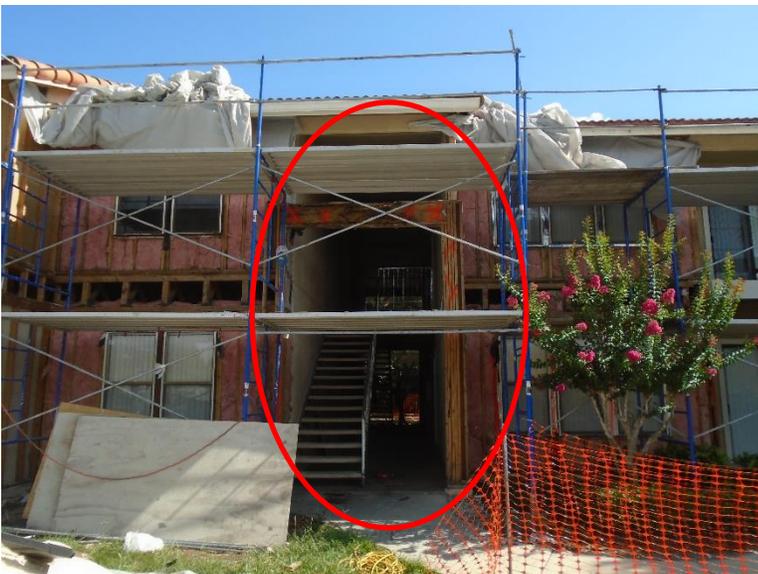
PHOTOGRAPH #24

**BUILDING 21
SECTION A**

Damaged breezeway framing inspected and marked for repairs.

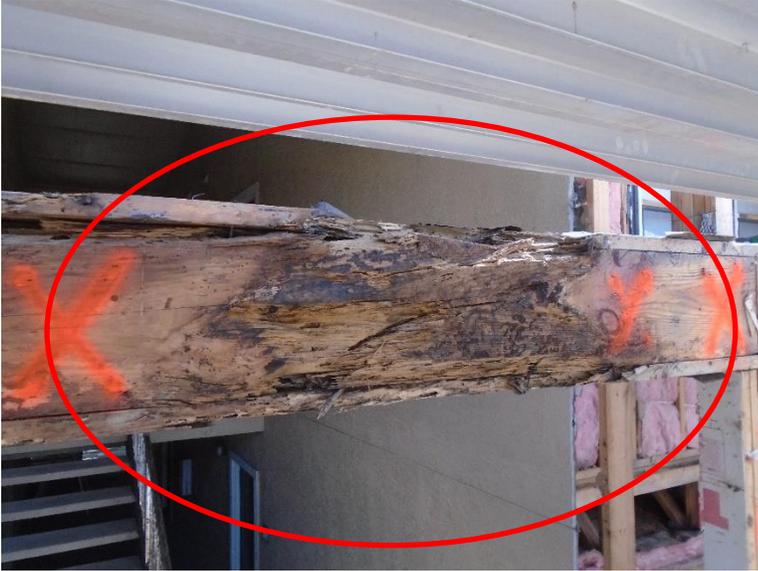
PHOTOGRAPH #25

**BUILDING 21
SECTION A**

Damaged breezeway framing inspected and marked for repairs.

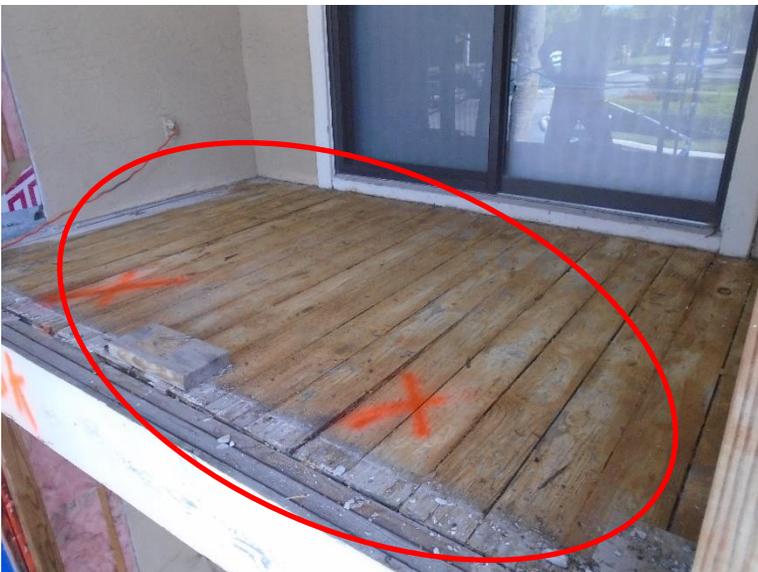
PHOTOGRAPH #26

**BUILDING 21
SECTION A**

Damaged balcony deck board have been identified and marked for repairs.

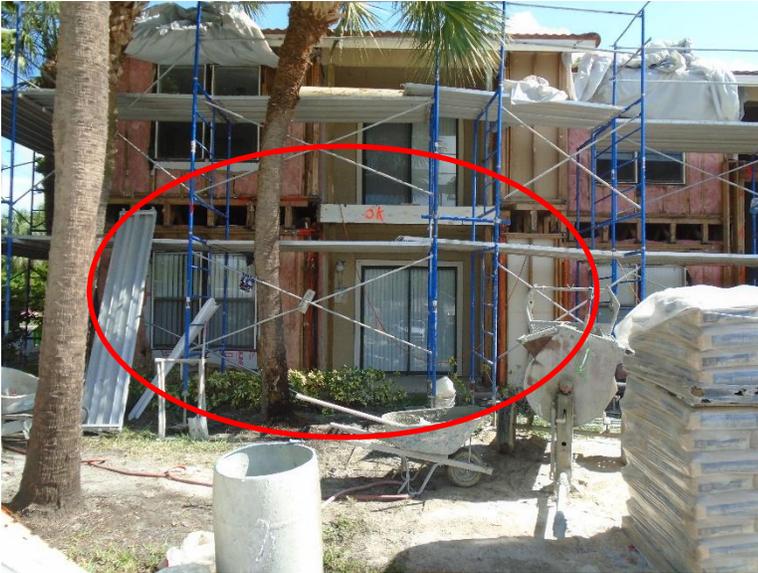
PHOTOGRAPH #27

**BUILDING 21
SECTION A**

Framing and balcony damage has been identified and marked for repairs.
