## PHOTOGRAPHS

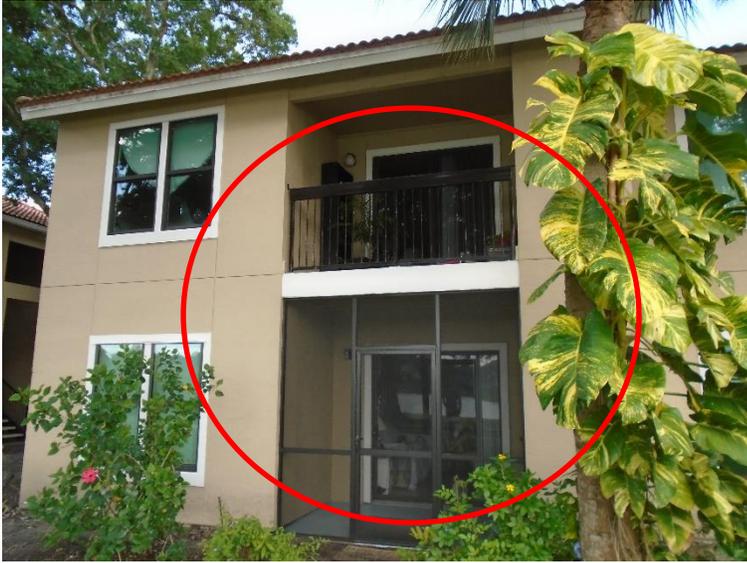
**PHOTOGRAPH #1**

### **BUILDING 23 SECTION A**

Contractor has installed screen enclosures and completed upper balcony handrailing attachments.

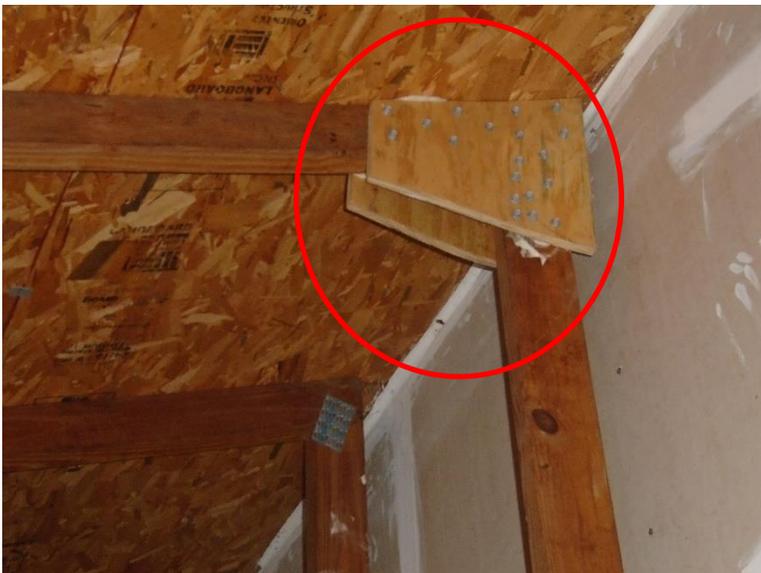
**PHOTOGRAPH #2**

### **BUILDING 23 ATTIC REPAIRS UNIT 2323**

Contractor has performed repairs at gussets, trusses, and fire walls.

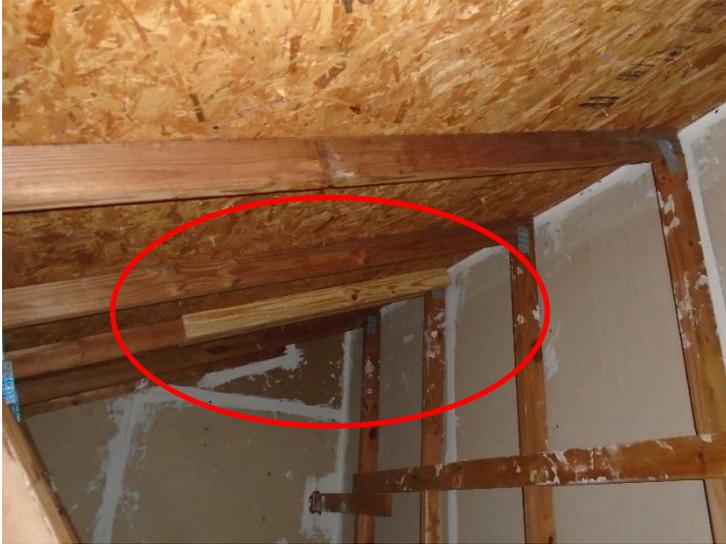
**PHOTOGRAPH #3**

**BUILDING 23  
ATTIC REPAIRS UNIT 2323**

Contactor has performed repairs at gussets, trusses, and fire walls.

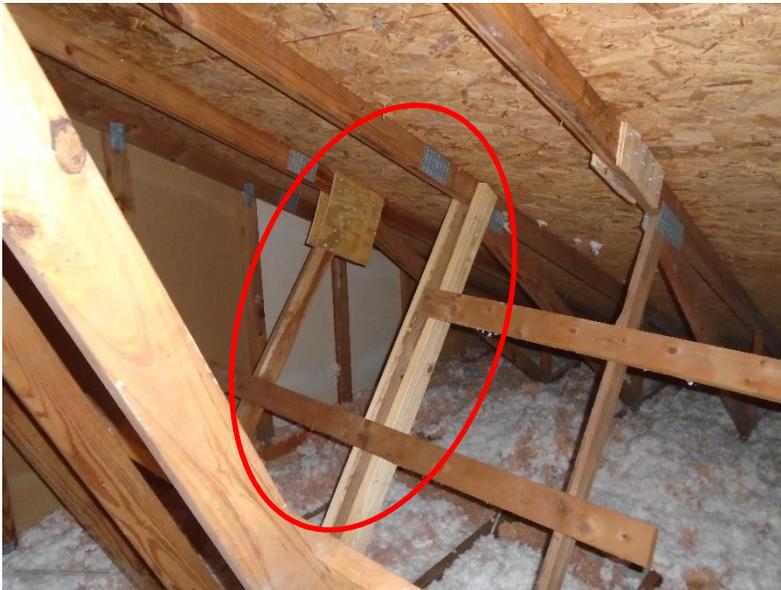
**PHOTOGRAPH #4**

**BUILDING 23  
ATTIC REPAIRS UNIT 2326**

Contactor has performed repairs at gussets, trusses, and fire walls.

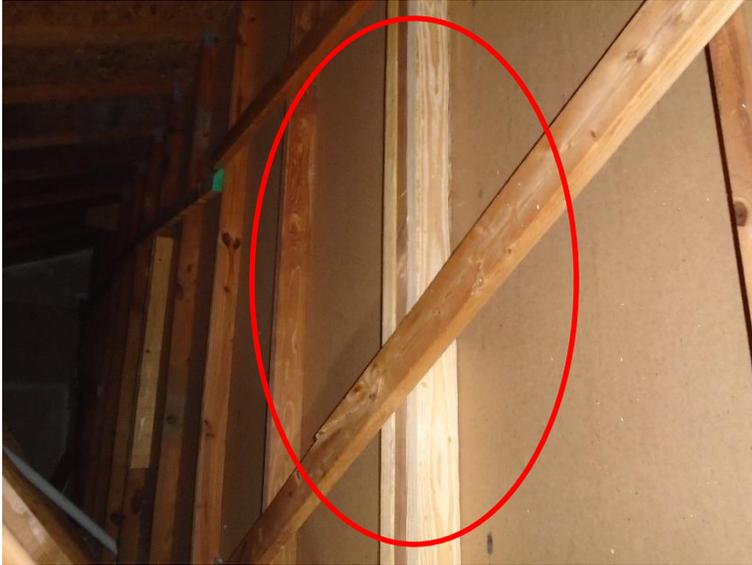
**PHOTOGRAPH #5**

**BUILDING 23  
ATTIC REPAIRS UNIT 2326**

Contactor has performed repairs at gussets, trusses, and fire walls.

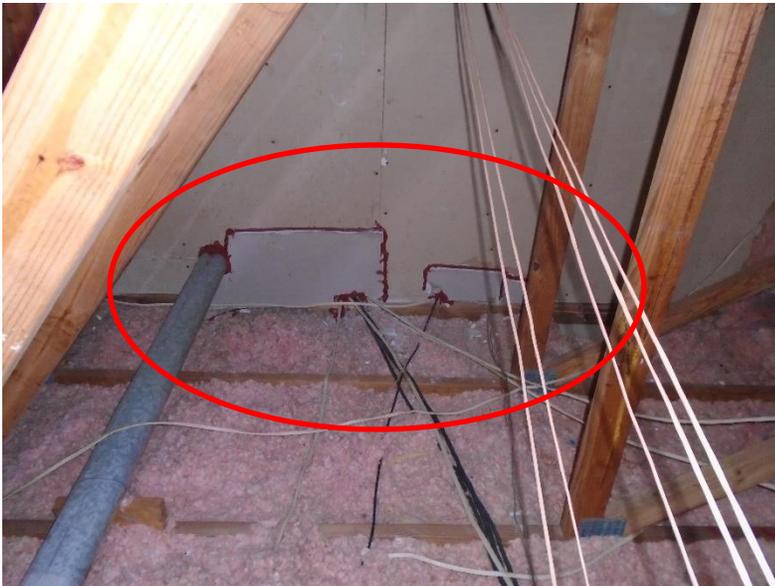
**PHOTOGRAPH #6**

**BUILDING 23  
ATTIC REPAIRS UNIT 2324**

Contactor has performed repairs at gussets, trusses, and fire walls.

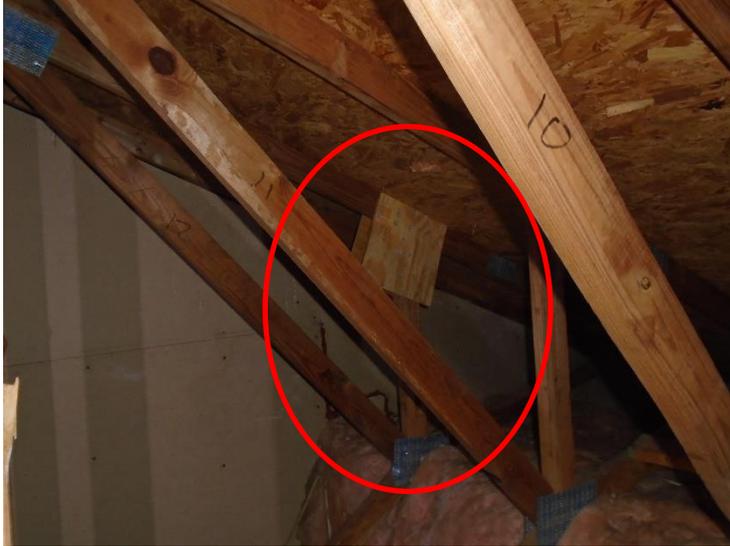
**PHOTOGRAPH #7**

**BUILDING 23  
ATTIC REPAIRS UNIT 2324**

Contractor has performed repairs at gussets, trusses, and fire walls.

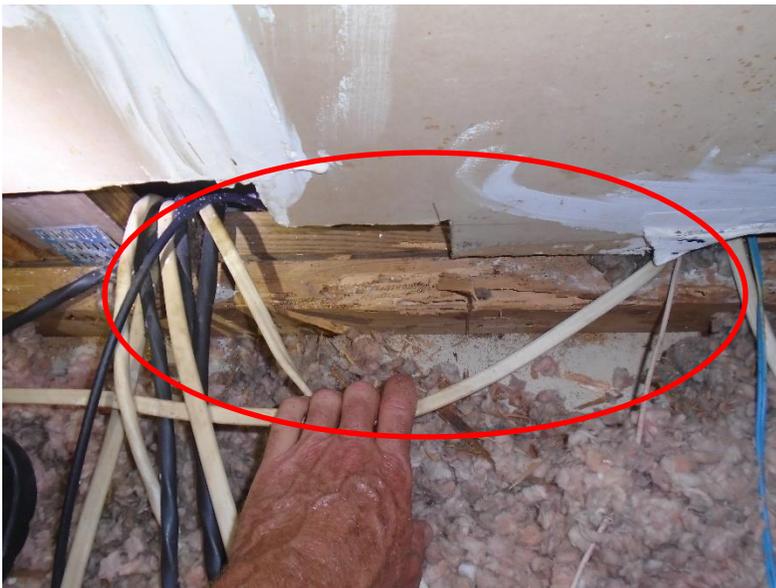
**PHOTOGRAPH #8**

**BUILDING 23  
ATTIC REPAIRS UNIT 2325**

Termite damage discovered will require additional investigation and repair details.

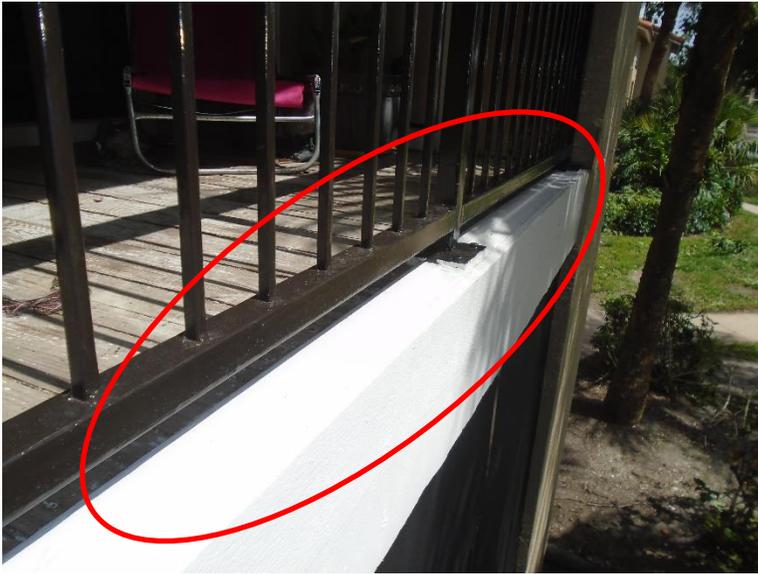
**PHOTOGRAPH #9**

**BUILDING 23  
SECTION E**

Contractor completed caulking details at top of rim joist and cedar face trim with urethane sealants.

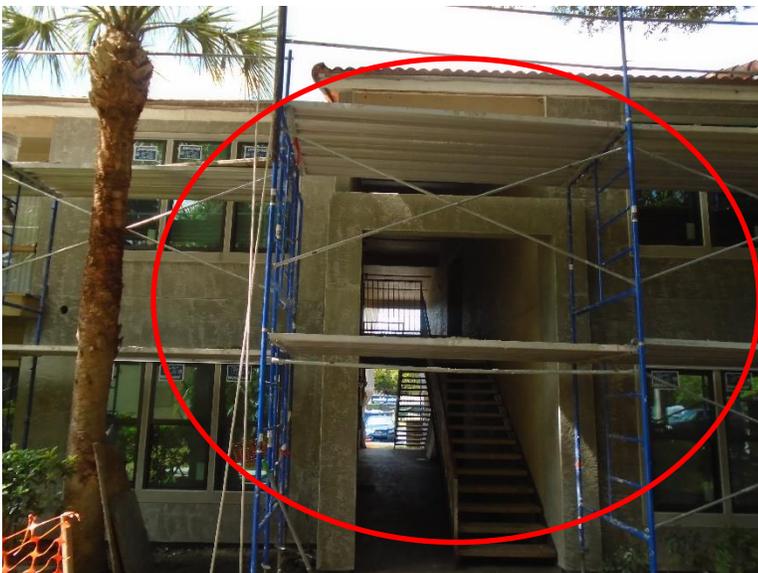
**PHOTOGRAPH #10**

**BUILDING 21  
SECTION G**

Stucco sub-contractor has applied finish coat of stucco.

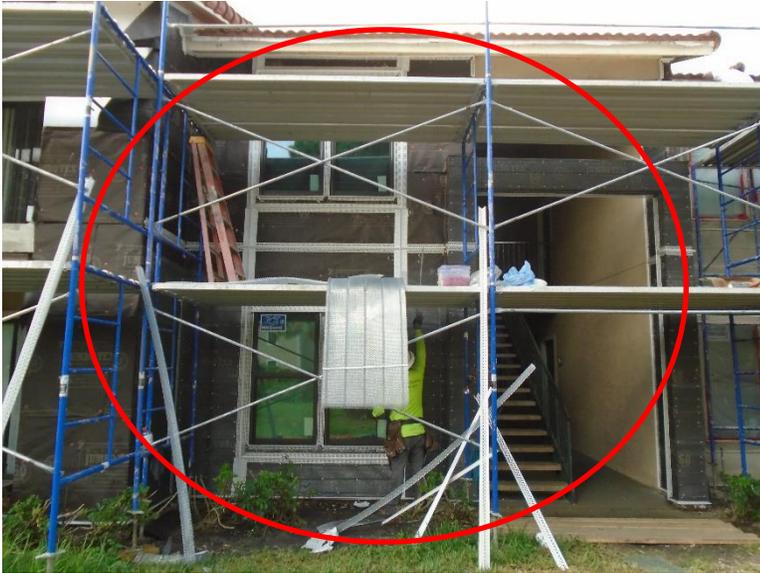
**PHOTOGRAPH #11**

**BUILDING 21  
SECTION E**

Stucco sub-contractor in process of applying stucco accessories and metal lathing.

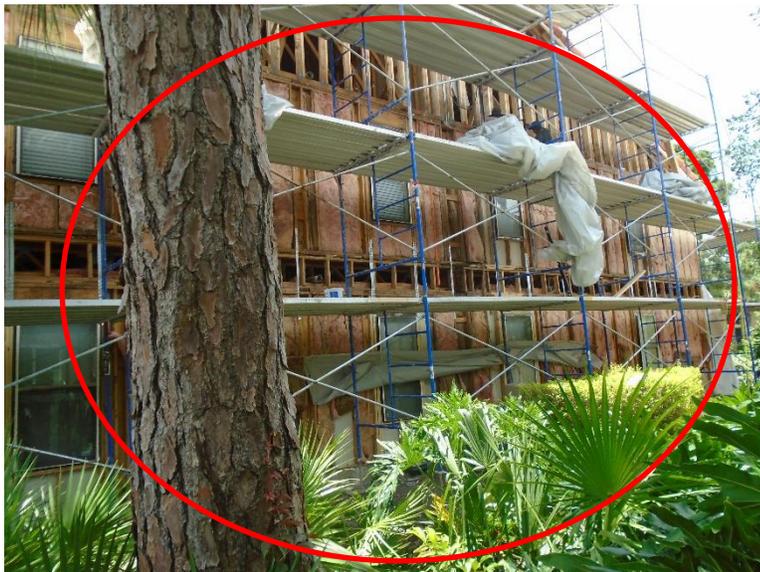
**PHOTOGRAPH #12**

**BUILDING 21  
SECTION D**

Damaged framing completed, strapping and gable end reinforcement repairs in progress.

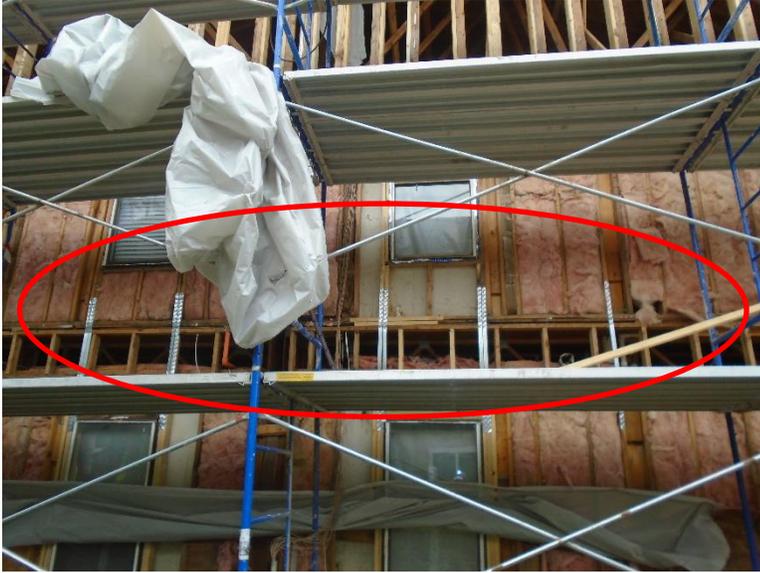
**PHOTOGRAPH #13**

**BUILDING 21  
SECTION D**

Simpson Strong-Tie strapping provided at wall framing.

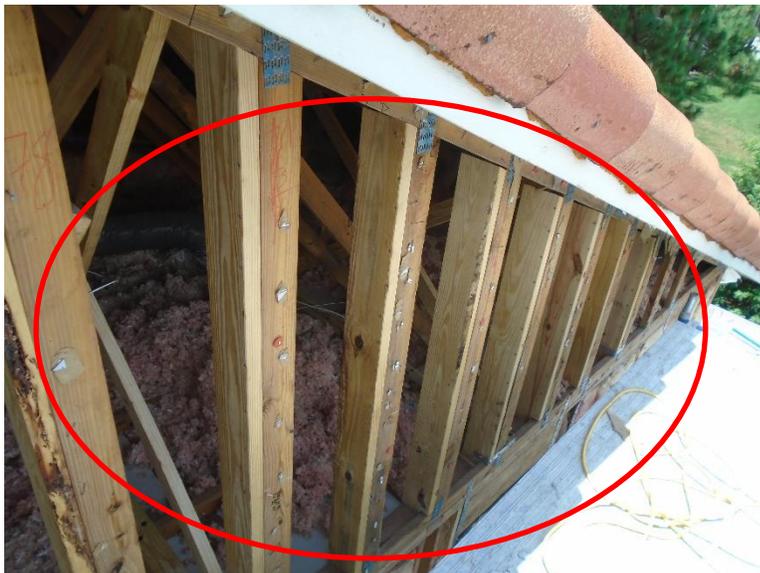
**PHOTOGRAPH #14**

**BUILDING 21  
SECTION D**

Gable end reinforcement and bracing repairs in progress.

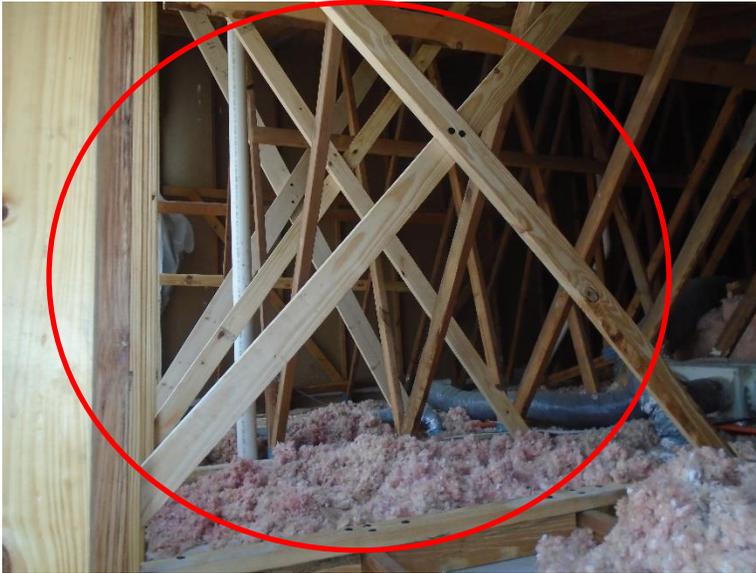
**PHOTOGRAPH #15**

**BUILDING 21  
SECTION D**

Gable end reinforcement and bracing repairs in progress.

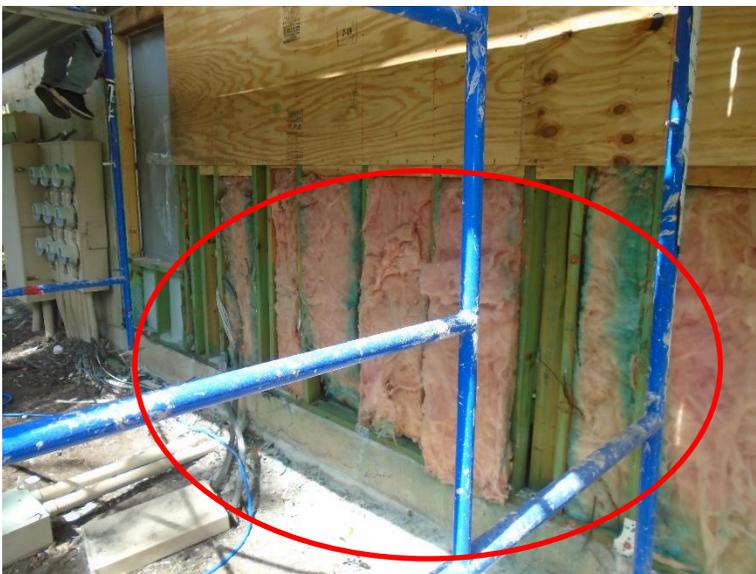
**PHOTOGRAPH #16**

**BUILDING 21  
SECTION D**

Bora Care termite treatment applied and plywood sheathing application in progress.

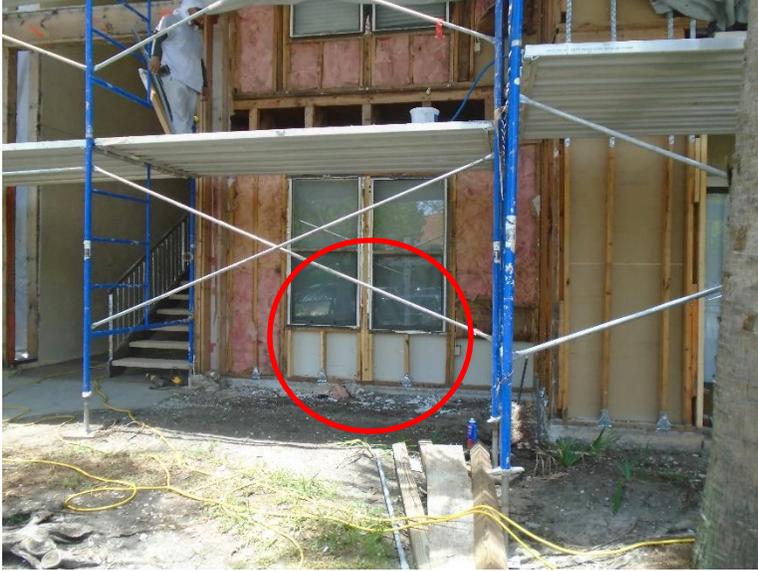
**PHOTOGRAPH #17**

**BUILDING 21  
SECTION C**

Framing damage repaired at window opening.
