PHOTOGRAPHS

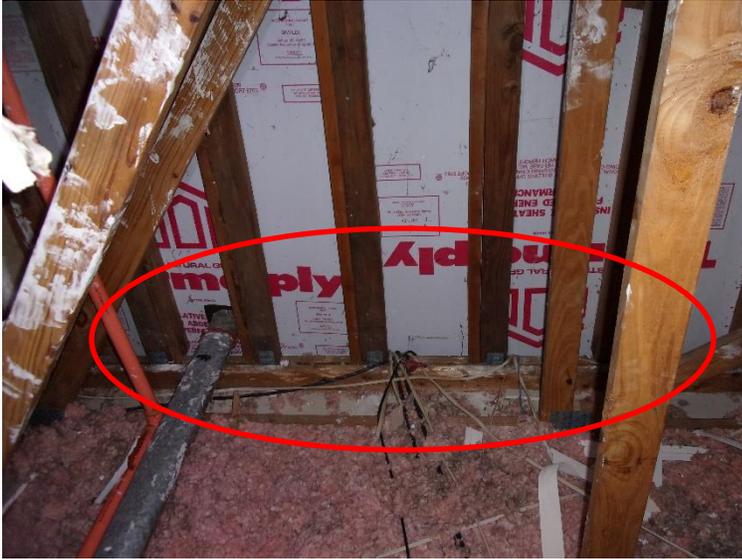
PHOTOGRAPH #1

**BUILDING 23
UNIT #2325- ATTIC**

Contractor has removed fire wall board for review of termite damage.

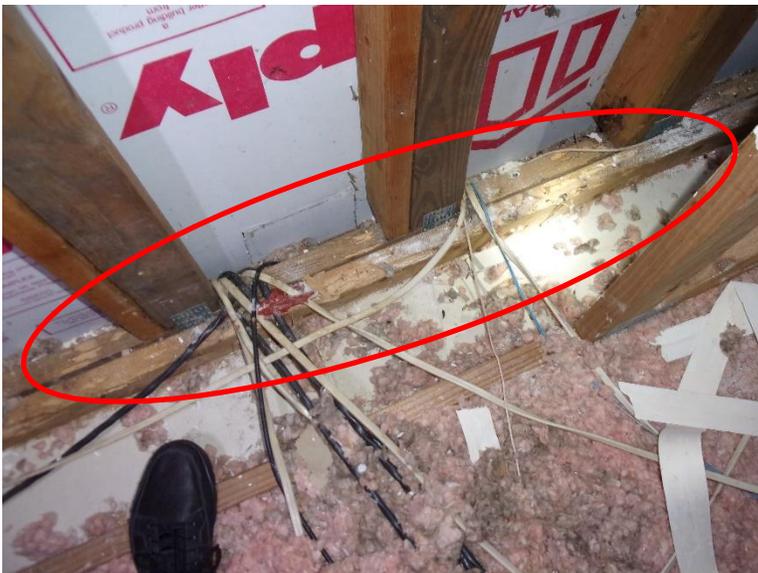
PHOTOGRAPH #2

**BUILDING 23
UNIT #2325- ATTIC**

Contractor has removed fire wall board for review of termite damage.

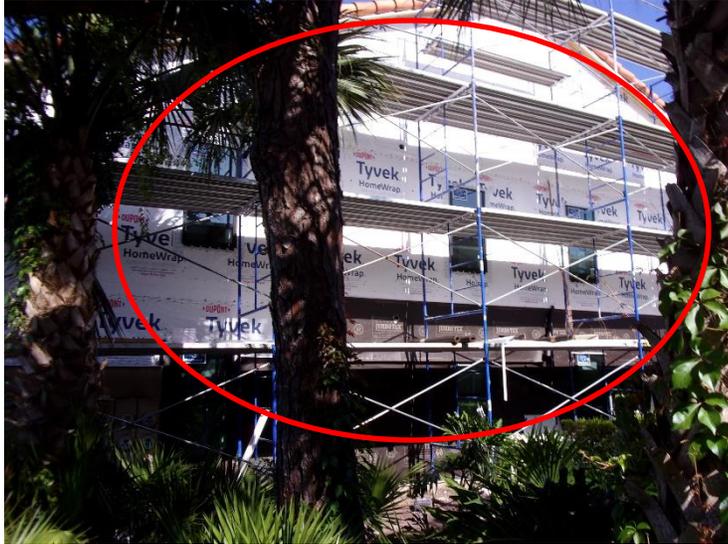
PHOTOGRAPH #3

**BUILDING 21
SECTION D**

Tyvek WRB installed over new sheathing. Dupont / Tyvek flashing installed at window openings and new PGT windows installed.

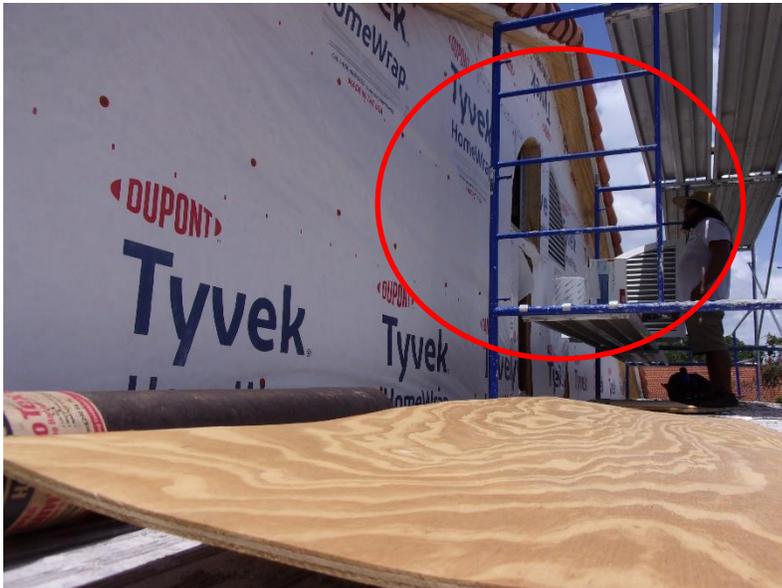
PHOTOGRAPH #4

**BUILDING 21
SECTION D**

Dupont / Tyvek flashings being installed at framing opening for new attic louvered vents.

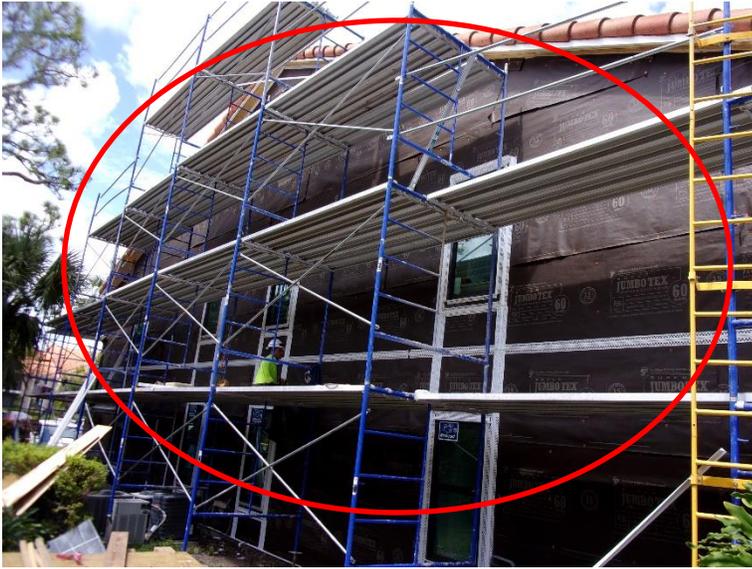
PHOTOGRAPH #5

**BUILDING 21
SECTION D**

Stucco sub-contractor has applied JumboTex secondary water-resistant barrier and in process of installing stucco accessories.

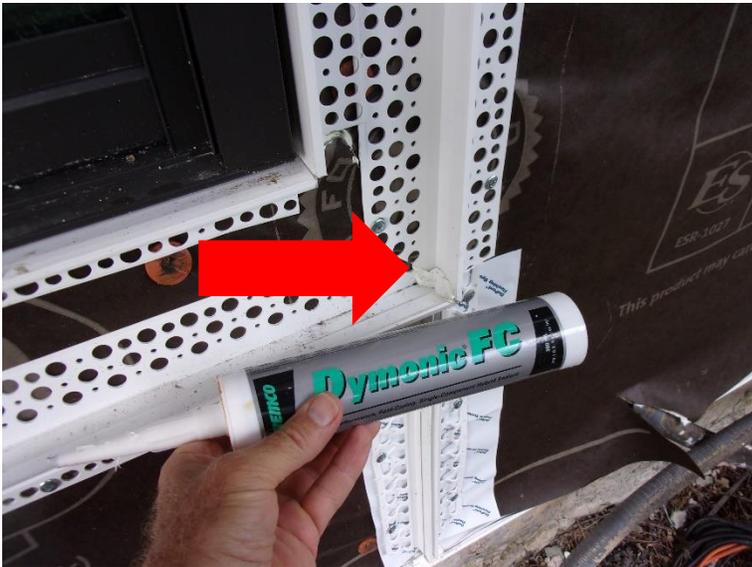
PHOTOGRAPH #6

**BUILDING 21
SECTION D**

Stucco accessories sealed at junctures and transitions with approve sealant.

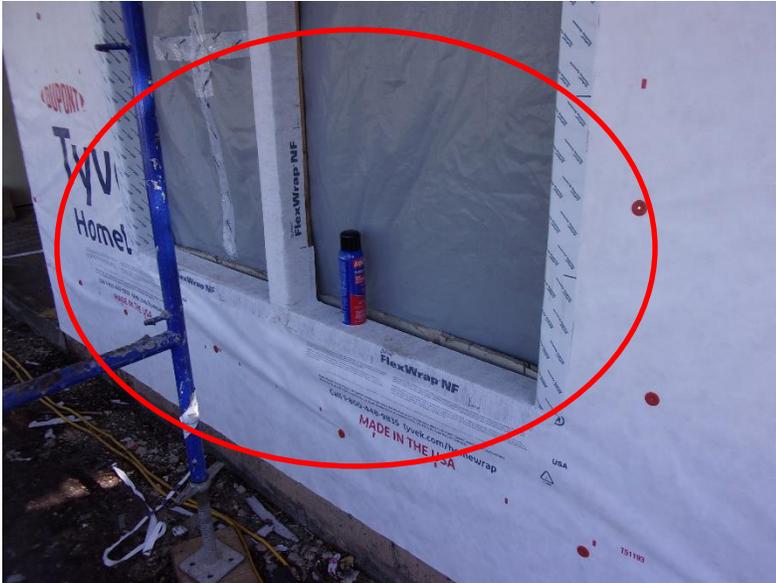
PHOTOGRAPH #7

**BUILDING 21
SECTION C**

Contractor has flashed window opening with Dupont / Tyvek flashings as recommended by manufacturers.

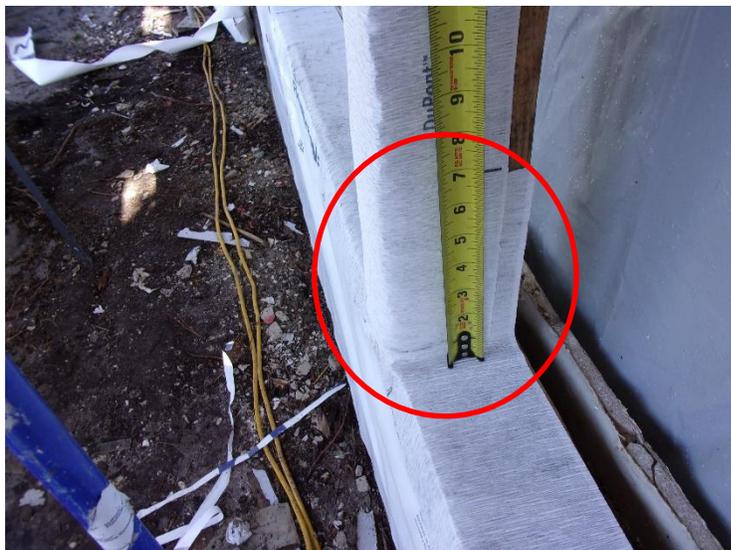
PHOTOGRAPH #8

**BUILDING 21
SECTION C**

Dupont / Tyvek flashings application inspected for compliance with manufacturers recommendations.

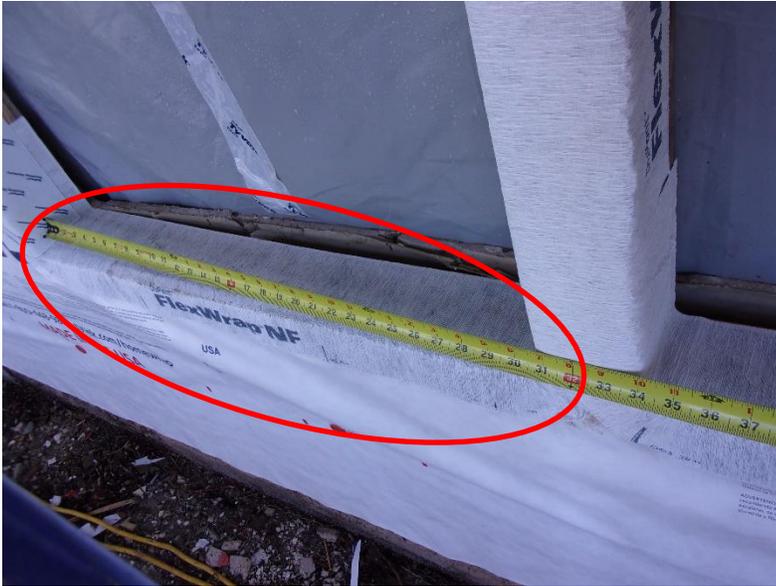
PHOTOGRAPH #9

**BUILDING 21
SECTION C**

Window opening measurements confirmed for window installation to meet manufacturers NOAs.

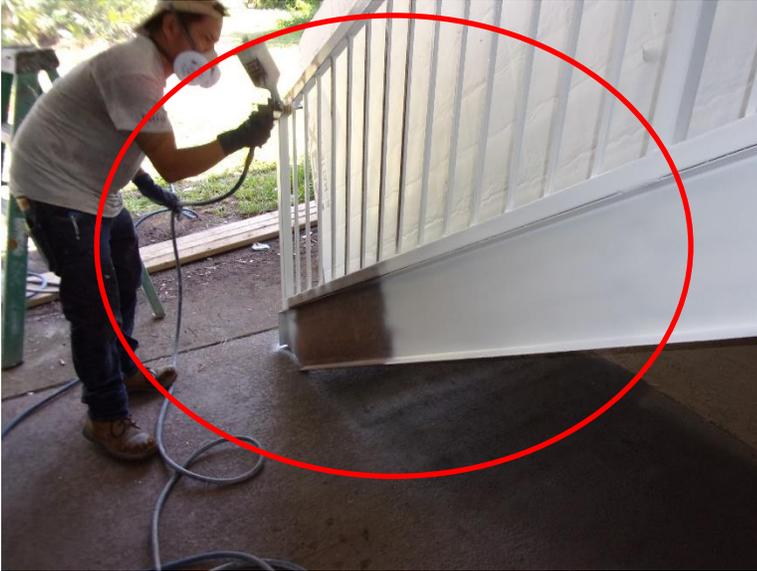
PHOTOGRAPH #11

**BUILDING 21
SECTION B - BREEZEWAY**

Contractor applying Sherwin Williams Encapsulon Epoxy Mastic Primer.

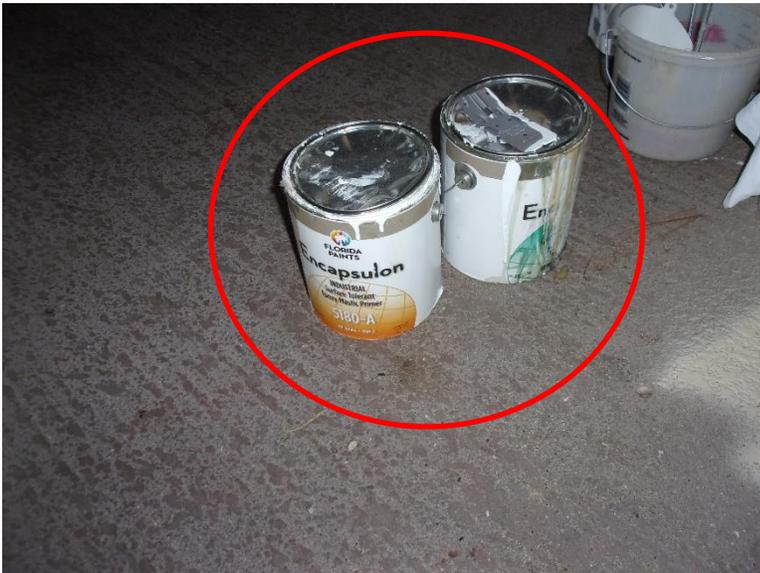
PHOTOGRAPH #12

**BUILDING 21
SECTION B - BREEZEWAY**

Contractor applying Sherwin Williams Encapsulon Epoxy Mastic Primer.

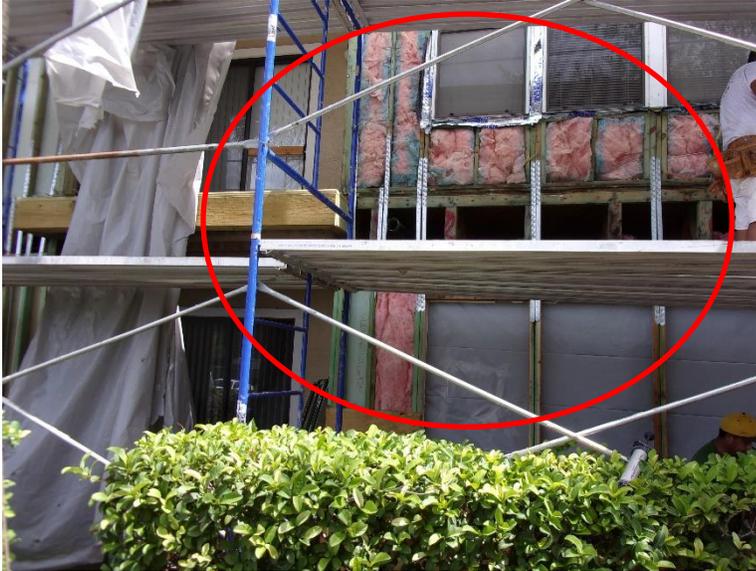
PHOTOGRAPH #13

**BUILDING 21
SECTION B**

Simson Strong -Tie strapping in place at framing as per specifications and drawings.

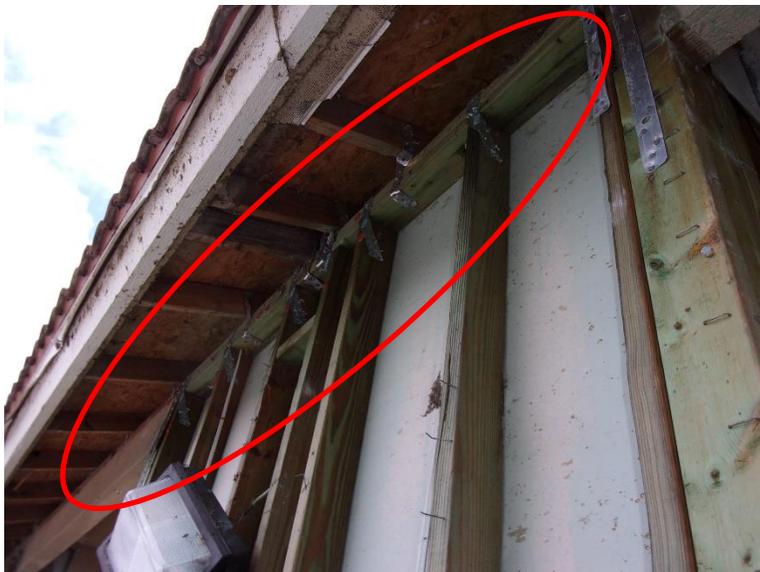
PHOTOGRAPH #14

**BUILDING 21
SECTION B**

Simson Strong -Tie connectors and screws in place at top plate and truss connection as per specifications and drawings.

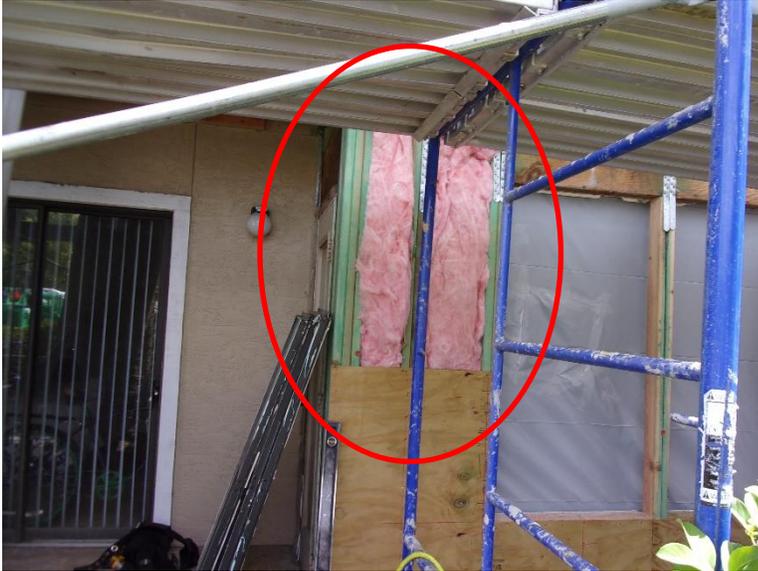
PHOTOGRAPH #15

**BUILDING 21
SECTION B**

New R-13 insulation installed where damaged or missing.

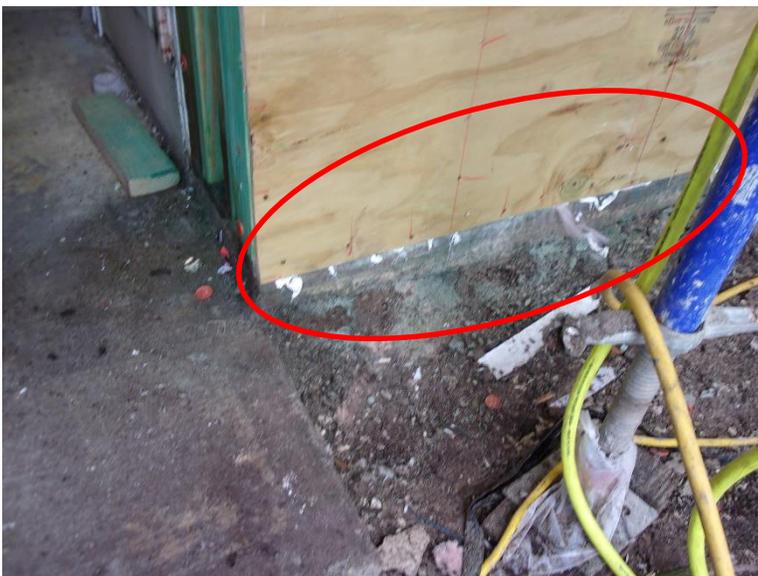
PHOTOGRAPH #16

**BUILDING 21
SECTION B**

Sealants installed at base of sheathing to bottom plate and concrete slab as directed by **ESI #1**.

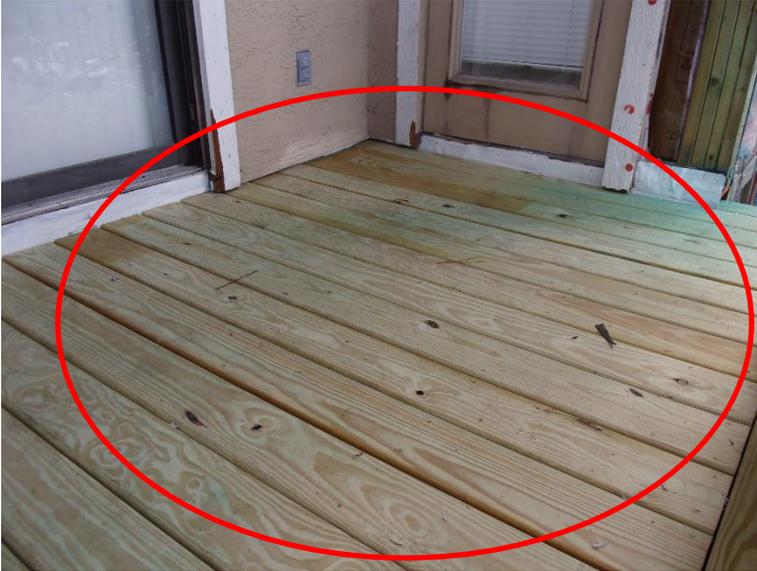
PHOTOGRAPH #17

**BUILDING 21
SECTION B**

New pressure treated wood decking provided at damaged balcony decks.

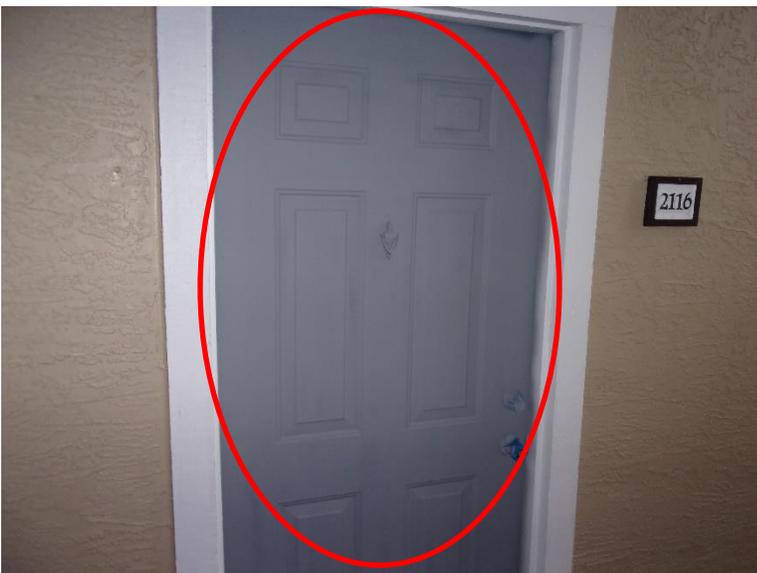
PHOTOGRAPH #18

**BUILDING 21
SECTION A**

Contractor has sprayed front doors with Sherwin Williams primer.

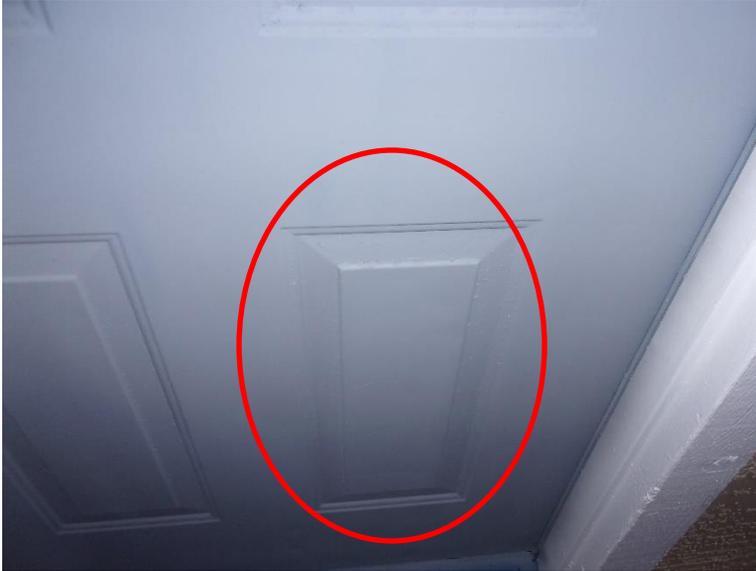
PHOTOGRAPH #19

**BUILDING 21
SECTION A**

Previous paint at unit doors peeling and blistered at several locations. Additional surface preparation required prior to primer application.

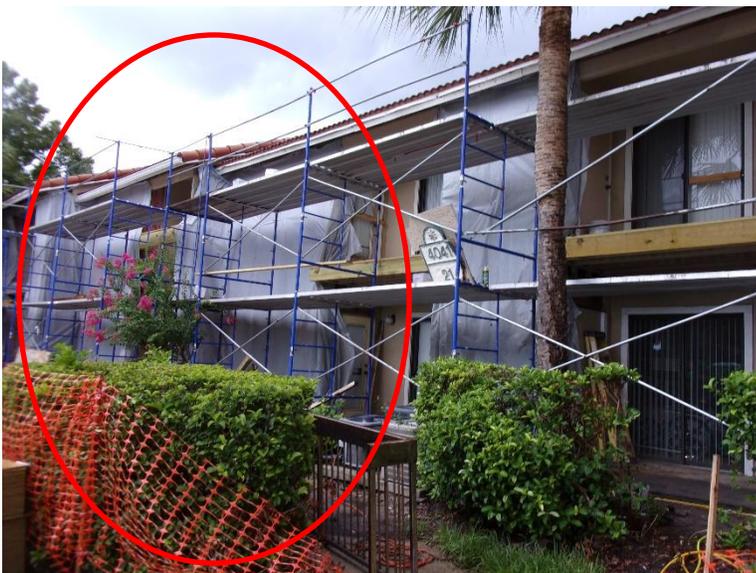
PHOTOGRAPH #20

**BUILDING 21
SECTION A**

Contractor has covered open walls with heavy plastic for protection during repairs.

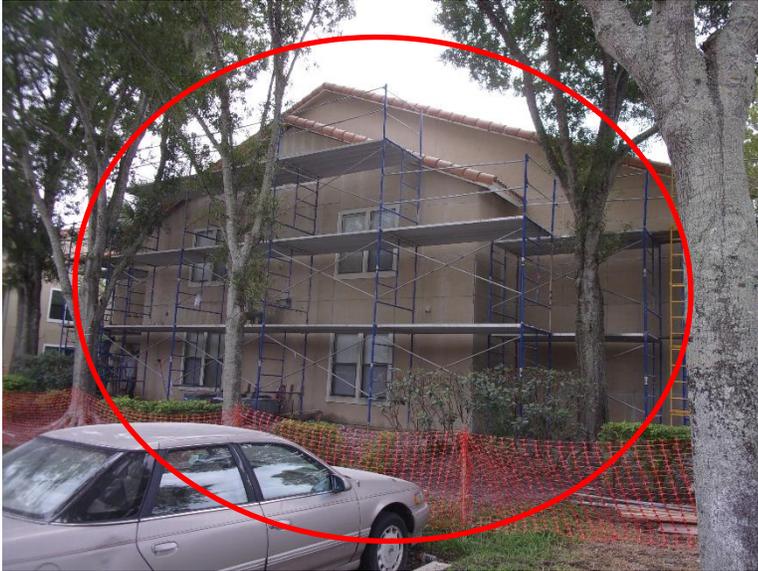
PHOTOGRAPH #21

**BUILDING 20
SECTION H**

Contractor has provided scaffolding for access, construction fencing and begun demolition for removal of stucco.

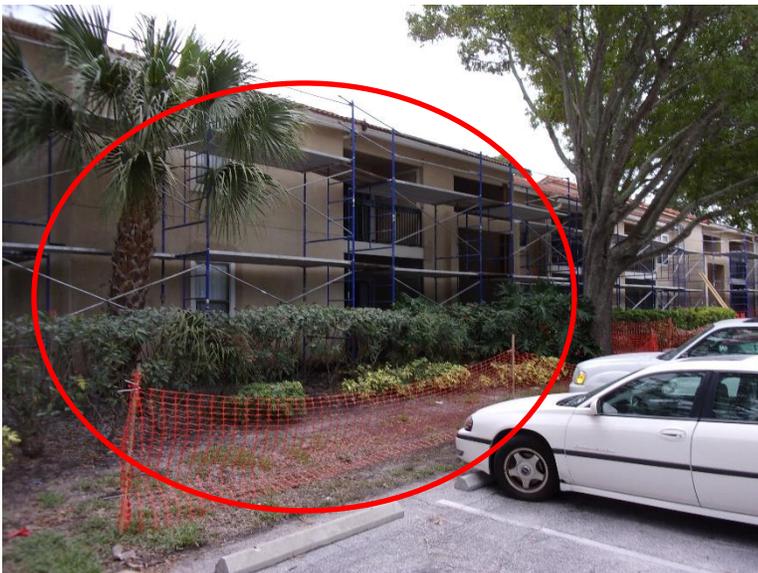
PHOTOGRAPH #22

**BUILDING 20
SECTION A**

Contractor has provided scaffolding for access, construction fencing.

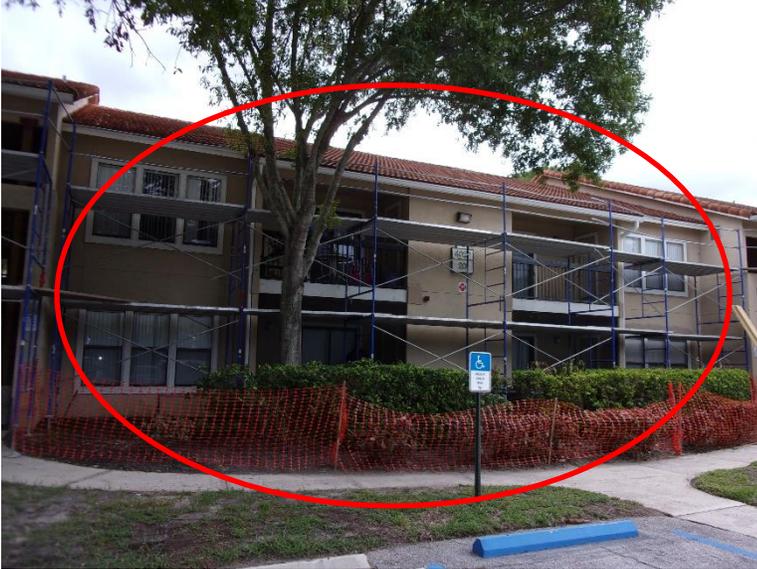
PHOTOGRAPH #23

**BUILDING 20
SECTION B**

Contractor has provided scaffolding for access, construction fencing.
