**PHOTOGRAPHS**

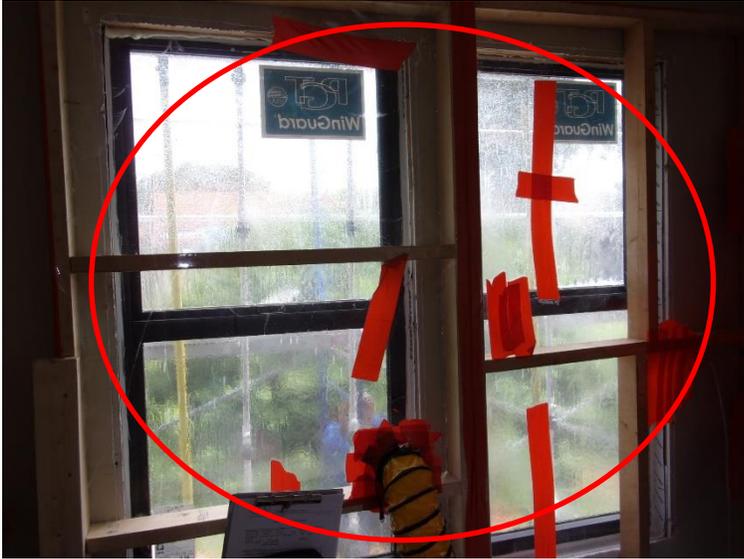
**PHOTOGRAPH #1**

**BUILDING 21  
UNIT #2128- WATER TEST**

Independent testing agency water tested double set of windows on E elevation as per AAMA 502. Water penetrated at lower left operable window frame, failing test.

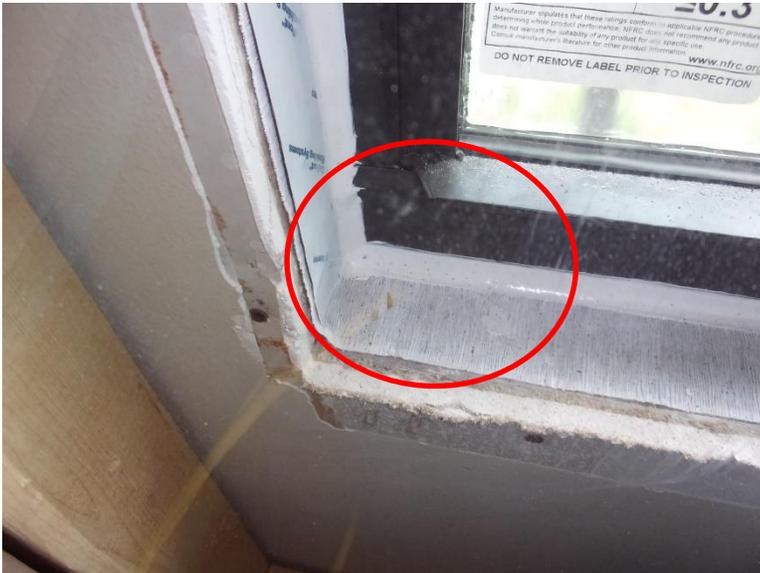
**PHOTOGRAPH #2**

**BUILDING 21  
UNIT #2128- WATER TEST**

Independent testing agency water tested double set of windows on E elevation as per AAMA 502. Water penetrated at lower left operable window frame, failing test.

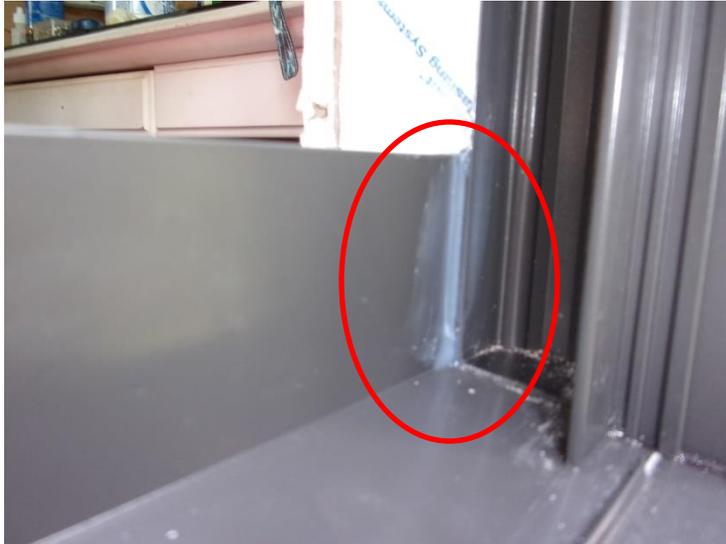
**PHOTOGRAPH #3**

**BUILDING 21  
UNIT #2128- WATER TEST**

Contractor sealed metal transition at riser framing with silicone sealant. Window was retested and passed test with no water penetration.

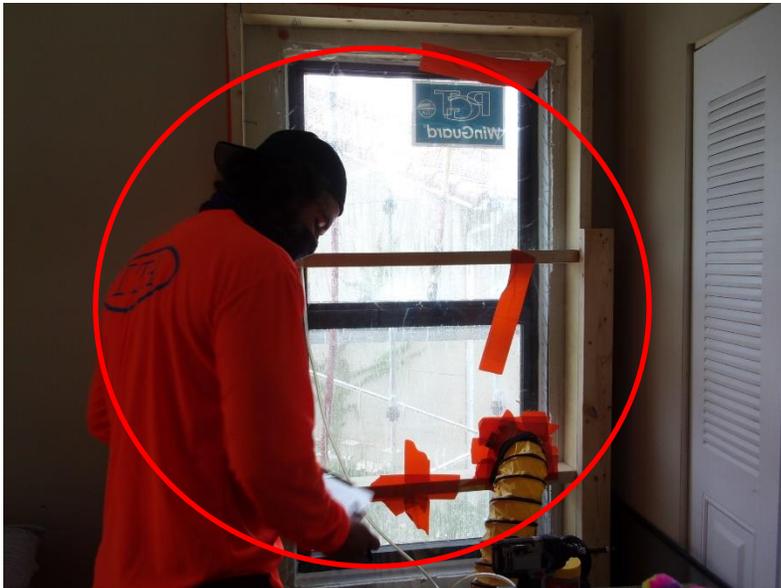
**PHOTOGRAPH #4**

**BUILDING 21  
UNIT #2128- WATER TEST**

Independent testing agency water tested single window on D elevation as per AAMA 502. Test passed.

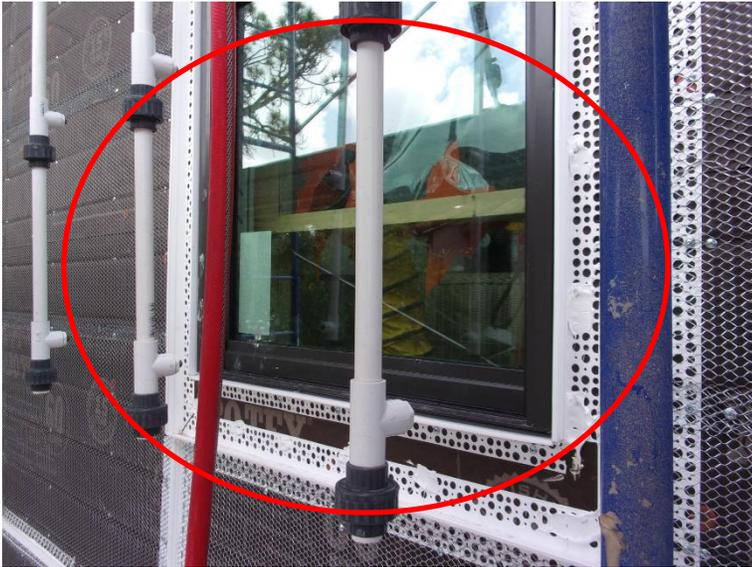
**PHOTOGRAPH #5**

**BUILDING 21  
UNIT #2128- WATER TEST**

Independent testing agency water tested single window on D elevation as per AAMA 502. Test passed.

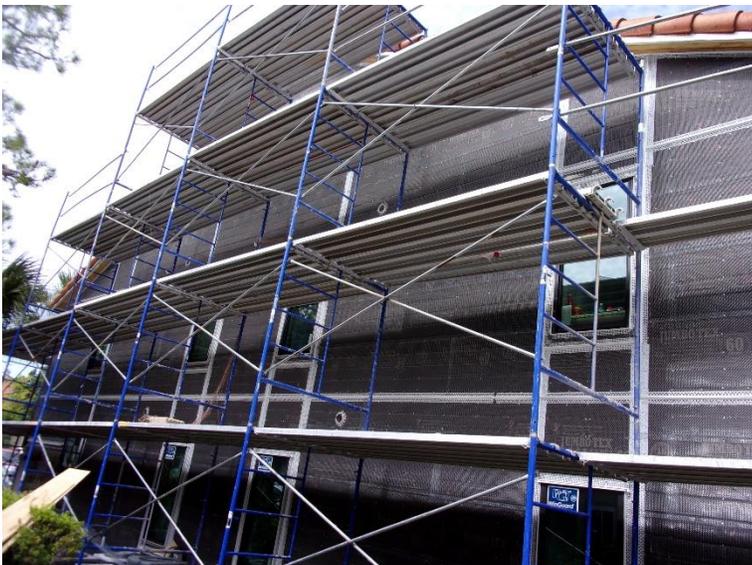
**PHOTOGRAPH #6**

**BUILDING 21  
SECTION D**

Stucco accessories and lath in place ready for stucco application.

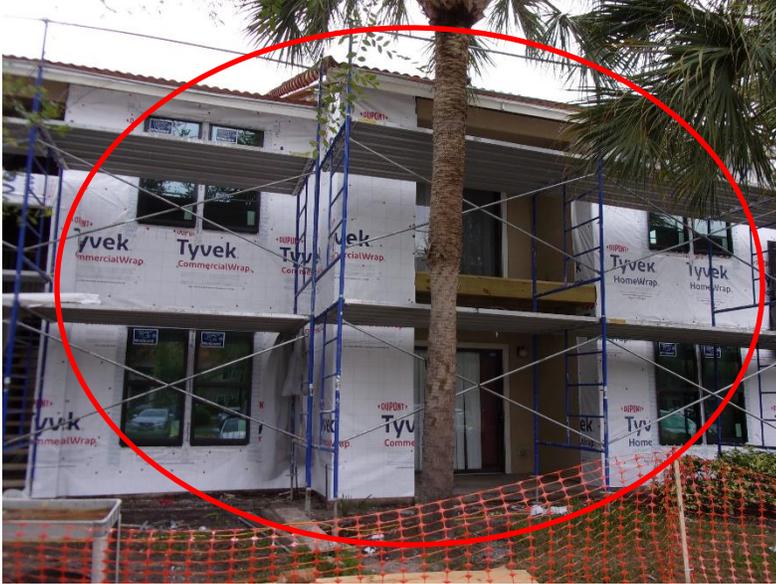
**PHOTOGRAPH #7**

**BUILDING 21  
SECTION C**

Contractor has installed new PGT windows with Dupont/Tyvek flashing details following AAMA guidelines and manufacturer's recommendations.

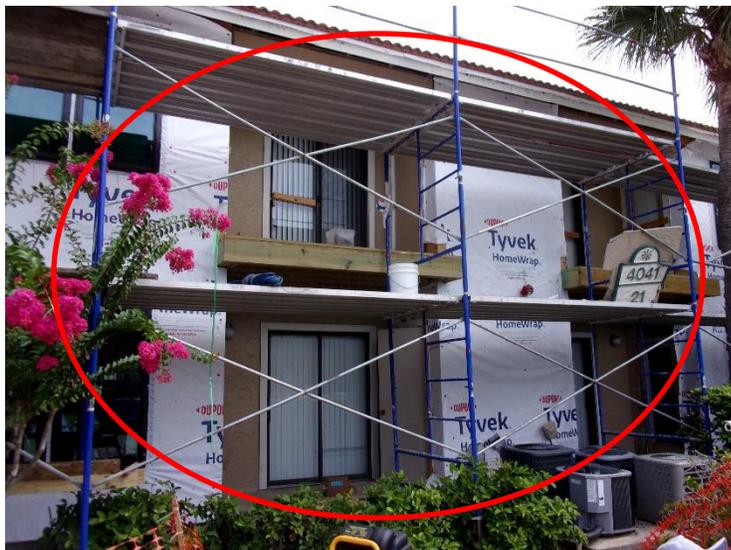
**PHOTOGRAPH #8**

**BUILDING 21  
SECTION B**

Contractor has completed repairs and installed new PGT windows with Dupont/Tyvek flashing details following AAMA guidelines and manufacturer's recommendations.

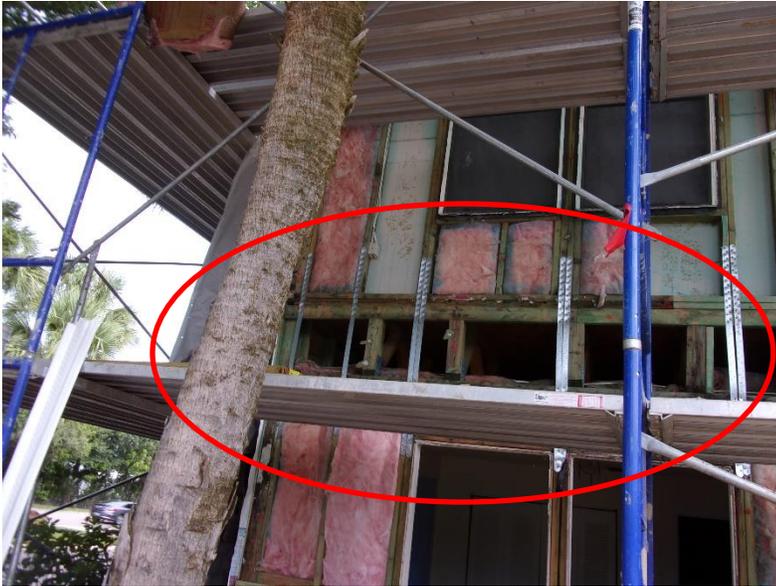
**PHOTOGRAPH #9**

**BUILDING 21  
SECTION A**

Termite treatment has been applied to framing and Simpson Strong-Tie straps and connectors provided.

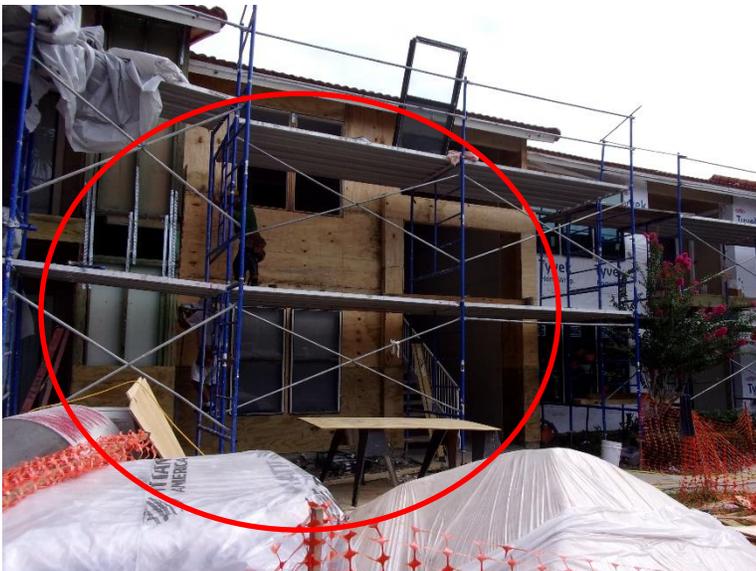
**PHOTOGRAPH #10**

**BUILDING 21  
SECTION A**

Contractor has installed R-13 insulation were damaged or missing and begun attaching new plywood sheathing.

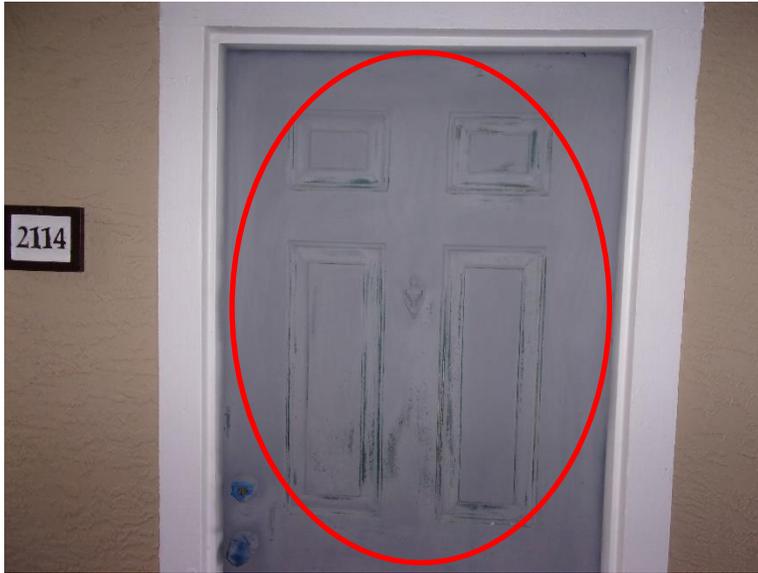
**PHOTOGRAPH #11**

**BUILDING 21  
SECTION A - BREEZEWAY**

Contractor has addressed previous failing paint and pre paired doors by sanding for re priming as directed.

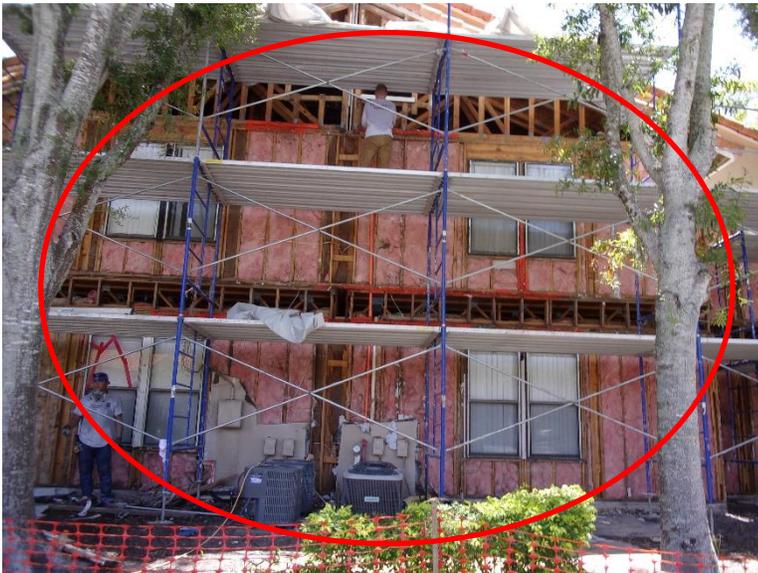
**PHOTOGRAPH #12**

**BUILDING 20  
SECTION H**

Damaged wood framing members inspected and marked for repairs.

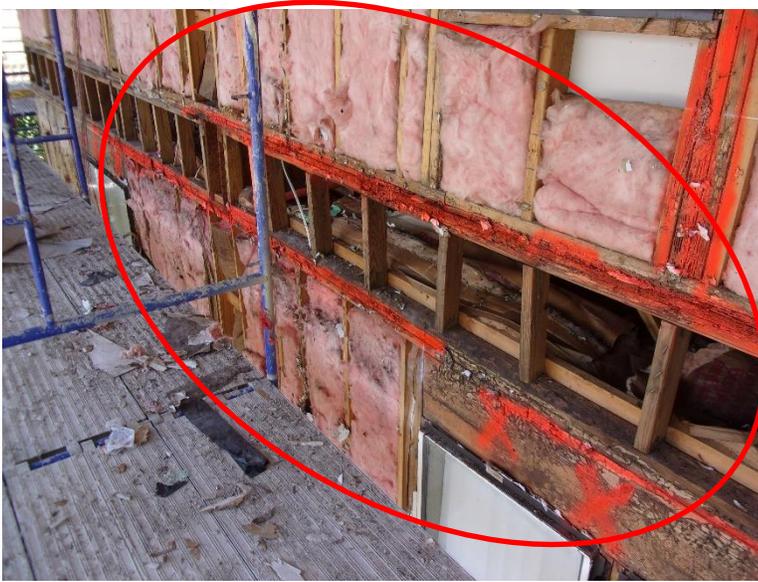
**PHOTOGRAPH #13**

**BUILDING 20  
SECTION H**

Damaged wood framing members inspected and marked for repairs.

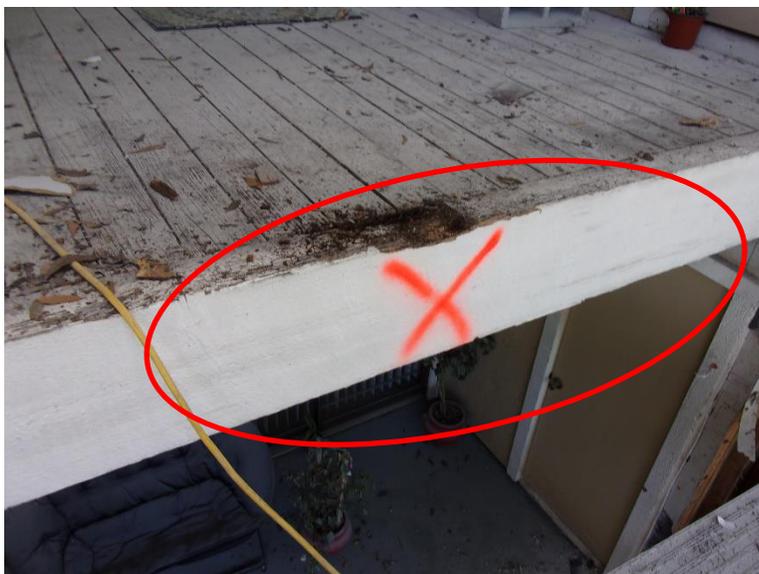
**PHOTOGRAPH #14**

**BUILDING 20  
SECTION A**

Original cedar balcony rim joist is damaged and has been marked for replacement.

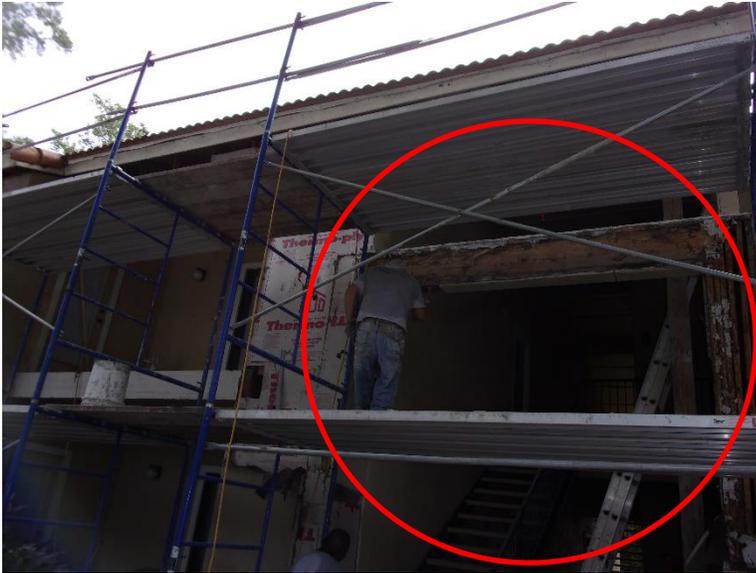
**PHOTOGRAPH #15**

**BUILDING 20  
SECTION A**

Stucco removed exposing previous sheathing and damaged framing.

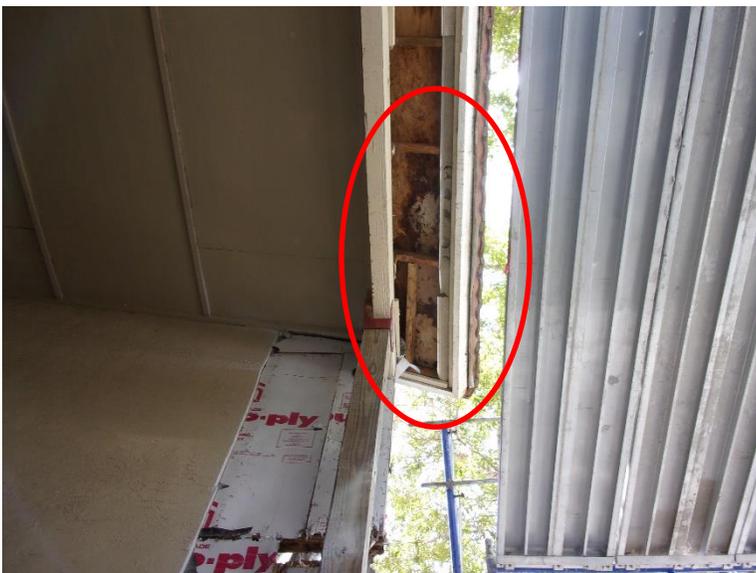
**PHOTOGRAPH #16**

**BUILDING 20  
SECTION A**

Roof sheathing has been damaged from roof leaks. Owners responsible for roof repairs.

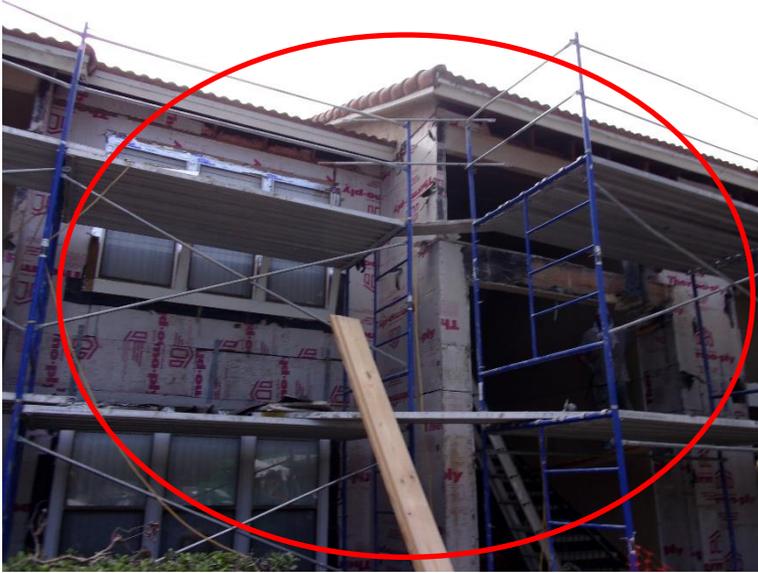
**PHOTOGRAPH #17**

**BUILDING 20  
SECTION B**

Stucco removed exposing previous sheathing and damaged framing.

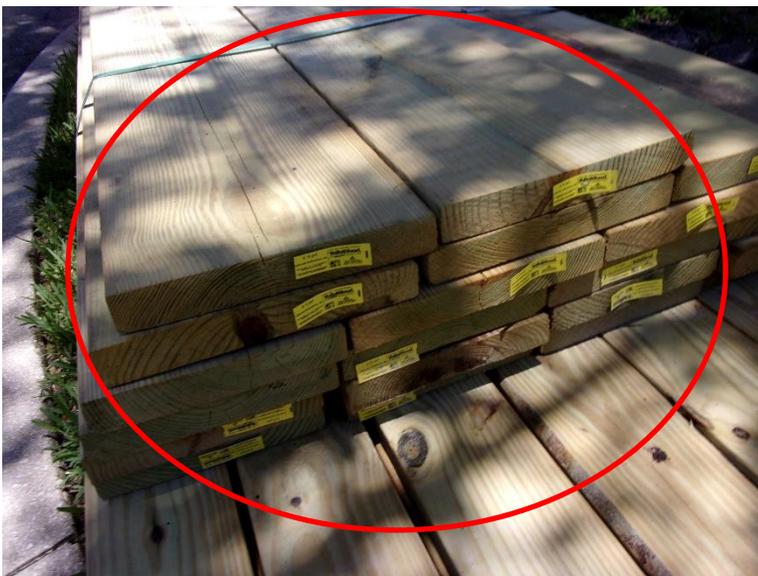
**PHOTOGRAPH #18**

**BUILDING 20  
SECTION B**

Pressure treated lumber and plywood delivered for repairs.

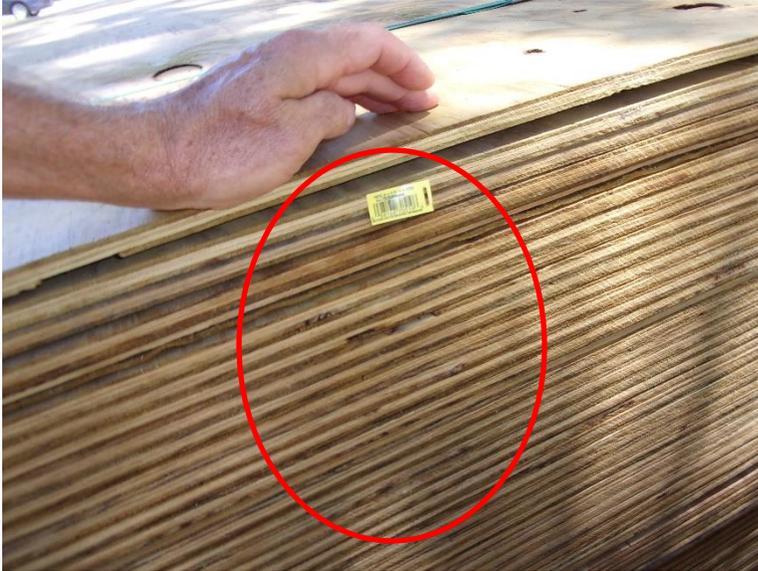
**PHOTOGRAPH #19**

**BUILDING 20  
SECTION B**

Pressure treated lumber and plywood delivered for repairs.
