PHOTOGRAPHS

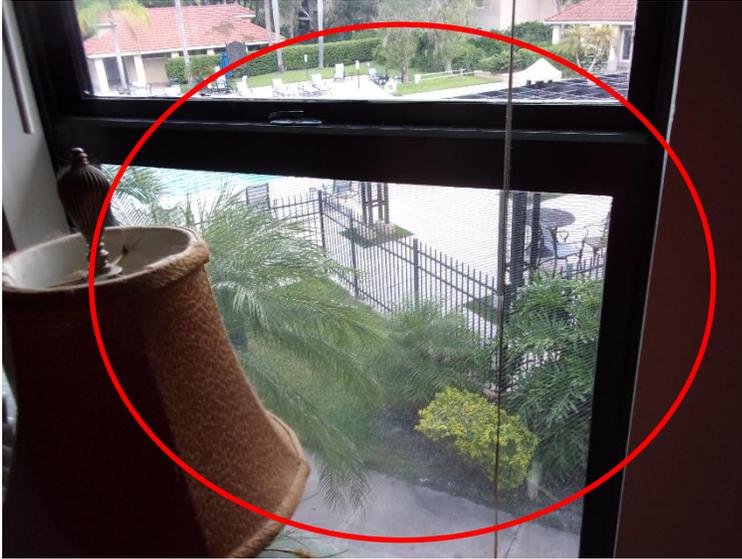
PHOTOGRAPH #1

Living room middle operable window has been repaired by PGT service team.

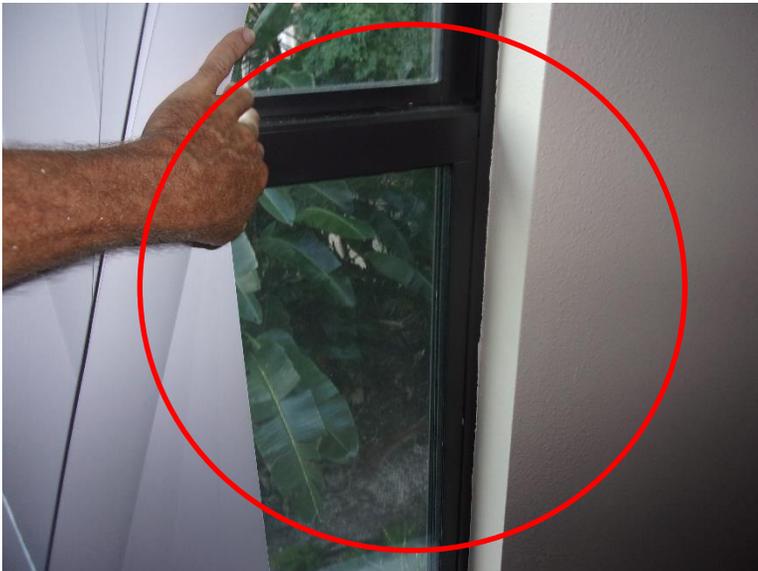
PHOTOGRAPH #2

Bedroom right operable window has been repaired by PGT service team.

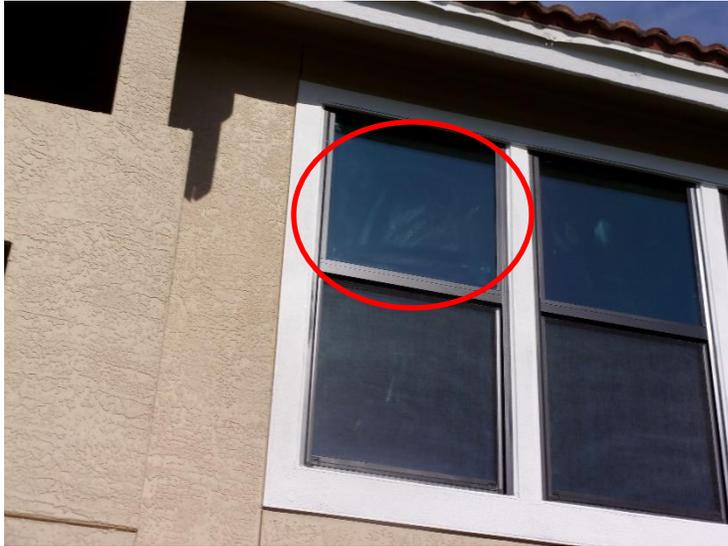
PHOTOGRAPH #3

Broken window has been replaced by PGT service team.

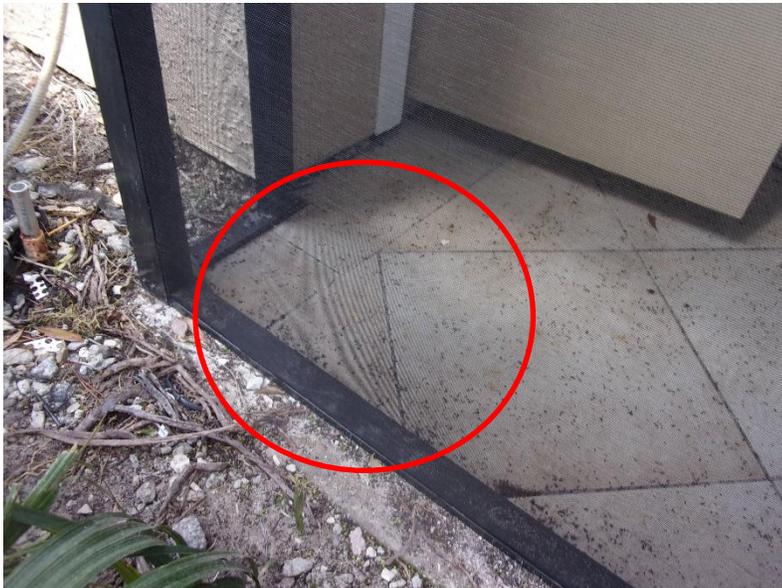
PHOTOGRAPH #4

Damaged screen at lower porch has been repaired.

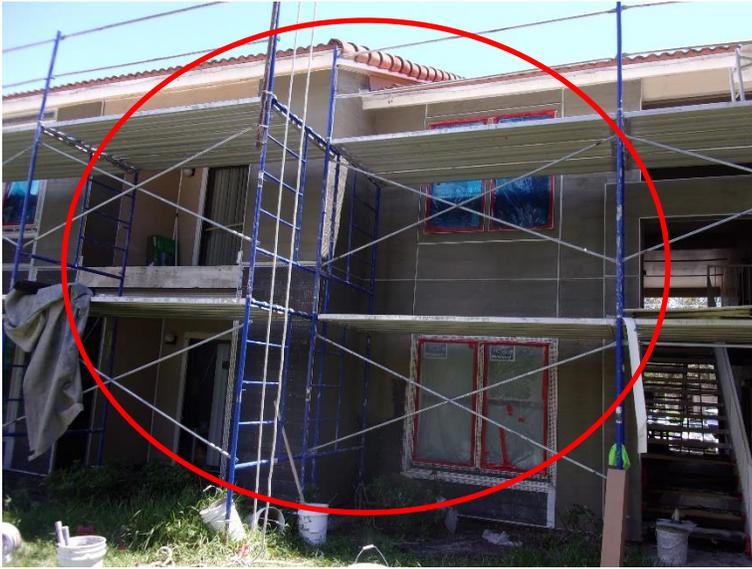
PHOTOGRAPH #5

Stucco sub-contractors applying brown coat of stucco.

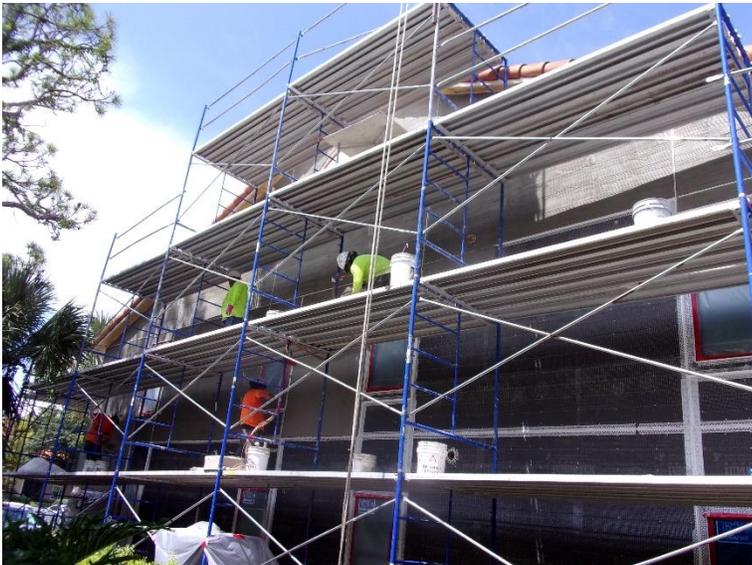
PHOTOGRAPH #6

Stucco sub-contractors applying scratch coat of stucco.

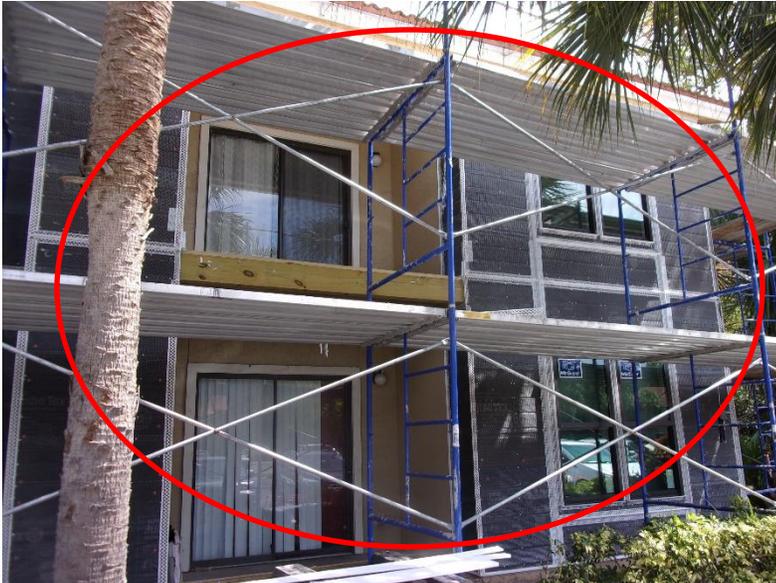
PHOTOGRAPH #7

Stucco subcontractor applying new stucco accessories and metal lathing.

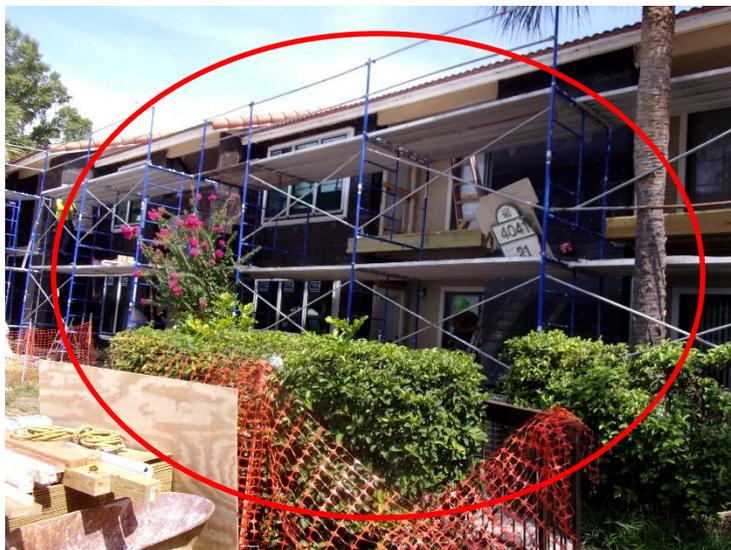
PHOTOGRAPH #8

Stucco subcontractors have applied JumboTex Super 60 water resistant barrier and begun application of new stucco accessories.

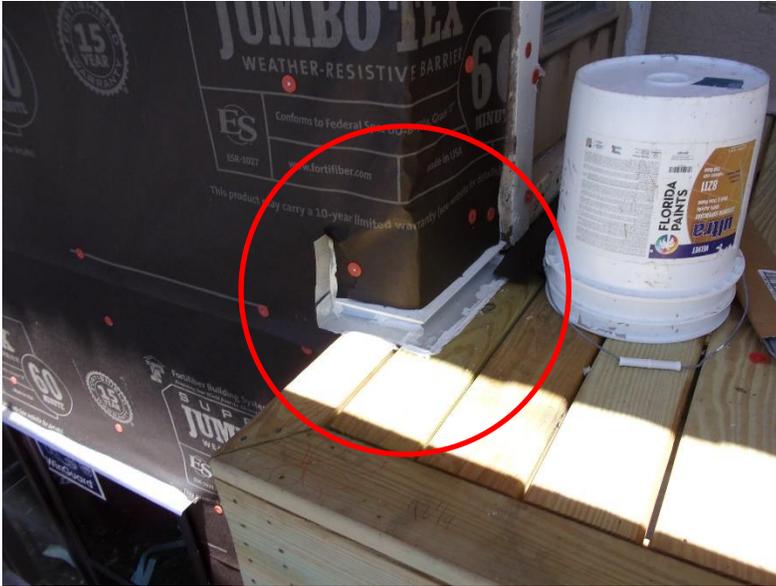
PHOTOGRAPH #9

New galvanized kick out flashing installed at balconies.

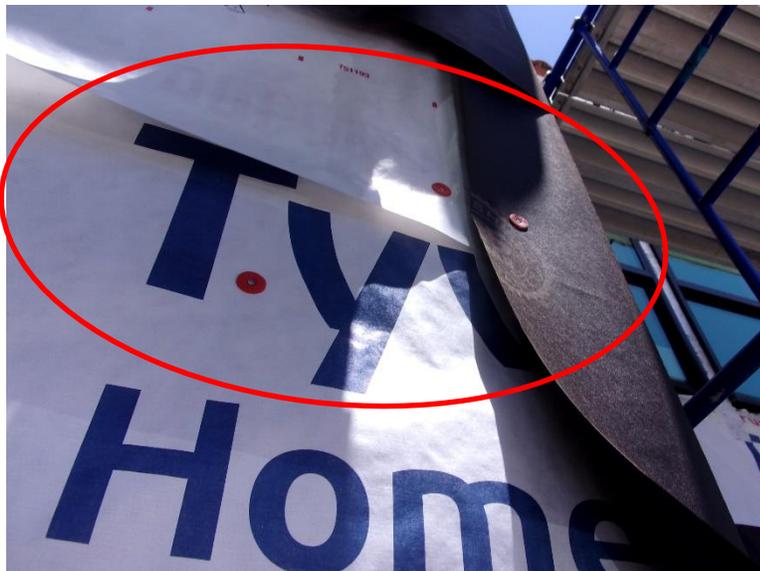
PHOTOGRAPH #10

Subcontractor began installation of JumboTex WRB before Tyvek seams had been sealed with seam tape.

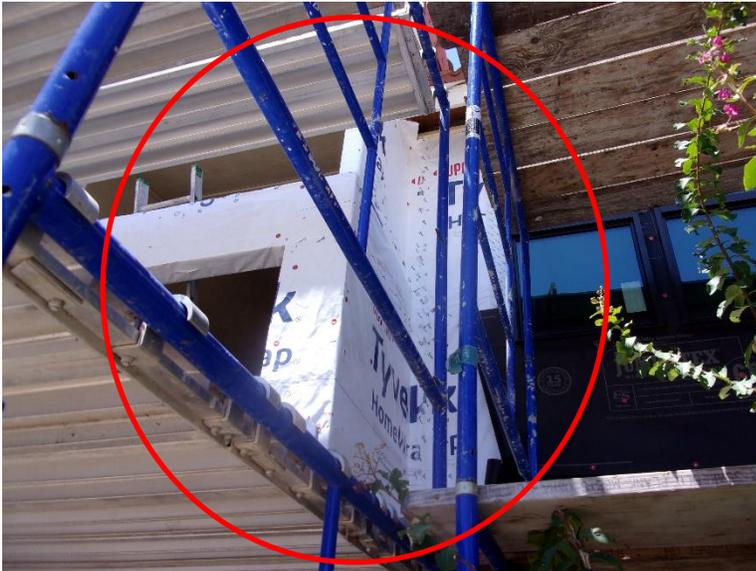
PHOTOGRAPH #11

At the direction of Delta, JumboTex WRB was removed and seam tape completed.

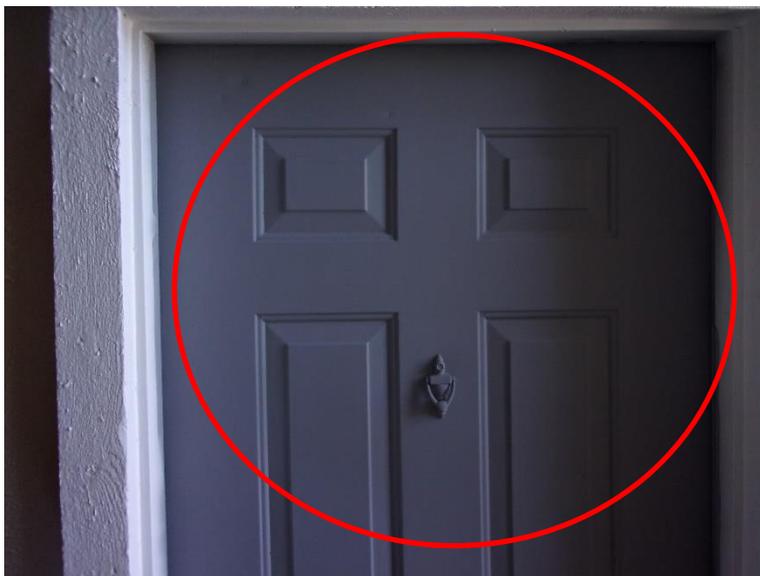
PHOTOGRAPH #12

Entrance doors recoated with primer prior to finish coat of paint.

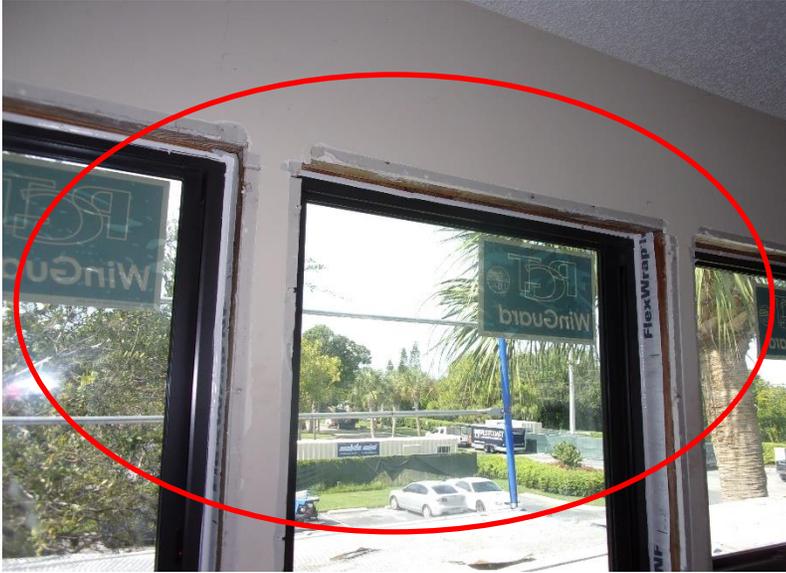
PHOTOGRAPH #13

Window installation, Dupont flashing and interior sealant inspected for compliance to manufacturer's requirements and AAMA standard practice guidelines.

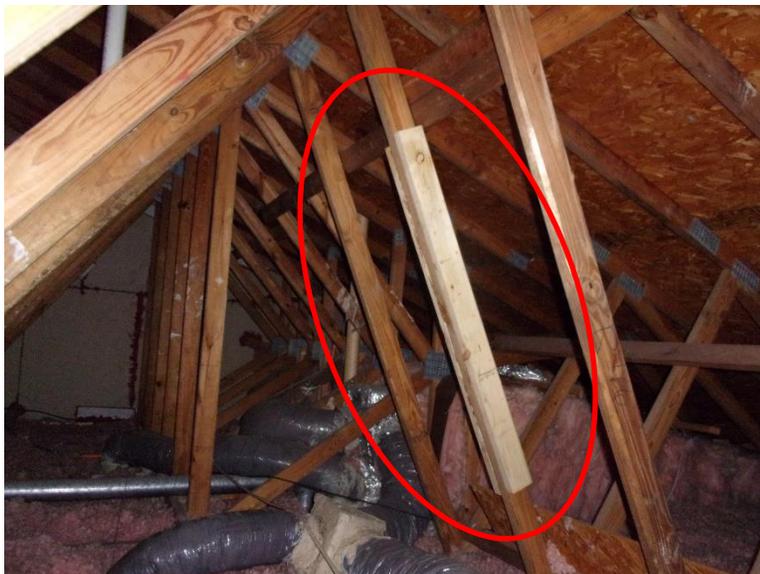
PHOTOGRAPH #14

Contractor has performed truss repairs and firewall repairs.

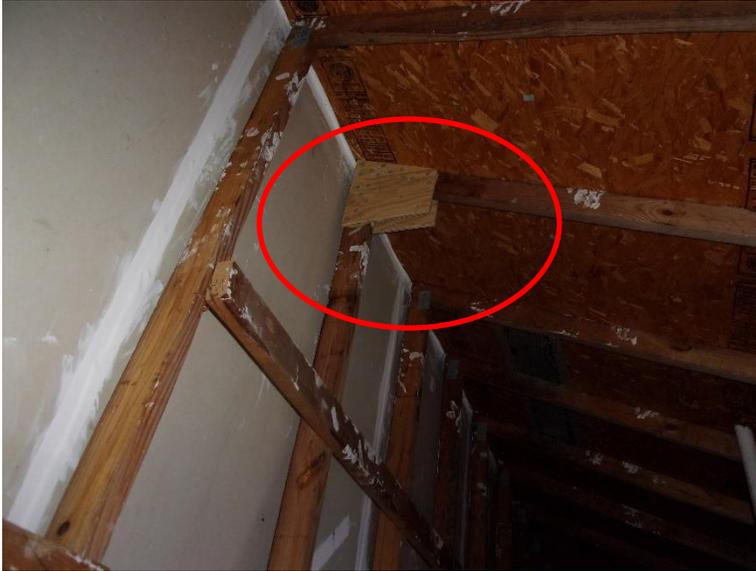
PHOTOGRAPH #15

Contractor has performed truss repairs and firewall repairs.

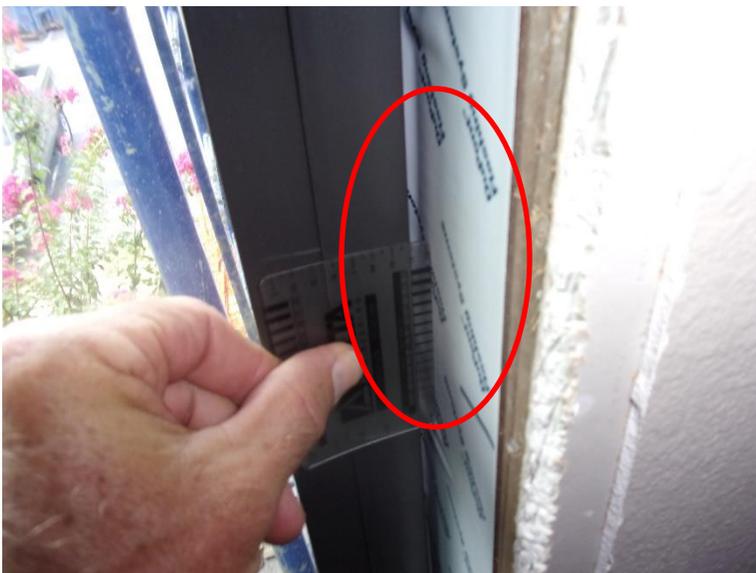
PHOTOGRAPH #16

Window installation and Dupont flashing inspected for compliance to manufacturer's requirements and AAMA standard practice guidelines.

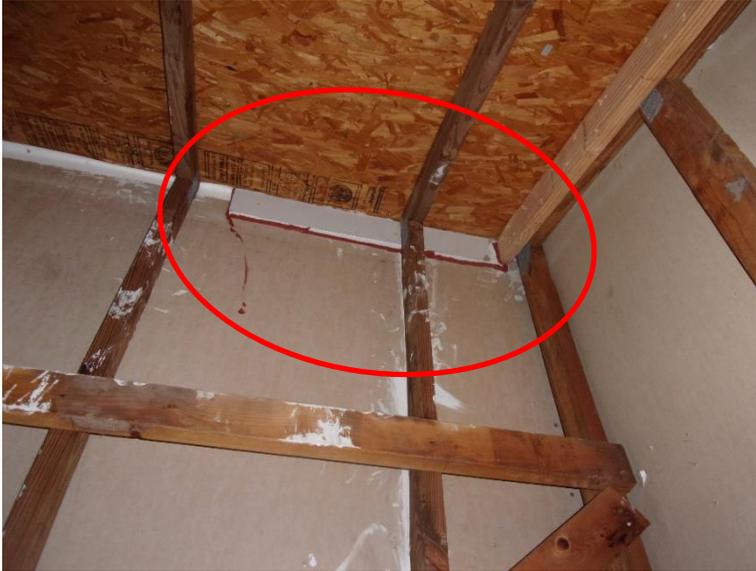
PHOTOGRAPH #17

Contractor has performed truss repairs
and firewall repairs.

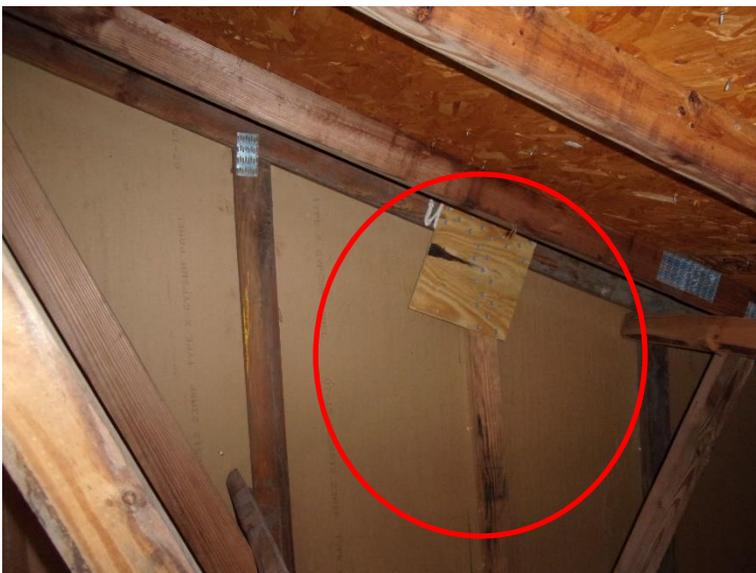
PHOTOGRAPH #18

Contractor has performed truss repairs
and firewall repairs.

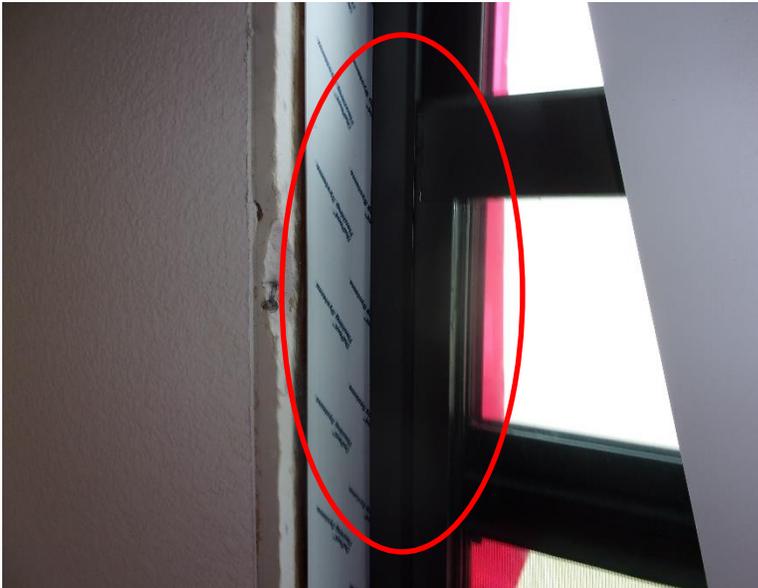
PHOTOGRAPH #19

Window installation and Dupont flashing inspected for compliance to manufacturer's requirements and AAMA standard practice guidelines.

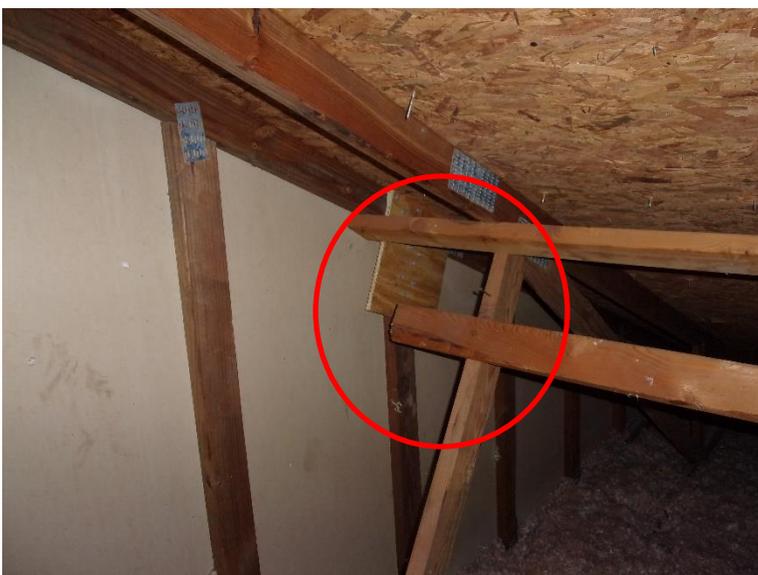
PHOTOGRAPH #20

Contractor has performed truss repairs and firewall repairs.

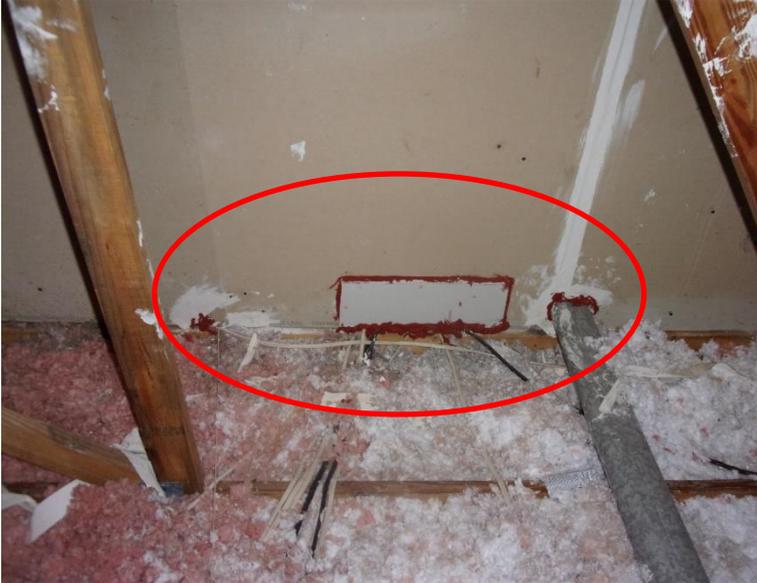
PHOTOGRAPH #21

Contractor has performed truss repairs and firewall repairs.

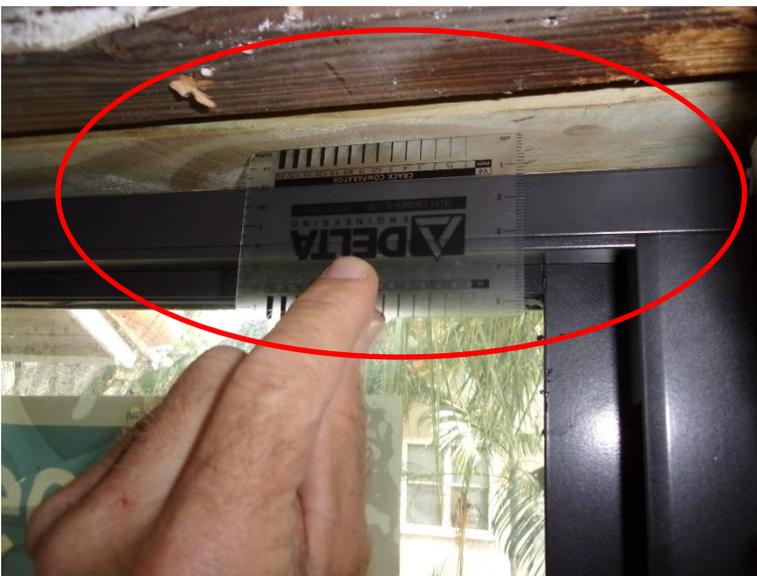
PHOTOGRAPH #22

Gap at heads of triple set of new windows is too wide to meet manufacturer's NOA requirements for fastening of integral fin window.

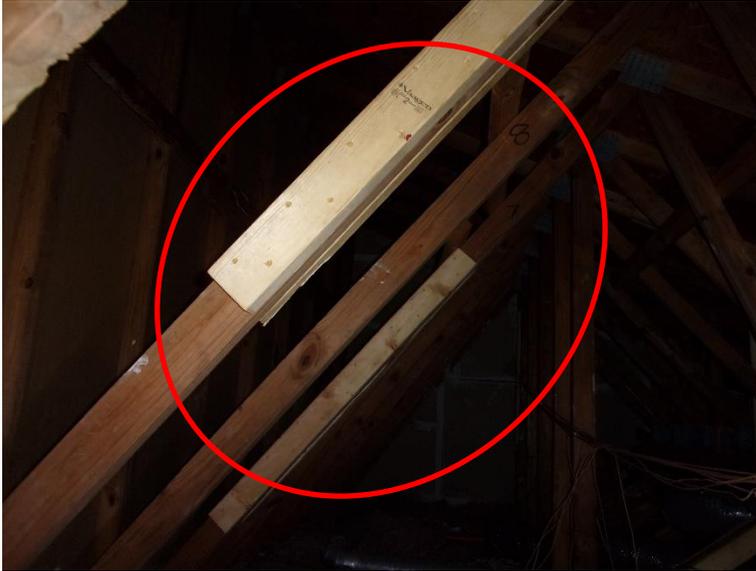
PHOTOGRAPH #23

Contractor has performed truss repairs
and firewall repairs.

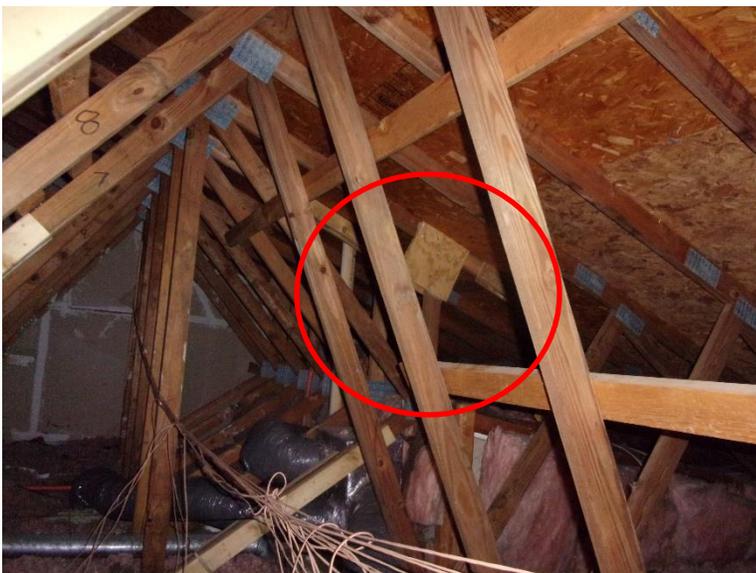
PHOTOGRAPH #24

Contractor has performed truss repairs
and firewall repairs.

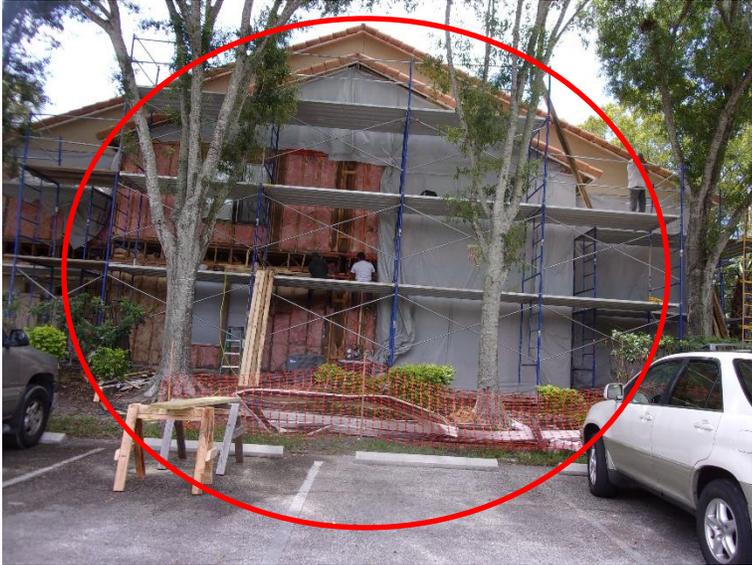
PHOTOGRAPH #25

Contractor has begun framing repairs marked by Delta.

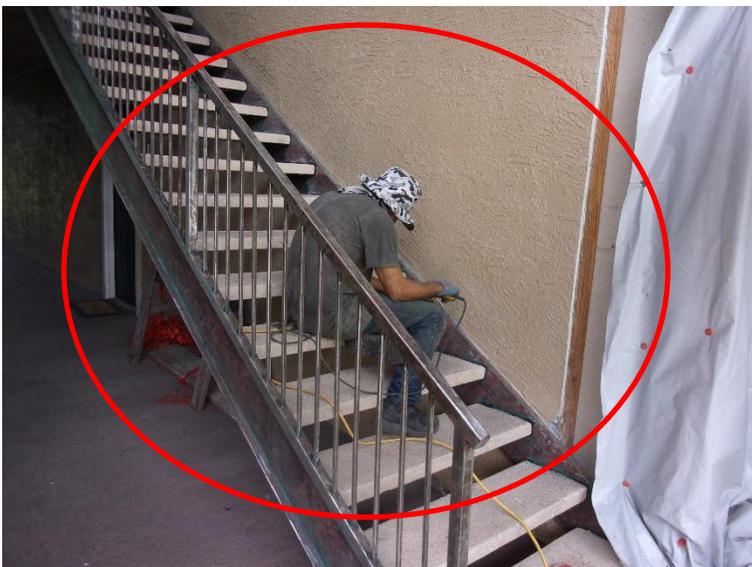
PHOTOGRAPH #26

Preparation of stairway railings in breezeway for paint applications has begun.

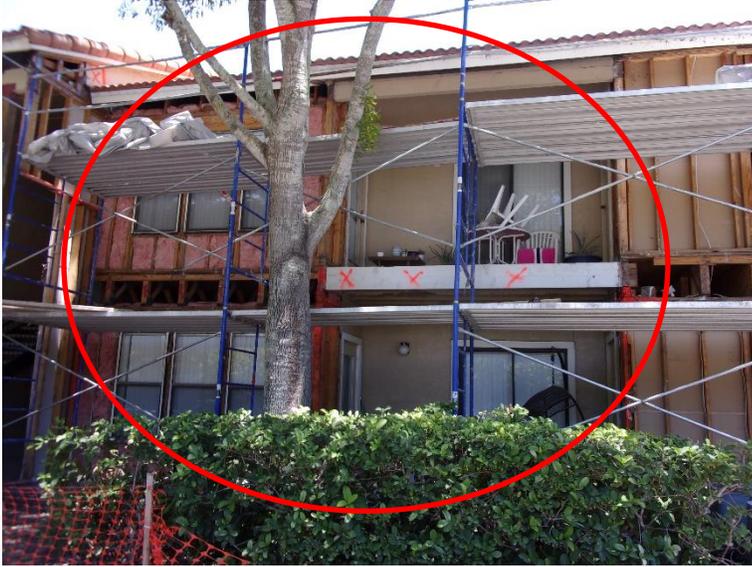
PHOTOGRAPH #27

Framing and balcony deck damage observed and marked for repairs.

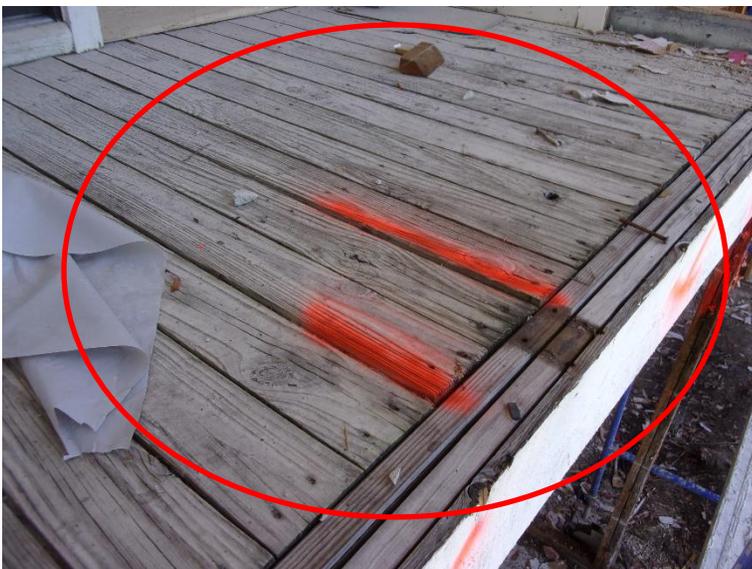
PHOTOGRAPH #28

Framing and balcony deck damage observed and marked for repairs.

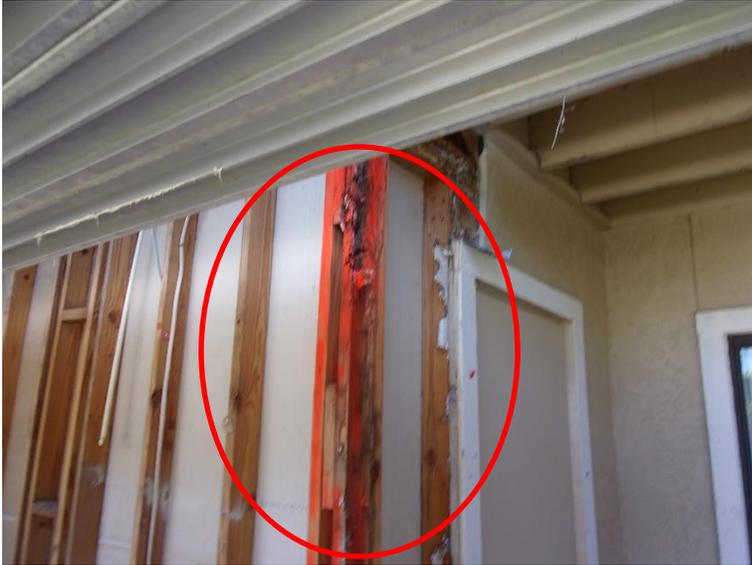
PHOTOGRAPH #29

Framing and balcony deck damage observed and marked for repairs.

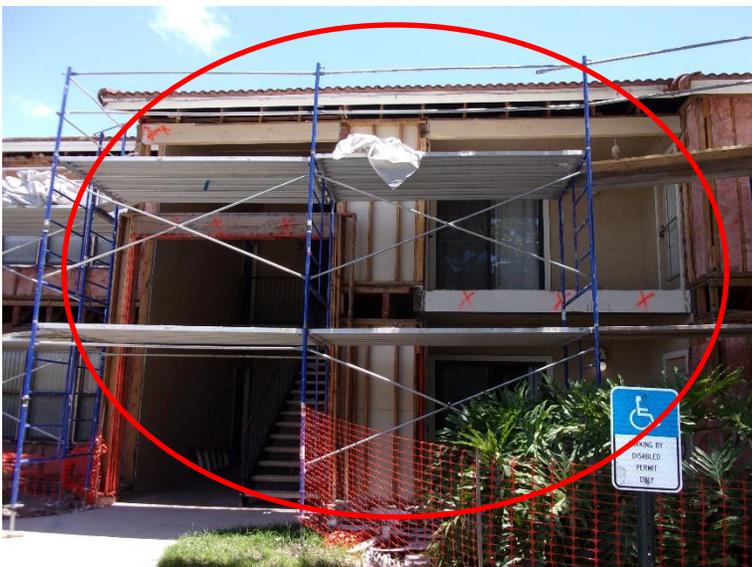
PHOTOGRAPH #30

Framing at breezeway, balconies and walls observed and marked for repairs.

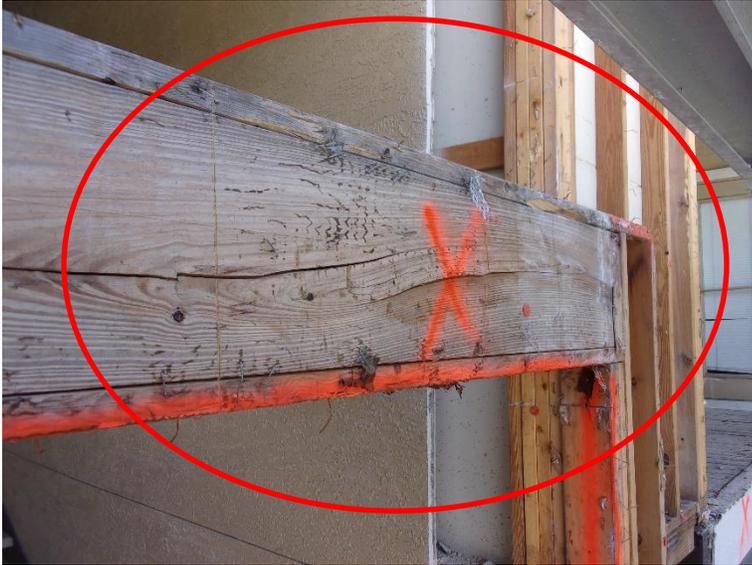
PHOTOGRAPH #31

Framing at breezeway, balconies and walls observed and marked for repairs.

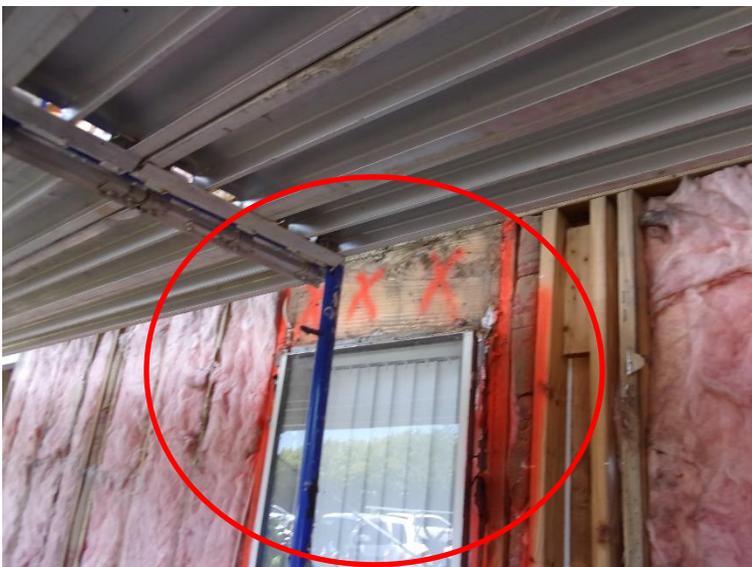
PHOTOGRAPH #32

Framing at breezeway, balconies and walls observed and marked for repairs.
