PHOTOGRAPHS

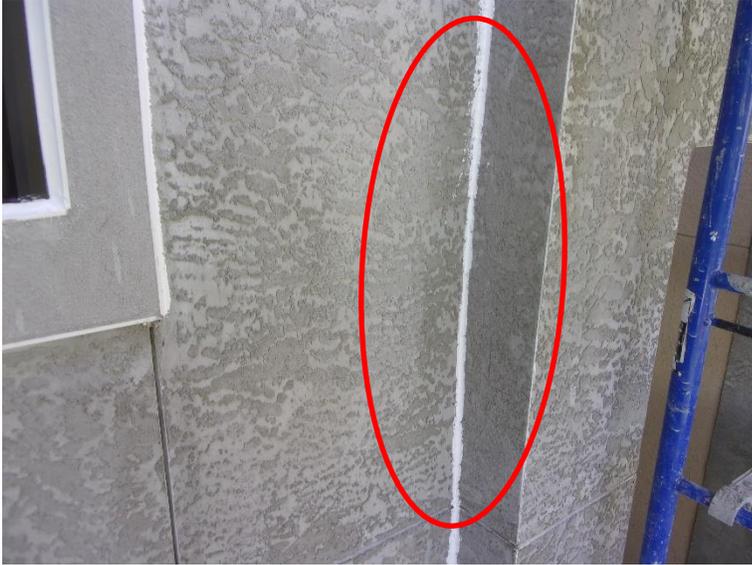
PHOTOGRAPH #1

BUILDING 21 SECTION F

Transition sealants being installed at inside corners are messy and will require professional tooling application.

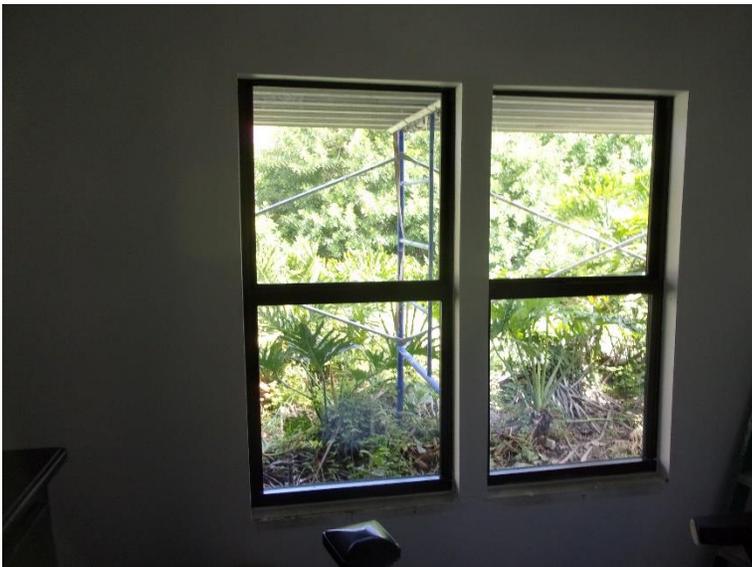
PHOTOGRAPH #2

BUILDING 21 SECTION E- UNIT #2118

Interior window installation inspection confirms flashings and sealants in accordance with AAMA and manufacturer installation guidelines.

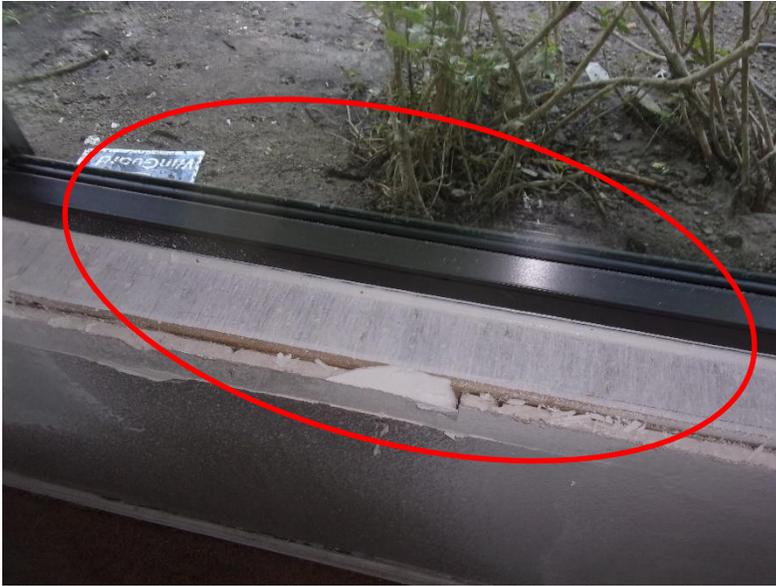
PHOTOGRAPH #3

**BUILDING 21
SECTION E- UNIT #2118**

Interior window installation inspection confirms flashings and sealants in accordance with AAMA and manufacturer installation guidelines.

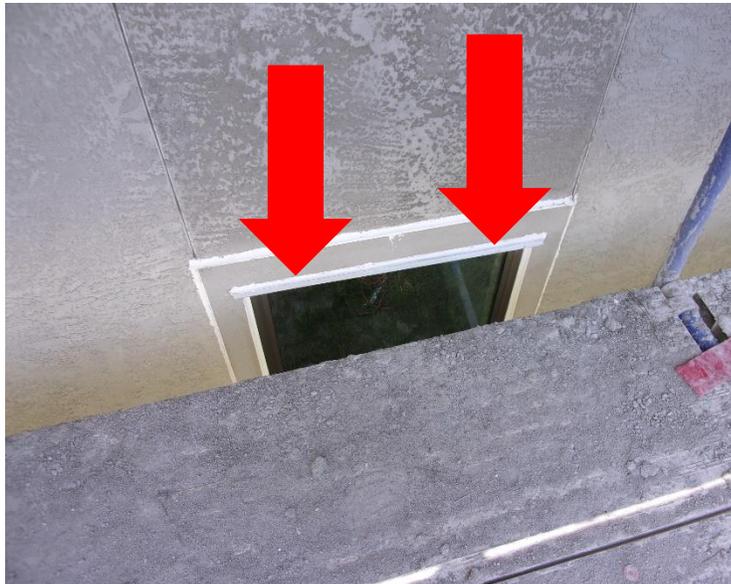
PHOTOGRAPH #4

**BUILDING 21
SECTION D**

Contractor has sealed several windows' above head flashing not allowing open weep design and will be required to remove sealant.

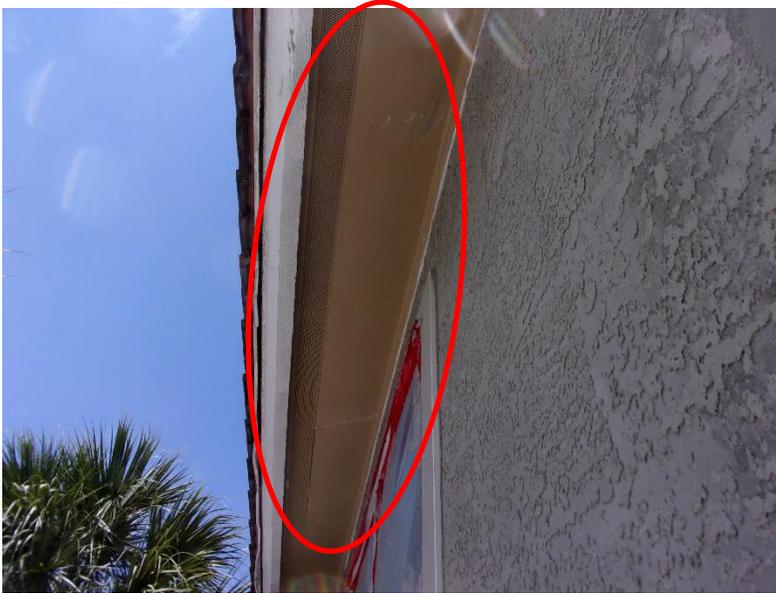
PHOTOGRAPH #5

**BUILDING 21
SECTION C**

Soffits have been primed and contractor is sealing wood to wood transitions as well as fastener holes in preparation for finish coat of paint.

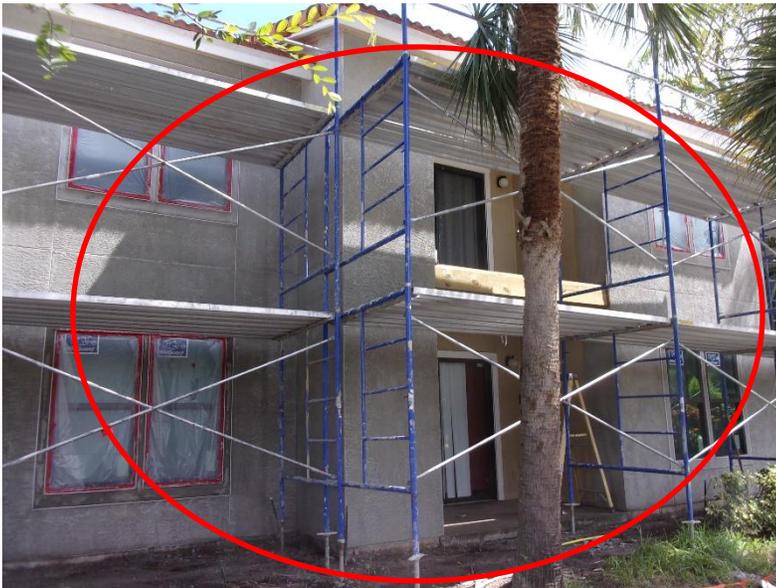
PHOTOGRAPH #6

**BUILDING 21
SECTION C**

Brown coat and finish coat of stucco has been applied.

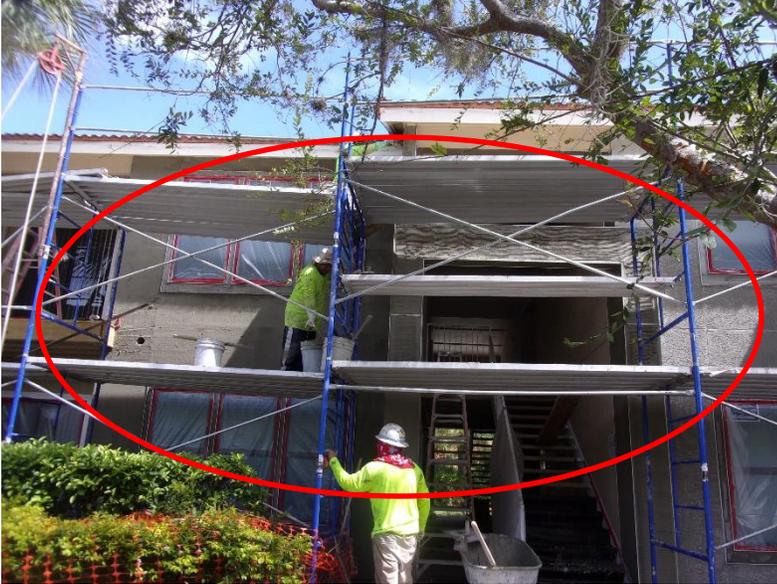
PHOTOGRAPH #7

**BUILDING 21
SECTION B**

Stucco sub-contractor applying scratch coat of stucco.

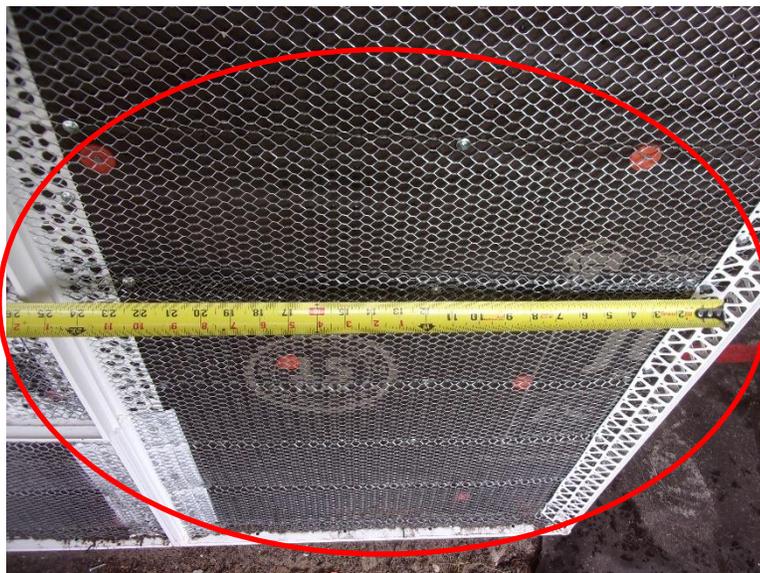
PHOTOGRAPH #8

**BUILDING 21
SECTION A**

Lath and stucco accessories checked for correct fasteners, tie wires and lapping compliance.

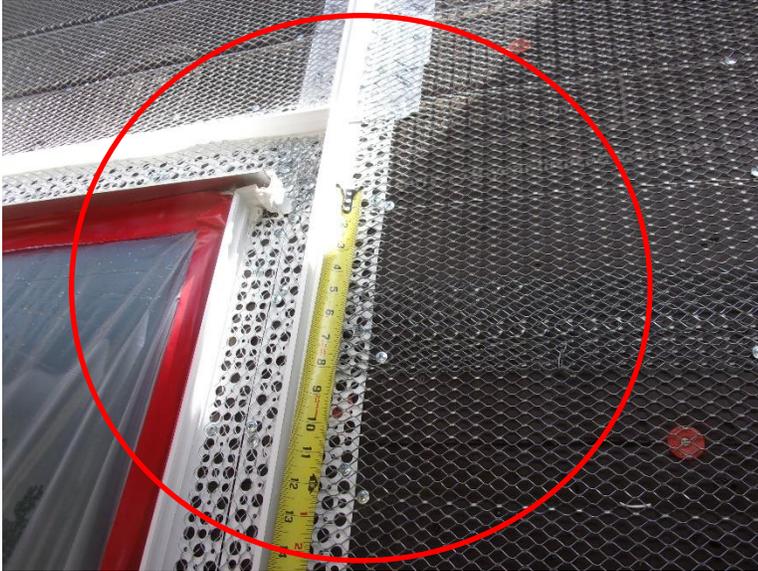
PHOTOGRAPH #9

**BUILDING 21
SECTION A**

Lath and stucco accessories checked for correct fasteners, tie wires and lapping compliance.

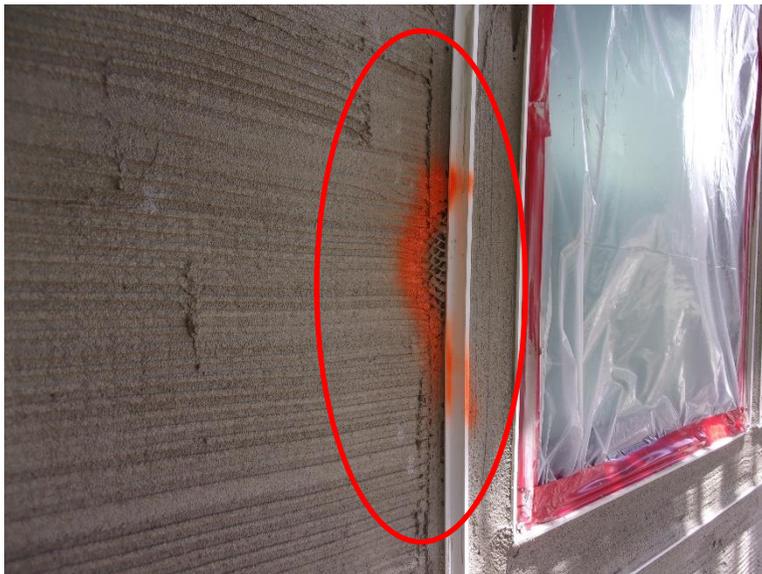
PHOTOGRAPH #10

**BUILDING 21
SECTION A**

Scratch coat of stucco did not fill lath properly at several locations.

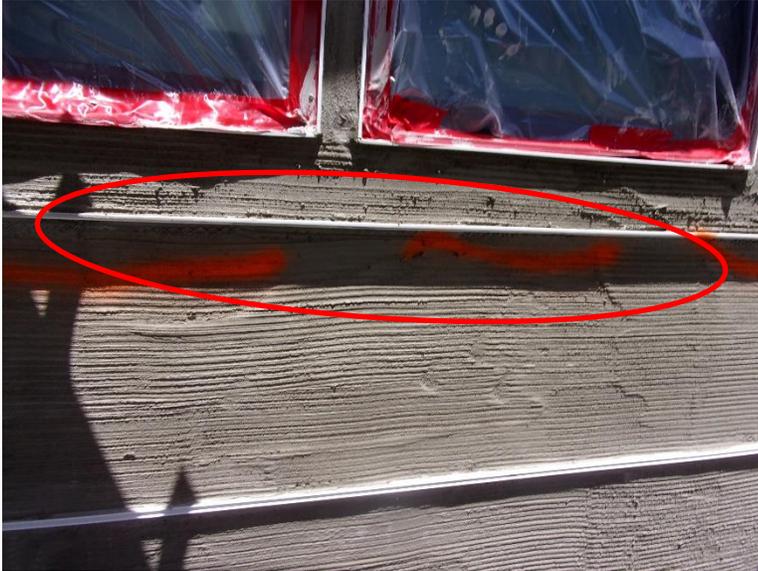
PHOTOGRAPH #11

**BUILDING 21
SECTION A**

Scratch coat of stucco did not fill lath properly at several locations.

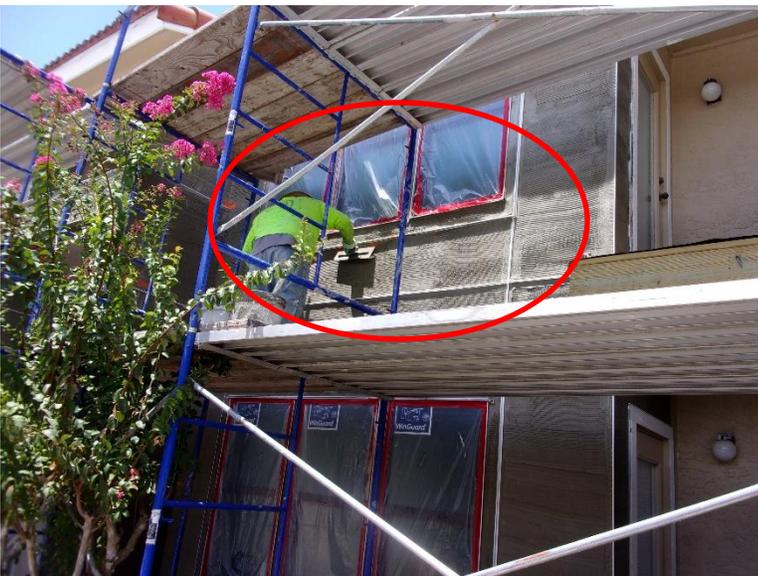
PHOTOGRAPH #12

**BUILDING 21
SECTION A**

Stucco sub-contractor made corrections at scratch coat as directed by Delta.

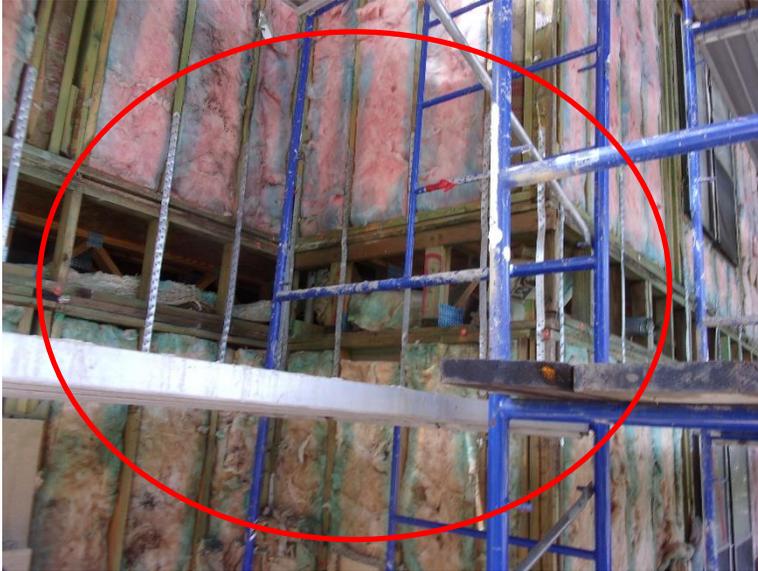
PHOTOGRAPH #13

**BUILDING 20
SECTION H**

Simpson Strong-Tie strapping and termite treatment has been provided.

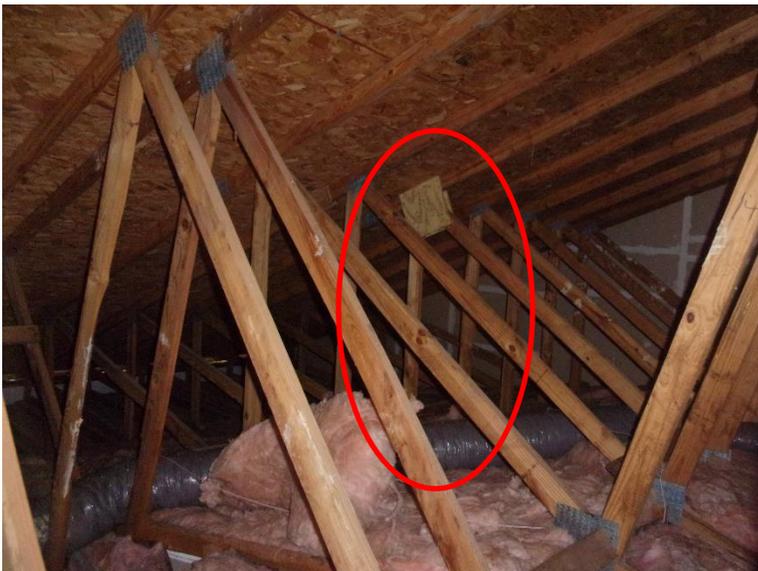
PHOTOGRAPH #14

**BUILDING 20
SECTION H – ATTIC #2022**

Gussets, scabs, and fire wall repairs performed and quantified.

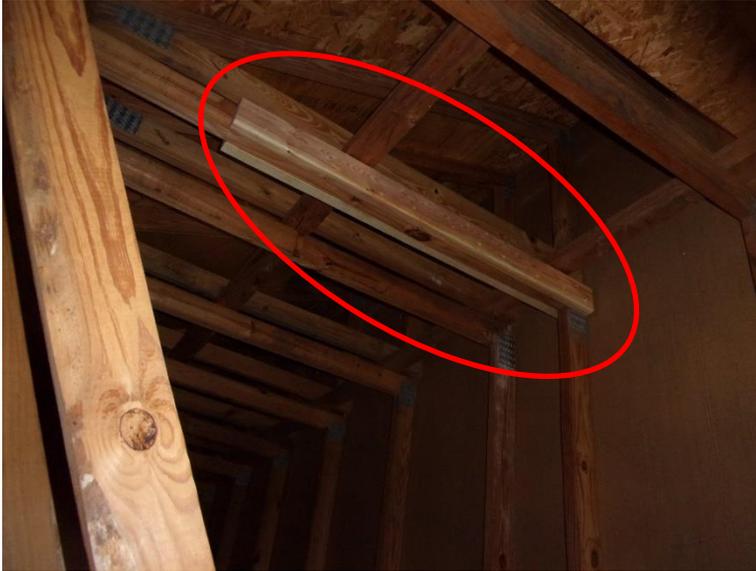
PHOTOGRAPH #15

**BUILDING 20
SECTION H – ATTIC #2022**

Gussets, scabs, and fire wall repairs performed and quantified

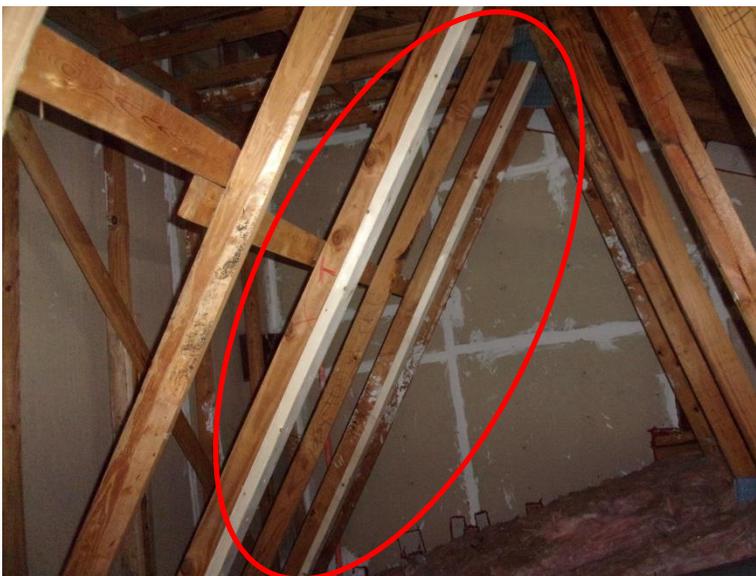
PHOTOGRAPH #16

**BUILDING 20
SECTION H – ATTIC #2021**

Gussets, scabs, and fire wall repairs performed and quantified.

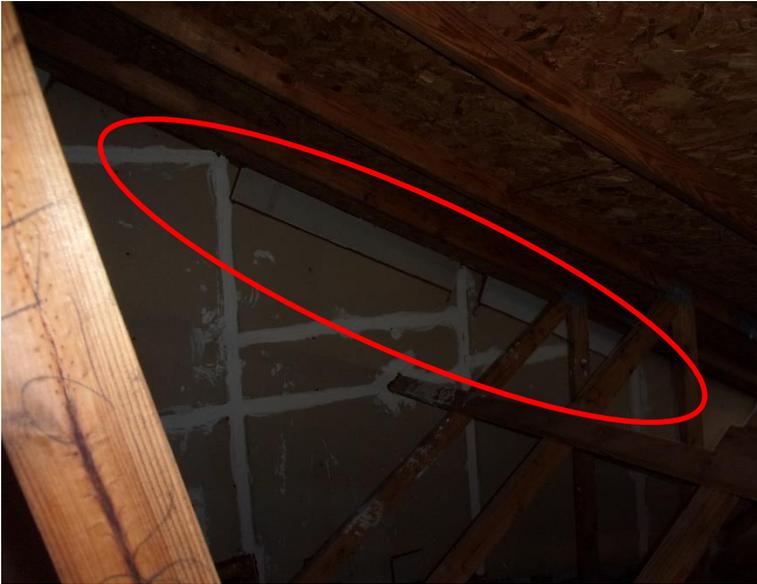
PHOTOGRAPH #17

**BUILDING 20
SECTION H – ATTIC #2021**

Gussets, scabs, and fire wall repairs performed and quantified.

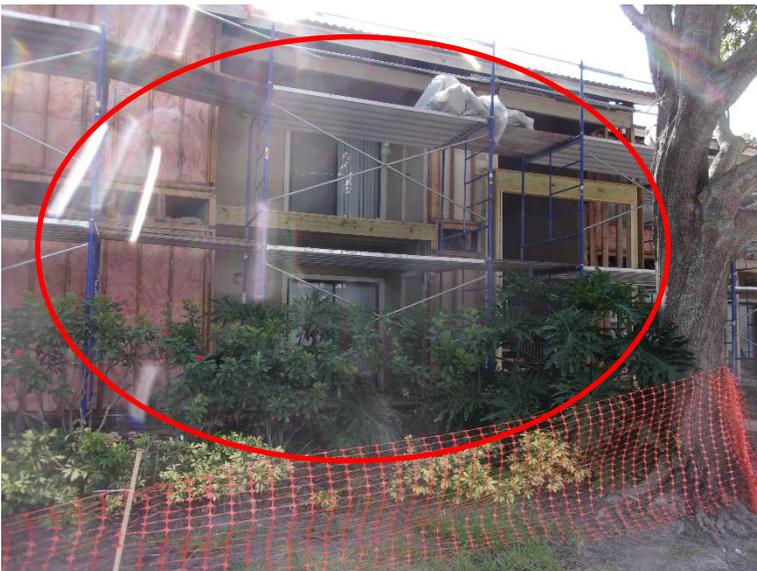
PHOTOGRAPH #18

**BUILDING 20
SECTION A**

Balcony and breezeway framing repairs performed and quantified.

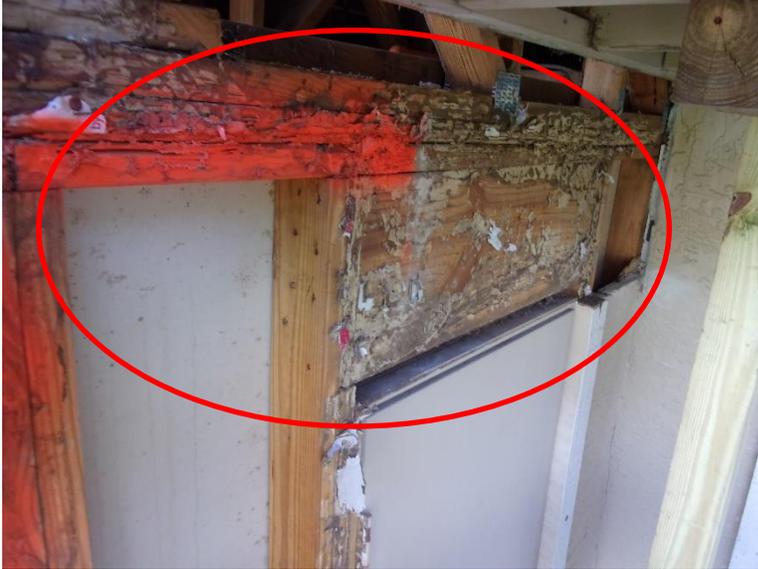
PHOTOGRAPH #19

**BUILDING 20
SECTION B**

Additional damage uncovered and repaired at patio storage door header and wall framing.

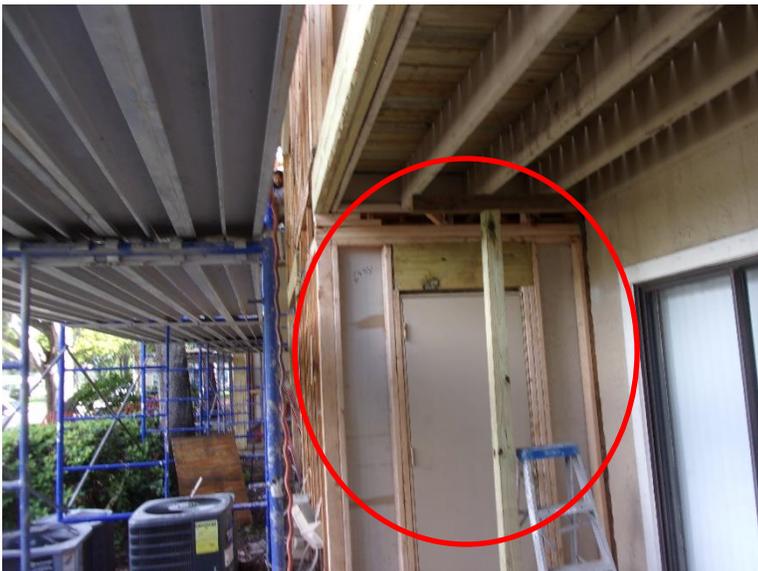
PHOTOGRAPH #20

**BUILDING 20
SECTION B**

Additional damage uncovered and repaired at patio storage door header and wall framing.

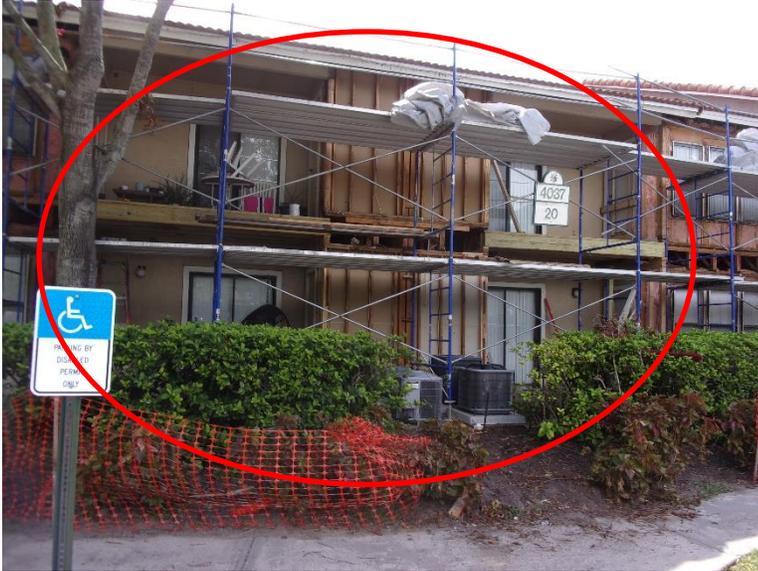
PHOTOGRAPH #21

**BUILDING 20
SECTION B**

Balcony framing and decking repaired and quantified.

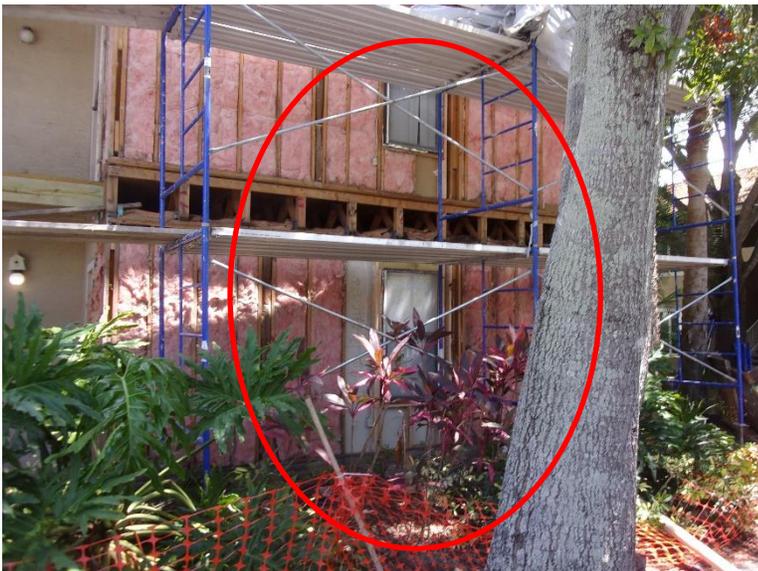
PHOTOGRAPH #22

**BUILDING 20
SECTION C**

Damaged window opening framing repaired and quantified.
