### PHOTOGRAPHS

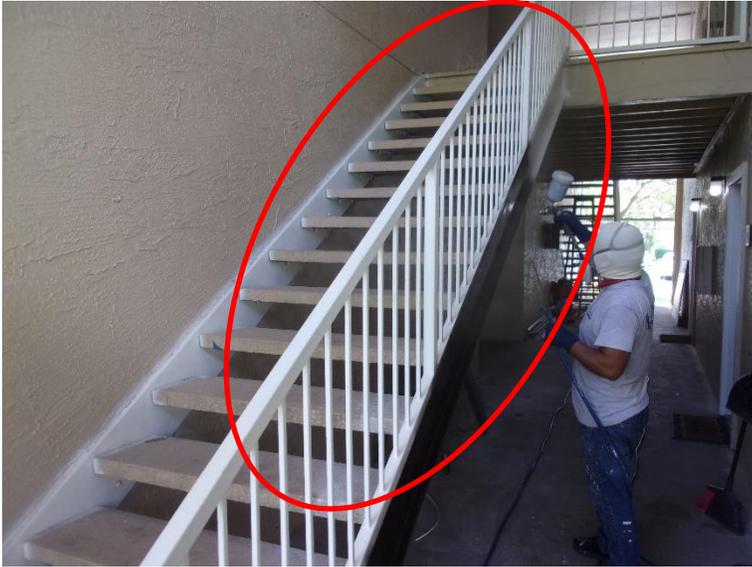
PHOTOGRAPH #1

#### BUILDING 21 SECTION G

Stairwell railing being painted with aliphatic urethane enamel finish coating.

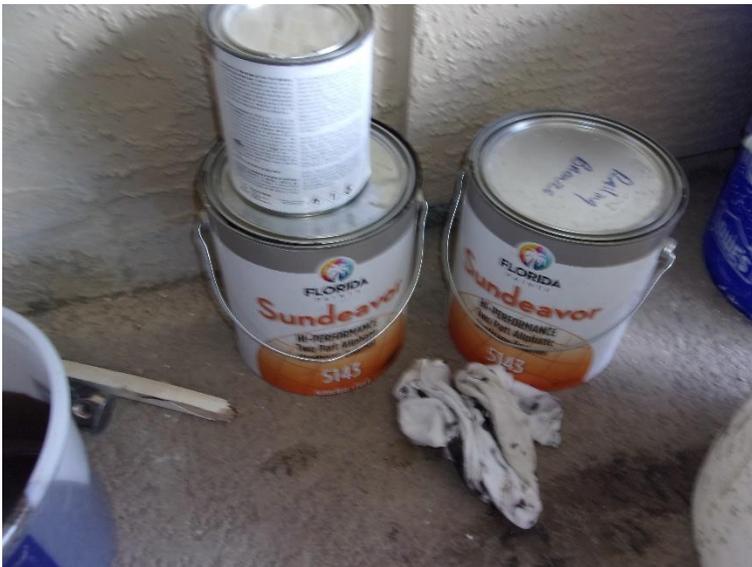
PHOTOGRAPH #2

#### BUILDING 21 SECTION G

Stairwell railing being painted with aliphatic urethane enamel finish coating.

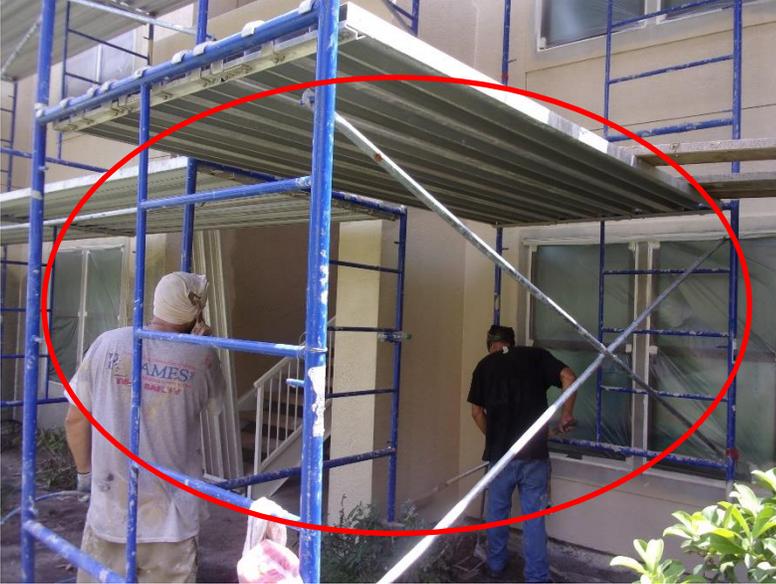
**PHOTOGRAPH #3**

**BUILDING 21  
SECTION F**

Stucco receiving Florida Paints masonry primer by spray and back rolling application.

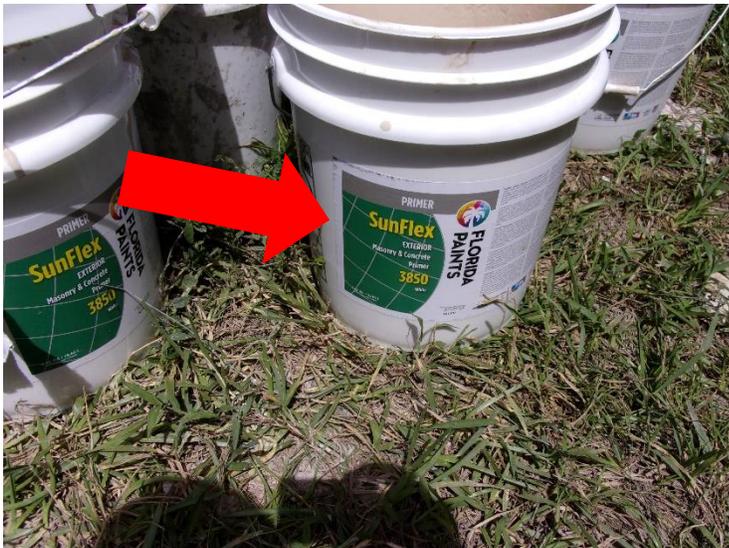
**PHOTOGRAPH #4**

**BUILDING 21  
SECTION F**

Stucco receiving Florida Paints masonry primer by spray and back rolling application.

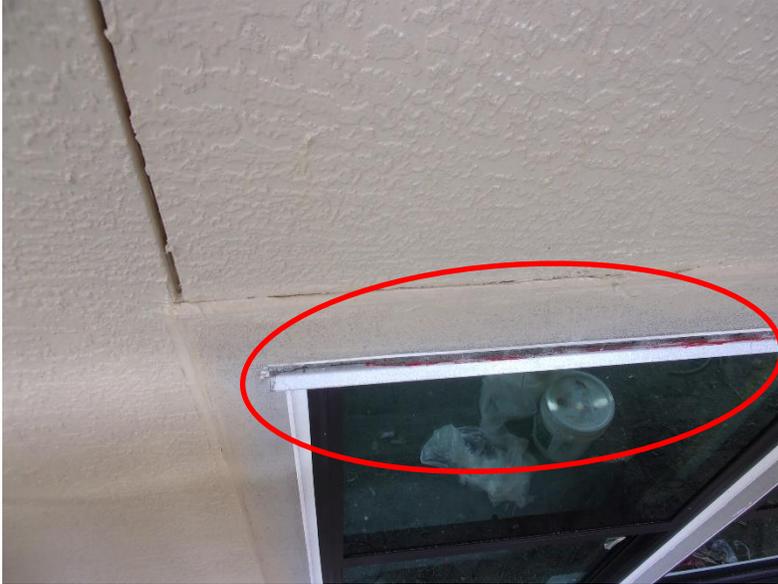
**PHOTOGRAPH #5**

**BUILDING 21  
SECTION D**

Sealant has been removed where improperly installed at head flashing.

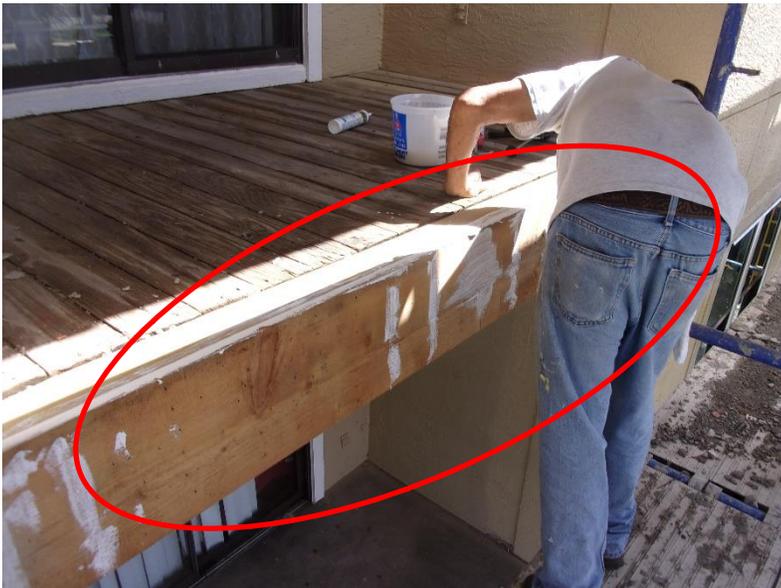
**PHOTOGRAPH #6**

**BUILDING 21  
SECTION C**

Cedar covering at built up balcony beams being prepared for painting applications.

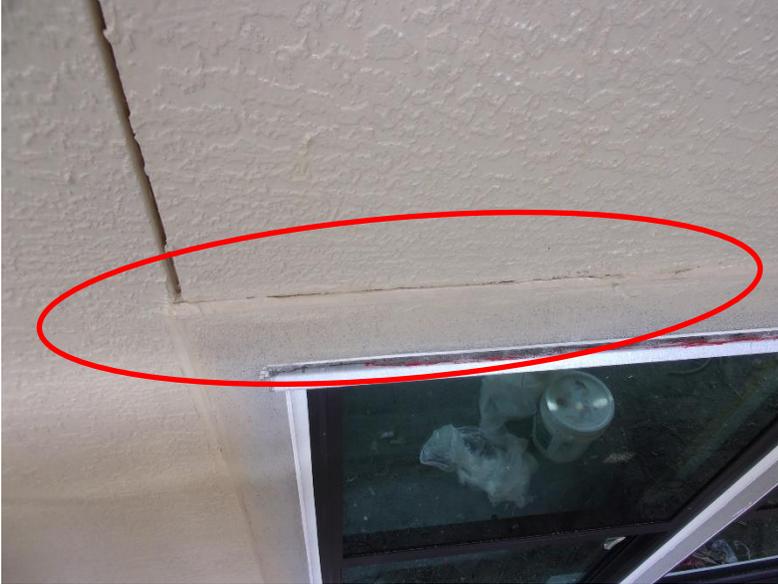
**PHOTOGRAPH #7**

**BUILDING 21  
SECTION B**

Several transition sealants are messy and will require professional tooling application.

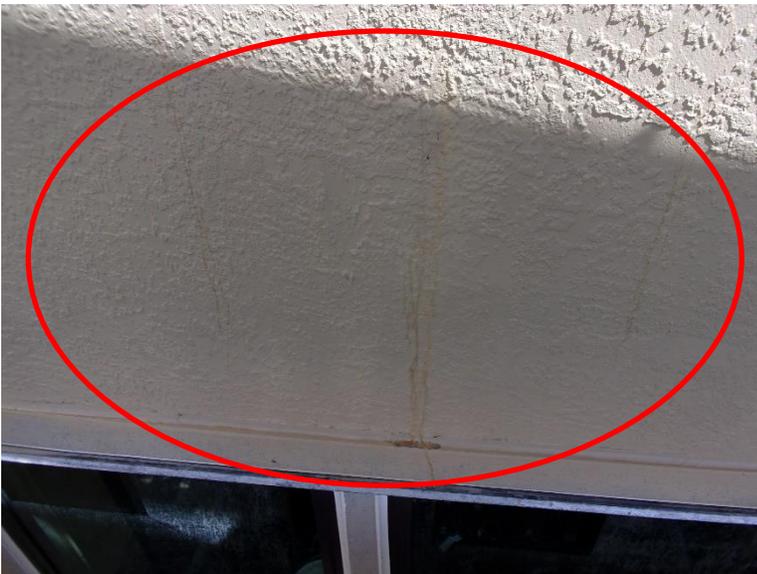
**PHOTOGRAPH #8**

**BUILDING 21  
SECTION B**

Several areas showing damage to newly applied finish coat due to excessive moisture prior to paint curing will require recoating.

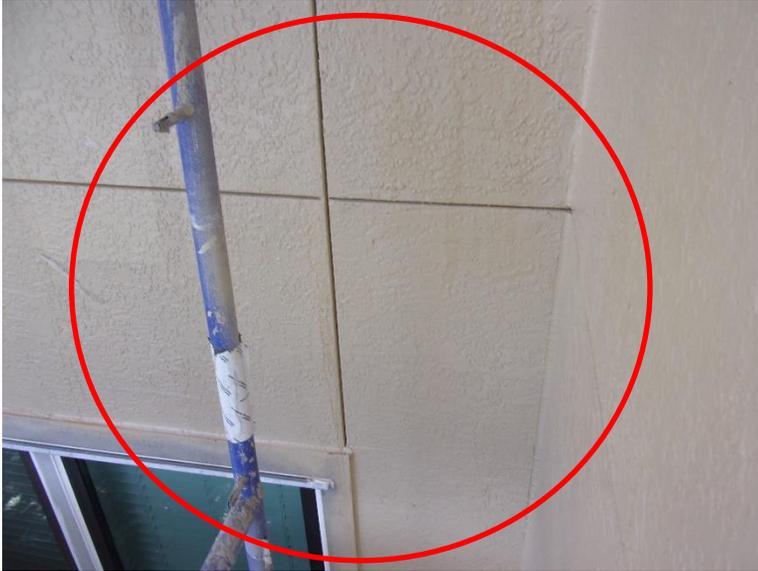
**PHOTOGRAPH #9**

**BUILDING 21  
SECTION B**

Several areas showing damage to newly applied finish coat due to excessive moisture prior to paint curing will require recoating.

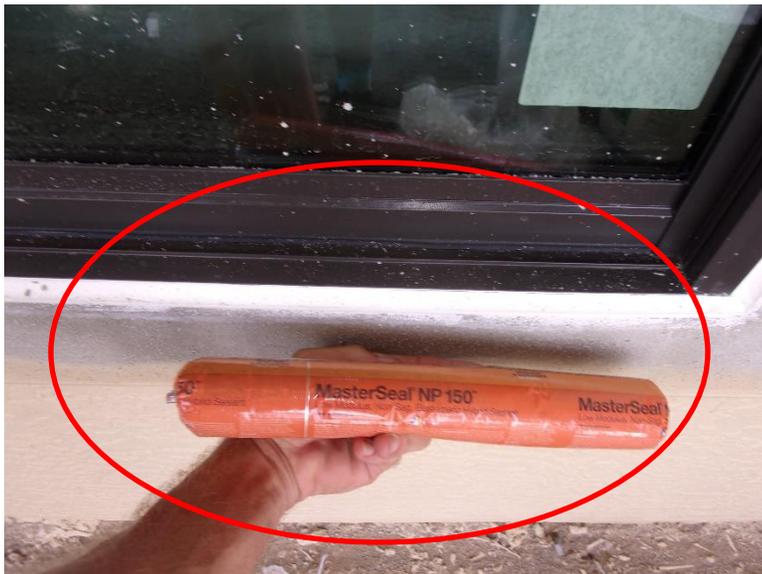
**PHOTOGRAPH #10**

**BUILDING 21  
SECTION B**

MasterSeal NP 150 sealant applied at Window perimeters.

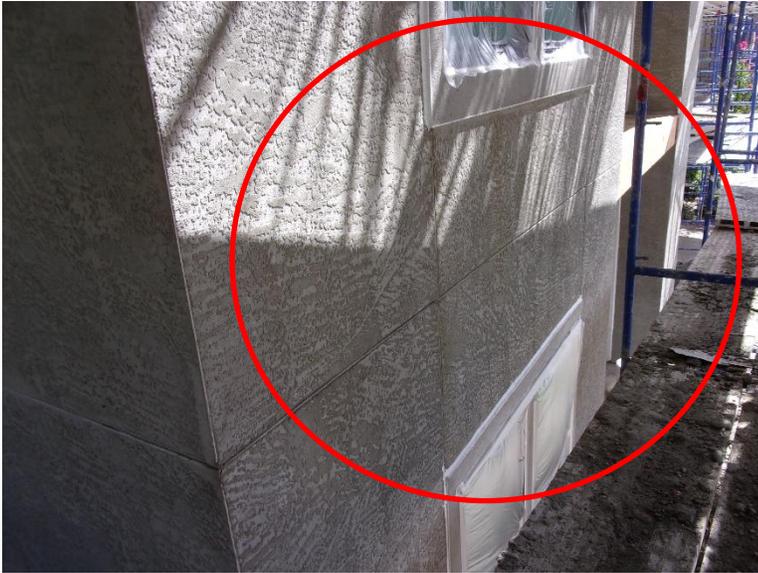
**PHOTOGRAPH #11**

**BUILDING 21  
SECTION A**

Finish stucco is awaiting PH testing by manufacturer's representative prior to starting coating process.

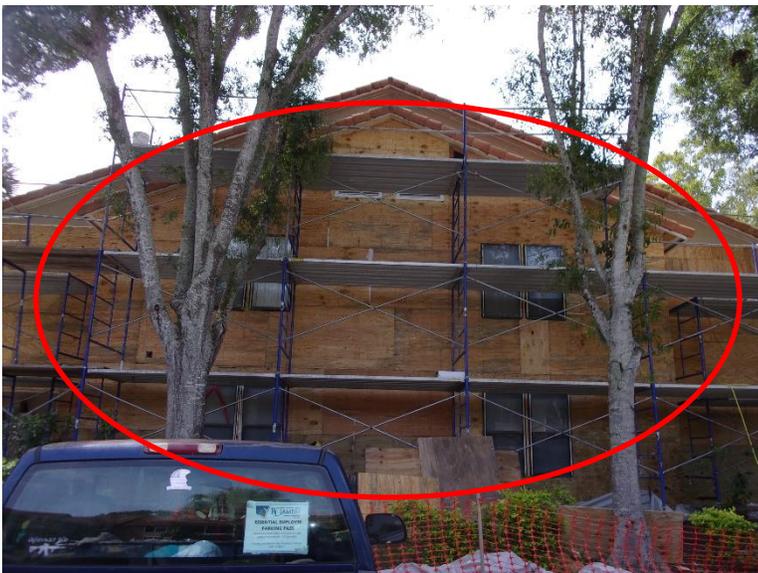
**PHOTOGRAPH #12**

**BUILDING 20  
SECTION H**

New 15/32" plywood sheathing applied and inspected.

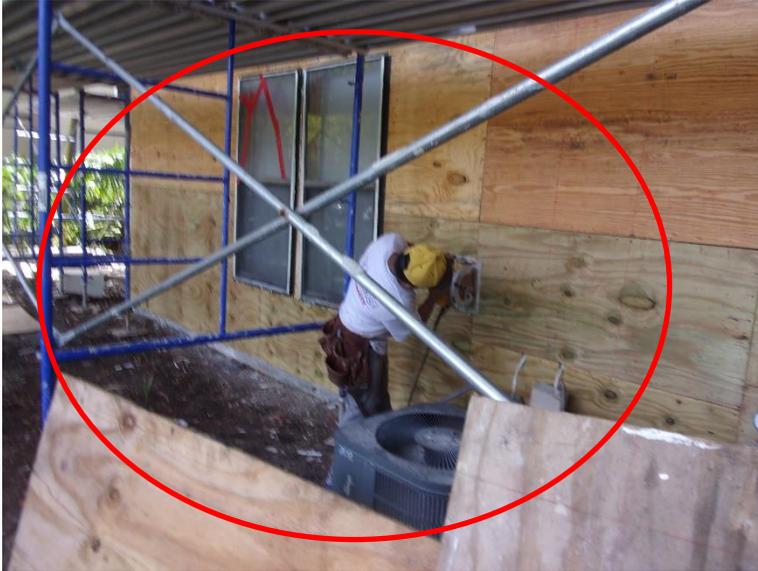
**PHOTOGRAPH #13**

**BUILDING 20  
SECTION H**

Contractor making corrections where lower pressure treated sheathing did not have proper gaps.

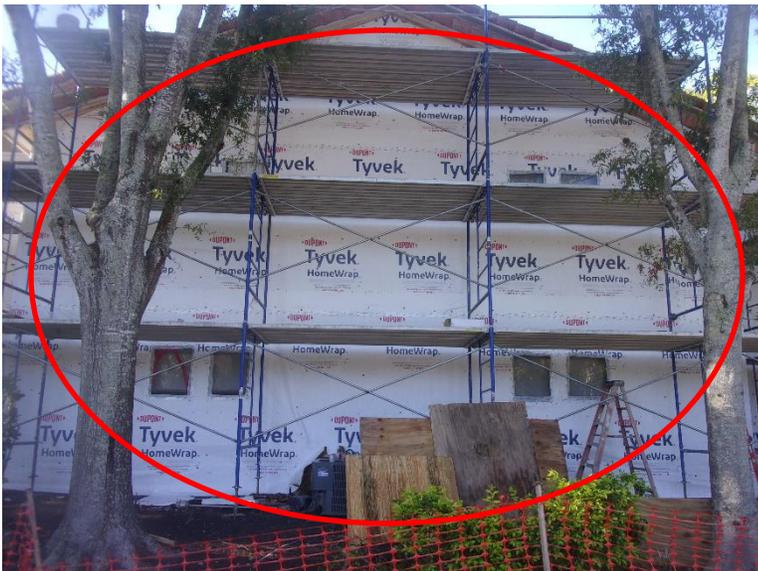
**PHOTOGRAPH #14**

**BUILDING 20  
SECTION H**

Tyvek HomeWrap applied over new sheathing. Contractor has temporarily reinstalled old windows allowing for some light in units while waiting for delayed delivery of windows by manufacturer.

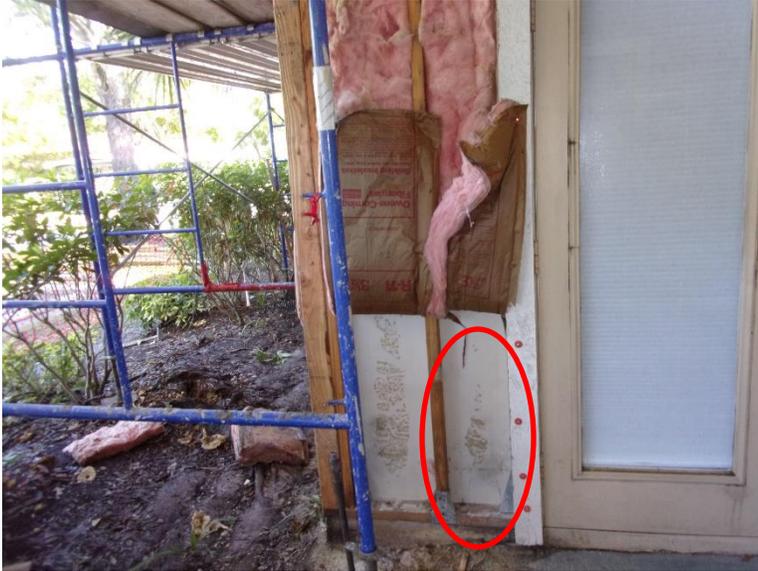
**PHOTOGRAPH #15**

**BUILDING 20  
SECTION A – UNIT #2011**

Contractor failed to fully cover open return wall at patio allowing minimal rain to wet insulation and small section of drywall. Insulation will be replaced and damaged drywall.

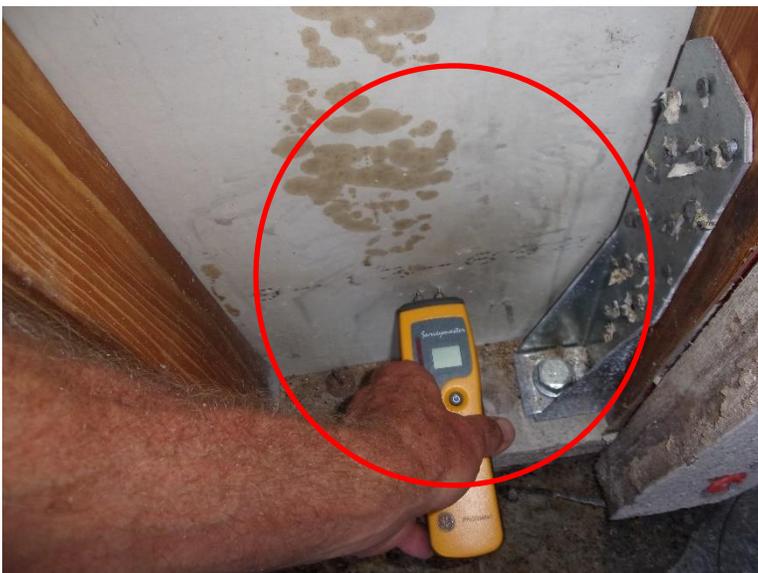
**PHOTOGRAPH #16**

**BUILDING 20  
SECTION A – UNIT #2011**

Moisture meter testing of drywall confirmed small section of drywall had received rain exposure.

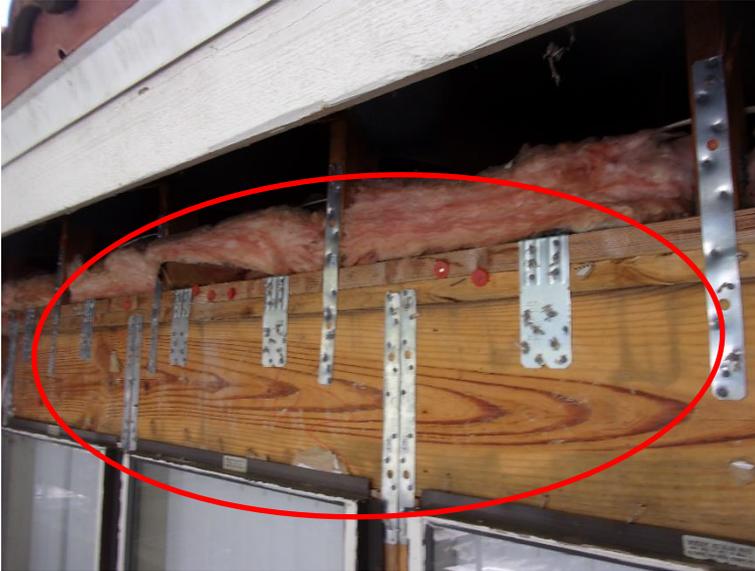
**PHOTOGRAPH #17**

**BUILDING 20  
SECTION B**

Simpson Strong-Tie connectors, straps and screws applied at headers top plates and trusses.

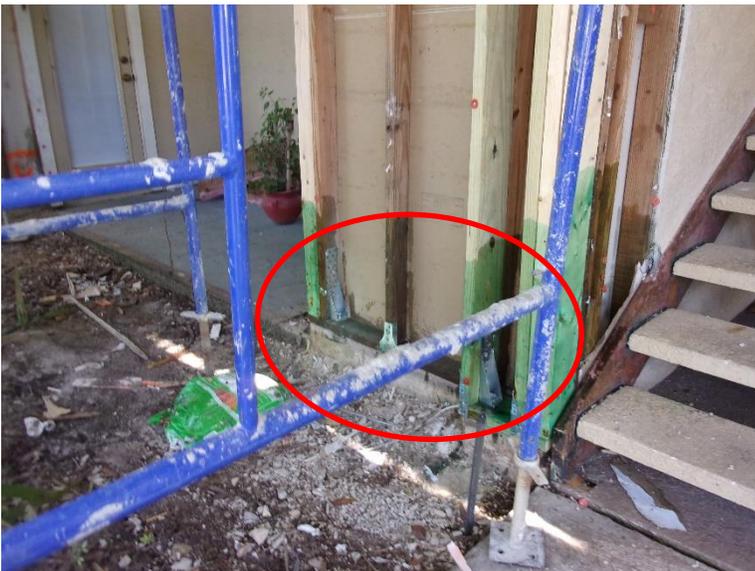
**PHOTOGRAPH #18**

**BUILDING 20  
SECTION B**

Simpson Strong-Tie connectors and Titan HD bolts inspected at wall framing and bottom plate.

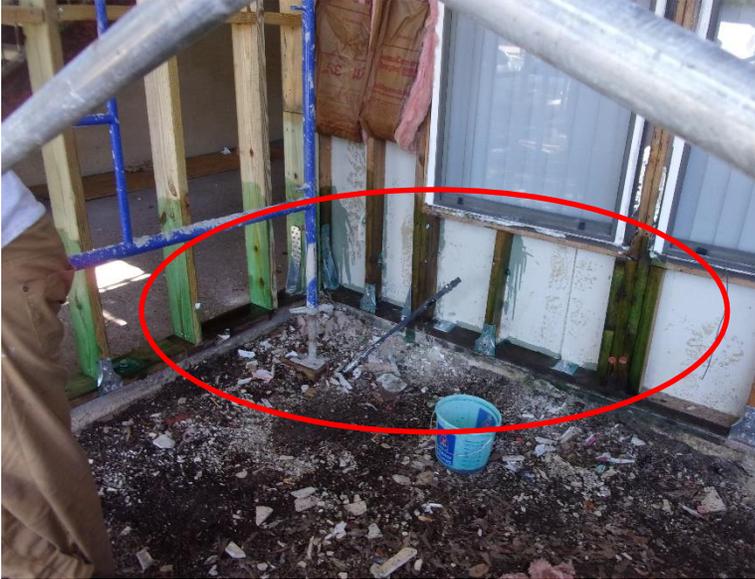
**PHOTOGRAPH #19**

**BUILDING 20  
SECTION B**

Contractor applying Copper Green wood preservative at bottom plate and lower 2' of wall framing.

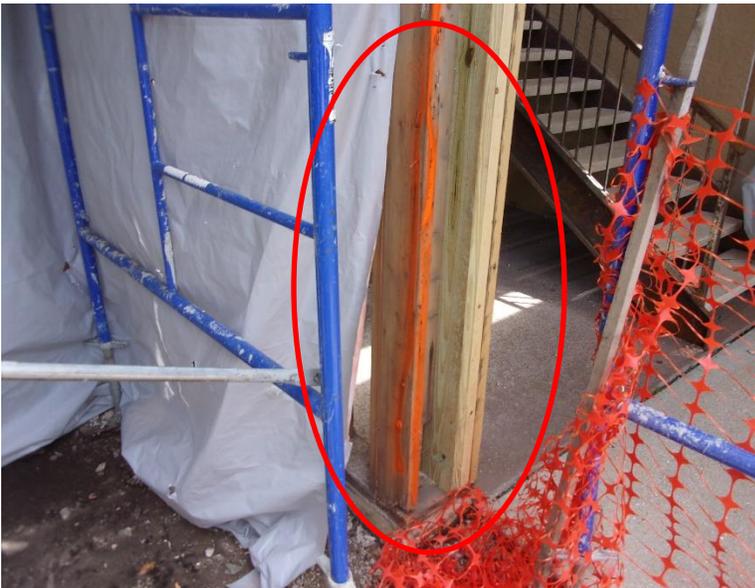
**PHOTOGRAPH #20**

**BUILDING 20  
SECTION C**

Additional framing marked and replaced at breezeway opening.

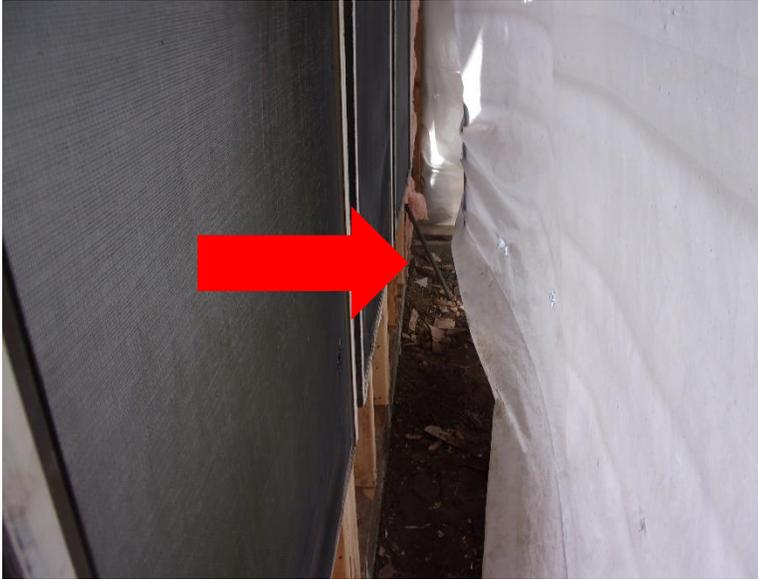
**PHOTOGRAPH #21**

**BUILDING 20  
SECTION C**

Sprinklers covered behind protection plastic. Contractor notified of potential damage and will assure these are not active during wall repair procedures.

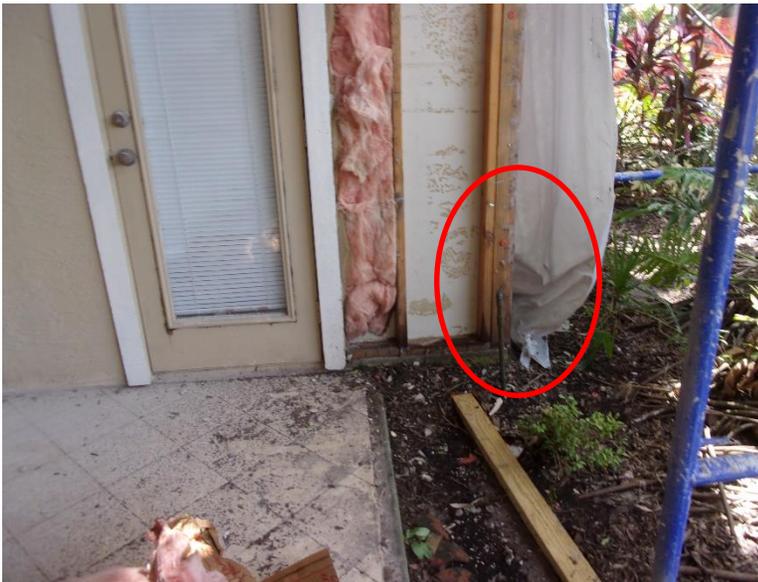
**PHOTOGRAPH #22**

**BUILDING 20  
SECTION C**

Sprinklers covered behind protection plastic. Contractor notified of potential damage and will assure these are not active during wall repair procedures.
