PHOTOGRAPHS

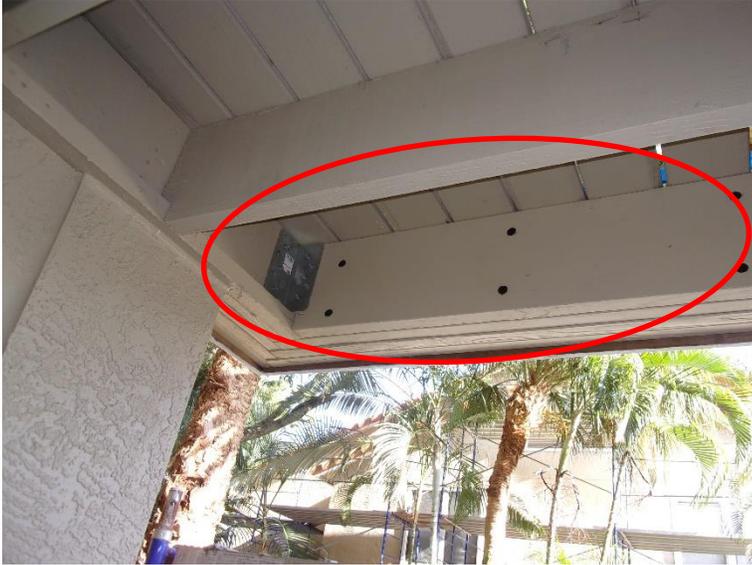
PHOTOGRAPH #1

BUILDING 21 SECTION G

Simpson Strong-Tie screws and clip hardware installed at balcony built up beams.

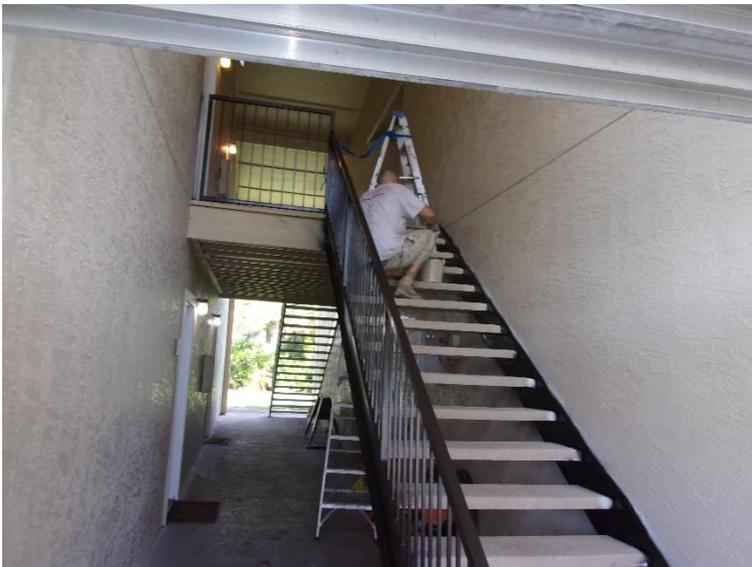
PHOTOGRAPH #2

BUILDING 21 SECTION G

Contractor painting stairway steps with Florida Paints concrete sealer.

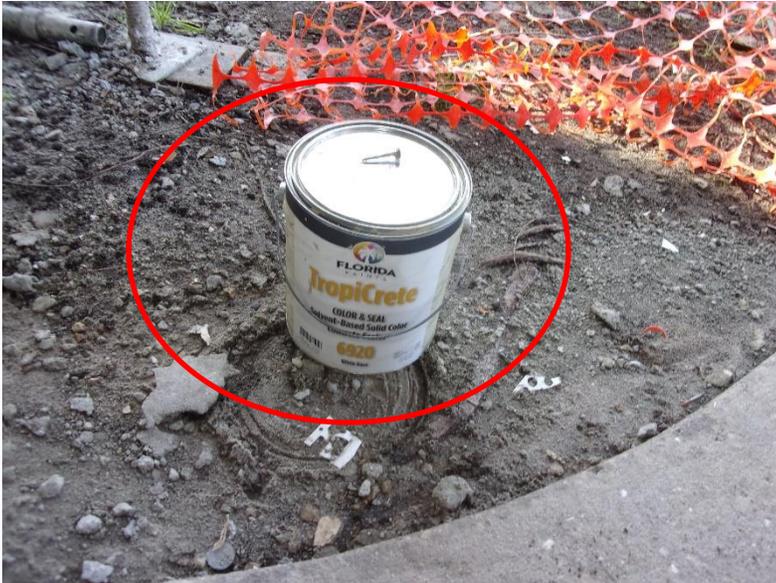
PHOTOGRAPH #3

**BUILDING 21
SECTION G**

Contractor painting stairway steps with Florida Paints concrete sealer.

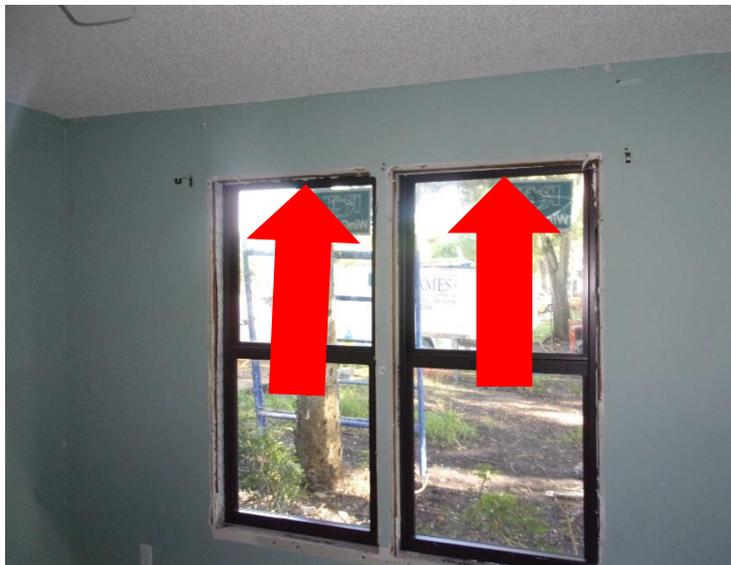
PHOTOGRAPH #4

**BUILDING 21
SECTION G- UNIT #2112**

Gaps at heads of 3 windows in bedroom area exceed maximum allowed gap for fastening of new PGT windows. Window will require corrective measures to meet manufacturer's NOA requirements.

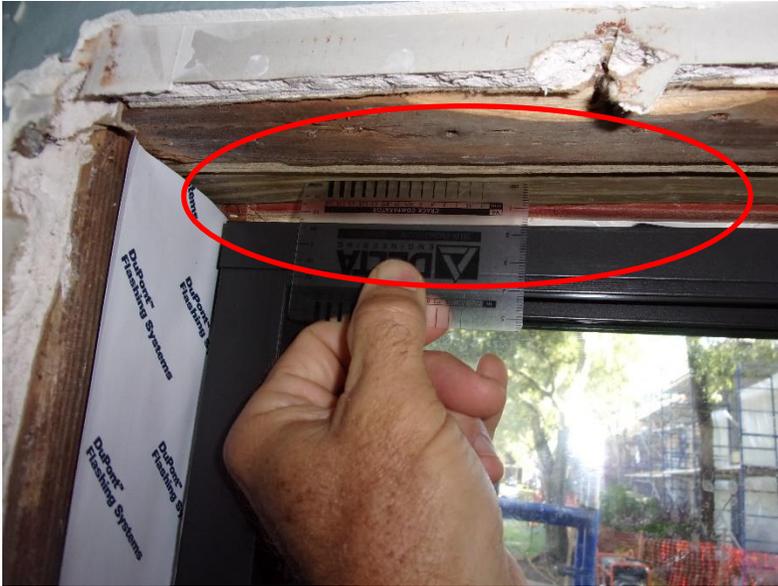
PHOTOGRAPH #5

**BUILDING 21
SECTION G- UNIT #2112**

Gaps at heads of 3 windows in bedroom area exceed maximum allowed gap for fastening of new PGT windows. Window will require corrective measures to meet manufacturer's NOA requirements.

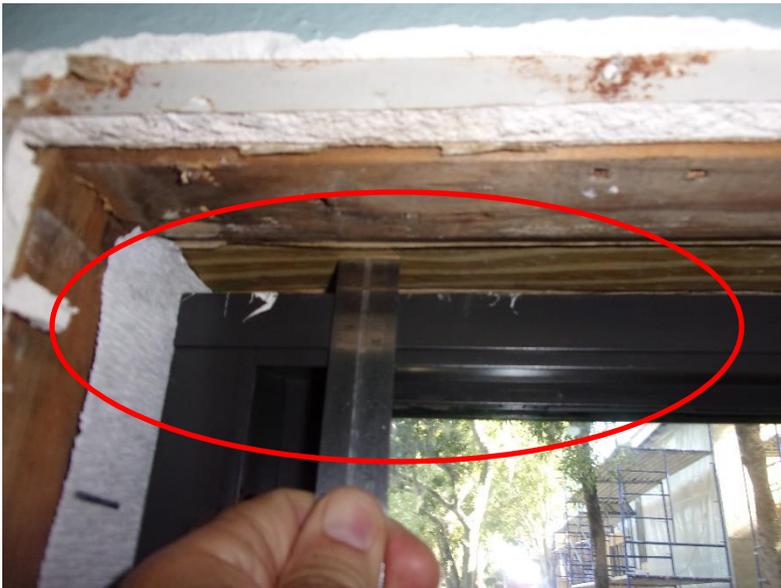
PHOTOGRAPH #6

**BUILDING 21
SECTION G- UNIT #2112**

Gaps at heads of 3 windows in bedroom area exceed maximum allowed gap for fastening of new PGT windows. Window will require corrective measures to meet manufacturer's NOA requirements.

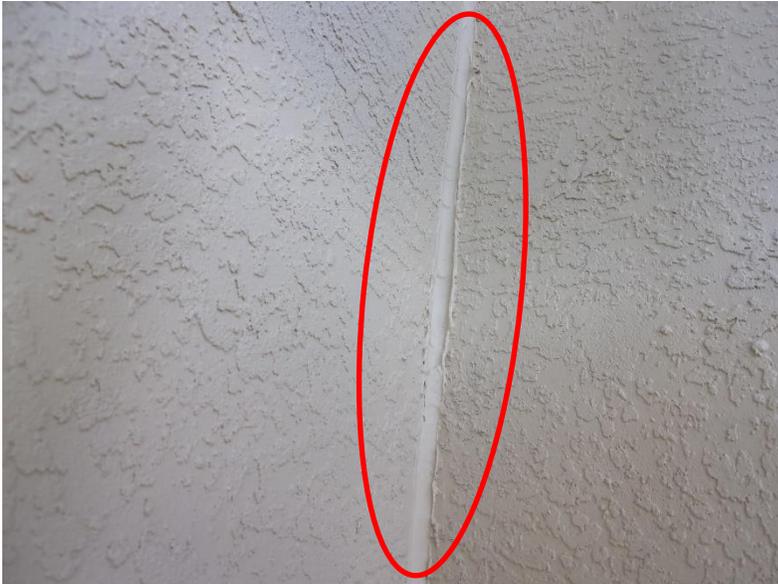
PHOTOGRAPH #7

**BUILDING 21
SECTION B**

Several transition sealants are messy and will require correction with professional tooling application.

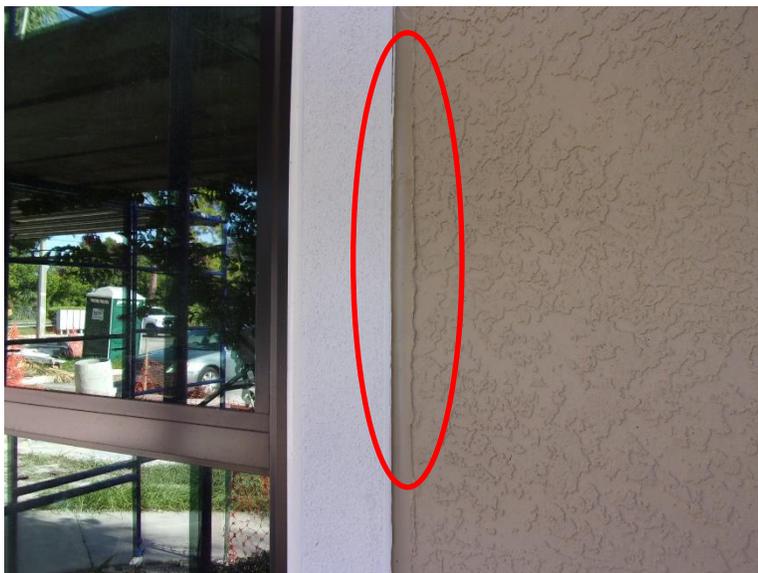
PHOTOGRAPH #8

**BUILDING 21
SECTION B**

Several transition sealants are messy and will require correction with professional tooling application.

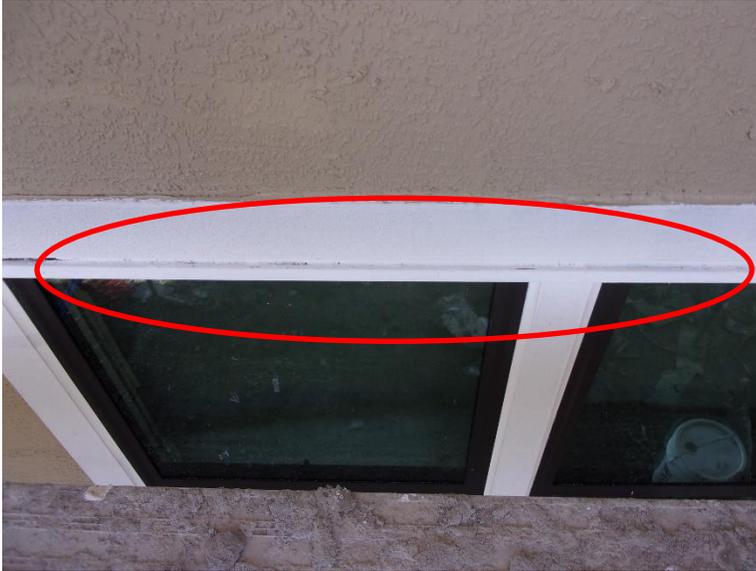
PHOTOGRAPH #9

**BUILDING 21
SECTION B**

Contractor has filled gap above flashing with paint and will be required to remove.

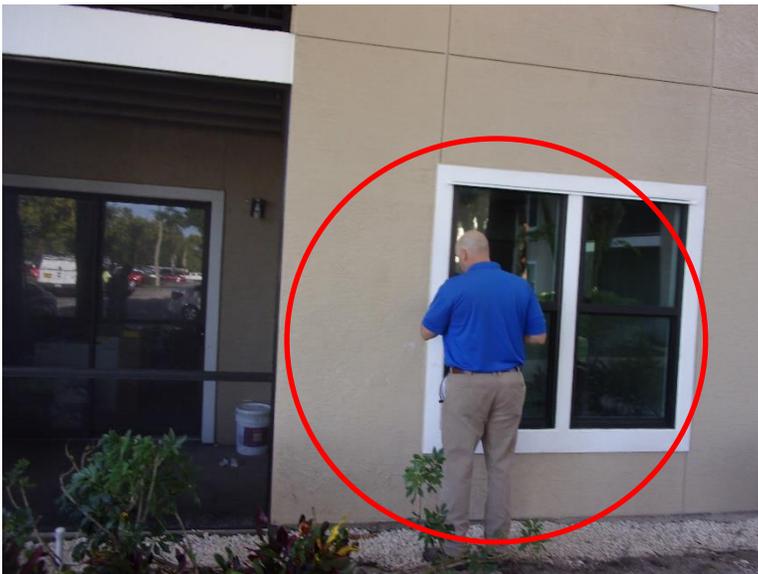
PHOTOGRAPH #10

**BUILDING 21
SECTION B**

BASF manufacturer's representative tested and passed new sealants at window perimeters and will produce report for job files.

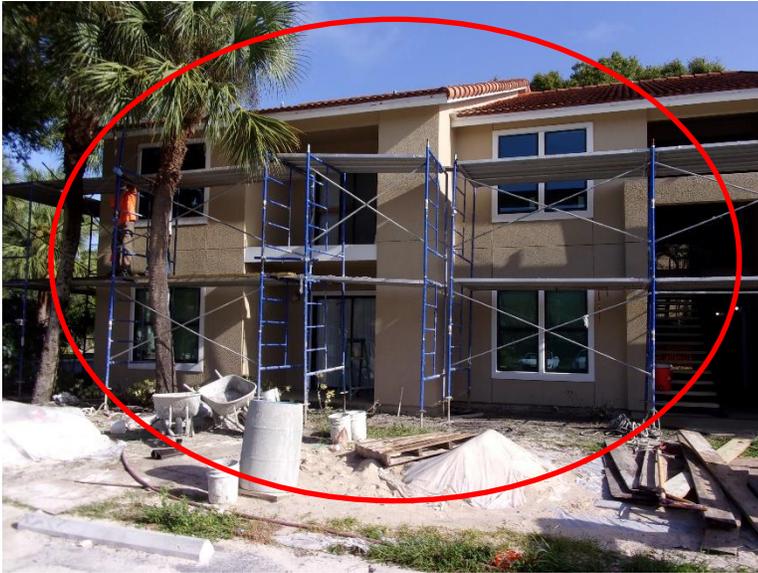
PHOTOGRAPH #11

**BUILDING 21
SECTION A**

Stucco painting has been completed and scaffolding is being removed.

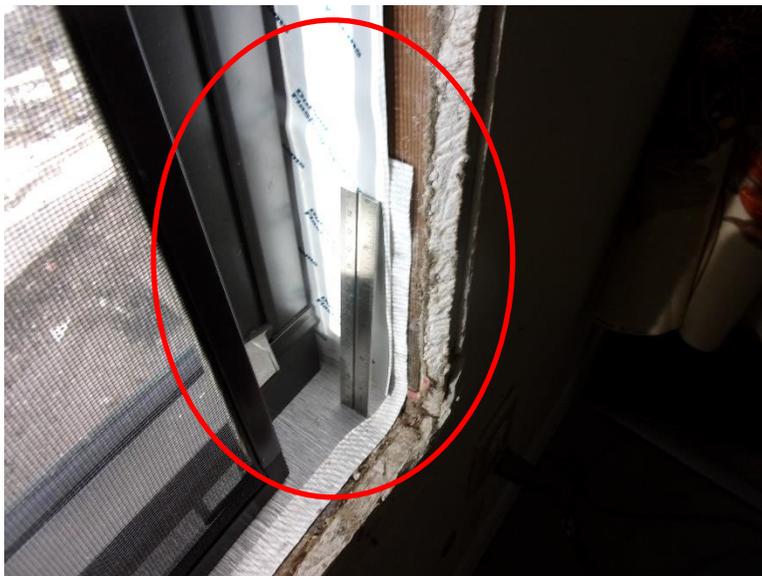
PHOTOGRAPH #12

**BUILDING 21
SECTION G- UNIT #2111**

Windows inspected at unit interior for compliance with PGT NOA requirements and Dupont/ Tyvek flashing requirements.

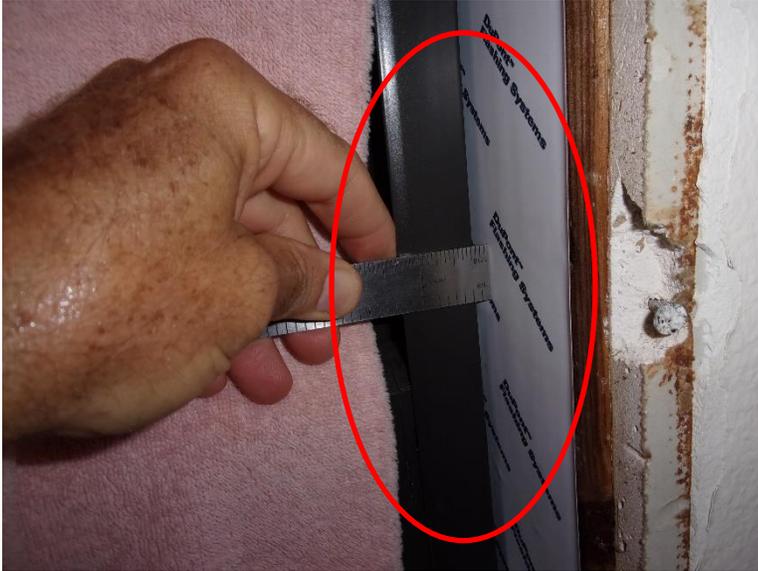
PHOTOGRAPH #13

**BUILDING 21
SECTION G- UNIT #2111**

Windows inspected at unit interior for compliance with PGT NOA requirements and Dupont/ Tyvek flashing requirements.

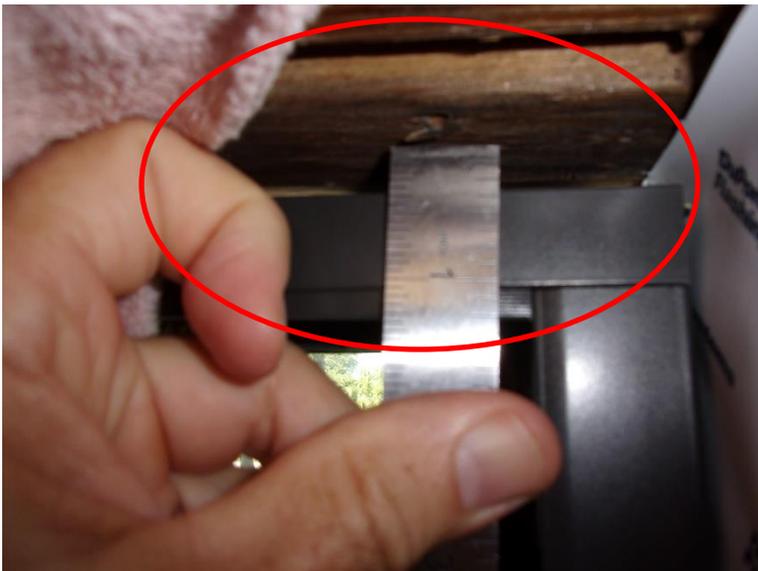
PHOTOGRAPH #14

**BUILDING 21
SECTION G- UNIT #2111**

Windows inspected at unit interior for compliance with PGT NOA requirements and Dupont/ Tyvek flashing requirements.

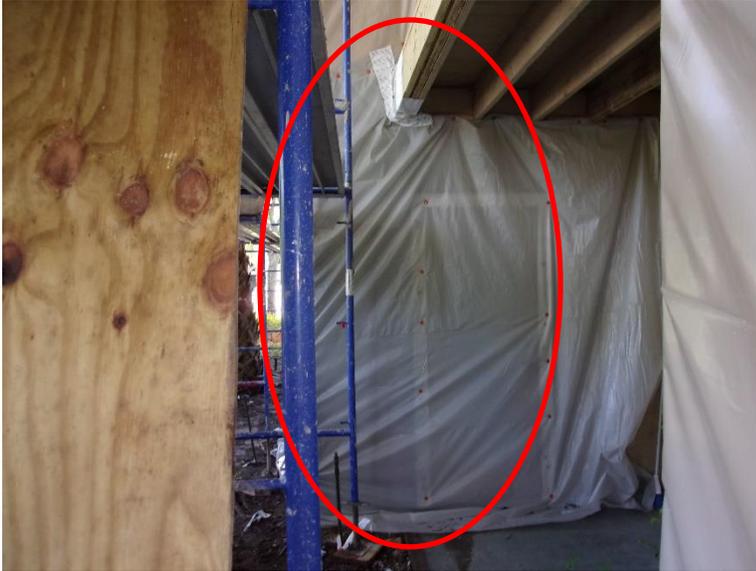
PHOTOGRAPH #15

**BUILDING 20
SECTION A – UNIT #2011**

Contractor has fully covered open walls preventing any damage from exterior elements while waiting for windows to complete finish work.

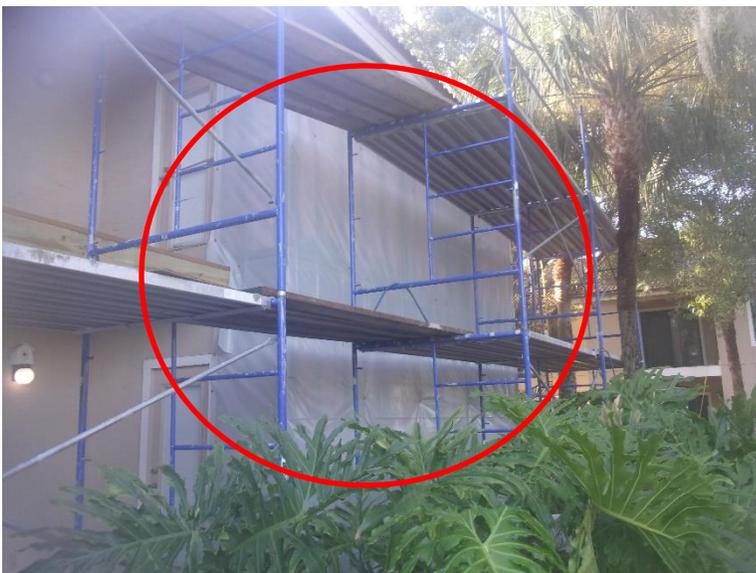
PHOTOGRAPH #16

**BUILDING 20
SECTION A**

Contractor has fully covered open walls preventing any damage from exterior elements while waiting for windows to complete finish work.

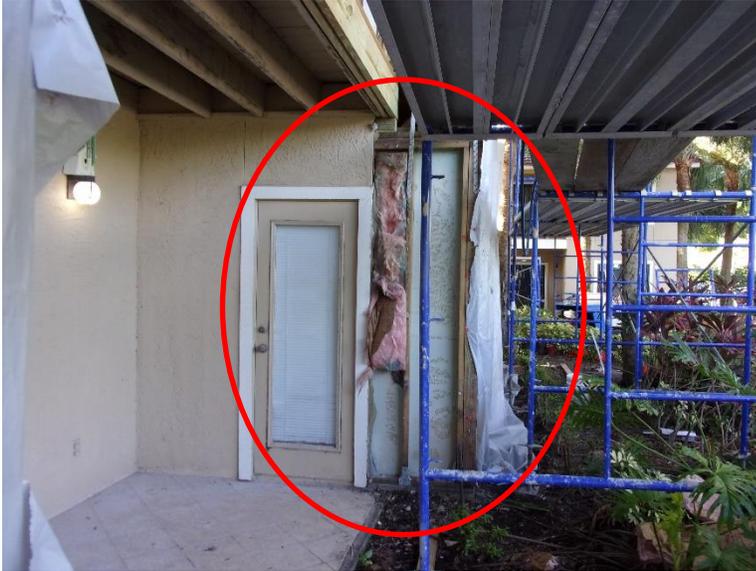
PHOTOGRAPH #17

**BUILDING 20
SECTION B**

Contractor had failed to cover open walls and insulation at balcony return areas resulting in insulation damage.

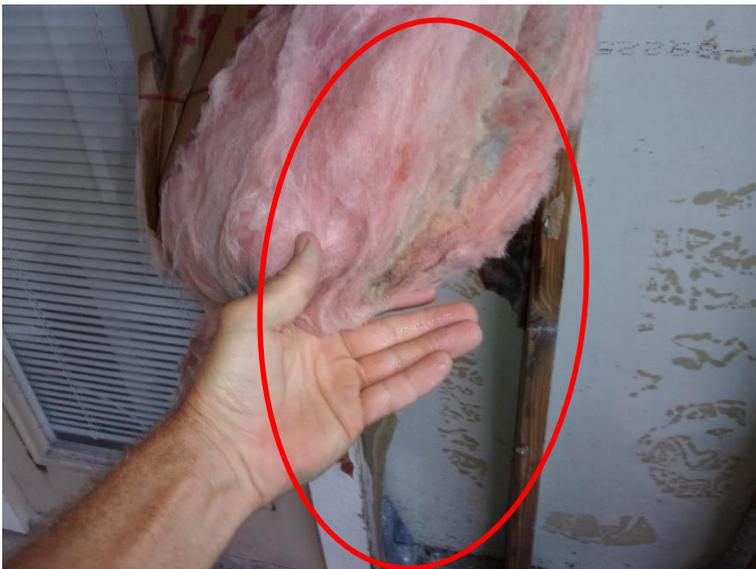
PHOTOGRAPH #18

**BUILDING 20
SECTION B**

Contractor had failed to cover open walls and insulation at balcony return areas resulting in insulation damage

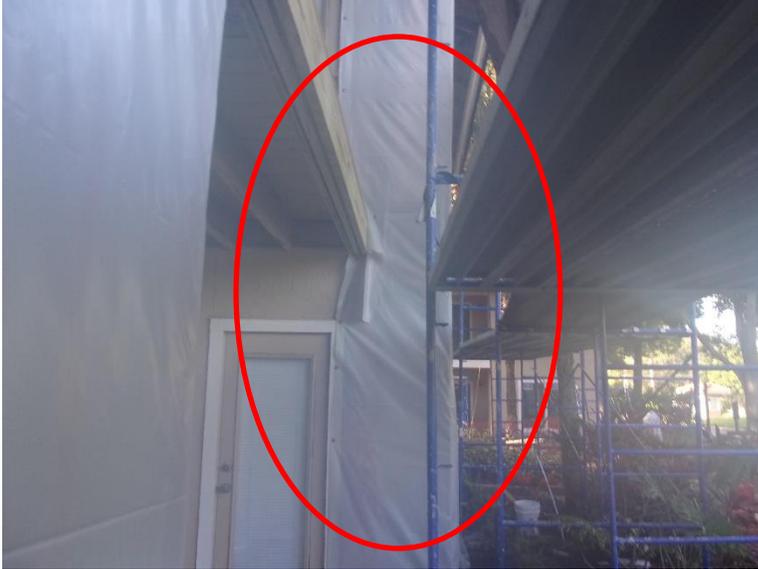
PHOTOGRAPH #19

**BUILDING 20
SECTION B**

Contractor fully covered and protected open walls at balcony return areas.

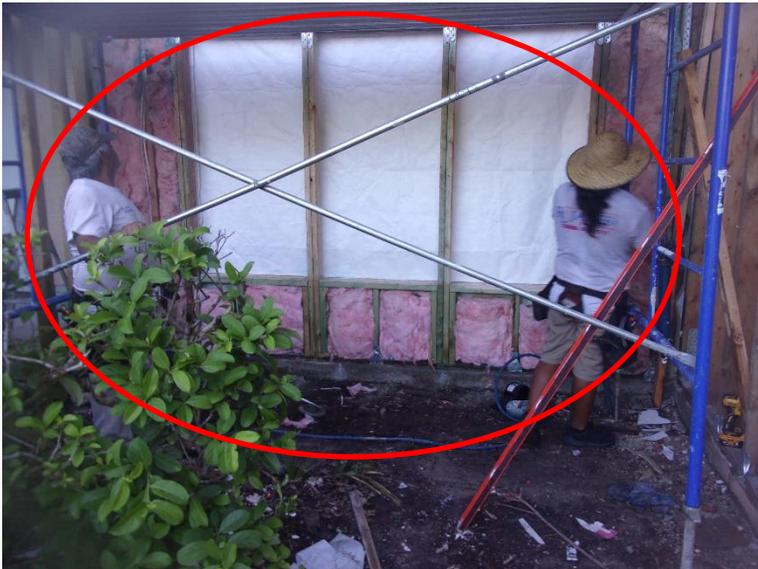
PHOTOGRAPH #20

**BUILDING 20
SECTION B**

New R-13 insulation installed where damaged or missing.

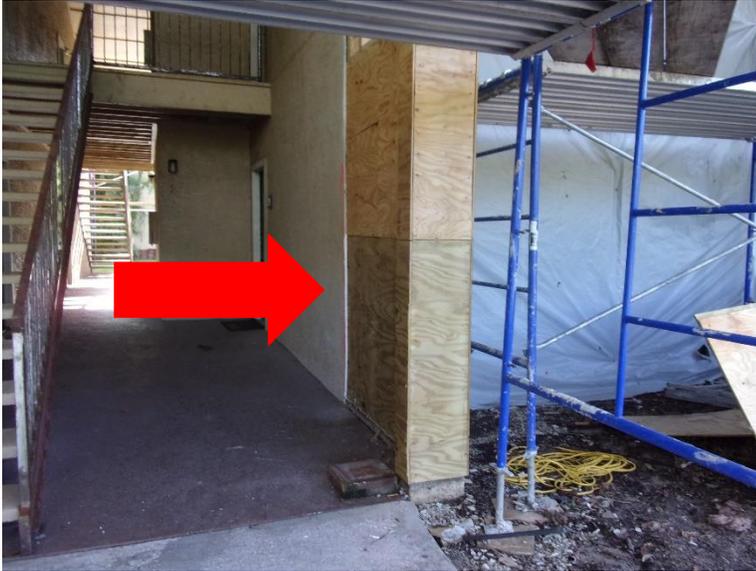
PHOTOGRAPH #21

**BUILDING 20
SECTION B**

Contractor installing plywood sheathing using pressure treated 15/32" at bottom sheet.

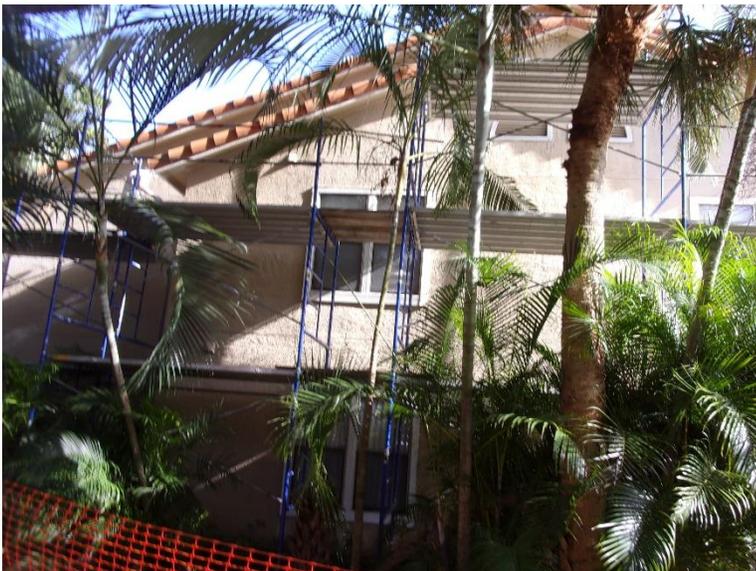
PHOTOGRAPH #22

**BUILDING 20
SECTION D**

Scaffolding has been erected and removal of stucco beginning.

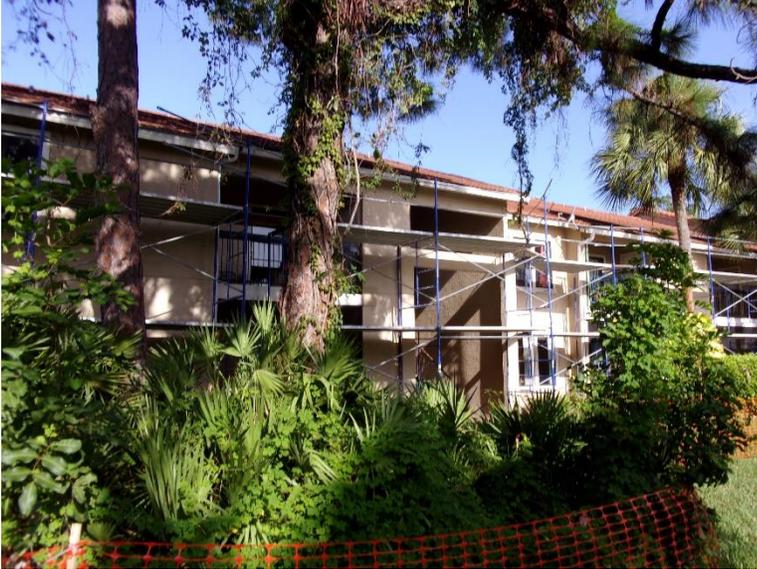
PHOTOGRAPH #23

**BUILDING 20
SECTION F**

Scaffolding has been erected and construction fencing placed at perimeter of work areas.
