PHOTOGRAPHS

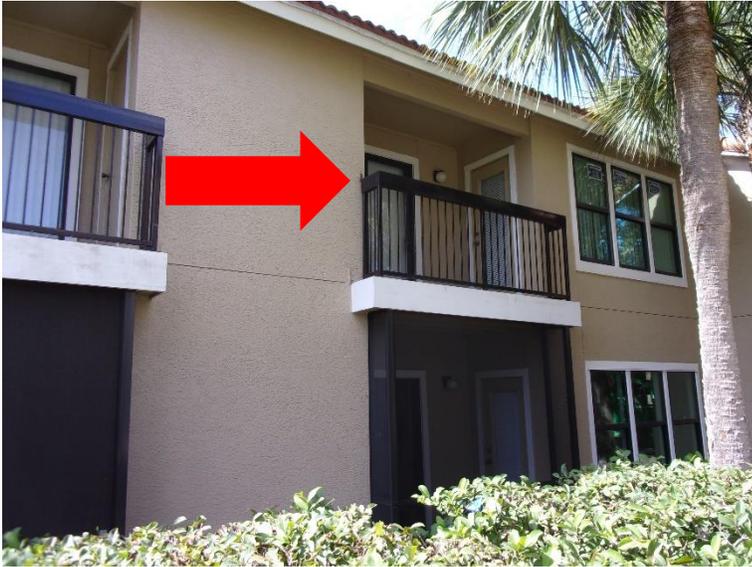
PHOTOGRAPH #1

BUILDING 21 SECTION F

Steel angles welded onto railing for fastening to walls at balconies.

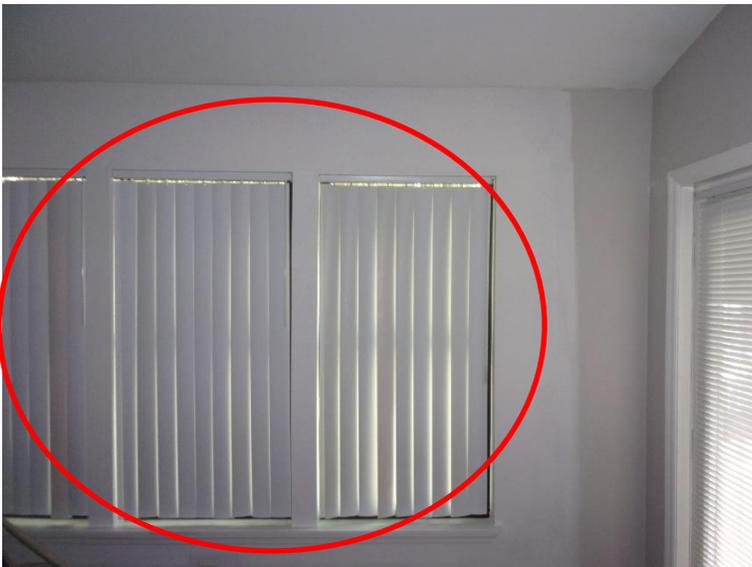
PHOTOGRAPH #2

BUILDING 21 UNIT #2124- SECTION F

Interior drywall and windowsill repaired, textured, and primed.

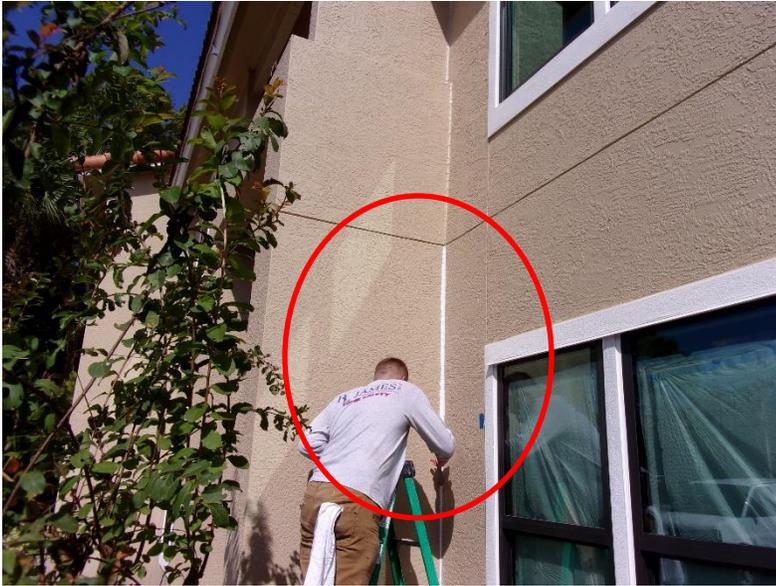
PHOTOGRAPH #3

**BUILDING 21
SECTION B**

Removal and repairs of messy transition sealants in progress.

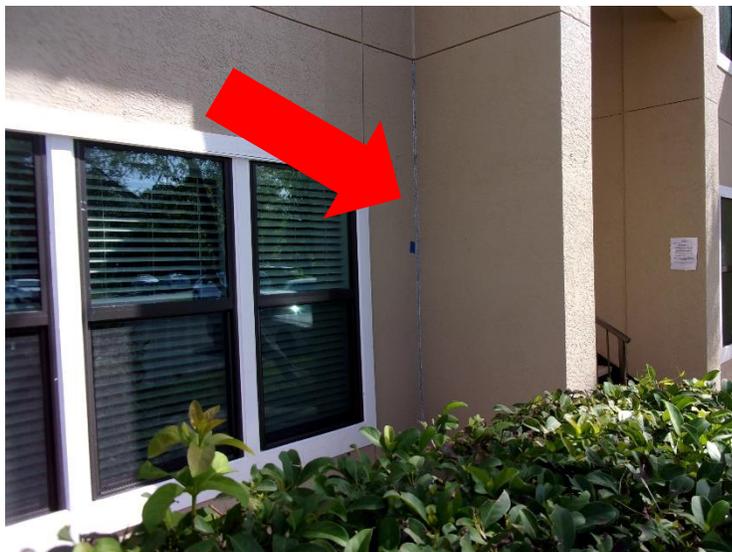
PHOTOGRAPH #4

**BUILDING 21
SECTION B**

Removal and repairs of messy transition sealants in progress.

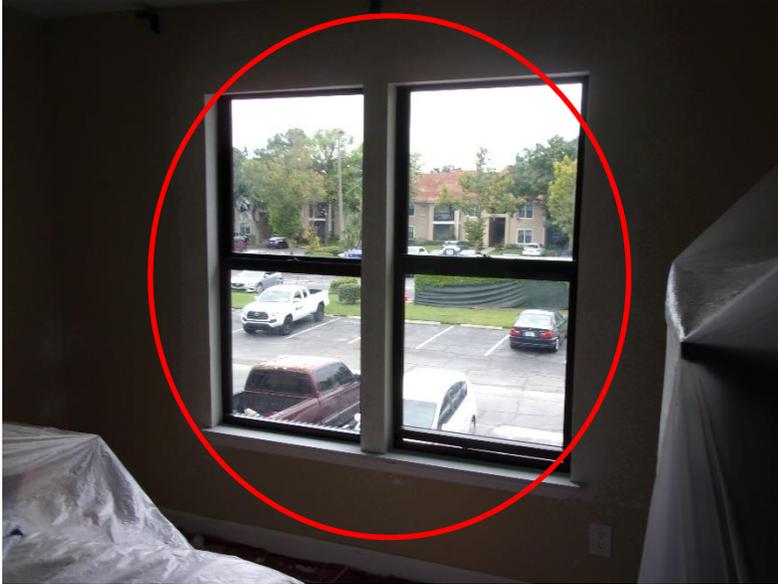
PHOTOGRAPH #5

**BUILDING 21
SECTION B- UNIT #2121**

Interior drywall and windowsill repaired, textured, and primed.

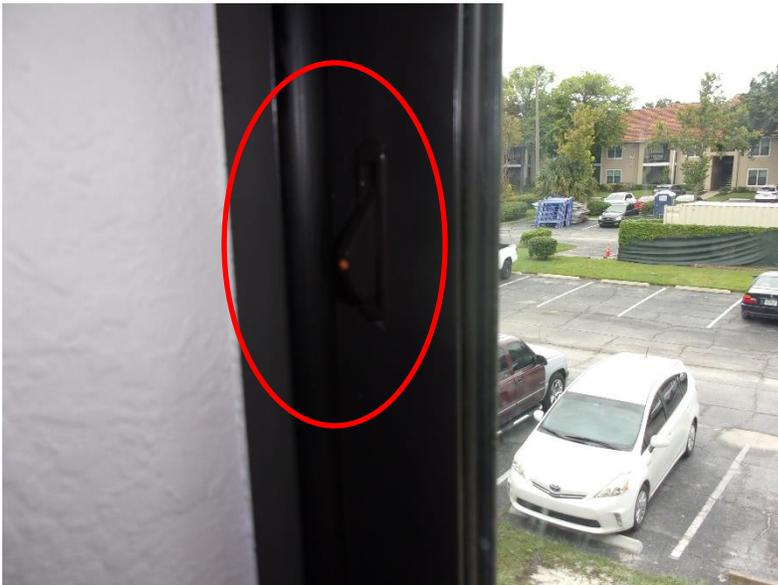
PHOTOGRAPH #6

**BUILDING 21
SECTION B- UNIT #2121**

PGT factory installed WOCD hardware at 2nd floor windows.

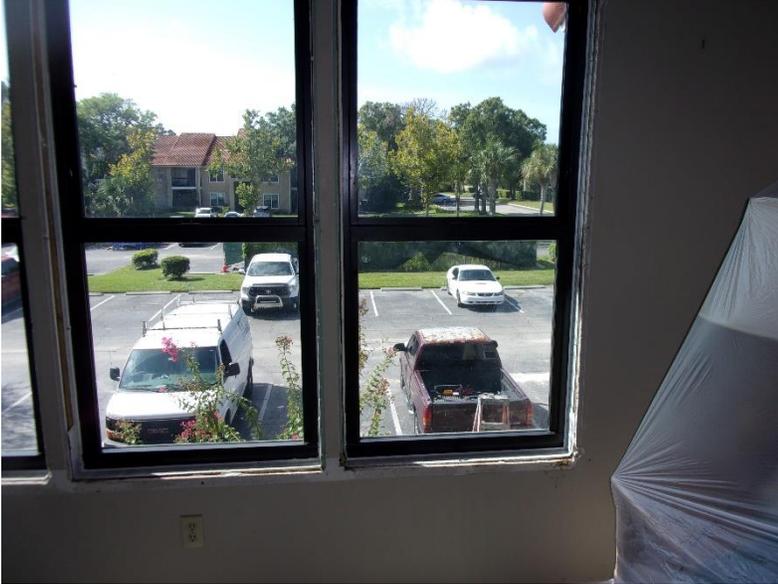
PHOTOGRAPH #7

**BUILDING 21
SECTION B- UNIT #2132**

Windows inspected from interior for proper gaps, Dupont flashing details and sealant details to meet specifications and manufacturer's NOA requirements.

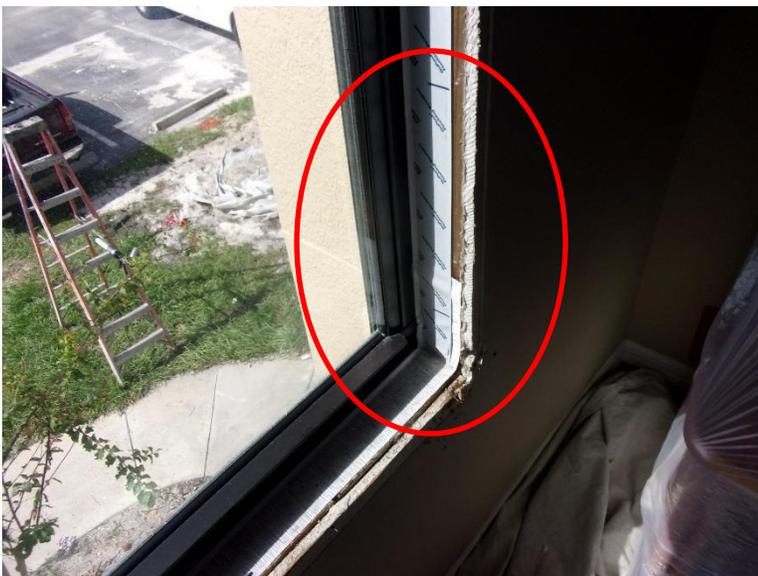
PHOTOGRAPH #8

**BUILDING 21
SECTION B- UNIT #2132**

Windows inspected from interior for proper gaps, Dupont flashing details and sealant details to meet specifications and manufacturer's NOA requirements.

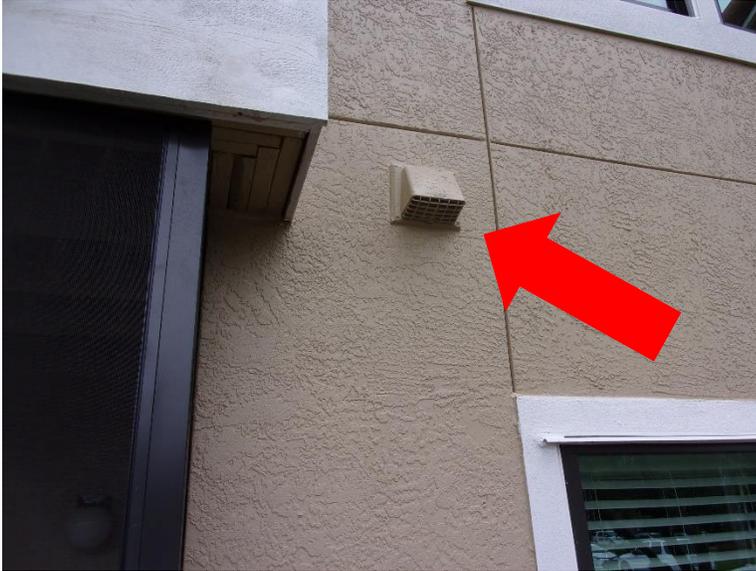
PHOTOGRAPH #9

**BUILDING 21
SECTION B**

Paint on several new dryer vents failing and will required correction.

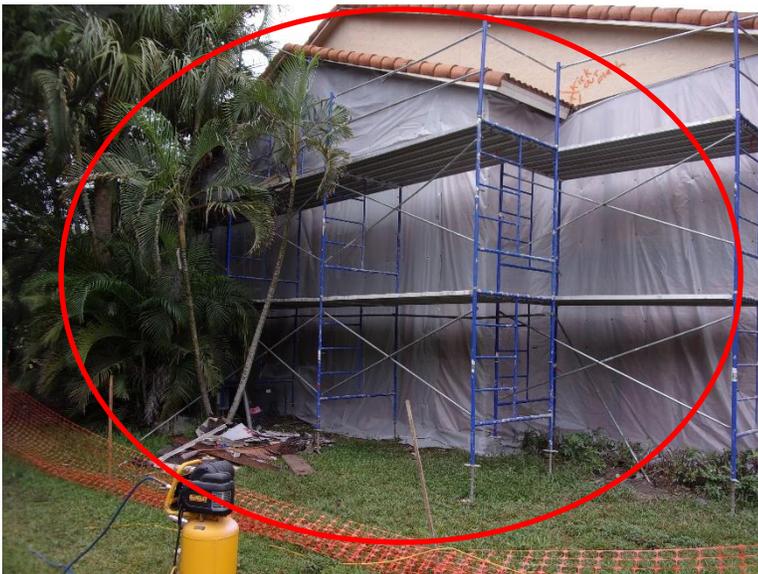
PHOTOGRAPH #10

**BUILDING 20
SECTION D**

Contractor is providing heavy plastic protection at walls where stucco has been removed during repairs.

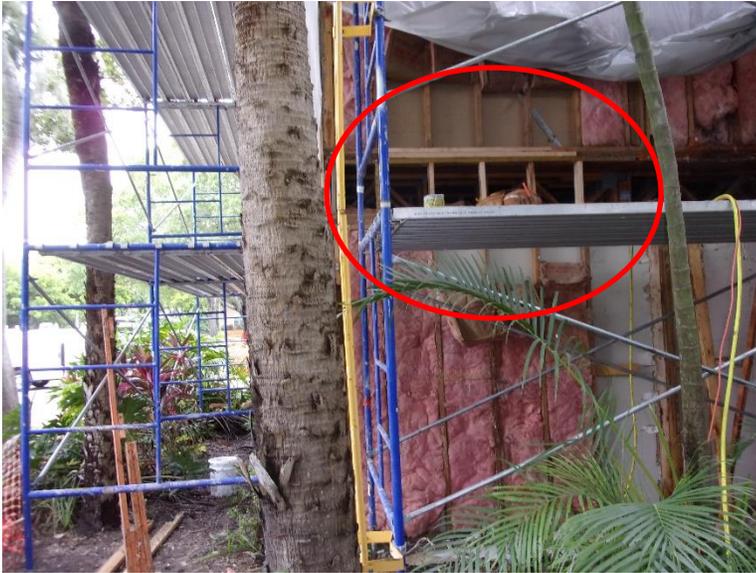
PHOTOGRAPH #11

**BUILDING 20
SECTION D**

Repairs performed at wall framing,
window framing and subflooring.

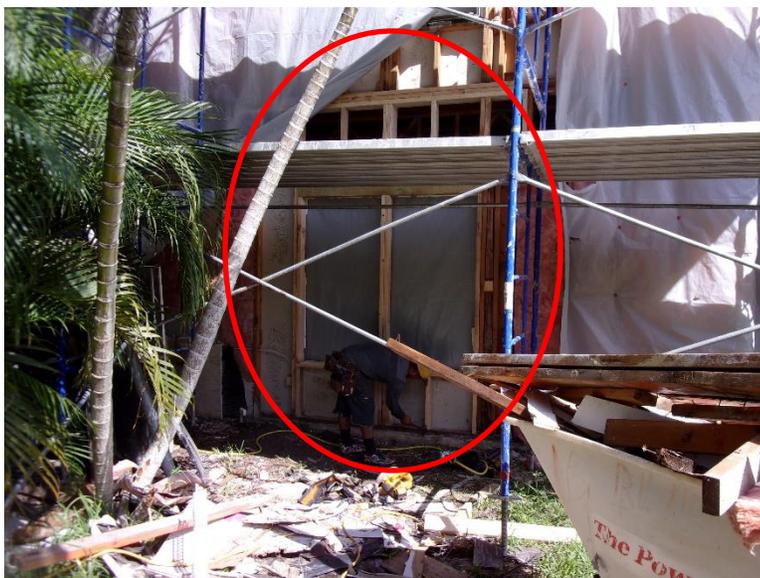
PHOTOGRAPH #12

**BUILDING 20
SECTION D**

Repairs performed at wall framing,
window framing and subflooring.

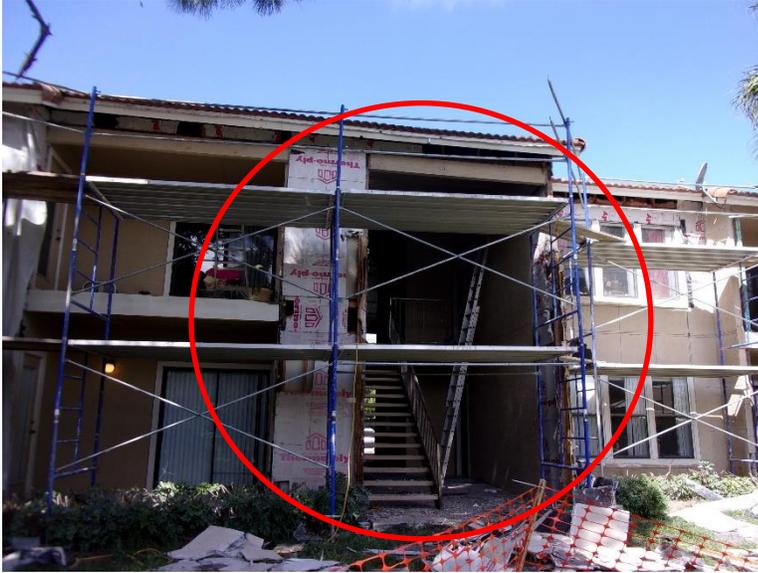
PHOTOGRAPH #13

**BUILDING 20
SECTION E**

Removal of existing stucco and Thermoply sheathing exposed damaged framing that partially collapsed when stucco was removed. Immediate shoring is required until repairs are in place.

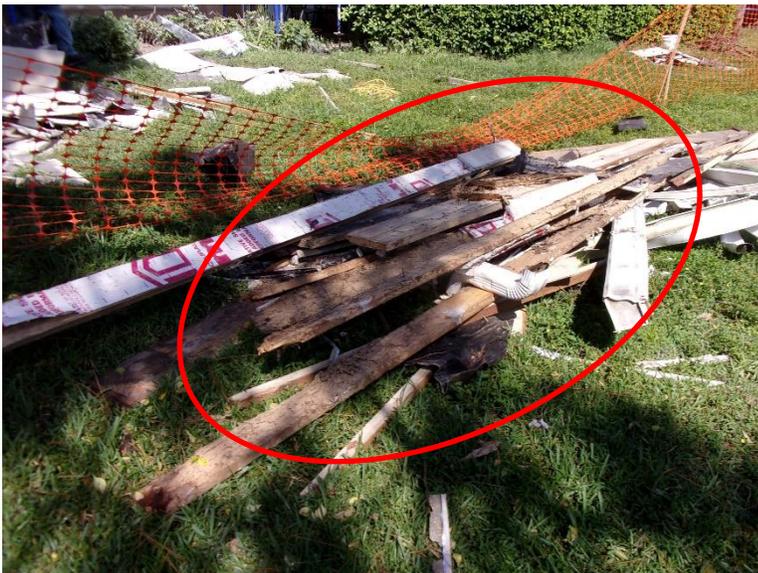
PHOTOGRAPH #14

**BUILDING 20
SECTION E**

Removal of existing stucco and Thermoply sheathing exposed damaged framing that partially collapsed when stucco was removed. Immediate shoring is required until repairs are in place.

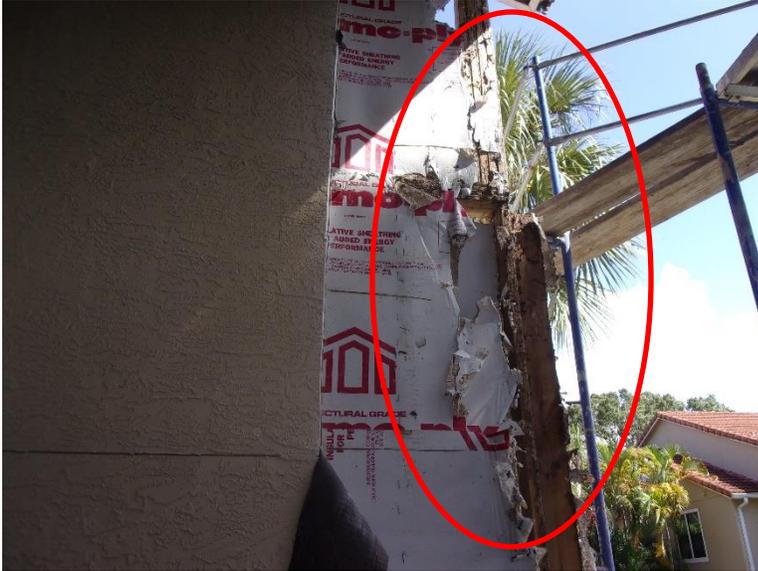
PHOTOGRAPH #15

**BUILDING 20
SECTION E**

Removal of existing stucco and Thermoply sheathing exposed damaged framing that partially collapsed when stucco was removed. Immediate shoring is required until repairs are in place.

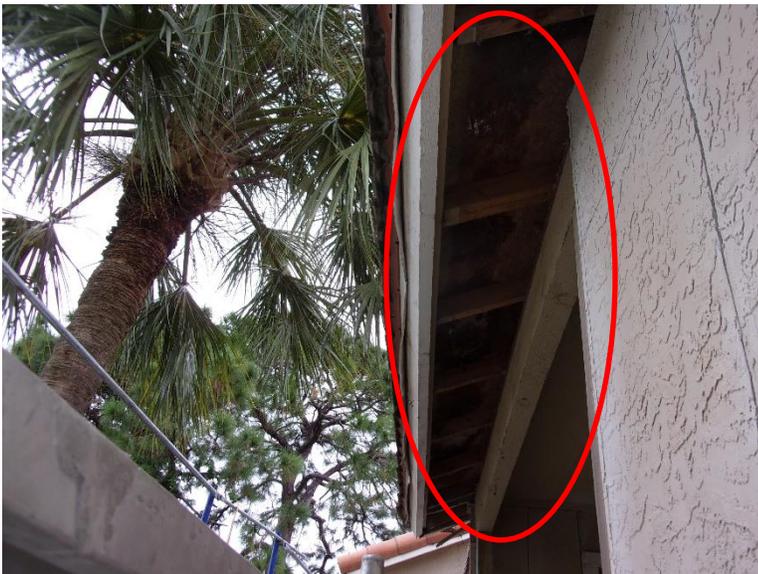
PHOTOGRAPH #16

**BUILDING 20
SECTION E**

Roof sheathing damage and evidence of active roof leaks.

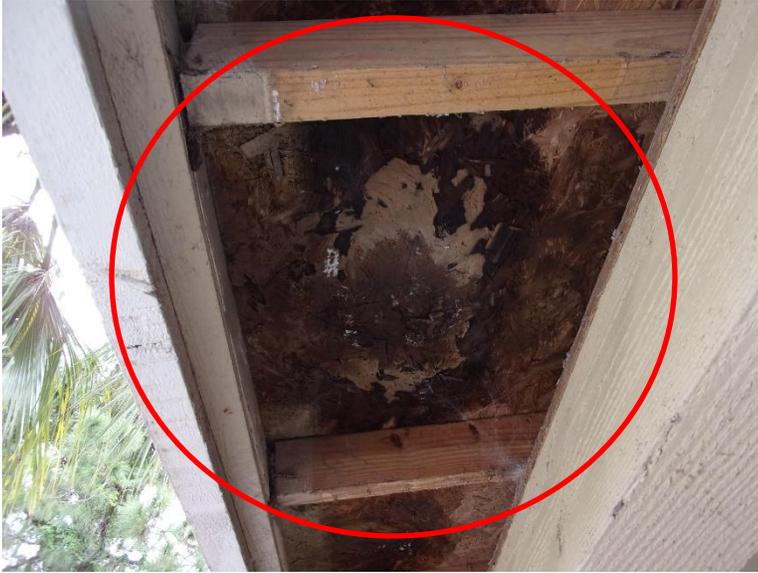
PHOTOGRAPH #17

**BUILDING 20
SECTION F**

Roof sheathing damage and evidence of active roof leaks.

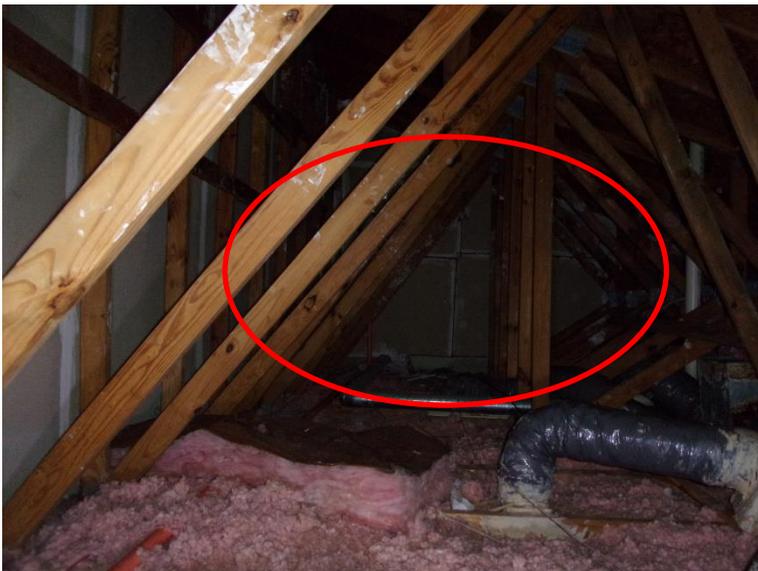
PHOTOGRAPH #18

**BUILDING 23
UNIT # 2325**

Firewall where removed for additional investigation has been replaced.

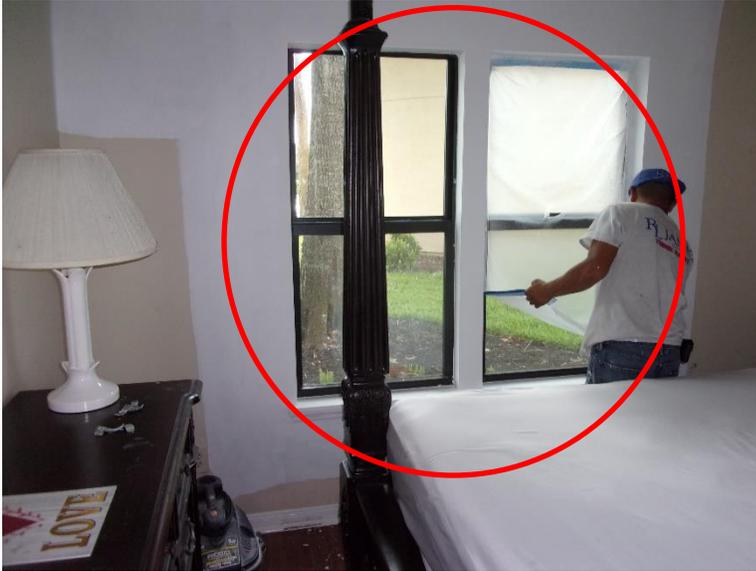
PHOTOGRAPH #19

**BUILDING 23
UNIT # 2316**

Protective coverings removed from windows. Identified during interior walk though.

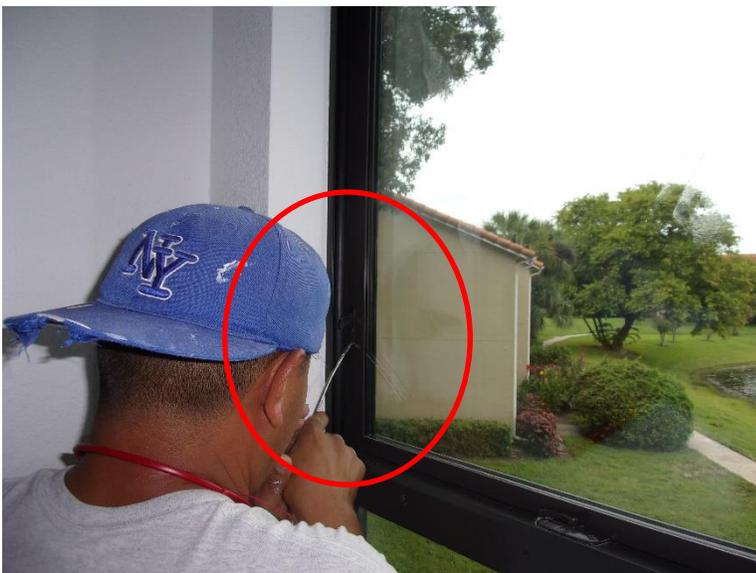
PHOTOGRAPH #20

**BUILDING 23
UNIT # 2322**

Broken WOCD replaced at new PGT window. Identified during interior walk though.

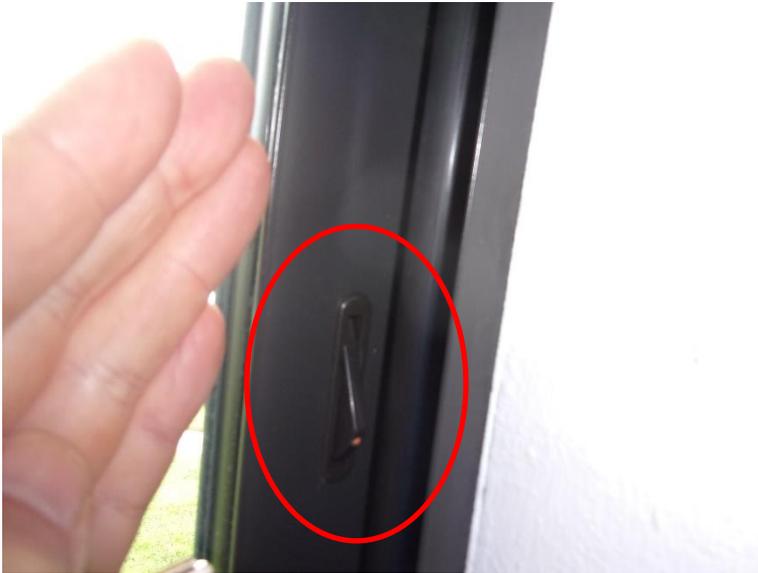
PHOTOGRAPH #21

**BUILDING 23
UNIT # 2322**

Broken WOCD replaced at new PGT window. Identified during interior walk though.
