PHOTOGRAPHS

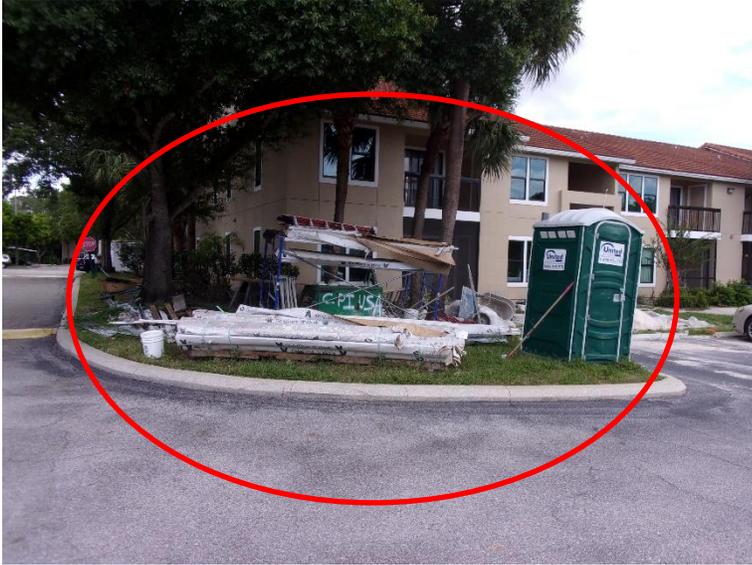
PHOTOGRAPH #1

BUILDING 21 SECTION A

Removal of all materials, equipment, portable toilet, and final cleanup of grounds will be performed as part of punch list.

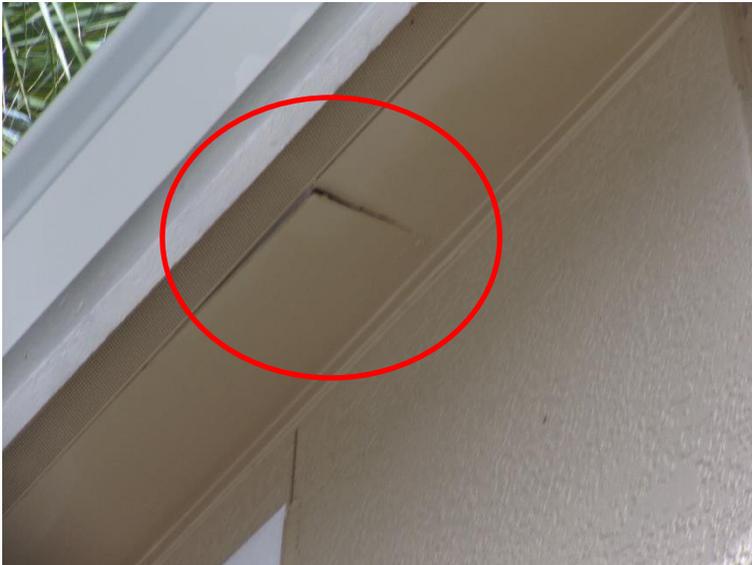
PHOTOGRAPH #2

BUILDING 21 SECTION A

Loose soffit will be properly fastened, caulked, and touched up as part of punch list.

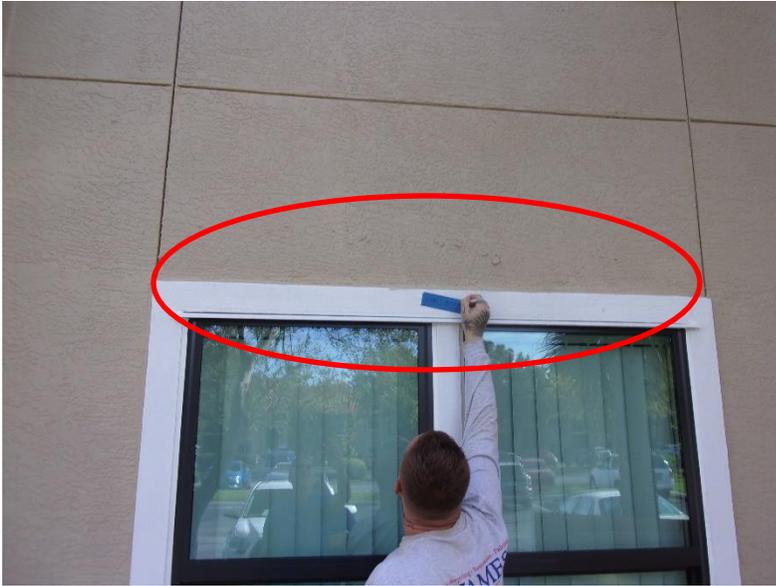
PHOTOGRAPH #3

**BUILDING 21
SECTION B**

Paint and stucco details noted for touch up during walk through with management to develop punch list.

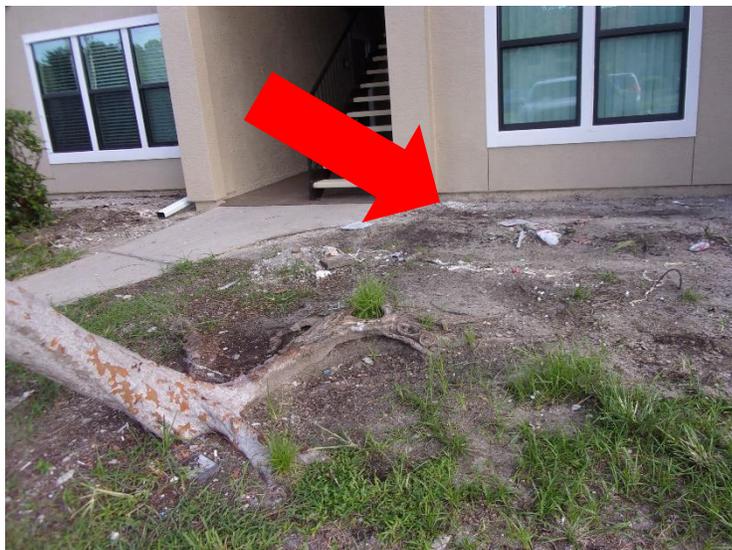
PHOTOGRAPH #4

**BUILDING 21
SECTION B**

Final cleanup of grounds will be performed as part of punch list.

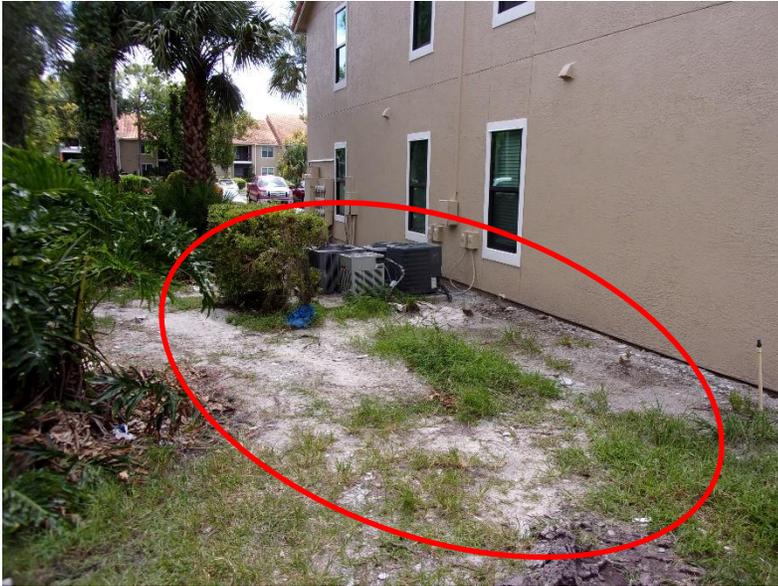
PHOTOGRAPH #5

**BUILDING 21
SECTION D**

Final cleanup of grounds will be performed as part of punch list.

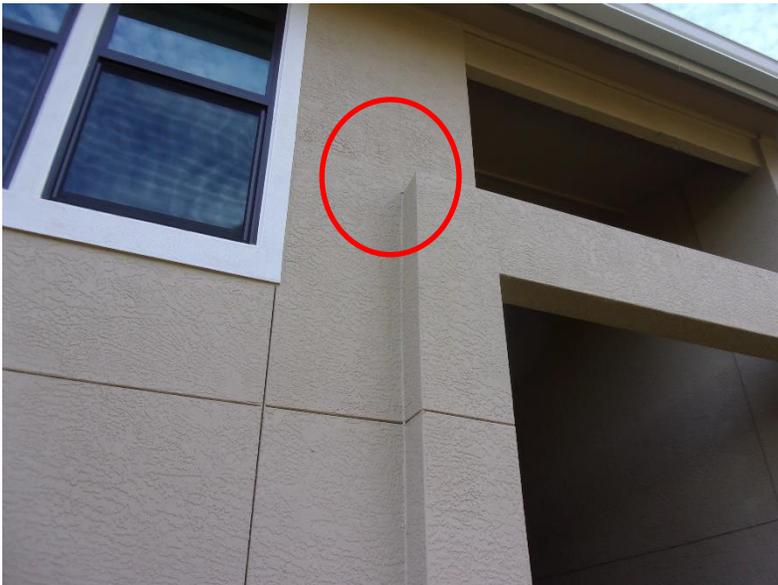
PHOTOGRAPH #6

**BUILDING 21
SECTION E**

Hole in sealant will be filled and touched up as part of punch list.

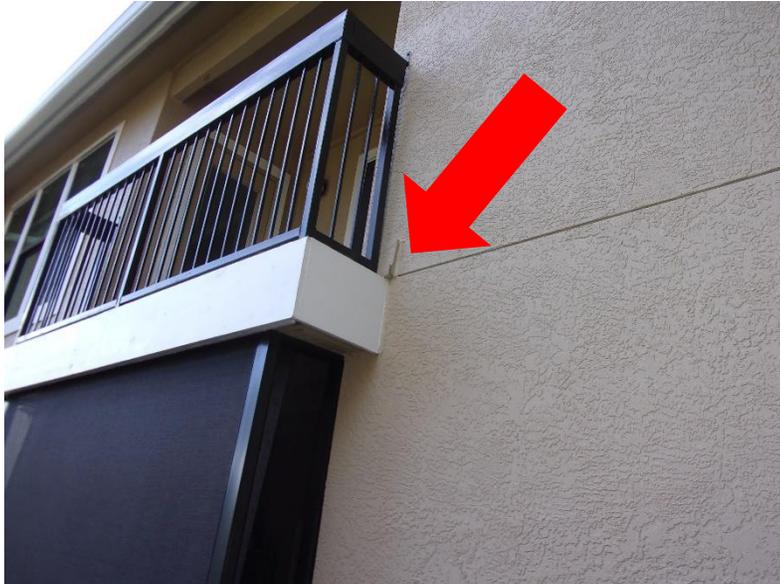
PHOTOGRAPH #7

**BUILDING 21
SECTION F**

Kick out flashing gaps will be filled as part of punch list.

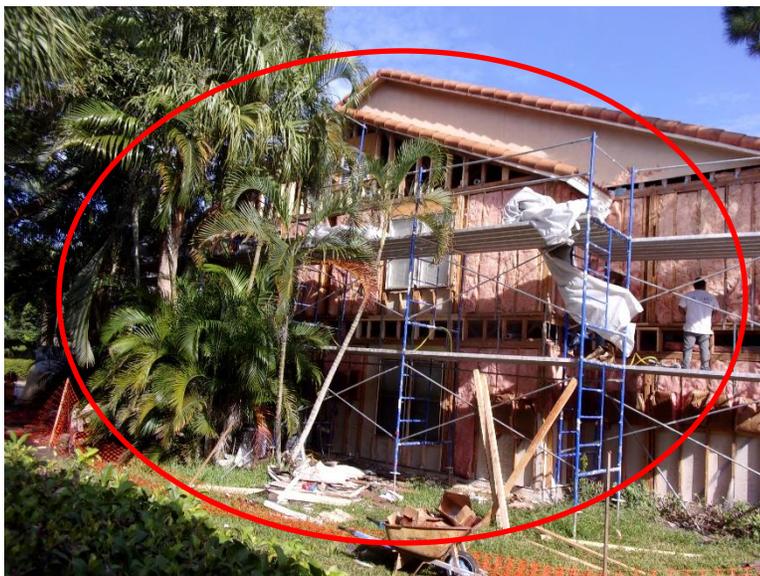
PHOTOGRAPH #8

**BUILDING 20
SECTION D**

Framing and gable end reinforcement repairs in place. Strapping and Simpson Strong-Tie hardware installation in progress.

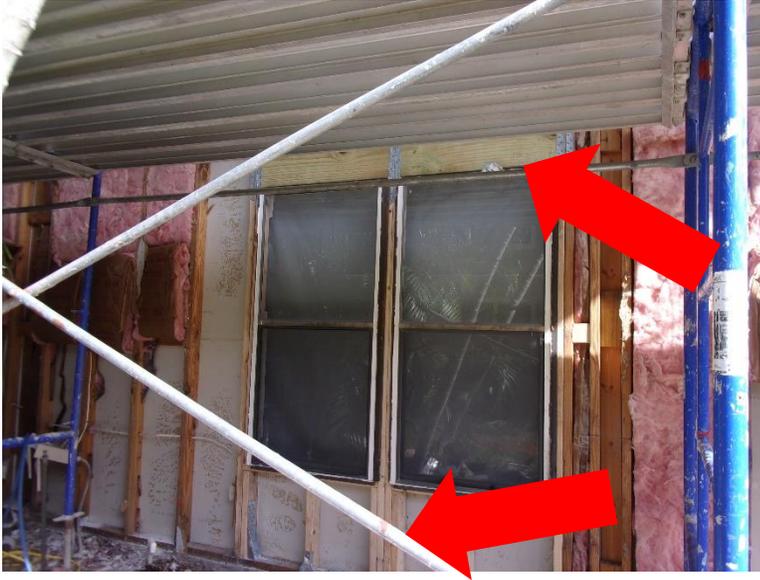
PHOTOGRAPH #9

**BUILDING 20
SECTION D**

Wood framing repairs at window openings and window headers completed and quantified.

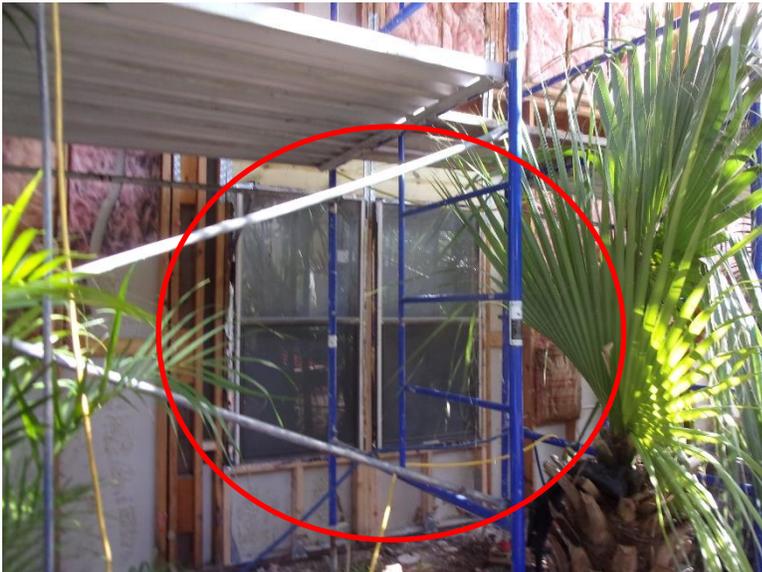
PHOTOGRAPH #10

**BUILDING 20
SECTION D**

Wood framing repairs at window openings and window headers completed and quantified.

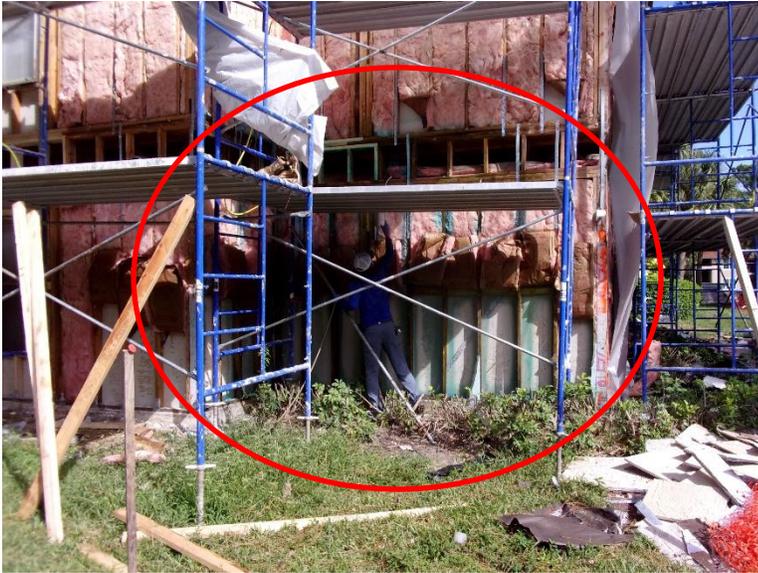
PHOTOGRAPH #11

**BUILDING 20
SECTION D**

Pest control contractor spraying BoraCare termite treatment on wall framing.

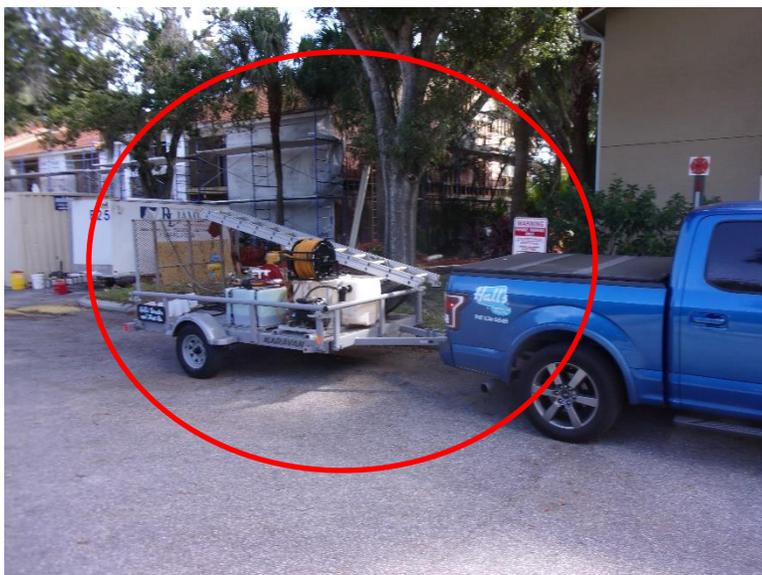
PHOTOGRAPH #12

**BUILDING 20
SECTION D**

Pest control contractor spraying BoraCare termite treatment on wall framing.

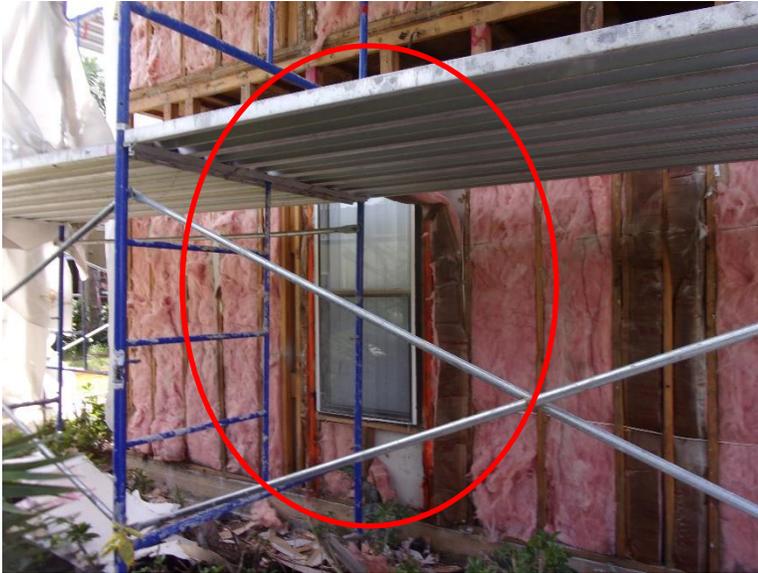
PHOTOGRAPH #13

**BUILDING 20
SECTION E**

Damaged wood framing at window openings identified and marked for repairs.

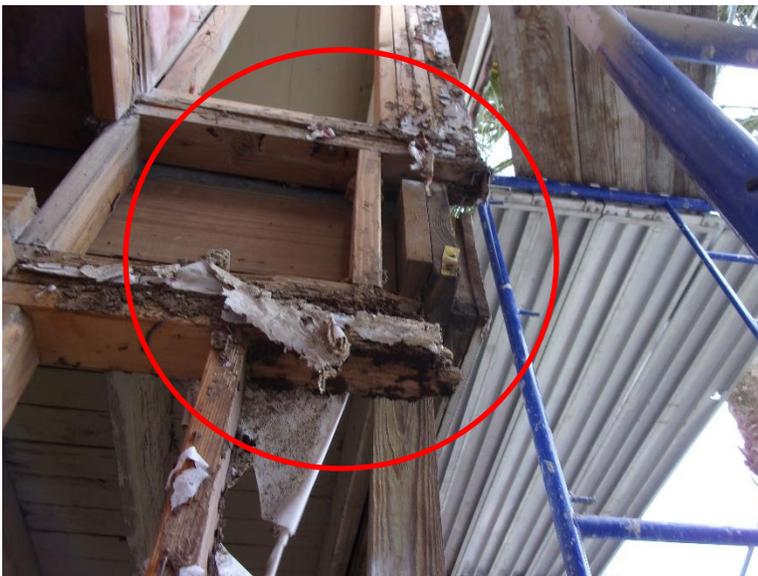
PHOTOGRAPH #14

**BUILDING 20
SECTION F**

Damaged wood framing at balcony and patio framing identified and marked for repairs.

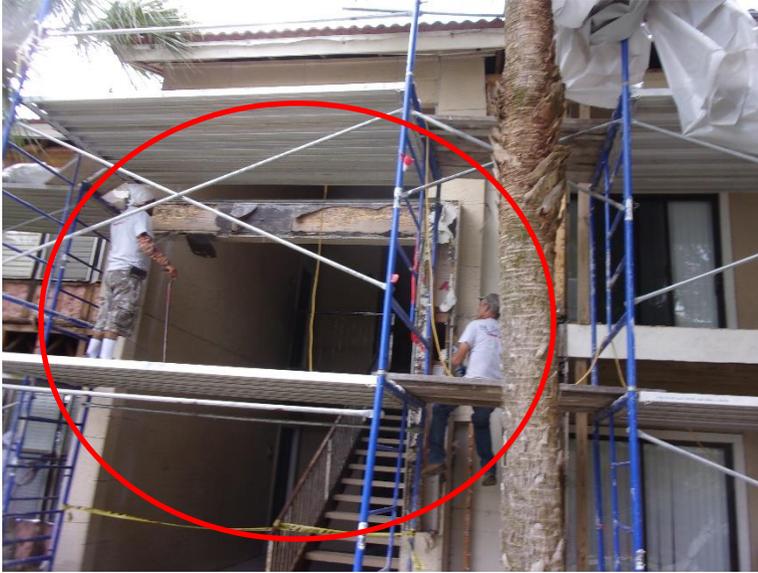
PHOTOGRAPH #15

**BUILDING 20
SECTION G- BREEZEWAY**

Removal of existing stucco and Thermoply sheathing exposed damaged framing that partially collapsed when stucco was removed. Immediate shoring is required until repairs are in place.

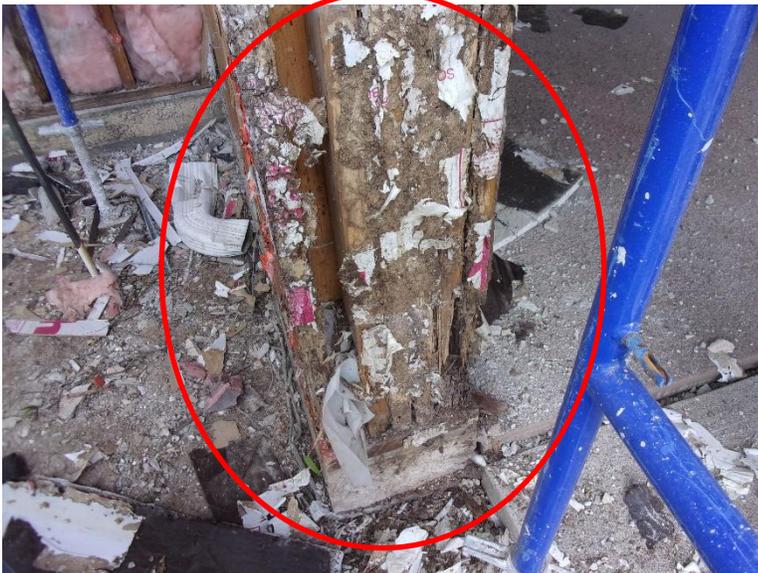
PHOTOGRAPH #16

**BUILDING 20
SECTION G- BREEZEWAY**

Removal of existing stucco and Thermoply sheathing exposed damaged framing that partially collapsed when stucco was removed. Immediate shoring is required until repairs are in place.

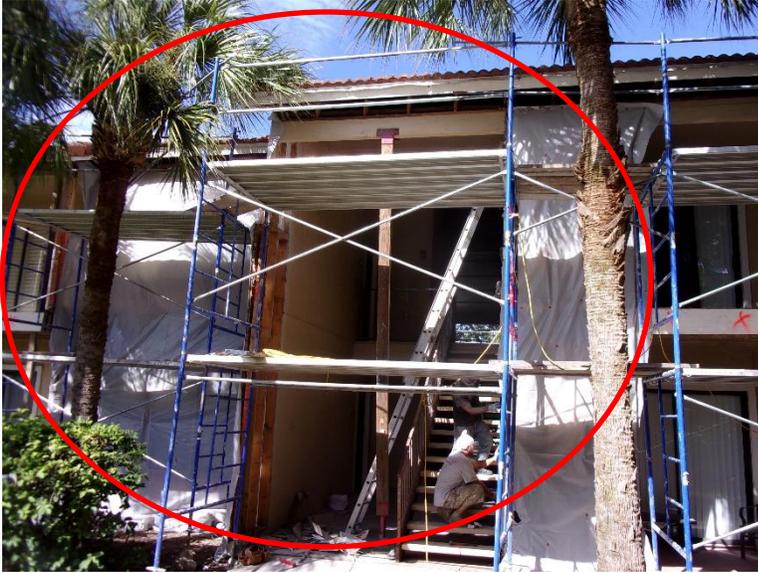
PHOTOGRAPH #17

**BUILDING 20
SECTION G-BREEZEWAY**

Contractor has provided shoring beam where damages are causing collapse.

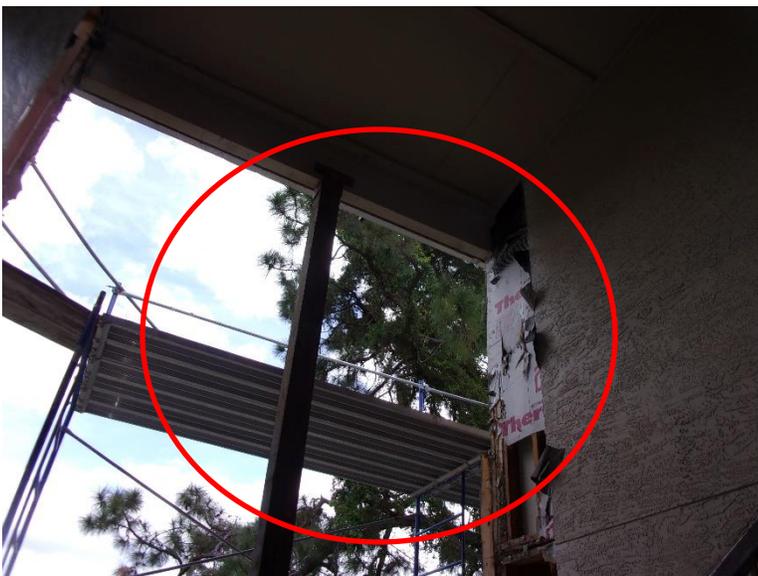
PHOTOGRAPH #18

**BUILDING 20
SECTION G-BREEZEWAY**

Contractor has provided shoring beam where damages are causing collapse.

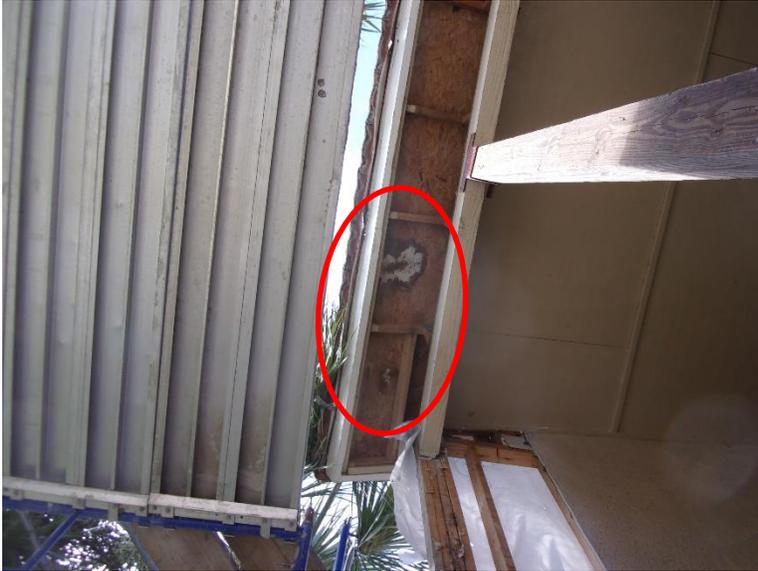
PHOTOGRAPH #19

**BUILDING 20
SECTION G**

Roof sheathing damage and evidence of active roof leaks.
