## PHOTOGRAPHS

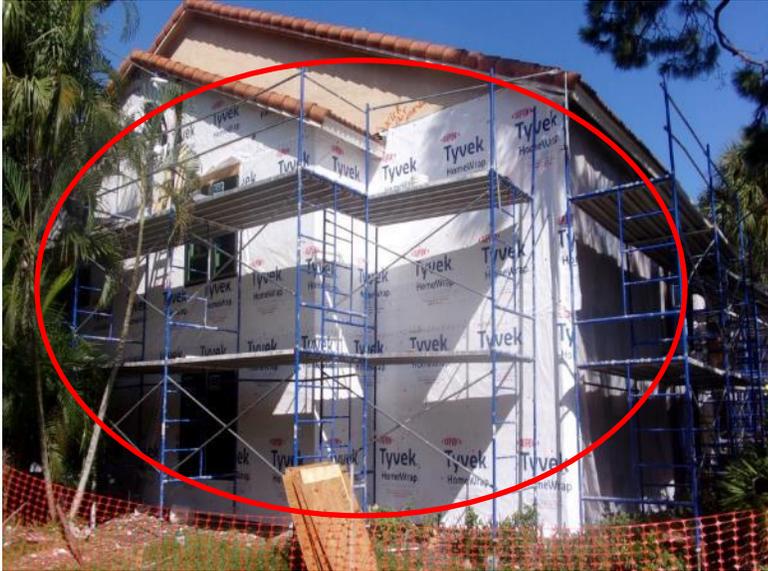
PHOTOGRAPH #1

### BUILDING 20 SECTION D

Installation of Tyvek weather barrier is in progress.

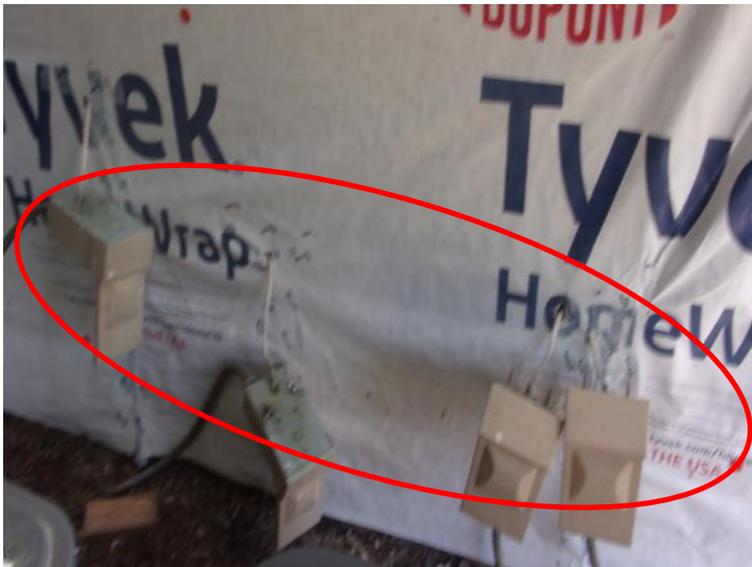
PHOTOGRAPH #2

### BUILDING 20 SECTION D

Installation of Tyvek flex wrap at A/C electrical boxes penetrations are in progress.

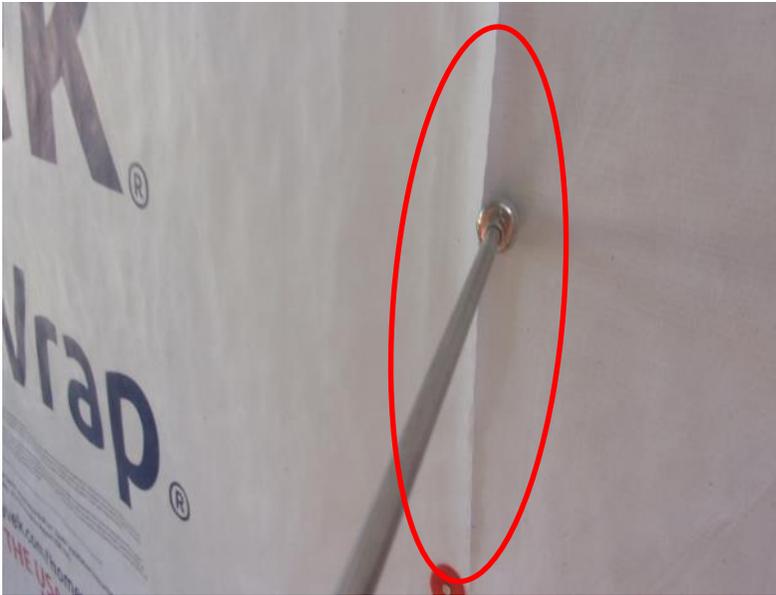
**PHOTOGRAPH #3**

**BUILDING 20  
SECTION D**

Installation of Tyvek weather barrier require Tyvek tap at laps seams.

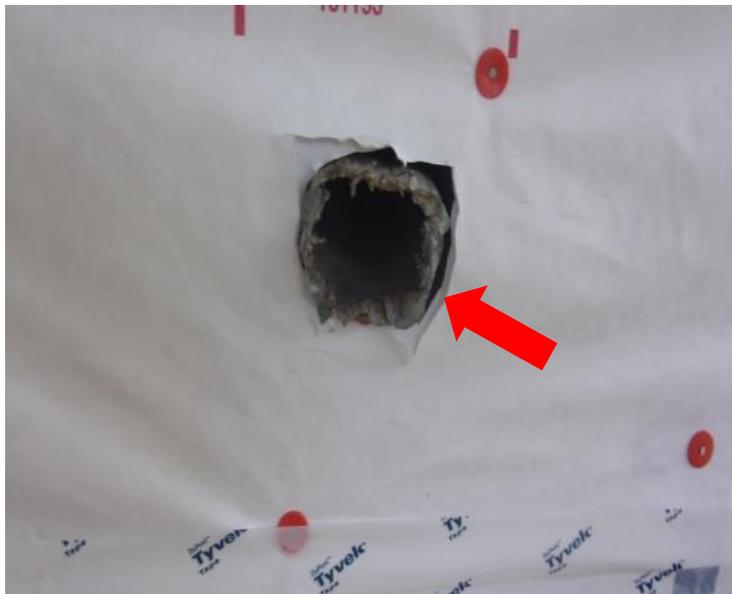
**PHOTOGRAPH #4**

**BUILDING 20  
SECTION D**

Installation of Tyvek flex wrap at dryer vent penetrations are in progress.

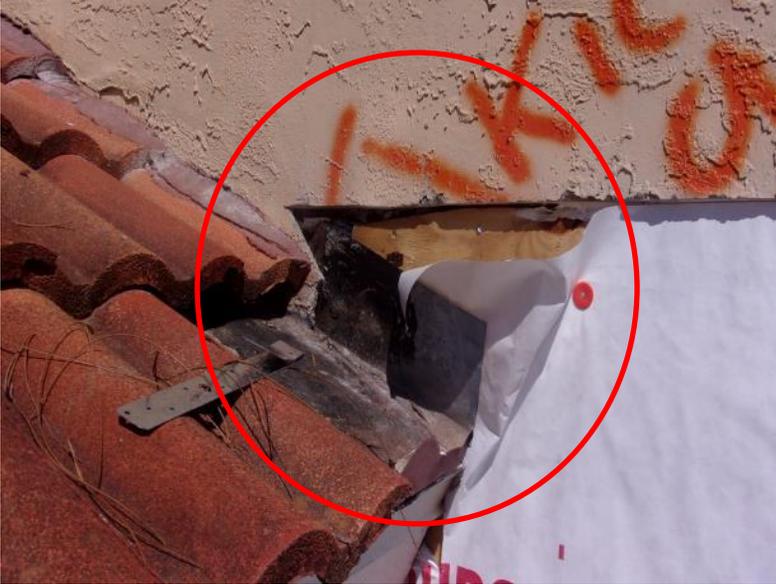
**PHOTOGRAPH #5**

**BUILDING 20  
SECTION D**

Installation of kick-out flashing is in progress.

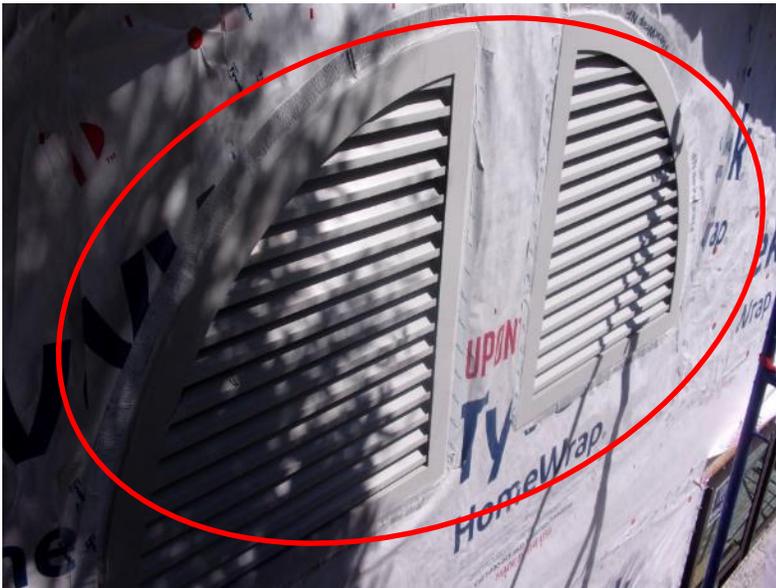
**PHOTOGRAPH #6**

**BUILDING 20  
SECTION D**

Louver installation has been completed.

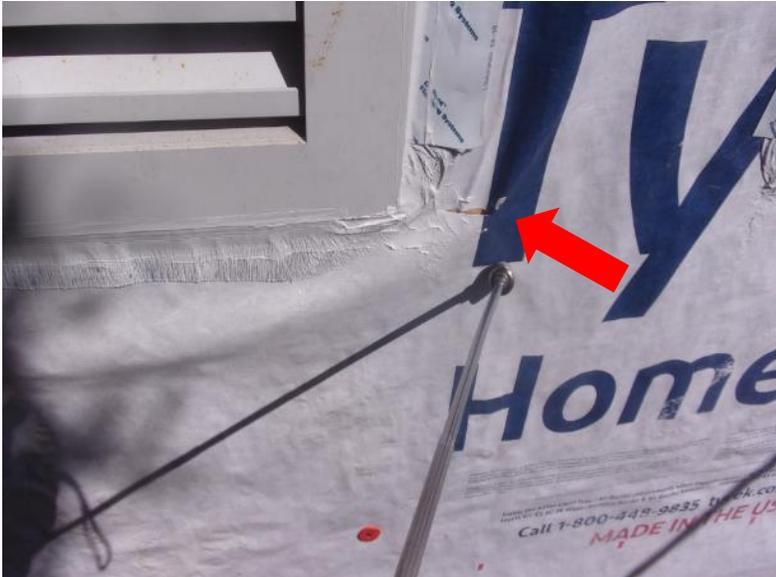
**PHOTOGRAPH #7**

**BUILDING 20  
SECTION D**

Tear in Tyvek weather barrier at corner of louvers was observed.

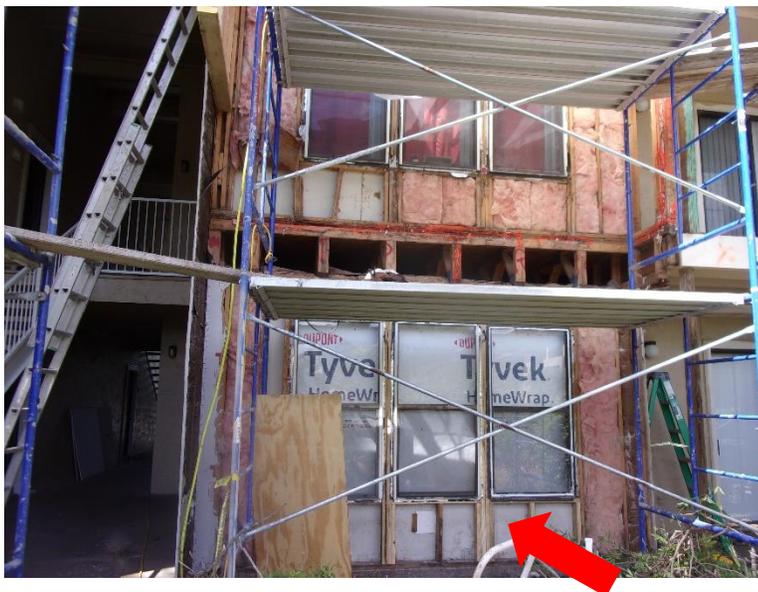
**PHOTOGRAPH #8**

**BUILDING 20  
SECTION F**

Framing repairs in progress at window openings.

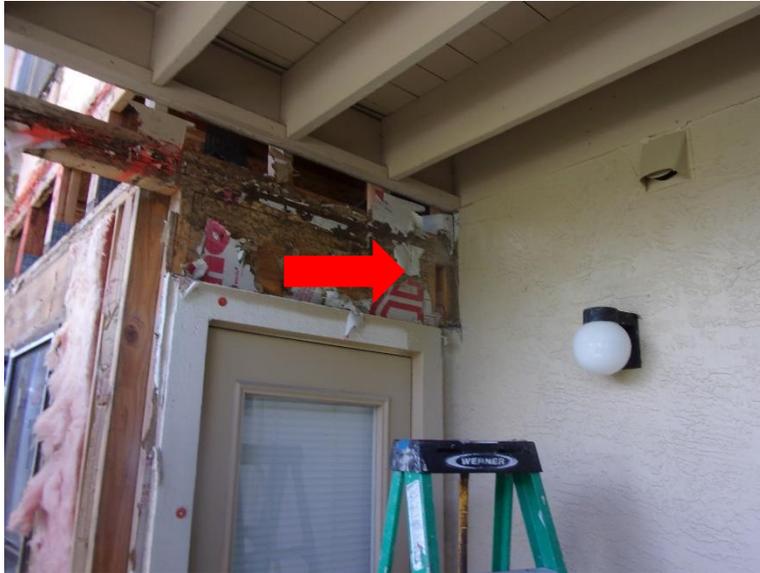
**PHOTOGRAPH #9**

**BUILDING 20  
SECTION F- UNIT #2016**

Damaged framing extending beyond patio return wall. Contractor directed to continue stucco removal to make additional repairs of damaged framing.

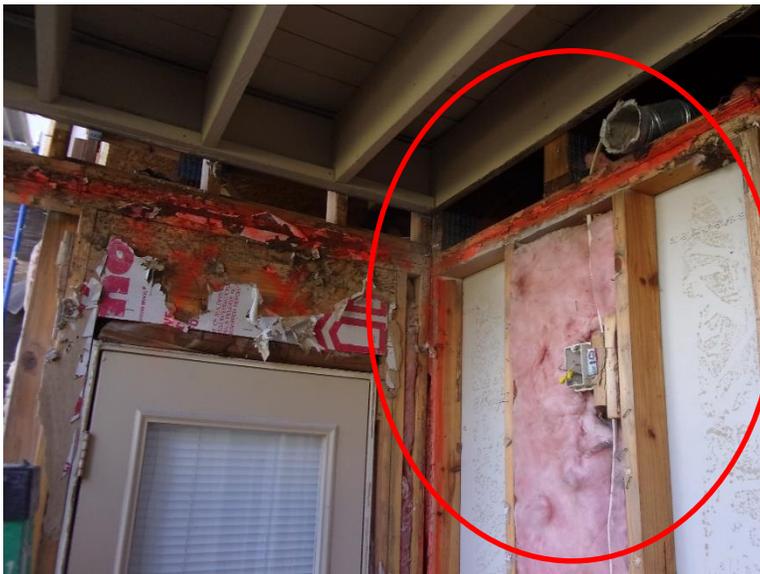
**PHOTOGRAPH #10**

**BUILDING 20  
SECTION F- UNIT 2016**

Damaged framing extending beyond patio return wall. Contractor directed to continue stucco removal to make additional repairs of damaged framing.

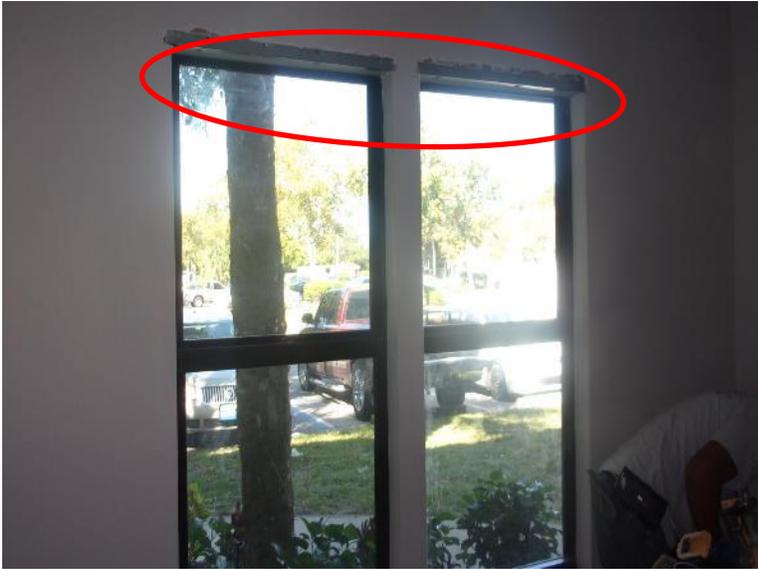
**PHOTOGRAPH #11**

**BUILDING 23  
SECTION B- UNIT #2317**

PGT repair protocol for gap at window header installed as described.

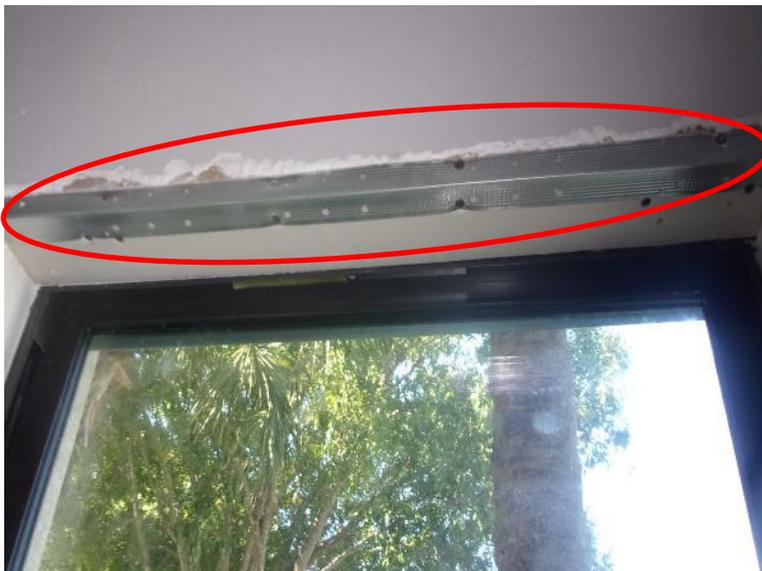
**PHOTOGRAPH #12**

**BUILDING 23  
SECTION B- UNIT #2317**

PGT repair protocol for gap at window header installed as described.
