**PHOTOGRAPHS**

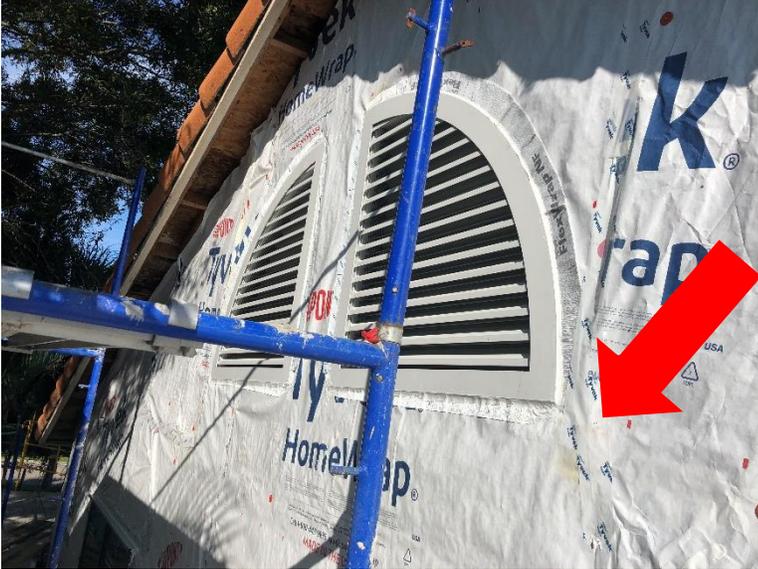
**PHOTOGRAPH #1**

**BUILDING 20  
SECTION D**

Installation of Tyvek weather barrier defects corrected by contractor.

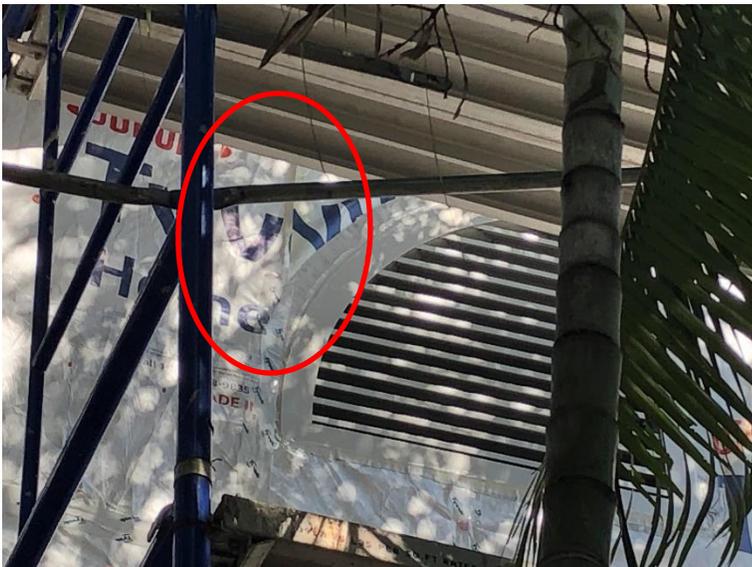
**PHOTOGRAPH #2**

**BUILDING 20  
SECTION D**

Tyvek seam not taped has been corrected by contractor above vent.

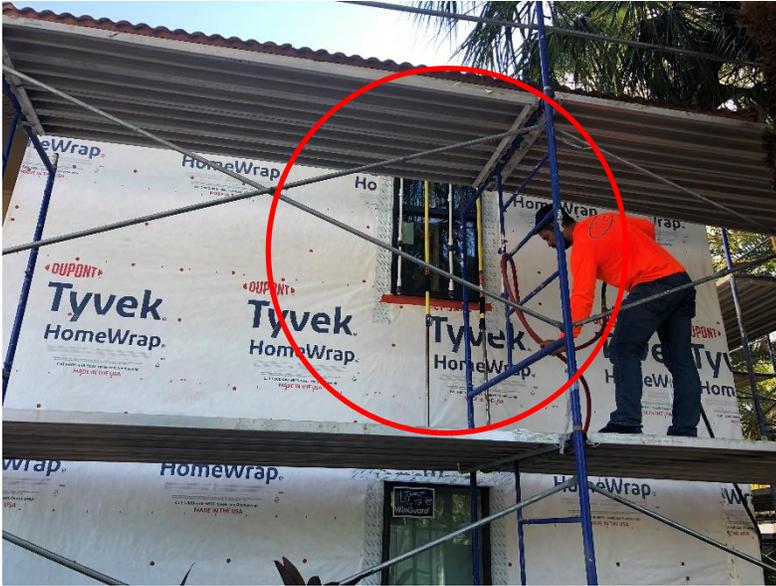
**PHOTOGRAPH #3**

**BUILDING 20  
SECTION D- UNIT #2027**

Independent testing agency performed and passed AAMA 502 water testing at 2<sup>nd</sup> floor single window.

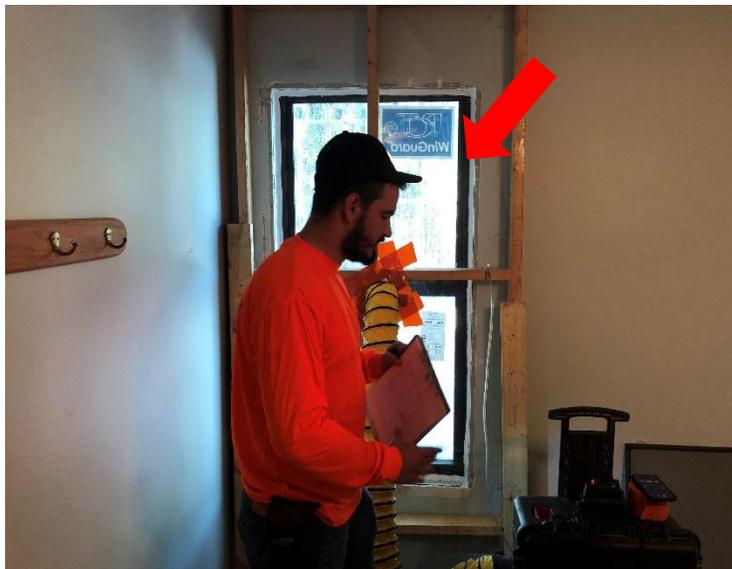
**PHOTOGRAPH #4**

**BUILDING 20  
SECTION D- UNIT #2027**

Independent testing agency performed and passed AAMA 502 water testing at 2<sup>nd</sup> floor single window.

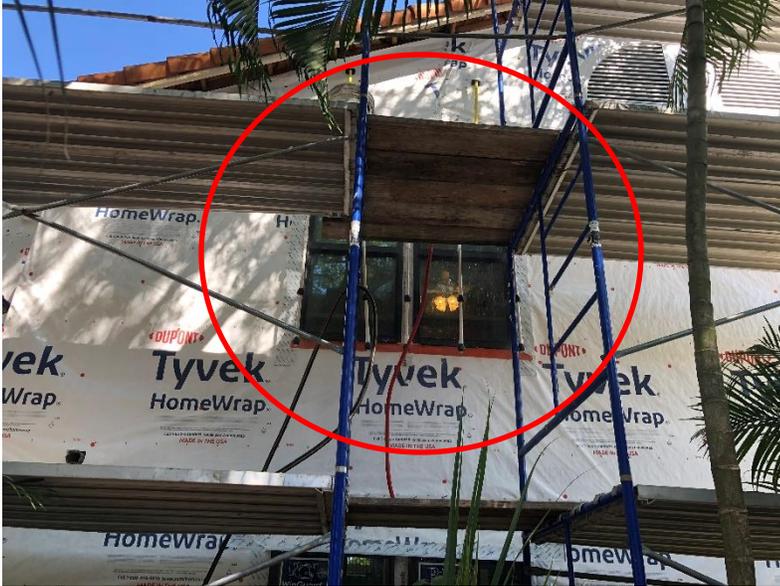
**PHOTOGRAPH #5**

**BUILDING 20  
SECTION D- UNIT #2027**

Independent testing agency performed and passed AAMA 502 water testing at 2<sup>nd</sup> floor double windows.

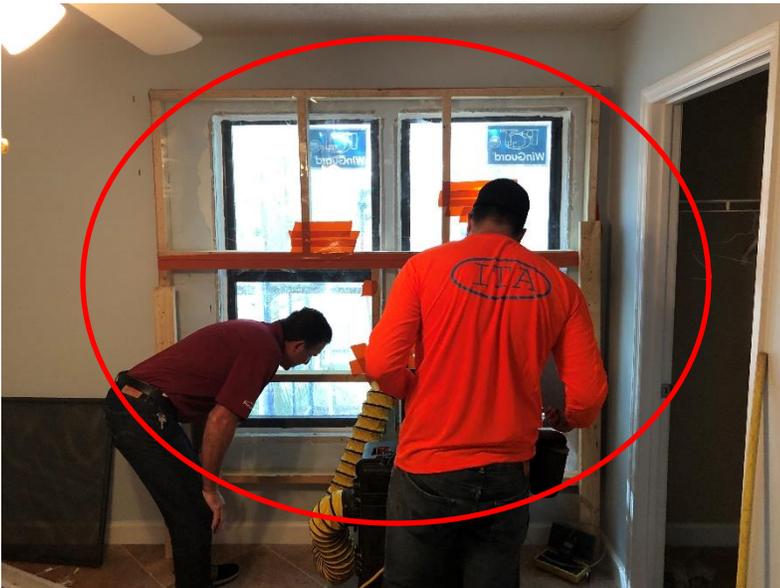
**PHOTOGRAPH #6**

**BUILDING 20  
SECTION D- UNIT #2027**

Independent testing agency performed and passed AAMA 502 water testing at 2<sup>nd</sup> floor double windows.

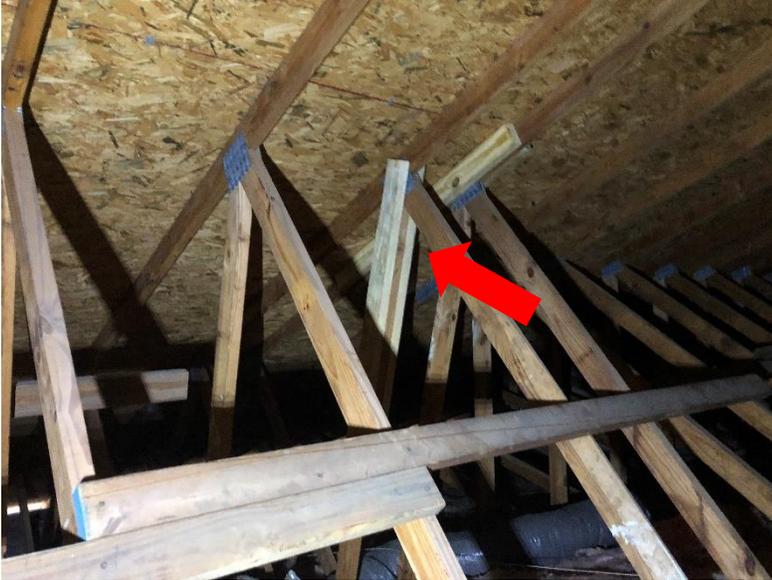
**PHOTOGRAPH #7**

**BUILDING 20  
SECTION D- ATTIC 2027**

Truss scabs, gussets and fire wall repairs performed.

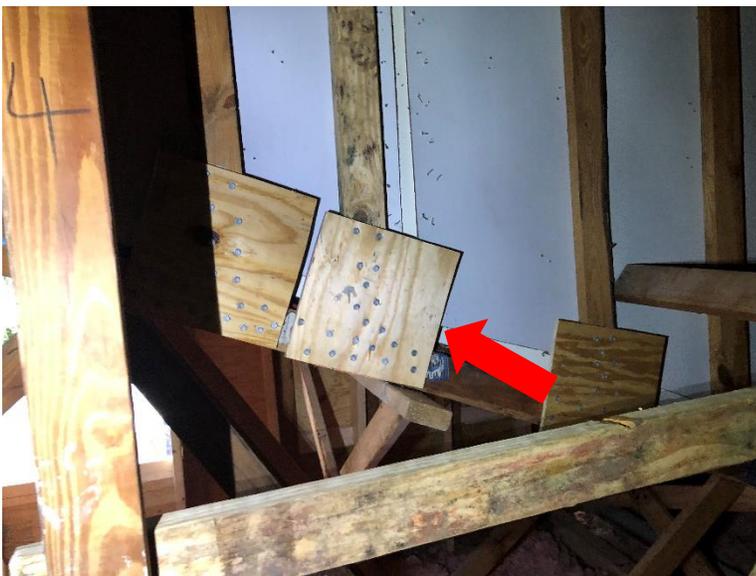
**PHOTOGRAPH #8**

**BUILDING 20  
SECTION D- ATTIC 2027**

Truss scabs, gussets and fire wall repairs performed.

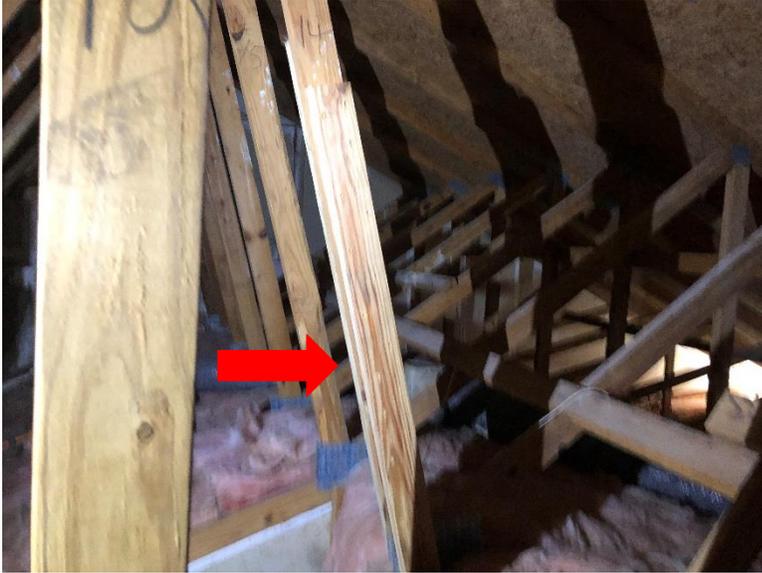
**PHOTOGRAPH #9**

**BUILDING 20  
SECTION D- ATTIC 2028**

Truss scabs, gussets and fire wall repairs performed.

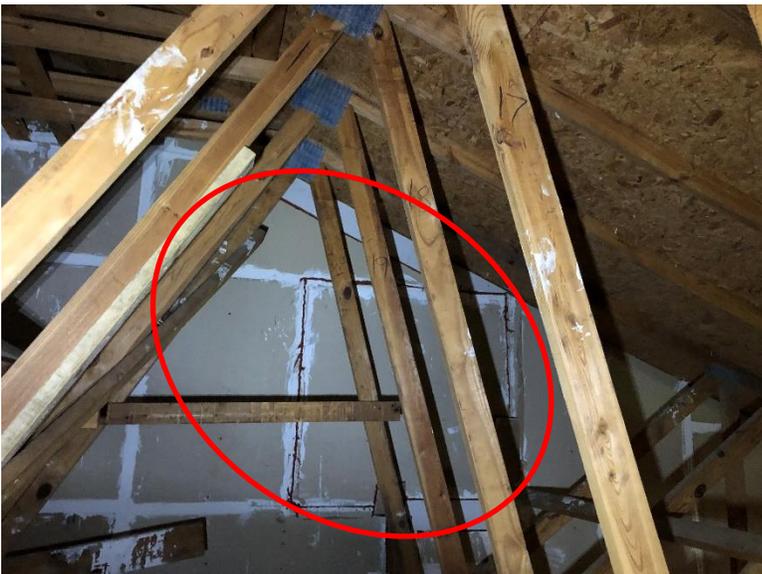
**PHOTOGRAPH #10**

**BUILDING 20  
SECTION D- ATTIC 2028**

Truss scabs, gussets and fire wall repairs performed.

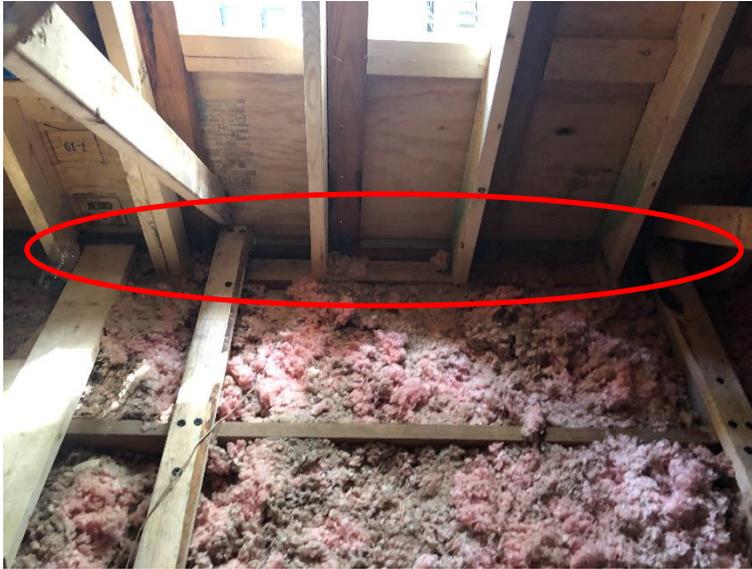
**PHOTOGRAPH #11**

**BUILDING 20  
SECTION D**

Simpson Strong -Tie HGA 10 clips have not been installed at top plate to new reinforcing studs as per specifications and drawings.

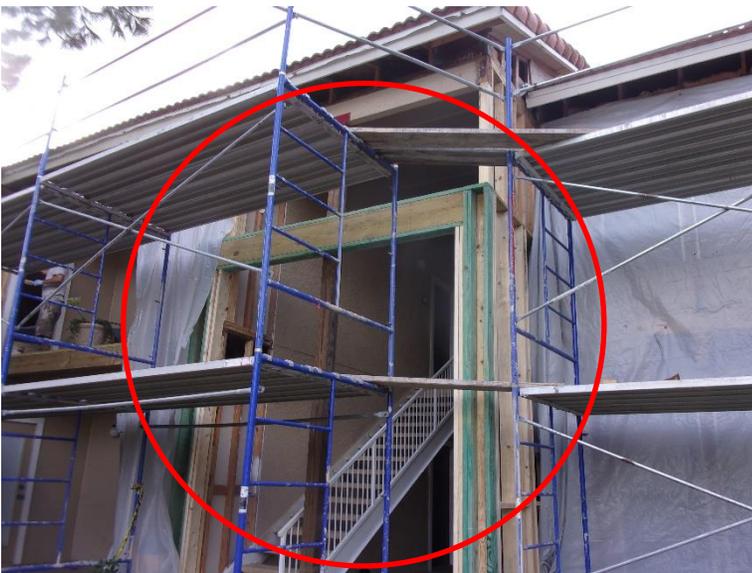
**PHOTOGRAPH #12**

**BUILDING 20  
SECTION E**

Full framing repairs performed at breezeway.

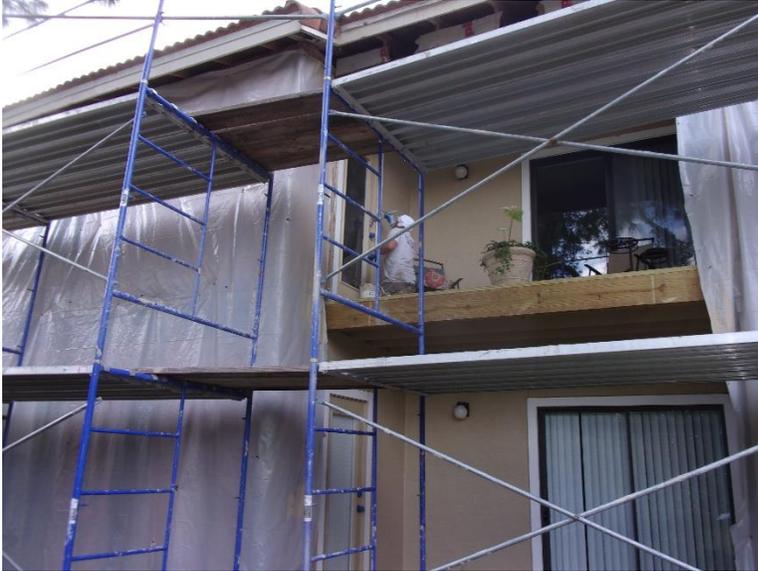
**PHOTOGRAPH #13**

**BUILDING 20  
SECTION E**

Finish painting in progress at Balconies and patios, with Florida Paints.

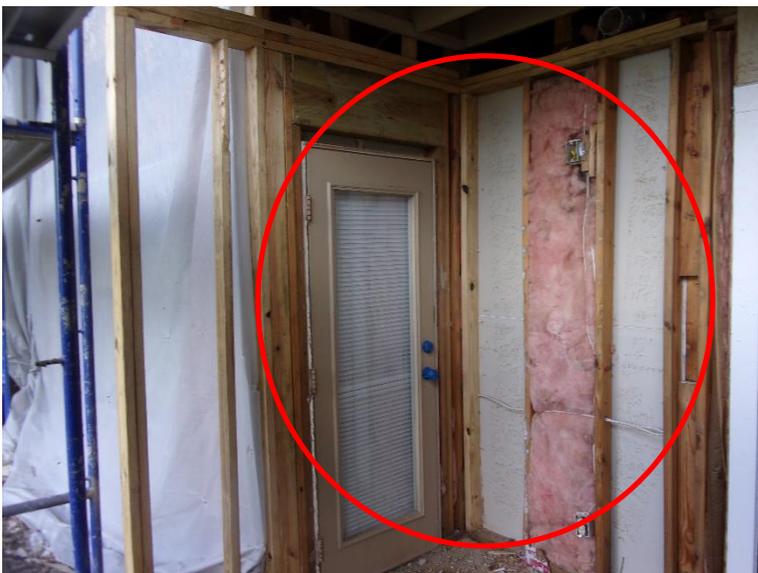
**PHOTOGRAPH #14**

**BUILDING 20  
SECTION F**

Additional repairs performed at patio door headers and walls.

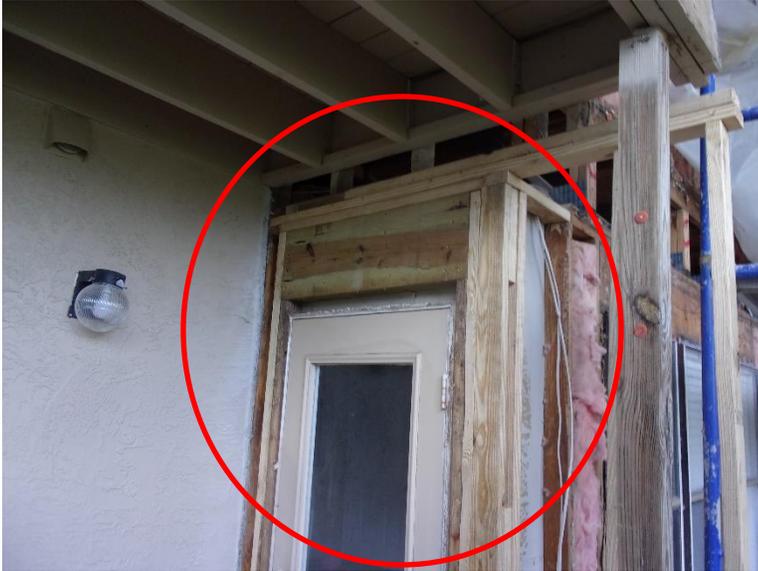
**PHOTOGRAPH #15**

**BUILDING 20  
SECTION F**

Additional repairs performed at patio door headers and walls.

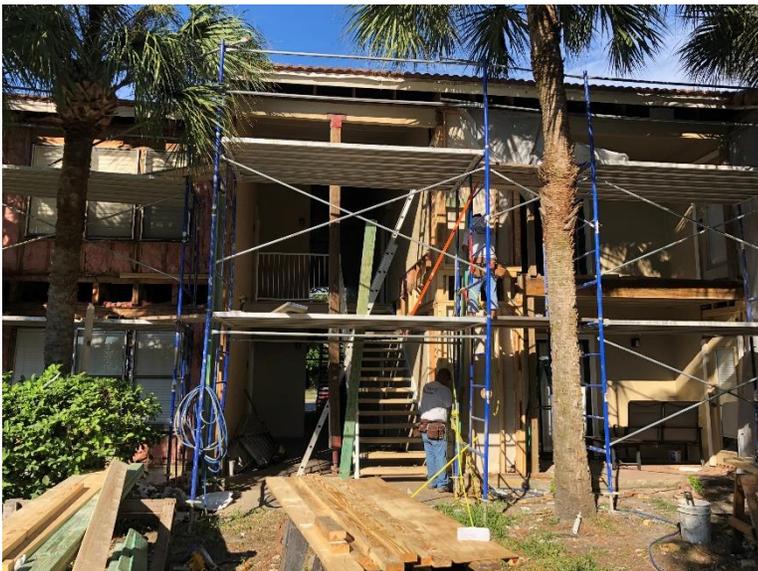
**PHOTOGRAPH #16**

**BUILDING 20  
SECTION G**

Framing repairs at breezeway and walls in progress.

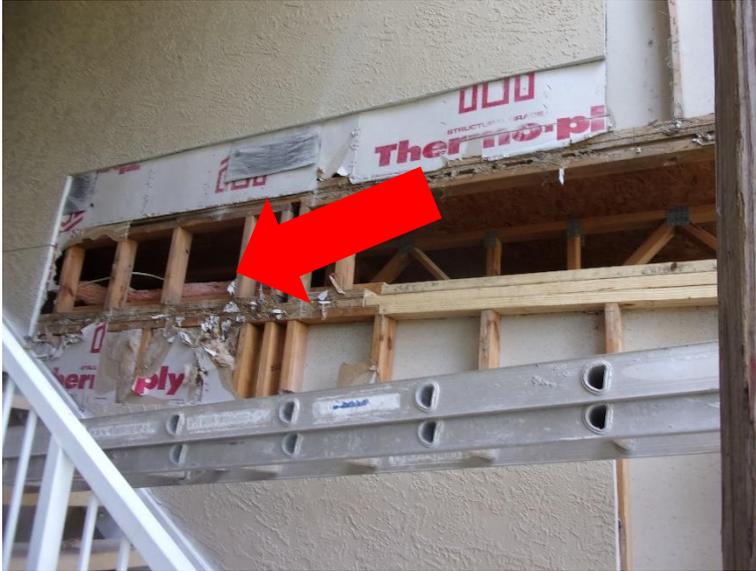
**PHOTOGRAPH #17**

**BUILDING 20  
SECTION G**

Additional termite damage to be repaired,  
extending into breezeway walls.

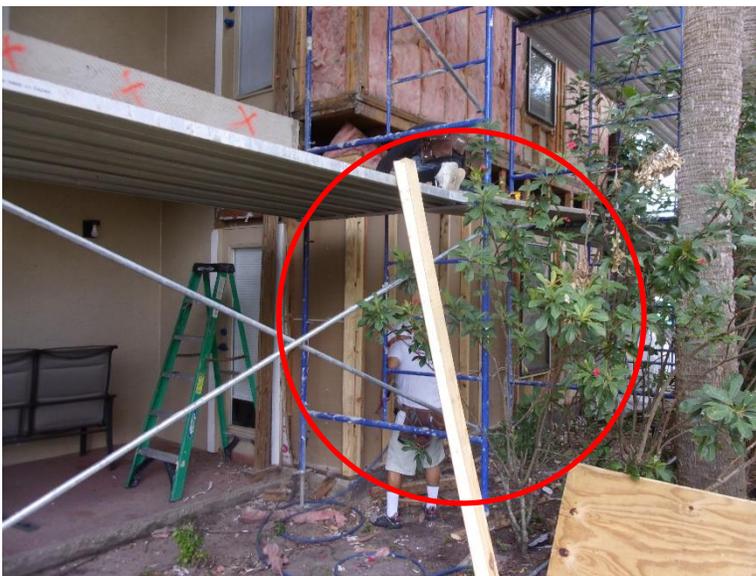
**PHOTOGRAPH #18**

**BUILDING 20  
SECTION G**

Framing repairs at balconies and walls in  
progress.

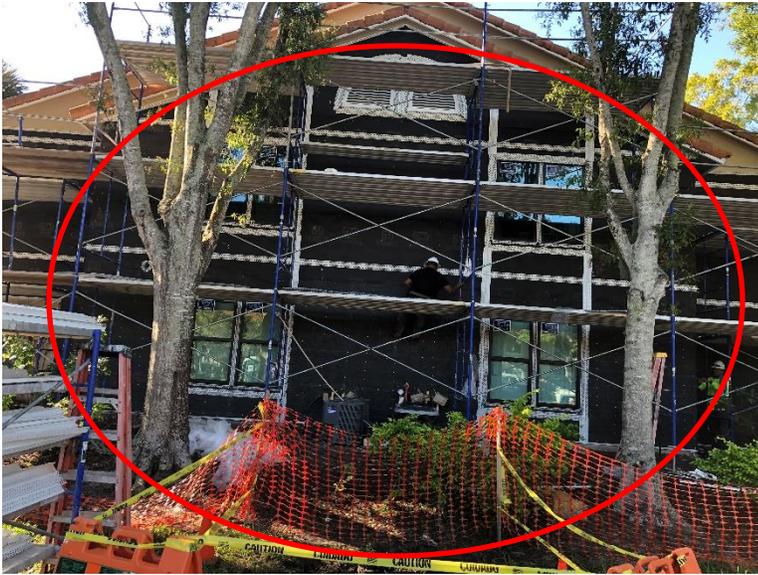
**PHOTOGRAPH #19**

**BUILDING 20  
SECTION H**

JumboTex WRB and stucco accessories applications have begun.
