PHOTOGRAPHS

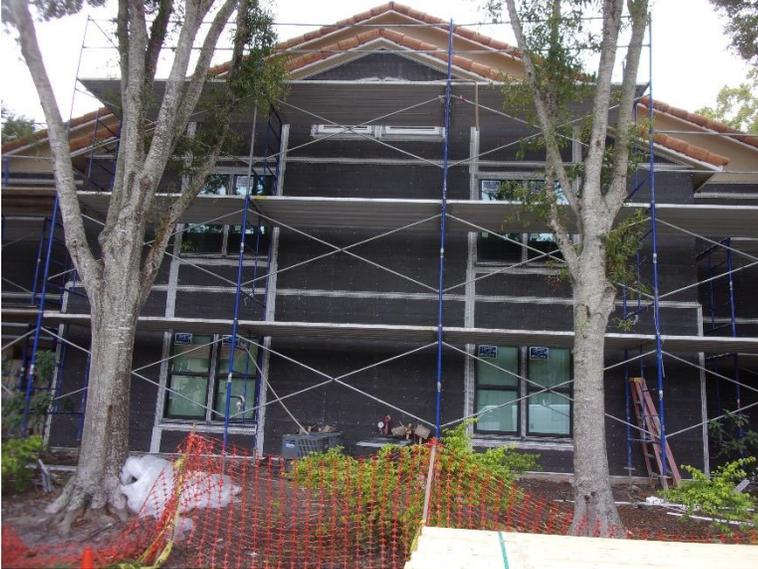
PHOTOGRAPH #1

**BUILDING 20
SECTION H**

Installation of JumboTex 60-minute WRB and stucco accessories in process.

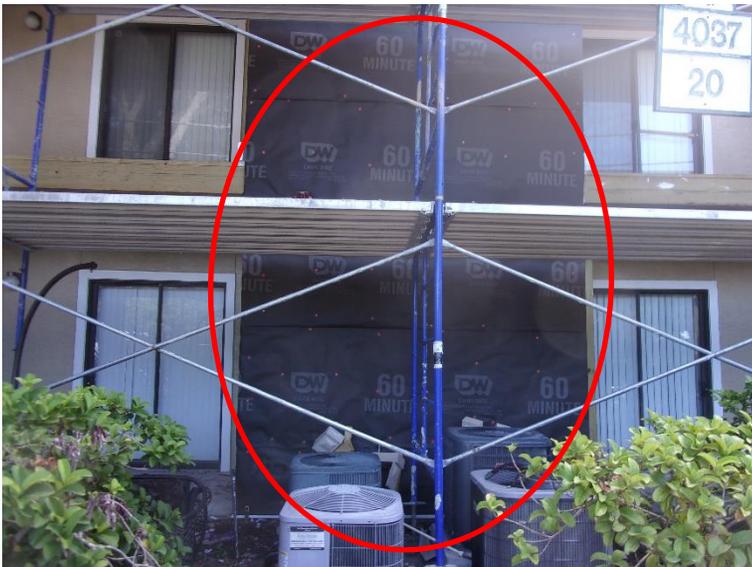
PHOTOGRAPH #2

**BUILDING 20
SECTION B**

Stucco sub contractor has applied different manufacturers 60-minute water resistant barrier that has not been submitted or approved.

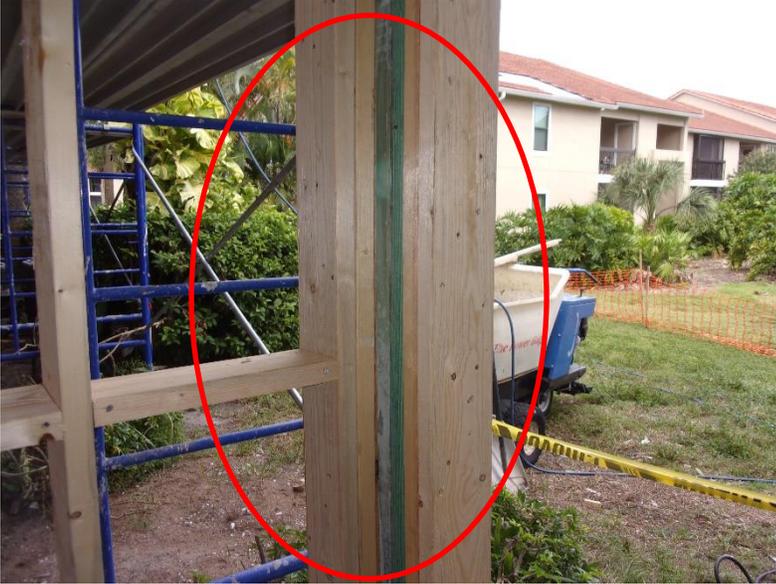
PHOTOGRAPH #3

**BUILDING 20
SECTION E**

New framing repairs inspected for approved lumber and nailing requirements.

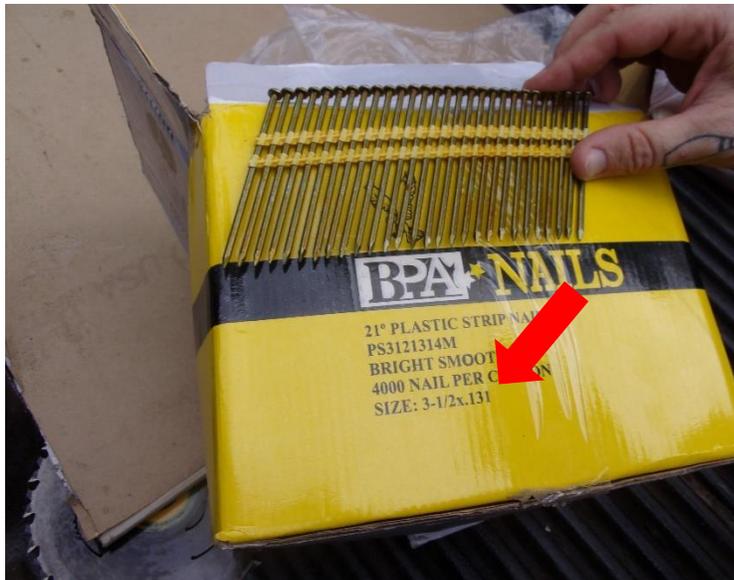
PHOTOGRAPH #4

**BUILDING 20
SECTION E**

Framing nails verified as 16D common as per drawings and specifications.

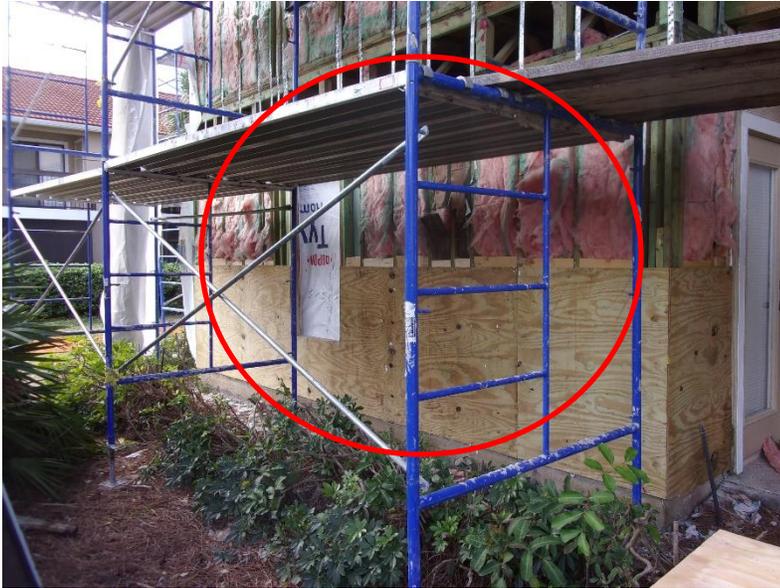
PHOTOGRAPH #5

**BUILDING 20
SECTION E**

Plywood sheathing application in progress. Lower sheet pressure treated plywood.

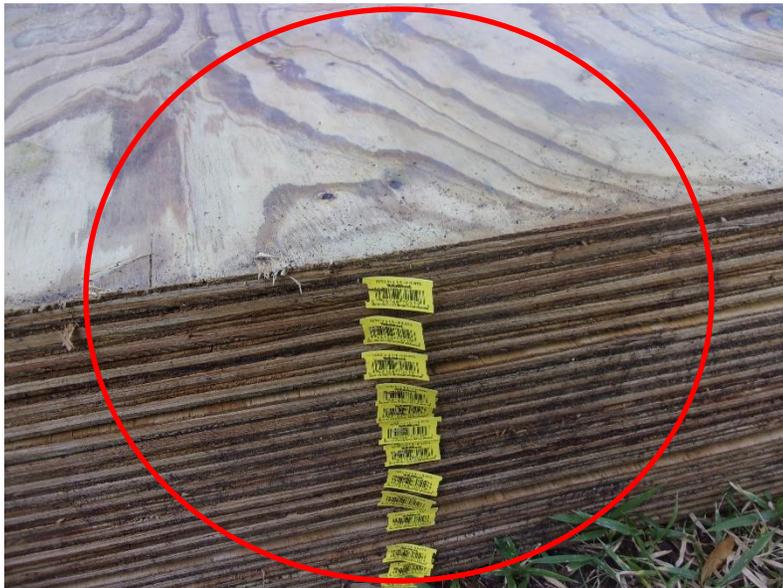
PHOTOGRAPH #6

**BUILDING 20
SECTION E**

Plywood sheathing application in progress. Lower sheet pressure treated Plywood.

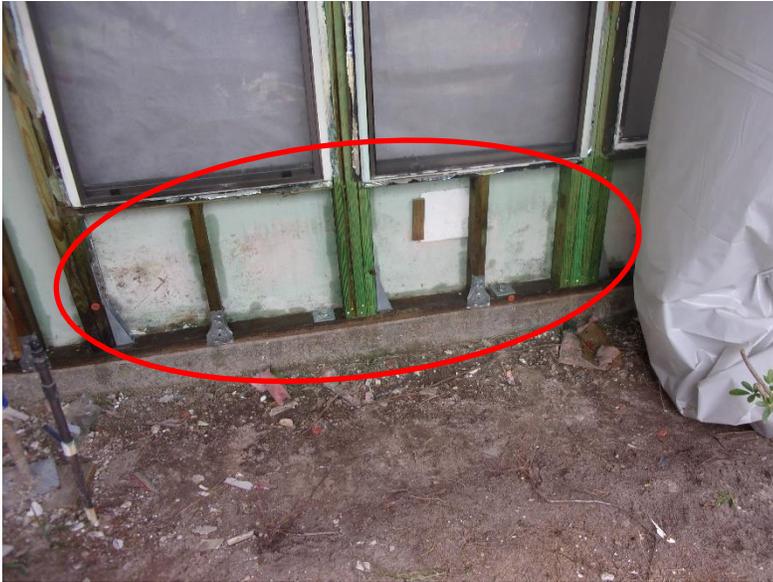
PHOTOGRAPH #7

**BUILDING 20
SECTION F**

Simpson Strong-Tie connectors and Titen anchors installed at base plate for framing attachments and tie downs as per drawings.

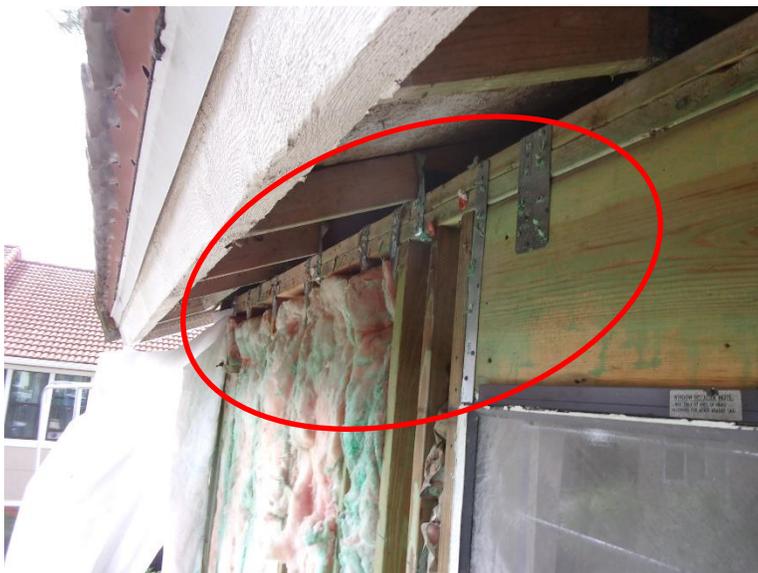
PHOTOGRAPH #8

**BUILDING 20
SECTION F**

Simpson Strong-Tie connectors, straps and screws installed at top plate and trusses as per drawings.

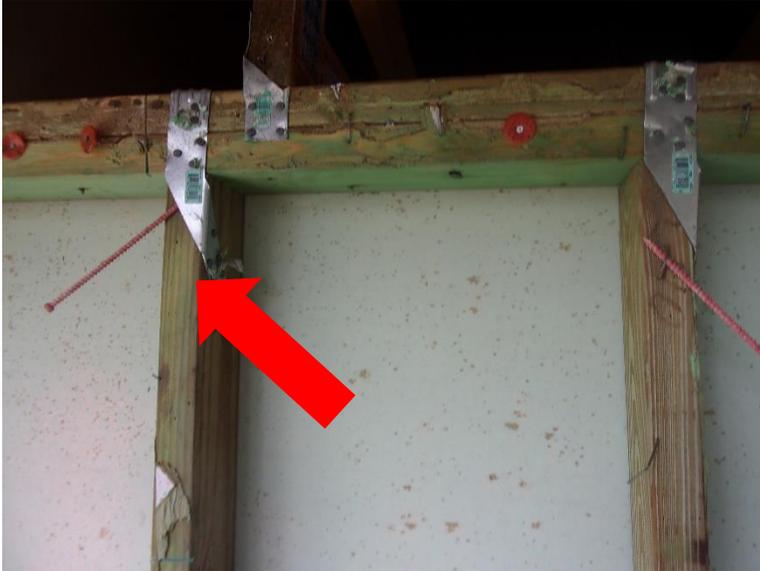
PHOTOGRAPH #9

**BUILDING 20
SECTION G**

Contractor had missed a few screws required for stud to top plate attachment.

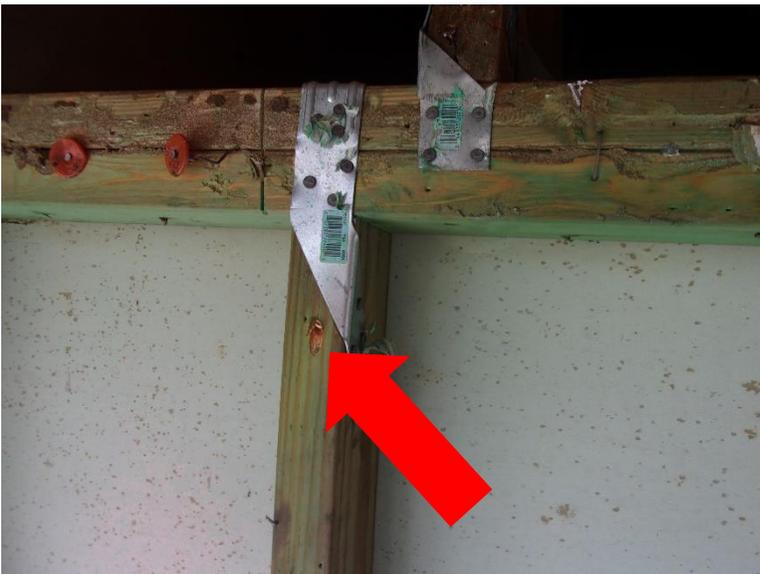
PHOTOGRAPH #10

**BUILDING 20
SECTION G**

Contractor has installed missed screws at stud to top plate attachments.

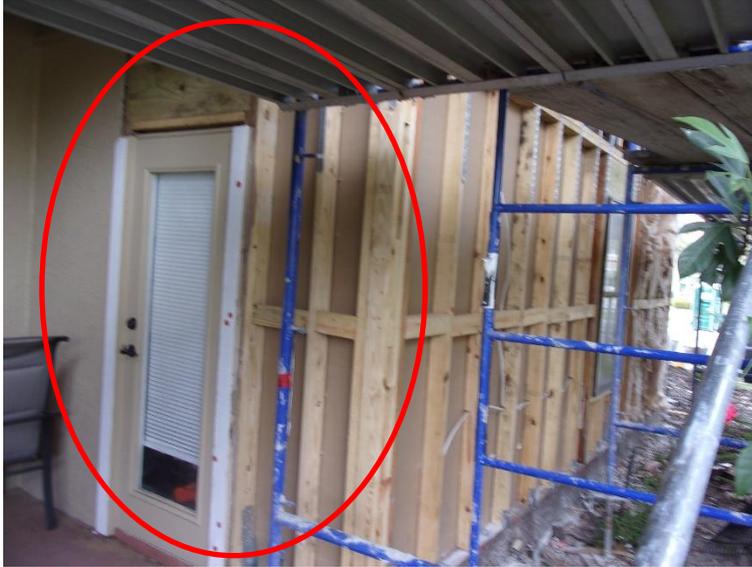
PHOTOGRAPH #11

**BUILDING 20
SECTION G**

Added framing repairs and headers at balconies and walls.

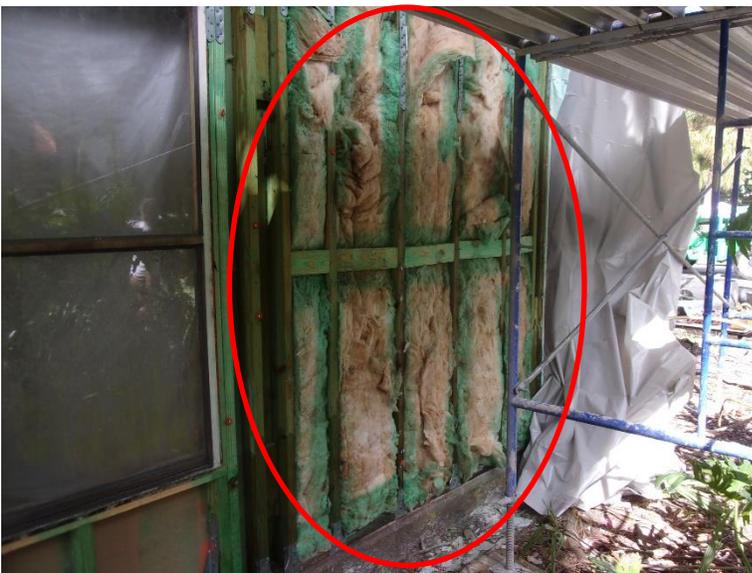
PHOTOGRAPH #12

**BUILDING 20
SECTION G**

BoraCare termite treatment applied by pest contractor at all framing walls.

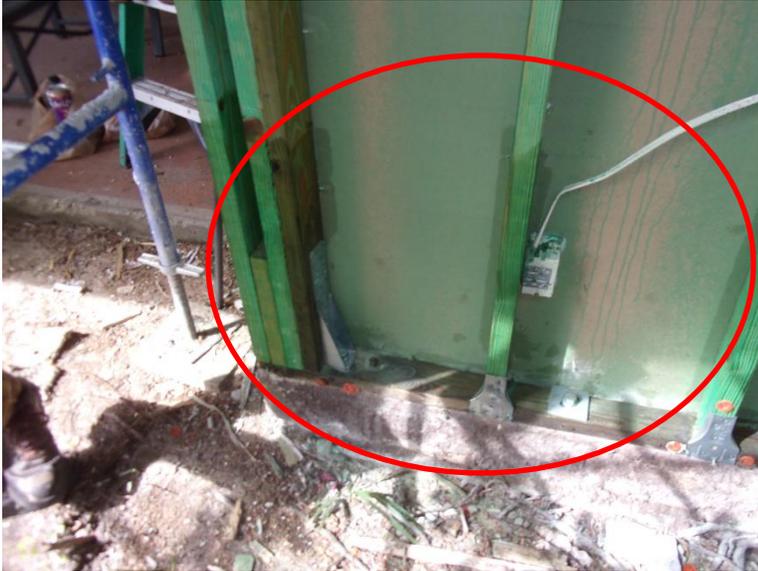
PHOTOGRAPH #13

**BUILDING 20
SECTION G**

Bottom plate and lower two feet of framing wood received Copper Green wood preservative.
