PHOTOGRAPHS

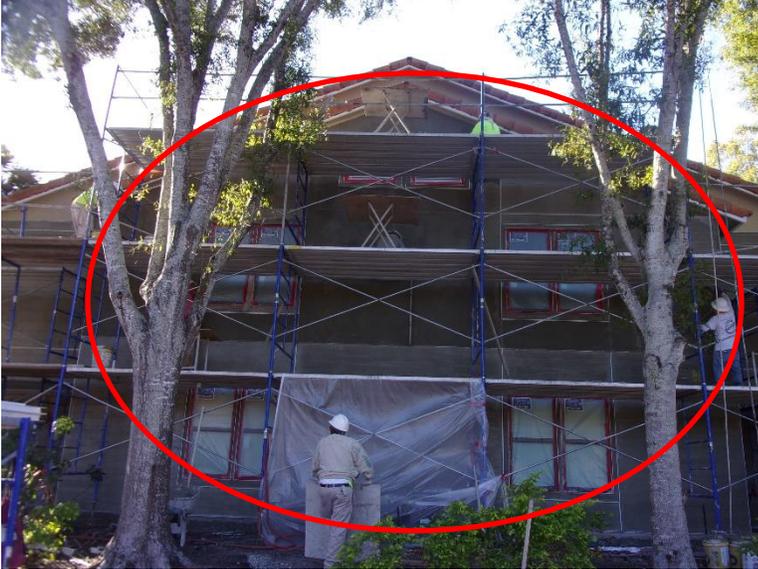
PHOTOGRAPH #1

BUILDING 20 SECTION H

Stucco scratch coat has set and brown coat application in progress.

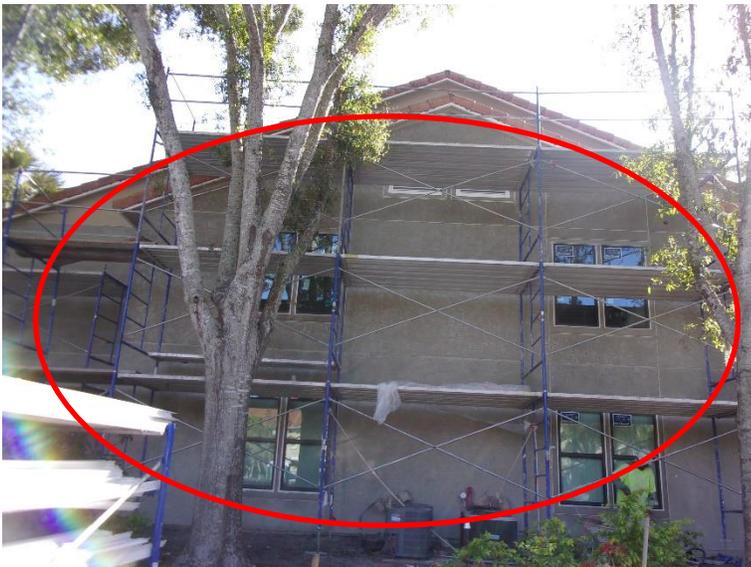
PHOTOGRAPH #2

BUILDING 20 SECTION H

7/8" three coat stucco system in place and wet curing in progress.

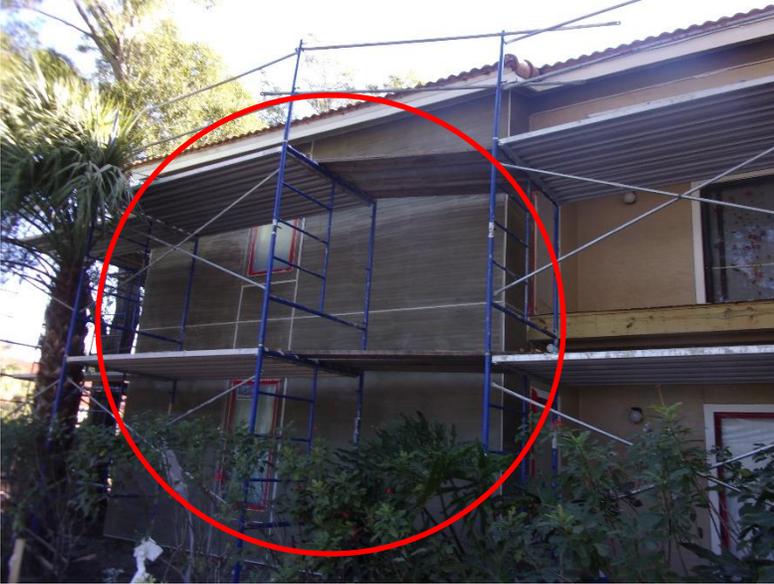
PHOTOGRAPH #3

**BUILDING 20
SECTION A**

Adjacent surfaces protected and scratch coat of stucco applied.

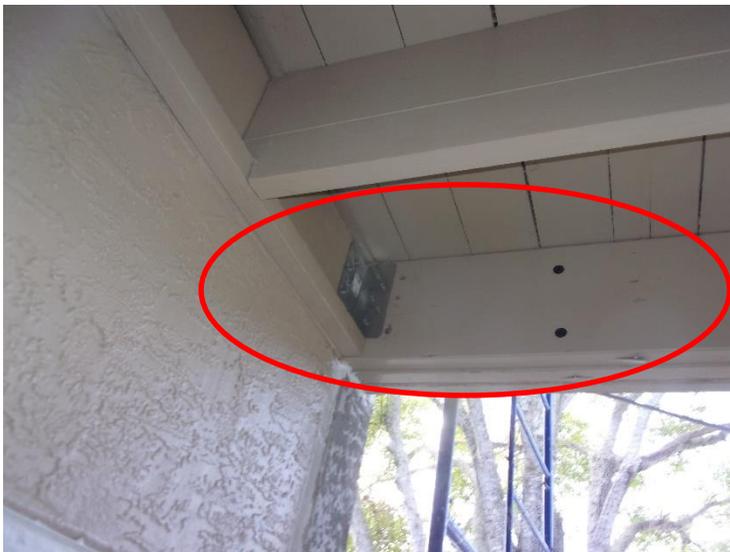
PHOTOGRAPH #4

**BUILDING 20
SECTION A**

Simpson Strong -Tie shear clips and screws installed at balcony built up beam locations.

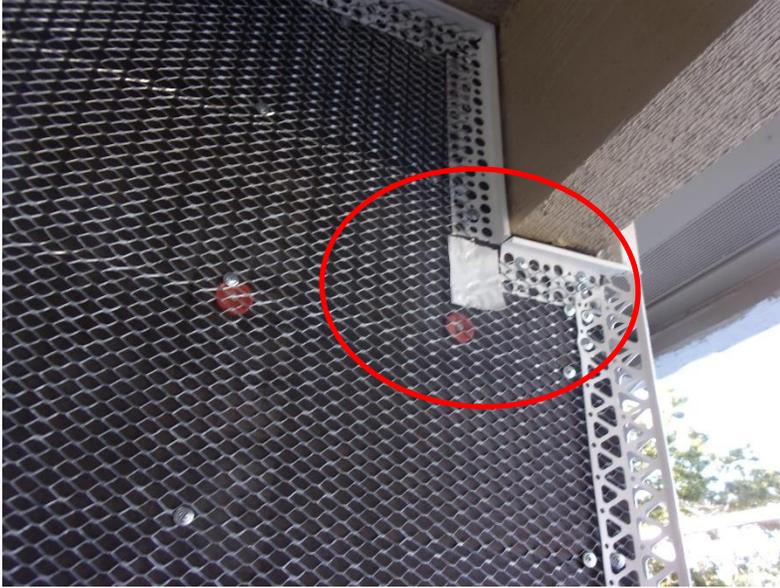
PHOTOGRAPH #5

**BUILDING 20
SECTION B**

Missing sealant marked for correction at stucco stop accessory juncture.

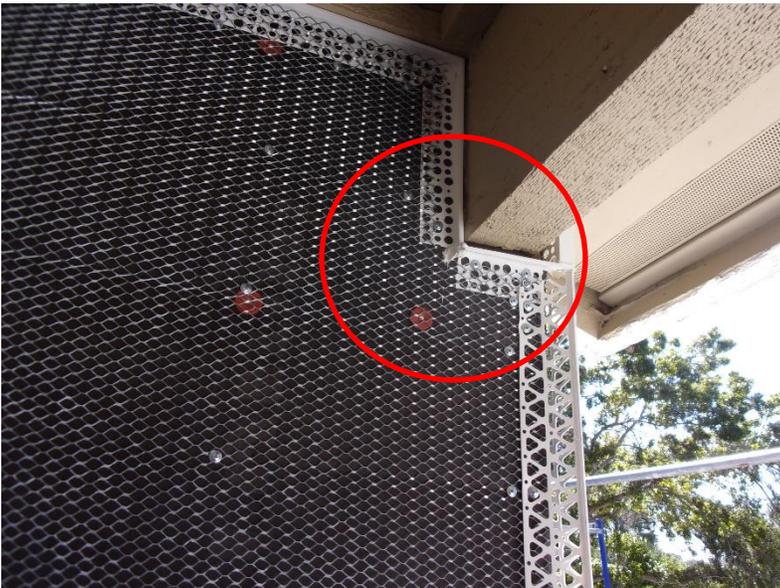
PHOTOGRAPH #6

**BUILDING 20
SECTION B**

Missing sealant at stucco stop accessory juncture sealed.

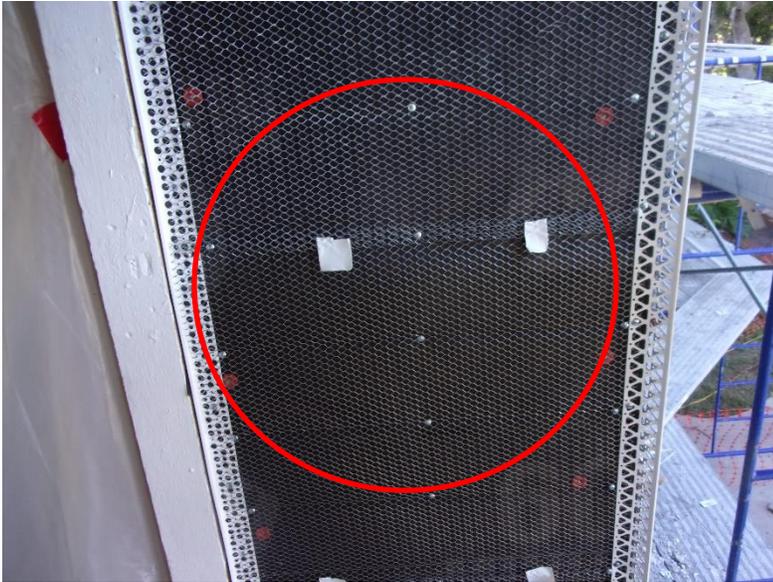
PHOTOGRAPH #7

**BUILDING 20
SECTION B**

Missing tie wires at metal lath lapping
marked for correction.

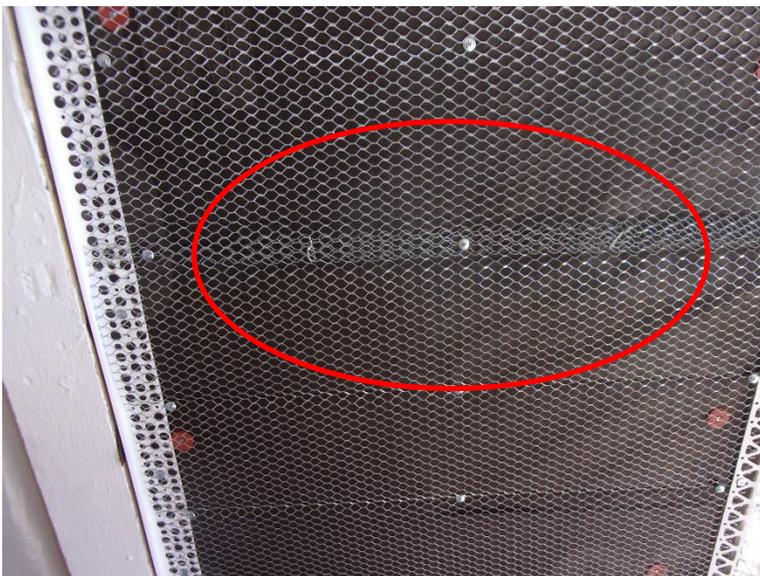
PHOTOGRAPH #8

**BUILDING 20
SECTION B**

Missing tie wires at metal lath lapping
corrected.

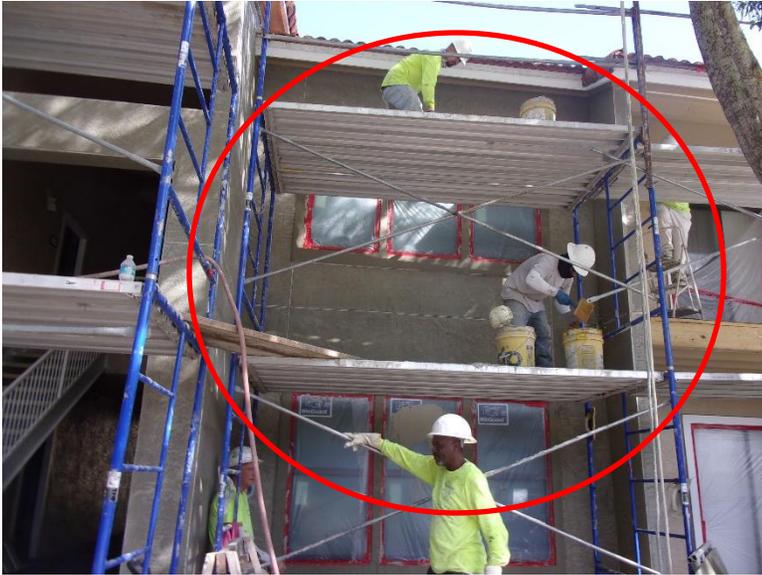
PHOTOGRAPH #9

**BUILDING 20
SECTION B**

Finish coat of stucco being applied over brown coat.

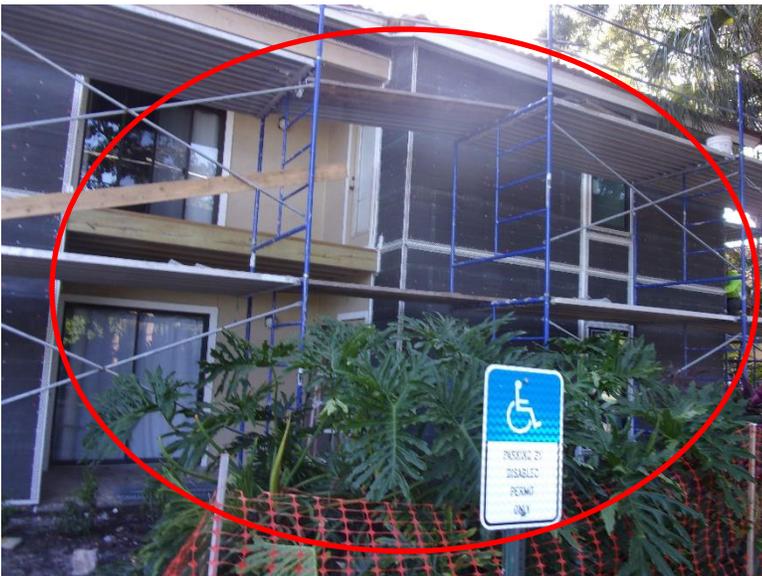
PHOTOGRAPH #10

**BUILDING 20
SECTION C**

Stucco accessories and metal lathing placed and ready for stucco applications.

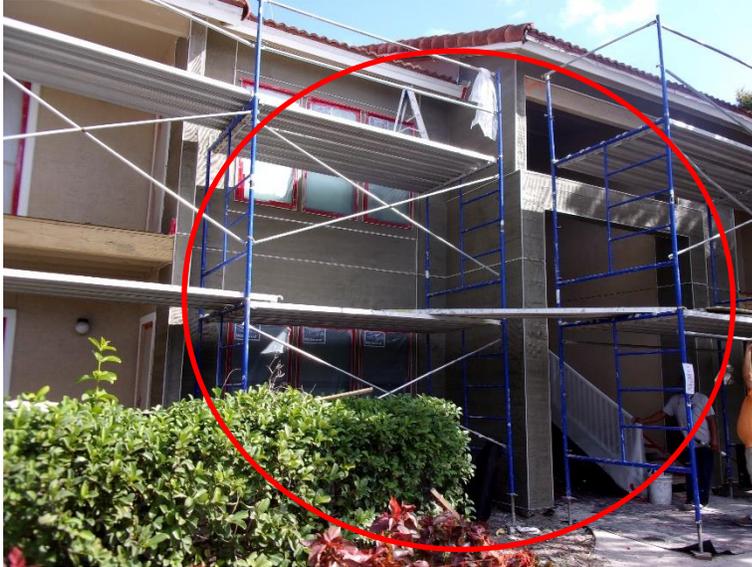
PHOTOGRAPH #11

**BUILDING 20
SECTION C**

Adjacent surfaces protected and scratch coat of stucco applied.

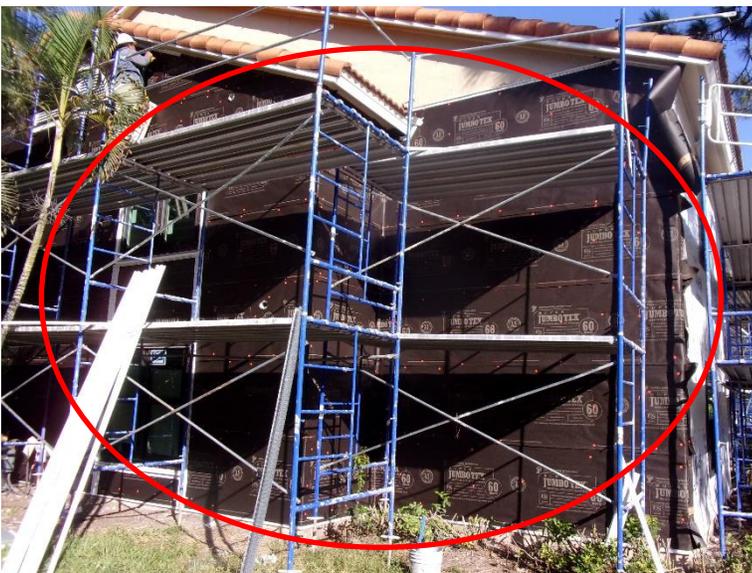
PHOTOGRAPH #12

**BUILDING 20
SECTION D**

JumboTex water resistant barrier applied over Tyvek HomeWrap.

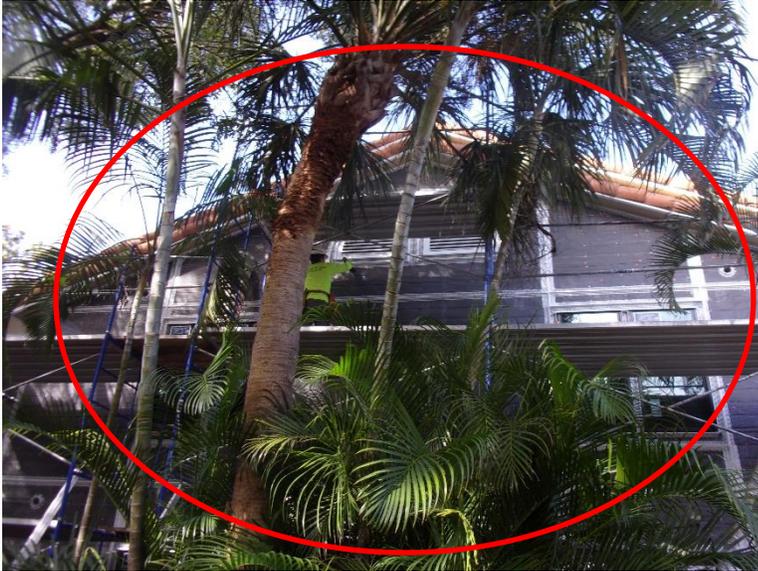
PHOTOGRAPH #13

**BUILDING 20
SECTION D**

Stucco accessories and metal lathing applications in progress.

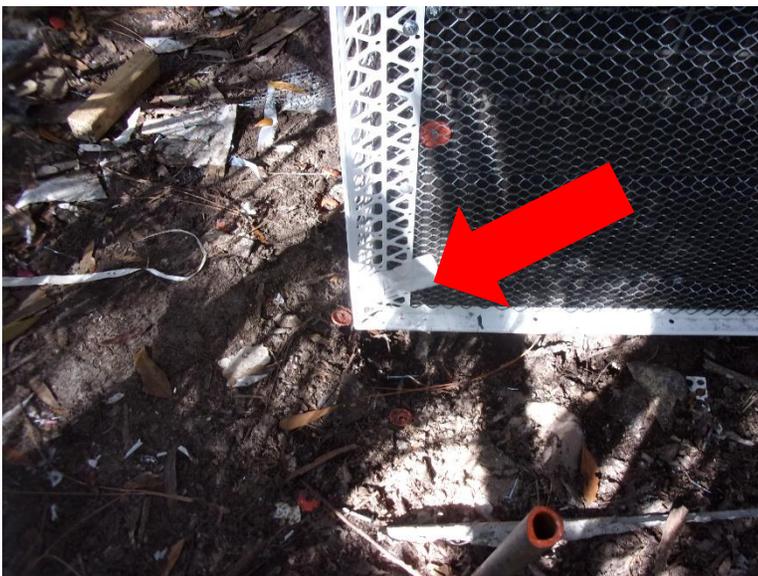
PHOTOGRAPH #14

**BUILDING 21
SECTION D**

Sealant missing at casing bead to weep screed accessory juncture.

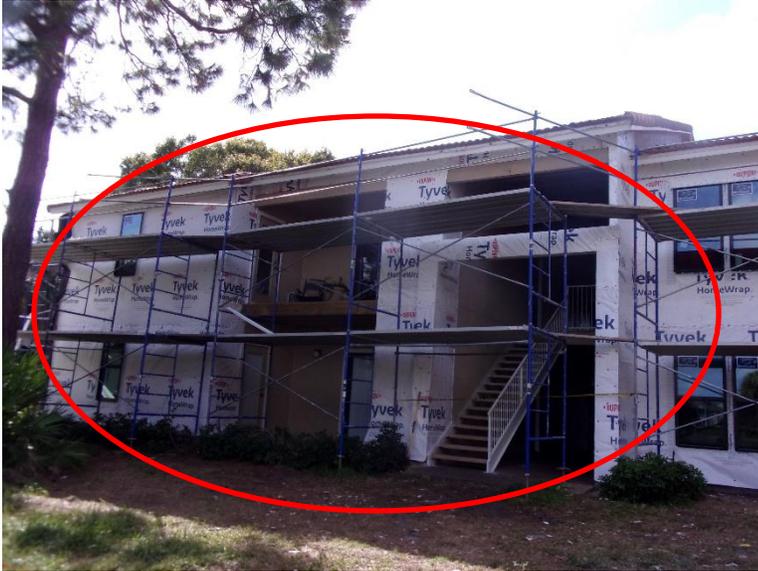
PHOTOGRAPH #15

**BUILDING 20
SECTION E**

Tyvek HomeWrap WRB applied and new PGT windows installed with Dupont flashing details.

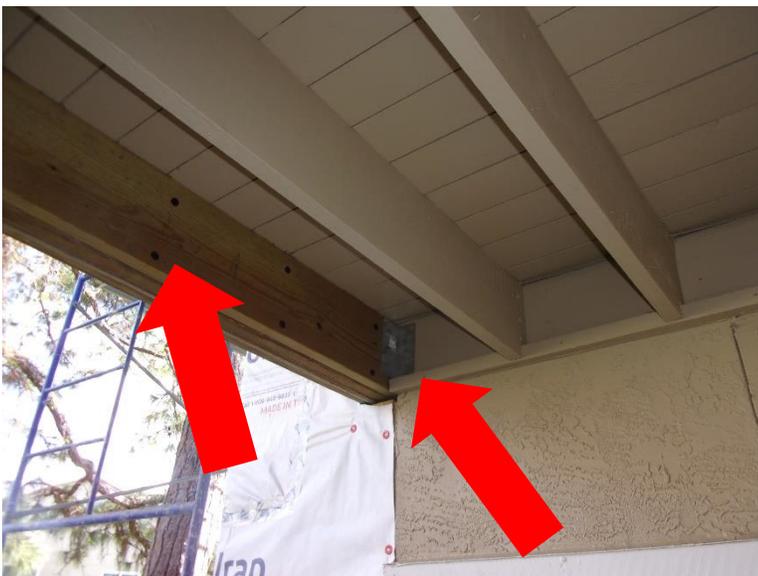
PHOTOGRAPH #16

**BUILDING 20
SECTION E**

Simpson strong-Tie shear clips and screws installed at balcony built up beam locations.

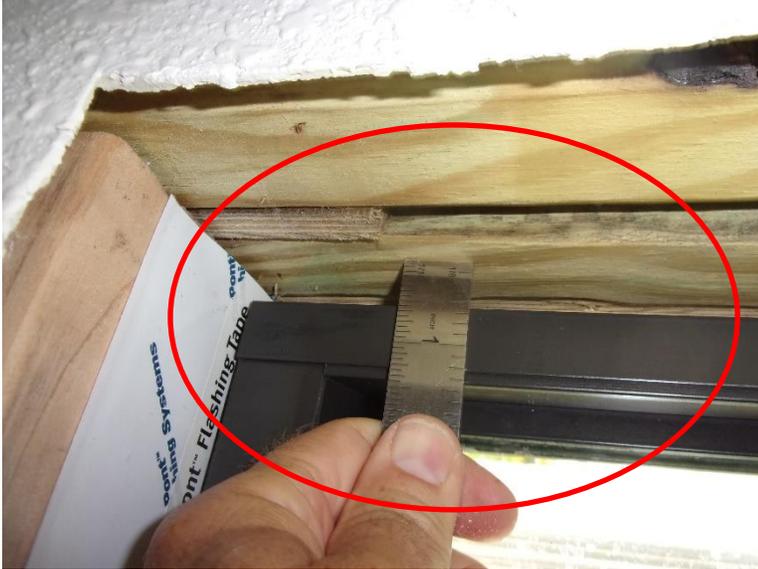
PHOTOGRAPH #17

**BUILDING 20
UNIT #2018 - SECTION E**

Gap from new window to wood framing at head is more than maximum allowable space for compliance with window manufactures NOA requirements and will require removal and reinstallation of window to meet requirements.

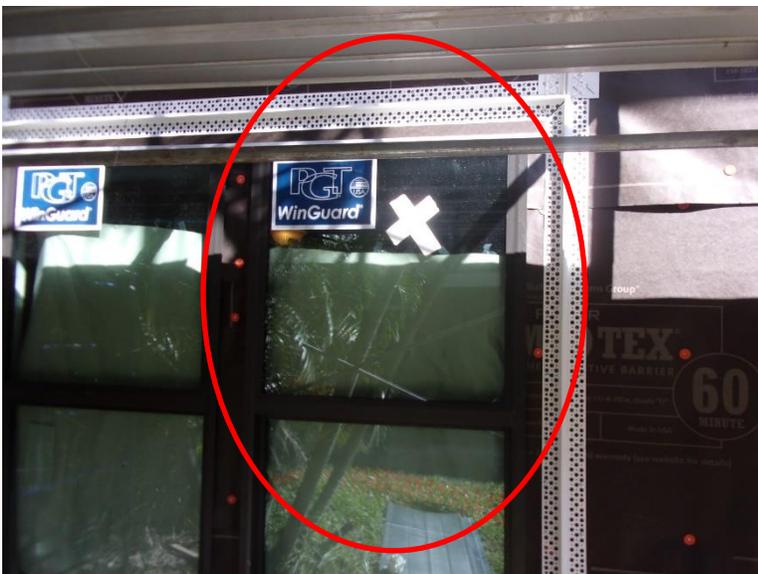
PHOTOGRAPH #18

**BUILDING 20
UNIT #2018- SECTION E**

Gap from new window to wood framing at head is more than maximum allowable space for compliance with window manufactures NOA requirements and will require removal and reinstallation of window to meet requirements

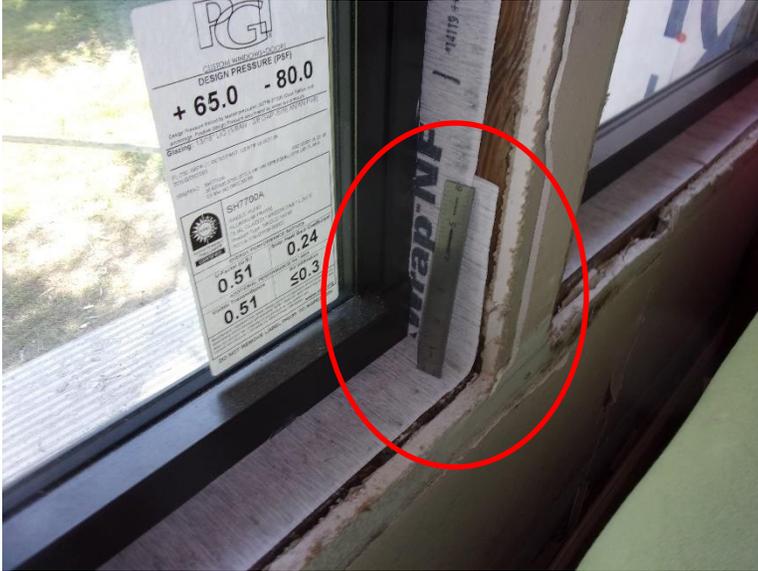
PHOTOGRAPH #19

**BUILDING 20
UNIT #2026- SECTION F**

New window installations inspected for Dupont flashing applications and spacing requirements.

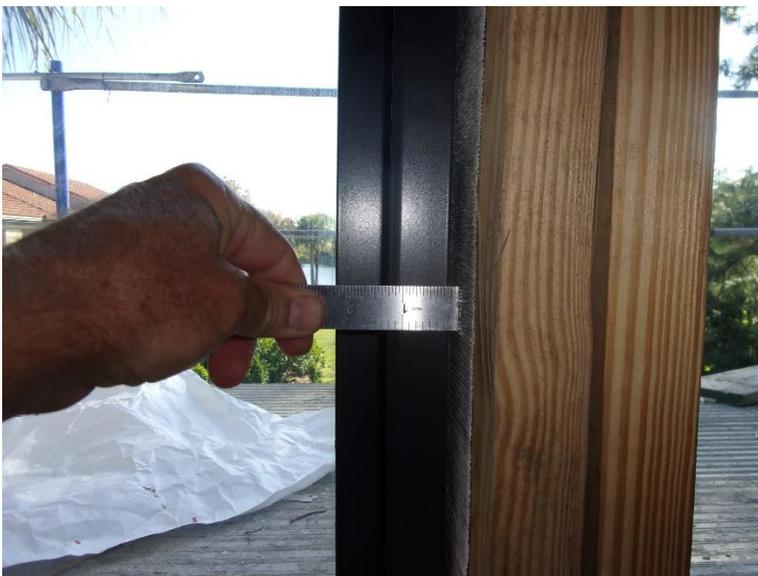
PHOTOGRAPH #20

**BUILDING 20
UNIT #2026- SECTION F**

New window installations inspected for Dupont flashing applications and spacing requirements.

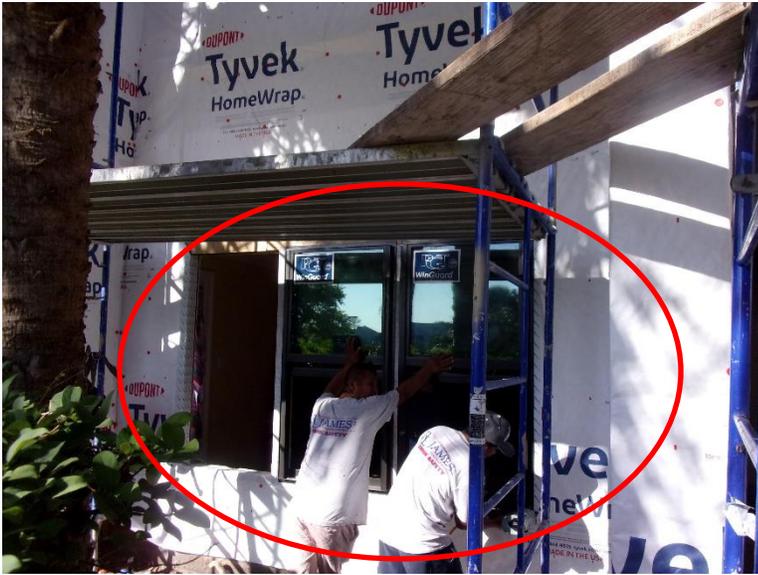
PHOTOGRAPH #21

**BUILDING 20
UNIT #2014- SECTION F**

New PGT SH7700A window being installed.

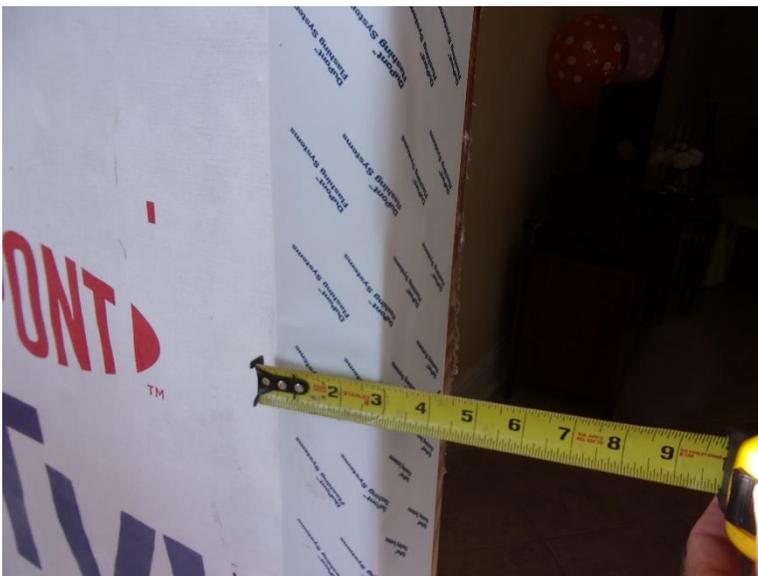
PHOTOGRAPH #22

**BUILDING 20
UNIT #2014- SECTION F**

New window installations inspected for Dupont flashing applications and spacing requirements.

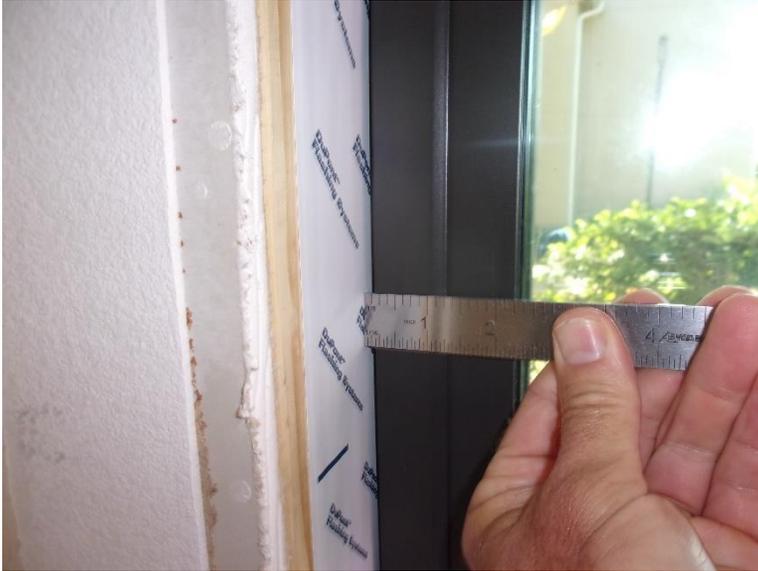
PHOTOGRAPH #23

**BUILDING 20
UNIT #2014- SECTION F**

New window installations inspected for Dupont flashing applications and spacing requirements.

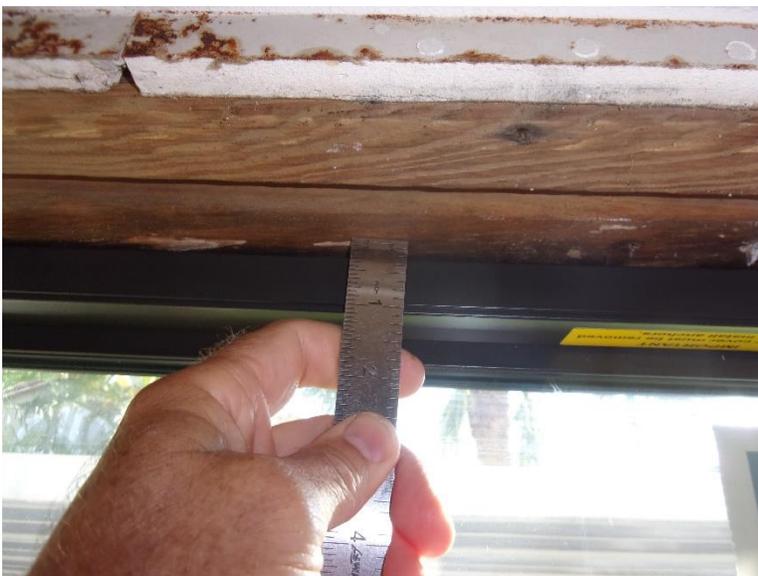
PHOTOGRAPH #24

**BUILDING 20
UNIT #2014- SECTION F**

New window installations inspected for Dupont flashing applications and spacing requirements.

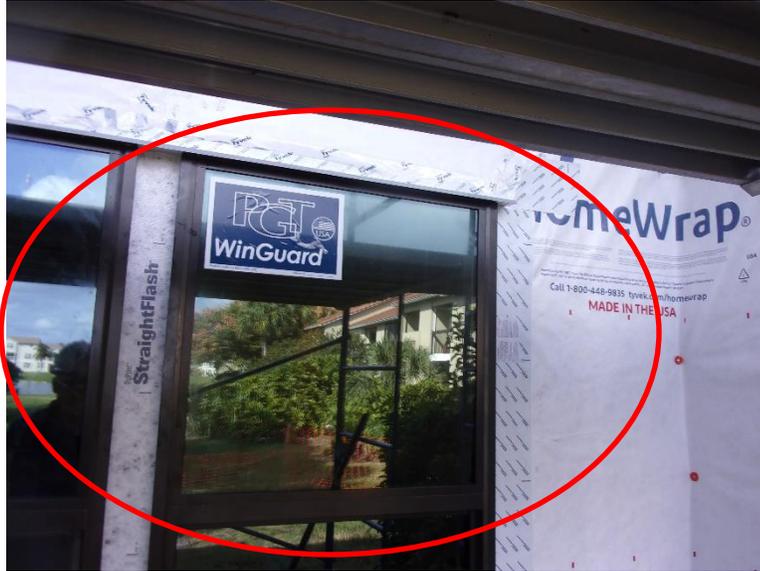
PHOTOGRAPH #25

**BUILDING 20
SECTION F**

Head flashing and final Dupont flashing details applied as per specifications, drawings and manufactures guidelines.

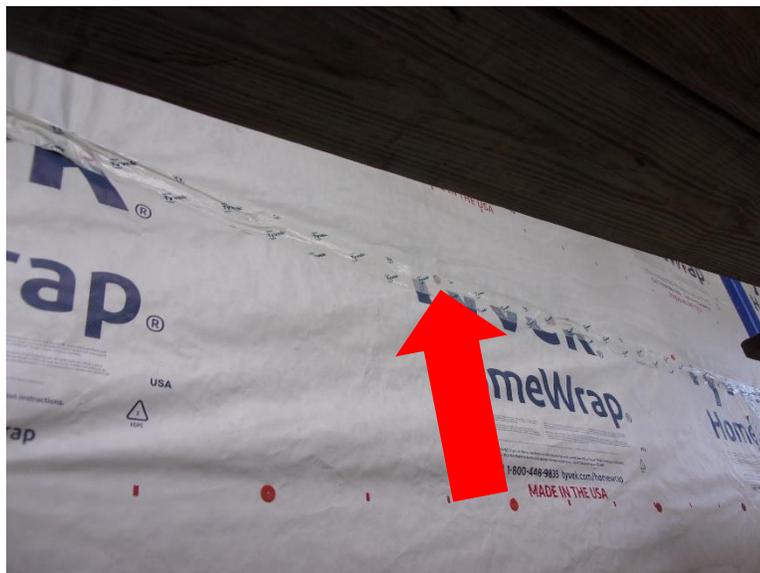
PHOTOGRAPH #26

**BUILDING 20
SECTION F**

Tyvek seam tape has been improperly applied over fastener tabs and is required to be removed and corrected.

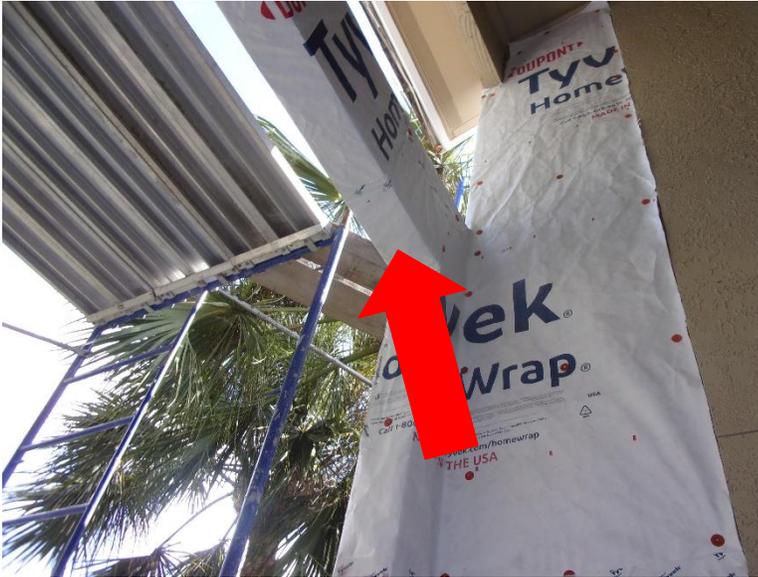
PHOTOGRAPH #27

**BUILDING 20
SECTION G**

Tyvek HomeWrap covering underside of horizontal surface will require weep penetrations that have not yet been installed at breezeway beam locations.
