PHOTOGRAPHS

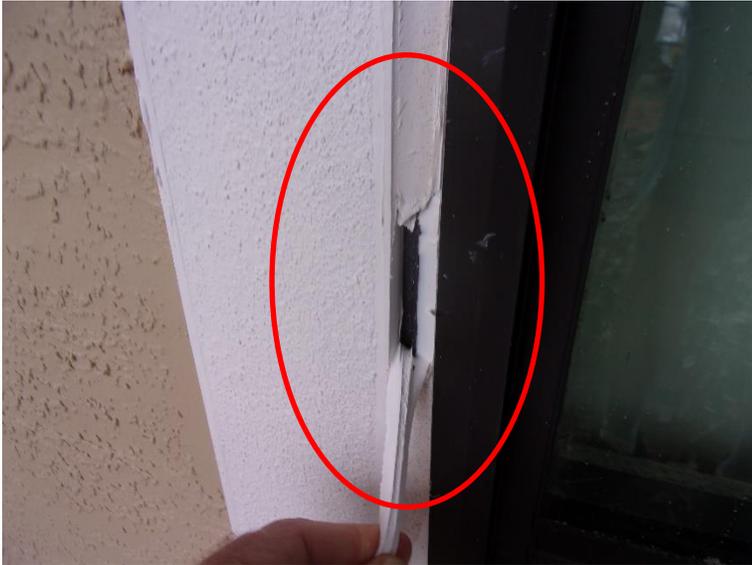
PHOTOGRAPH #1

BUILDING 20 SECTION H

Sealant adhesion pull test performed at window perimeter confirming sealant application and performance.

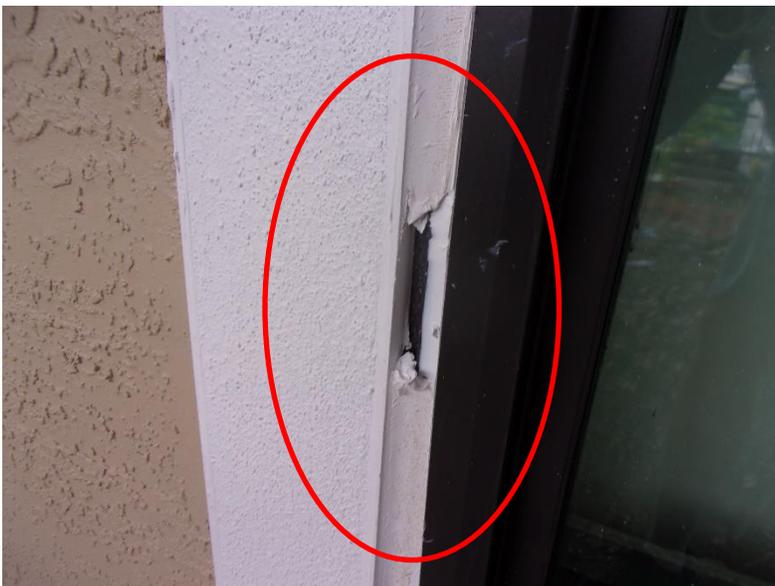
PHOTOGRAPH #2

BUILDING 20 SECTION H

Sealant adhesion pull test performed at window perimeter confirming sealant application and performance

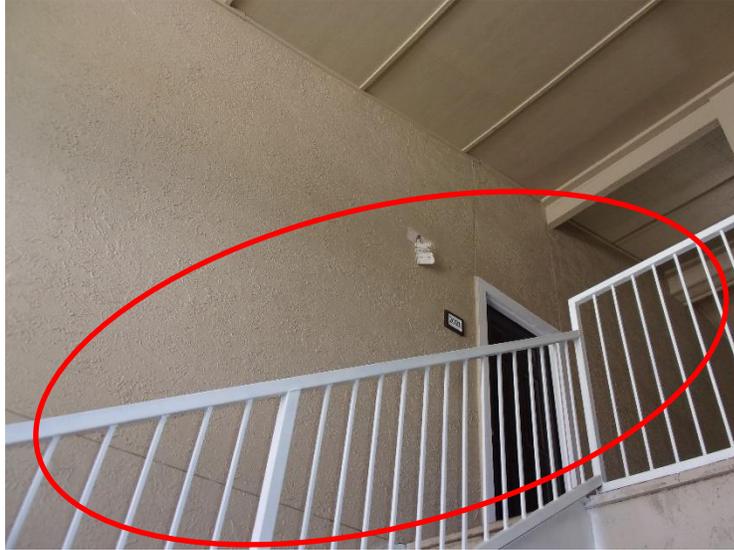
PHOTOGRAPH #3

**BUILDING 20
SECTION A**

Stairway railings primed with Florida Paints Encapsulon industrial epoxy mastic primer.

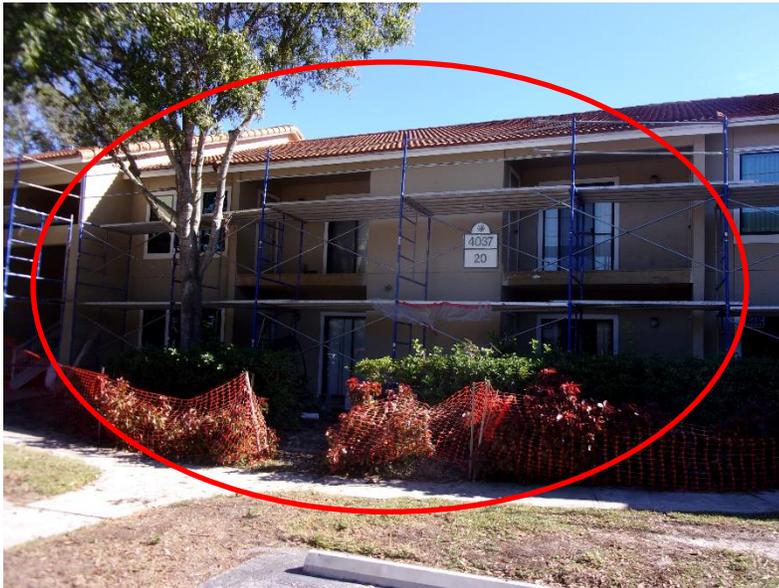
PHOTOGRAPH #4

**BUILDING 20
SECTION B**

New stucco primed and painted with Florida paints acrylic coatings.

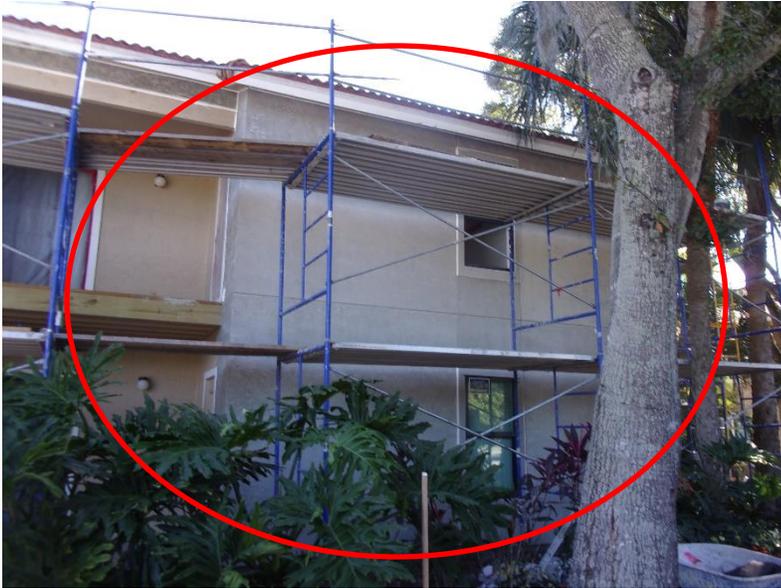
PHOTOGRAPH #5

**BUILDING 20
SECTION C**

Three coat 7/8" stucco system applied.
Wet curing in progress.

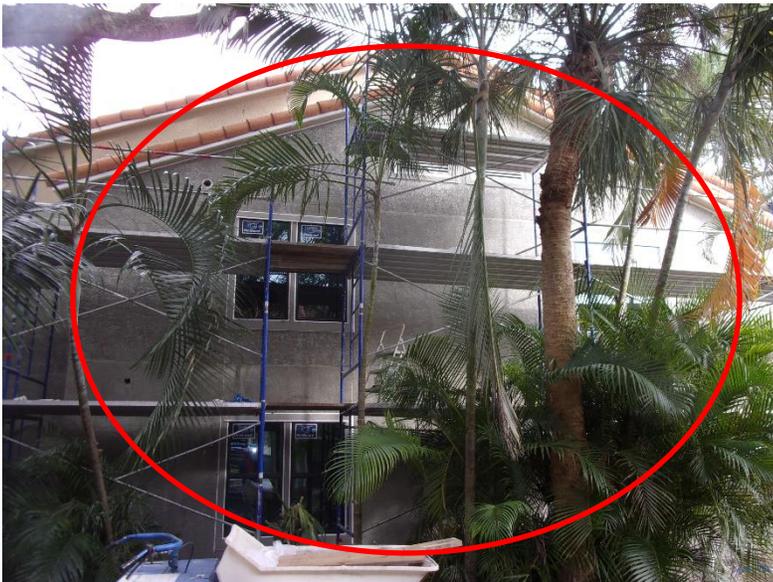
PHOTOGRAPH #6

**BUILDING 20
SECTION D**

Three coat 7/8" stucco system applied.
Wet curing in progress.

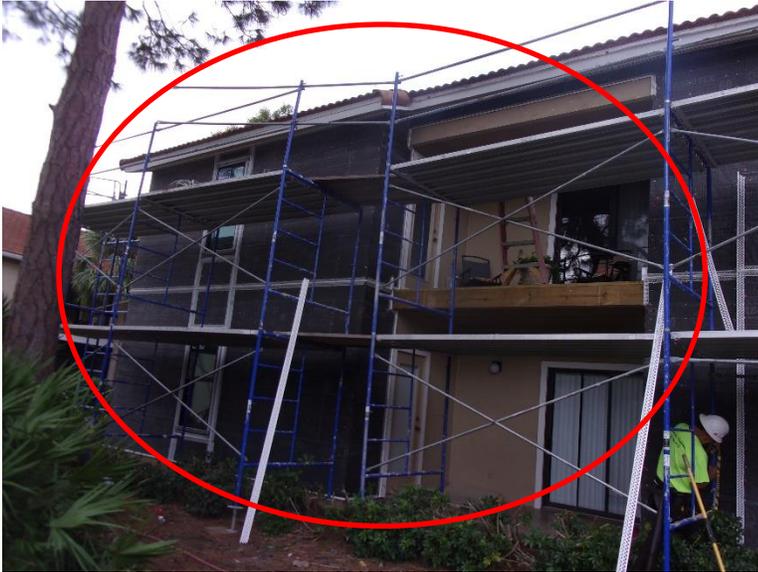
PHOTOGRAPH #7

**BUILDING 20
SECTION E**

Stucco accessories and metal lathing applications in progress.

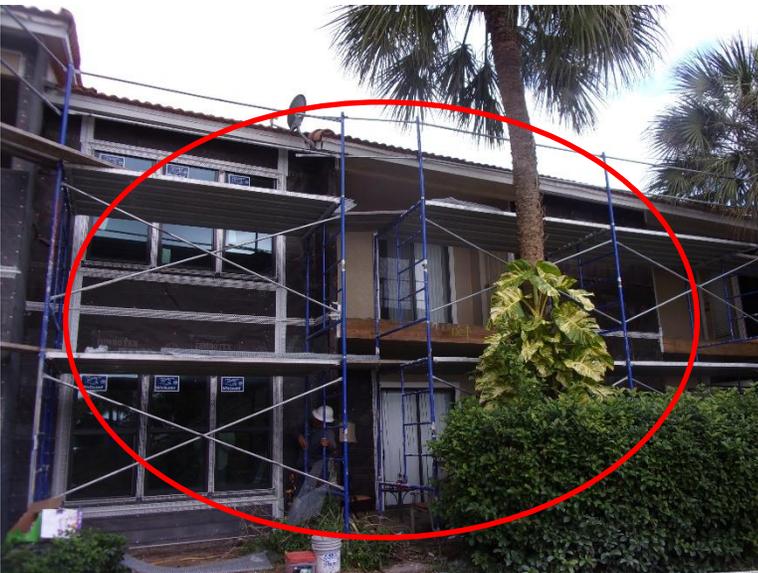
PHOTOGRAPH #8

**BUILDING 20
SECTION F**

Stucco accessories and metal lathing applications in progress.

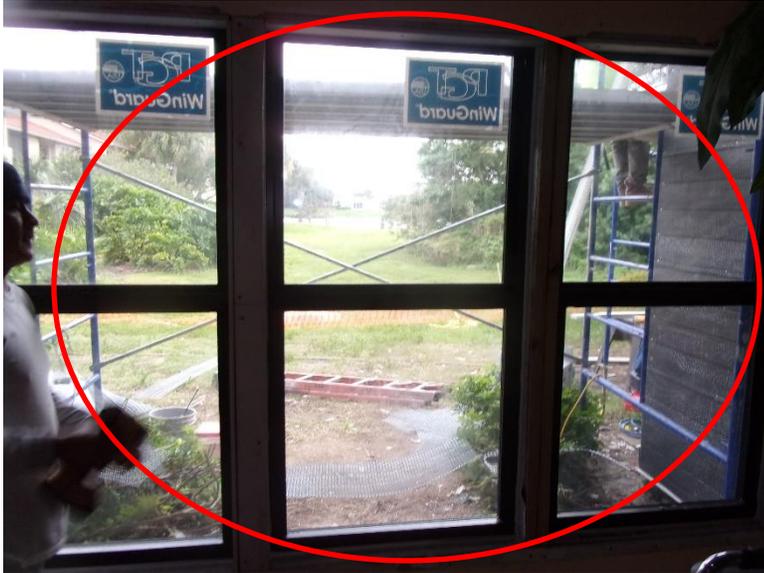
PHOTOGRAPH #9

**BUILDING 20
UNIT # 2016- SECTION F**

Contractor applying finish drywall and new windowsills at new window areas.

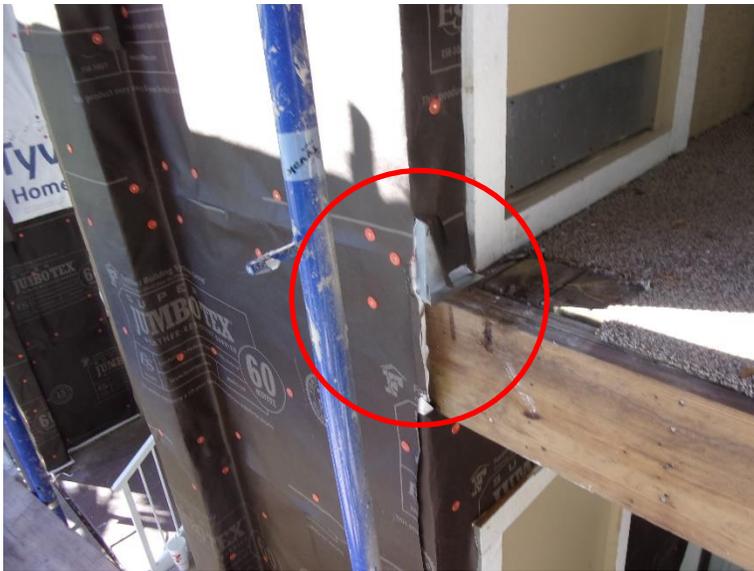
PHOTOGRAPH #10

**BUILDING 20
SECTION F**

Kickout flashings at balconies repositioned for stucco application consistency.

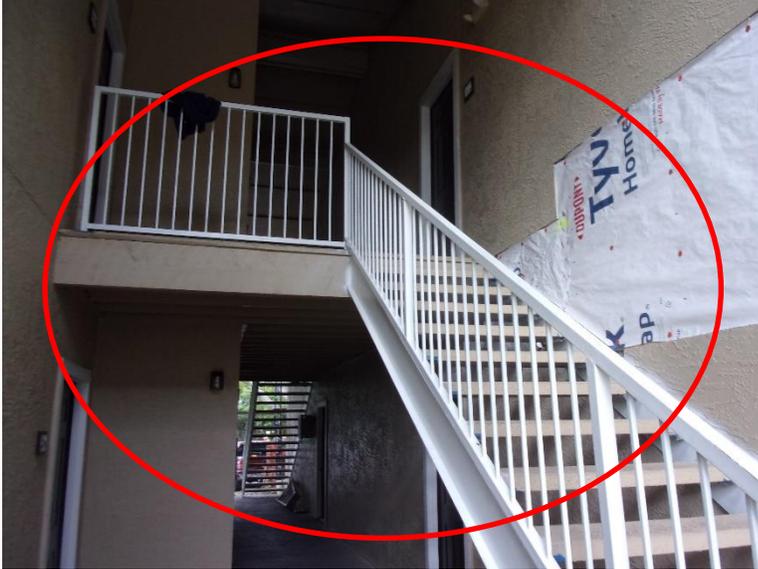
PHOTOGRAPH #11

**BUILDING 20
SECTION F**

Stairway railings primed with Florida Paints Encapsulon industrial epoxy mastic primer.

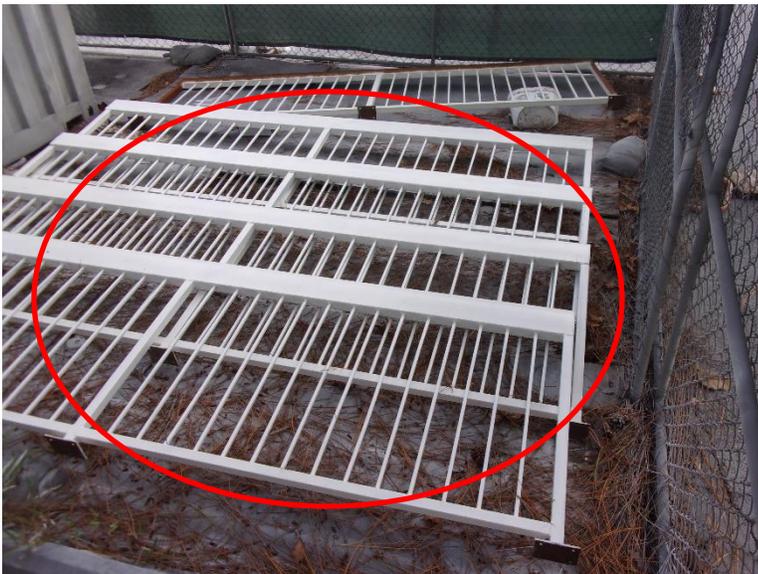
PHOTOGRAPH #12

**BUILDING 20
SECTION F**

Railings removed from balconies prepped and primed with Encapsulon industrial epoxy mastic primer.

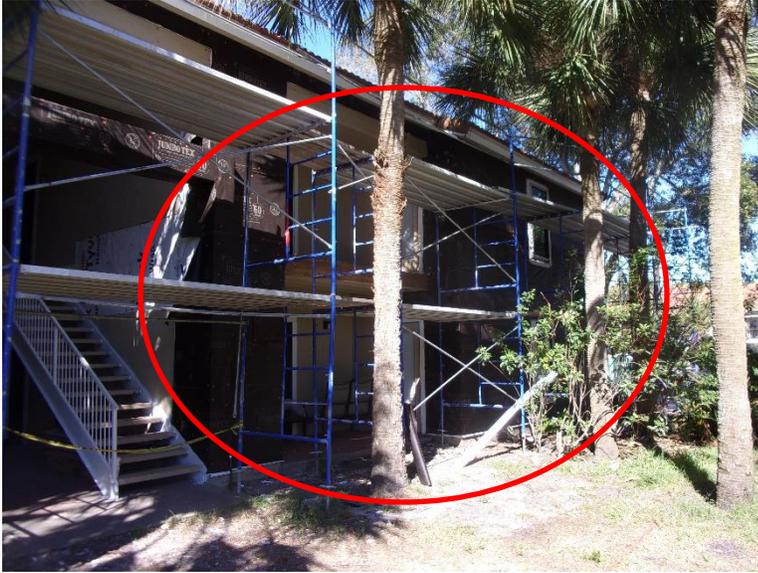
PHOTOGRAPH #13

**BUILDING 20
SECTION G**

JumboTex water resistant barrier application in progress.
