PHOTOGRAPHS

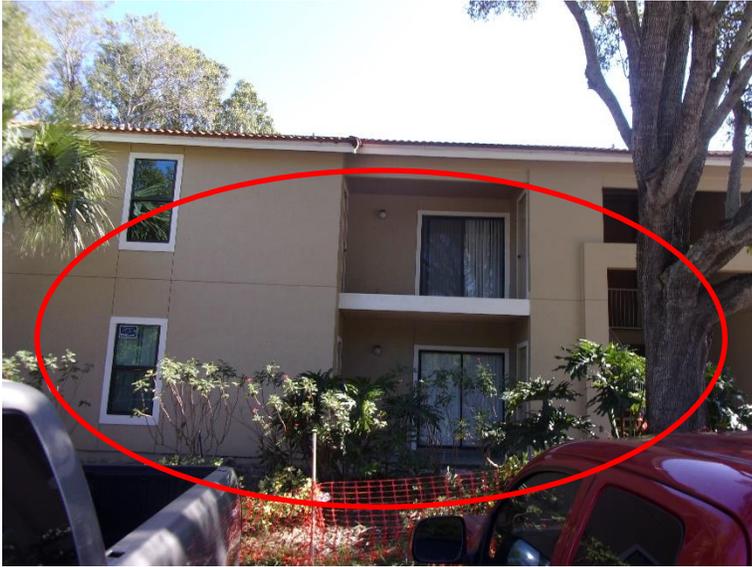
PHOTOGRAPH #1

**BUILDING 20
SECTION A**

Finish painting completed at new stucco
and balcony trim wood.

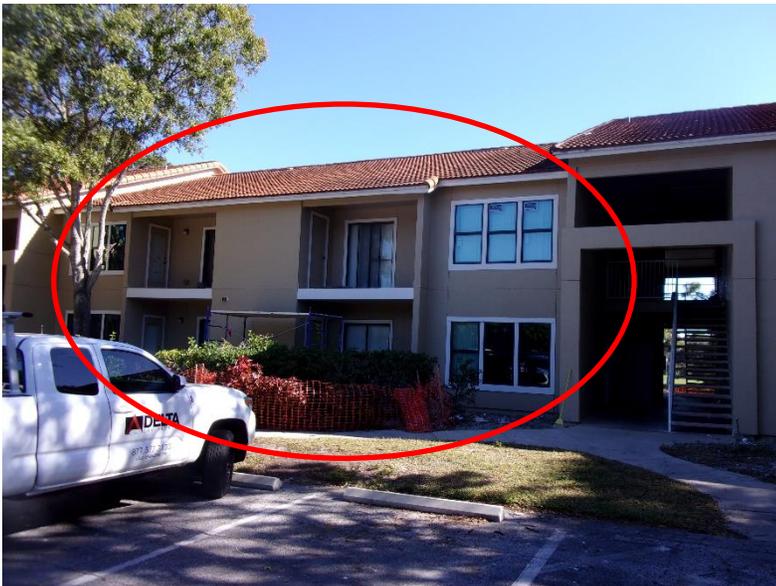
PHOTOGRAPH #2

**BUILDING 20
SECTION B**

Finish painting completed at new stucco
and balcony trim wood.

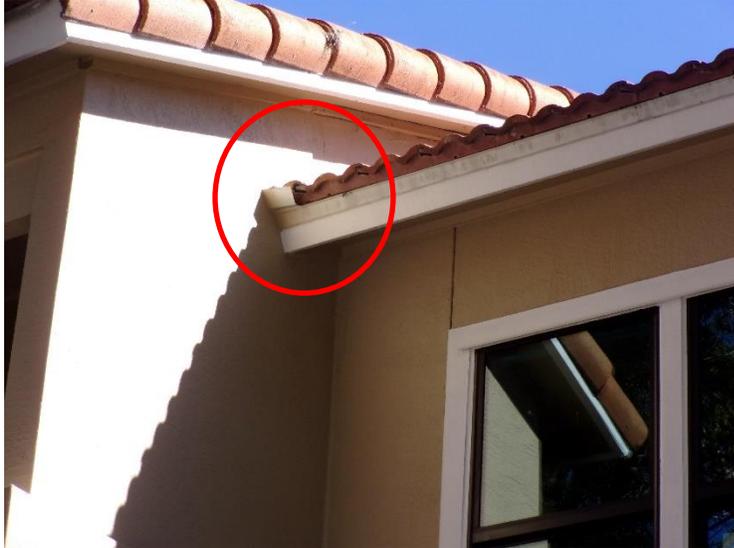
PHOTOGRAPH #3

**BUILDING 20
SECTION B**

Roofing Kick out flashing details performed and roof tiles re set.

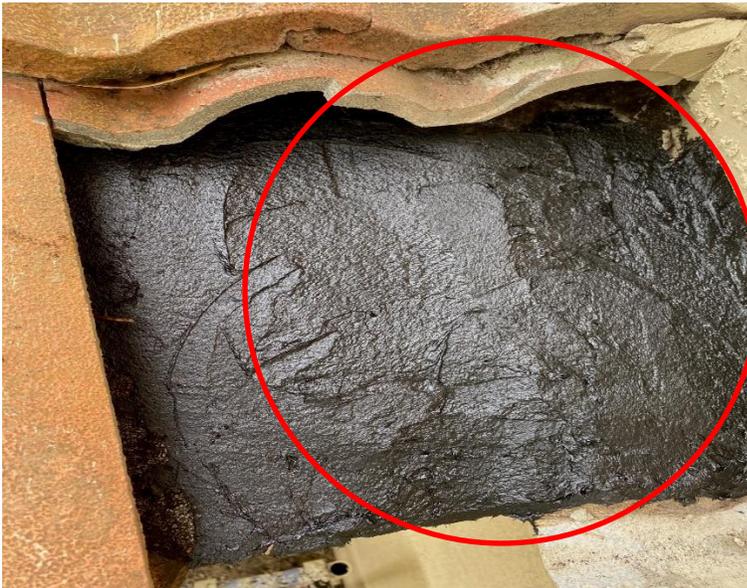
PHOTOGRAPH #4

**BUILDING 20
SECTION B**

New roofing mastic applied at kick out flashing details before roof tiles replaced.

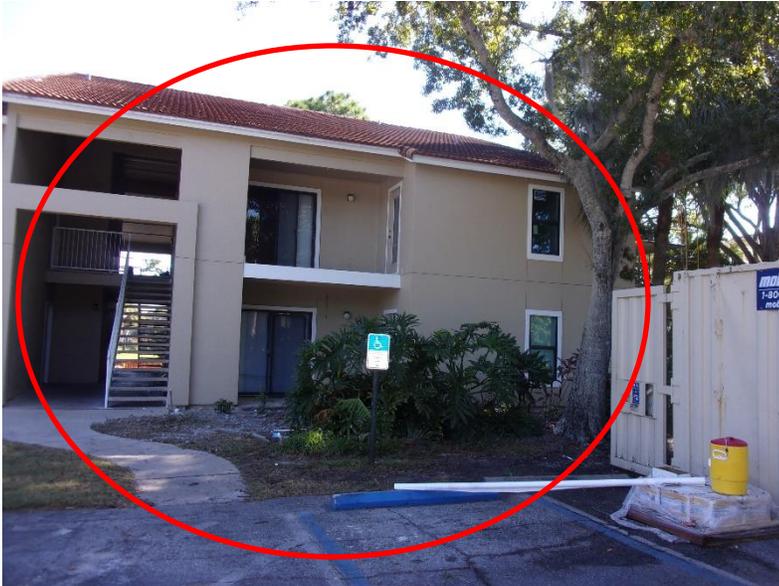
PHOTOGRAPH #5

**BUILDING 20
SECTION C**

Finish painting completed at new stucco and balcony trim wood.

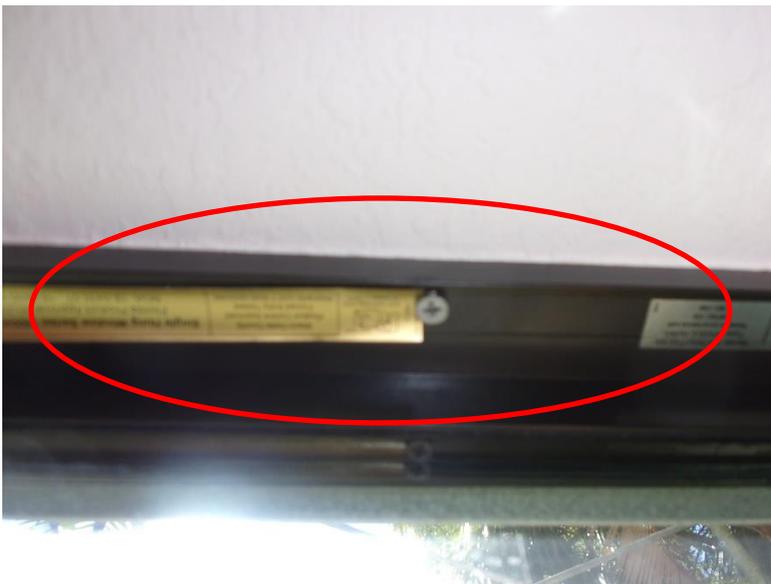
PHOTOGRAPH #6

**BUILDING 20
SECTION D - UNIT #2018**

Contractor has installed additional fastener at window head as corrective measure in compliance with PGT engineering letter.

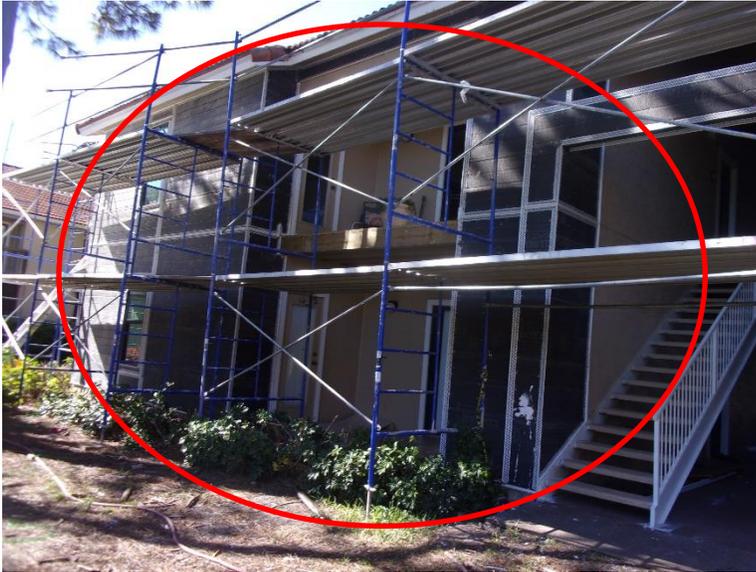
PHOTOGRAPH #7

**BUILDING 20
SECTION E**

Stucco accessories and metal lathing applications inspected and approved for stucco applications.

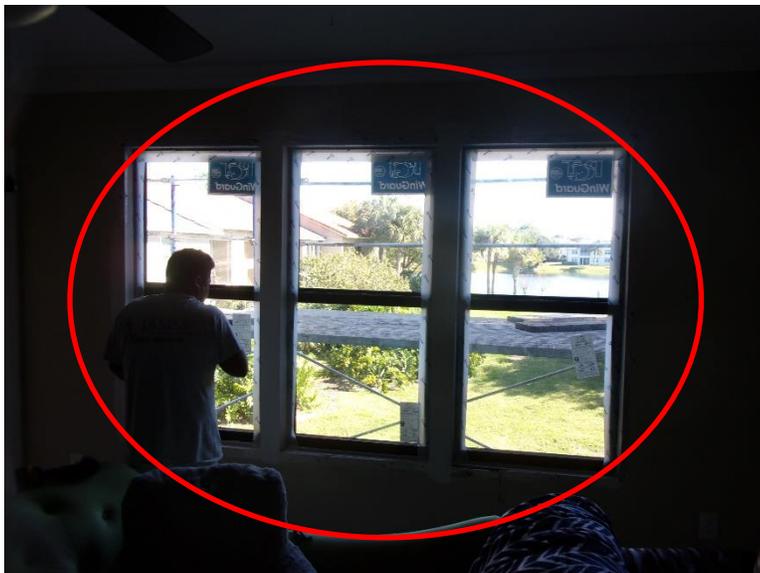
PHOTOGRAPH #8

**BUILDING 20
SECTION F- UNIT #2026**

Contractor applying finish drywall and new windowsills at new window areas.

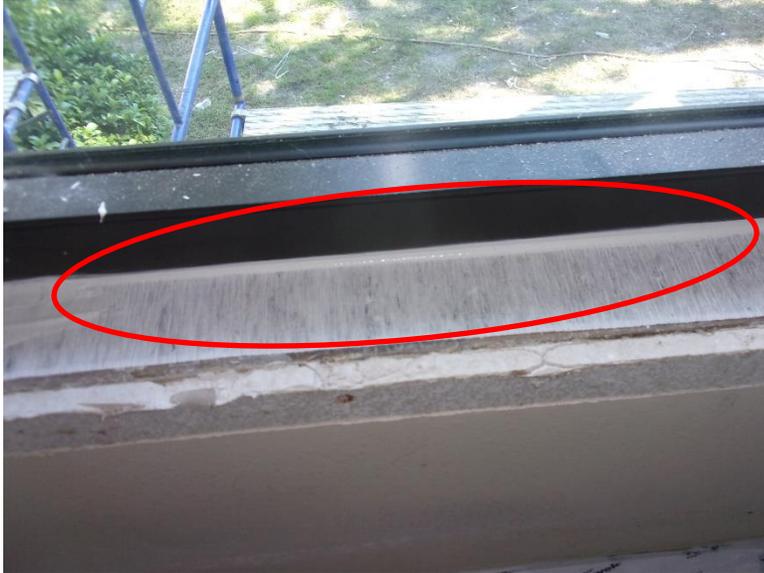
PHOTOGRAPH #9

**BUILDING 20
SECTION F- UNIT #2026**

New interior perimeter sealants in compliance with AAMA window installation guidelines.

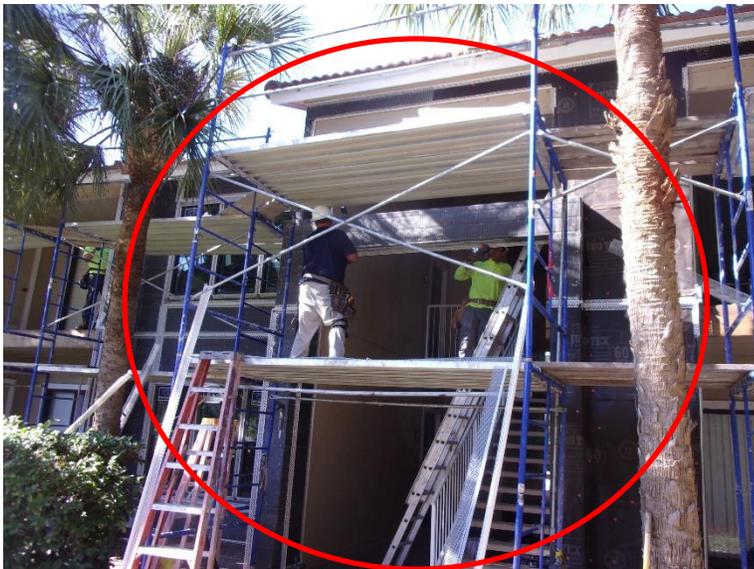
PHOTOGRAPH #10

**BUILDING 20
SECTION G**

Stucco accessories and metal lathing applications in progress.
