PHOTOGRAPHS

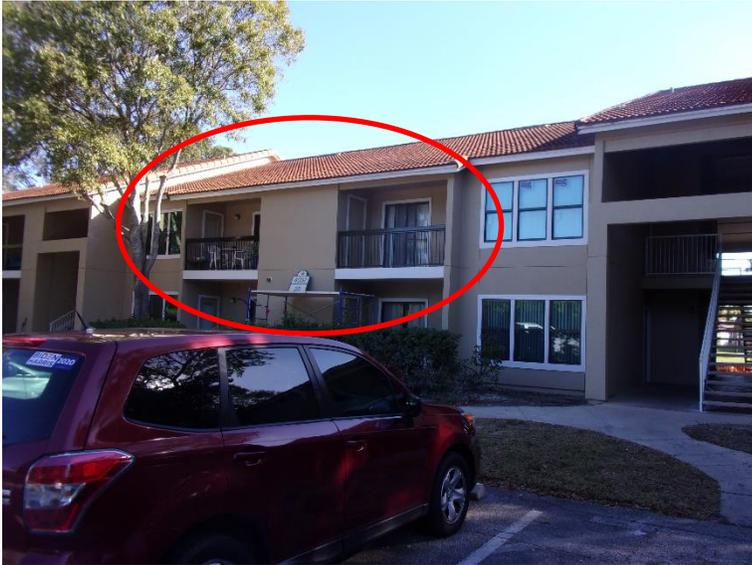
PHOTOGRAPH #1

BUILDING 20 SECTION B

Newly painted railings re installed at balconies with lag bolts as per drawings.

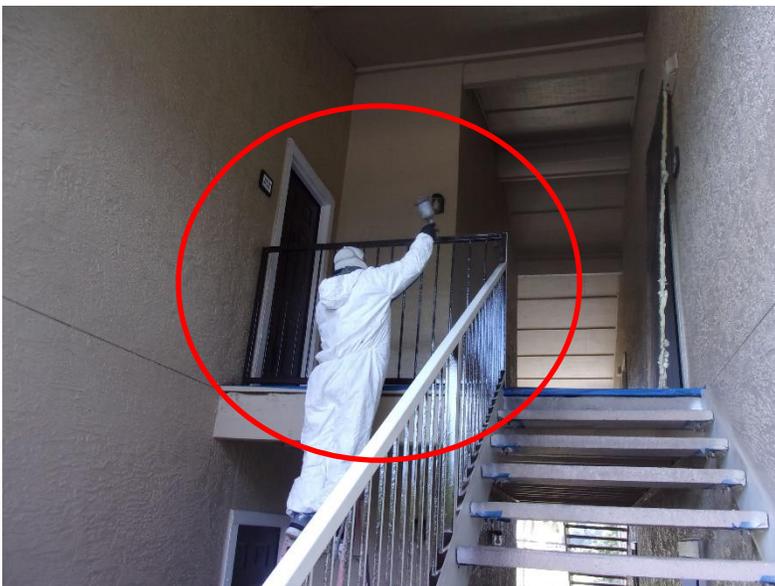
PHOTOGRAPH #2

BUILDING 20 SECTION C

Florida Paints, Hi-performance aliphatic Urethane Enamel spray applied at stairway railings.

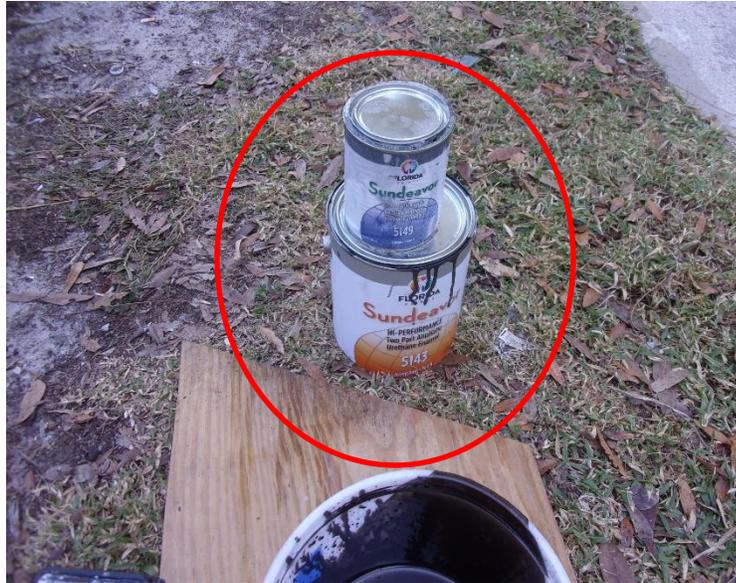
PHOTOGRAPH #3

**BUILDING 20
SECTION C**

Florida Paints, Hi-performance aliphatic Urethane Enamel spray applied at stairway railings.

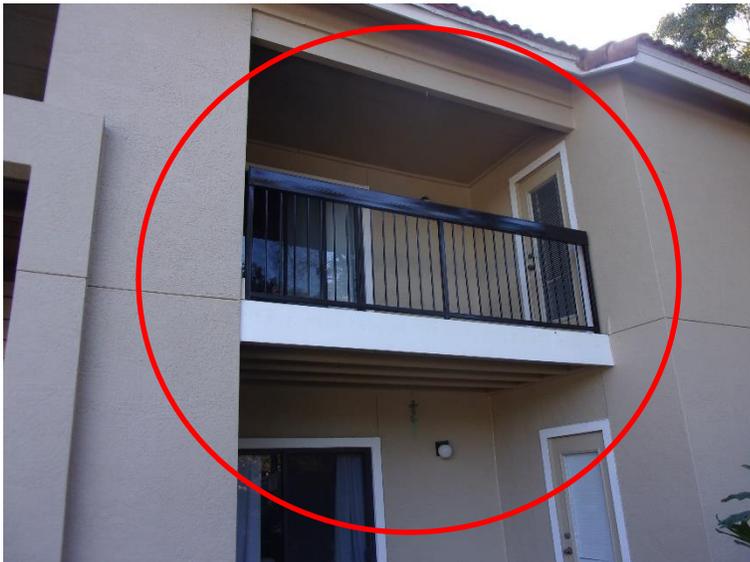
PHOTOGRAPH #4

**BUILDING 20
SECTION C**

Newly painted railings re installed at balconies with lag bolts as per drawings.

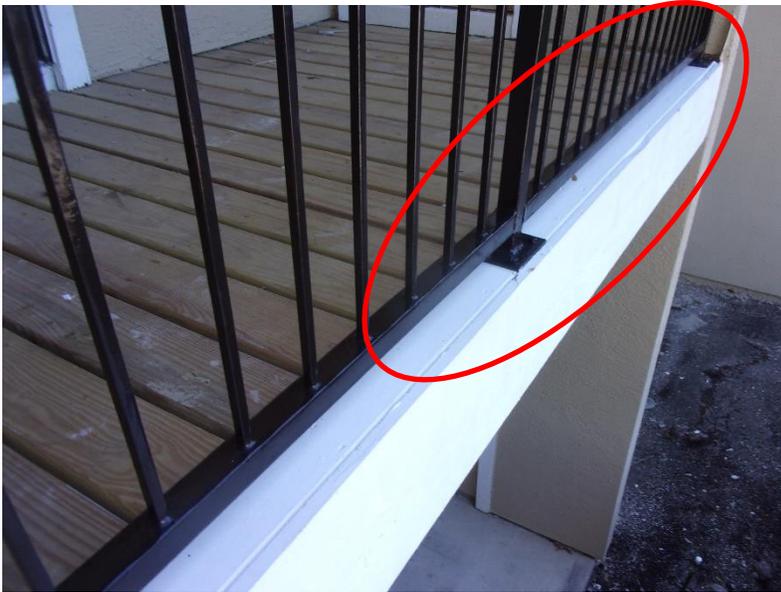
PHOTOGRAPH #5

**BUILDING 20
SECTION C**

Newly painted railings re installed at balconies with lag bolts as per drawings.

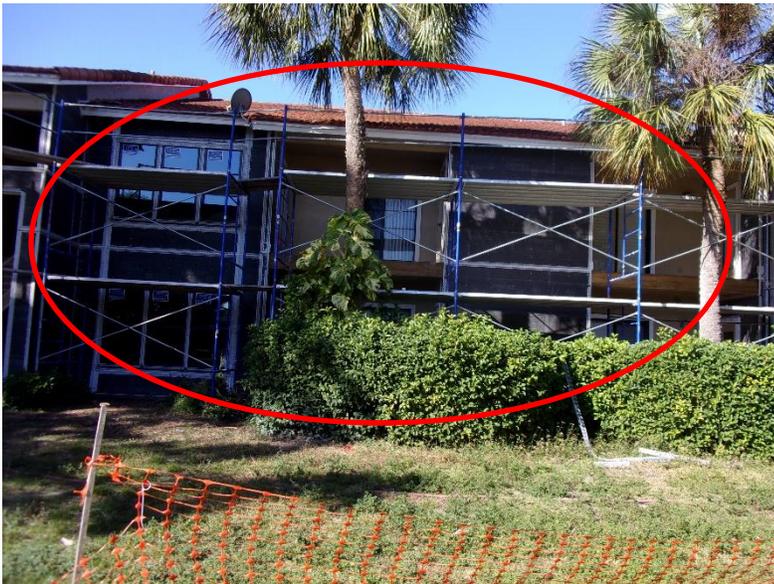
PHOTOGRAPH #6

**BUILDING 20
SECTION F**

Stucco accessories and metal lathing applications inspected and approved for stucco applications.

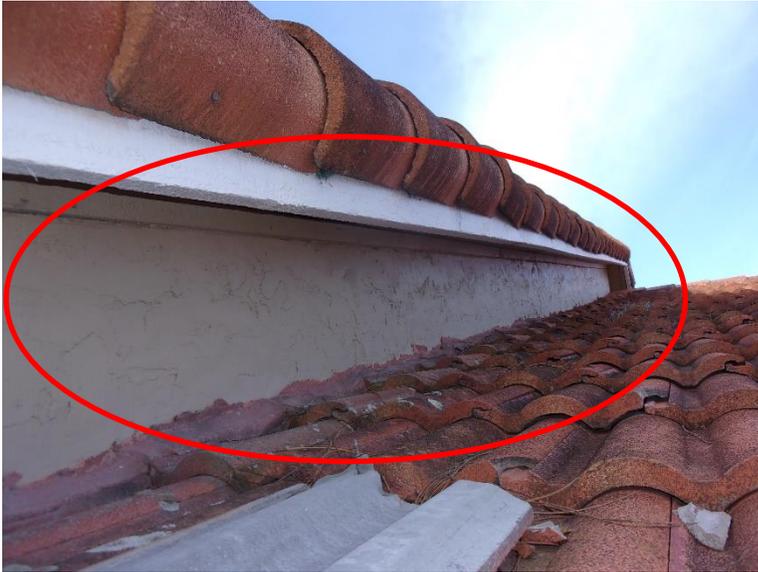
PHOTOGRAPH #7

**BUILDING 20
SECTION F**

Stucco and soffit areas above roof tiles have not been finish painted.

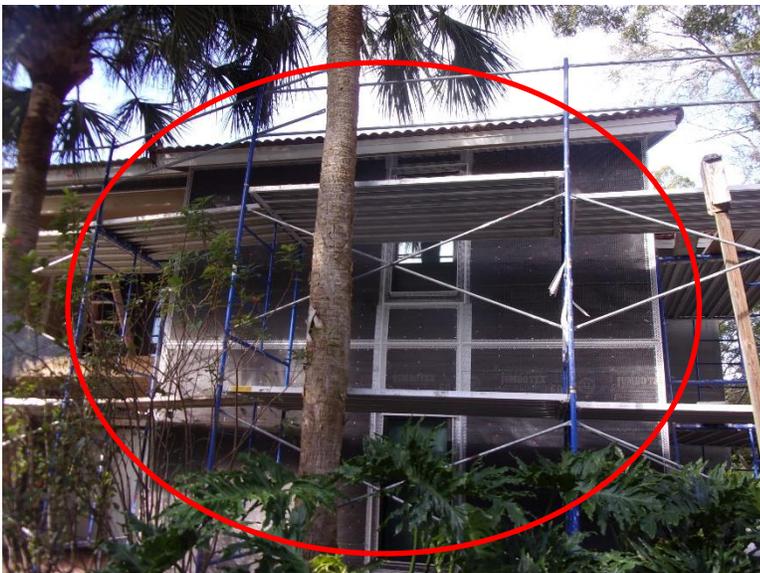
PHOTOGRAPH #8

**BUILDING 20
SECTION G**

Stucco accessories and metal lathing applications inspected and approved for stucco applications.
