PHOTOGRAPHS

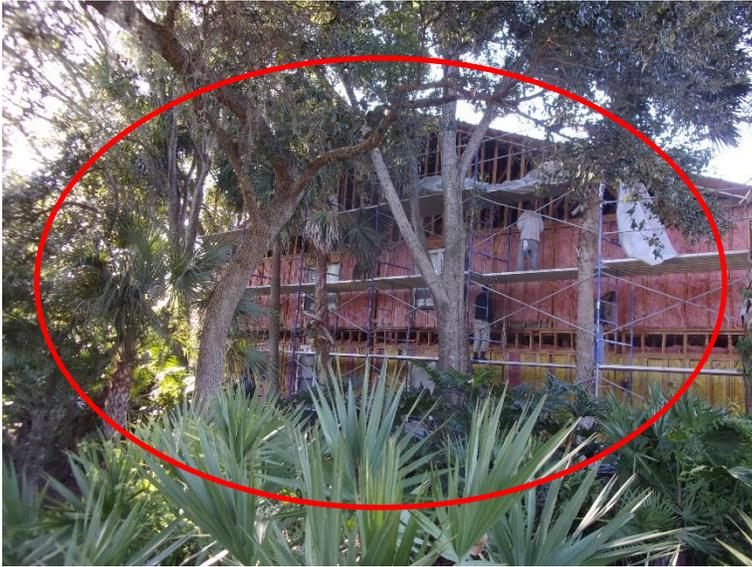
PHOTOGRAPH #1

BUILDING 1 SECTION H

Existing stucco and Thermo-ply removed.

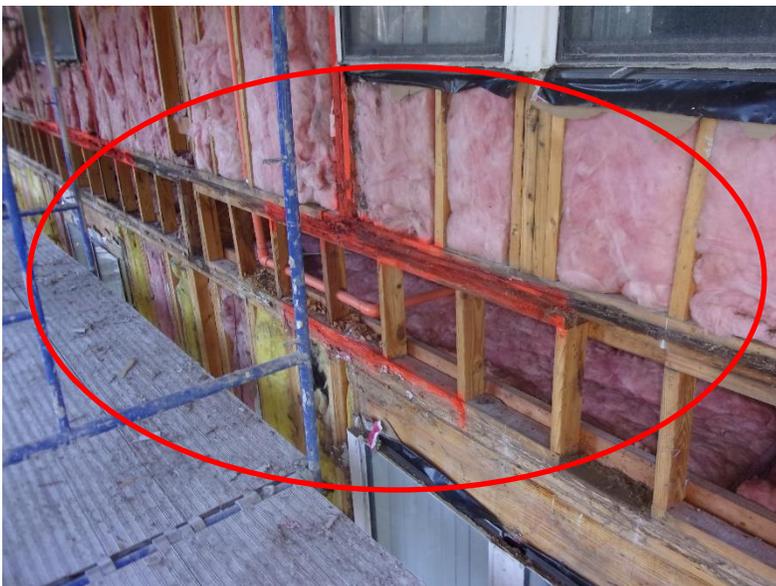
PHOTOGRAPH #2

BUILDING 1 SECTION H

Damaged framing marked for repairs at wall studs, plates, and window framing.

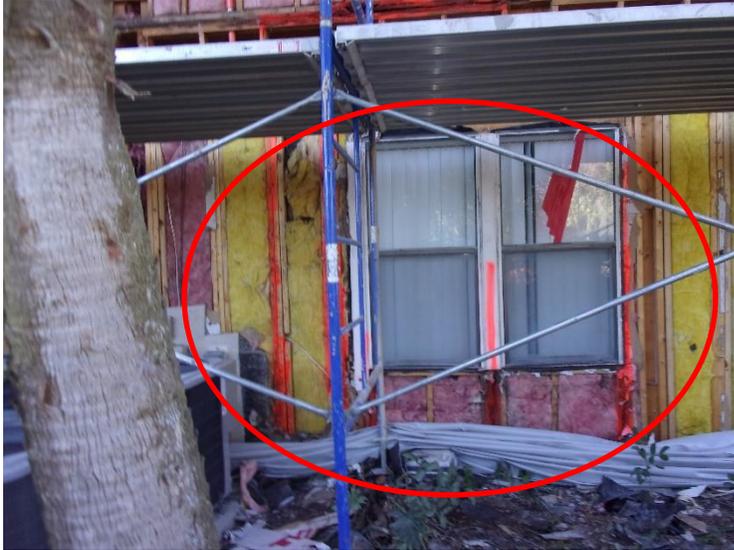
PHOTOGRAPH #3

**BUILDING 1
SECTION H**

Damaged framing marked for repairs at wall studs, plates, and window framing.

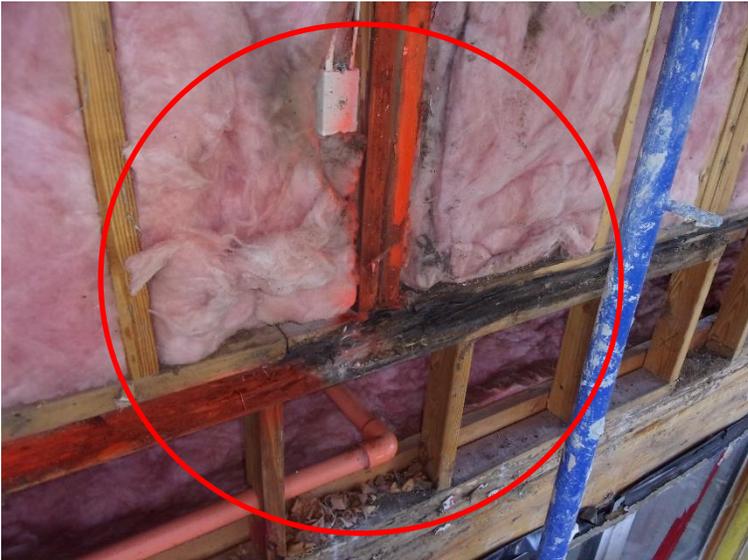
PHOTOGRAPH #4

**BUILDING 1
SECTION H**

Damaged framing marked for repairs at wall studs, plates, and window framing.

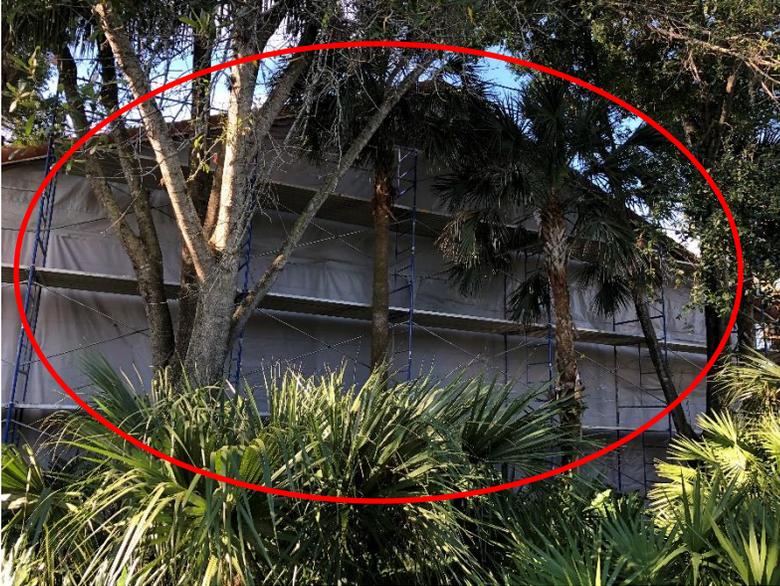
PHOTOGRAPH #5

**BUILDING 1
SECTION H**

Open wall protected with heavy plastic sheathing.

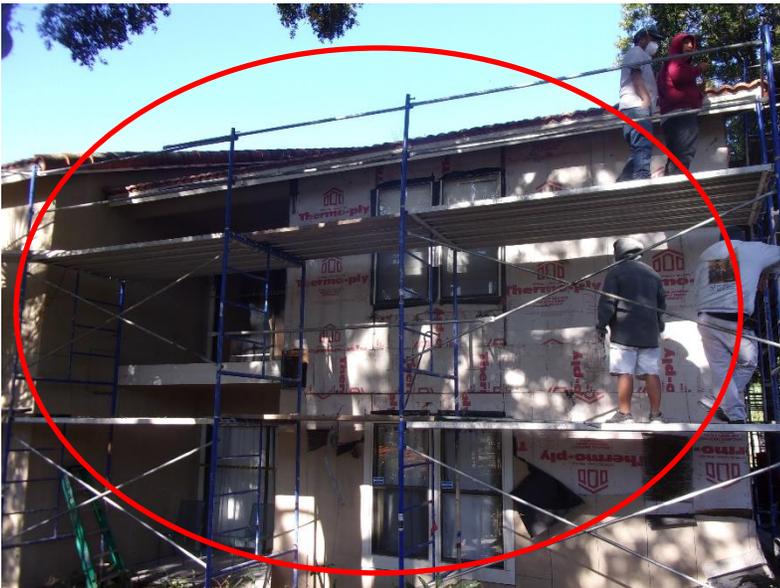
PHOTOGRAPH #6

**BUILDING 1
SECTION G**

Removal of stucco and Thermo-ply in progress.

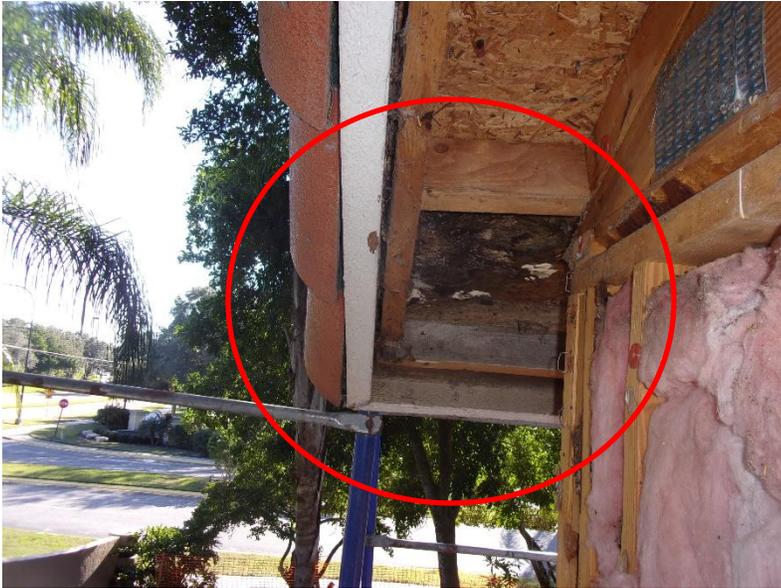
PHOTOGRAPH #7

**BUILDING 1
SECTION G**

Roof sheathing damage exposed. Active leaks observed at several locations.

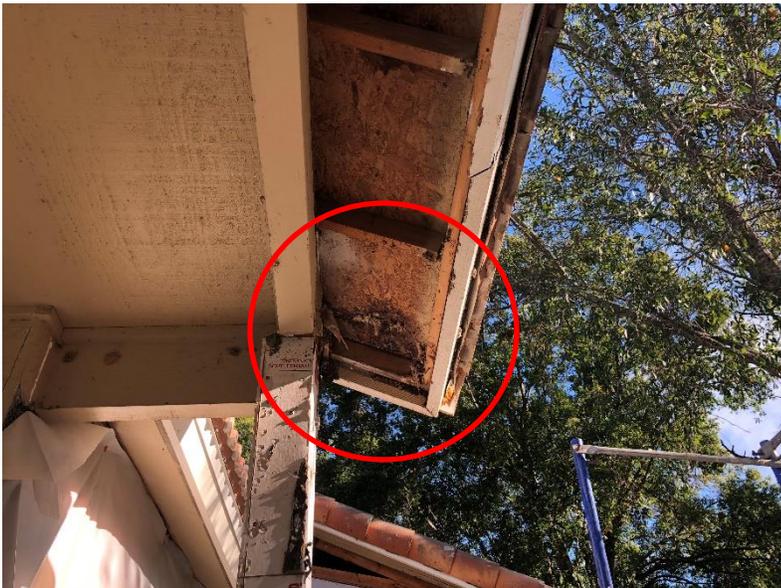
PHOTOGRAPH #8

**BUILDING 1
SECTION G**

Roof sheathing damage exposed. Active leaks observed at several locations.

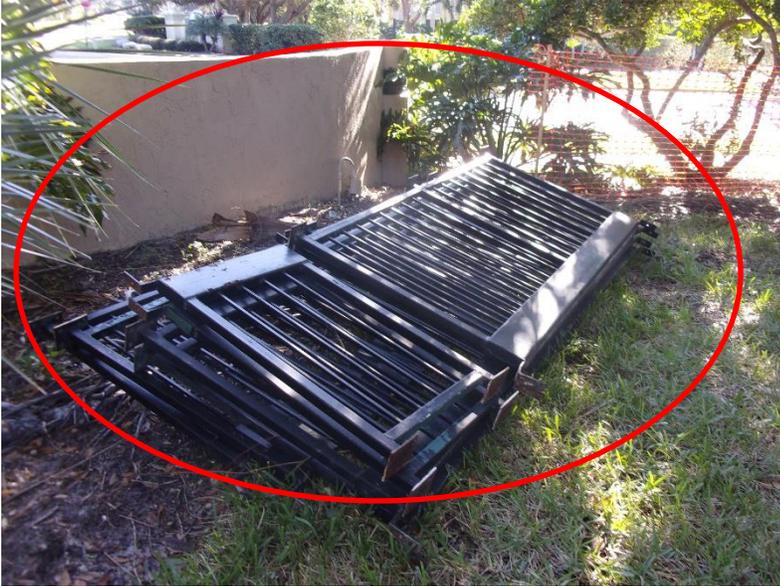
PHOTOGRAPH #9

**BUILDING 1
SECTION G**

Balcony railings removed for re-painting prior to reinstallation.

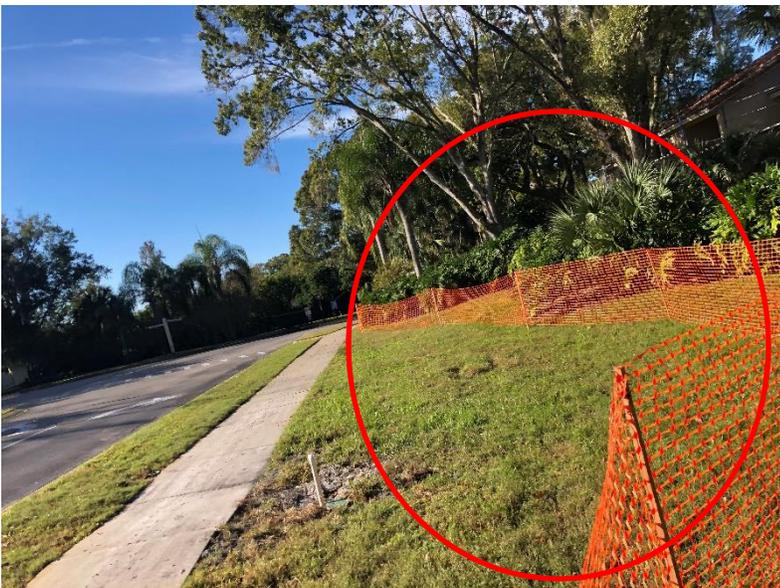
PHOTOGRAPH #10

**BUILDING 1
SECTION F**

Construction fencing provided at site perimeters for pedestrian safety.

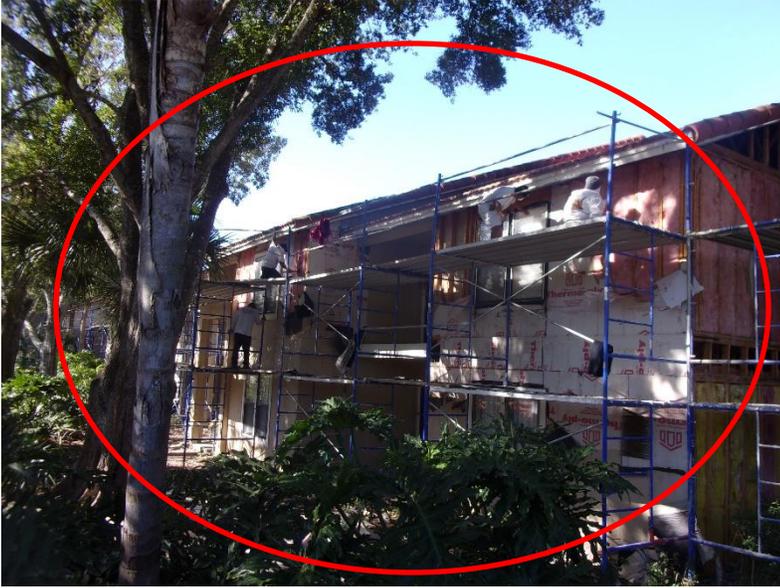
PHOTOGRAPH #11

**BUILDING 1
SECTION F**

Removal of stucco and Thermo-ply in progress.
