## PHOTOGRAPHS

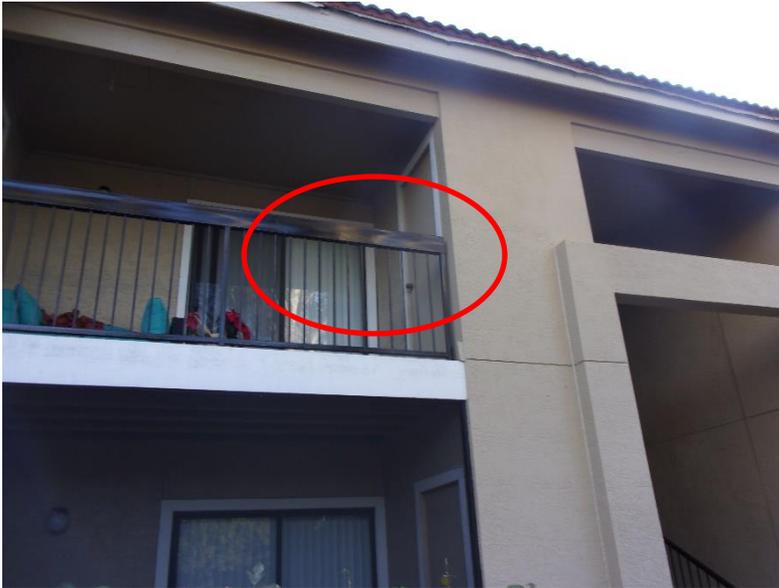
PHOTOGRAPH #1

### BUILDING 20 SECTION A

Reinstalled rails require welded angle re attached and fastened to wall.

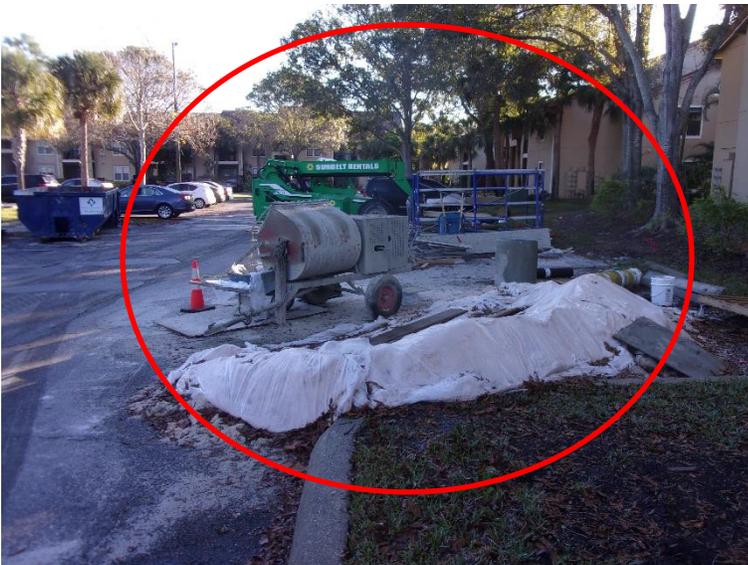
PHOTOGRAPH #2

### BUILDING 20 SECTION A

Stucco contractor's removal of equipment and cleanup work required.

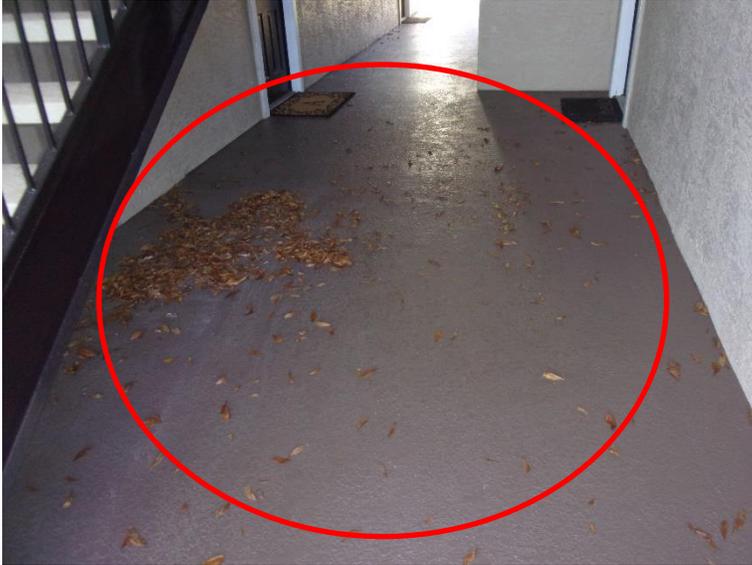
**PHOTOGRAPH #3**

**BUILDING 20  
SECTION A**

Breezeway floors finish painted.

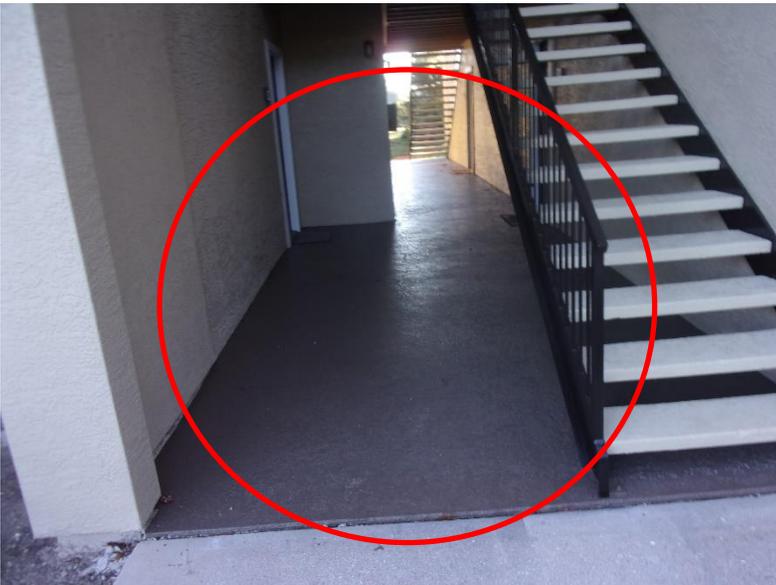
**PHOTOGRAPH #4**

**BUILDING 20  
SECTION C**

Breezeway floors finish painted.

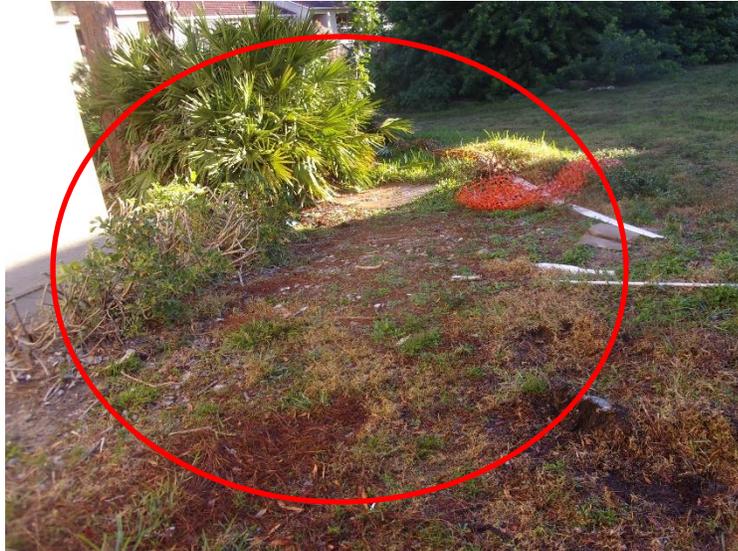
**PHOTOGRAPH #5**

**BUILDING 20  
SECTION D**

Clean up of debris and construction fencing required.

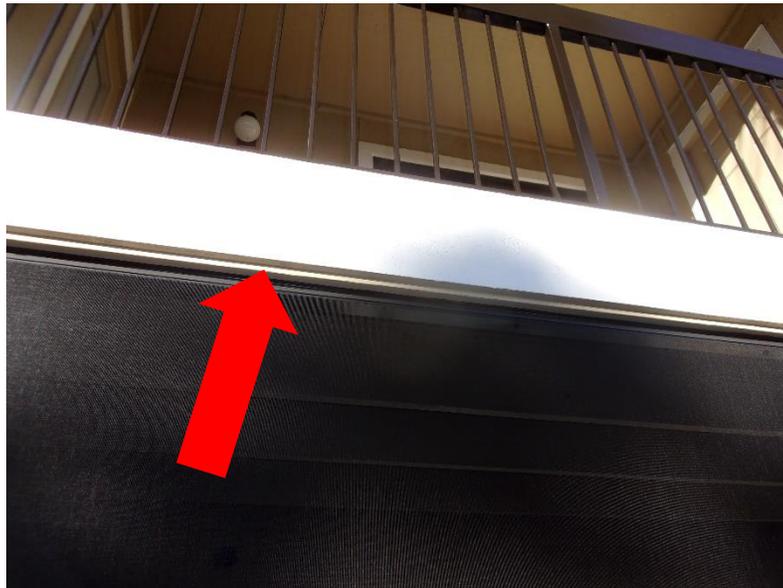
**PHOTOGRAPH #6**

**BUILDING 20  
SECTION F**

Cedar trim over built-up beam repair not covering properly at bottom edge.

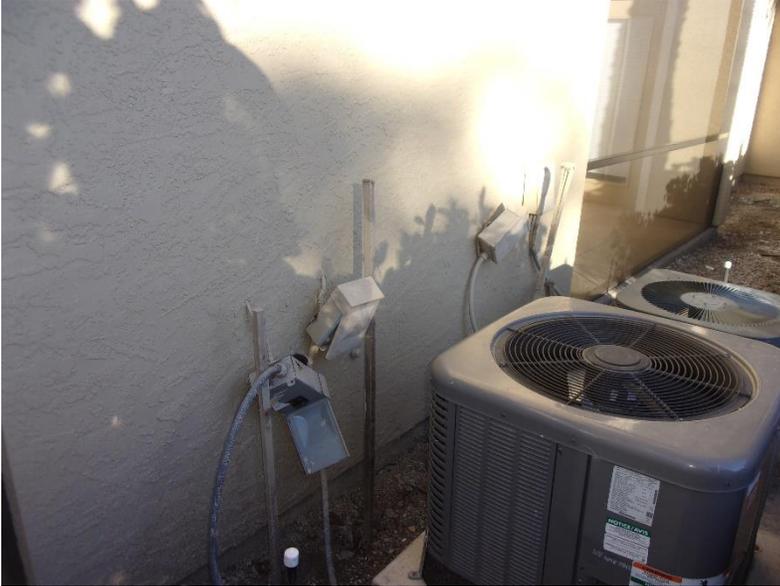
**PHOTOGRAPH #7**

**BUILDING 20  
SECTION F**

HVAC electrical boxes not re attached and sealed to stucco.

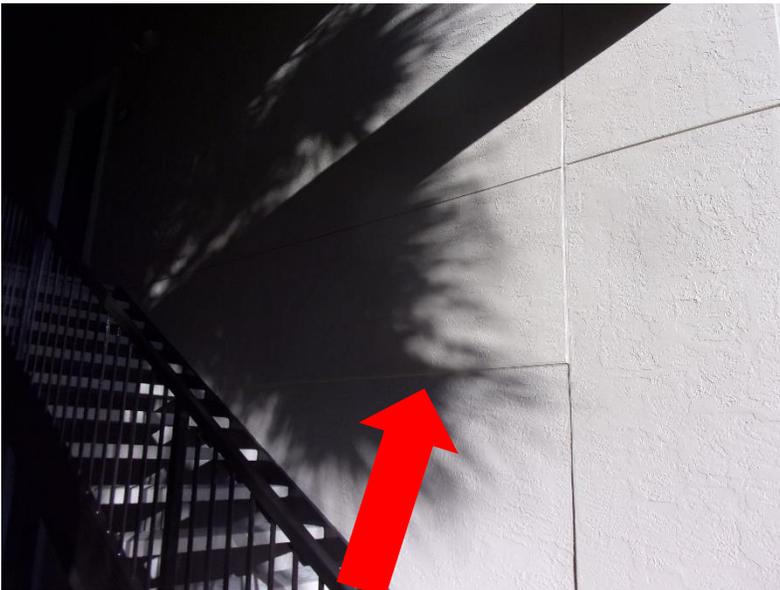
**PHOTOGRAPH #8**

**BUILDING 20  
SECTION G**

Stucco repairs do not blend into existing stucco at breezeway walls as required.
