PHOTOGRAPHS

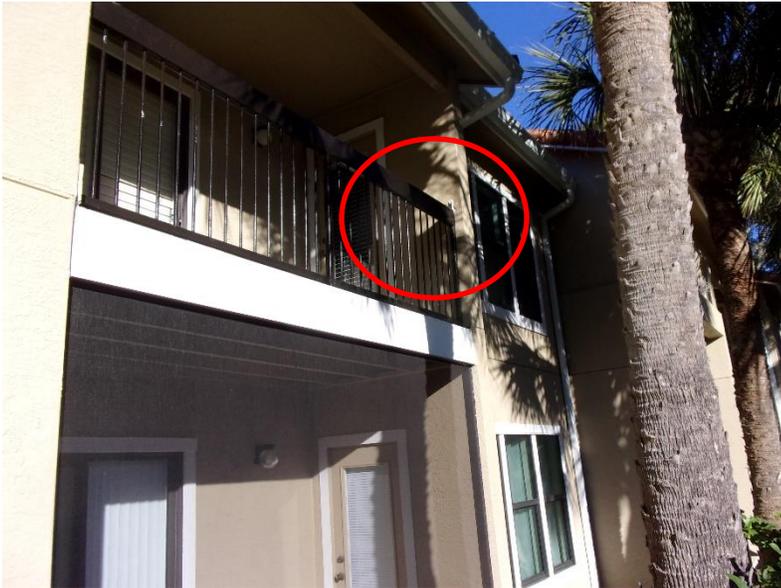
PHOTOGRAPH #1

BUILDING 20 SECTION A

Balcony rails re-attached to framing at top rails.

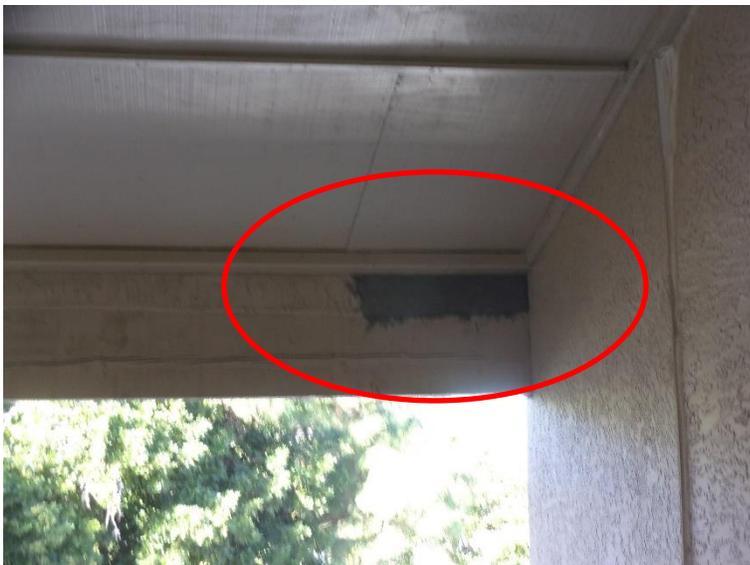
PHOTOGRAPH #2

BUILDING 20 SECTION C

Stucco patched above cedar beam in breezeway.

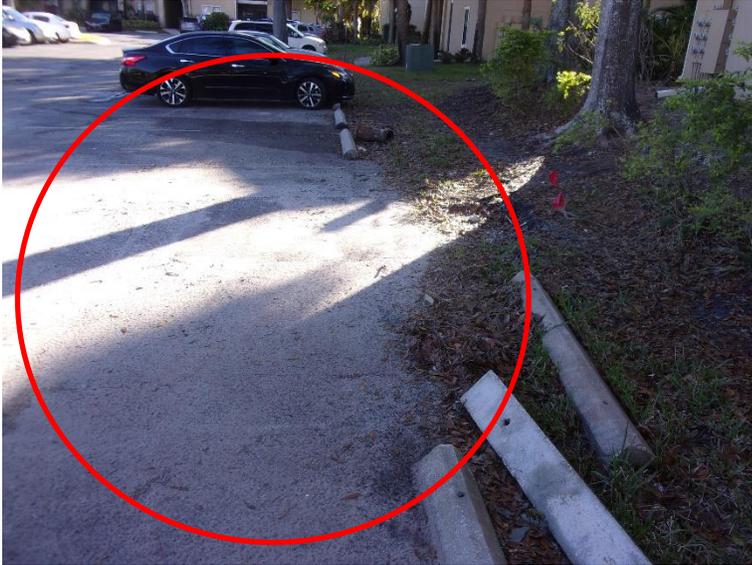
PHOTOGRAPH #3

**BUILDING 20
SECTION H**

Stucco contractor has removed materials and equipment from parking area. Parking stops removed by others.
