PHOTOGRAPHS

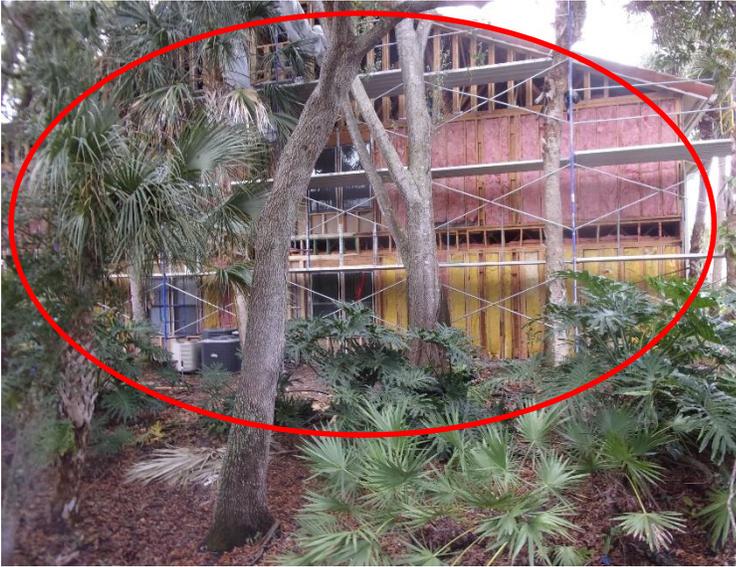
PHOTOGRAPH #1

BUILDING 1 SECTION H

Gable end wall bracing, strapping, and framing connectors repairs in progress.

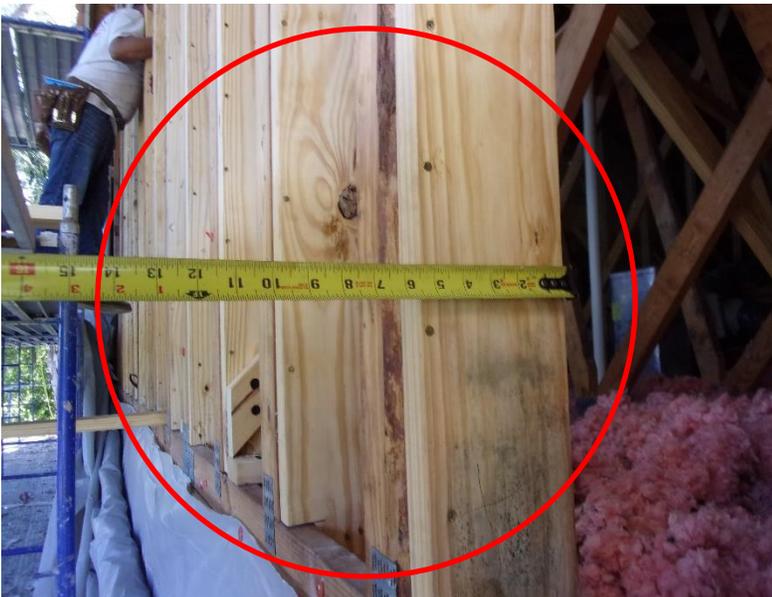
PHOTOGRAPH #2

BUILDING 1 SECTION H

2"X6" SYP reinforcement framing studs installed at gable end.

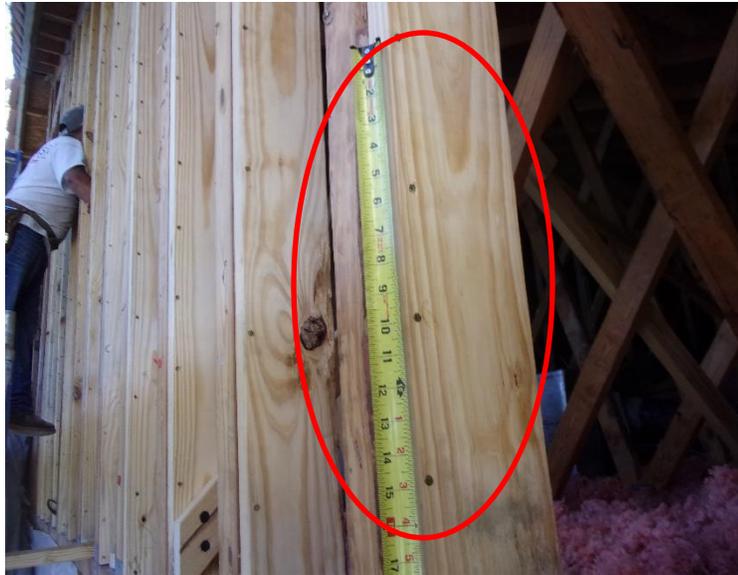
PHOTOGRAPH #3

**BUILDING 1
SECTION H**

Nailing assessed for compliance with drawings and specifications is measured at 6" O.C..

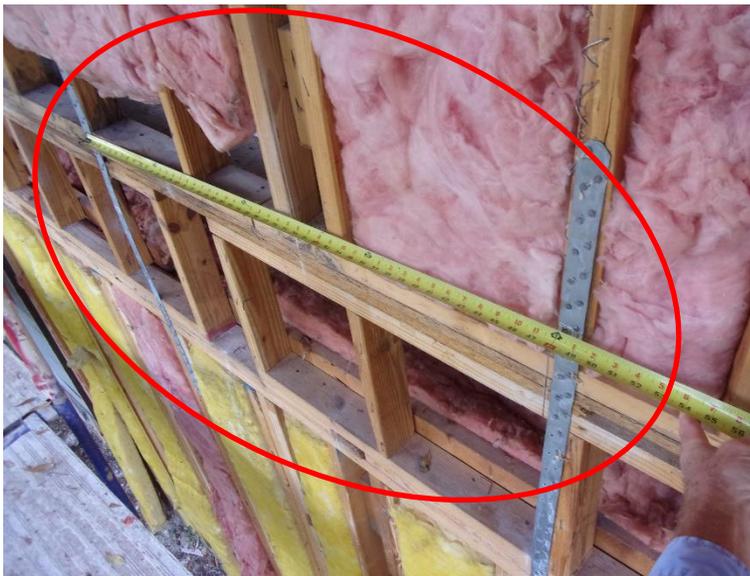
PHOTOGRAPH #4

**BUILDING 1
SECTION H**

Simpson Strong-Tie MST49 straps attached to studs at 48" O.C. as per drawing and specifications.

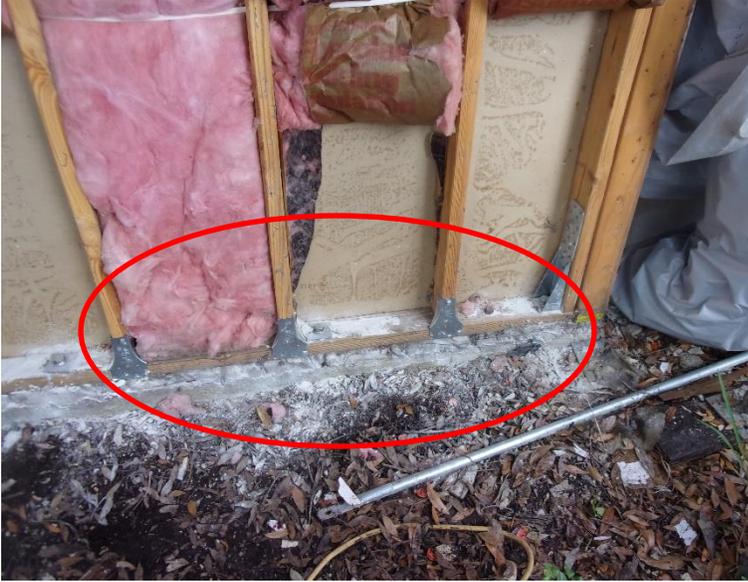
PHOTOGRAPH #5

**BUILDING 1
SECTION G**

Simpson Strong-Tie SP1 connector attached to studs and bottom plate @16" O.C. as per drawing and specifications.

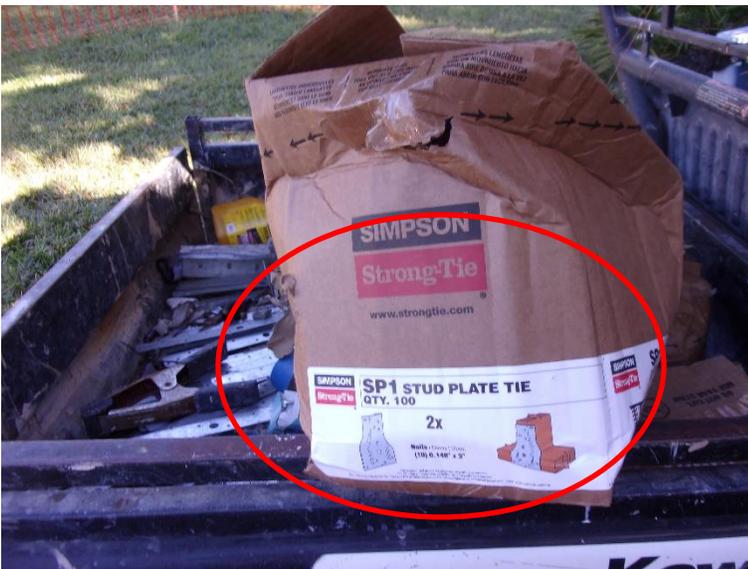
PHOTOGRAPH #6

**BUILDING 1
SECTION G**

Simpson Strong-Tie SP1 connector attached to studs and bottom plate @16" O.C. as per drawing and specifications.

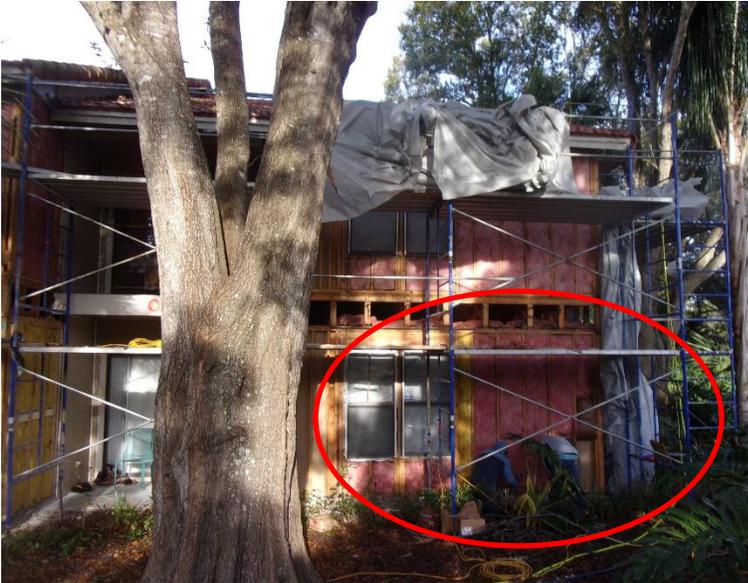
PHOTOGRAPH #7

**BUILDING 1
SECTION G**

Simpson Strong-Tie SP1 connectors and Titen HD anchors installation in progress.

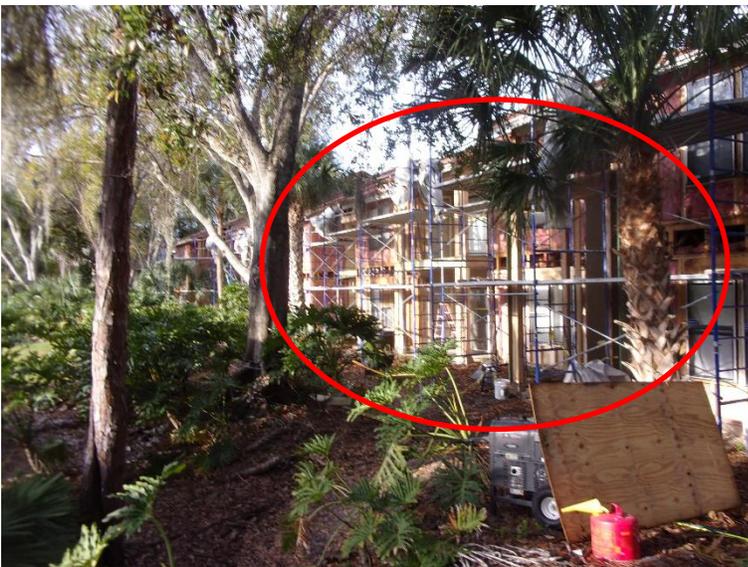
PHOTOGRAPH #8

**BUILDING 1
SECTION F**

Wood framing repairs in progress at balconies, breezeways, and exterior walls.

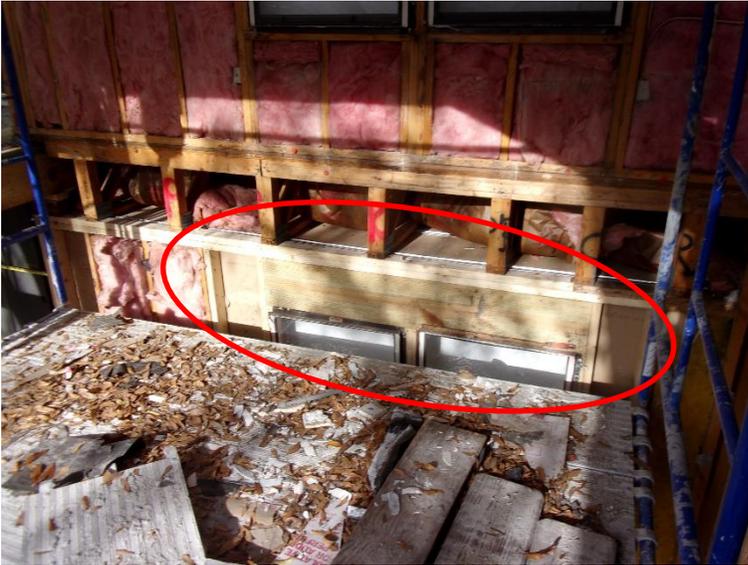
PHOTOGRAPH #9

**BUILDING 1
SECTION F**

Double window header and top plate replaced.

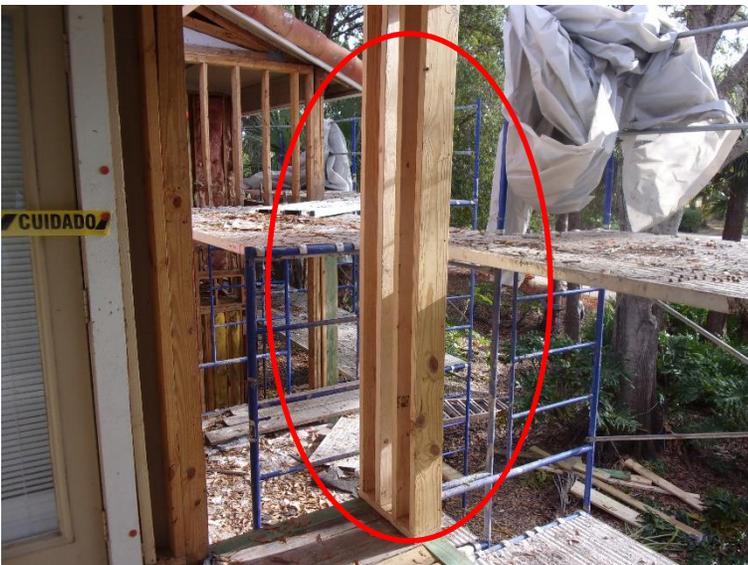
PHOTOGRAPH #10

**BUILDING 1
SECTION F**

Balcony column replaced as part of full balcony repairs.

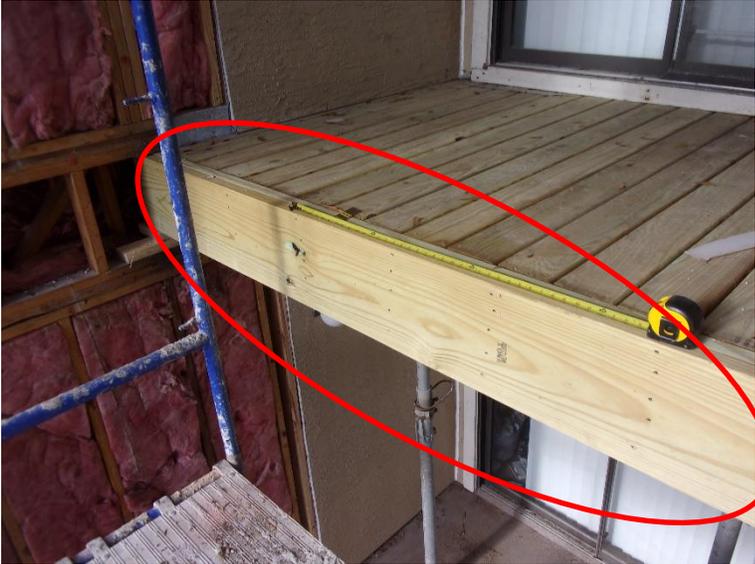
PHOTOGRAPH #11

**BUILDING 1
SECTION F**

Built up beam replacement performed as part of full balcony remove and repair.

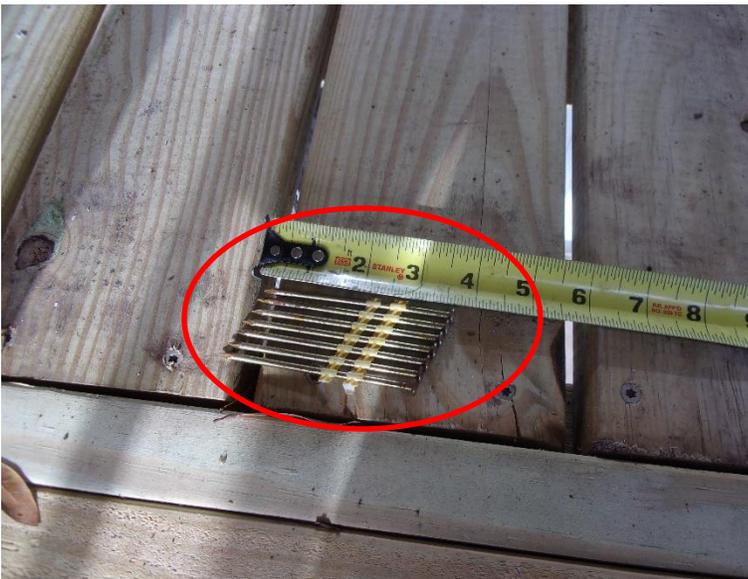
PHOTOGRAPH #12

**BUILDING 1
SECTION F**

3 1/2" 16d common nails used for framing repairs.

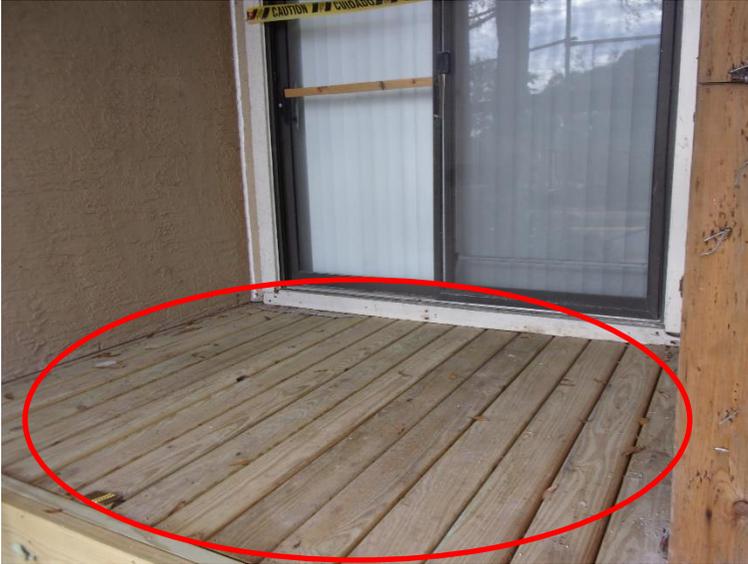
PHOTOGRAPH #13

**BUILDING 1
SECTION F**

Full 2"x6" deck boards removed and replaced.

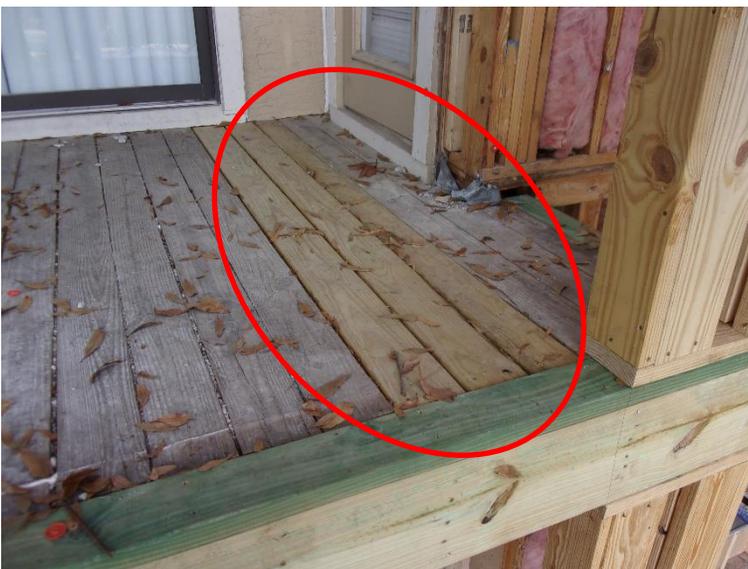
PHOTOGRAPH #14

**BUILDING 1
SECTION F**

Partial selected 2"x6" deck boards removed and replaced.

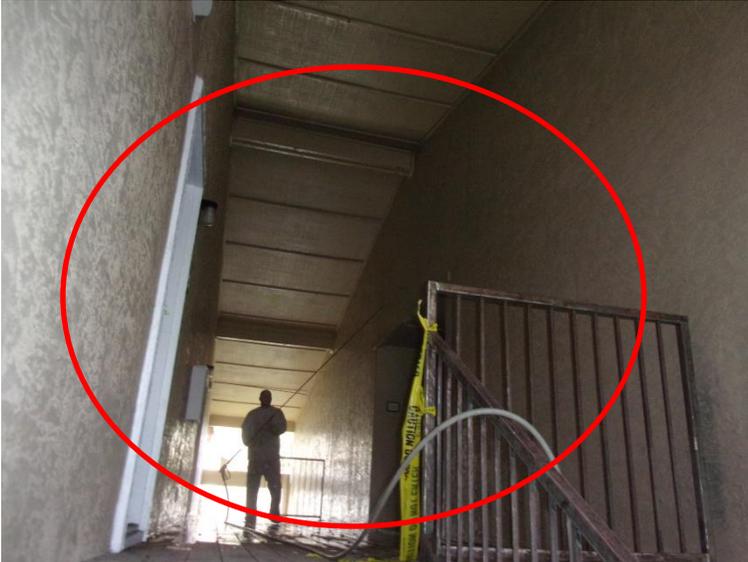
PHOTOGRAPH #15

**BUILDING 1
SECTION E-STAIRWAY**

Existing stucco, pressure cleaned in preparation for primer and finish painting.

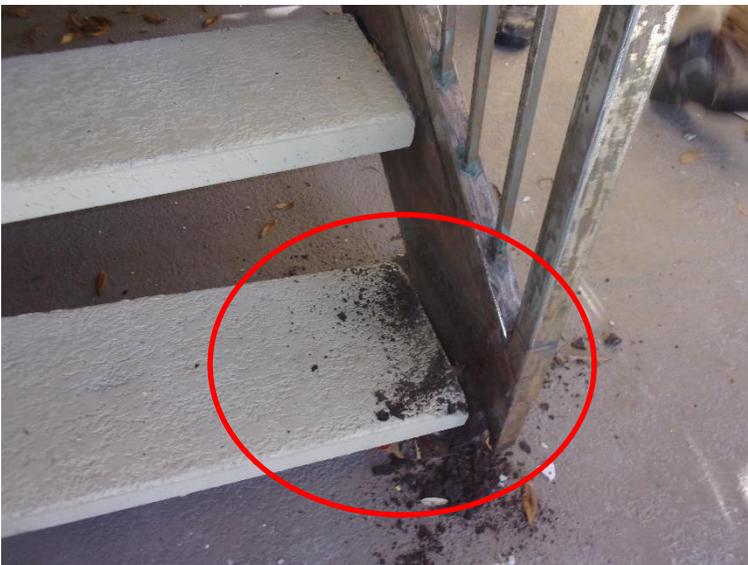
PHOTOGRAPH #16

**BUILDING 1
SECTION E-STAIRWAY**

Bottom step steel angle has deteriorated and failed.

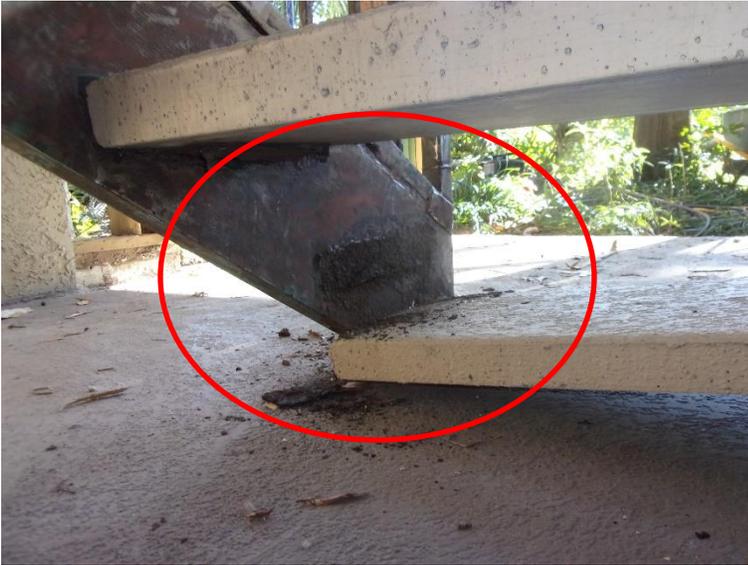
PHOTOGRAPH #117

**BUILDING 1
SECTION E-STAIRWAY**

Bottom step steel angle has deteriorated and failed.

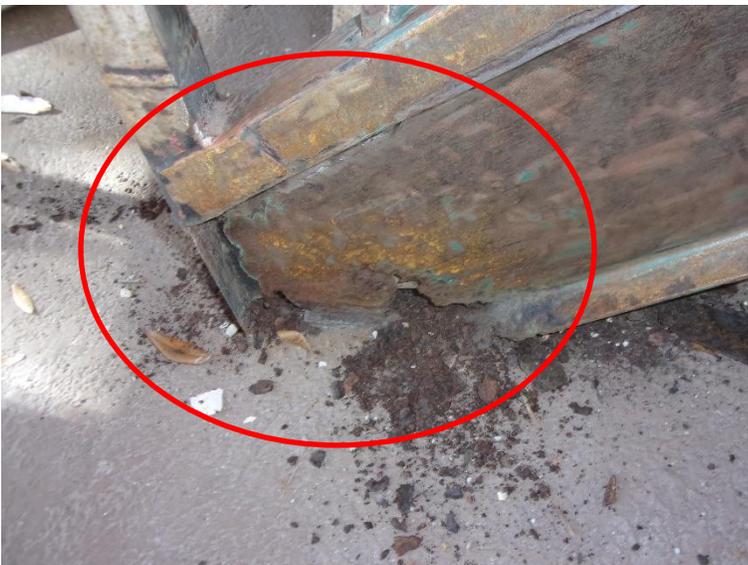
PHOTOGRAPH #18

**BUILDING 1
SECTION E-STAIRWAY**

Stairway steel beam stringer has significant loss at base and fastening connection to concrete decking.

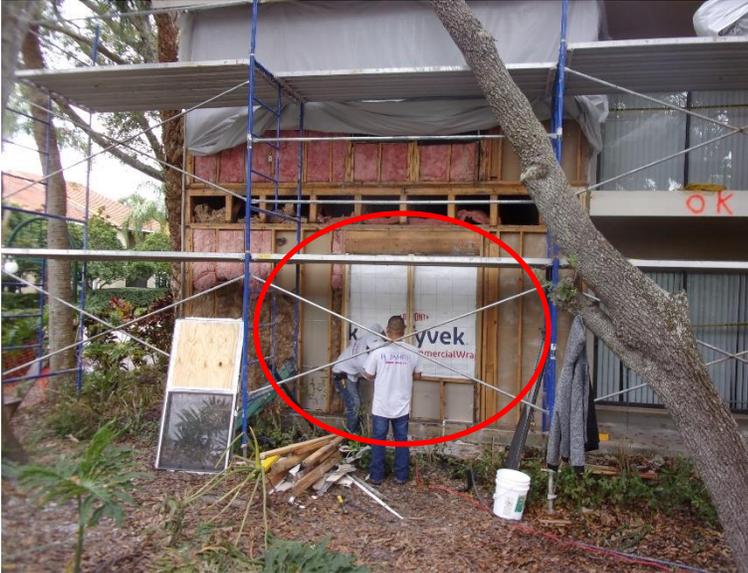
PHOTOGRAPH #19

**BUILDING 1
SECTION E**

Window framing king stud replacement due to existing framing not plum and straight.

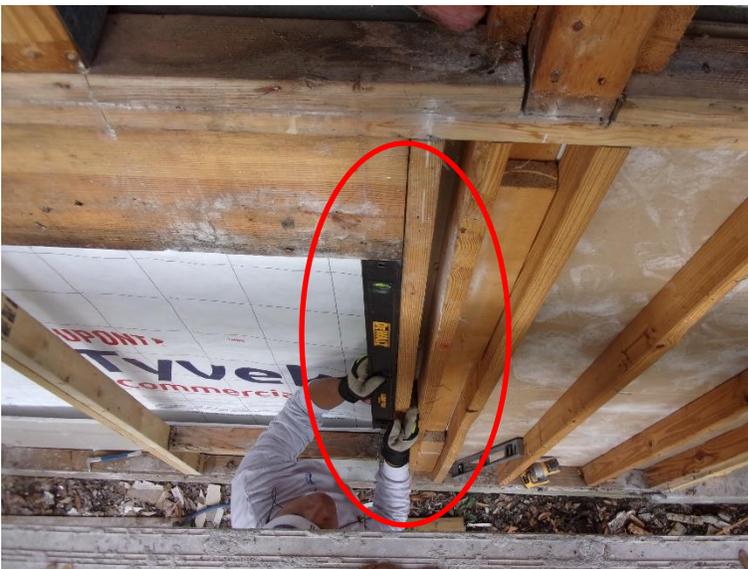
PHOTOGRAPH #20

**BUILDING 1
SECTION E**

Window framing king stud replacement due to existing framing not plum and straight.
