## PHOTOGRAPHS

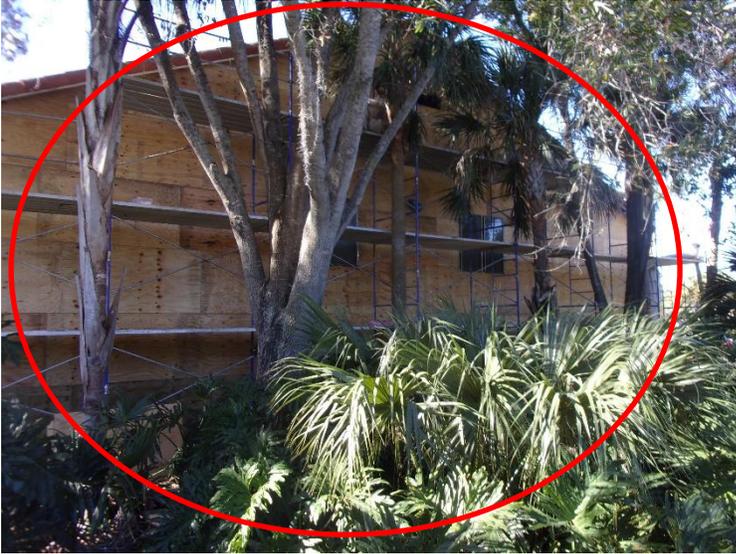
PHOTOGRAPH #1

### BUILDING 1 SECTION H

Insulation and 15/32" plywood sheathing installed.

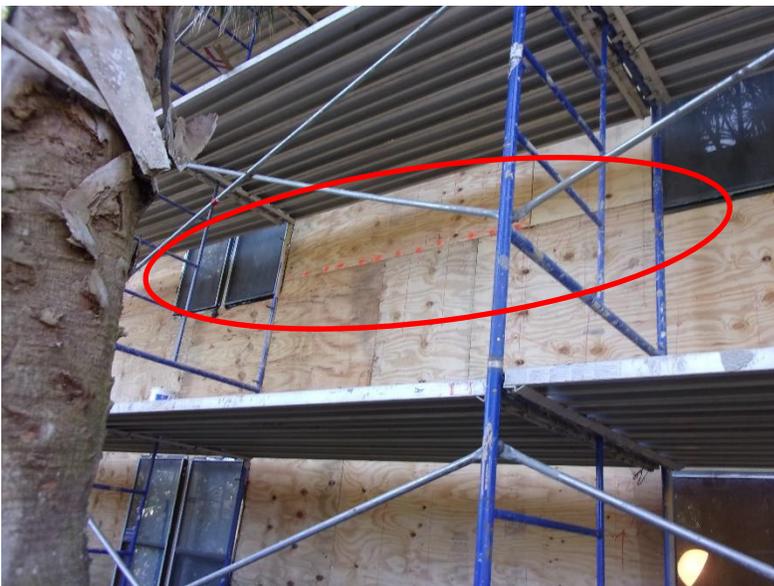
PHOTOGRAPH #2

### BUILDING 1 SECTION H

Contractor installed missing fasteners at plywood sheathing as marked.

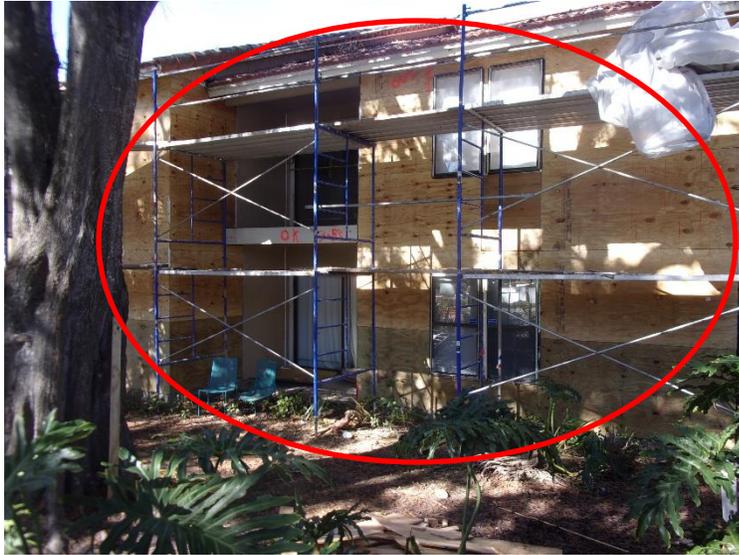
**PHOTOGRAPH #3**

**BUILDING 1  
SECTION G**

Insulation and 15/32" plywood sheathing installed.

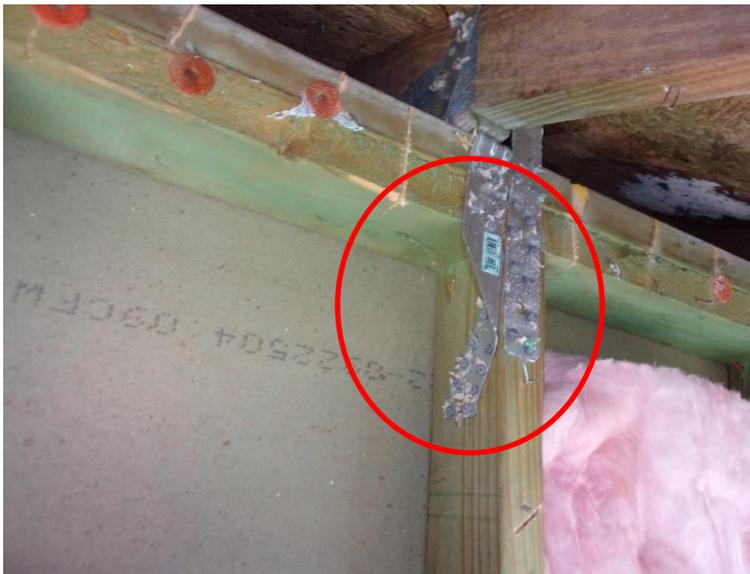
**PHOTOGRAPH #4**

**BUILDING 1  
SECTION G**

Contractor corrected missing nails at Simpson Strong-Tie TSP connectors.

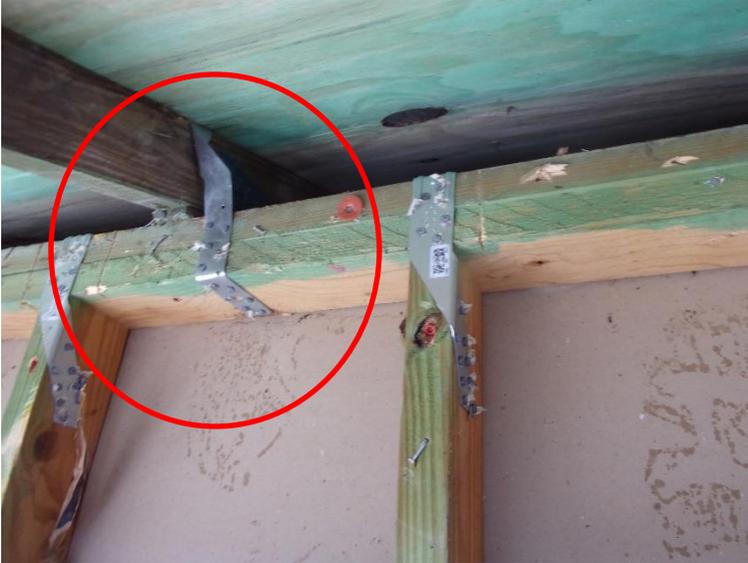
**PHOTOGRAPH #5**

**BUILDING 1  
SECTION G**

Contractor corrected incomplete attachment of Simpson Strong-Tie straps at top plate to trusses locations.

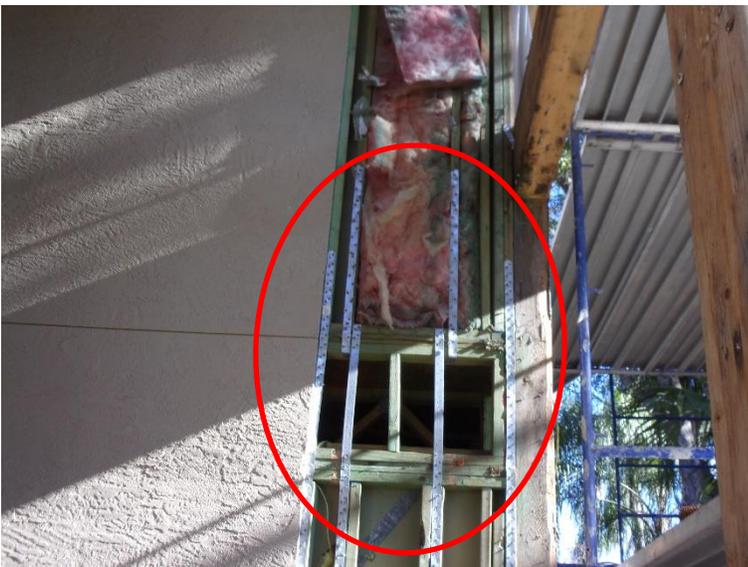
**PHOTOGRAPH #6**

**BUILDING 1  
SECTION G**

Contractor corrected Improper attachment of Simpson Strong-Tie straps at floor truss locations.

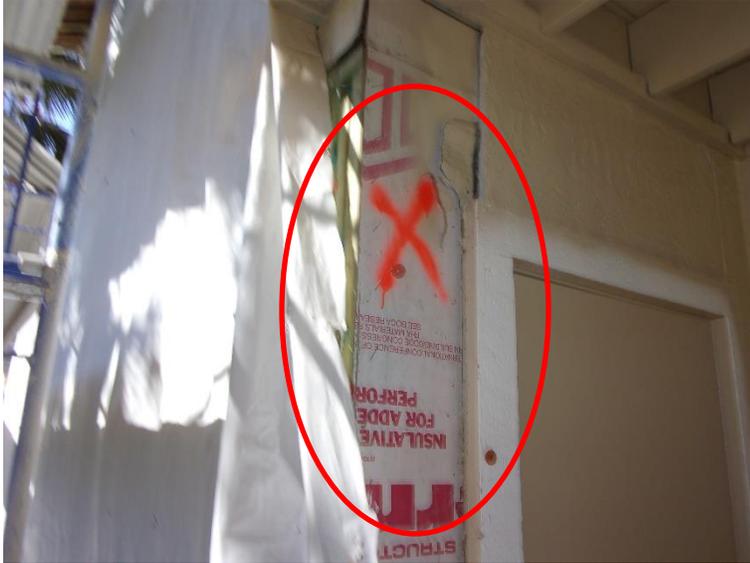
**PHOTOGRAPH #7**

**BUILDING 1  
SECTION F**

Existing Thermo-Ply sheathing marked for removal.

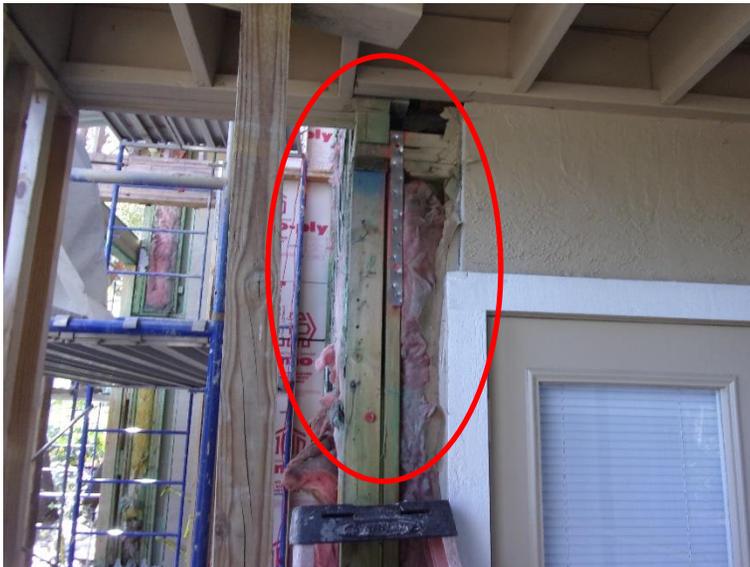
**PHOTOGRAPH #8**

**BUILDING 1  
SECTION F**

Thermo-Ply sheathing removed and strapping attached were marked.

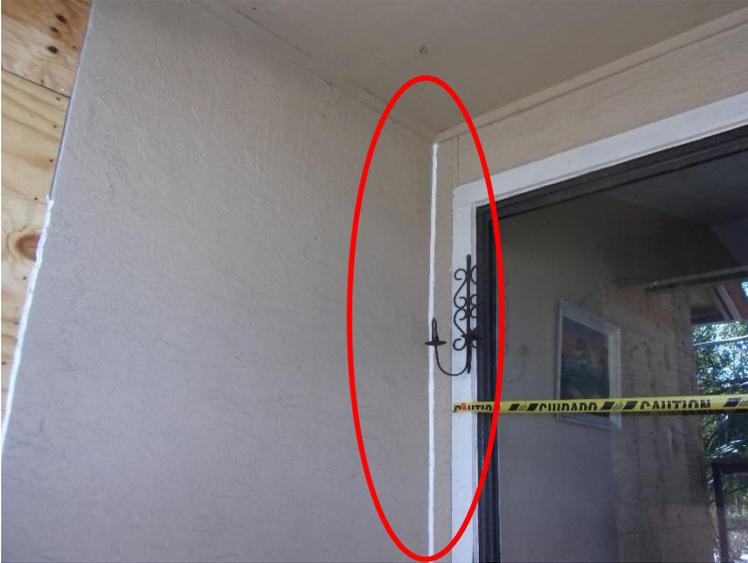
**PHOTOGRAPH #9**

**BUILDING 1  
SECTION F**

New sealants applied at inside corners and transitions prior to repainting at balconies and patios.

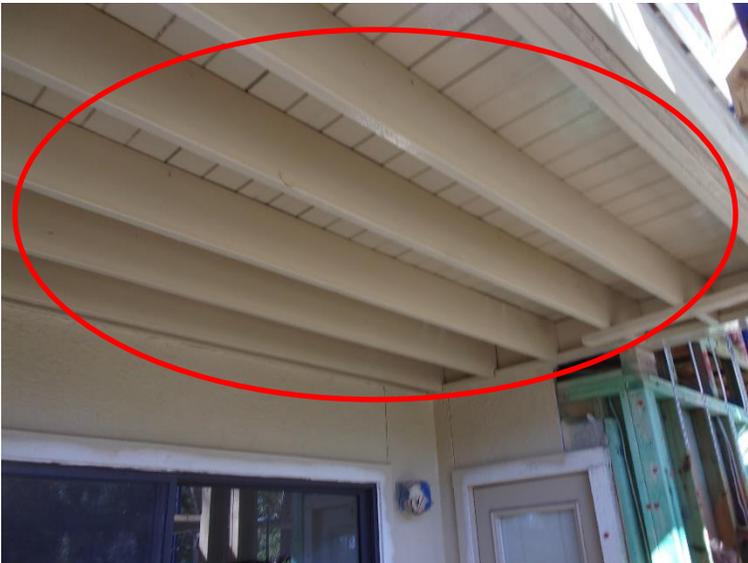
**PHOTOGRAPH #10**

**BUILDING 1  
SECTION F**

Finish painting in progress at patio and balcony ceiling surfaces.

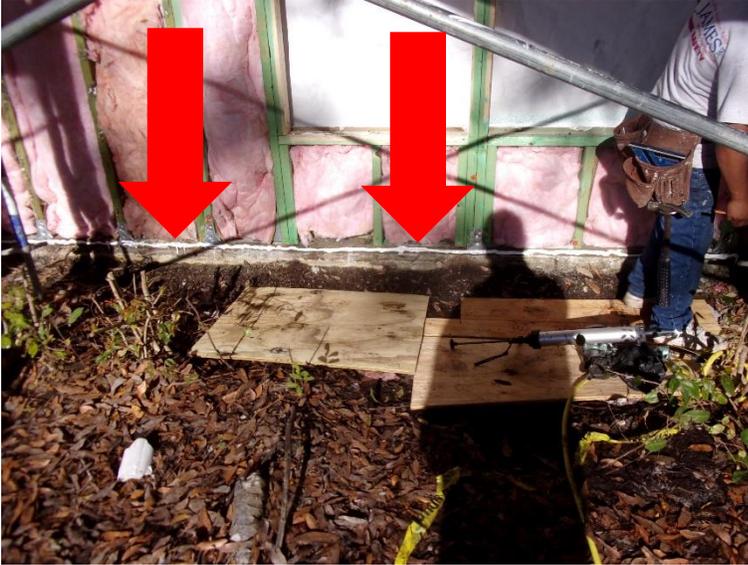
**PHOTOGRAPH #13**

**BUILDING 1  
SECTION F**

Urethane sealant applied at base plate to concrete footing prior to application of new sheathing.

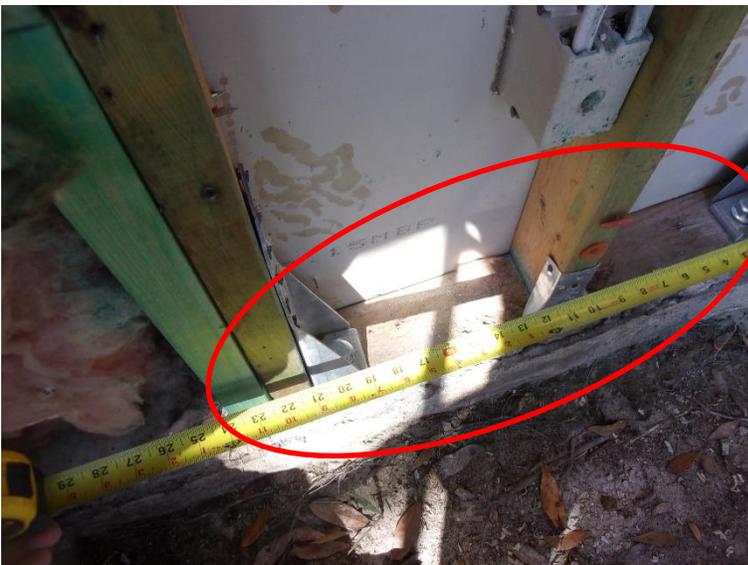
**PHOTOGRAPH #14**

**BUILDING 1  
SECTION F**

Titen HD anchors and Simpson Strong - Tie connectors installed as required by drawings and specifications.

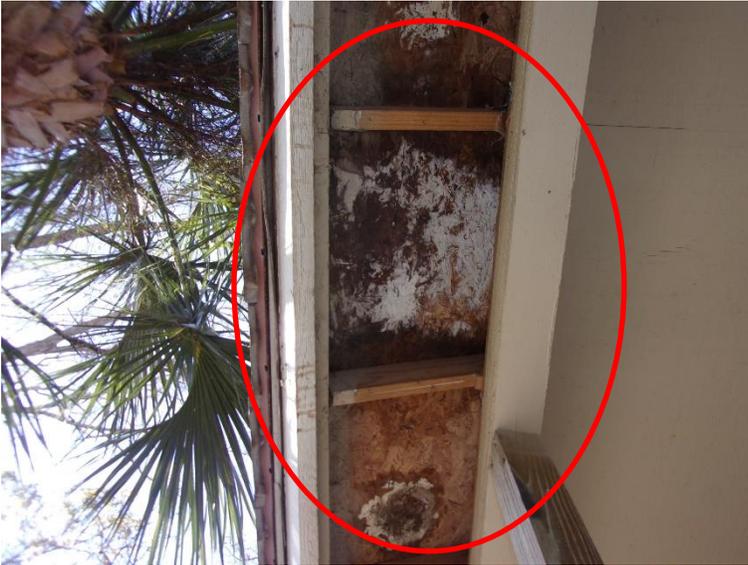
**PHOTOGRAPH #15**

**BUILDING 1  
SECTION F**

Roof sheathing damage exposed. Active leaks observed at several locations. Owners roofing contractor to do repairs.

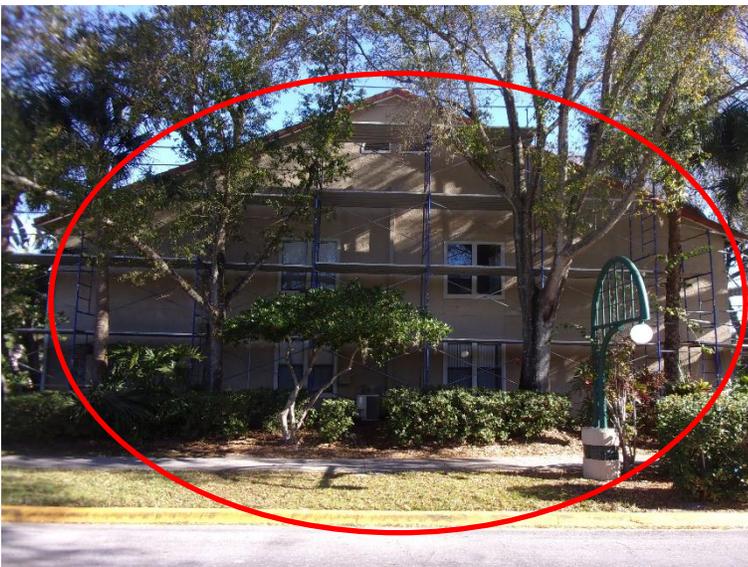
**PHOTOGRAPH #16**

**BUILDING 1  
SECTION D**

Erection of access scaffolding in progress.

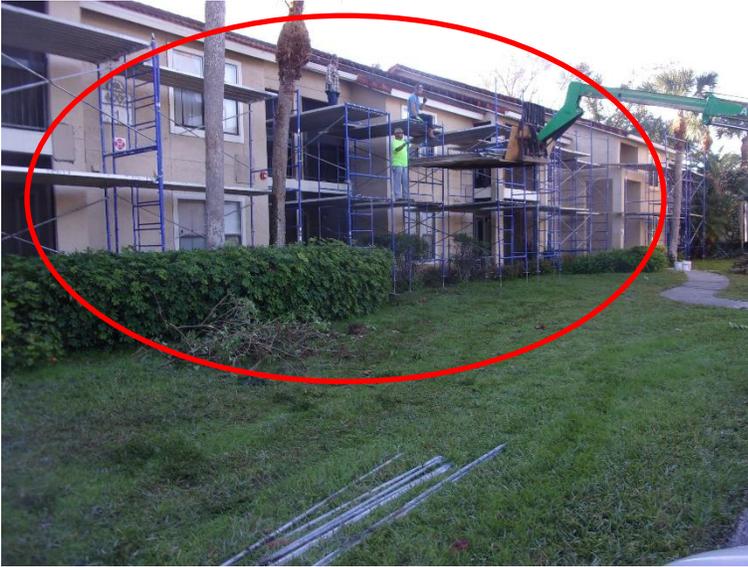
**PHOTOGRAPH #17**

**BUILDING 1  
SECTION B**

Erection of access scaffolding in progress.
