PHOTOGRAPHS

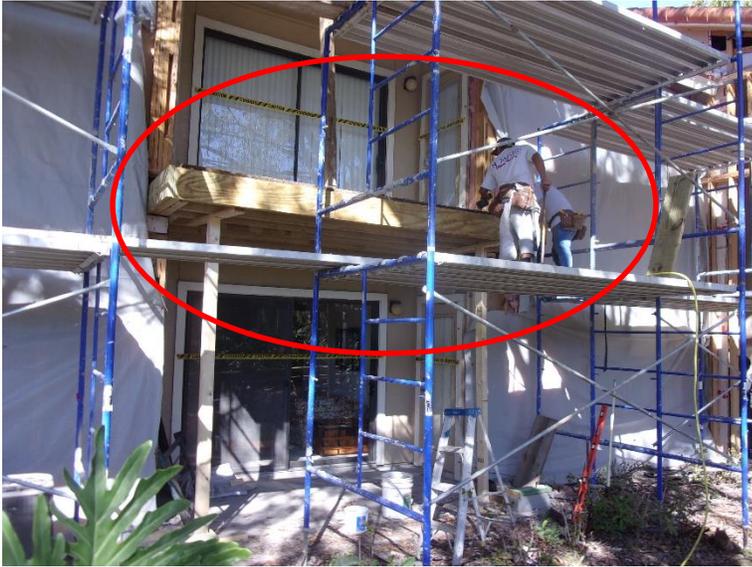
PHOTOGRAPH #1

BUILDING 1 SECTION F

Type C1A balcony repairs have begun on built up beams and columns.

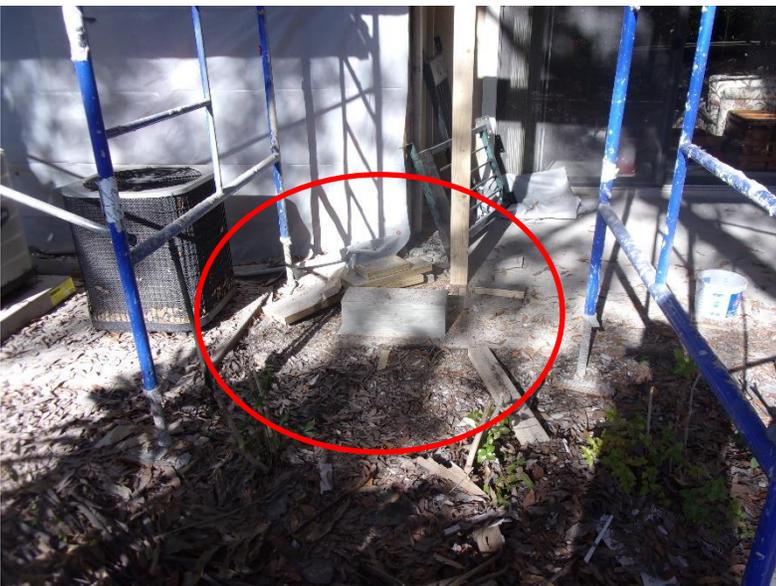
PHOTOGRAPH #2

BUILDING 1 SECTION F

Balcony column concrete curbs have been poured in place.

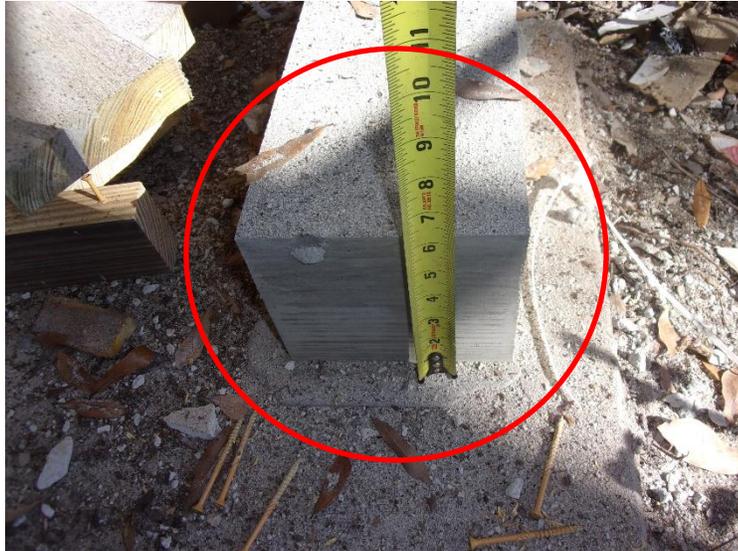
PHOTOGRAPH #3

**BUILDING 1
SECTION F**

Balcony column concrete curbs have been poured in place.

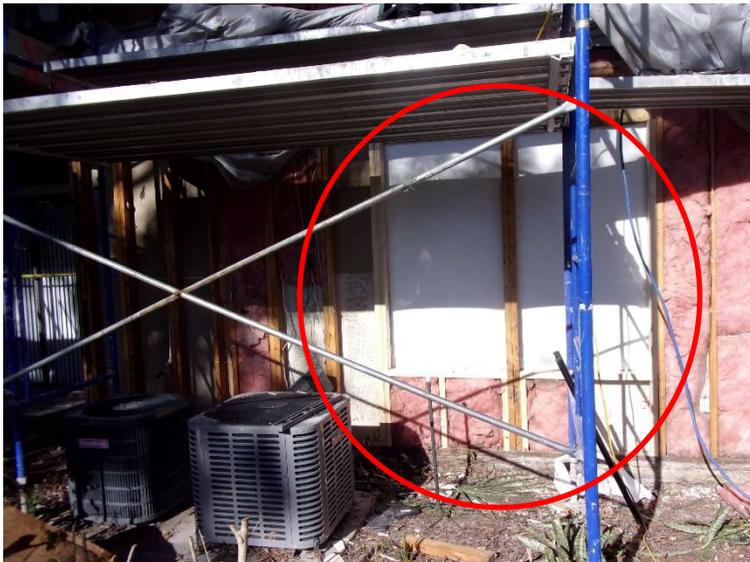
PHOTOGRAPH #4

**BUILDING 1
SECTION F**

Wood framing repairs have begun at wall studs, window openings and headers.

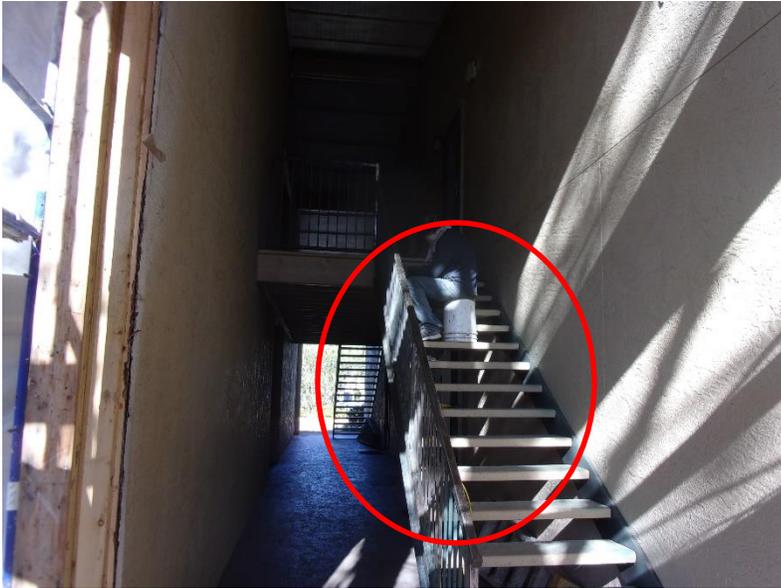
PHOTOGRAPH #5

**BUILDING 1
SECTION G**

Stairway railing preparation in progress. Removing all rust and previous coatings by hand grinding.

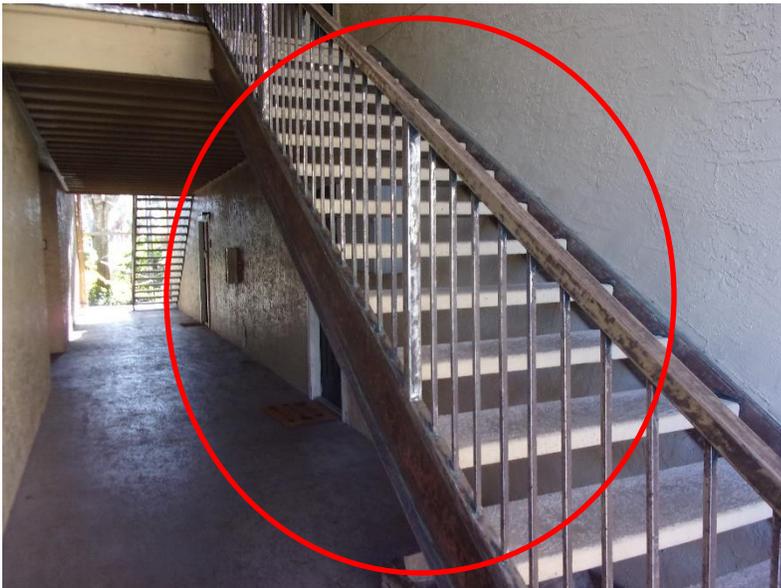
PHOTOGRAPH #6

**BUILDING 1
SECTION G**

Stairway railing preparation in progress. Removing all rust and previous coatings by hand grinding.

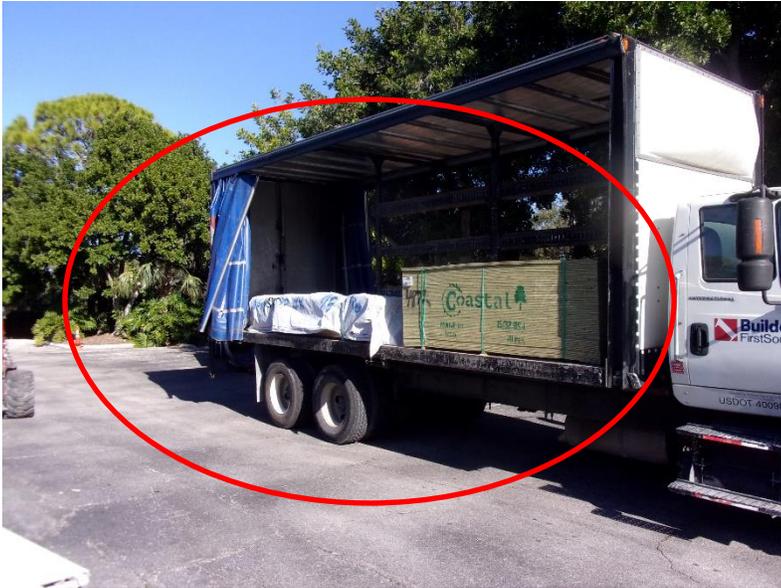
PHOTOGRAPH #7

**BUILDING 1
STORAGE AREA**

New yellow pine lumber and plywood sheathing delivered for repairs.
