## PHOTOGRAPHS

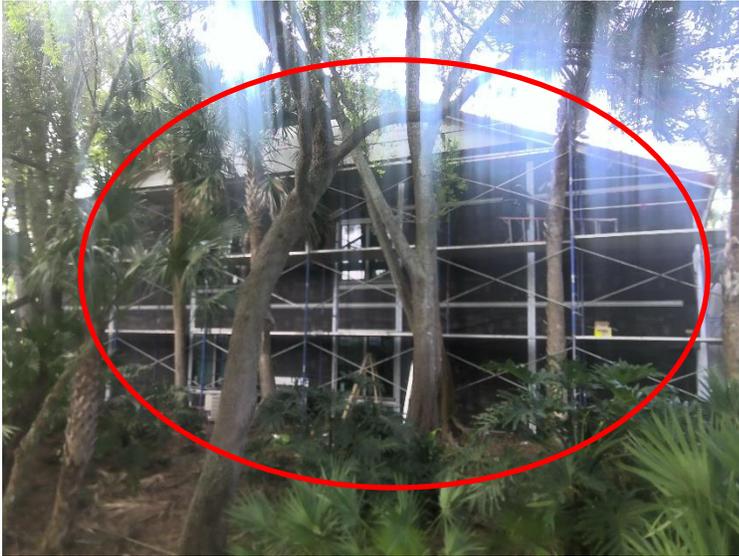
**PHOTOGRAPH #1**

### **BUILDING 1 SECTION H**

Stucco sub-contractor has installed second water resistant barrier and begun installing stucco accessories.

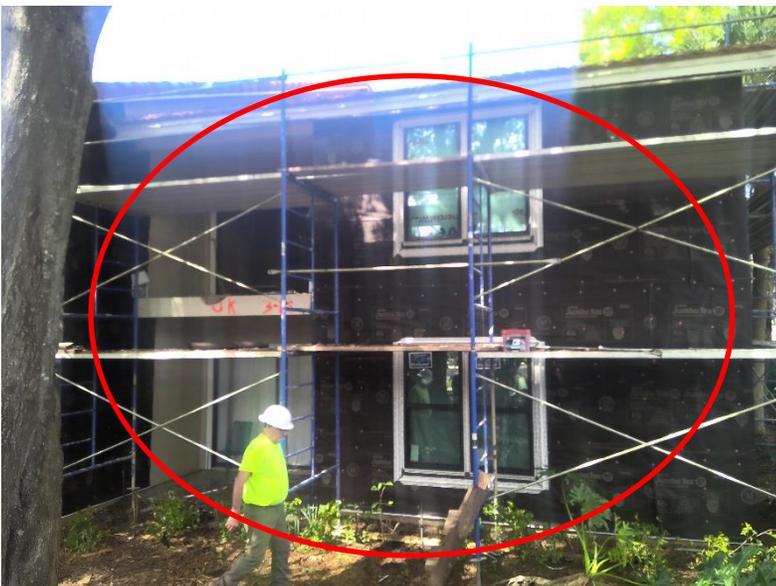
**PHOTOGRAPH #2**

### **BUILDING 1 SECTION G**

Stucco sub-contractor has installed second water resistant barrier and begun installing stucco accessories.

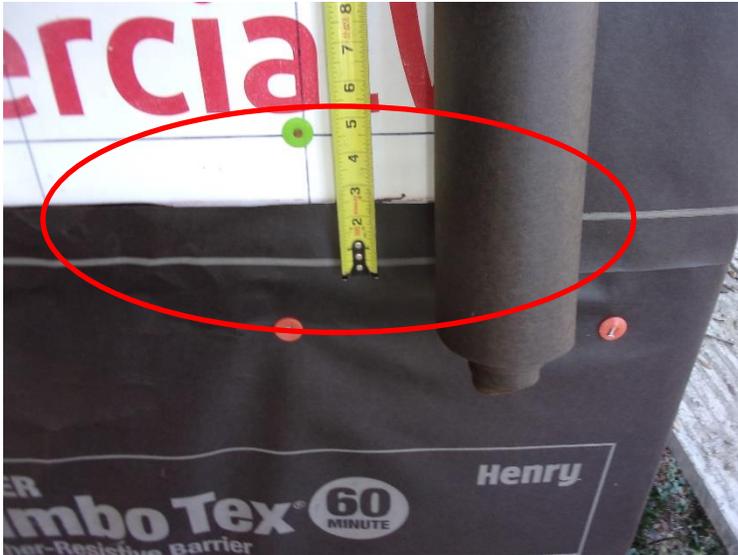
**PHOTOGRAPH #3**

**BUILDING 1  
SECTION G**

Proper overlapping of second water resistant barrier with Jumbo Tex 60.

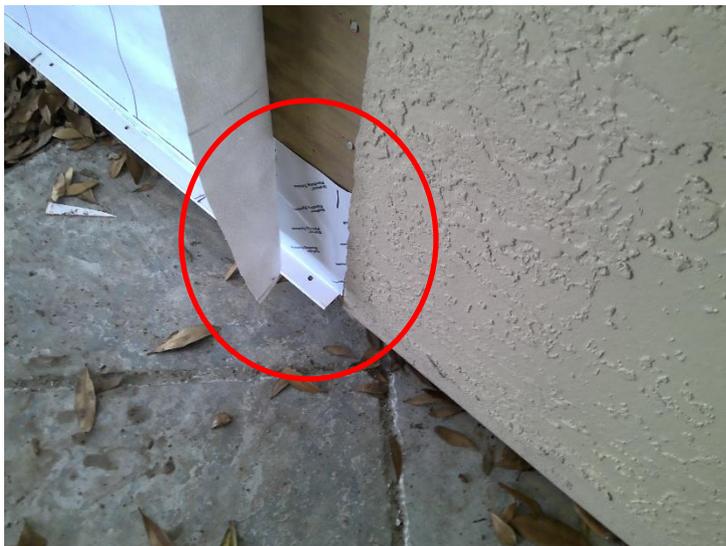
**PHOTOGRAPH #4**

**BUILDING 1  
SECTION F**

Dupont straight flashing applied at weep accessory to plywood sheathing prior to lapping over with Tyvek Wrap.

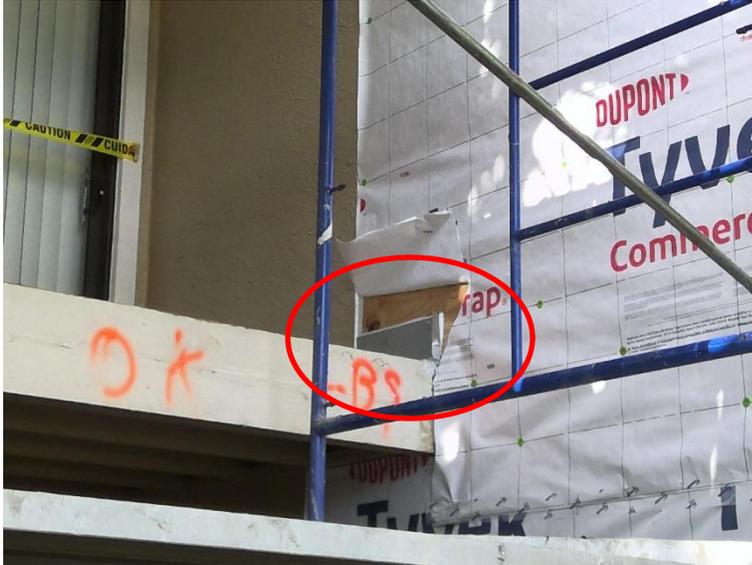
**PHOTOGRAPH #5**

**BUILDING 1  
SECTION E**

Contractor has installed and sealed kick out flashings with urethane sealants at balcony decks.

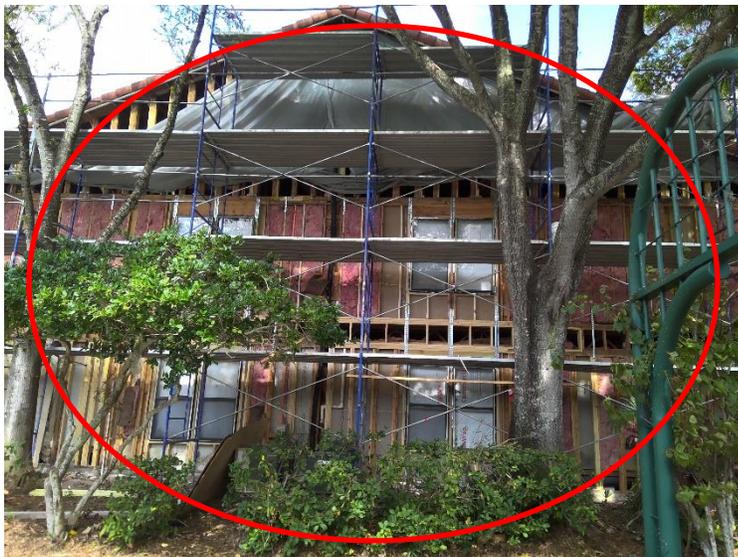
**PHOTOGRAPH #6**

**BUILDING 1  
SECTION D**

Framing repairs competed and Simpson Strong - Tie connectors installed.

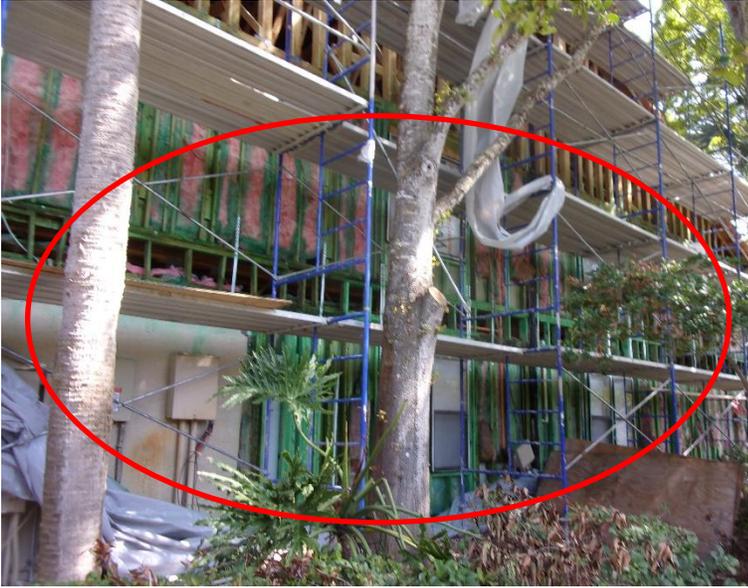
**PHOTOGRAPH #7**

**BUILDING 1  
SECTION D**

Termite contractor applying Bora Care termite treatment at wall framing.

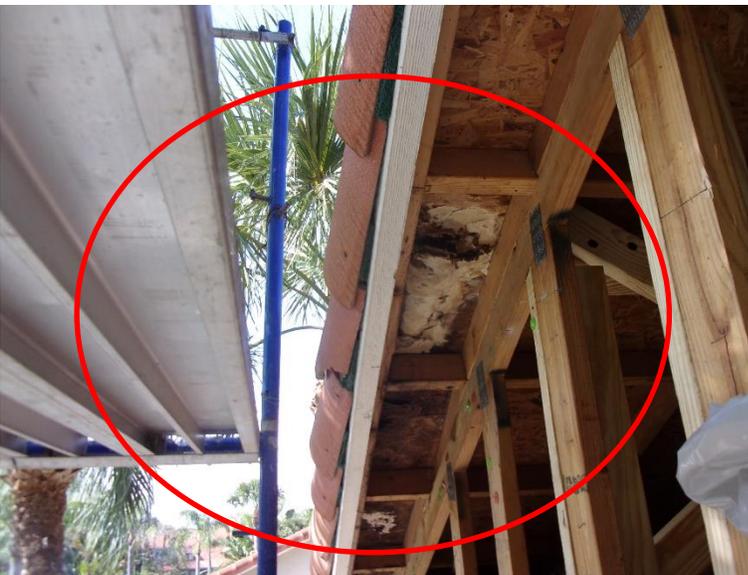
**PHOTOGRAPH #8**

**BUILDING 1  
SECTION D**

Roof sheathing damage exposed to be repaired by owners roofing contractor.

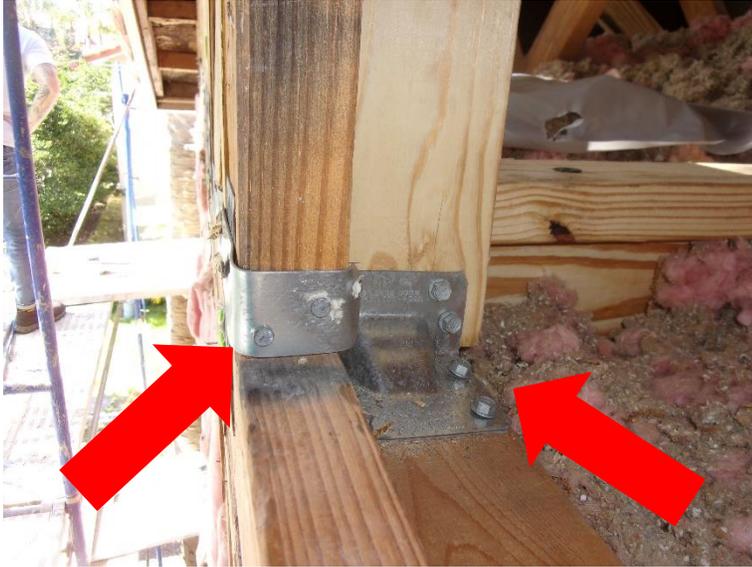
**PHOTOGRAPH #9**

**BUILDING 1  
SECTION D**

Simpson Strong-Tie connectors installed at gable end reinforcement repairs.

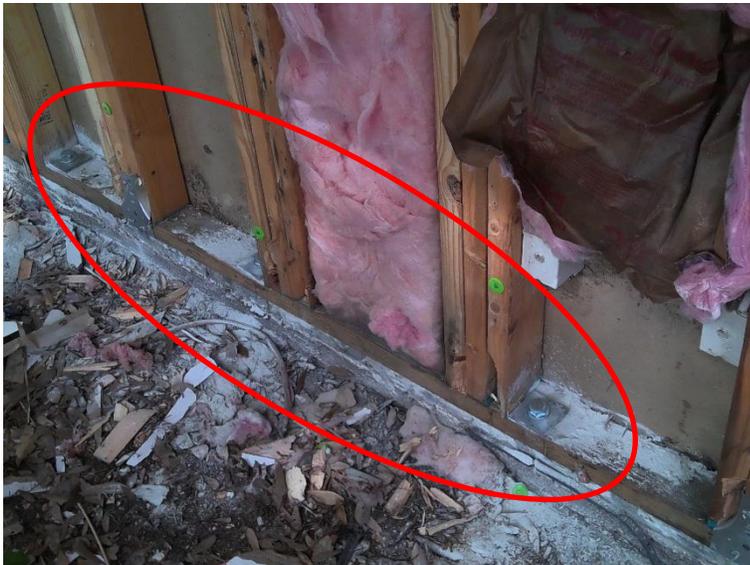
**PHOTOGRAPH #10**

**BUILDING 1  
SECTION D**

Simpson 5/8" Titen HD anchors installed at bottom plate.

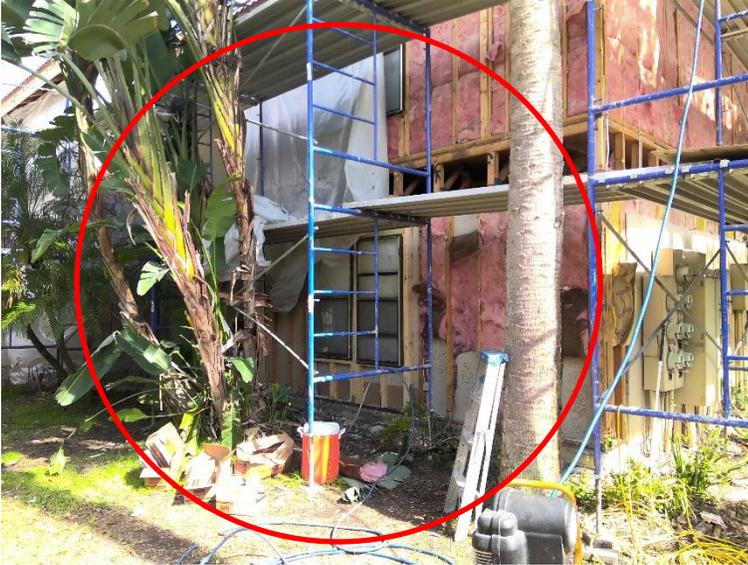
**PHOTOGRAPH #11**

**BUILDING 1  
SECTION C**

Framing repairs in place at window headers, window frames, plates, and studs.

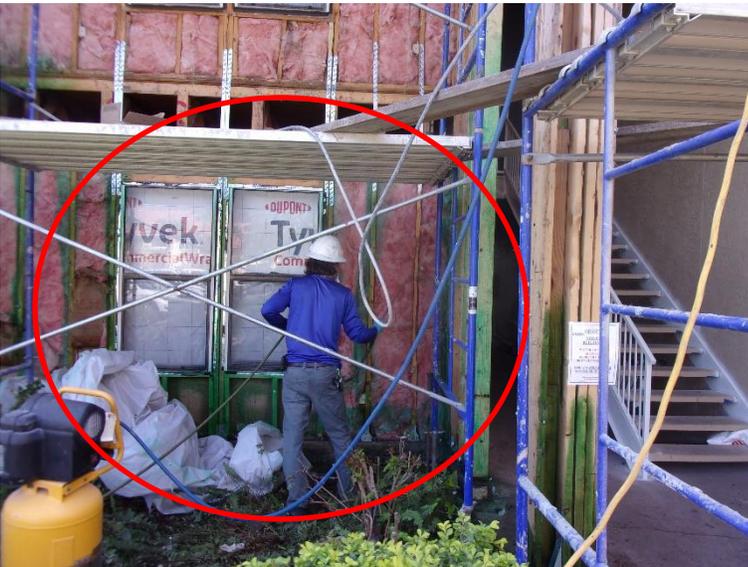
**PHOTOGRAPH #12**

**BUILDING 1  
SECTION B**

Termite contractor applying Bora Care termite treatment at wall framing.

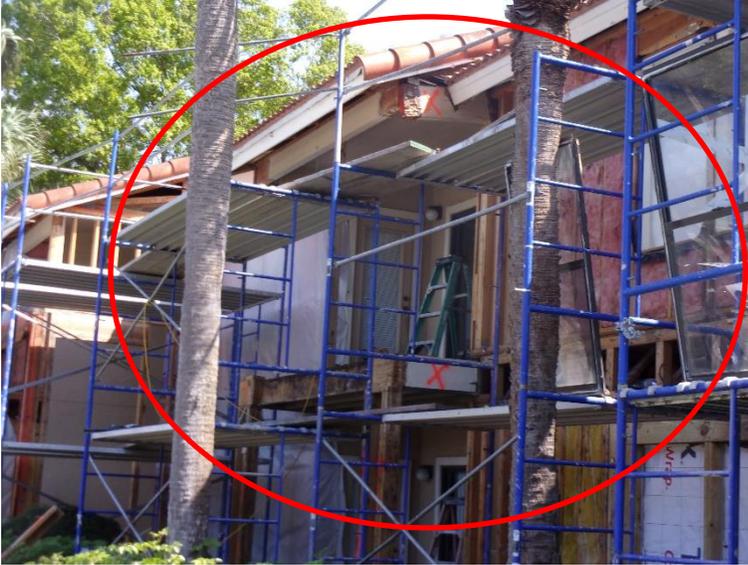
**PHOTOGRAPH #13**

**BUILDING 1  
SECTION B**

Balcony and framing repairs in progress.

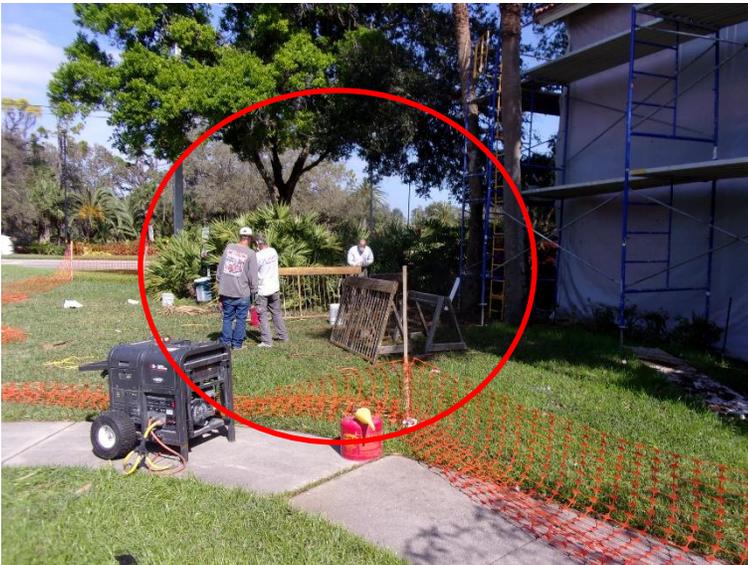
**PHOTOGRAPH #14**

**BUILDING 1  
SECTION A**

Balcony railing preparation for painting in progress.
